MIDLAND UNITS 1 & 2
JOB NO. 7220

REVIEW OF U.S. TESTING
FIELD AND LABORATORY CONSTRUCTION
TEST DATA ON SOILS USED AS FILL

PREPARED BY
BECHTEL POWER CORPORATION
JUNE 12, 1979

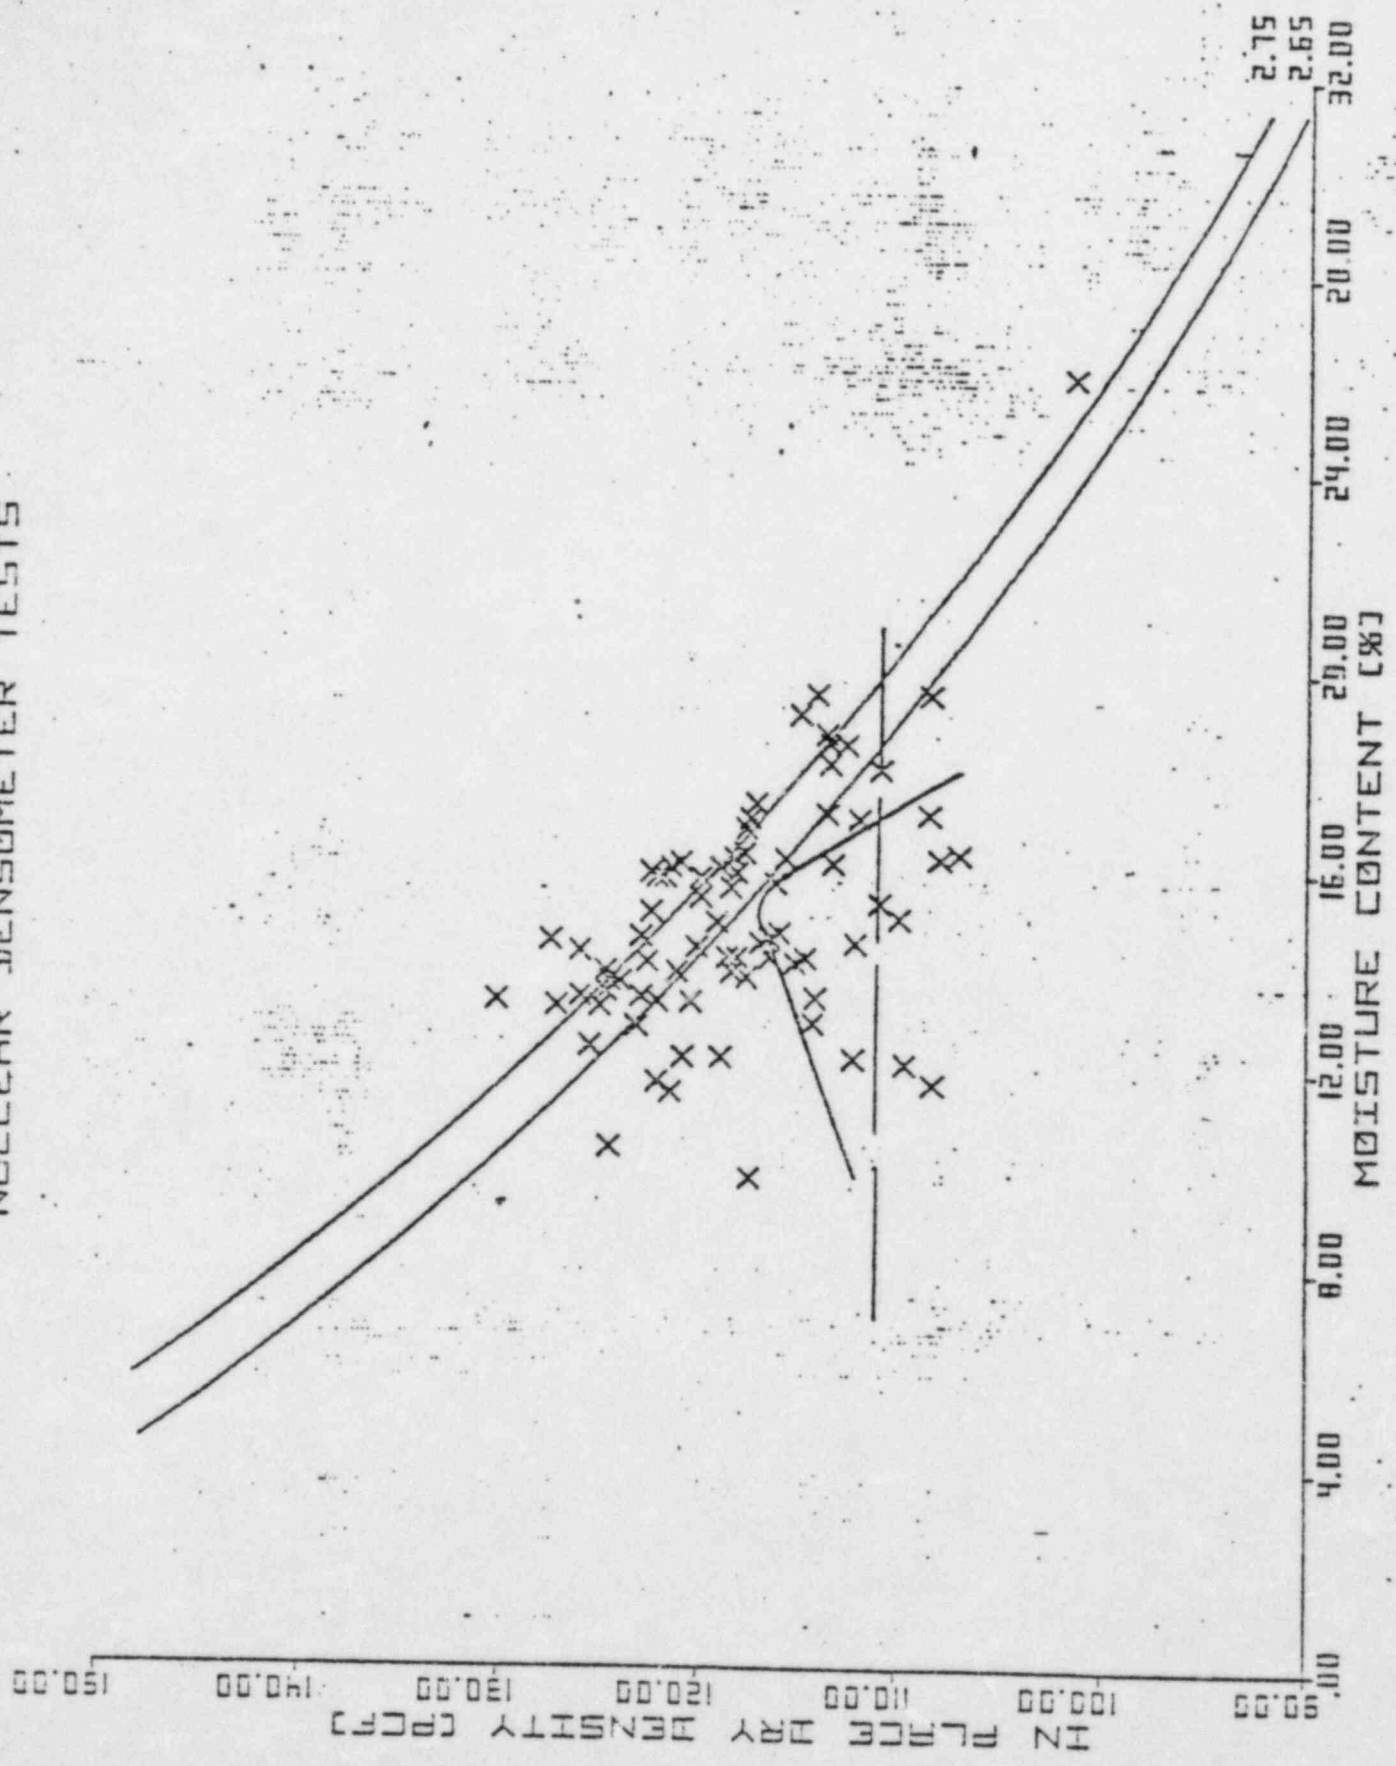
FIG. 3

on figures 2 through 6. The title of each figure gives the assumptions made in plotting data for that figure. In comparing figures 3 and 4 it is seen that a majority of field tests were made using the nuclear device. The two test results shown on figure 4 for the sand cone method indicates one test result on each side of the zero air voids curve. Ironically, the one falling above the zero air voids curve (shown on figure 4) is designated as the only passing sand cone test (shown on figure 6) by U-S Testing Company.

MOISTURE-DENSITY FOR BNP 278
 SPECIFIC GRAVITY = 2.65
 NUCLEAR DENSOMETER TESTS

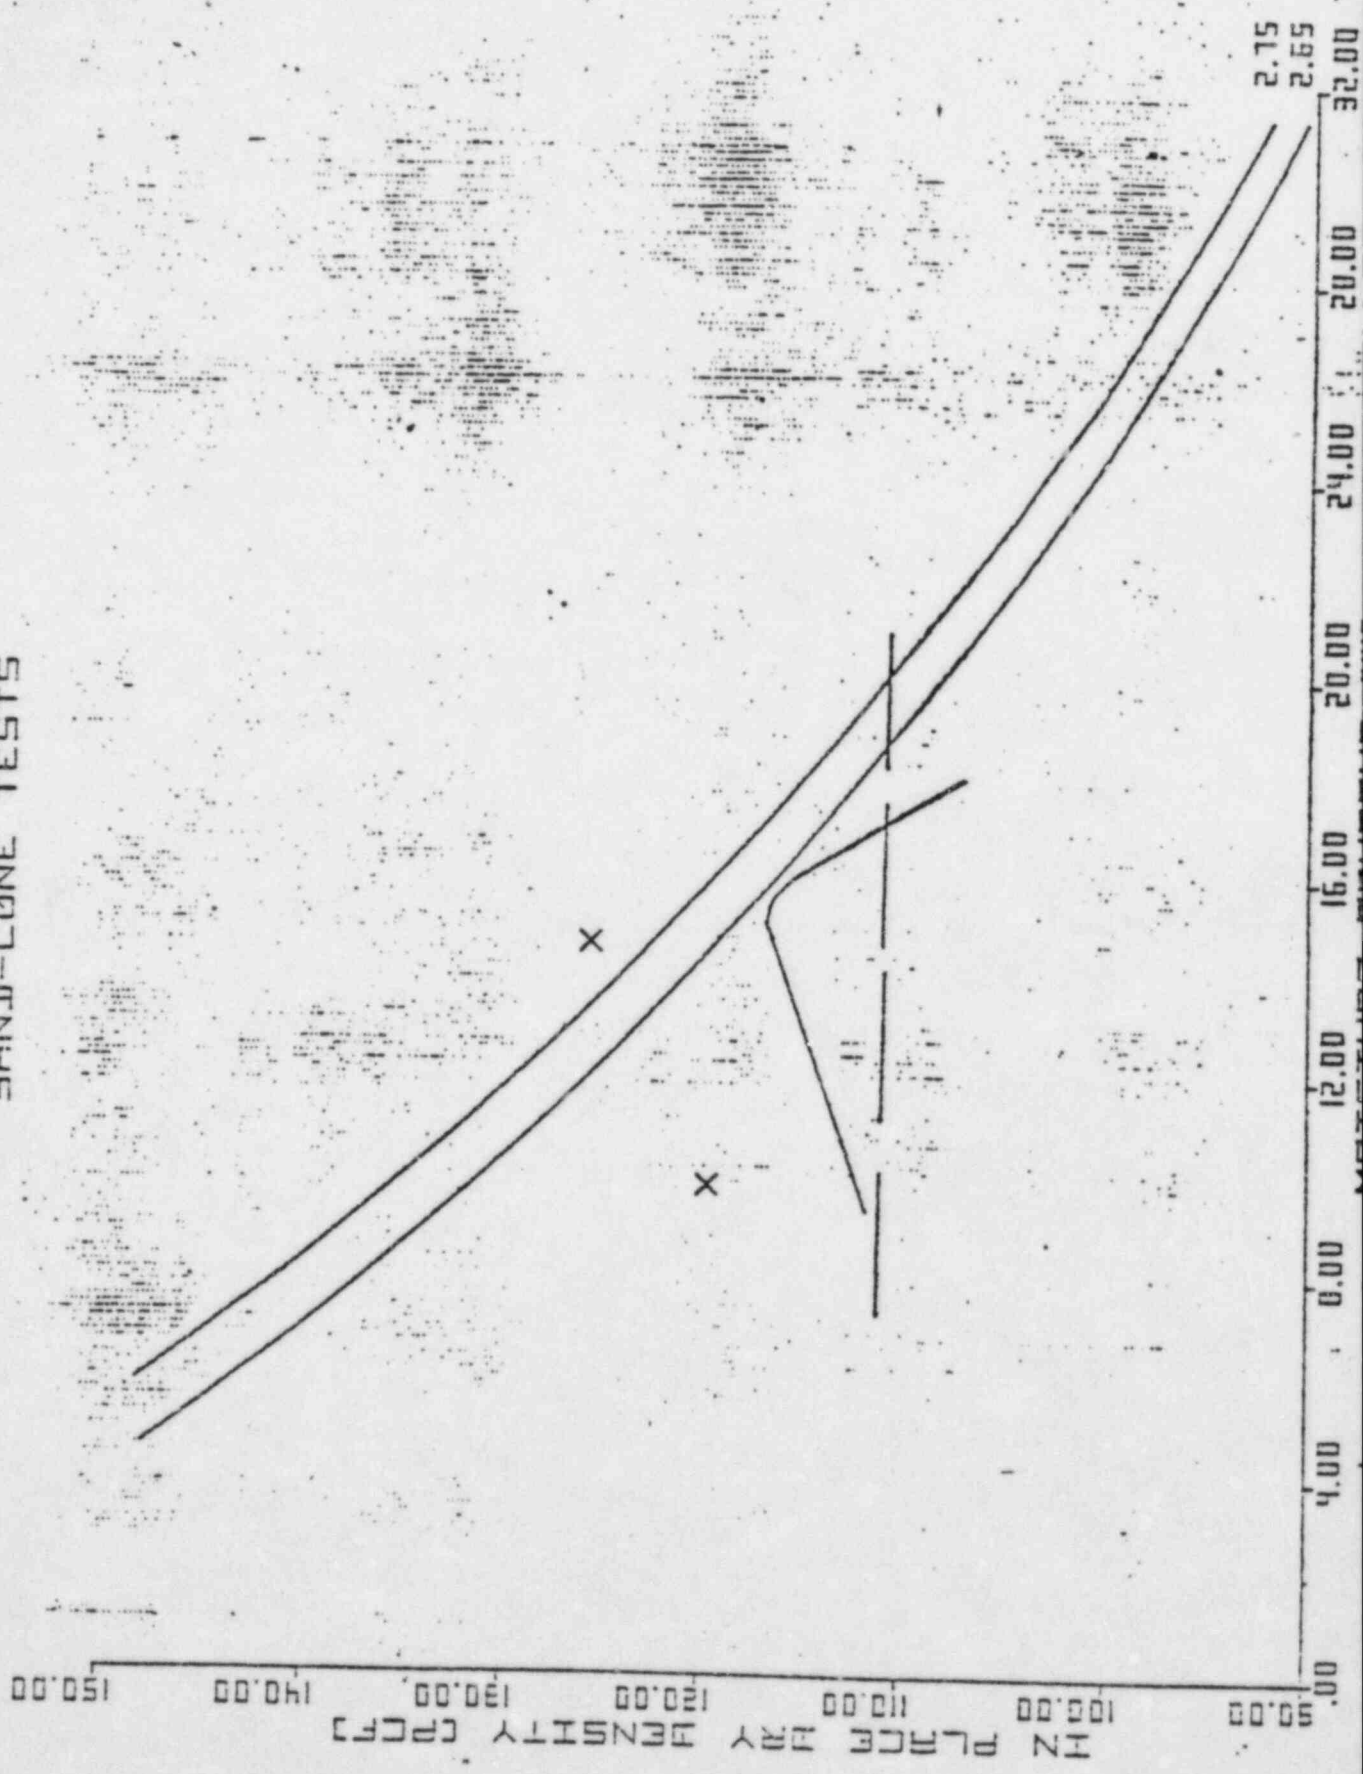
FIG 4

MOISTURE-DENSITY FOR BMP 278
 SPECIFIC GRAVITY = 2.65
 SAND-CONE TESTS

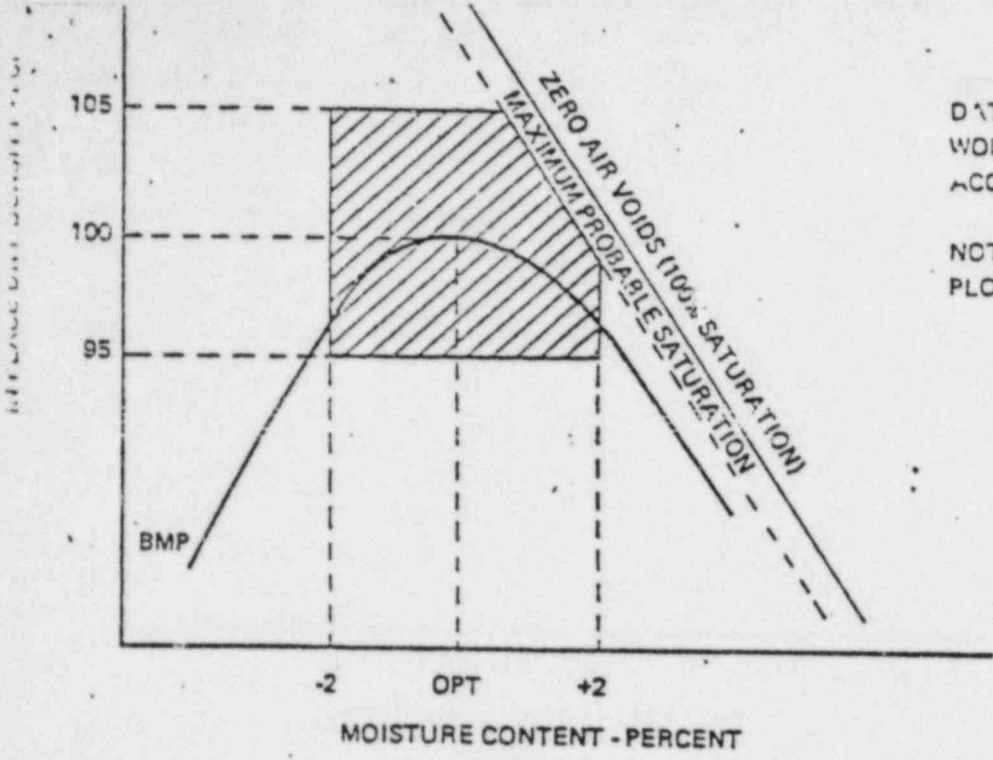
FIGURE 7-A-

DATA POINTS THAT PLOT IN SHADED AREA WOULD BE GENERALLY ACCEPTABLE ACCORDING TO SPECIFICATIONS

NOTE: ABOUT 25% OF ALL FIELD DATA PLOTS IN THE SHADED AREA

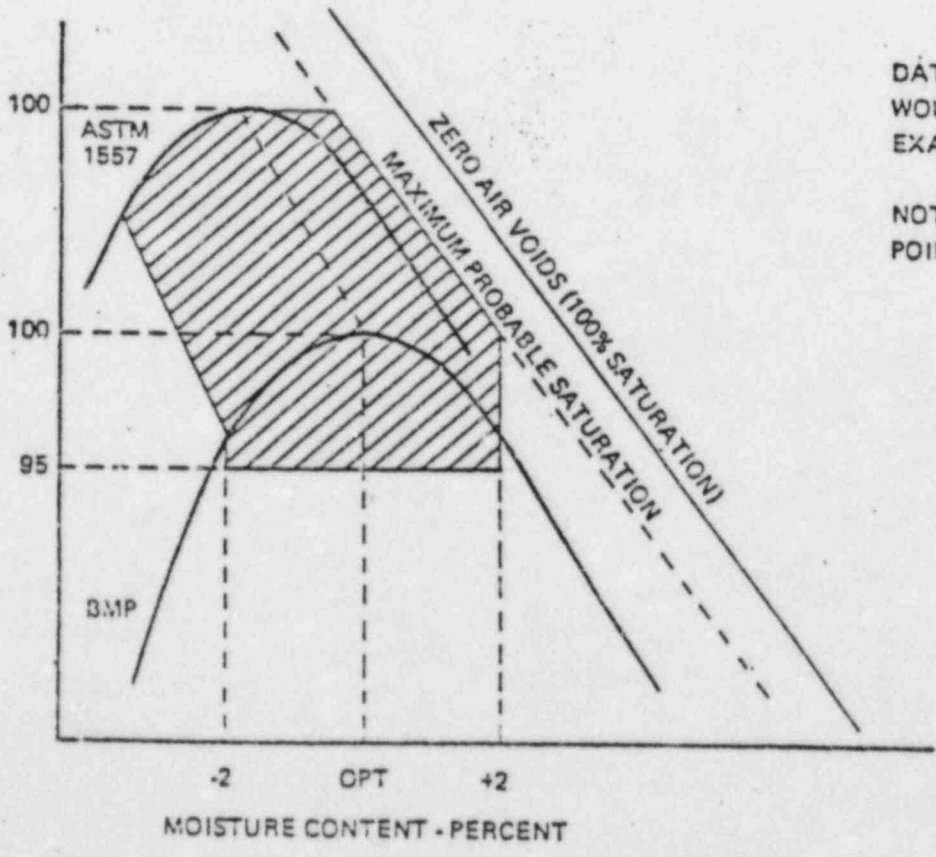
DATA POINTS THAT PLOT IN SHADED AREA WOULD BE ACCEPTABLE REGARDLESS OF EXACT SPECIFICATION WORDING

NOTE: ABOUT 40% OF ALL FIELD DATA POINTS PLOT IN THE SHADED AREA

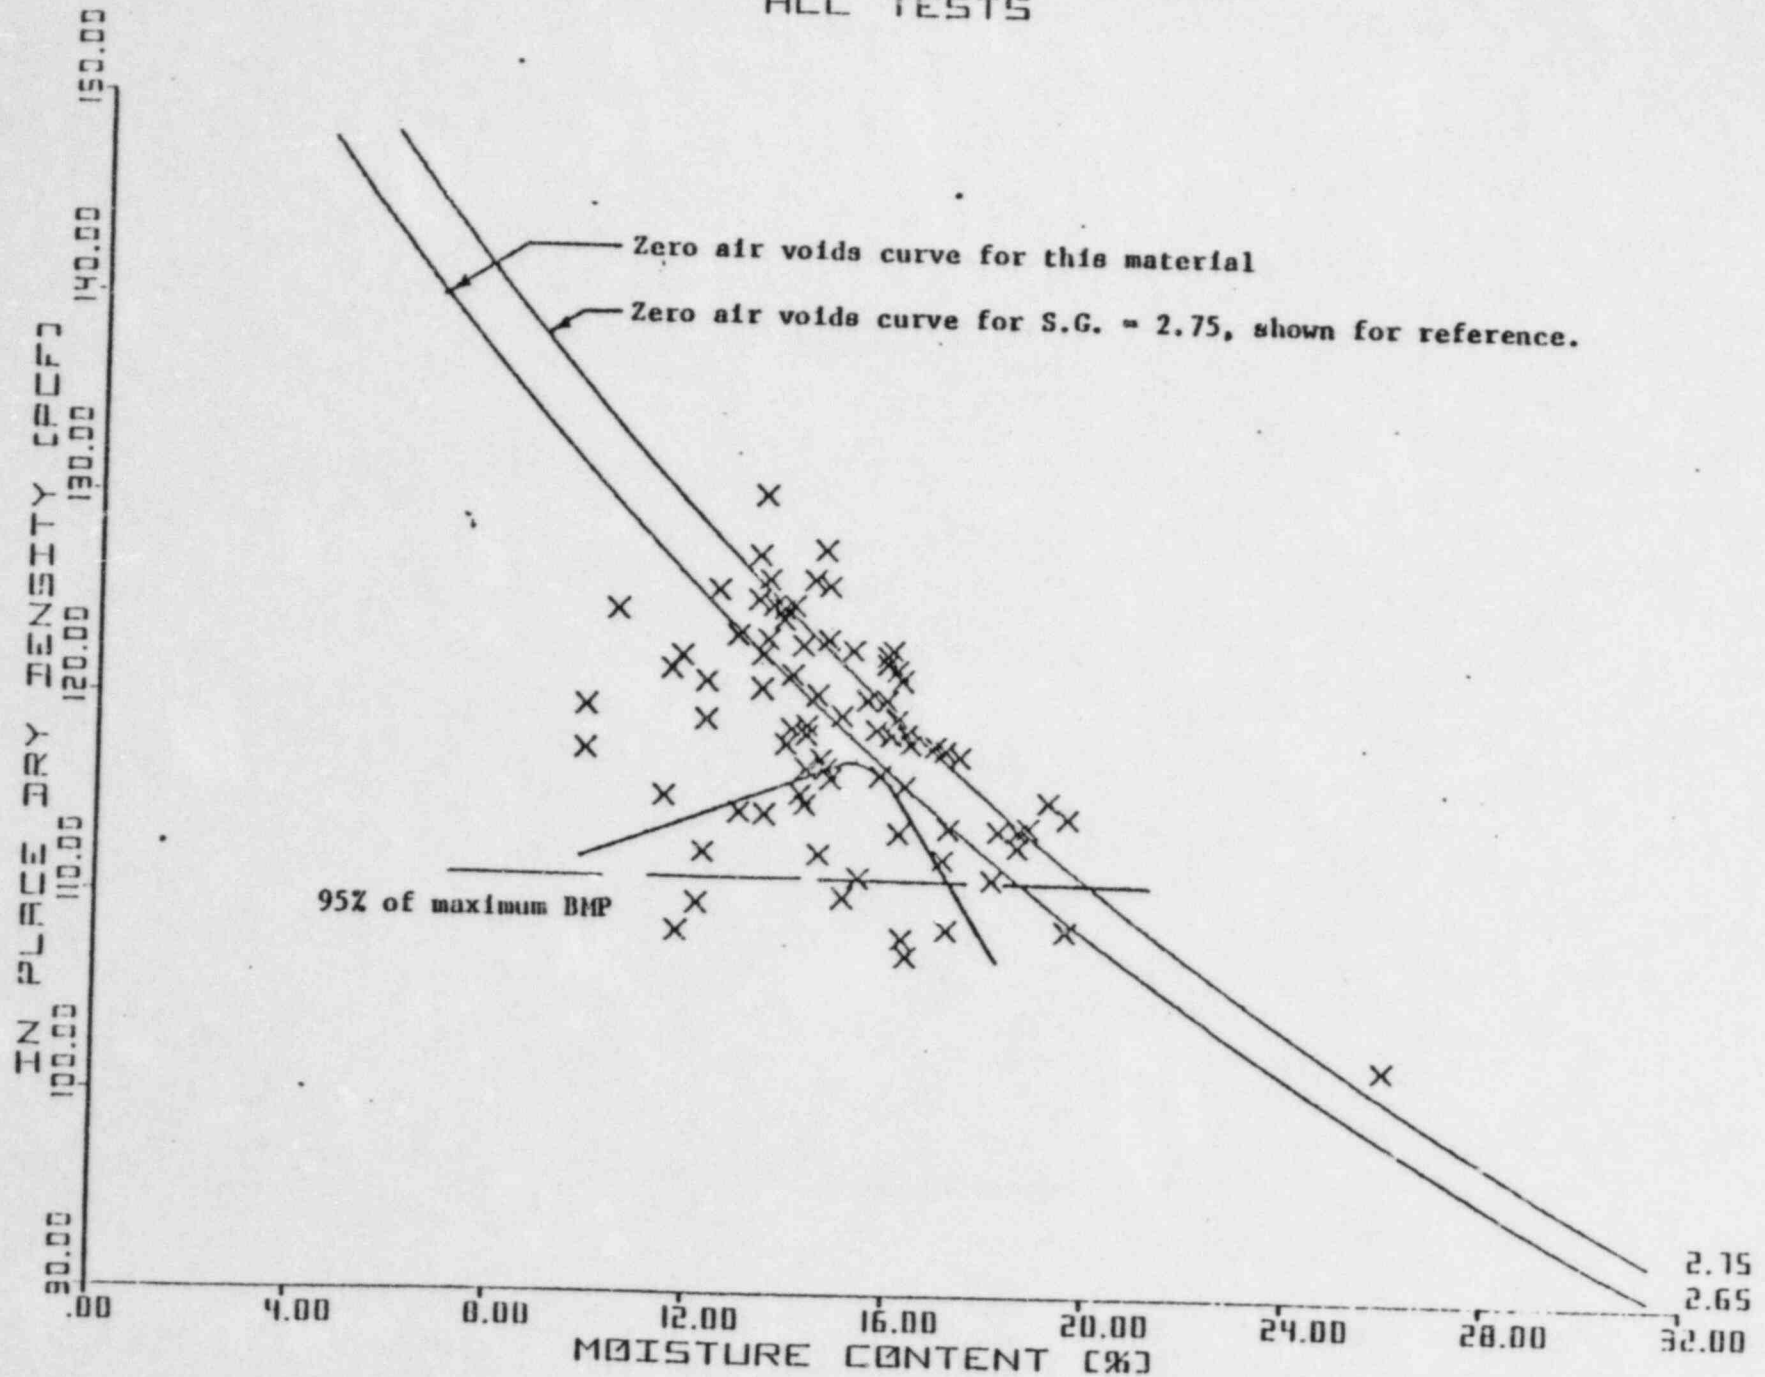
FIGURE 1

Also, referring to Figure 1 it would appear that soil density varied widely. Specifications called for compactive effort results as defined by ASTM D 1557 which is 56,255 ft-lb/ft³ energy. This was modified to a laboratory test compactive effort of about 20,000 ft-lbs/ft³ energy, often referred to as Bechtel Modified Proctor (BMP). Laboratory compaction test curves should be related to the same effort as that called for in the field for use in comparing with field density tests. According to plots of field data shown on Figure 1, density varied from about 108 lbs/ft³ to about 130 lbs/ft³. It is doubtful that the soil classification or other properties would be similar for such a wide variation in density. It is noted that 100 percent of modified Proctor (ASTM D 1557) which is difficult to obtain, is rated at 56,255 ft-lbs/ft³ energy. The curve plotted on Figure 1 is at about 20,000 ft-lbs/ft³ energy. For comparative purposes it was determined by U. S. Testing in 1974 that 100 percent of specified effort (20,000 ft-lbs/ft³) is approximately equal to 95 percent of the maximum density as determined by ASTM D 1557 (56,255 ft-lbs/ft³) Reference Figure 8. This means that a density up to 5 percent greater (dry density of 123.2 lbs/ft³) than that specified (dry density of 117.0 lbs/ft³) could be possible. However, some points shown on Figure 1 give an apparent density up to 11 percent above that specified.

MOISTURE-DENSITY FOR BMP 278

SPECIFIC GRAVITY = 2.65
ALL TESTS

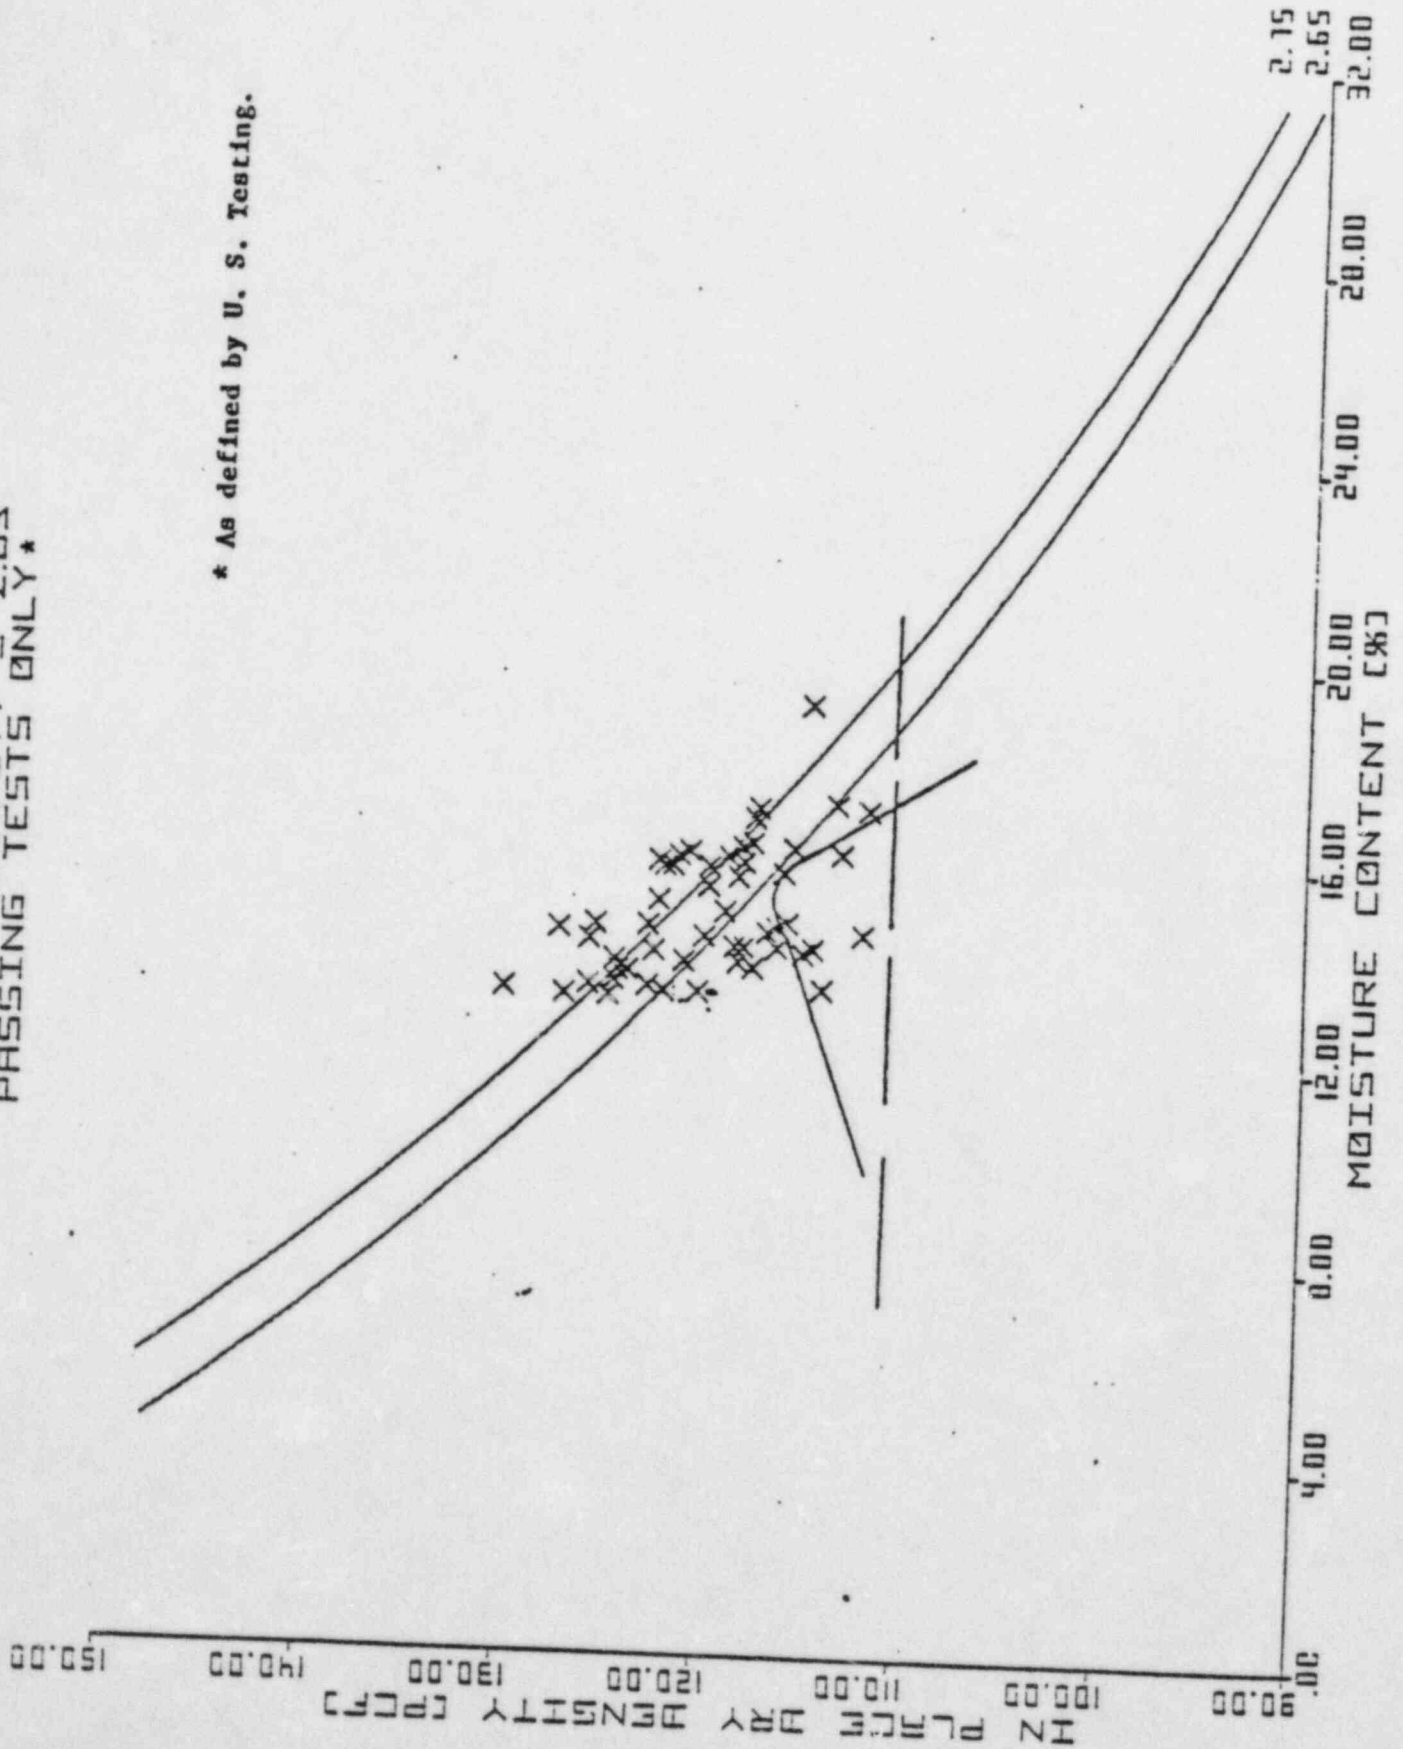
FIGURE 2

MOISTURE-DENSITY FOR BMP 278
 SPECIFIC GRAVITY = 2.65
 PASSING TESTS ONLY*

* As defined by U. S. Testing.

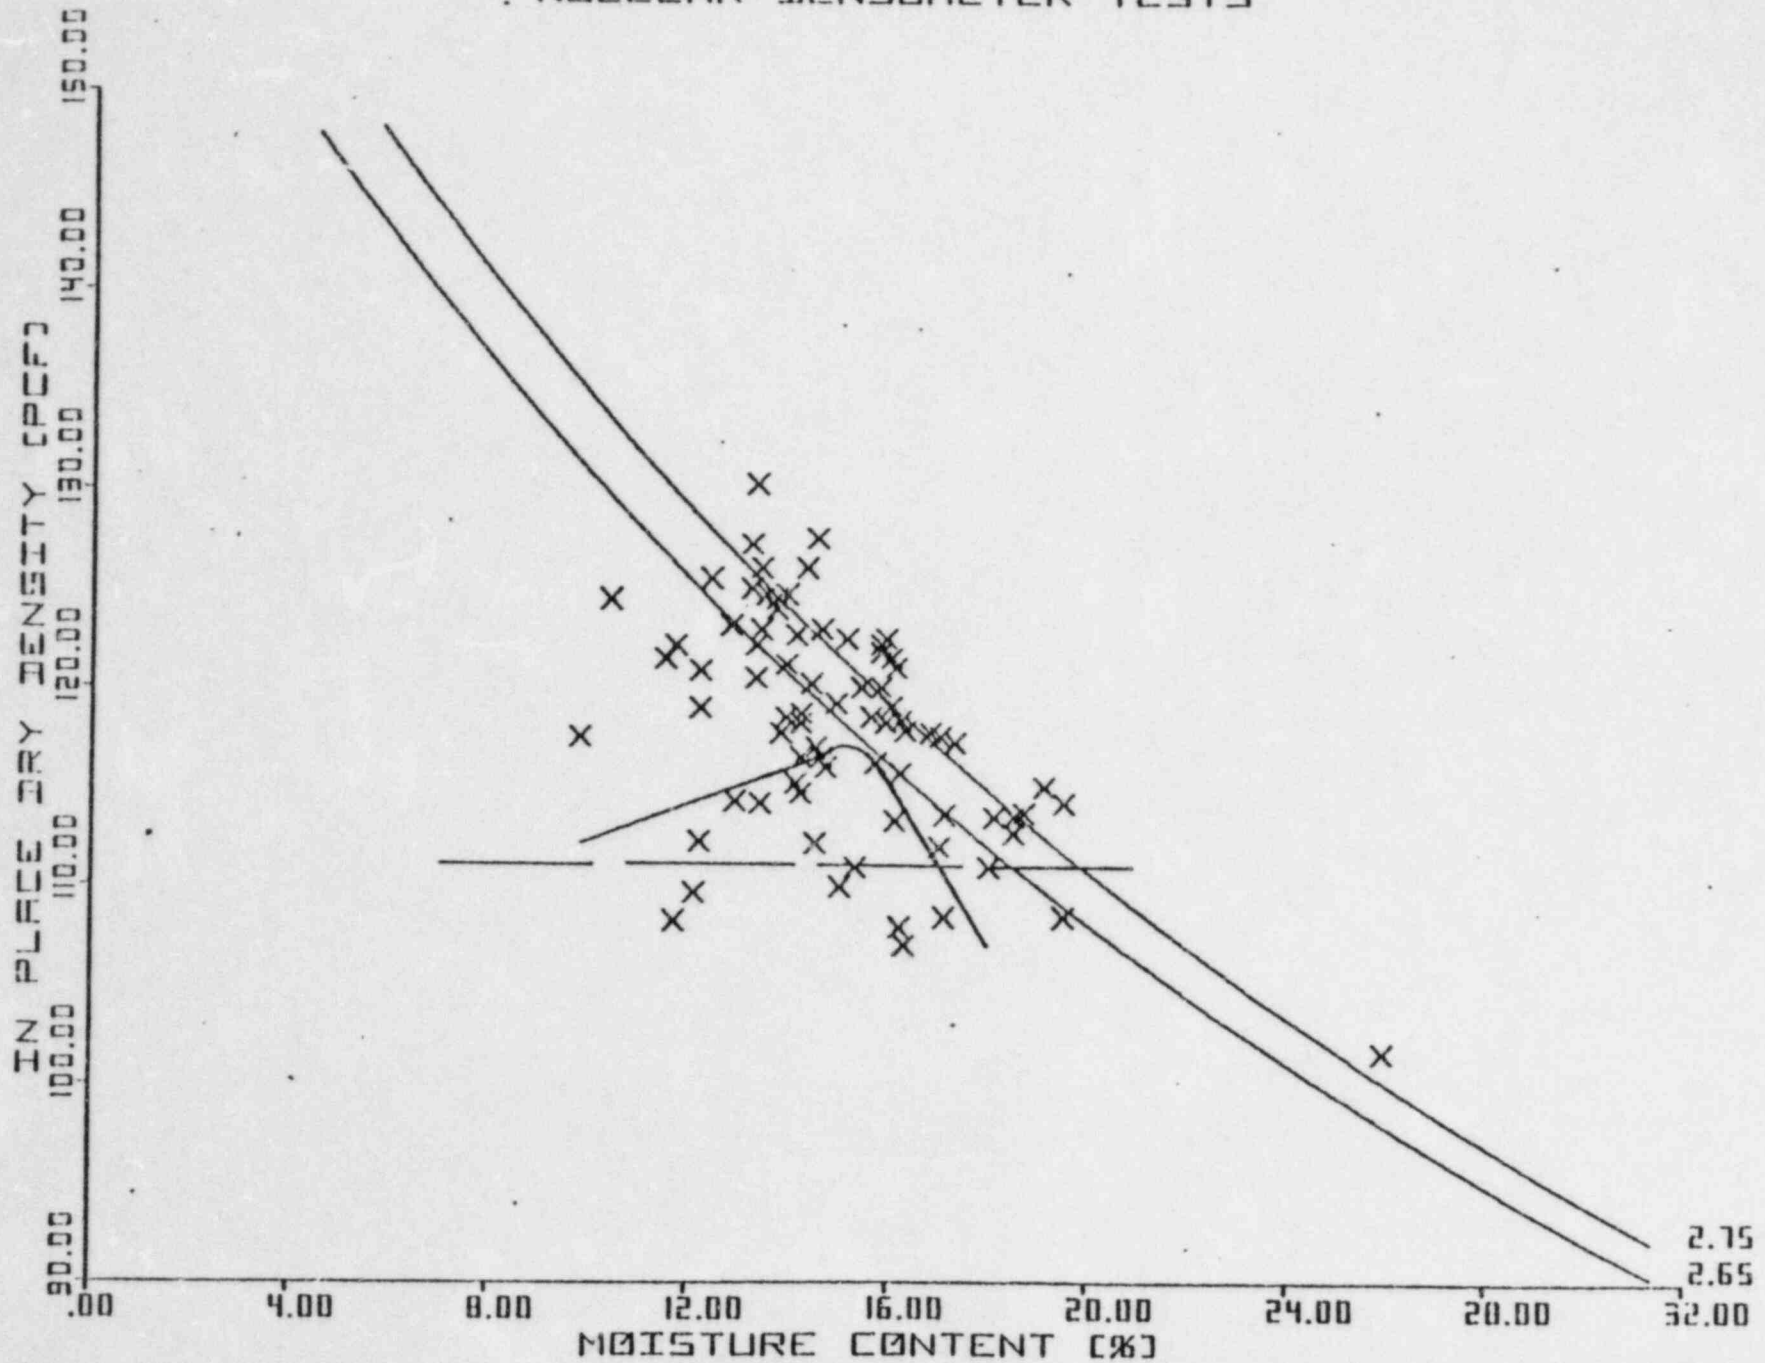
FIGURE 3

MOISTURE-DENSITY FOR BMP 278

SPECIFIC GRAVITY = 2.65
NUCLEAR DENSOMETER TESTS

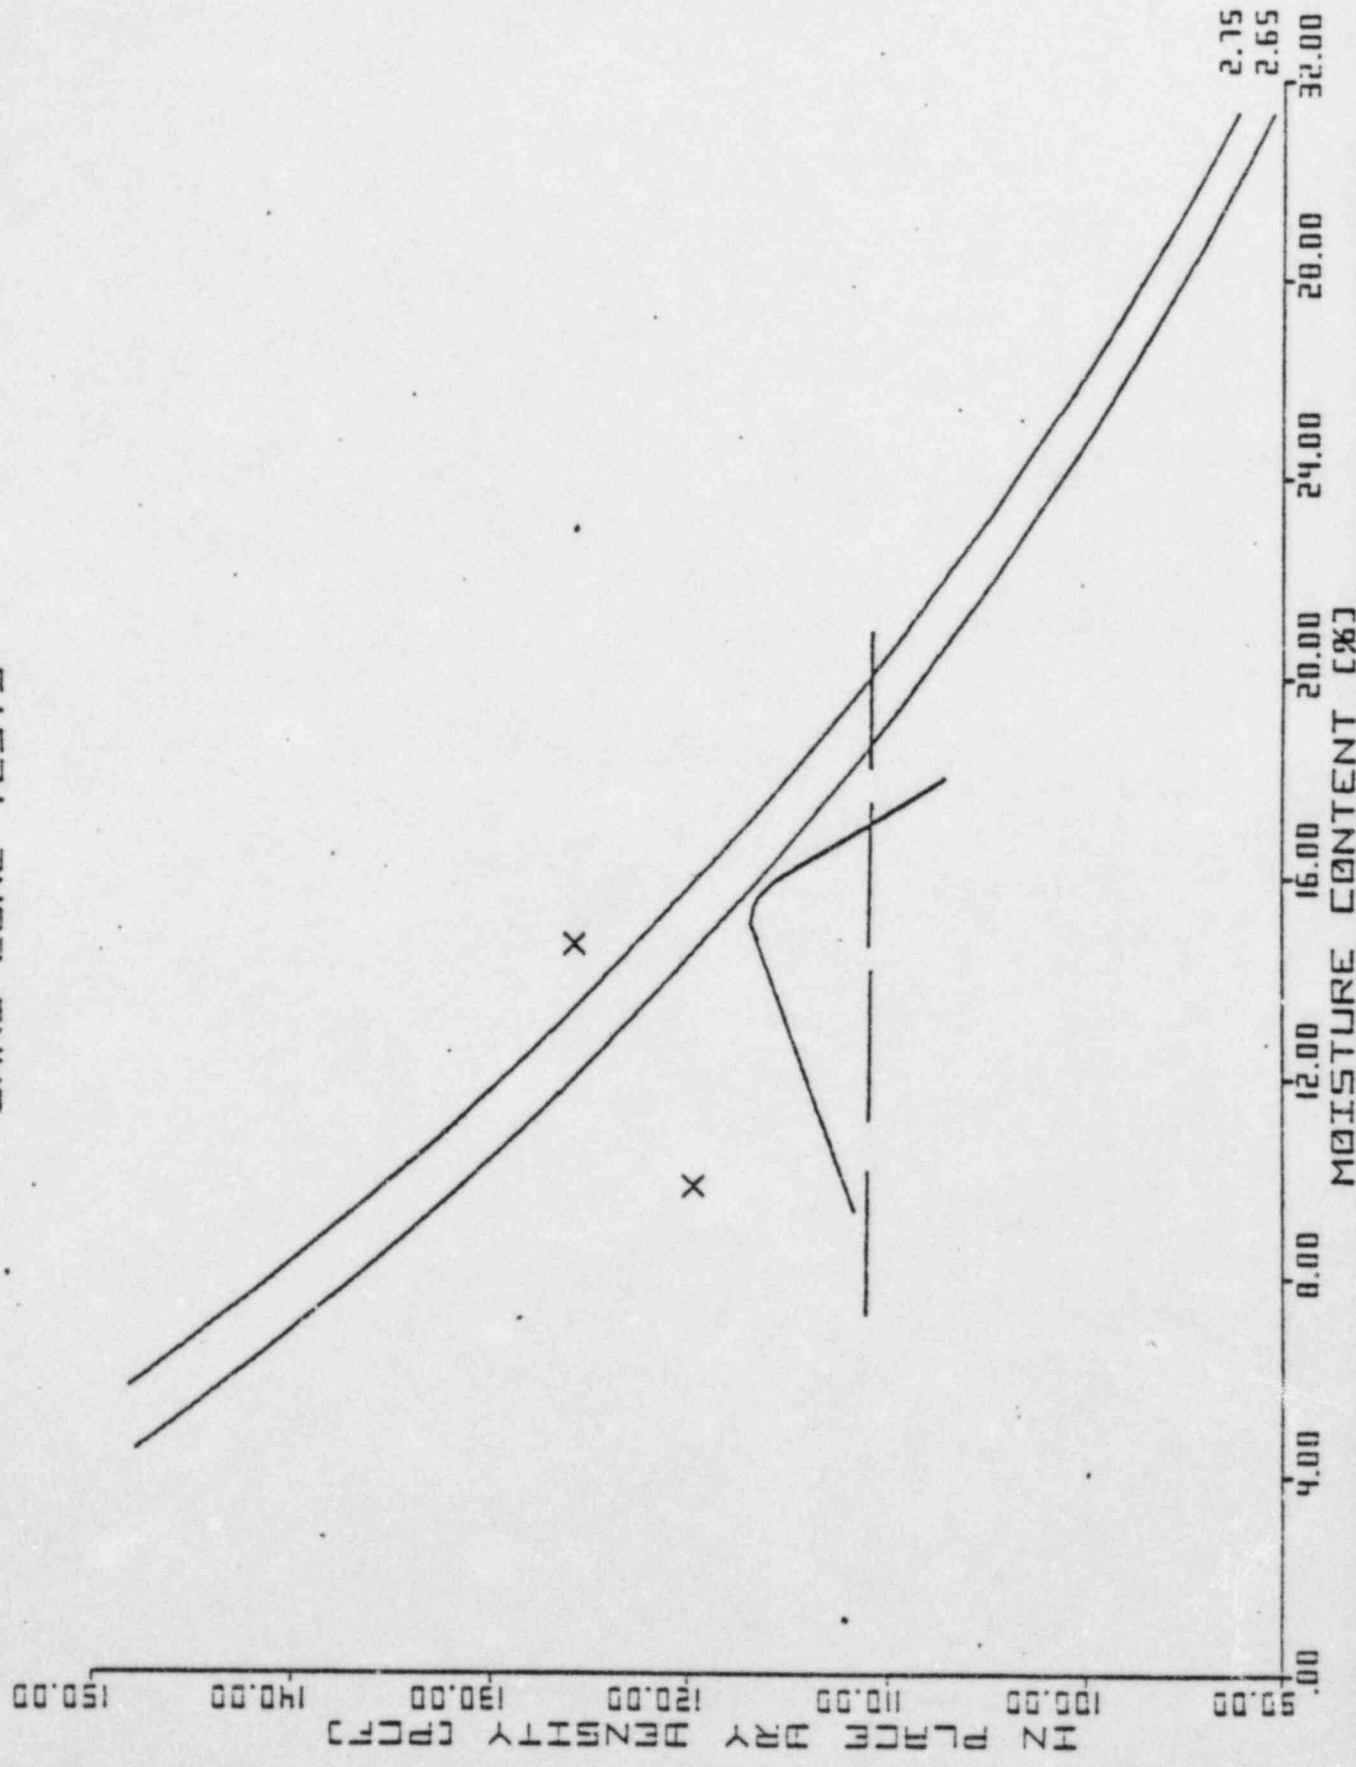
FIGURE 4

MOISTURE-DENSITY FOR BMP 278
 SPECIFIC GRAVITY = 2.65
 SAND-CONE TESTS

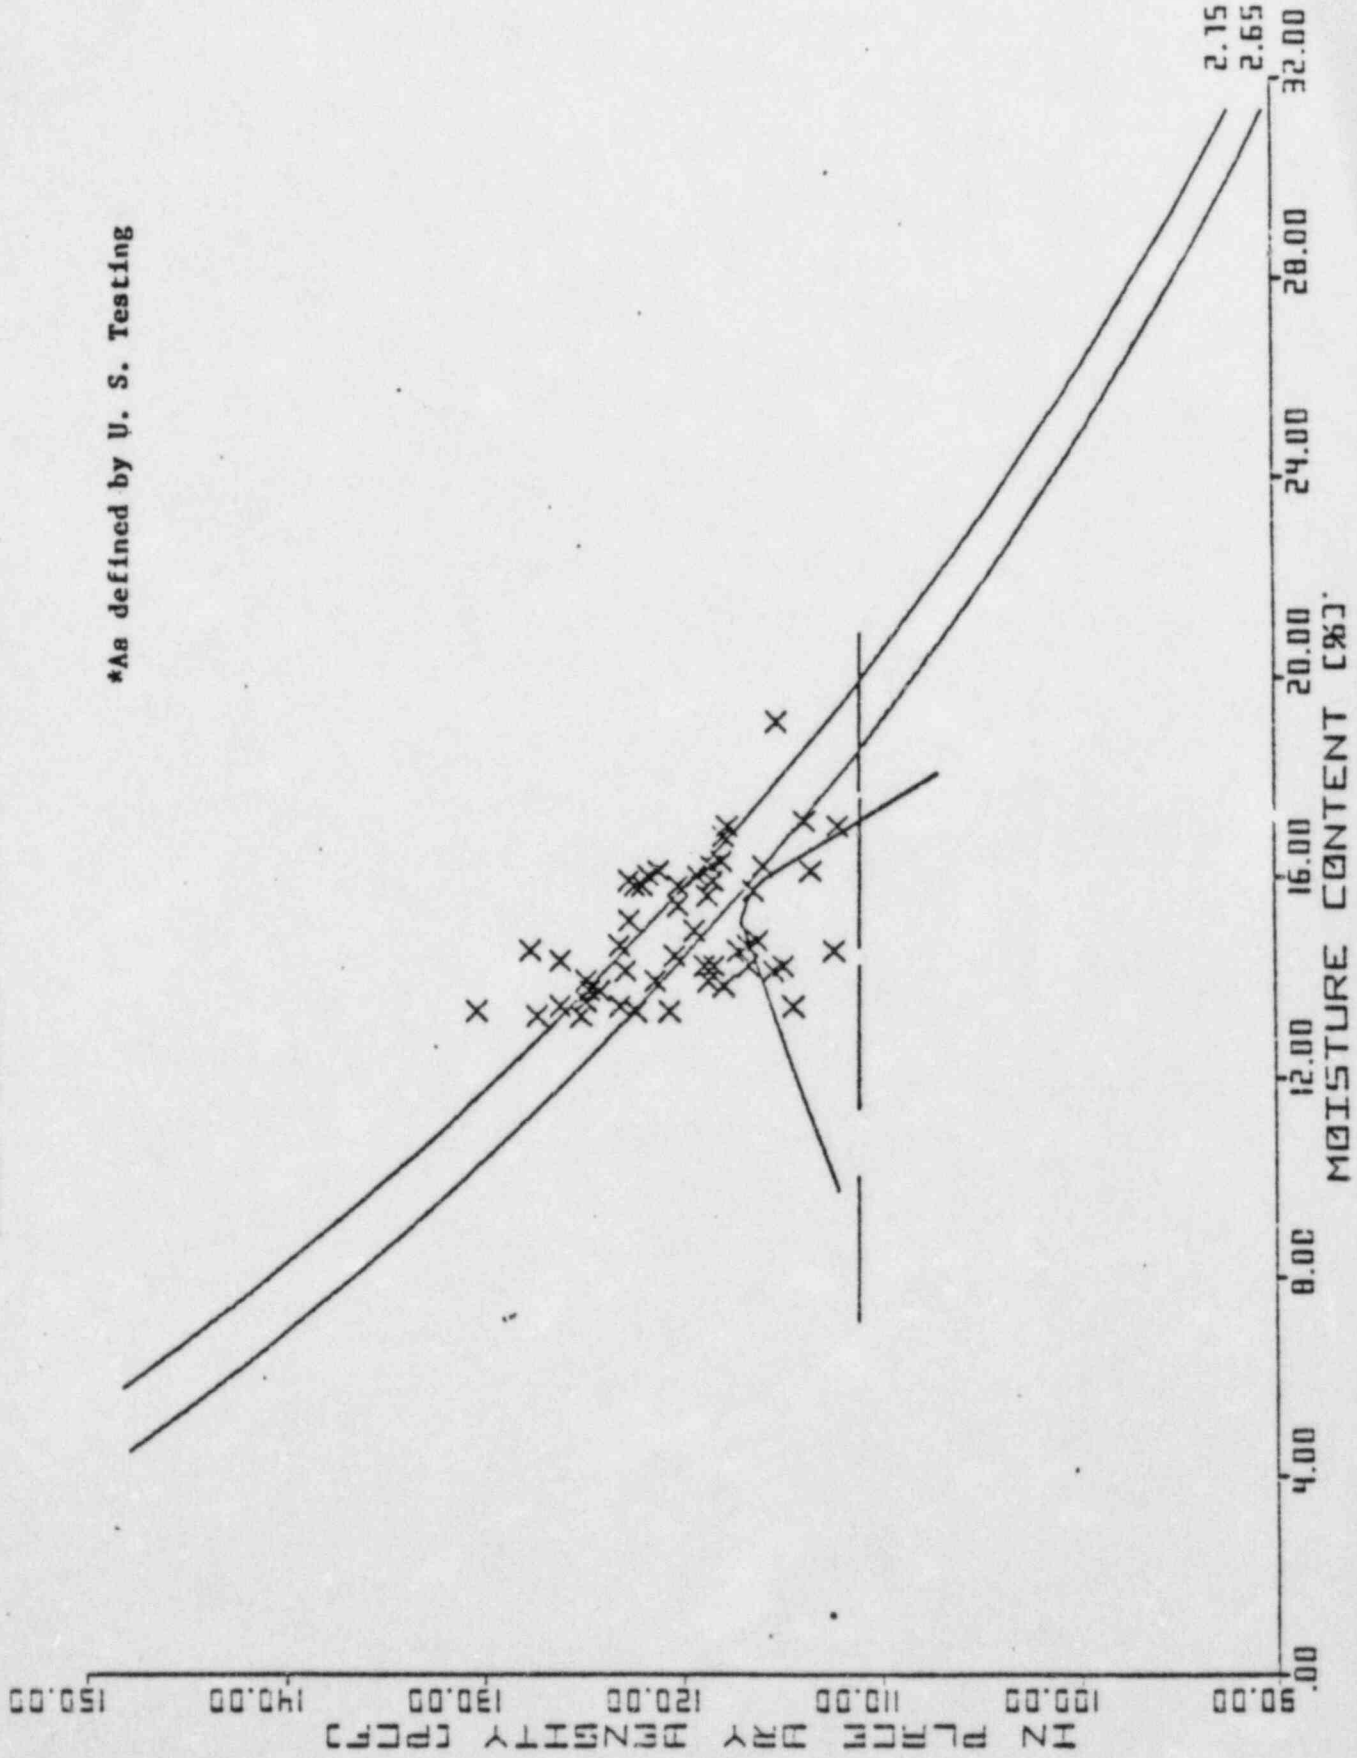
FIGURE 5

MOISTURE DENSITY FOR BMP 278

SPECIFIC GRAVITY = 2.65
 NUC. DENS. PASSING TESTS*

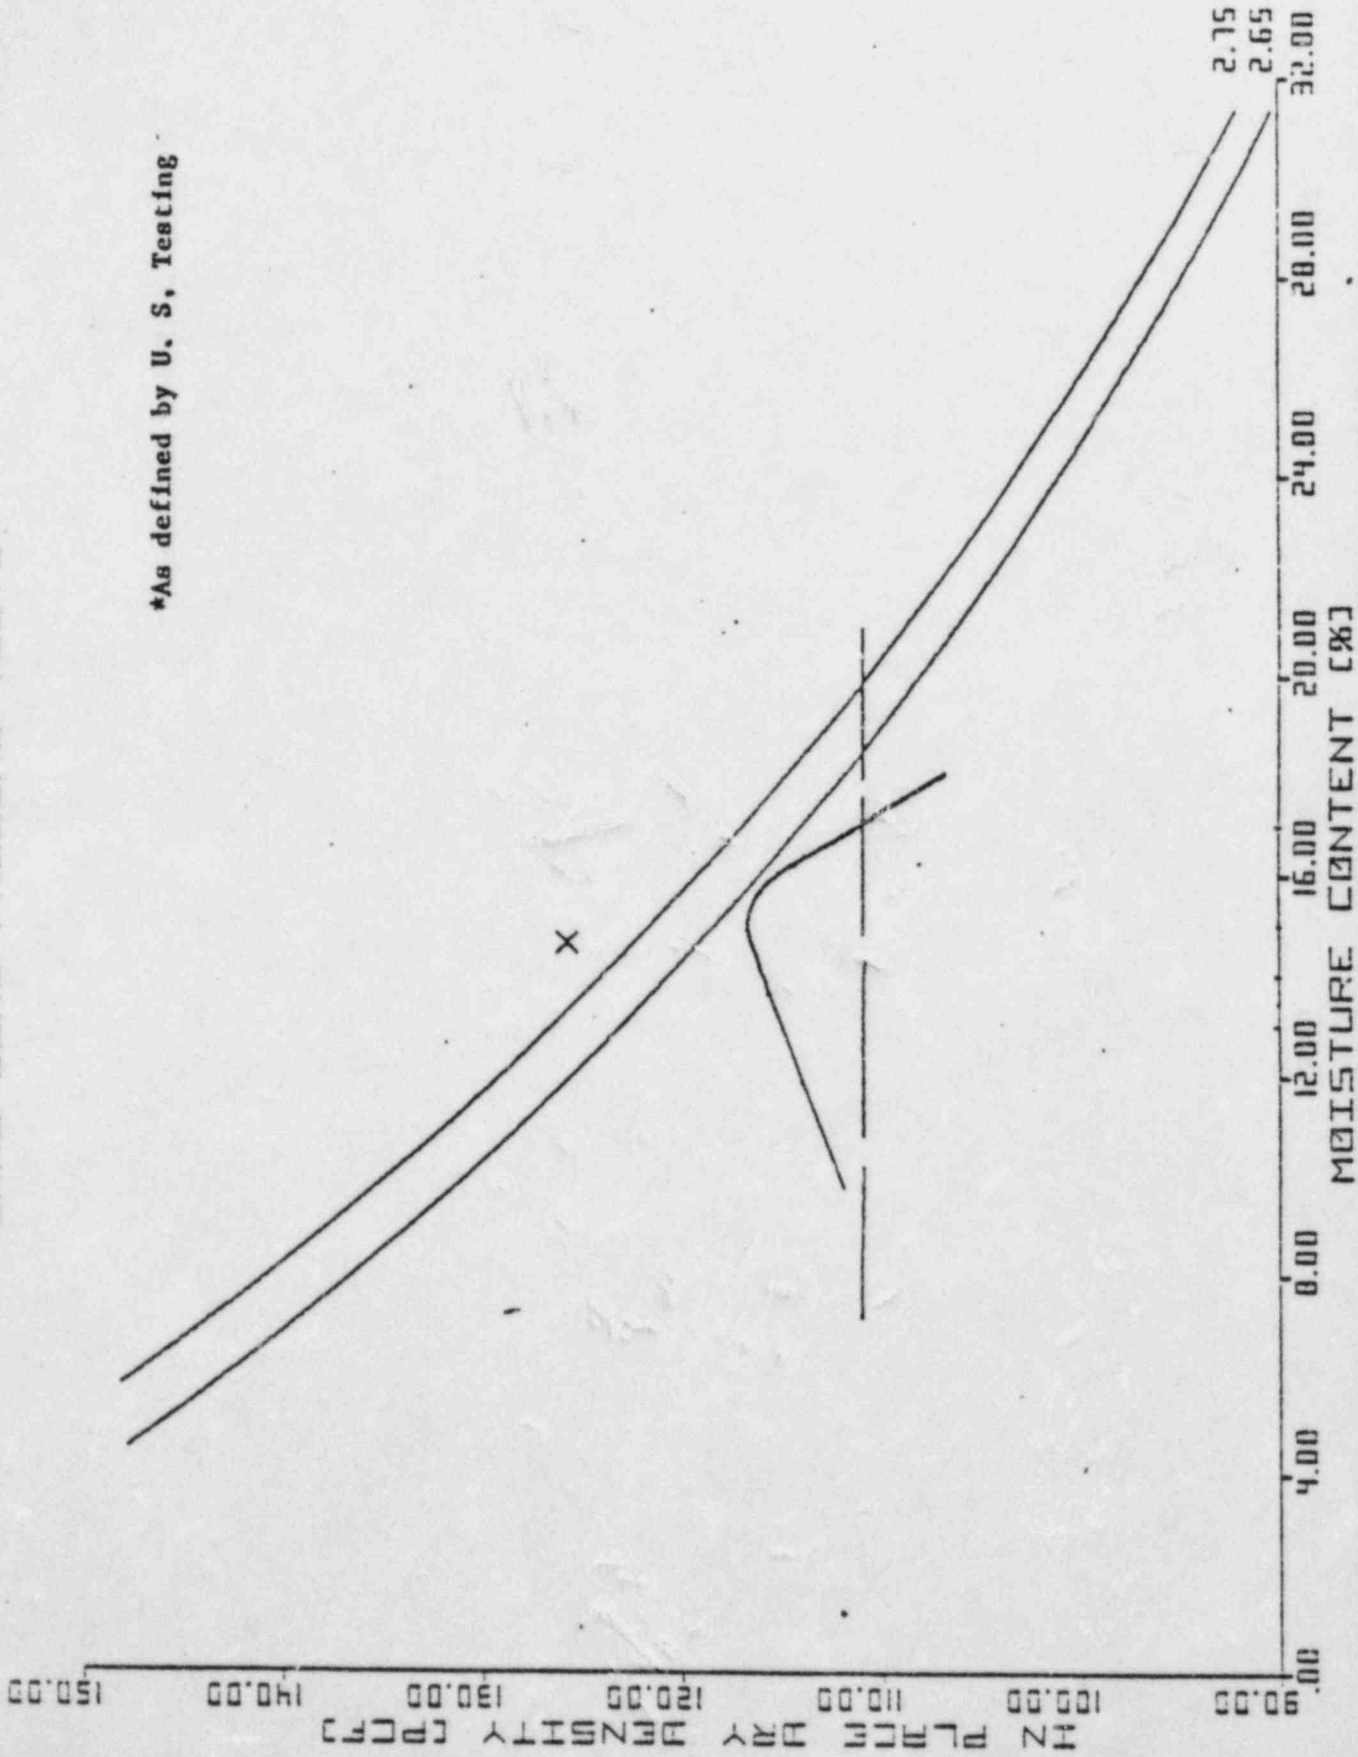
FIGURE 6

MOISTURE-DENSITY FOR BMP 278
 SPECIFIC GRAVITY = 2.65
 SAND-CONE PASSING TESTS *

*As defined by U. S. Testing

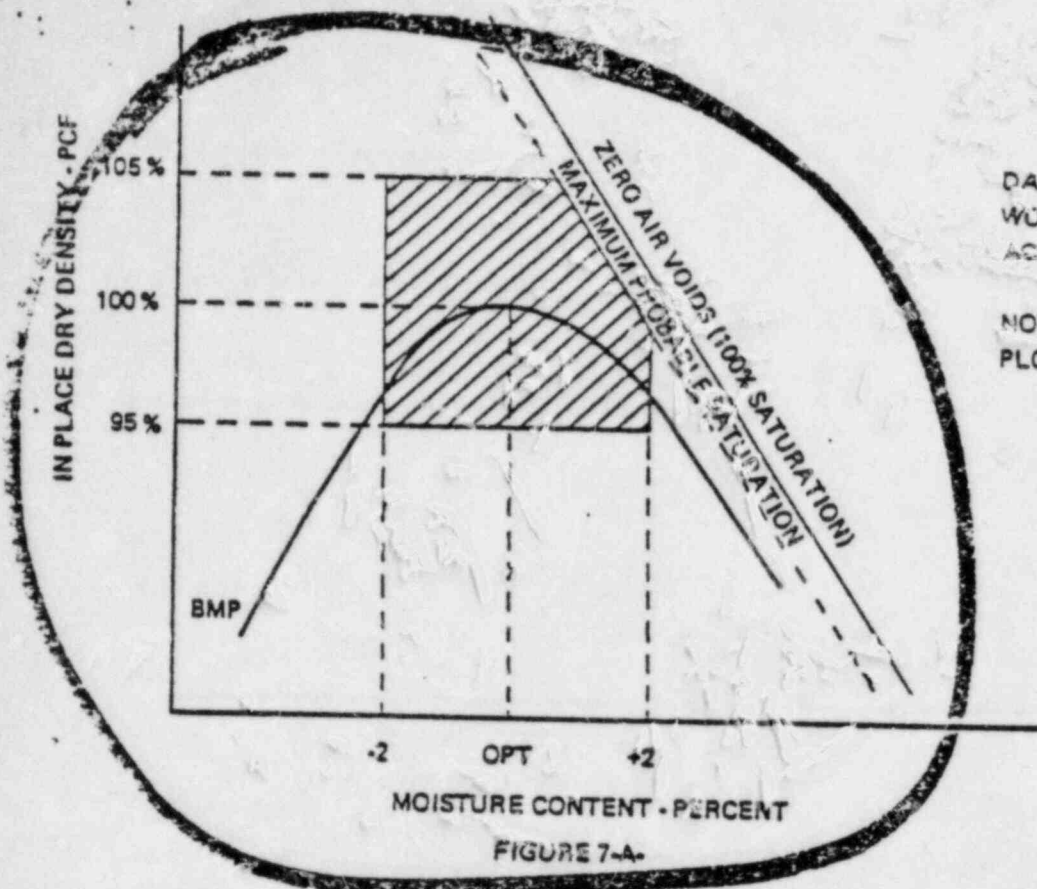
FIGURE 7-A-

DATA POINTS THAT PLOT IN SHADED AREA WOULD BE GENERALLY ACCEPTABLE ACCORDING TO SPECIFICATIONS

NOTE: ABOUT 25% OF ALL FIELD DATA PLOTS IN THE SHADED AREA
