MIDLAND UNITS 1 & 2
JOB NO. 7220

REVIEW OF U.S. TESTING
FIELD AND LABORATORY CONSTRUCTION
TEST DATA ON SOILS USED AS FILL

PREPARED BY
BECHTEL POWER CORPORATION
JUNE 12, 1979

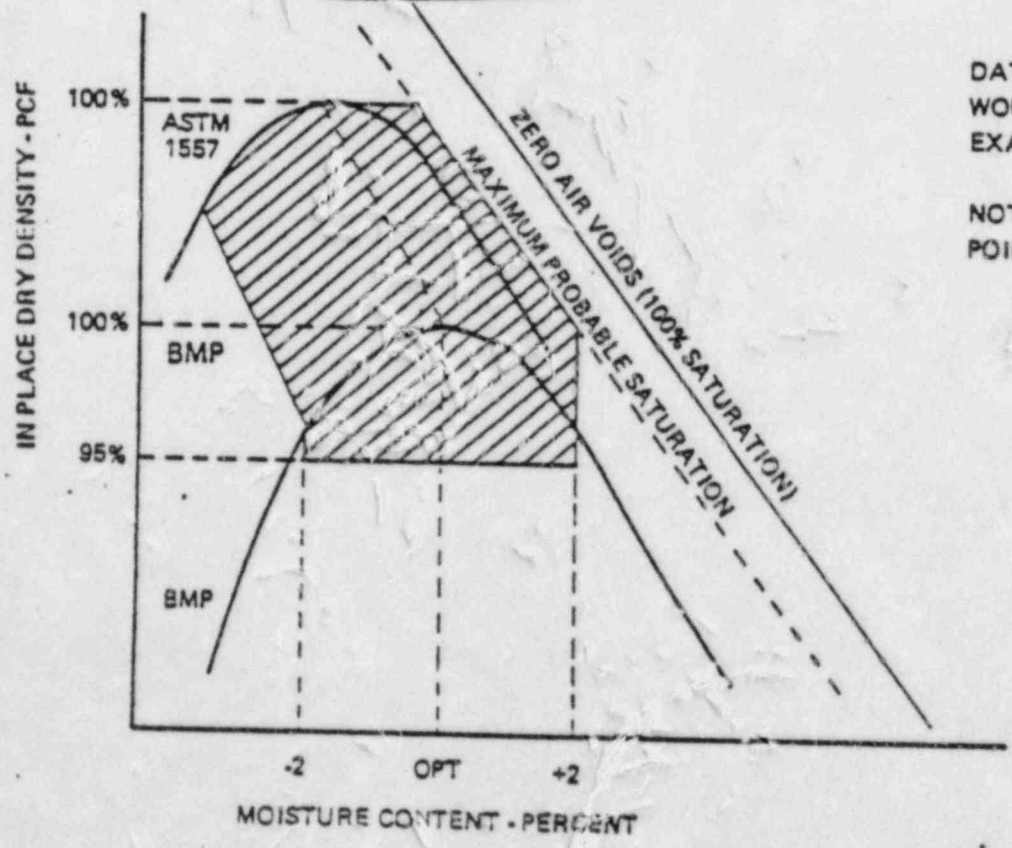
DATA POINTS THAT PLOT IN SHADED AREA WOULD BE ACCEPTABLE REGARDLESS OF EXACT SPECIFICATION WORDING

NOTE: ABOUT 40% OF ALL FIELD DATA POINTS PLOT IN THE SHADED AREA

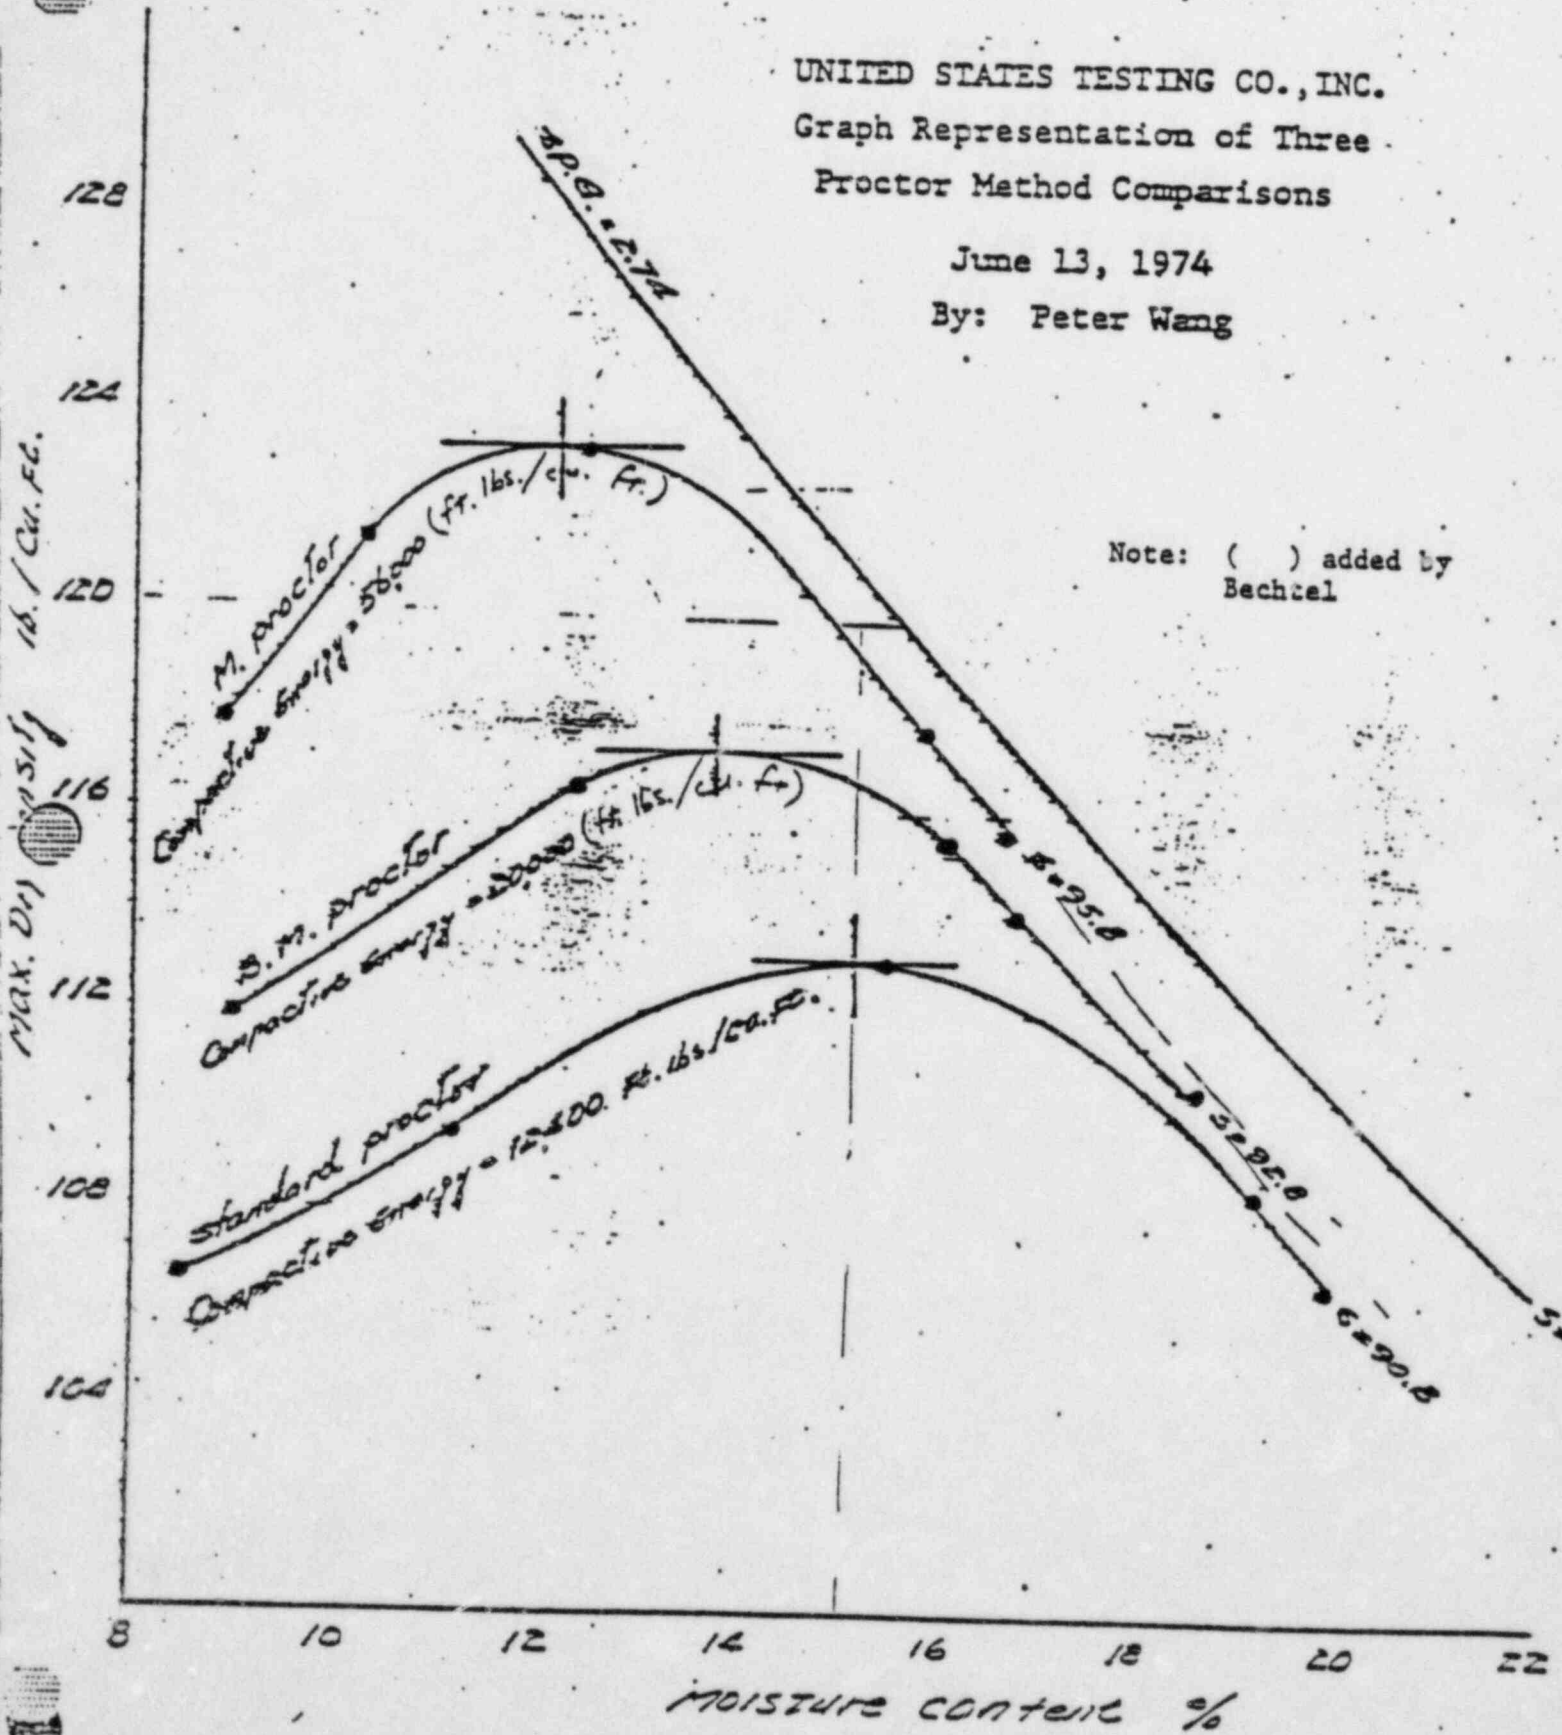
FIGURE 8

Also, referring to Figure 1 it would appear that soil density varied widely. Specifications called for compactive effort results as defined by ASTM D 1557 which is 56,255 ft-lb/ft³ energy. This was modified to a laboratory test compactive effort of about 20,000 ft-lbs/ft³ energy, often referred to as Bechtel Modified Proctor (BMP). Laboratory compaction test curves should be related to the same effort as that called for in the field for use in comparing with field density tests to determine percent compaction. According to plots of field data shown on Figure 1, density varied from about 108 lb/ft³ to about 130 lb/ft³. It is doubtful that the soil classification or other properties would be similar for such a wide variation in density. It is noted that 100 percent of modified Proctor (ASTM D 1557) which is difficult to obtain, is rated at 56,255 ft-lb/ft³ energy. The curve plotted on Figure 1 is at about 20,000 ft-lb/ft³ energy. For comparative purposes it was determined by U. S. Testing in 1974 that 100 percent of specified effort (20,000 ft-lb/ft³) is approximately equal to 95 percent of the maximum density as determined by ASTM D 1557 (56,255 ft-lb/ft³) Reference Figure 8.
