This evaluation was undertaken in response to suggestions from Bechtel QA and Geotech that the Troxler Nuclear Guage was responsible for field density tests plotting outside the zero-air-void curve on moisture-density plots of cohesive fill placed in the Midland plant area. It was felt that the initial studies which resulted in approval of the Troxler might give some indication of its accuracy. Primary reference is Item "I" attached to a letter from K. Rademacher of U. S. Testing Co. to E. Felton of Bechtel, dated 5/30/74, (see Appendix A).

Report on failure of grade beam @
0.4 line - Administration Building.

DIESEL GENERATOR BUILDING TASK GROUP

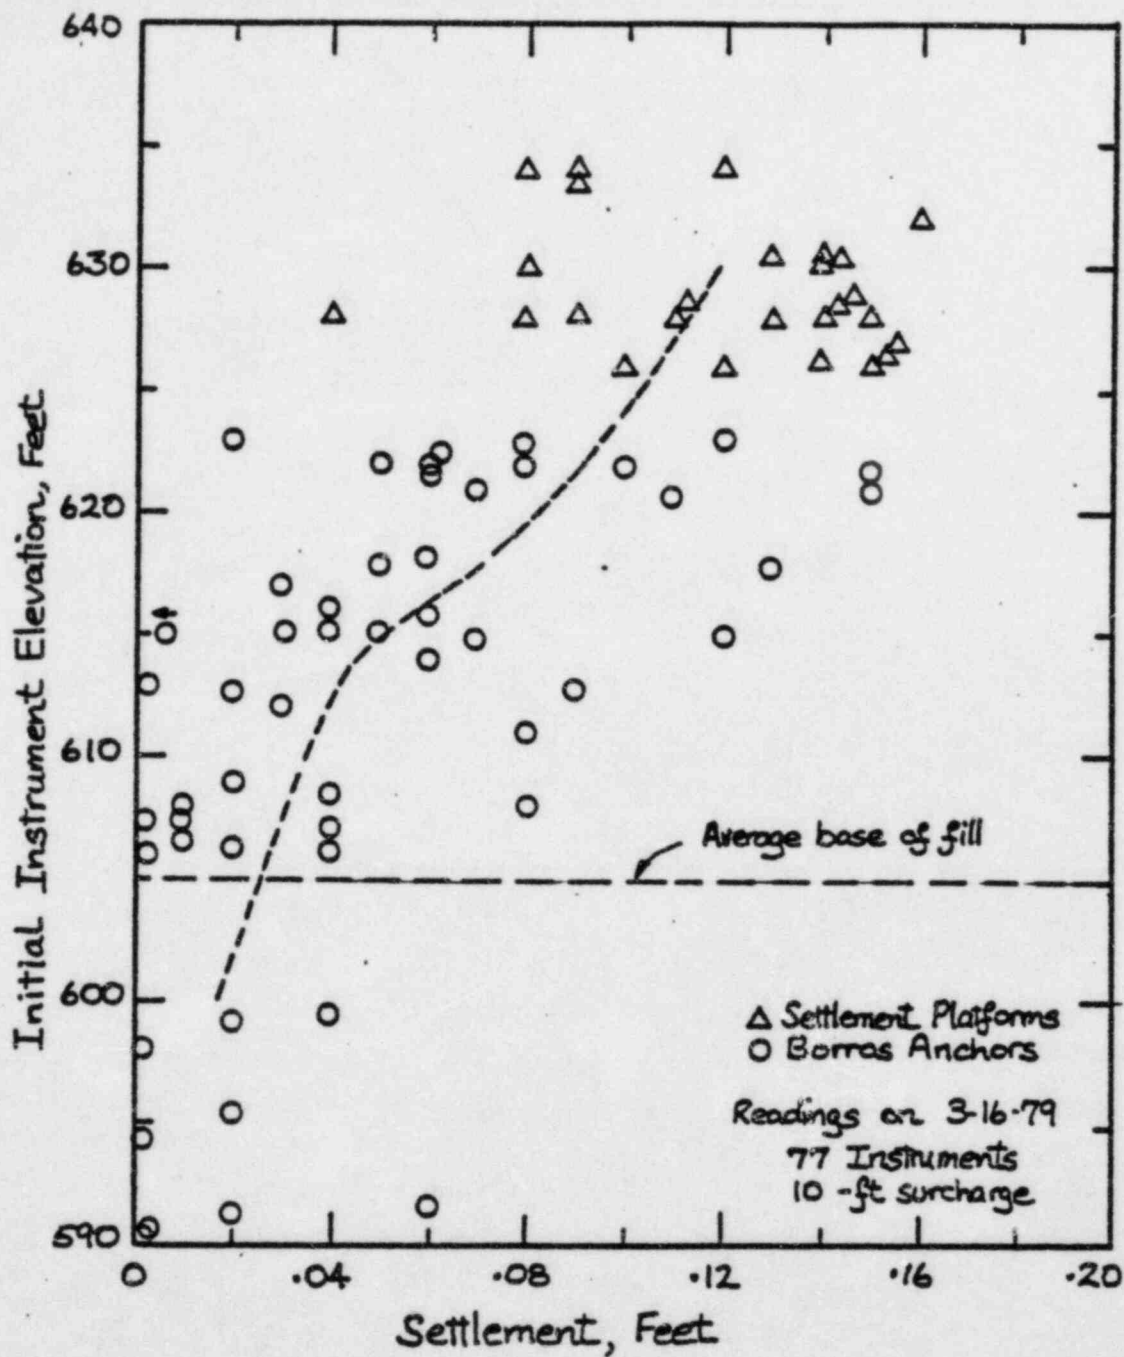
DIESEL GENERATOR BUILDING : AVERAGE SETTLEMENT VS. SURCHARGE -TIME

ANSWER 14 Based on observed settlements for the diesel generator building and soil properties determined from the current drilling and testing program, settlement analyses to predict future settlements have been made. Table _____ compares originally predicted settlement with that currently anticipated.

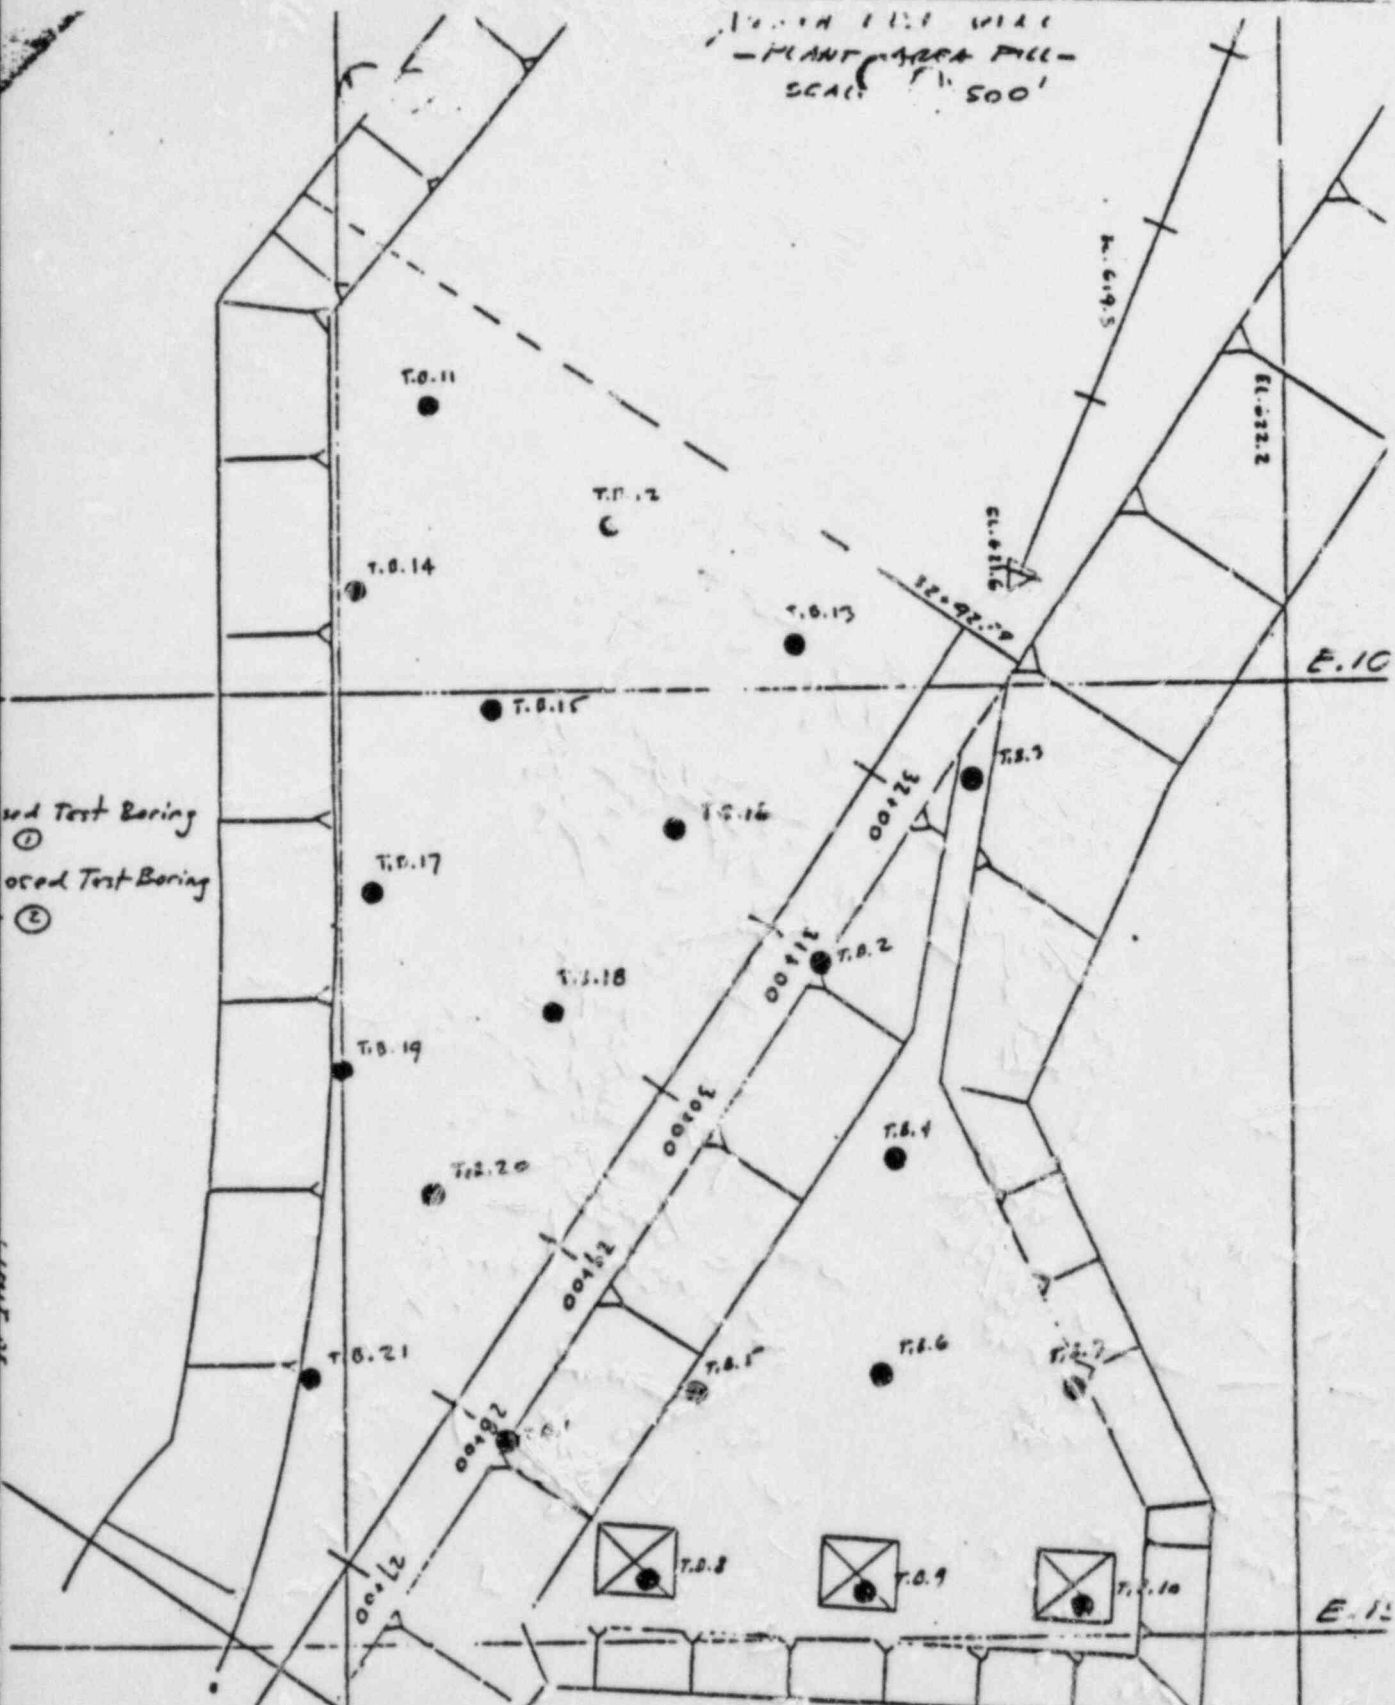
PLANT AREA FULL SCALE 1" = 500'

Proposed Test Boring Zone ①
 Proposed Test Boring Zone ②

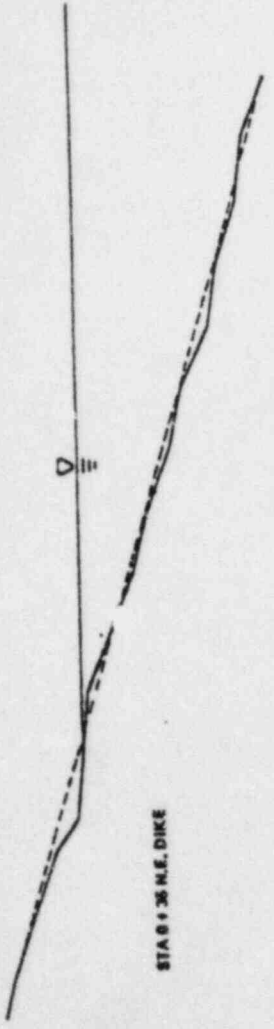
STA 6+36 N.E. DIKE

- 1. SURVEY WAS TAKEN AUGUST 18, 1979
- 2. WATER SURFACE ELEVATION IS 621.4
- 3. TOP OF SLOPE IS ROAD SHOULDER

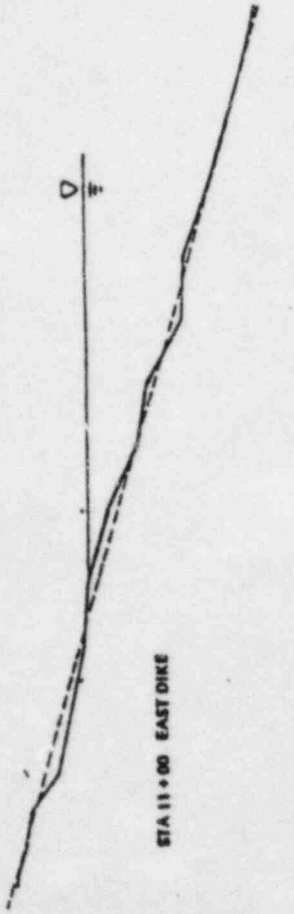
STA 11+00 EAST DIKE

1. SURVEY WAS TAKEN AUGUST 12, 1973
2. WATER SURFACE ELEVATION IS 626.4
3. TOP OF SLOPE IS 810.4 SURFACE DTM

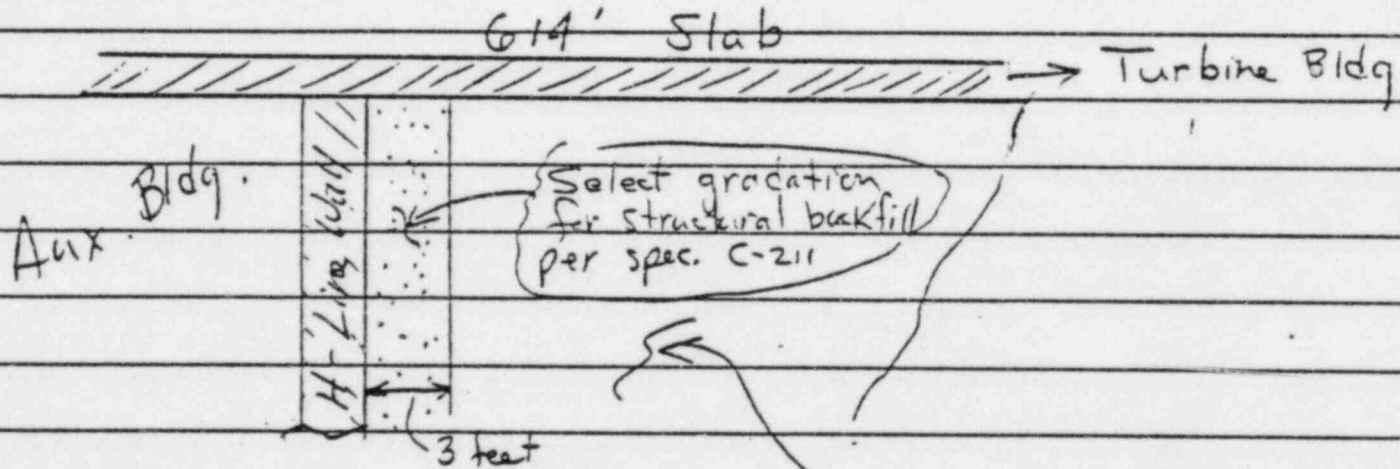
2. Why is structural backfill^{material} only req'd. within 3 feet of a bldg. wall and not under a structure? For example:

Ans.: In most cases Zone 2 → req'd. in this area?
