FURCO
Company

REPORT NO E-77-32

PLANT: Midland UNIT 1 &
SUBJECT OF AUDIT: Soil Placement
Records

I. AUDIT SCOPE

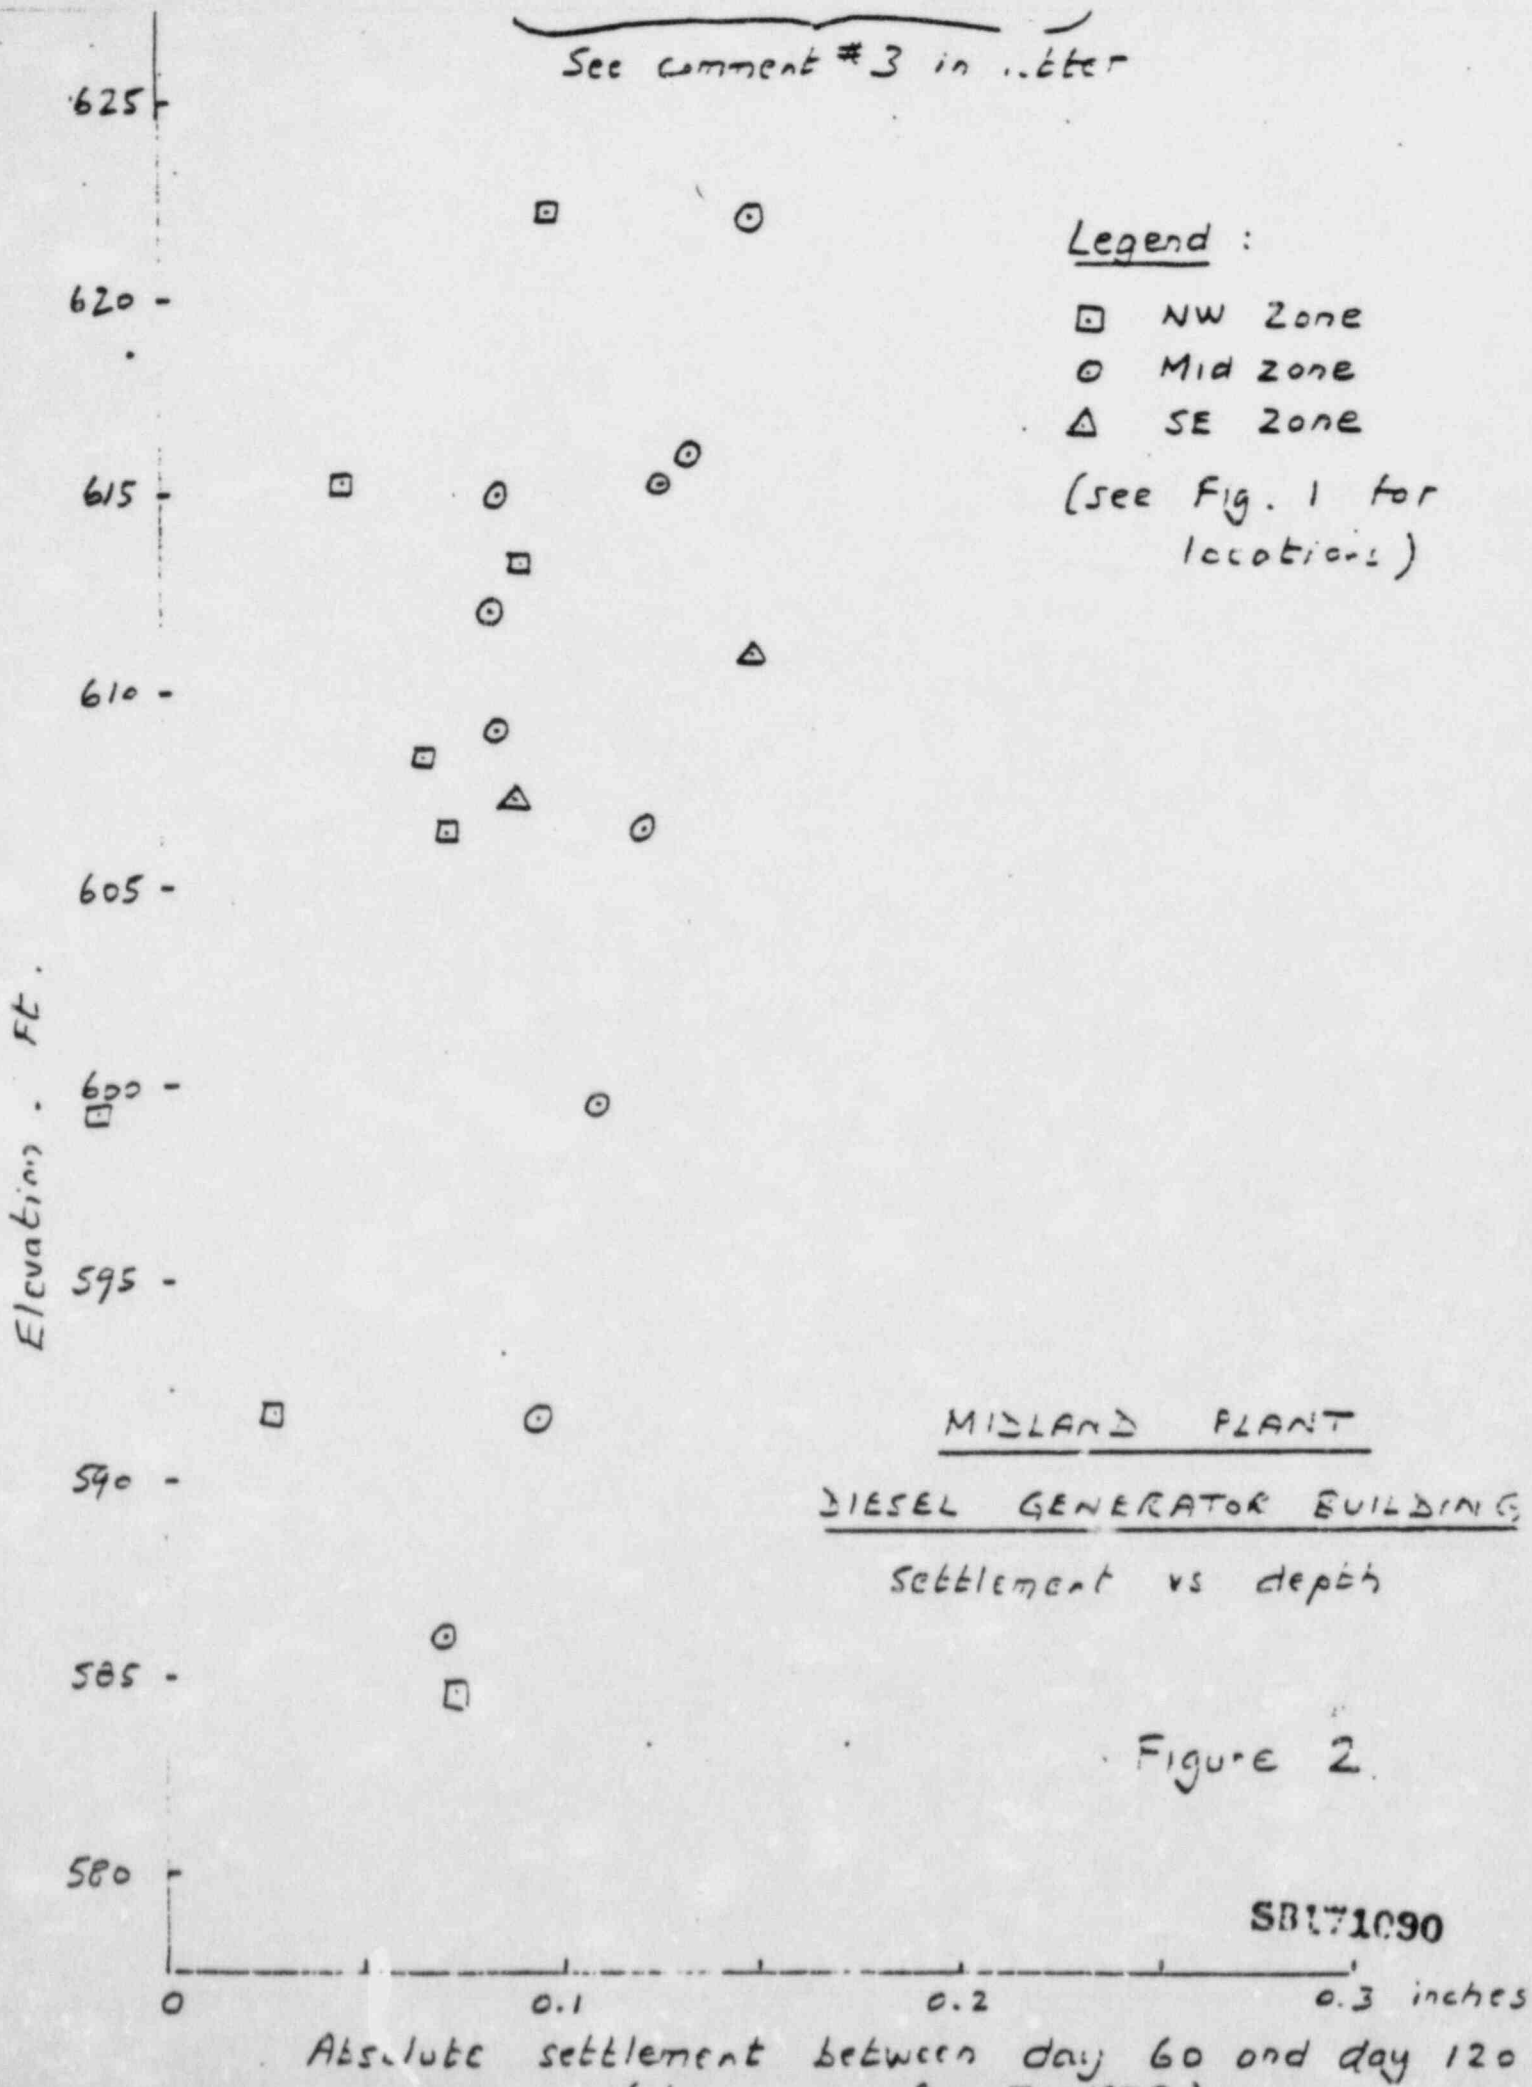
FIGURE 1

3. Fig. 2 indicates the same type of scatter noted on the optical survey Borros anchor and settlement platform plots (Eleventh sheet of your June meeting handout, here as Fig. 6) and I recommend that you work with these data in cluster groups, as you did to derive the twelfth sheet (Fig. 7). Fig. 2 shows, as it should, generally lesser settlement with depth and generally lesser settlement towards the NW zone. It also shows continuing settlement below elev. 585 ft. I believe it is realistic to add the four BA 61 through 64 points (0.230, 0.195, 0.140, 0.095 inches) on Fig. 2 at the elevation of the bottom of the footings (628 ft ?), i.e. to assume no significant length change between footings and mezzanine floor.

See comment #3 in letter
