U. S. NUCLEAR REGULATORY COMMISSION

Report No.: 50-306/92005

Facility Name: Prairie Island Nuclear Generating Plant

Special, unannounced safety inspection by an NRC Augmented Inspection Team to determine the facts and to perform evaluations relating to a loss of residual heat removal system event at the Unit 2 reactor which occurred on February 20, 1992. Information was collected for an independent risk assessment. The onsite inspection effort concluded with a public "exit" meeting.

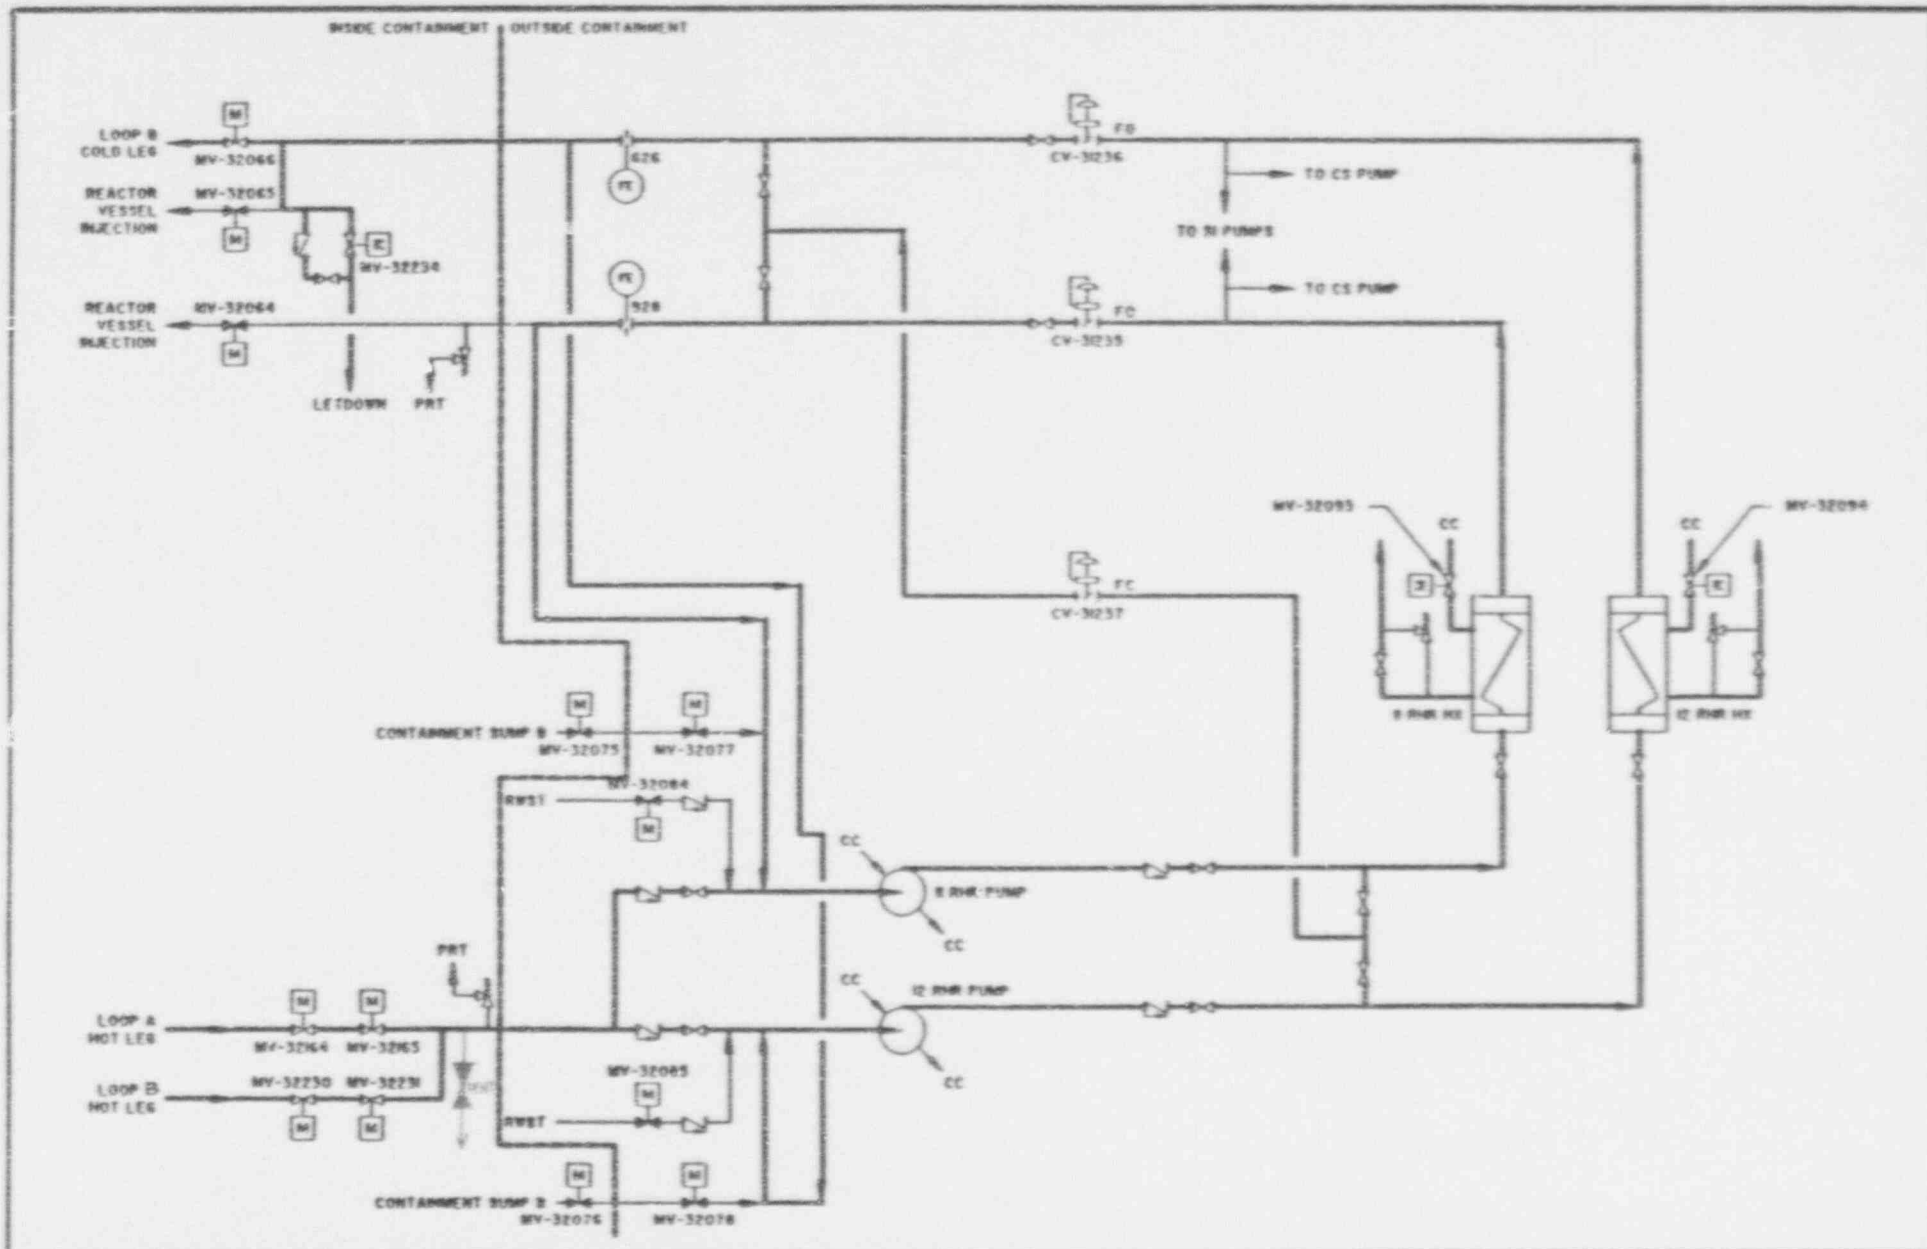
FIGURE 2

The residual heat removal (RHR) system at Prairie Island Unit 2 performs the shutdown cooling function and also operates in the Low-Pressure Safety Injection mode as part of the Emergency Core Cooling System. The RHR system is a two train system with two pumps, two heat exchangers, and several suction and discharge locations. See Figure 2 for a schematic of this system.

RESIDUAL HEAT REMOVAL SYSTEM
COOLDOWN FLOWPATH

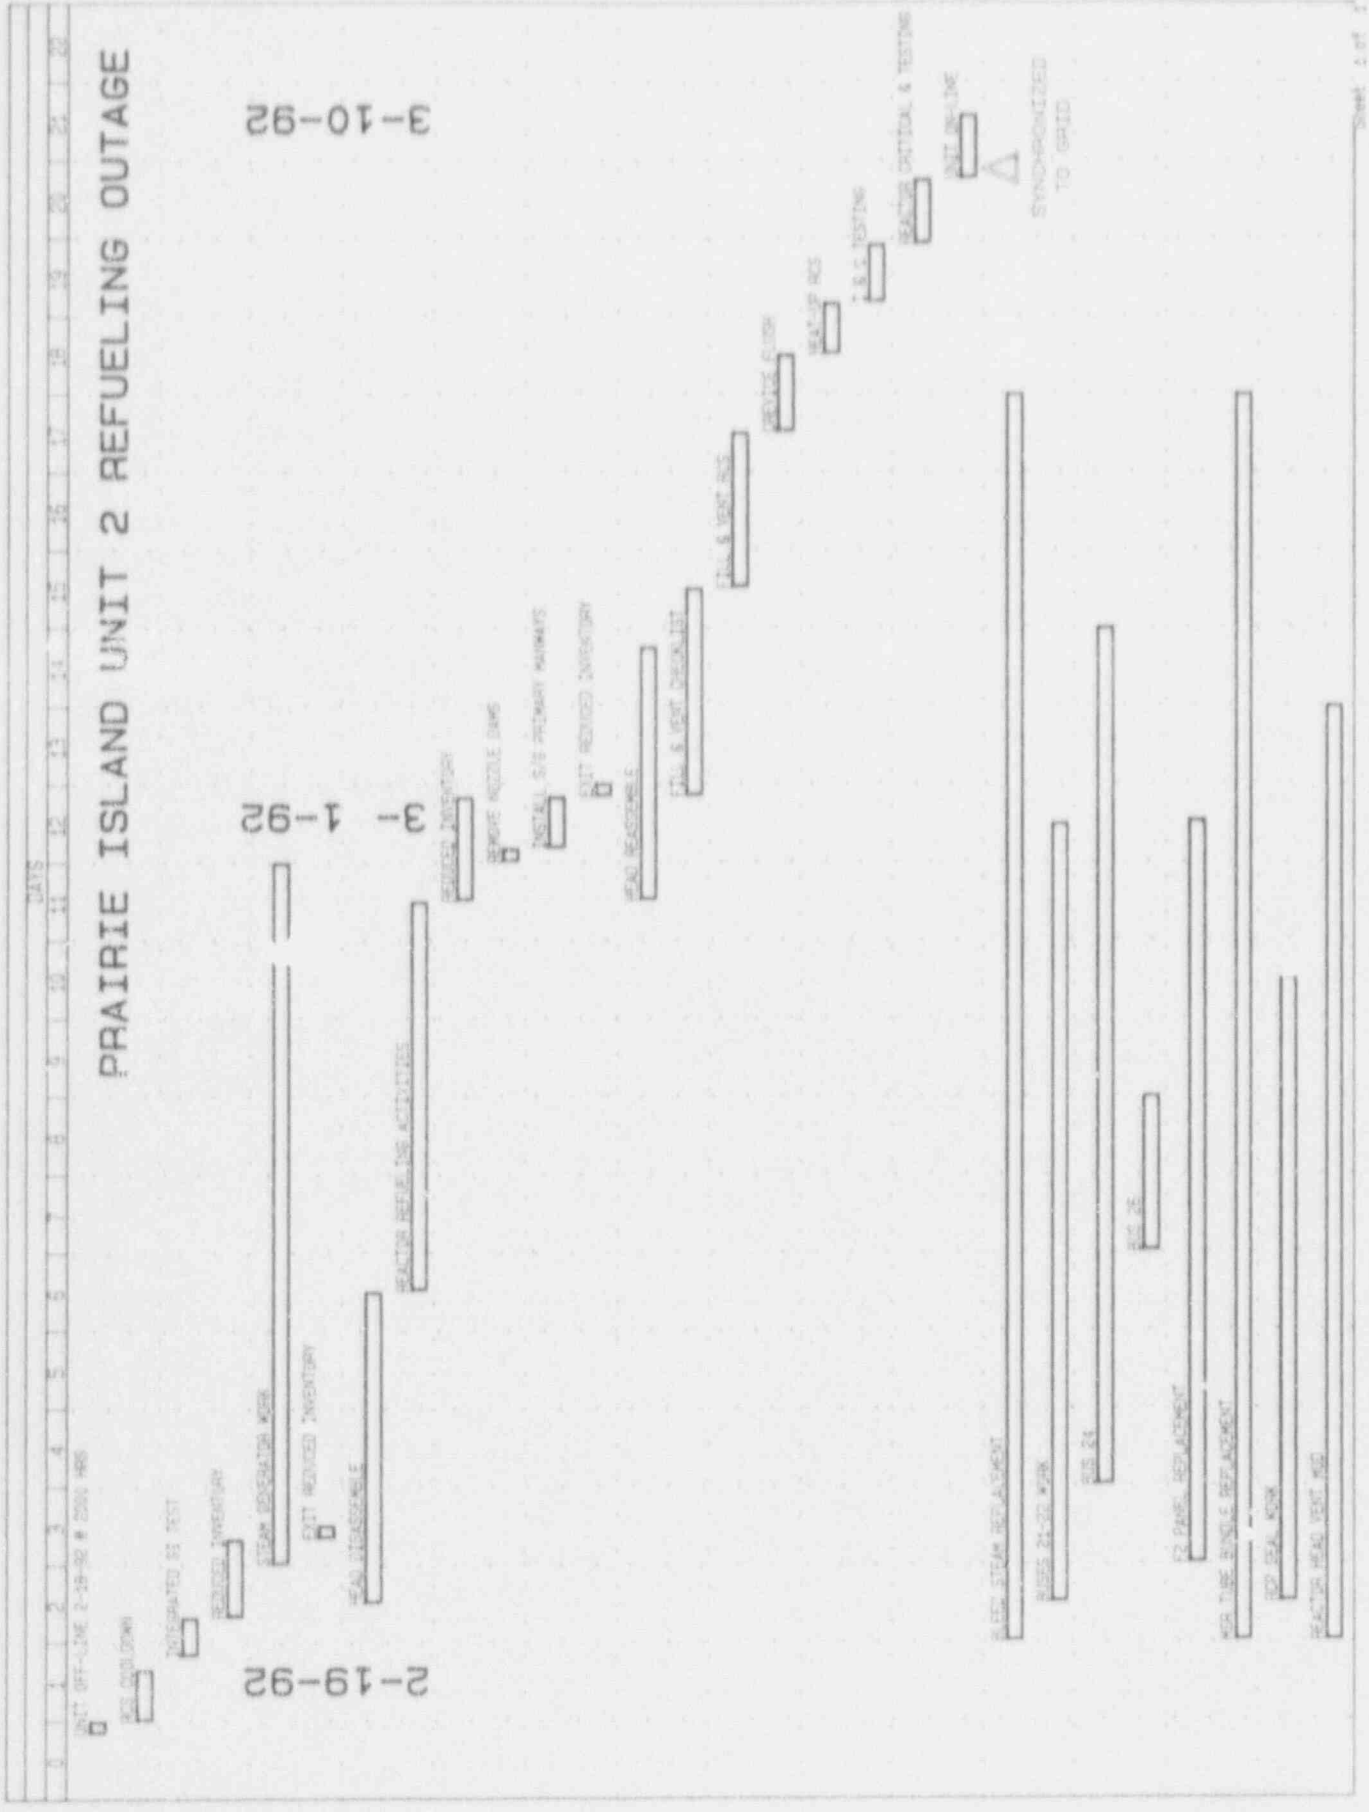
FIGURE 3

The February 20, 1990, event occurred early in the refueling outage. The planned outage schedule is summarized in Figure 3. Figure 4 shows the reactor coolant system water level during the outage. Note that:

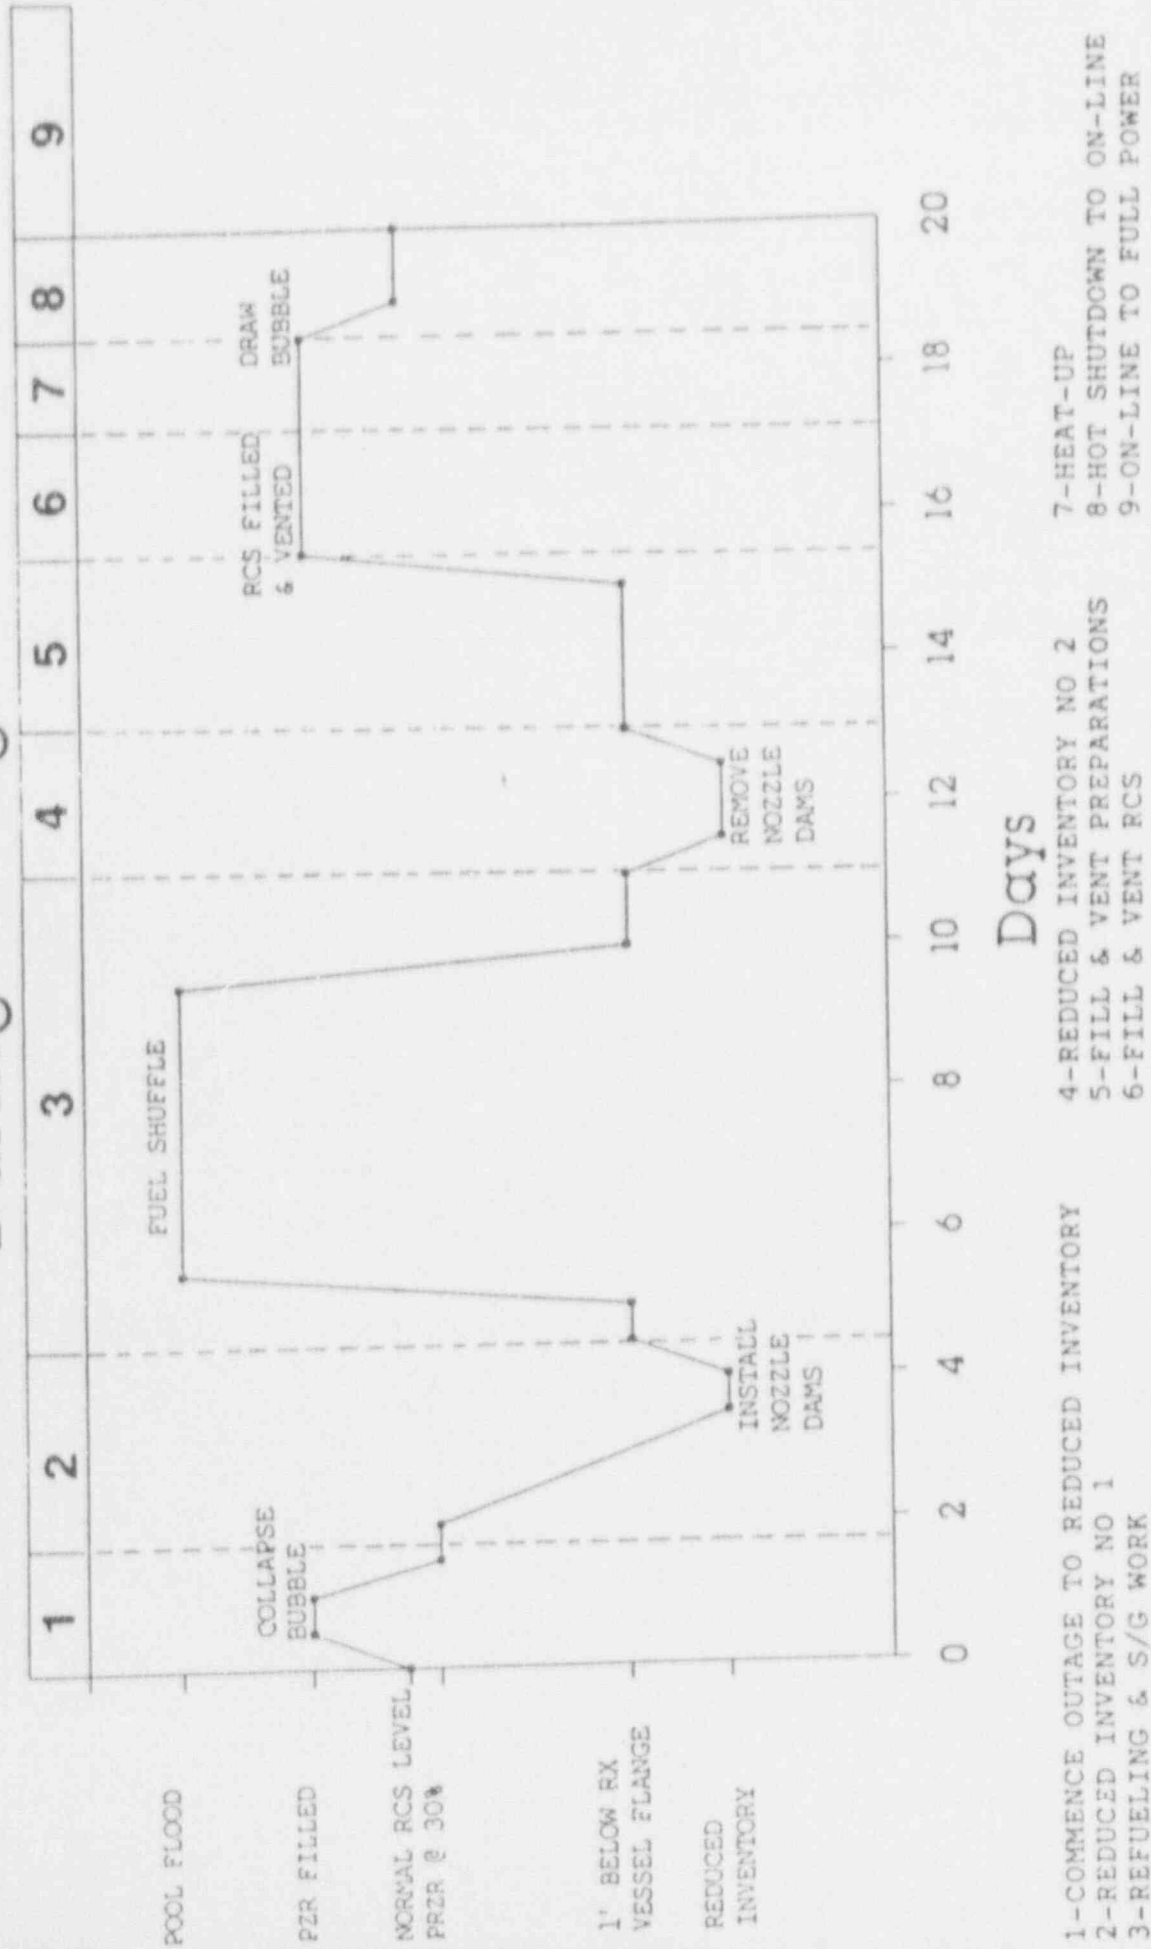
FIGURE 4

RCS Water Inventory During Outage
