NUREG/CR-5762
WYLE 60101

Comprehensive Aging Assessment of Circuit Breakers and Relays

Wyle Laboratories

Prepared for
U.S. Nuclear Regulatory Commission

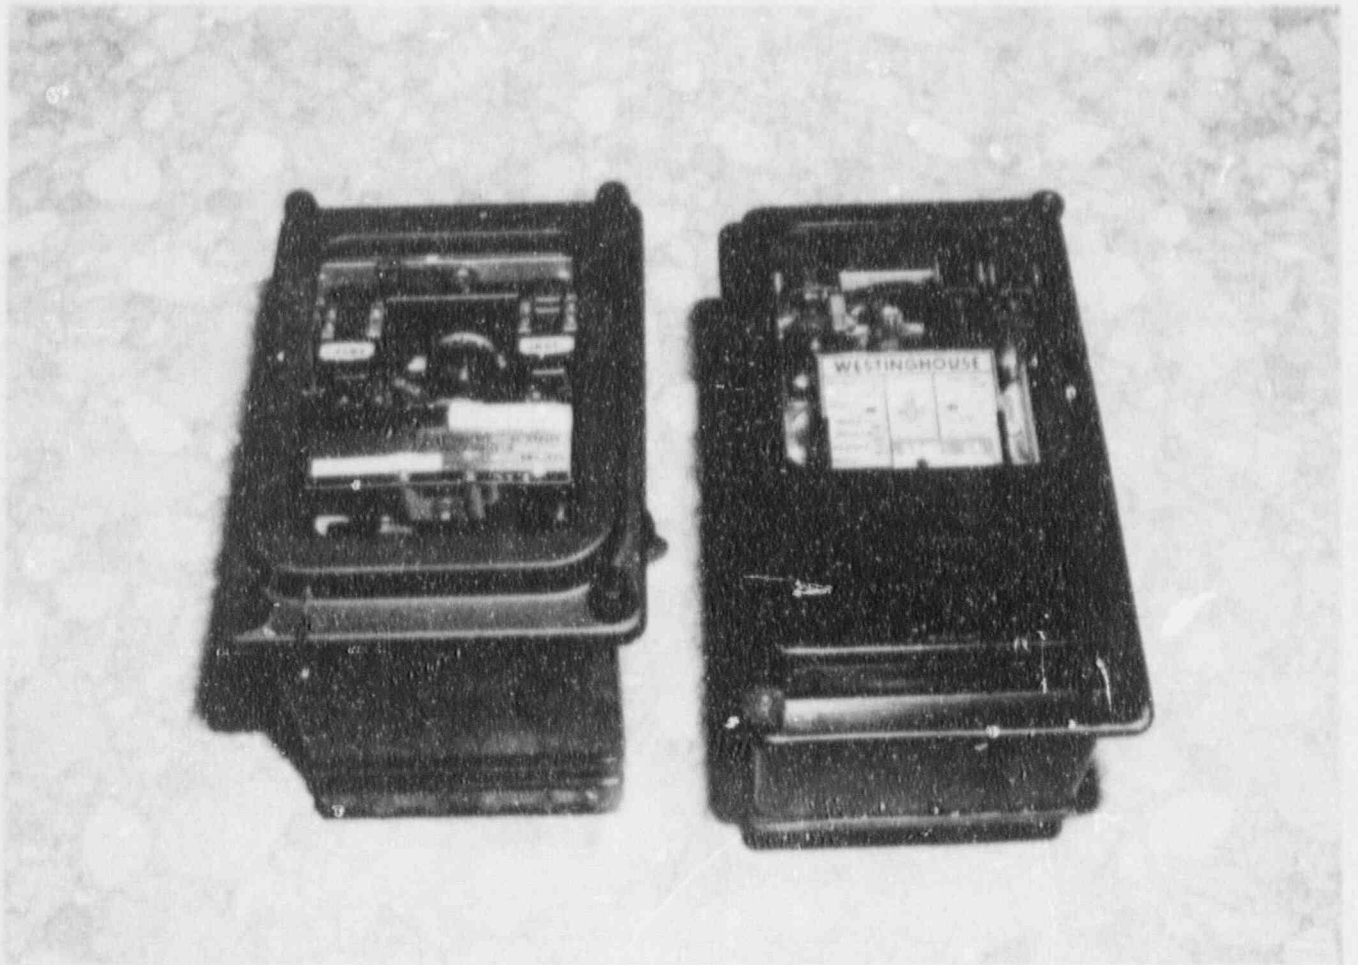
Figure 3-1. Protective Relays
General Electric 12IAC53B101A and
Westinghouse Model CO

All three GE specimens had calibration tags which indicated that they were last calibrated on November 21, 1985. Calibration was due November, 1986. The 24 year relay was extremely clean and appeared to have seen little service.

The moving contacts of the seal-in and instantaneous unit were open and operated freely on all specimens. The instantaneous and seal-in contact surfaces of the 10 year and 24 year specimens were slightly worn. The metal surfaces on the connecting plug of all three specimens exhibited brown discoloration. The connecting plug of the 24 year specimen had three connections that were highly discolored with areas of brown and blue. The auxiliary brushes inside the case of all three specimens were discolored similarly to the connecting plug metal surfaces. The metal brushes on the connecting block underneath each of the relays were highly oxidized.

The induction disk, instantaneous and seal-in contacts, which were silver or silver alloy, of the 10 year specimen showed no signs of unusual wear or contact pitting. However, the contacts on the 13 year and 24 year specimens were lightly discolored and worn. The insulation of tap lead wires 4 & 5 on the 10 year specimen were discolored and appeared overheated. The 13 year and 24 year specimens showed no evidence of tap or coil lead wire insulation damage. The coil and drag magnets of each specimen were checked for debris and metal filings. The coil magnet of the 10 year and 13 year specimens were lightly covered with metal filings. The coil magnet of the 24 year specimen was clean. The drag magnet on all three specimens had a slight amount of metal filings attached to its surface. Each specimen was checked for evidence of loose connections or parts and none were found.

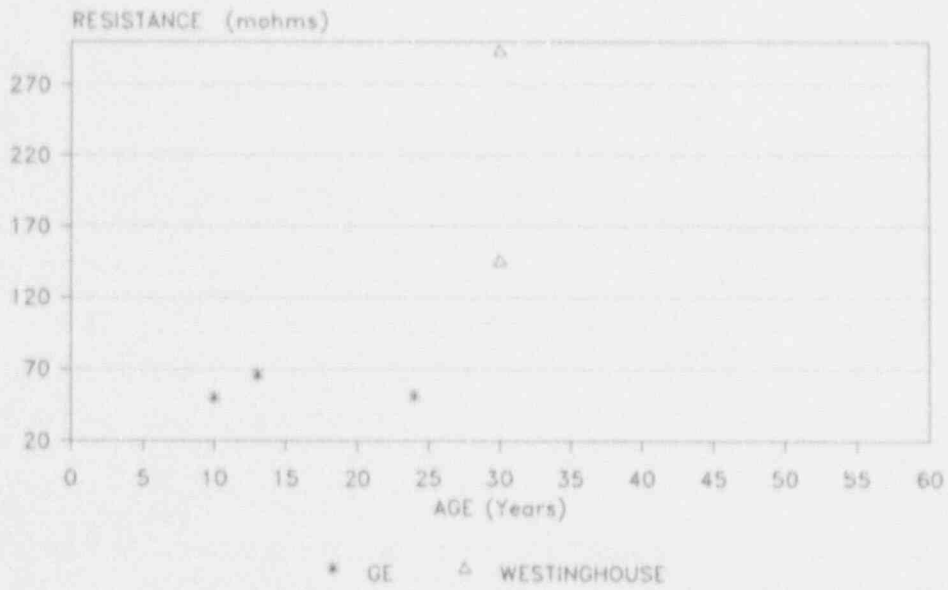
Figure 3-2. Coil Resistance Comparison Protective Relays

Coil resistance is plotted against specimen age in Figure 3-2. The 10, 13 and 24 year specimens had resistances of 49.8, 65.5 and 50.9 milliohms respectively. The 13 year specimen had the highest resistance value and may have been a contributing factor to the significant percent change in induction unit pick-up, noted later. The Westinghouse specimens even though the same age, had

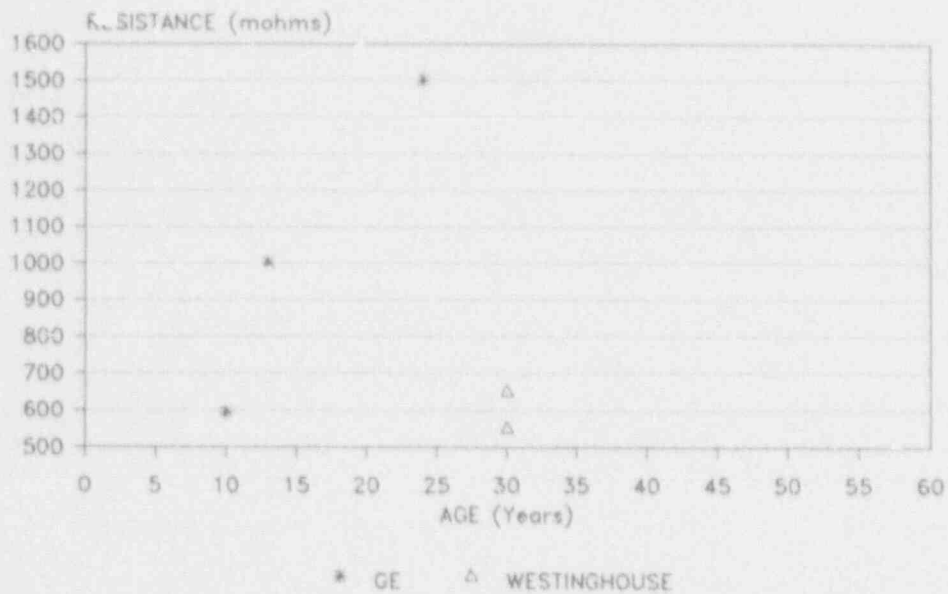
Figure 3-3. Contact Resistance Comparison Protective Relays

The contact resistance exhibited a definite trend with age. Figure 3-3 shows this increase in resistance with age and the relative difference in magnitude when compared to the Westinghouse specimens. The high resistance values obtained with the 13 and 24 year specimens may have been due to the high oxidation observed on the stationary contacts and on the metal surfaces of the contact blocks. The higher contact resistance values obtained with the GE specimens may also have contributed to the slight variation shown in the time/current characteristic, discussed later. The Westinghouse specimens had resistance values of 551 and 649 milliohms respectively. The resistance difference, 98 milliohms, between the two specimens may have been a contributing factor to the large variance in timing ranges obtained in time/current characteristic.

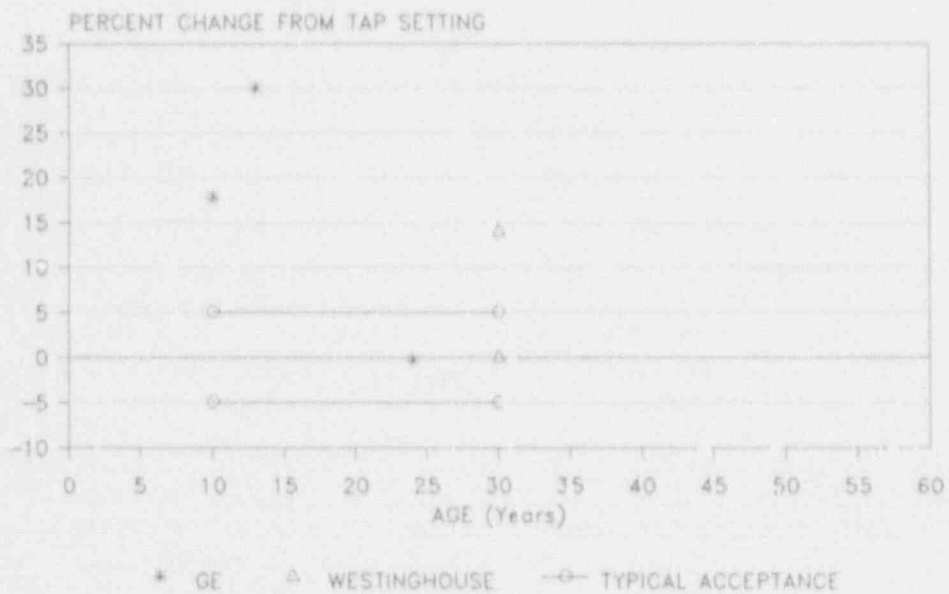
Figure 3-5. Induction Unit Pickup Comparison Protective Relays

Since the relays were from different manufactures and were not of the same model type, the percent change between the tap setting of the unit and the induction unit pickup current was calculated and compared along with the typical $\pm 5\%$ acceptance criteria, Figure 3-5. Three of the five specimens were outside of the typical acceptance criteria. The 24 year GE and one of the 30 year Westinghouse specimens had a percent change of zero. The reason for the 24 year GE being in specification, when last calibrated at the same time as the other GE specimens, as noted on the calibration tag, may be due to its cleanliness and suggestion that it had seen little use.

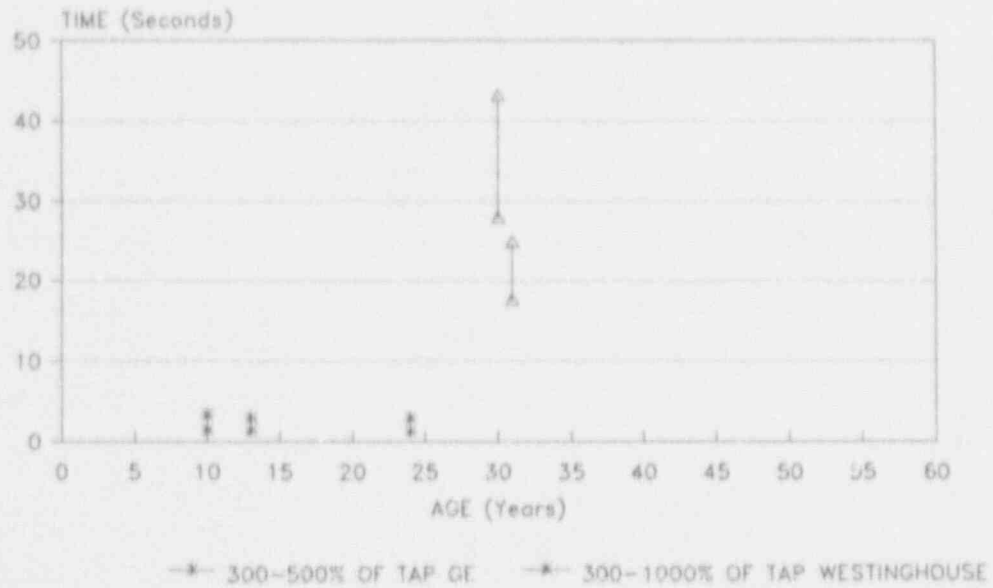
Figure 3-6. Induction Unit Timing Comparison Protective Relays

The time-current characteristics were measured at 300%, 400% and 500% of tap value current for the GE specimens and 300%, 500% and 1000% of tap value current for the Westinghouse specimens. Figure 3-6 shows the time range for contact closure for the range of values measured. The timing ranges for the GE 10 year, 13 year and 24 year were 3.2-1.4, 2.9-1.3 and 2.8-1.2 seconds respectively. The times obtained for the GE specimens were compared to the

manufactures time/current characteristic curves and were all found to be within the specifications. Although the change was very slight, a 0.1 to 0.2 second decrease in time occurred with the increasing age of each device. This appears to be correlated with the increase in contact resistance with age, observed in the contact resistance method.

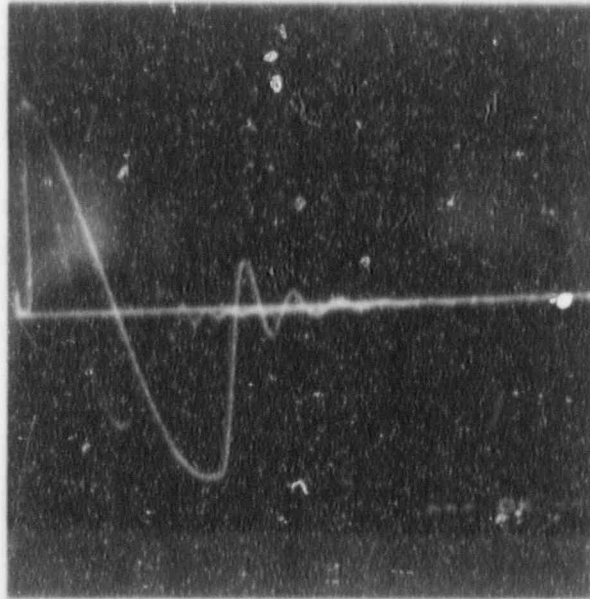
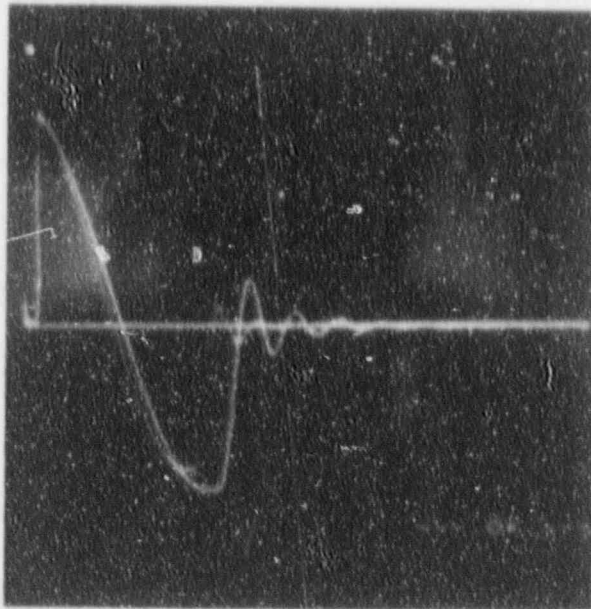
The variations in waveforms between the GE specimens was most likely caused by changes in the magnetic circuit of each specimen which may be due to aging of the coil insulation, but could be due to differences in the manufacturing process. The current surge comparison on protective relays may indicate a trend with age.

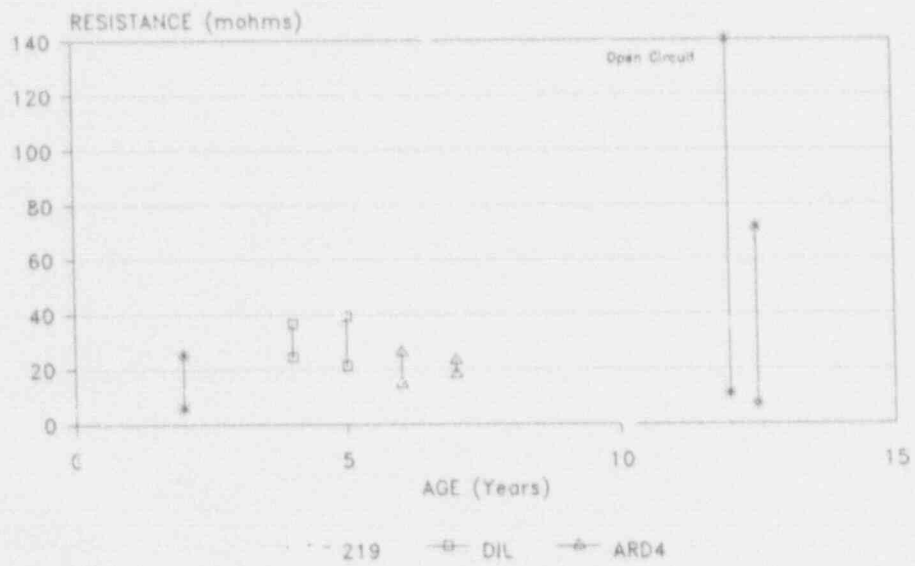
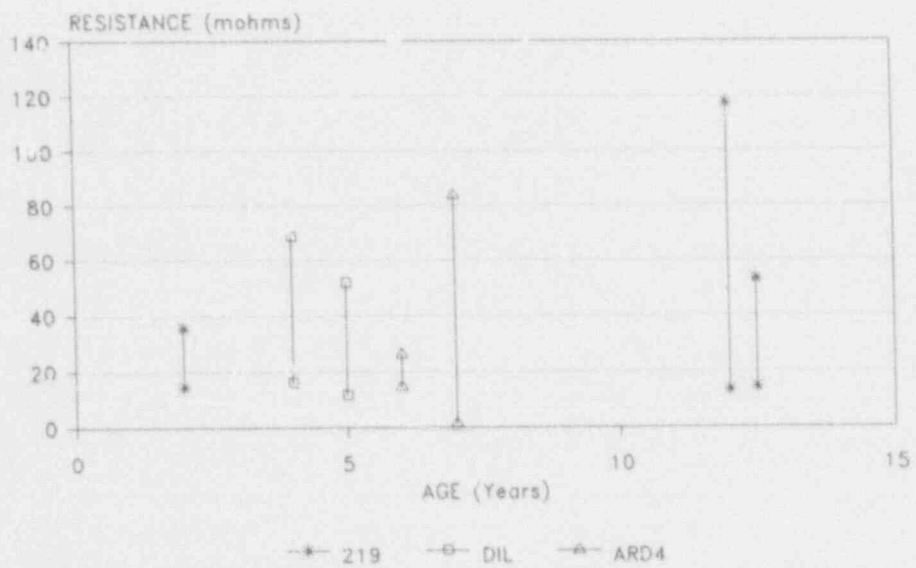
The contact resistance was measured in the as received condition for each specimen and after testing the other ISM methods. The lowest to highest resistances measured for the contact sets of each relay were summarized in Figure 3-18 for the as received initial condition and in Figure 3-19 for the post test condition. The contact resistance of the SD219 relays increased with specimen age. The initial contact resistance of the two year old specimen ranged from a low on one contact set of 5.9 milliohms to a high on another contact set of 25.2 milliohms. Contact resistance for one 12 year old specimen ranged from a low on one contact set of 11 milliohms to an open circuit on another contact set. The open circuit was reduced to 15 milliohms after relay operation. The contact resistance of the other 12 year specimen ranged from a low on one contact set of 7.3 milliohms to a high of 71.3 milliohms.

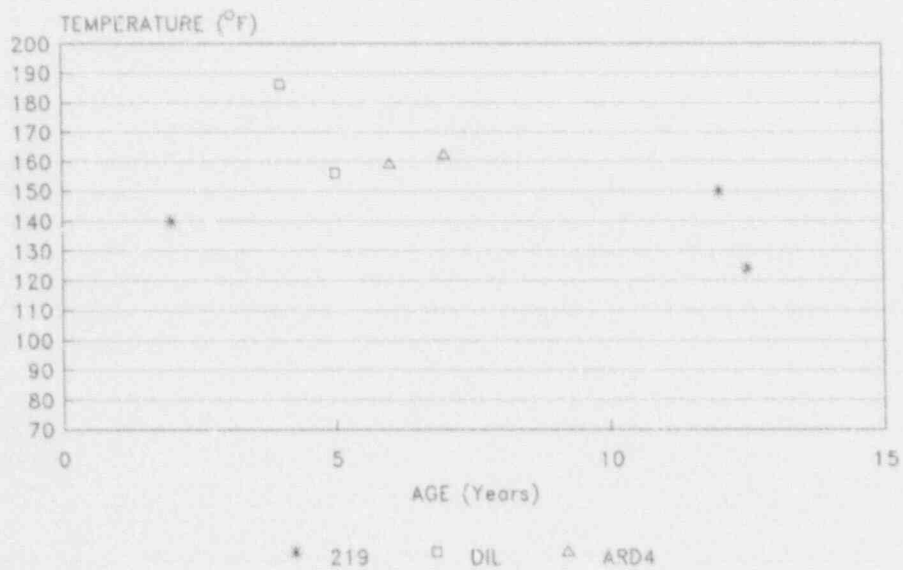
Figure 3-25. Infrared Pyrometry Comparison Control Relays

The maximum temperature measured is shown in Figure 3-25. The one 12 year SD219 relay was cooler than the 2 and other 12 year specimens and correlates with the holding current which was less for this specimen. One of the Klockner-Moeller DIL relays was considerably hotter than the other by 30 °F. This style of control relay has no cover and connections and portions of the coil were visible in the three views (normal, right 45° and left 45°). On one specimen, the maximum temperature was 156°F on the left side of the coil. The other specimen had a reading of 148°F in this same area. The hottest spot of 186°F was in the area of a connection on the right side of the relay.

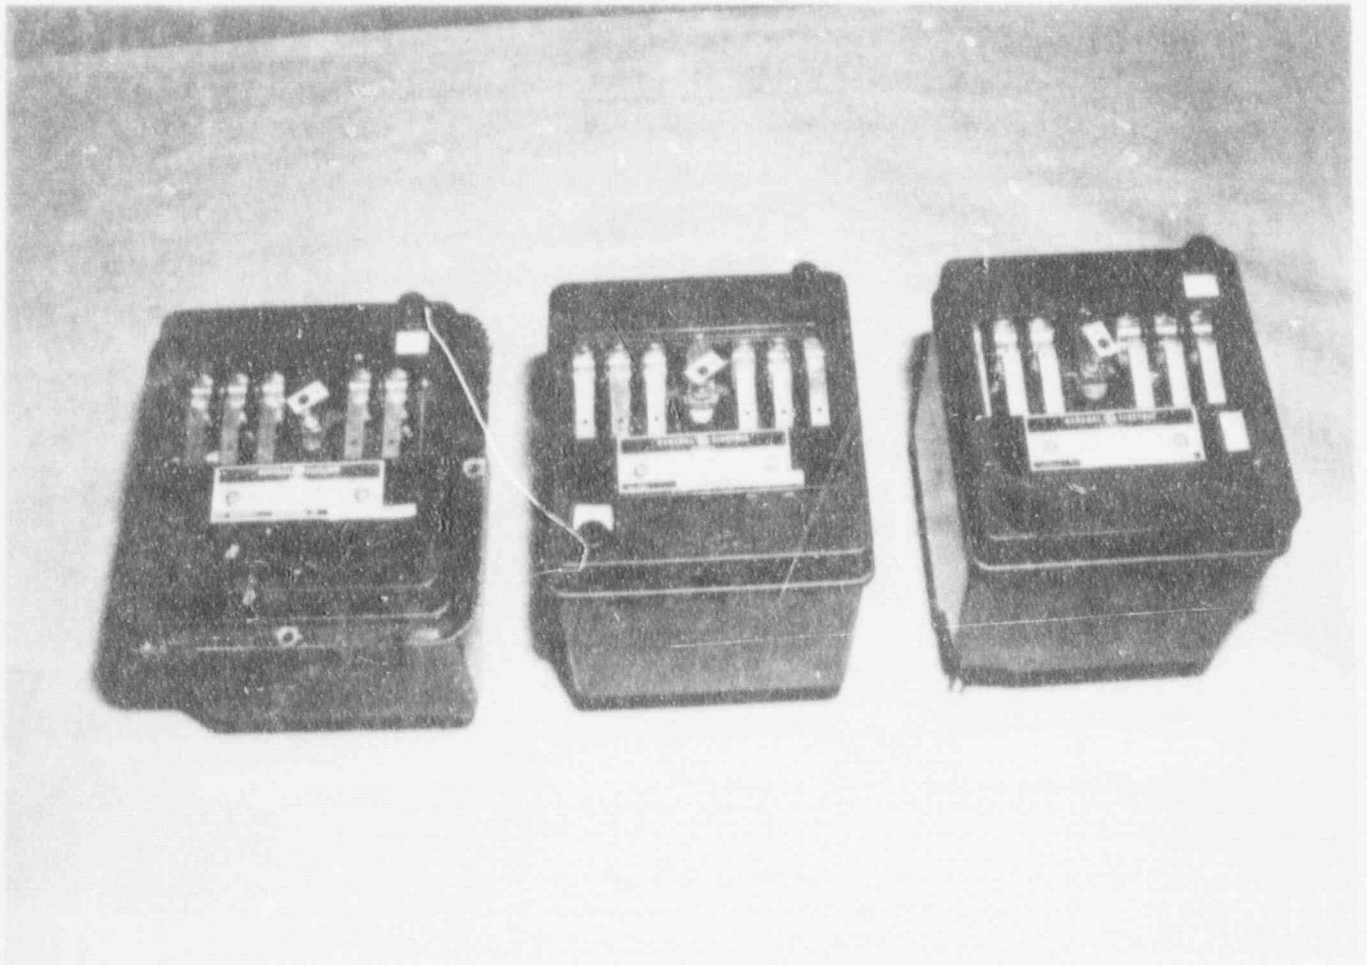
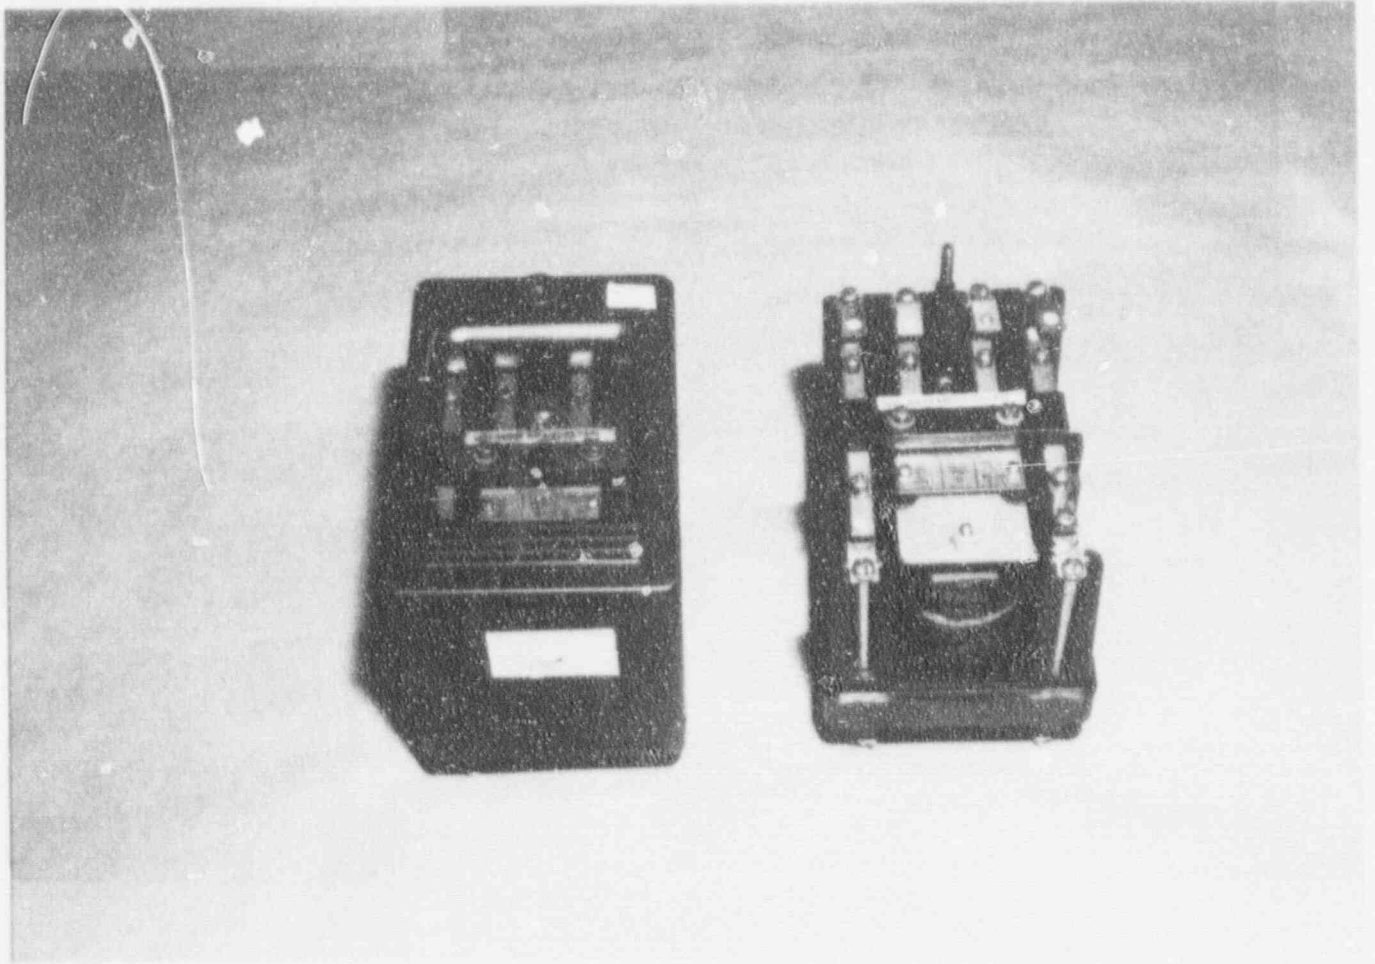
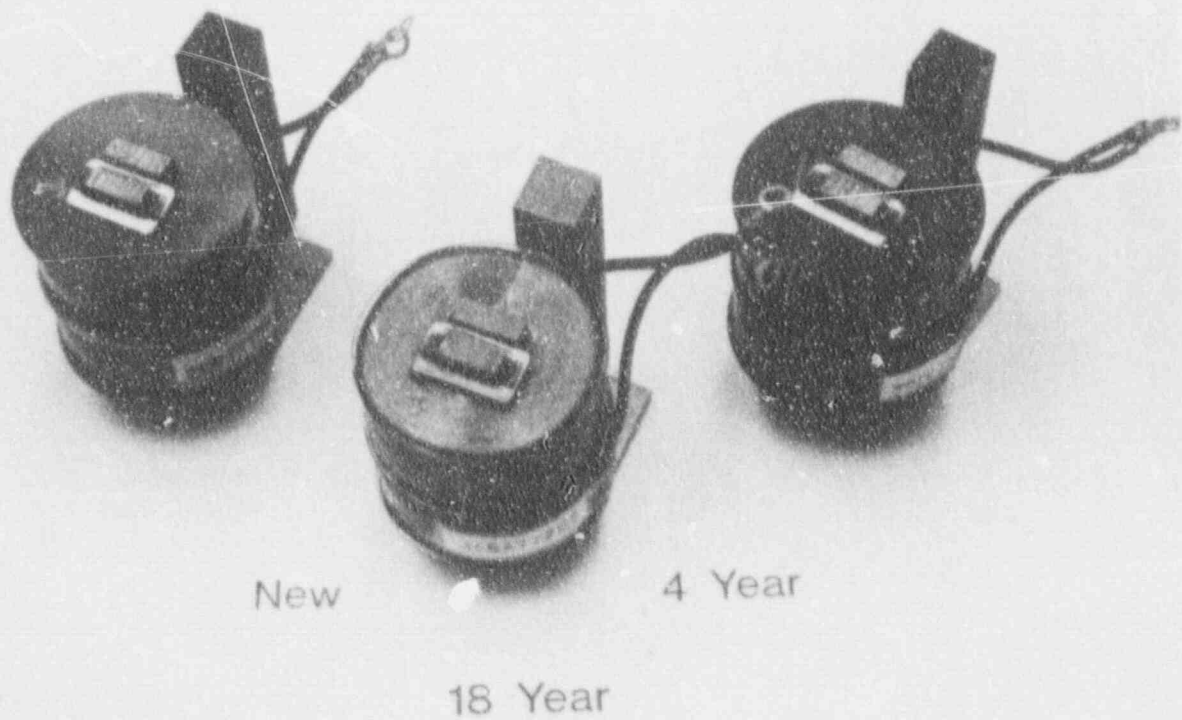
been recommended by IE Bulletin 76-02. All bobbins were in good condition and had no noticeable damaged or broken parts, Figure 3-31.

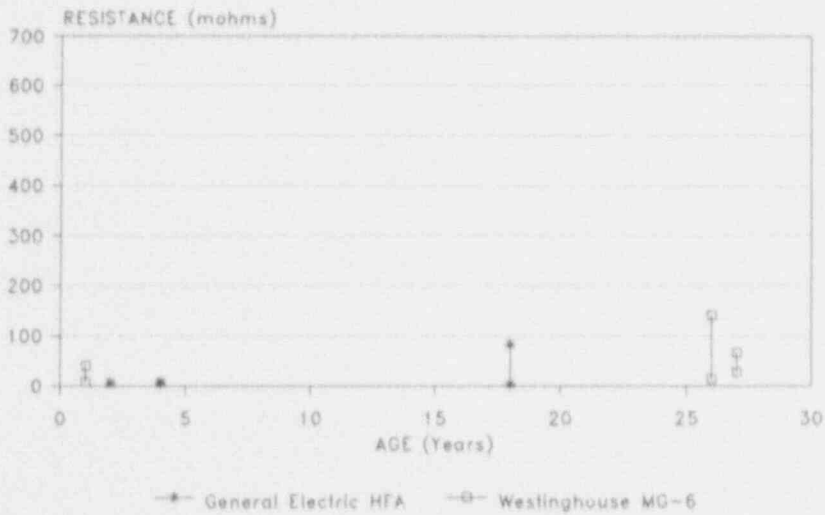
Figure 3-32. Initial Contact Resistance Comparison Auxiliary Relays

The contact resistance for each contact set of the auxiliary relays was obtained by the Kelvin method at 1 Amp. The contact resistance was measured in the as received condition for each specimen and after testing the other ISM methods. The lowest to highest resistances measured for the contact sets of each relay were summarized in Figure 3-32 for the as received initial condition and in Figure 3-33 for the post test condition. The contact resistance of both HFA and MG-6 auxiliary relays increased with specimen age.

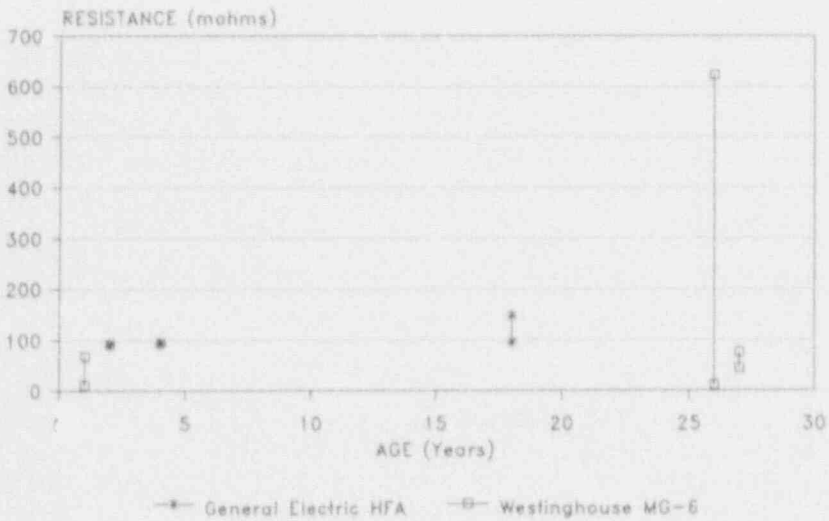
Figure 3-33. Post Test Contact Resistance Comparison Auxiliary Relays

The MG-6 relays were within the manufacturers acceptance criteria, did not change after energization and did not exhibit a trend with age.

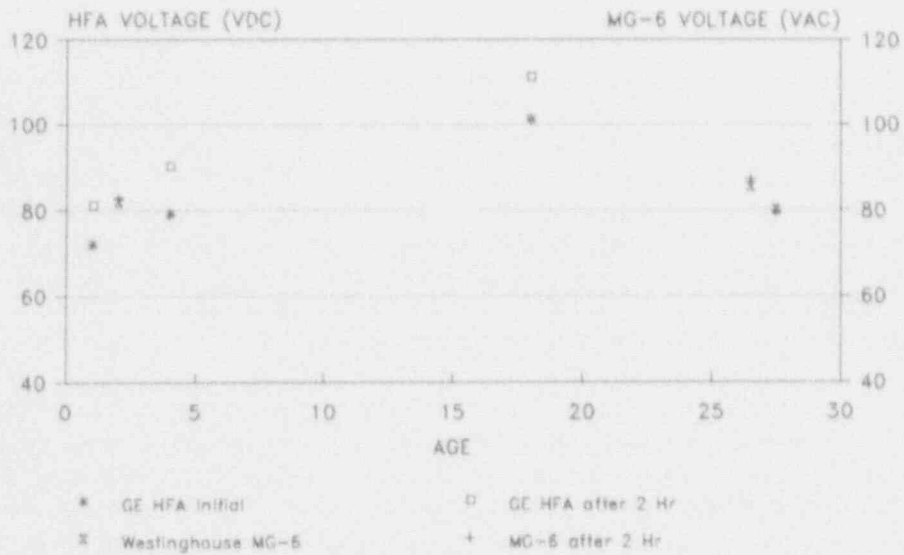
Figure 3-35. Pick-up Voltage Comparison Auxiliary Relays

The significant result for pick-up voltage was the trend towards increased pick-up voltage requirements on the HFA with age and the increase in pick-up voltage requirements after energization. For drop out voltage, no trend with age and no correlation with significant results of other ISM methods were found.

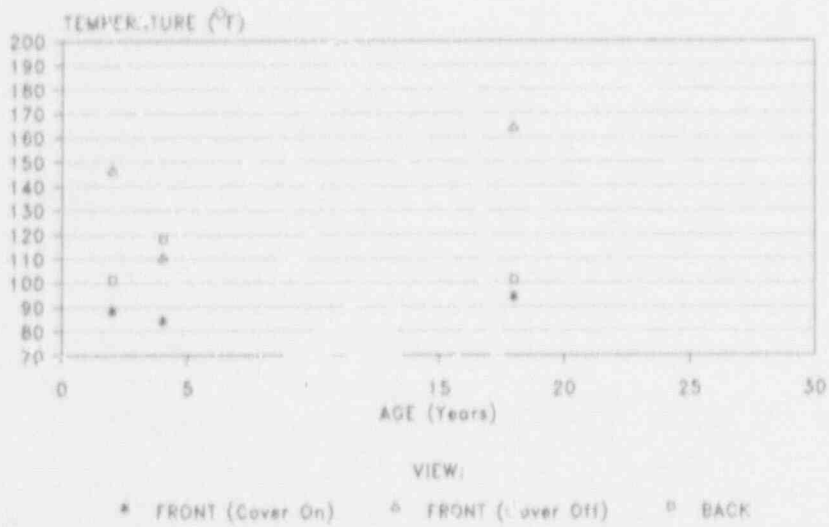
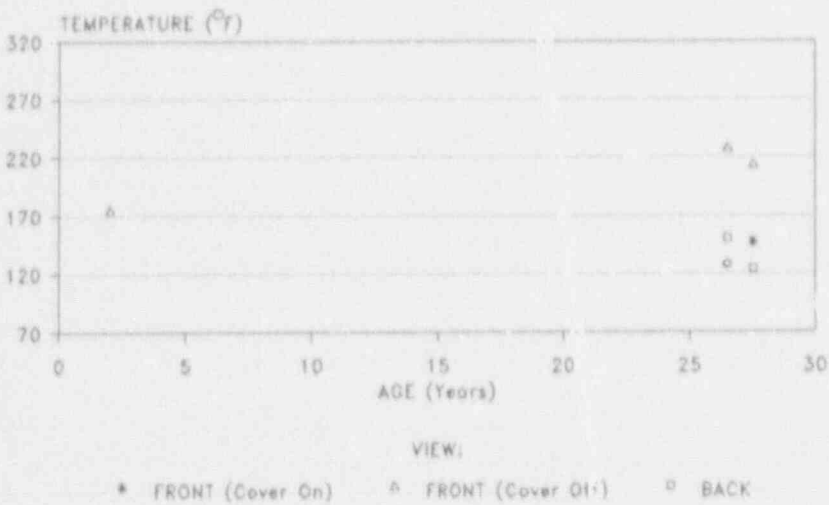
The maximum temperatures measured for the HFA and MG-6 relays are shown, respectively, in Figures 3-36 and 3-37 for the front of the relay with the cover on, front with cover off and the back of the relay for those which were door mounted.

Infrared pyrometry showed some significant differences among the devices. The auxiliary relays exhibited a trend towards increased temperature with age which was observable when the cover was removed. For the 4 year HFA, the hottest spot, which was obtained by the scanner and on-contact temperature measurement from around the coil, was missed with the pyrometer. It was apparently overlooked since the pyrometer requires focusing a 0.25 inch spot on the specimen. Figure 3-36 shows the maximum temperature to be 110°F, which should have been approximately 150°F. Also, for the 18 year HFA relay, pyrometry and on-contact methods missed the hottest spot on the back of the relay, which was shown to be 100°F hotter with the scanner.

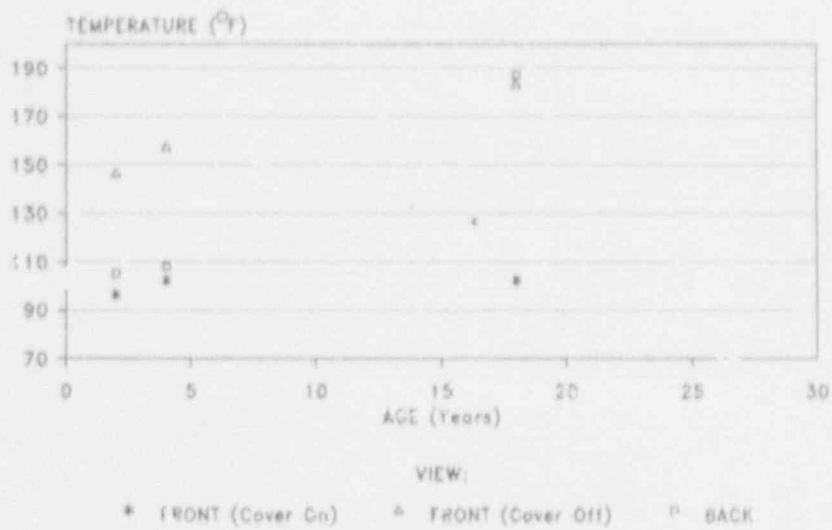
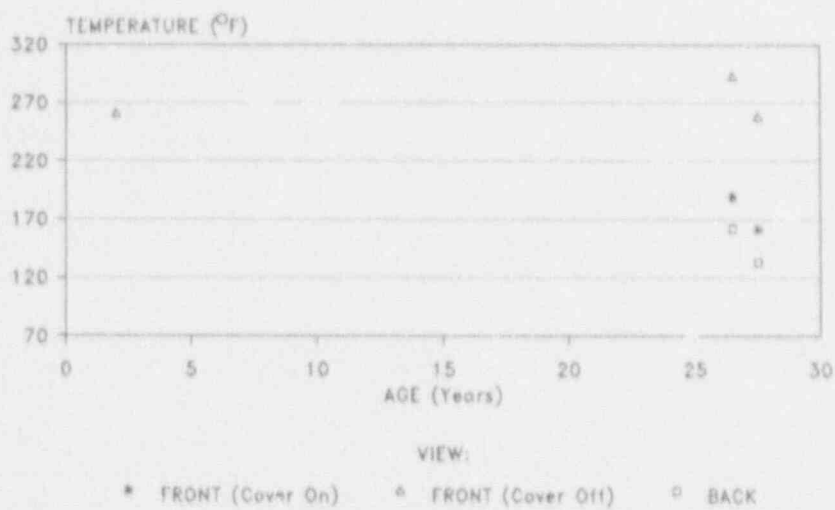
The maximum temperatures measured are shown in Figures 3-38 and 3-39 for the HFA and MG-6 relays, respectively. Infrared scanning showed the same trends as infrared pyrometry. The maximum temperature was measured to be slightly hotter with scanning than pyrometry in five out of six relays. The clear bobbin on the 18 year HFA coil made the magnetic wire visible and this coil exhibited a higher temperature of approximately 30°F than the other coils. The scanner showed that the back of the 18 year HFA relay, opposite the coil, was 100°F hotter than obtained with the pyrometer and on-contact methods.

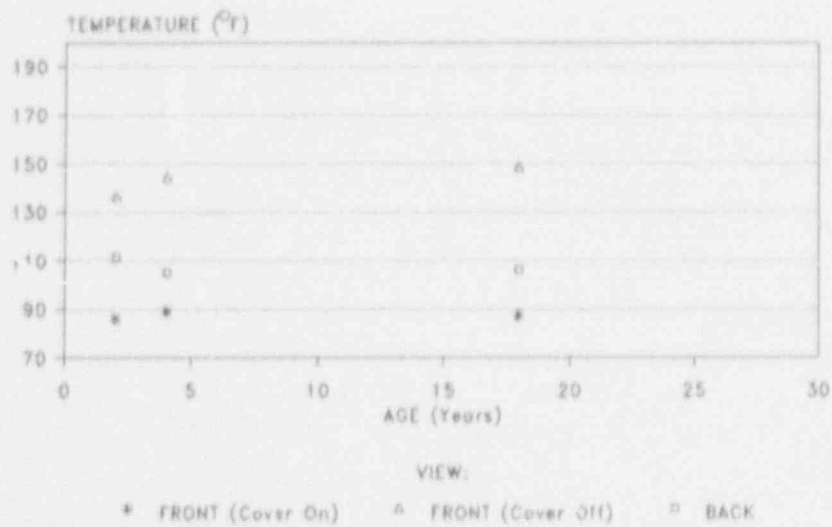
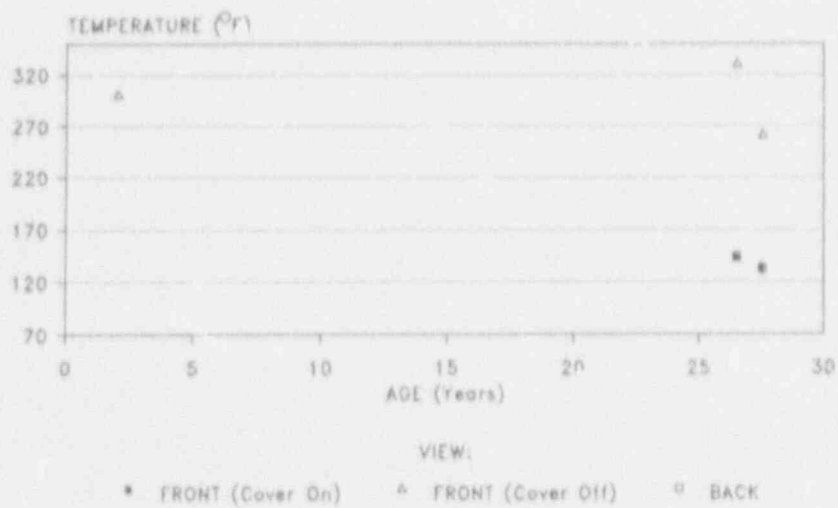
The maximum temperatures measured are shown in Figures 3-40 and 3-41 for the HFA and MG-6 relays, respectively. For the MG-6 relays, on-contact measured significantly hotter temperatures, with the cover off, since the actual hottest spot was accessible with the on-contact probe for this model of relay. For the HFA relays, on-contact measured the hot spots at approximately 10°F less than the scanner and approximately the same as the pyrometer, with two exceptions. For the 18 year HFA, the on-contact measurement on the coil was 35°F less than the scanner. The on-contact measurements were less because the hottest spots, the coil, was inaccessible by the probe. Also, for the 18 year HFA relay, pyrometry and on-contact missed the hottest spot on the back of the relay, which was shown to be 100°F hotter with the scanner. The on-contact method

pinpoints a spot, therefore the location of the hottest spot was overlooked because it was on the case in a location not near the contacts, which were suspected to contain the hottest spot.

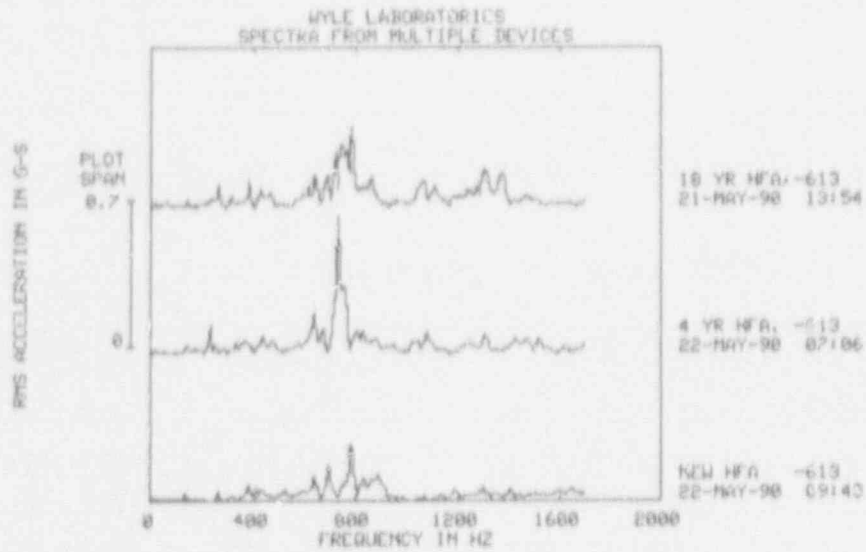
Figure 3-42. Vibration Signatures of GE HFA Auxiliary Relays

Vibration signatures were obtained during the pick-up tests. The vibration signatures were repeatable and differences noted among the different aged specimens for both the HFA and MG-6 auxiliary relays. The vibration signatures for the HFA relays are shown in Figure 3-42. Differences in the vibration signatures were mainly in the range from 636 Hz to 800 Hz although several additional peaks were noted on the 18 year HFA.

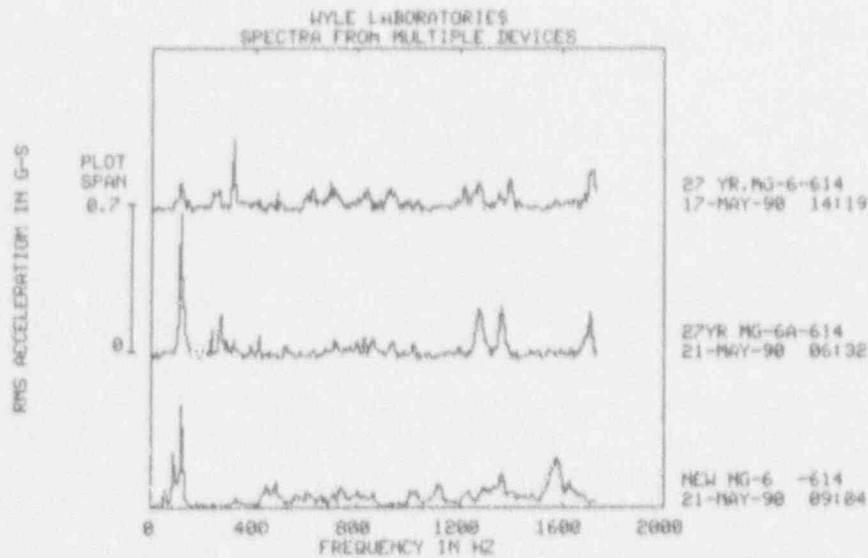
Figure 3-43. Vibration Signatures of Westinghouse MG-6 Auxiliary Relays

For the MG-6 relays, Figure 3-43 shows the differences among the three relay specimens. Changes were noted in the peaks at approximately 110 Hz, the addition of peaks at 1272, 1358 and 1800 Hz and loss of peak at approximately 1600 Hz in the 27 year specimens.

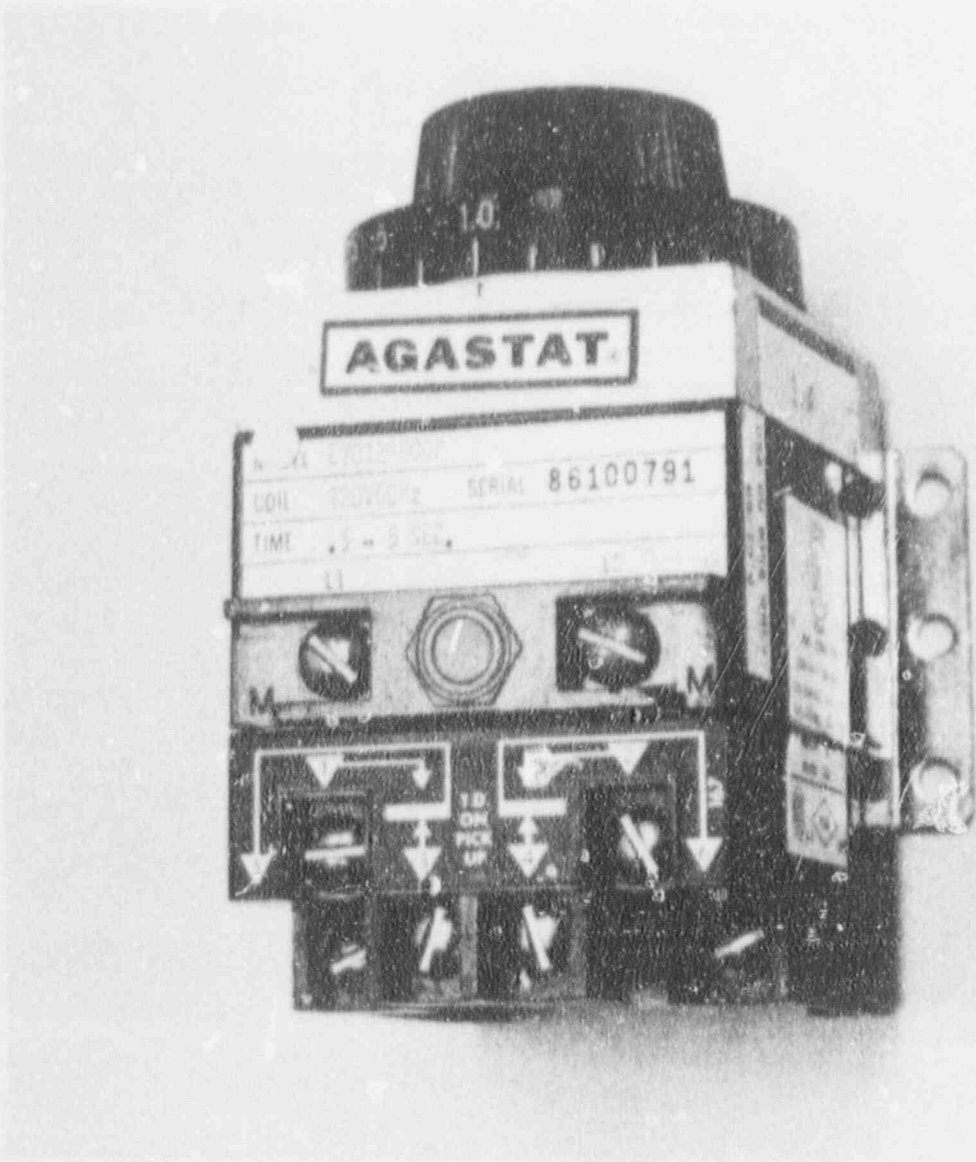
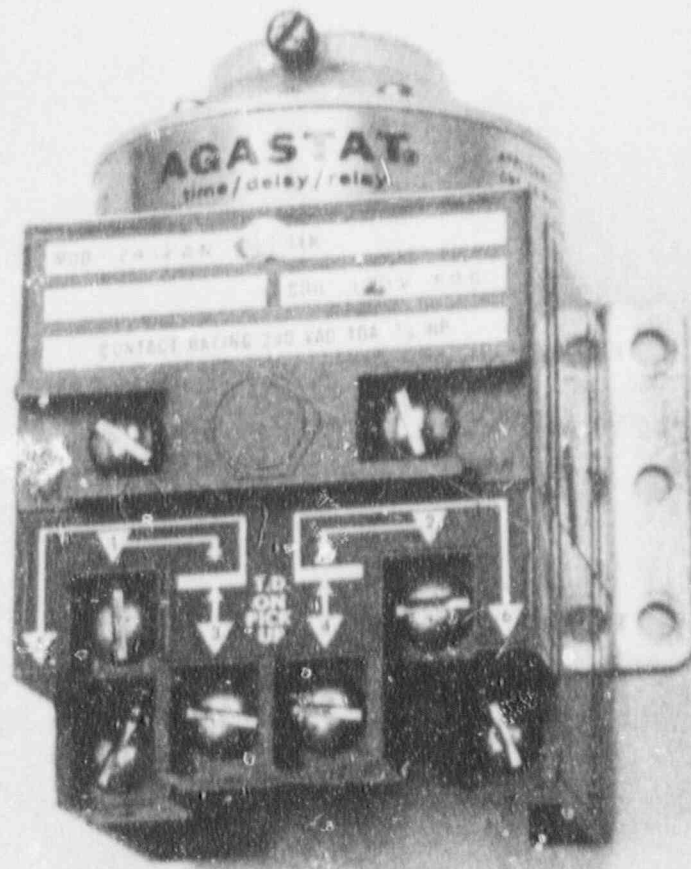
The visual inspections on the timing relays showed no obvious problems existed and all appeared to be in good condition. Figures 3-44 and 3-45 show the 4 year E7012AB and 23 year 2412AN, respectively.

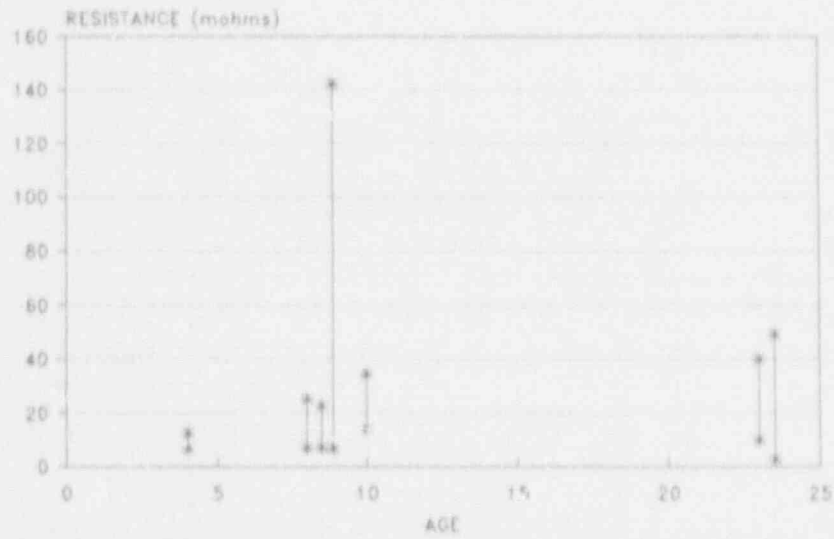
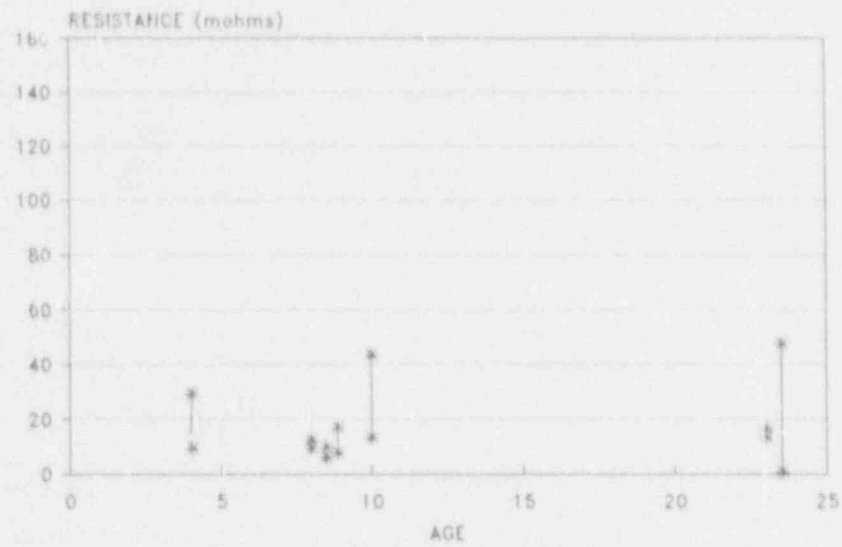
The contact resistance was measured in the as received condition for each specimen and after testing the other ISM methods. The lowest to highest resistances measured for the contact sets of each relay were summarized in Figure 3-46 for the as received initial condition and in Figure 3-47 for the post test condition. The contact resistance did not change significantly with age.

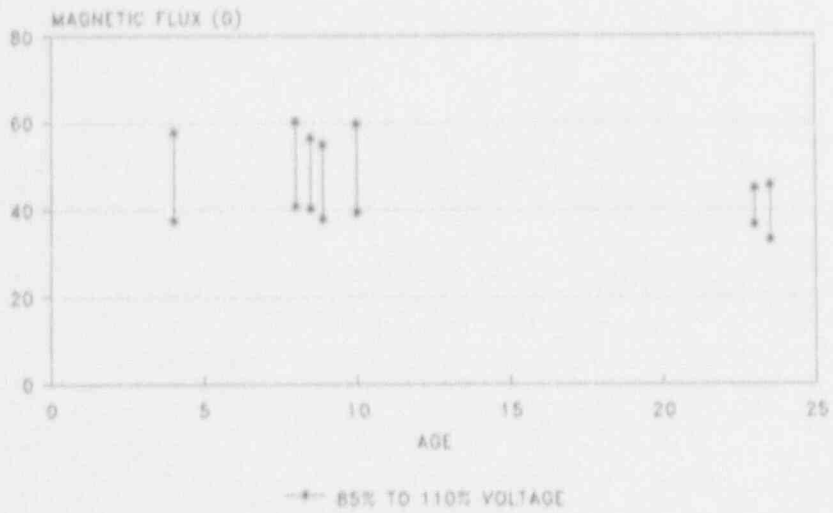
Figure 3-48. Magnetic Field Comparison Timing Relays

The relay specimens were measured at 85%, 100%, and 110% of rated coil voltage and were plotted in Figure 3-48 showing the value at 80% voltage at the bottom and the value at 110% voltage at the top of each band. The differences in magnetic flux were not considered to be significant and no correlation with significant results of other ISM methods were found.

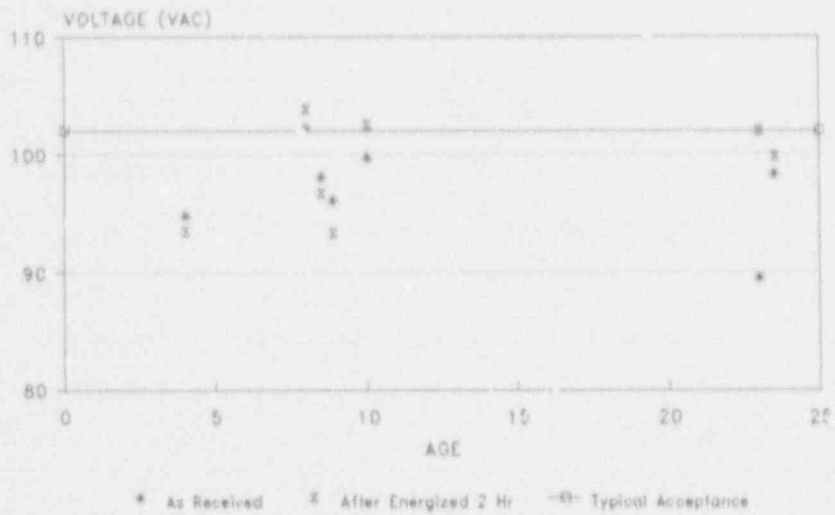
Figure 3-49. Pick-up Voltage Comparison Timing Relays

The pick-up voltages for the timing relays were taken three times when the relay was at ambient conditions in the as received condition and three more times after it had been energized for 2 hours, Figure 3-49. The pick-up voltage on the 8 year 7012AC timing relay was out of the typical acceptance criteria of 102 volts in the as received condition. After energization for 2 hours, the pick-up voltage increased for four out of the seven timing relays. The pick-up voltages on the 8 year 7012AC, 10 year 7012AC and 23 year 2412AN relays exceeded the typical acceptance criteria.

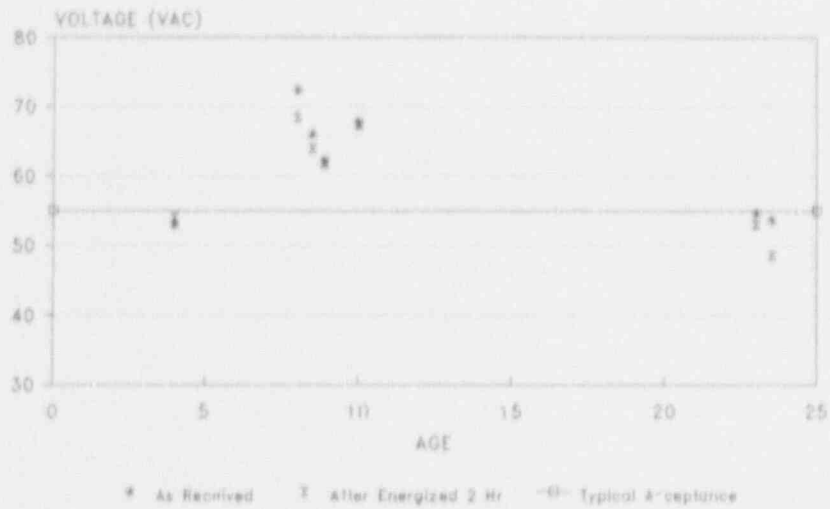
Figure 3-50. Drop Out Voltage Comparison Timing Relays

The drop out voltages for the 4 year E7012AB, 23 year 2412AN and 2412AD exceeded the typical acceptance criteria of 50% rating, Figure 3-50.

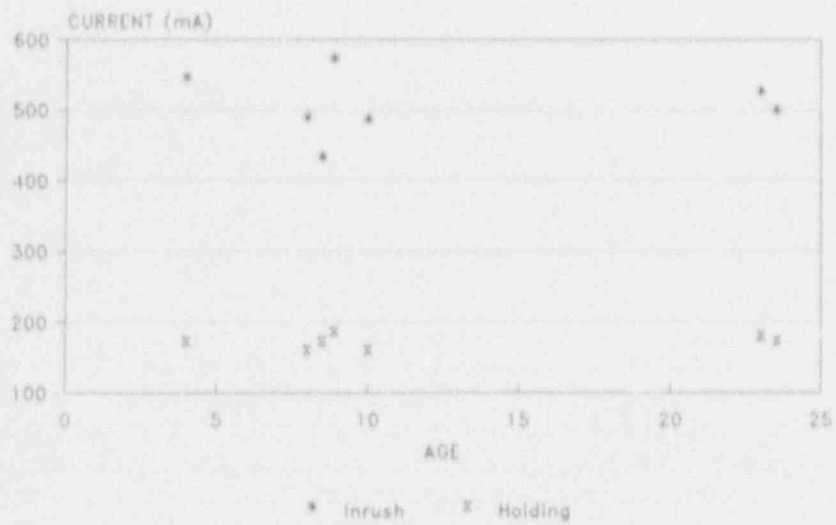
Figure 3-51. Inrush and Holding Current Comparison Timing Relays

Differences in inrush and holding current for the timing relays were not significant, Figure 3-51. No trend with age and no correlation with significant results of other ISM methods were found.
