NUREG/CR-5762
WYLE 60101

Comprehensive Aging Assessment of Circuit Breakers and Relays

Wyle Laboratories

Prepared for
U.S. Nuclear Regulatory Commission

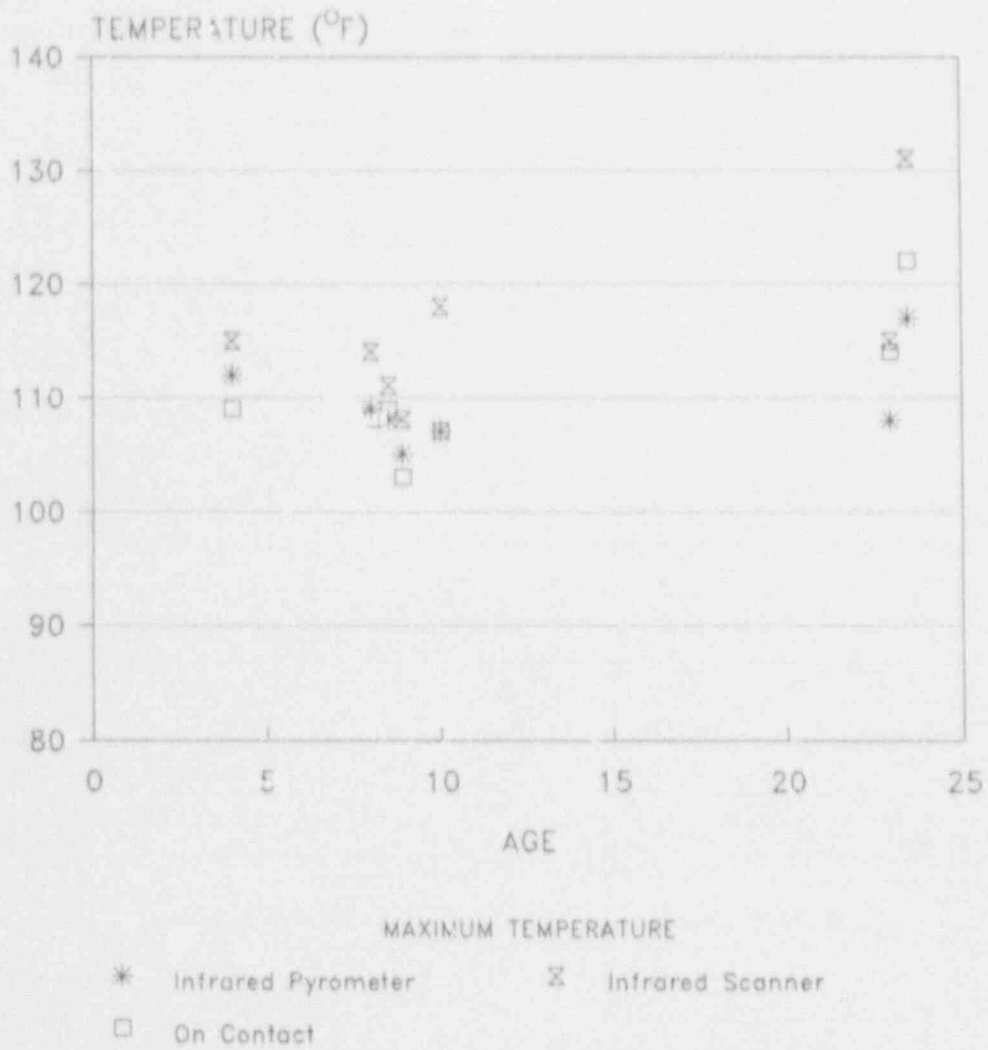
Figure 3-53. Temperature Comparison Timing Relays

The scanner showed the maximum temperatures, Figure 3-53, to be hotter than the pyrometer and on-contact methods for all seven relays. A trend towards increased temperature with age was noted with the scanner. The 23 year 2412AD relay was the hottest relay.

The maximum temperatures obtained are shown in Figure 3-53. The on-contact method pinpoints a spot, therefore the area of the hottest spot was overlooked on the 8 year 7012AC, 10 year 7012AC and 23 year 2412AD, because it was on the case in an area not near the contacts, which were suspected to contain the hottest spot. Thus the on-contact method did not show the trend towards increased temperatures with age that was noted with the scanner.

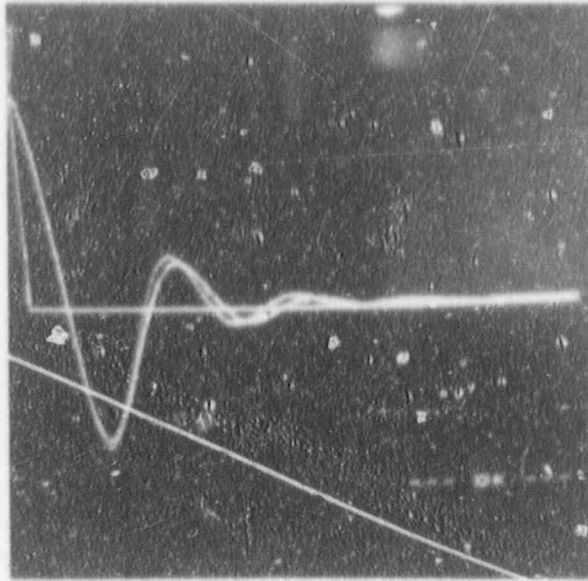
Figure 3-54. Current Surge Comparison
on 23 Year Old 2412AD Timing Relay

Ringng was noticeable on the two 23 year timing relays, which may be due to aging of the coil insulation, but could be due to differences in the manufacturing process. The waveform comparison is shown in Figure 3-54 for the 23 year 2412AD, which had the most noticeable ringing. The current surge comparison on timing relays may indicate a trend with age.

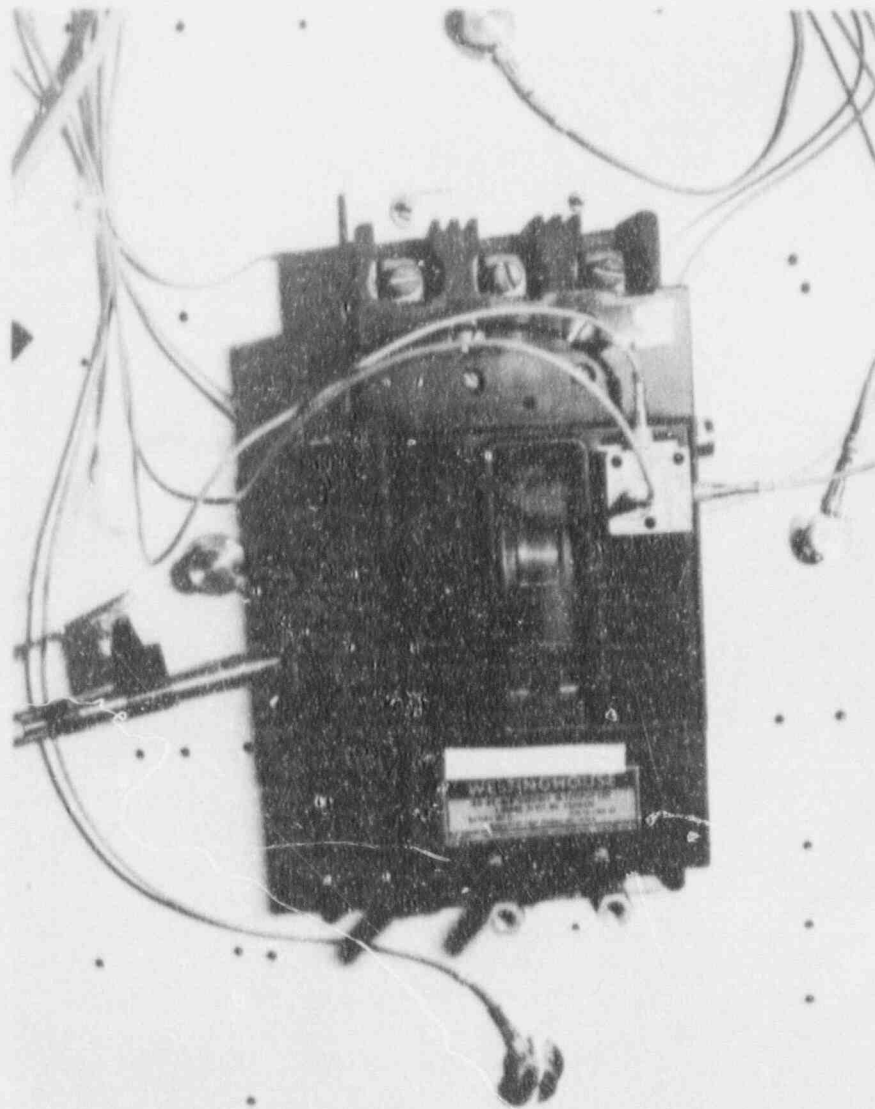
The Westinghouse AB DE-ION circuit breakers were 100 amp, 600 VAC adjustable magnetic trip only. The magnetic adjustment range was 500 amps to 1500 amps. The specimens were extremely dusty but showed no signs of physical damage or missing parts. There were no signs of electrical damage such as melting insulation or discolored terminal lugs and the closing and opening actions were crisp. The sealing compound covering the back screws of the circuit breaker was present and undamaged. Figure 3-55 shows a 30 year Westinghouse AB DE-ION, Style Number 1222077A mounted for testing.

Figure 3-55. Westinghouse AB DE-ION Style
1222077A Molded Case Circuit Breaker
Showing Location of Vibration Accelerometers
and Acoustic Microphone

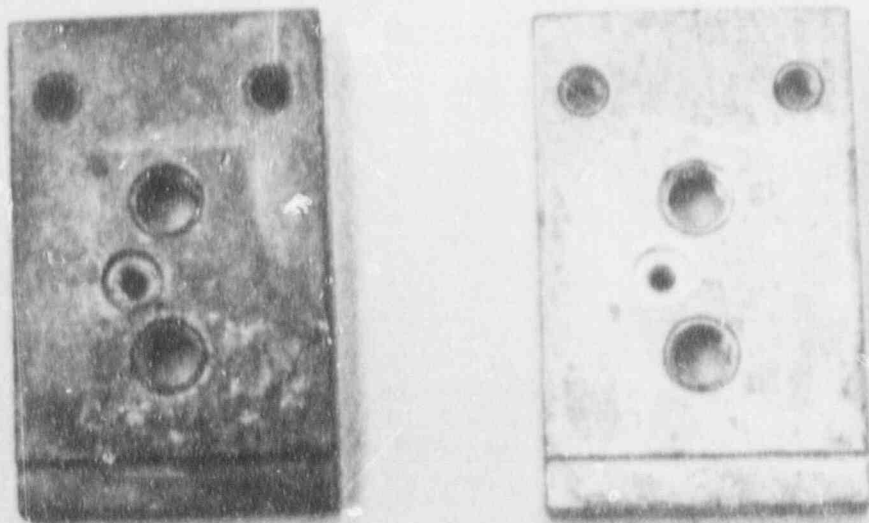
The ITE KMB2F800 was a 800 amp, 600 VAC adjustable magnetic trip circuit breaker. The adjustable magnetic trip range was 3200 to 5600 amps. The specimen was clean except for dust on the top near the arc chutes and dust and cobwebs inside the cover on the line side of the breaker. The load and line poles of pole number one were significantly discolored and had evidence of having been overheated. The operating handle was cracked at the base. The breaker was manually closed and then opened with the manual trip button, which operates the instantaneous trip mechanism for pole number 2. The breaker operated properly when manually set, tripped and reset. The history of this breaker was that it had been tripping at less than rated loads, which had been traced to a loose

connection on the incoming bus, after the breaker had been replaced. Figure 3-56 shows the KMB2F800 and Figure 3-57 shows the differences in color between the overheated pole 1 and normal pole 2.

Figure 3-57. Overheated Pole 1 Compared to Pole 2
of ITE KMB2F800 Molded Case Circuit Breaker
(Pole 1 on Left)

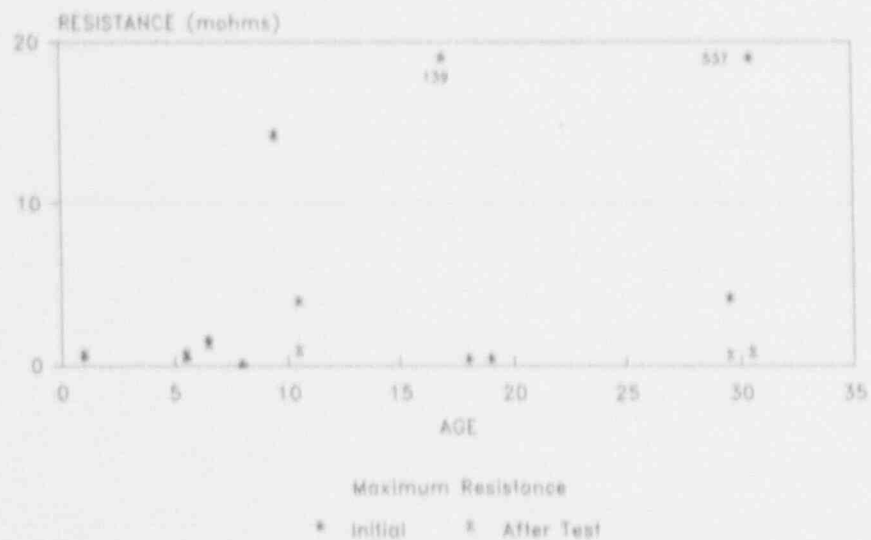
Figure 3-58. Pole Resistance Comparison Molded Case Circuit Breakers

The pole resistance was measured in the as received condition for each specimen and after testing the other ISM methods. The highest resistances measured for the poles of each circuit breaker were summarized in Figure 3-58 for the as received initial condition and for the post test condition. The pole resistance of one of the HFB breakers was 139 mohms and one of the poles of a 30 year breaker was 537 mohms. The pole resistance showed a trend towards increased resistance with age. Lack of operation appears to contribute to this increase in pole resistance since the initial values were higher than the value obtained after the ISM methods had been performed. Pole resistance in general did not correlate with problems noted in the other ISM techniques except for the temperatures noted on the 30 year breaker with high resistance.

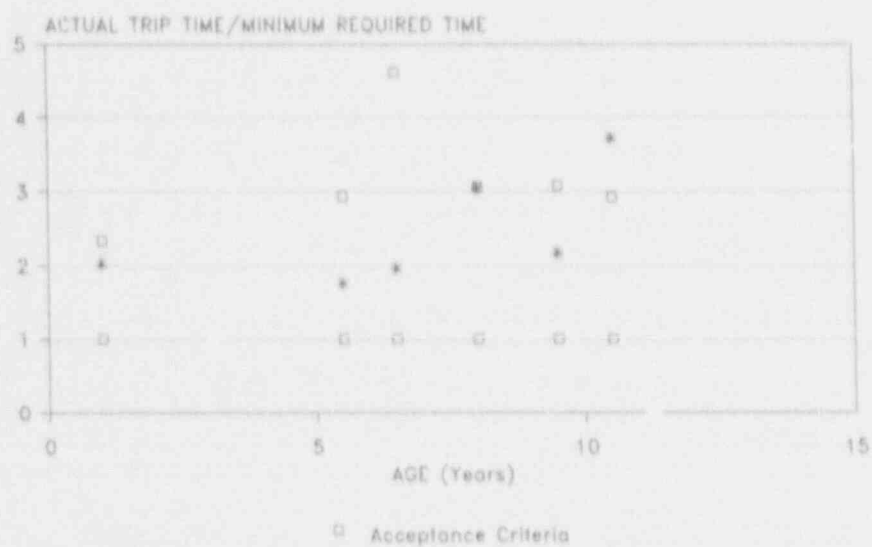
Figure 3-59. 300% Overcurrent Comparison Molded Case Circuit Breakers

The results of the 300% overcurrent method were summarized for the circuit breaker specimens in Figure 3-59 and the performance of each pole of each breaker were compared in Table 3-1.

In Figure 3-59, the actual trip time was divided by the manufacturer's minimum required trip time from each manufacturer's trip curves for the pole with the greatest trip time. This allowed a comparison of all breakers tested. Two breakers had significant results. The 8 year ITE KMB2F800 circuit breaker was out of the manufacturer's specification on pole one. Additionally, the ten year Klockner-Moeller NZMH6-100 was out of specification on all three poles. The out of specification condition on both molded case circuit breakers allowed the breakers to conduct higher current for a longer period of time before the breakers interrupted the circuit.

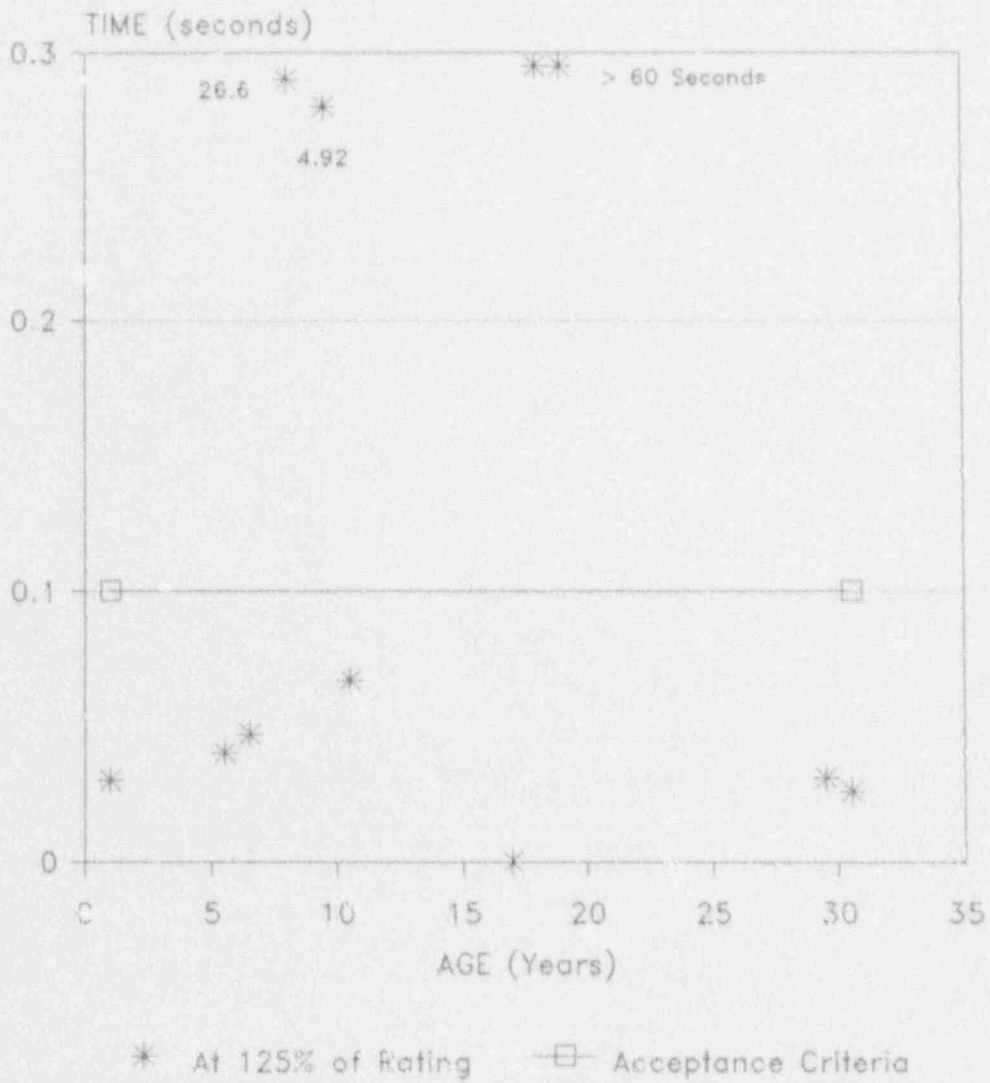
Figure 3-62. Instantaneous Trip Comparison Molded Case Circuit Breakers

Four out of the eleven molded case circuit breakers exceeded the typical 0.1 second acceptance criteria at the 125% test point, Figure 3-62. They were the 8 year ITE KMB2F900, 10 year Klockner-Moeller NZMH6-40, and the two Westinghouse HFB31550 molded case circuit breakers.

For the ITE KMB2F800, the trip time at 125% of the upper magnetic threshold at the low setting of the magnetic adjustment was 26.6 and 0.07 seconds for poles 1 and 2 respectively. At 120% of the upper magnetic threshold at the high setting of the magnetic adjustment, neither pole was less than 0.1 seconds. A current of 5600 amps should have caused an instantaneous trip. Pole 1 was tested as high as 22,000 amps, using a short duration current pulse, and never tripped instantaneously. Pole 2 tripped instantaneously at a current of 9,160 amps.

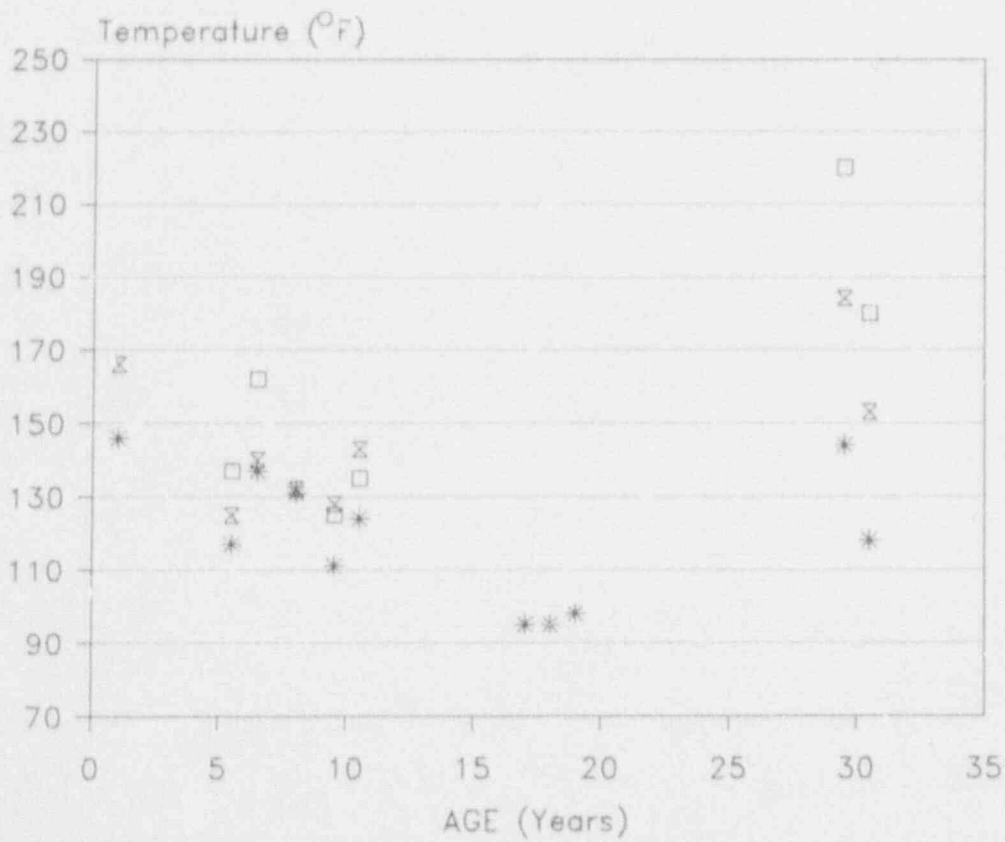
The scanner showed the maximum temperatures, Figure 3-68, to be hotter than the pyrometer for all eight circuit breakers measured. No trend with age was noted with the scanner although the highest temperatures were measured on one of the 30 year breakers.

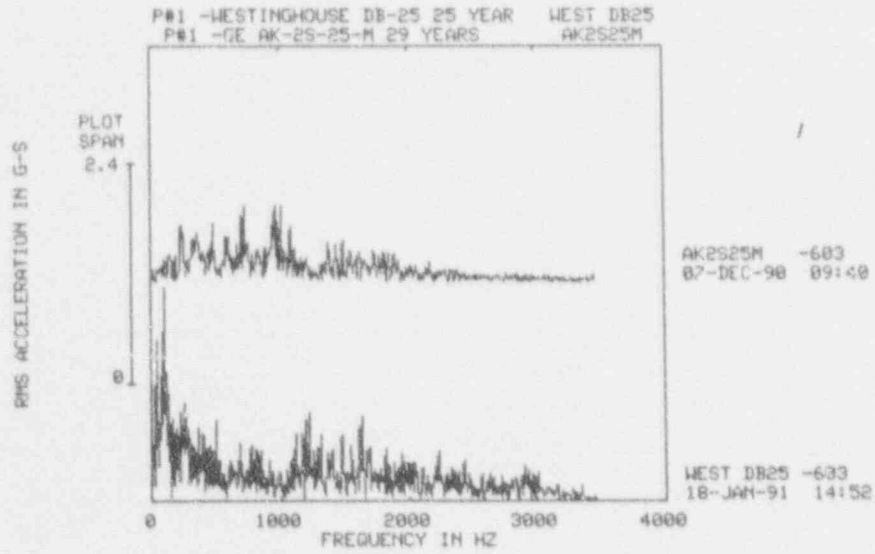
Figure 3-71. Vibration Signatures of
Metal Clad Circuit Breakers

Vibration signatures were obtained during manual actuation, the long time delay and short time delay overcurrent tests. The vibration signatures were repeatable for each breaker. Differences were noted between the metal clad circuit breakers. The vibration signatures were analyzed in the frequency domain, Figure 3-71. The specimens had different trip mechanisms and therefore the differences in the vibration signatures could not solely, be attributed to age but were a reflection of the different breaker styles and their trip mechanisms.

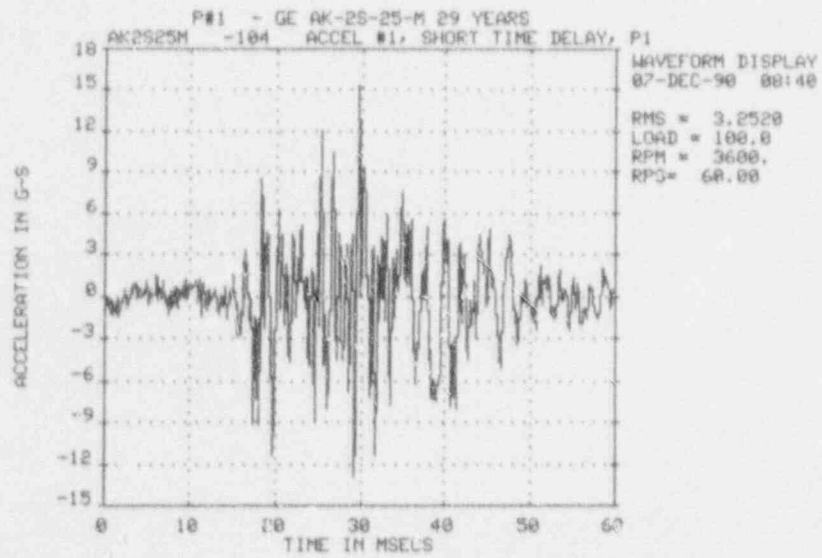
Figure 3-72. Vibration Time History
 Signature of GE AK-2S-25-M
 Metal Clad Circuit Breaker

The main vibration signature was caused by the tripping of the main contacts. The vibration signature was continuously monitored, before and during the manual actuation, the long time delay and short time delay overcurrent tests. When the vibration exceeded a trigger level, caused by the main breaker trip, the vibration signature and a set portion of the signature prior to the trip were captured and stored. The portion of the signature prior to the trigger event was known as pre-trigger. Figure 3-72 shows the time history of the vibration signature for the GE AK-2S-25-M, from a short time delay overcurrent trip on pole 1. The main vibration starts at approximately 18 milliseconds and lasts for approximately 30 milliseconds. The pre-trigger portion, prior to 18

milliseconds, of the time history signature contained the information on the initiating vibration from the short time delay function for the EC-1 trip device.

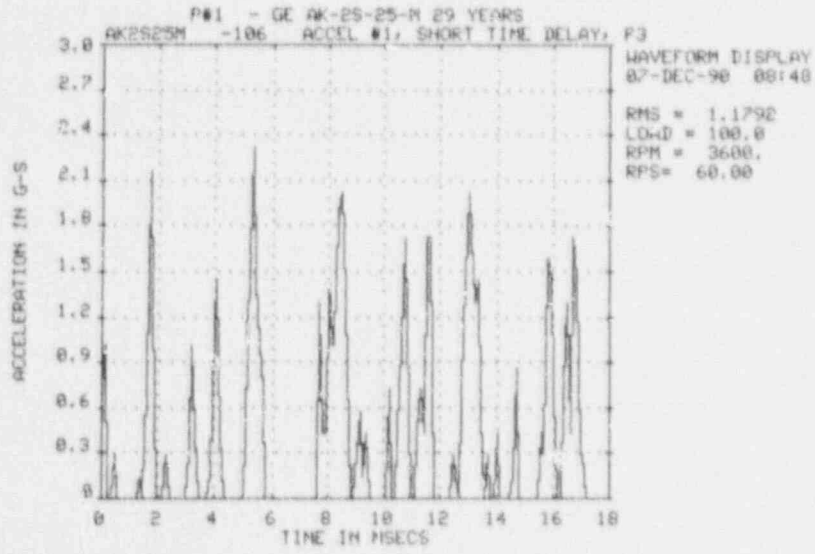
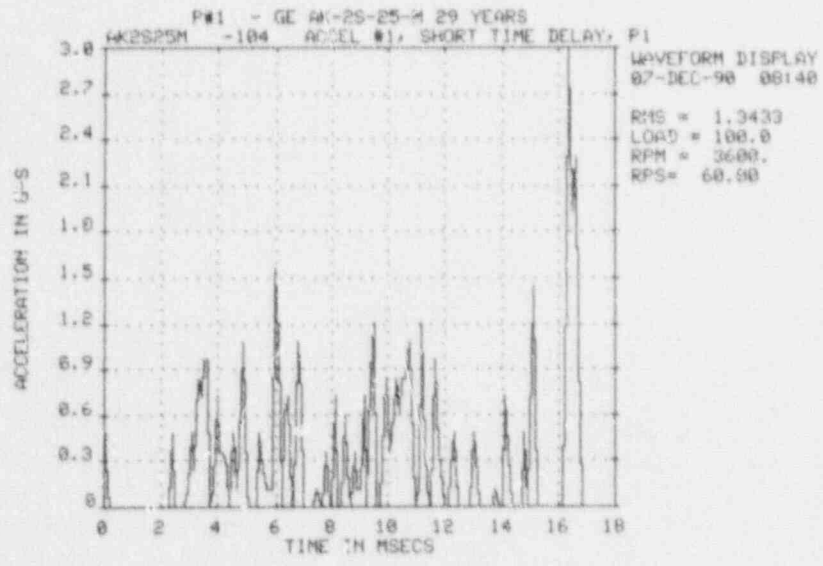
Figure 3-73. Vibration Time History Comparison of EC-1 Trip Devices on Pole 1 and Pole 2

Analyses of the vibration signature time histories for the initiating events of manual trip, short time delay overcurrent trip and long time delay overcurrent trip were performed for the pole 1 and pole 2 EC-1 trip devices. Significant differences were noted among the three initiating events and between the performance of the EC-1 trip devices on each pole. Figure 3-73 shows the difference between the EC-1 trip devices on pole 1 and pole 2 for the short time delay overcurrent trip. The higher pre-trigger vibrations noted in pole 2 were caused from the defective long time delay overcurrent trip function of the EC-1 on pole 2 which was out of oil and therefore not providing any delay. The analysis of the vibration signature correlated with the time characteristic information obtained from the short time delay overcurrent method to show that the EC-1 on pole 2 was defective.

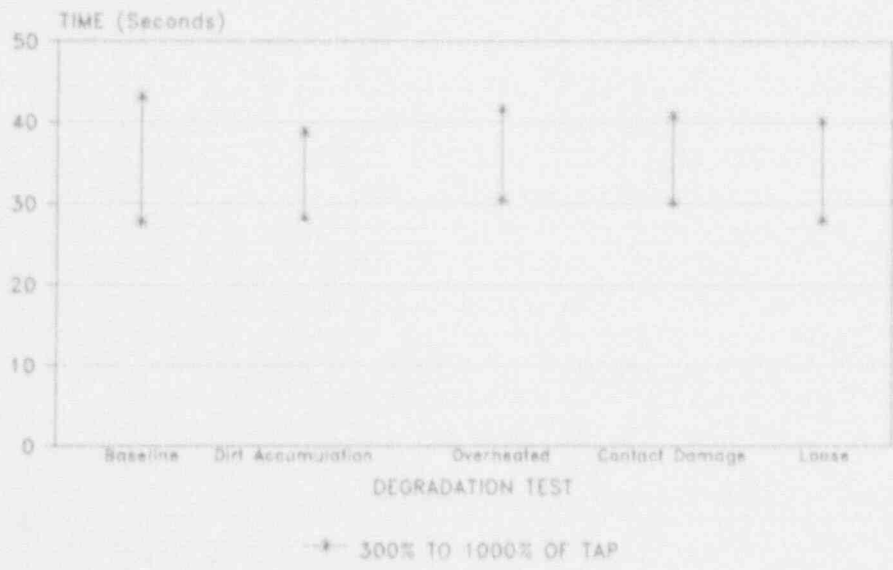
Figure 4-1. Induction Unit Timing Comparison Protective Relay Westinghouse

The ISM methods of insulation resistance, zero check, time / current characteristic, instantaneous trip unit, inrush current, operating current and ion detection did not show any significant change from the original baseline parameters during any of the degradation tests. Figures 4-1 through 4-4 show the results of induction unit timing(time / current characteristic), inrush / operating current and instantaneous trip unit.

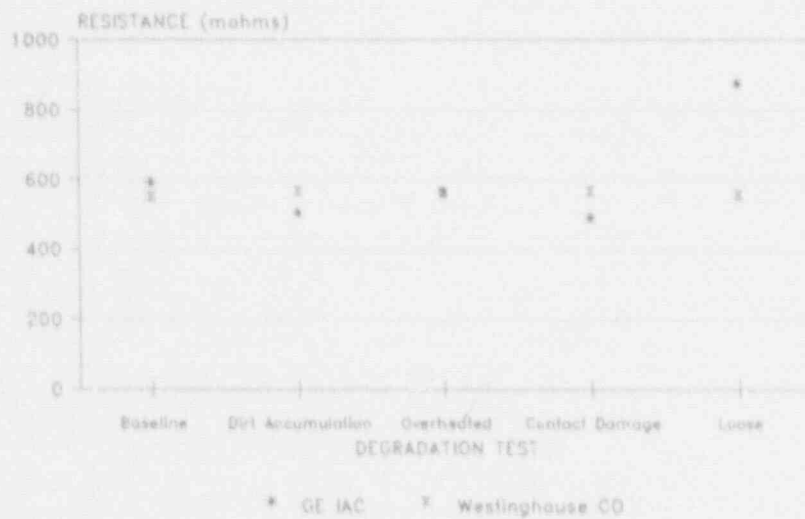
Figure 4-5. Contact Resistance Comparison Protective Relays

Contact resistance changed significantly in one out of the five degraded conditions on the GE relay, Figure 4-5, and was about the same or increased slightly on four out of five degraded conditions on the Westinghouse relay, Figure 4-5. The significant increase in contact resistance was on the GE specimen during the loose connections test. It increased 48% from baseline.

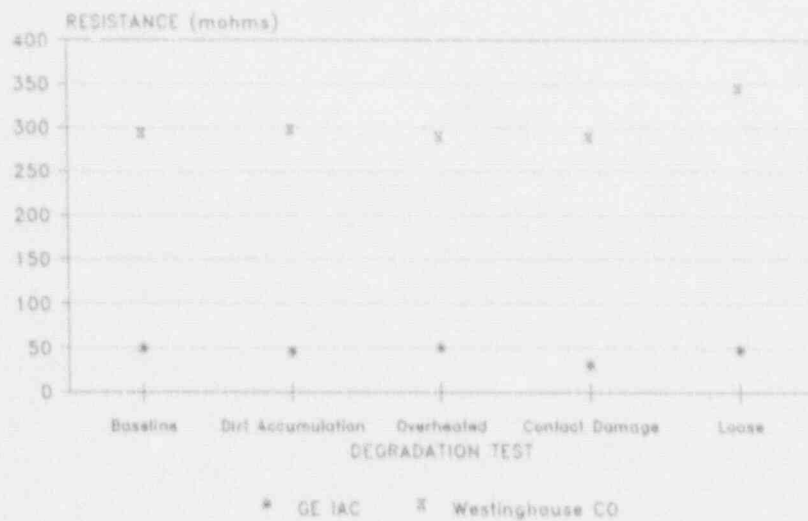
Figure 4-6. Coil Resistance Comparison Protective Relays

Coil resistance changed significantly in one out of the five degraded conditions on the Westinghouse relay and the GE relay, Figure 4-6. The loose connections test caused an increase of 17% from baseline for the Westinghouse relay. The contact damage, when the induction unit contacts of the GE specimen were soldered

together, resulted in a coil resistance decrease of 37.4% from baseline.

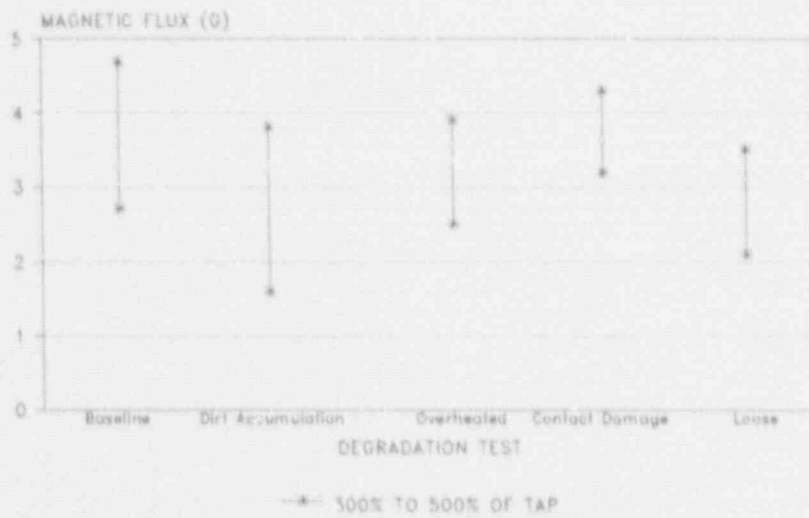
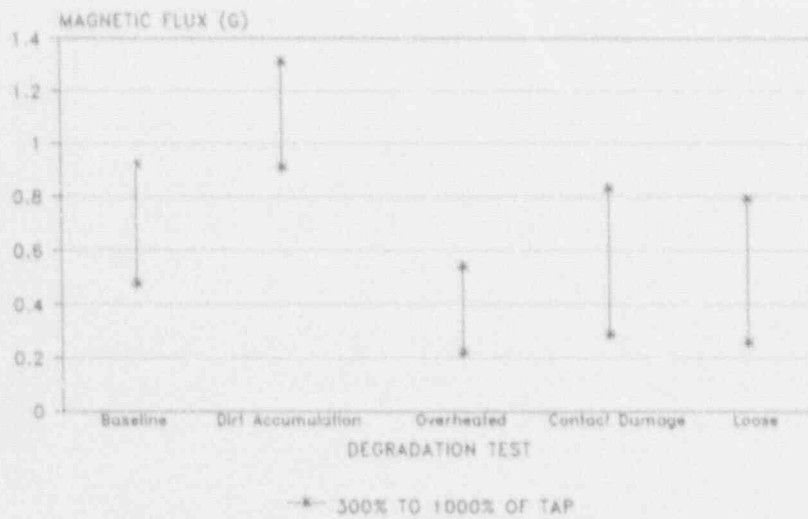
Magnetic flux changed significantly in four of the five degraded conditions. Dirt accumulation, overheated, contact damage and loose connections all caused the flux to decrease or shift for both specimens, Figures 4-7 and 4-8.

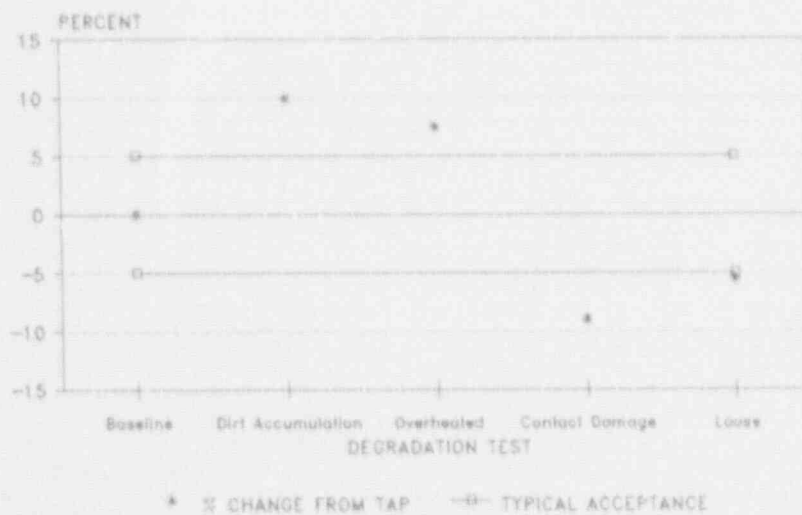
Figure 4-9. Induction Unit Pickup Comparison Protective Relay Westinghouse

Induction unit pick-up changed significantly in four of the five degraded conditions for the Westinghouse relay and one out of five for the GE relay. All degraded conditions except for high potential testing caused the Westinghouse relay to go out of specification. Figure 4-9 shows the pick-up current of the Westinghouse specimen outside of the typical $\pm 5\%$ of nominal tap setting for these devices. The pick-up current increased to 10% during the dirt accumulation test and 7% during the overheated test. The pick-up values went the opposite direction during the contact damage and loose connections tests resulting in decreases of 9% and 5.5% respectively.

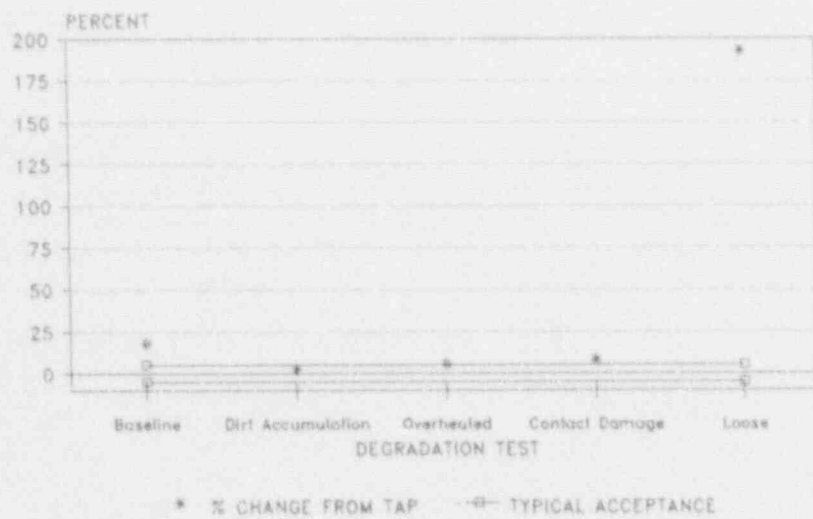
Figure 4-10. Induction Unit Pickup Comparison Protective Relay GE IAC

The GE relay had been out of specification initially for induction unit pick-up. The induction unit pick-up deviation approached or became within specification during the degraded conditions of dirt accumulation, overheated and contact damage. The loose connection degraded condition caused the induction unit pick-up to increase 149% over the baseline value of 4.61 amperes, Figure 4-10.

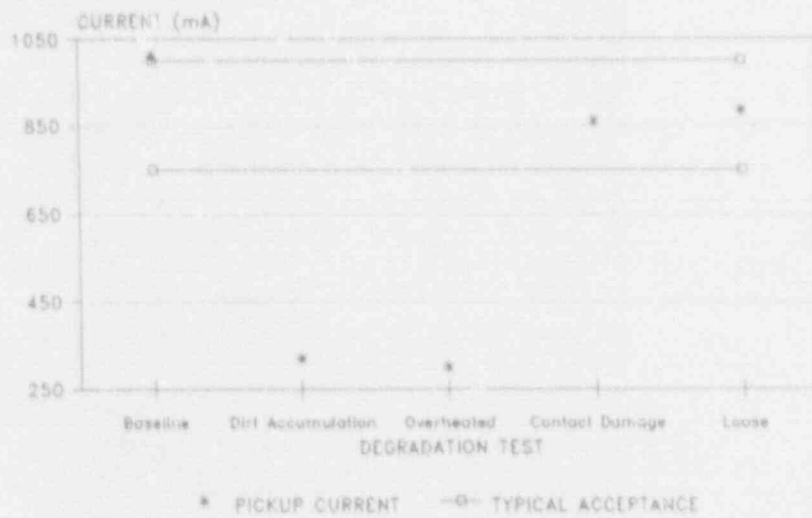
Figure 4-11. ICS Pickup Comparison
Protective Relay Westinghouse

The target and seal-in method (indicating contactor switch ICS for Westinghouse) changed only on the Westinghouse specimen. Two conditions, dirt accumulation and overheated, caused changes, Figure 4-11. The ICS pick-up values were 320 and 300 milliamperes for the dirt accumulation and overheated tests respectively. These values were below the typical pick-up range which is 75% to 100% of seal-in or ICS tap setting. In contrast, Figure 4-12 shows the target and seal-in to be unaffected in the GE relay by the degraded conditions.

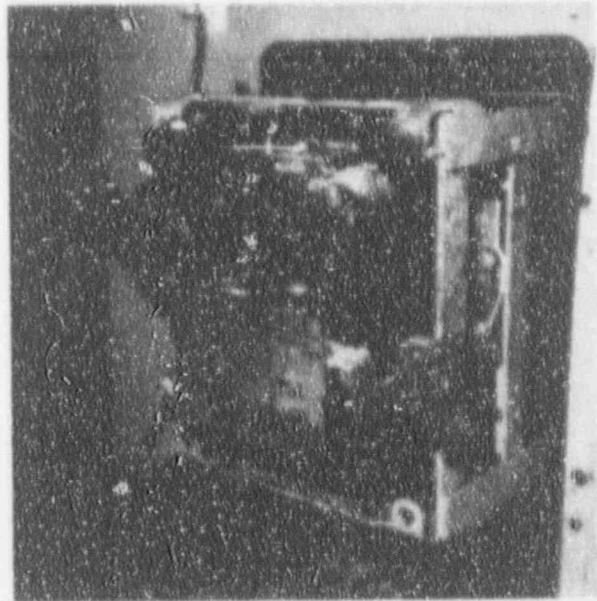
Figure 4-13 shows the Westinghouse relay after overheat and dirt accumulation. This figure attests to the fact that the degraded condition after overheat and dirt accumulation was sufficiently severe as to constitute a worst case.

Figure 4-13. Westinghouse Protective Relay After Overheat and Dirt Accumulation Degradation Tests.

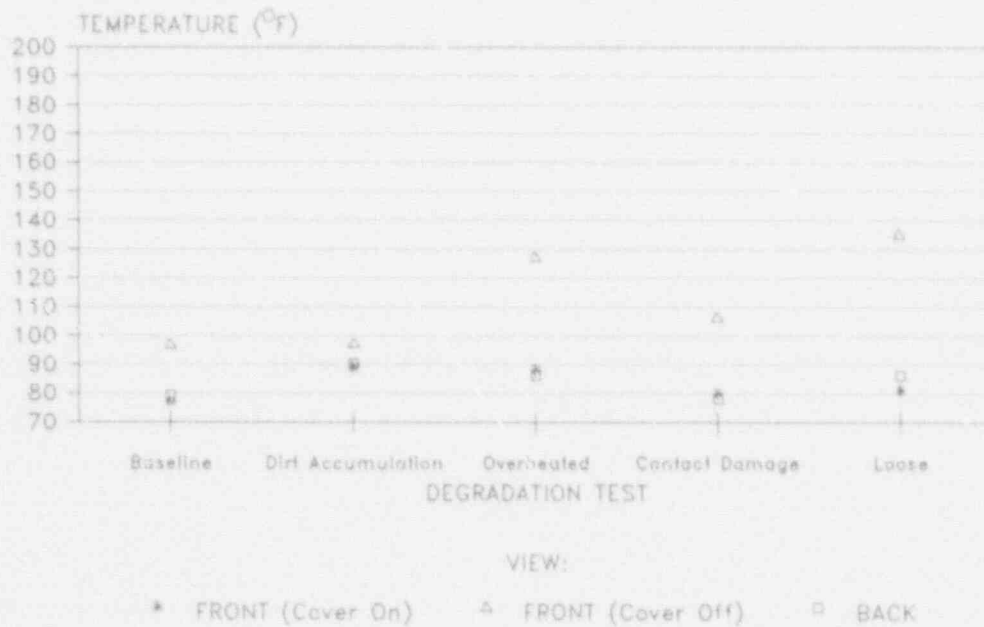
Figure 4-14. Infrared Pyrometry Comparison Protective Relay Westinghouse

Infrared pyrometry showed temperature changes in two out of five degraded conditions for the Westinghouse relay and four out of five for the GE relay. Overheat and loose connections caused over 30°F increase in temperatures when viewed with the cover off for the Westinghouse relay, Figure 4-14. Dirt accumulation, contact damage and loose connections caused over 20°F increase in

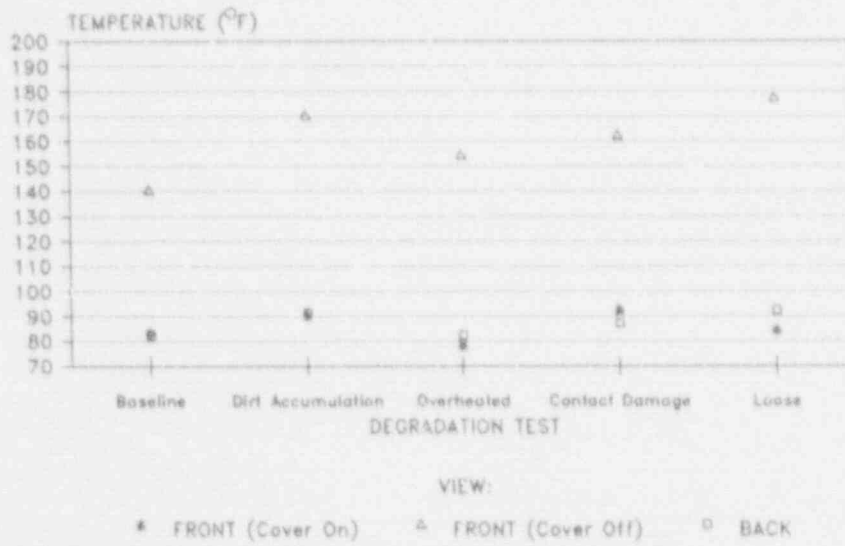
Figure 4-15. Infrared Temperature Comparison Protective Relay GE IAC

temperatures when viewed with the cover off for the GE relay Figure 4-15.

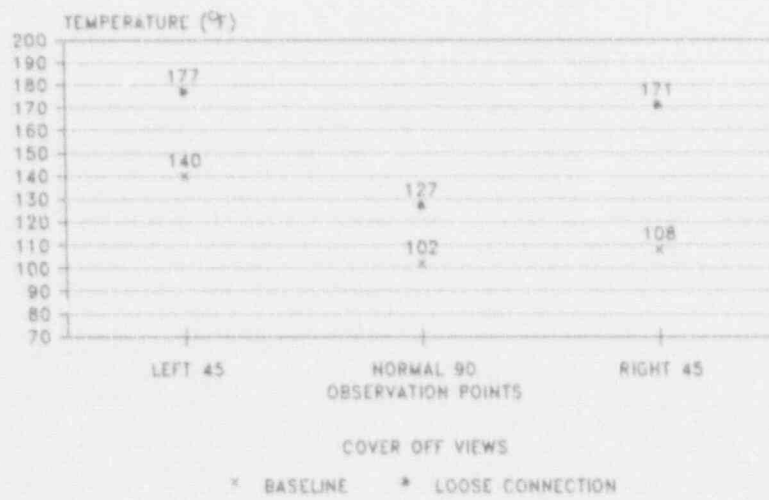
Figure 4-16. Infrared Pyrometry Comparison Protective Relay GE IAC

When viewed with the cover on and from the back of the relays, significant variations in temperature were undetectable. The angle of view was also significant for these relays. Figure 4-16 shows that the hottest temperatures were masked in normal 90° view but were detectable when viewed at 45° angles to the right or left of normal.

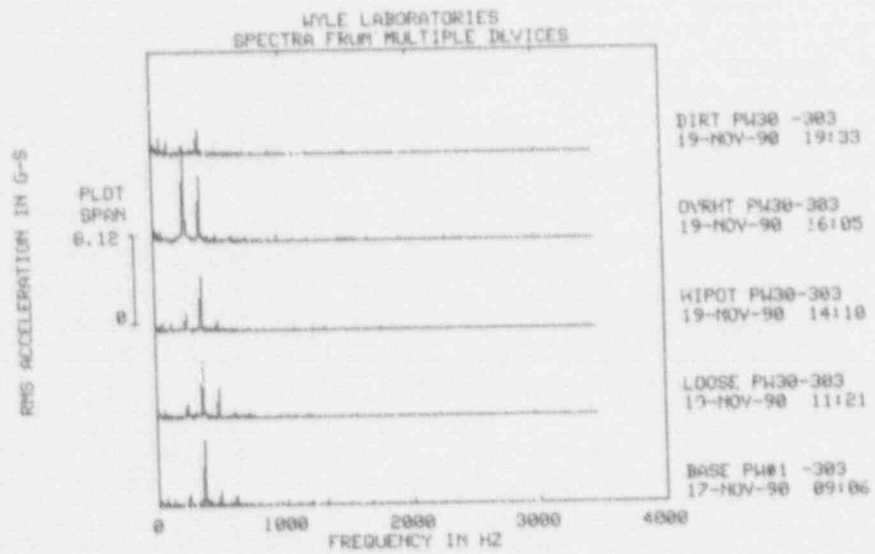
Vibration signature differences were caused by three of the degraded conditions on the Westinghouse relay. Figure 4-17 shows that loose connections caused a peak at 480 Hz. Overheat caused a peak at 242 Hz and the characteristic peak at 359 Hz decreased to approximately one third by dirt accumulation. Acoustic signature differences were caused by the same three conditions, although not as noticeably. The vibration and acoustic signatures on the GE relay were different but the levels were too low to attribute the changes to the degraded conditions.

Figure 4-17. Vibration Signature Comparison
of Westinghouse Protective Relay
Before and After Degraded Conditions

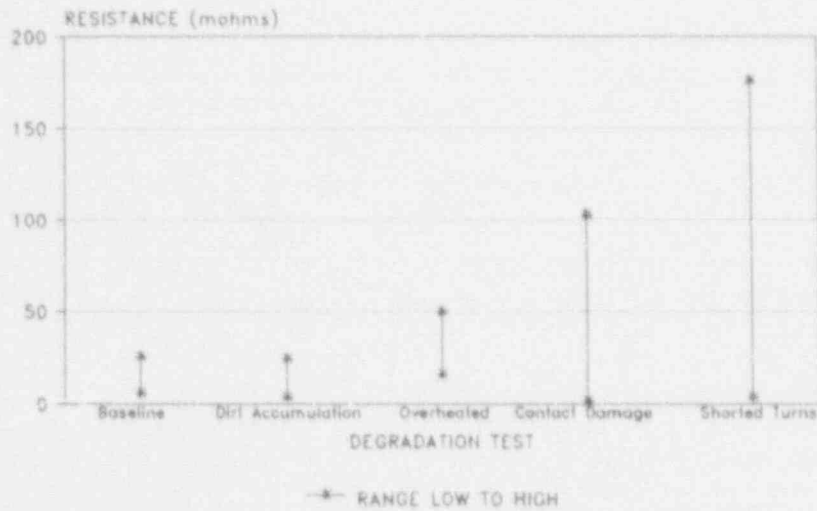
Figure 4-18. Contact Resistance Comparison Control Relay SD219

Contact resistance changed significantly in four out of the ten degraded conditions. Figure 4-18 shows the range of contact resistances for each contact set after each of the degraded conditions. Additionally, the contact resistance increased the most, to a peak of 995 mohms during the blocked armature degradation since the contacts did not fully close.

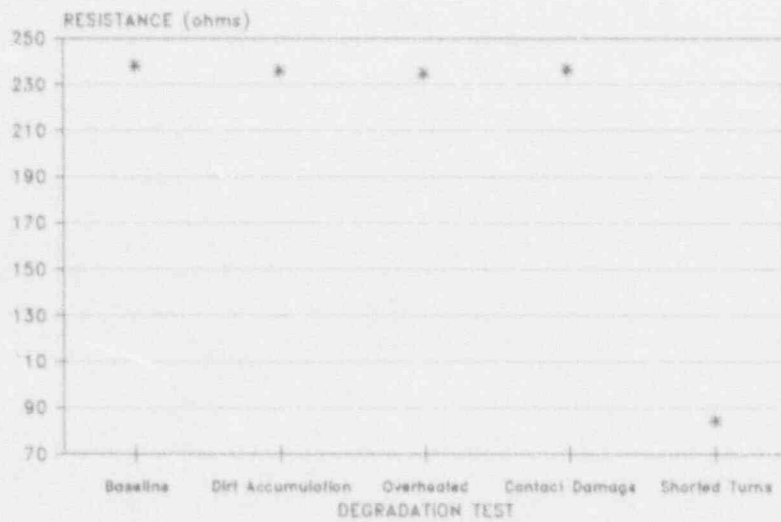
Figure 4-19. Coil Resistance Comparison Control Relay SD219

Coil resistance changed significantly in one out of the ten degraded conditions. Shorted turns caused a 60 % drop in coil resistance, Figure 4-19.

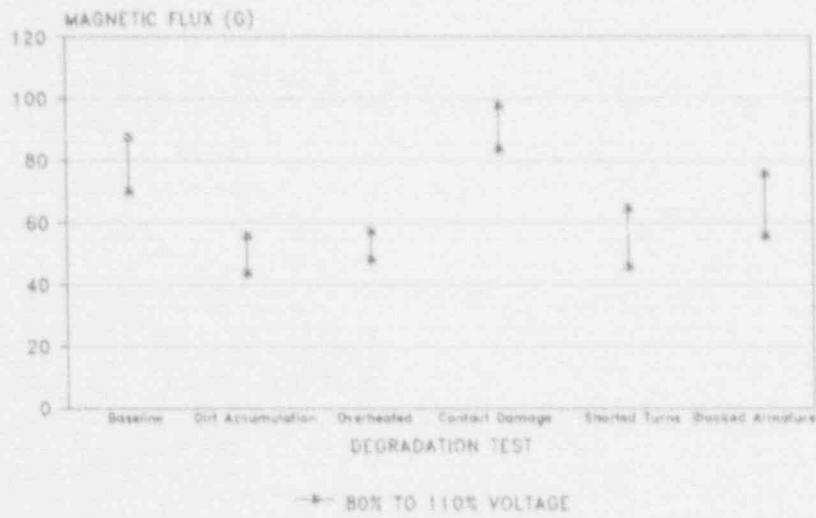
Figure 4-20. Magnetic Field Comparison Control Relay SD219

Magnetic flux changed significantly in five of the ten degraded conditions. Dirt accumulation, overheated, shorted coil turns and blocked armature all caused the magnetic flux to decrease and contact damage caused an increase, Figure 4-20.

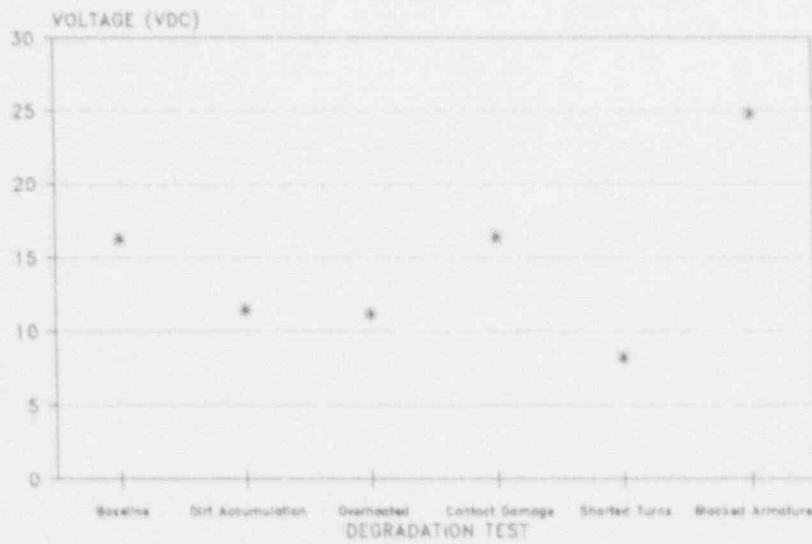
Figure 4-21. Pickup Voltage Comparison Control Relay SD219

Pick-up voltage increased in only one of the ten degraded conditions and decreased in three others. The decrease in pick-up voltage would normally be misinterpreted as an improvement, but since the relays were actually degraded, this is shown to be misleading. Blocked armature caused pick-up voltage to increase and dirt accumulation, overheated and shorted coil turns caused decreases in pick-up voltage, Figure 4-21. Blocked armature caused the pick-up voltage to exceed the specification.

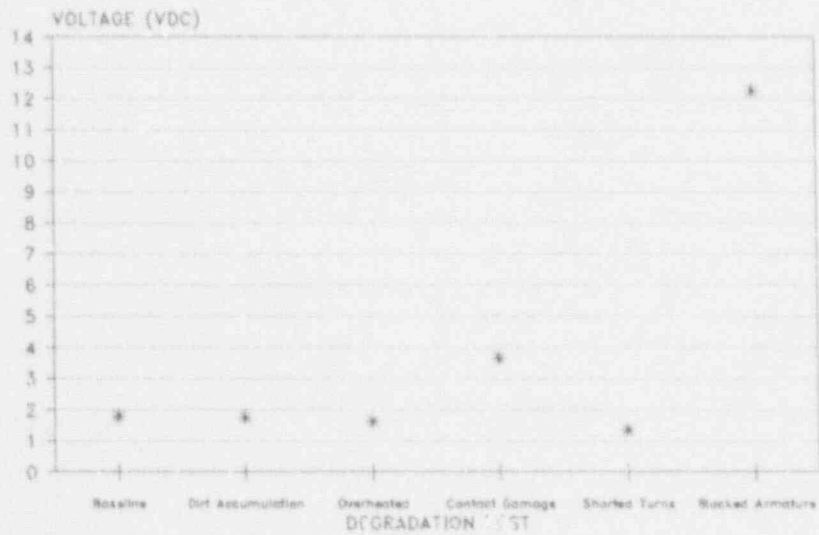
Figure 4-22. Drop-Out Voltage Comparison Control Relay SD219

Drop out voltage changed in two of the ten degraded conditions, Figure 4-22. Contact damage of a welded contact caused the drop out to increase since the moving contact bar is directly connected to the armature. Shorted coil turns caused a decrease in drop out voltage.

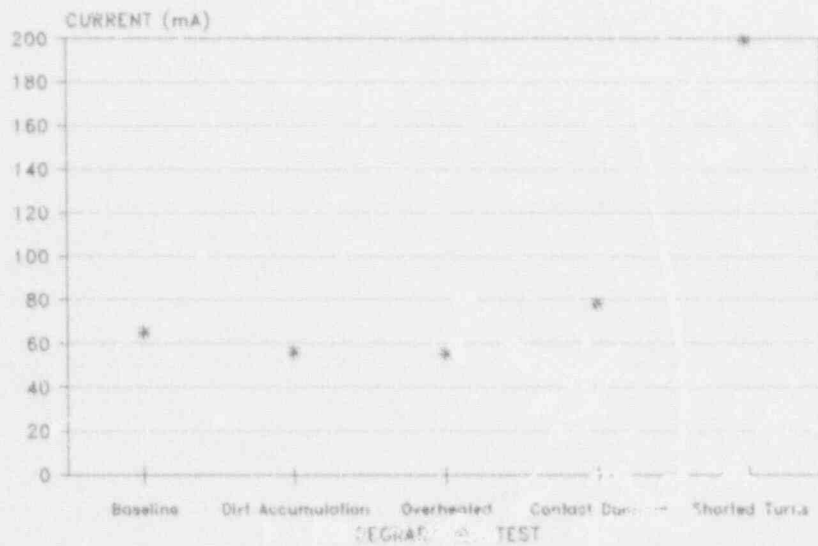
Figure 4-23. Inrush Current Comparison Control Relay SD219

Inrush and holding current changed in one out of ten degraded conditions. Shorted coil turns caused an increase of over 200% for both inrush and holding current, Figure 4-23 and 4-24.

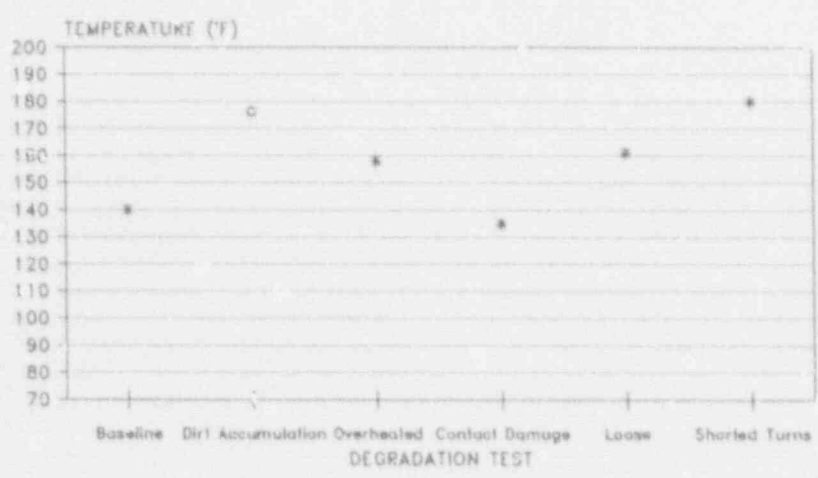
Figure 4-25. Infrared Pyrometry Comparison Control Relay SD219

temperature of approximately 20°F. Dirt accumulation and shorted coil turns caused an increase in maximum temperature of 35°F and 40°F, respectively. These temperature increases would be expected to reduce the expected life of the relays. A 40°F temperature rise would be expected to reduce the life to approximately 25% of the original expected life.

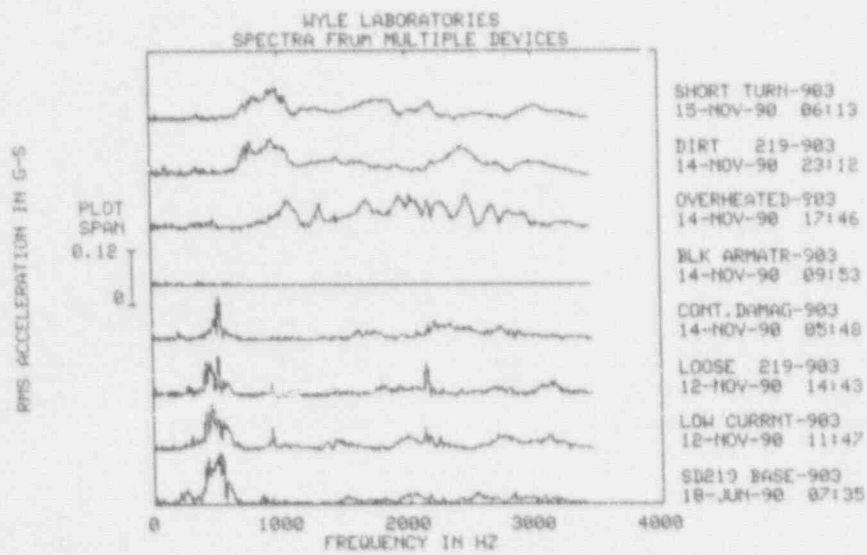
Vibration signature differences were caused by seven of the ten degraded conditions. Figure 4-27 shows that low contact current, and loose connections caused a peak at 1000 Hz. Contact damage resulted in a narrowing of the peak from 300 to 700 Hz. Blocked armature resulted in significant signal reduction. Overheat caused re-characterization of the vibration signature even though the relay continued to pick-up and drop out. Additionally, differences in the vibration signatures caused by the degradations of dirt accumulation and shorted coil turns were confounded and difficult to see since the changes from the overheated degradation were significant. The overheated degradation was performed prior to the degraded conditions of dirt accumulation and shorted coil turns.

Figure 4-27. Vibration Signatures of Degraded Conditions of Struthers-Dunn 219 Control Relay

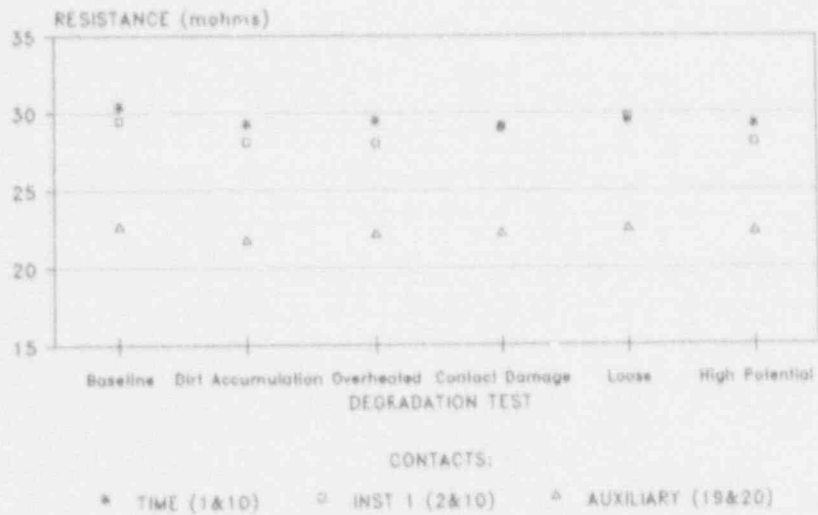
The ISM methods of contact resistance, coil resistance, time/ current characteristic, infrared pyrometry, acoustic testing and ion detection did not show any significant change from the original baseline parameters during any of the degradation tests. Figures 4-28 through 4-31 show the results of contact resistance, coil resistance, overcurrent timing(time/ current characteristic), and infrared pyrometry.

Figure 4-28. Contact Resistance Comparison Electronic Relay BE1-51

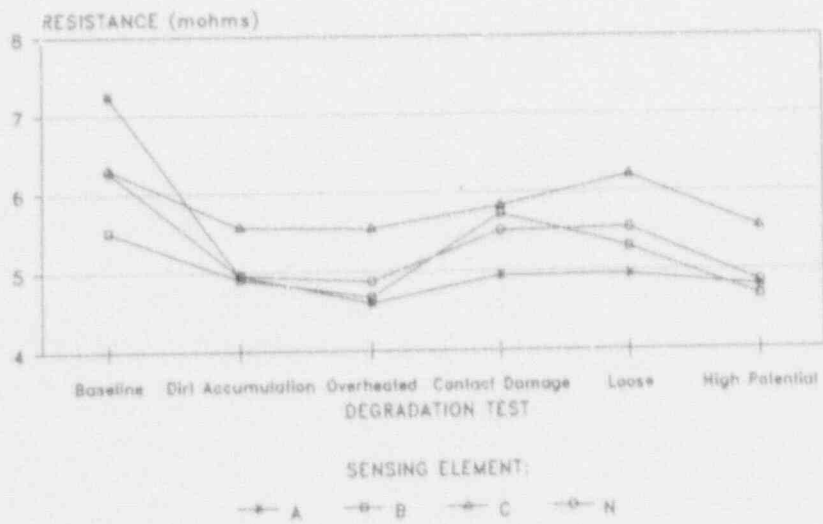
Figure 4-29. Coil Resistance Comparison Electronic Relay BE1-51
