NUREG/CR-5762
WYLE 60101

Comprehensive Aging Assessment of Circuit Breakers and Relays

Wyle Laboratories

Prepared for
U.S. Nuclear Regulatory Commission

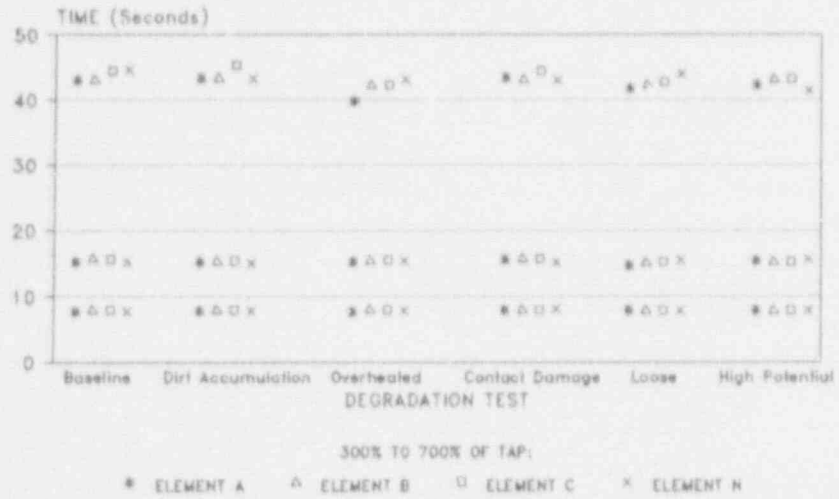
The ISM methods of contact resistance, coil resistance, time/ current characteristic, infrared pyrometry, acoustic testing and ion detection did not show any significant change from the original baseline parameters during any of the degradation tests. Figures 4-28 through 4-31 show the results of contact resistance, coil resistance, overcurrent timing(time/ current characteristic), and infrared pyrometry.

Figure 4-30. Overcurrent Timing Comparison Electronic Relay BE1-51

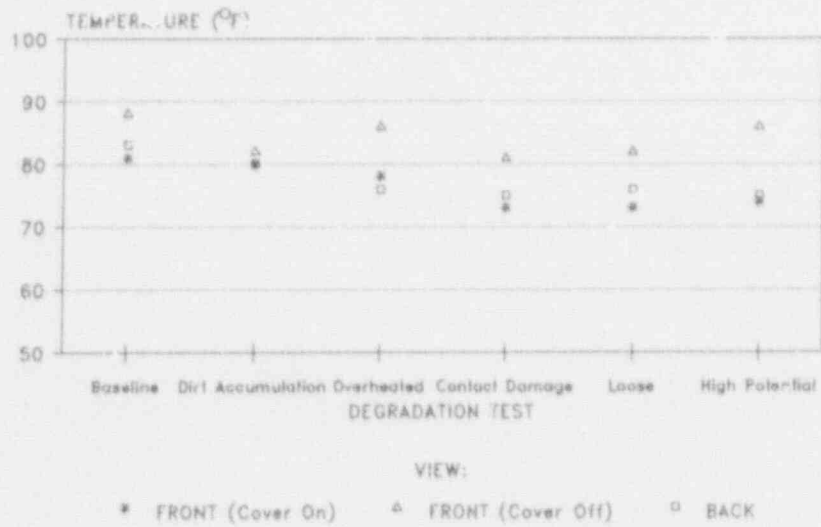
Figure 4-31. Infrared Pyrometry Comparison Electronic Relay BE1-51

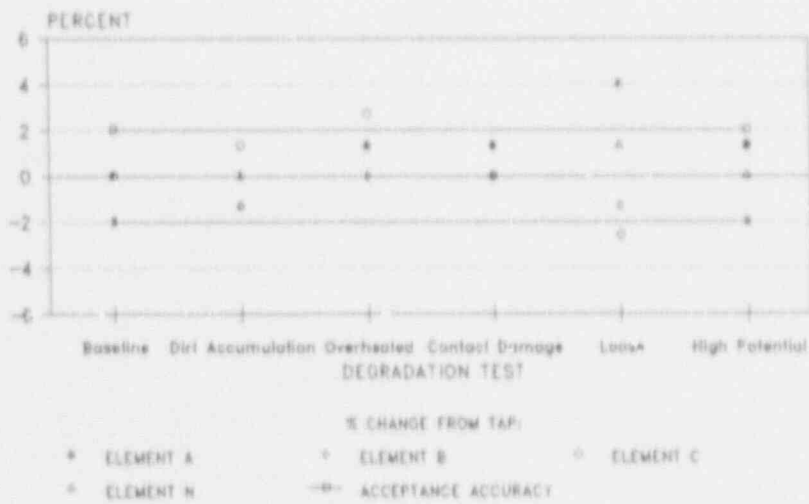
Overcurrent sensing changed in two of the five degradation conditions. Loose connections and overheated caused at least one element to exceed the $\pm 2\%$ acceptance criteria, Figure 4-33.

Figure 4-33. Overcurrent Sensing Pickup Comparison Electronic Relay BE1-51

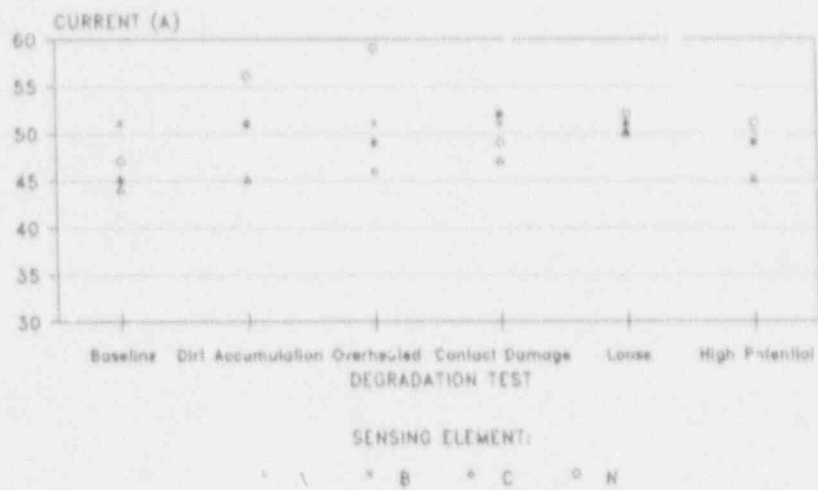
Instantaneous overcurrent was changed in all five degraded conditions. The instantaneous overcurrent pick-up varied more than the typical acceptance criteria of $\pm 2\%$ of the pick-up values obtained during baseline testing for each degraded condition for three out of four sensing elements. Only element B changed less than $\pm 2\%$, Figure 4-34. It should be noted that the levels of change may not be totally attributed to the degraded conditions since specific manufacturer's test equipment, designed in conjunction with the electronic relay, was unavailable for this research. This special test equipment may have shown less change and shown better precision for this method. The use of manufacturer's test equipment for electronic relays is recommended.

Figure 4-34. Instantaneous Current Pickup Comparison Electronic Relay BE1-51

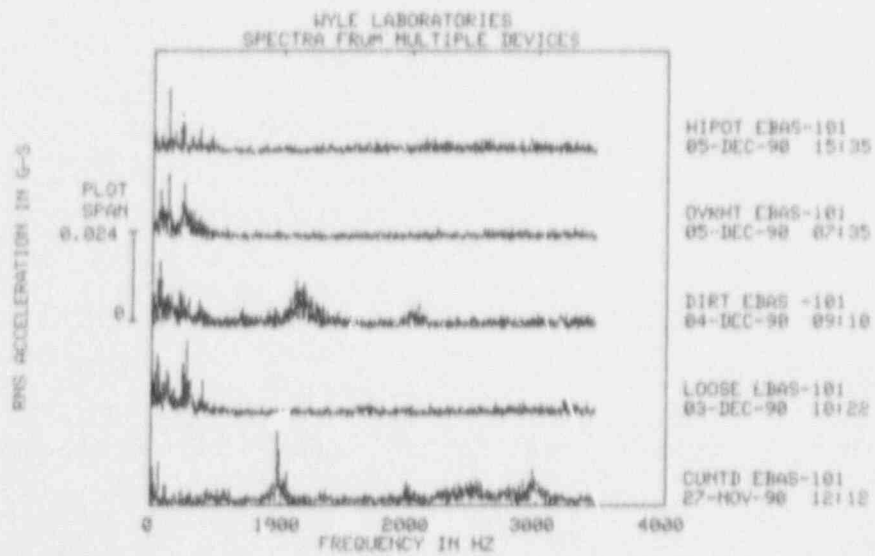
Vibration signature differences were noted among all five degraded conditions. In Figure 4-35 the vibration signatures for the five degradation conditions were compared. Differences were most noticeable with the degraded conditions of contact damage and dirt accumulation. The vibration signatures on the electronic relay were different but the levels were too low to attribute all of the changes to the degraded conditions.

Figure 4-35. Vibration Signatures of Degraded Conditions of Basler Electronic Relay

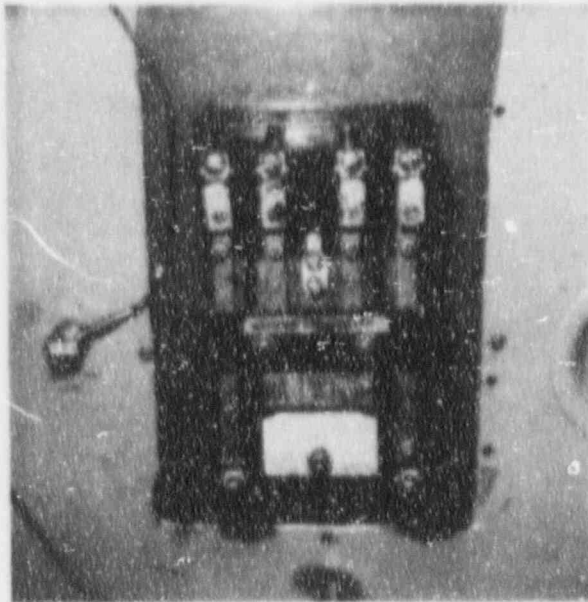
Figure 4-36 shows the blistered surface on the GE HFA caused by the overheated degradation and Figure 4-37 shows the dirt accumulation degradation on the Westinghouse MG-6. It is noted that these degradations have been purposely significant in order to constitute a worst case.

Figure 4-37. Westinghouse MG-6 Auxiliary Relay in
Dirt Accumulation Degraded Condition

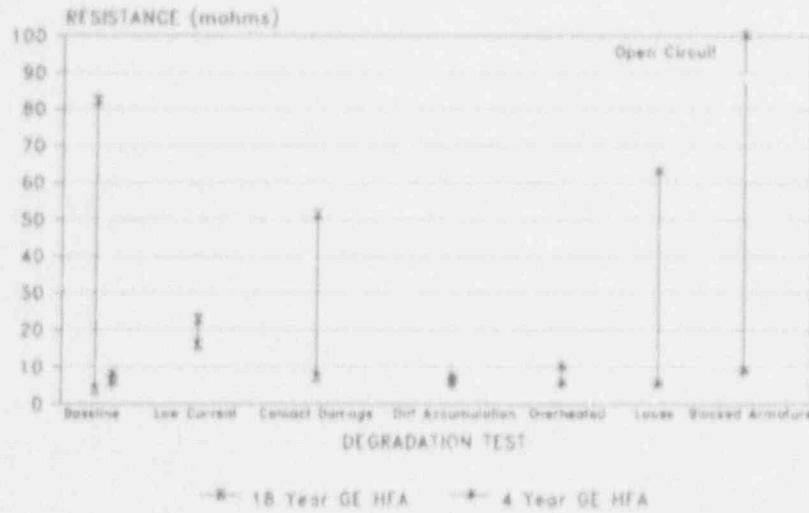
Contact resistance changed significantly in two out of the ten degraded conditions on the HFA and six out of ten on the MG-6 relay. For the 4 year HFA relay, loose connections and blocked armature caused significant increases in contact resistance, Figure 4-38. This figure shows the range of contact resistances for each contact set after each of the degraded conditions. Additionally, the contact resistance of the 18 year HFA relay varied considerably in the as received condition. The contact resistance improved after operation in the low contact current test and then increased because of the contact damage degradation for the 18 year relay.

Figure 4-38. Contact Resistance Comparison Auxiliary Relay GE HFA

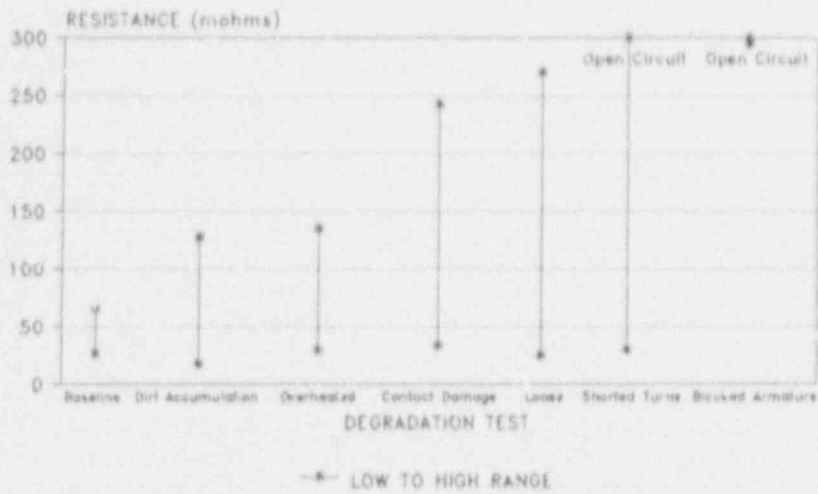
For the MG-6 relay, dirt accumulation, overheated, contact damage, loose connections, shorted coil turns and blocked armature caused significant increases in contact resistance, Figure 4-39. The contact resistance increased the most during the blocked armature degradation since the contacts did not fully close.

Figure 4-39. Contact Resistance Comparison Auxiliary Relay Westinghouse MG-6

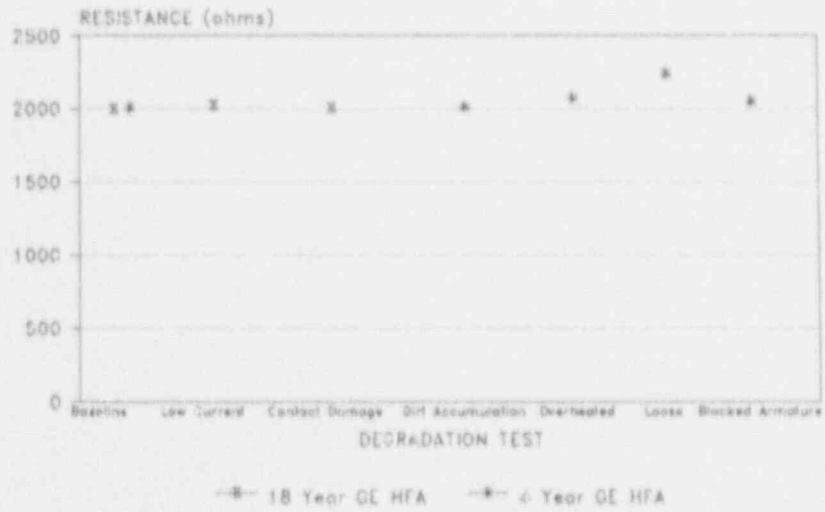
Coil resistance changed significantly in one out of the ten degraded conditions for each of the auxiliary relays. Loose connections caused an increase of 12% for the HFA relay, Figure 4-40. Shorted coil turns caused over a 25 % drop in coil resistance for the MG-6 relay, Figure 4-41.

Figure 4-40. Coil Resistance Comparison Auxiliary Relay GE HFA

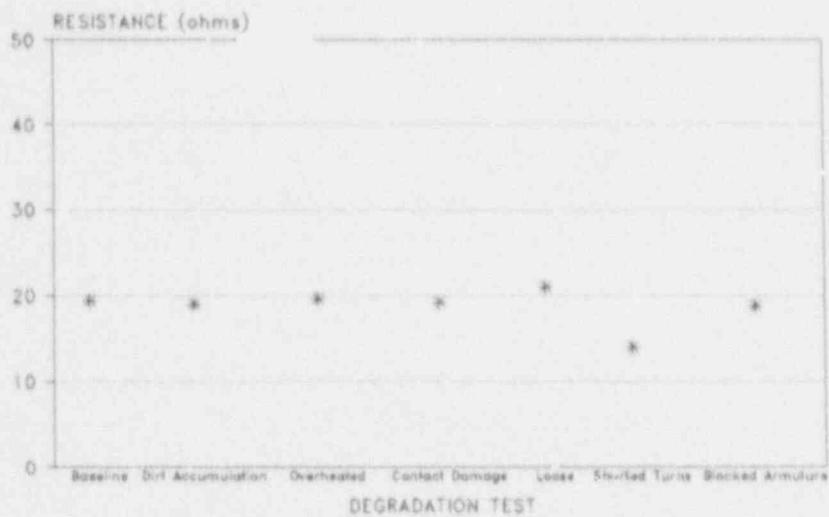
Figure 4-41. Coil Resistance Comparison Auxiliary Relay Westinghouse MG-6

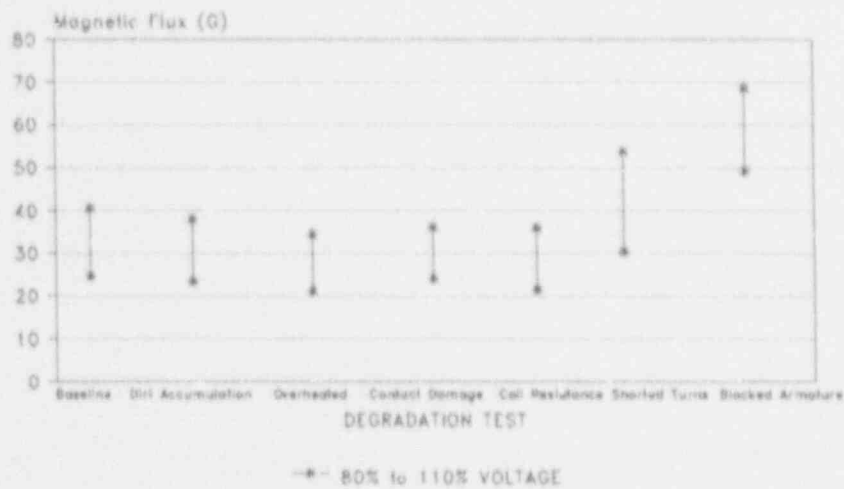
Magnetic flux changed significantly in two of the seven degraded conditions in which it was measured on the MG-6. It was not measured on the HFA due to equipment unavailability. Shorted coil turns and blocked armature caused the magnetic flux to increase, Figure 4-42.

Figure 4-42. Magnetic Field Comparison Auxiliary Relay Westinghouse MG-6

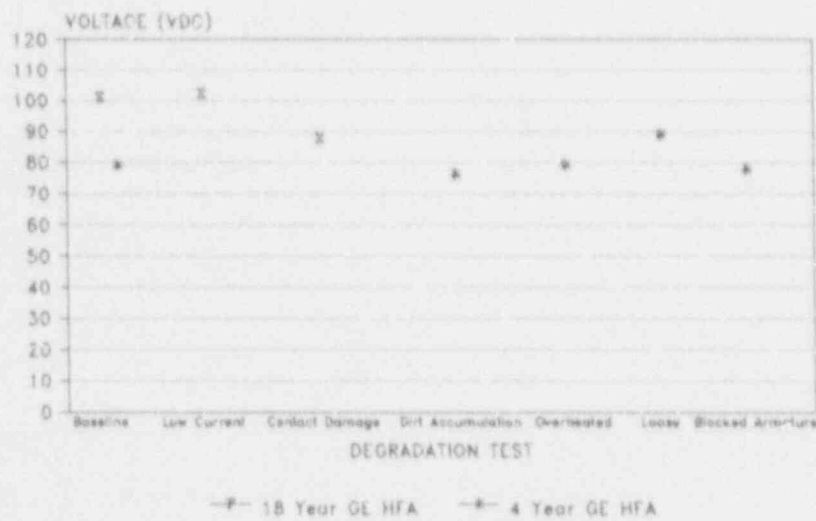
The significance of the pick-up voltage results was that for 90% of the degraded conditions, either there was no change in pick-up voltage or it decreased, which would normally be interpreted as improving. Thus it was only effective at detecting 10% of the degraded conditions. For the HFA relays, since the 18 year relay was out of specification for pick-up voltage in the as received condition, it decreased to within specification after the contact damage degradation. Additional comparisons were made on the 4 year HFA relay, which increased pick-up voltage in one out of eight degraded conditions. Loose connections caused an increase in pick-up voltage of 13%, Figure 4-43. Pick-up voltage changed in two of the ten degraded conditions for the MG-6 relay. Contact damage caused pick-up voltage to increase and shorted coil turns caused pick-up voltage to decrease, Figure 4-44.

Figure 4-43. Pick-up Voltage Comparison Auxiliary Relay GE HFA

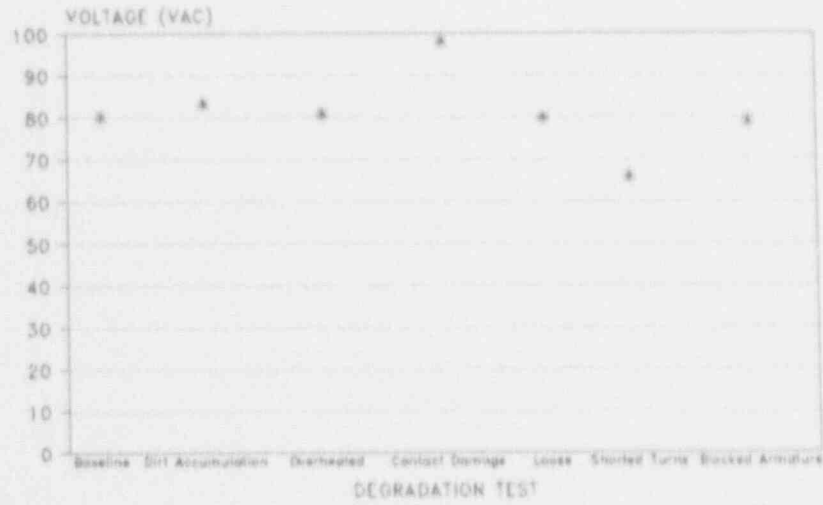
Figure 4-44. Pick-up Voltage Comparison Auxiliary Relay Westinghouse MG-6

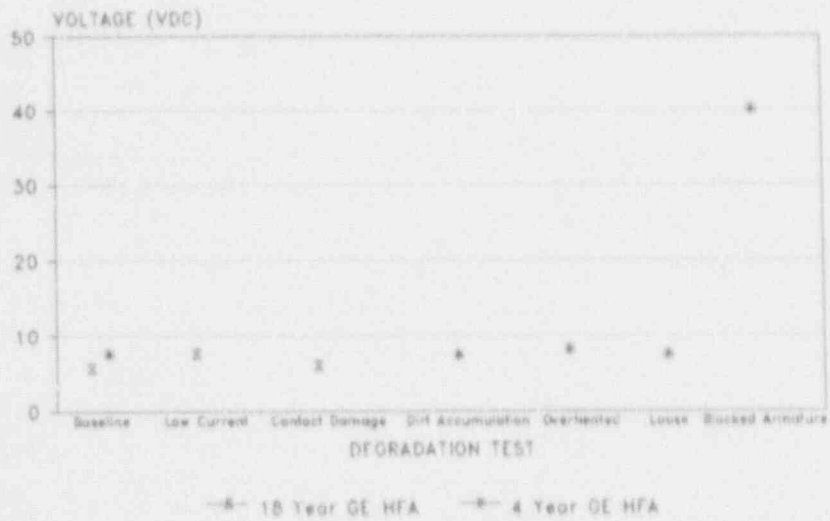
Drop out voltage changed significantly in one out of the ten degraded conditions on the HFA and five out of ten on the MG-6 relay. For the HFA relay, Figure 4-45, the blocked armature degradation caused an increase in drop out voltage of over 400%. For the MG-6 relay, the degraded conditions of dirt accumulation, loose connections and shorted coil turns caused a decrease in drop out voltage and contact damage and blocked armature caused increases in drop out voltage, Figure 4-46.

Figure 4-45. Drop Out Voltage Comparison Auxiliary Relay GE HFA

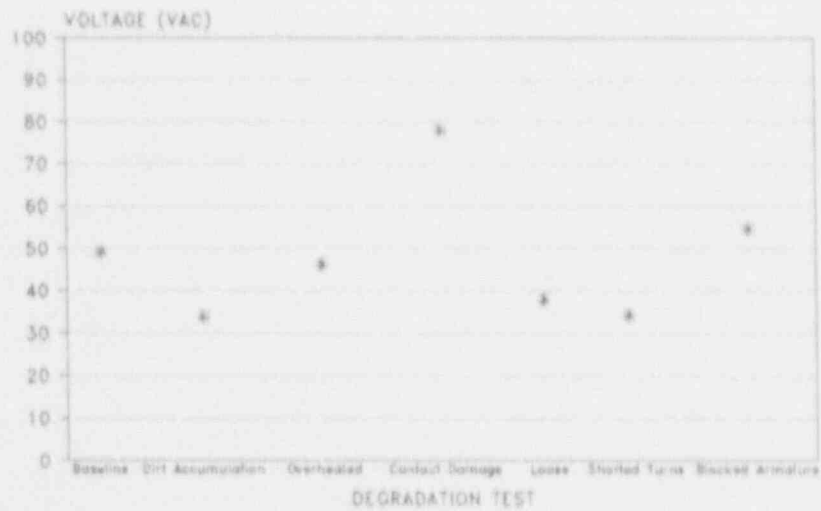
Figure 4-46. Drop Out Voltage
Comparison Auxiliary Relay
Westinghouse MG-6

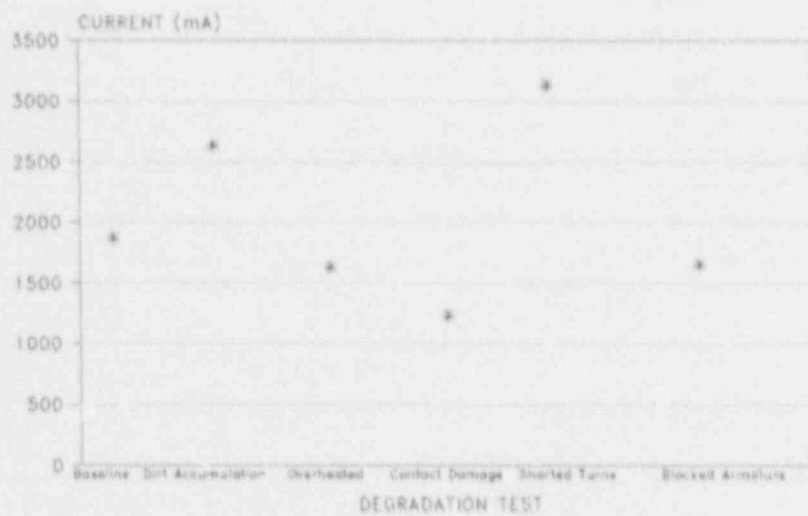
Inrush current changed significantly in three out of the ten degraded conditions for the MG-6. The degraded conditions of dirt accumulation and shorted coil turns caused increases of 40% and 68% respectively, Figure 4-47. The contact damage degradation caused a decrease of 34% in the inrush current.

Figure 4-47. Inrush Current
Comparison Auxiliary Relay
Westinghouse MG-6

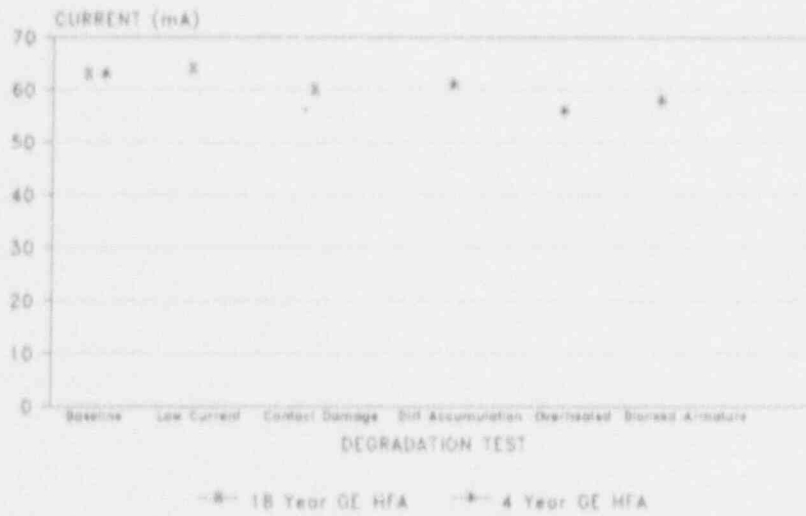
Holding current did not significantly change in the HFA relay, Figure 4-48, but did change significantly in two out of the ten degraded conditions on the MG-6 relay. Shorted coils turns caused an increase of over 100% and blocked armature caused an increase of 50% in the holding current, Figure 4-49. The excessive current drawn during the shorted coil turns test also caused significant temperature increases (over 300°F on the case) and produced smoke, visible through the glass on the case.

Figure 4-48. Holding Current Comparison Auxiliary Relay GE HFA

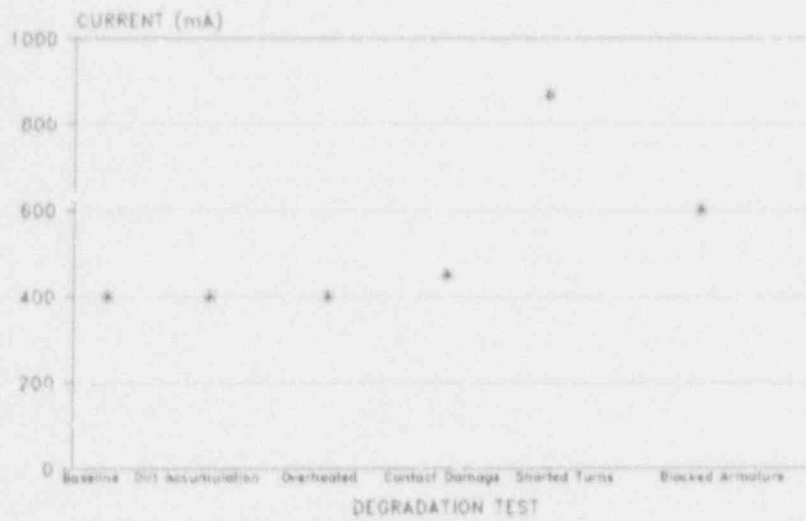
Figure 4-49. Holding Current Comparison Auxiliary Relay Westinghouse MG-6

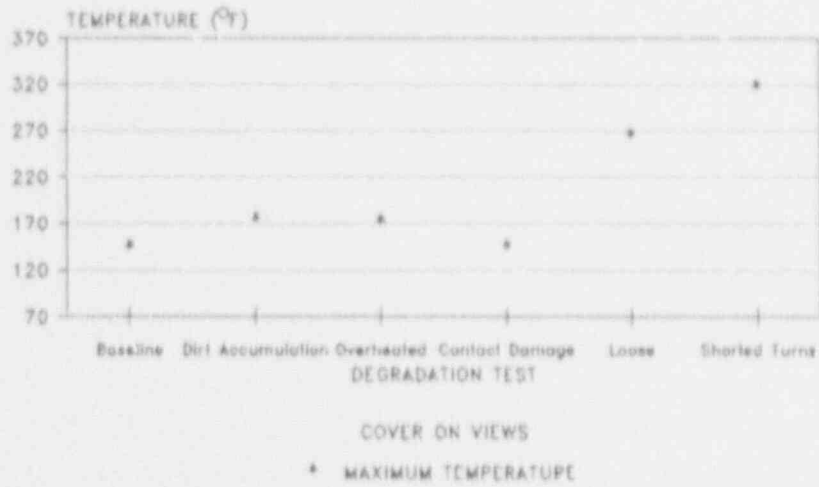
For the MG-6 relay, the degraded conditions of dirt accumulation, overheated, loose connections and shorted coil turns caused significant temperature increases. This relay also had a glass cover which masked some significant temperature changes, when it was in place. Figure 4-54 shows the maximum temperatures for the MG-6 relay with the cover on. Degraded conditions of dirt accumulation and overheated caused an increase of approximately 30°F. The loose connections degradation caused an increase of 120°F and the shorted coil turns degradation caused an increase of 170°F to be visible with the cover on.

Figure 4-54. Infrared Pyrometry Comparison Auxiliary Relay MG-6 (Cover on)

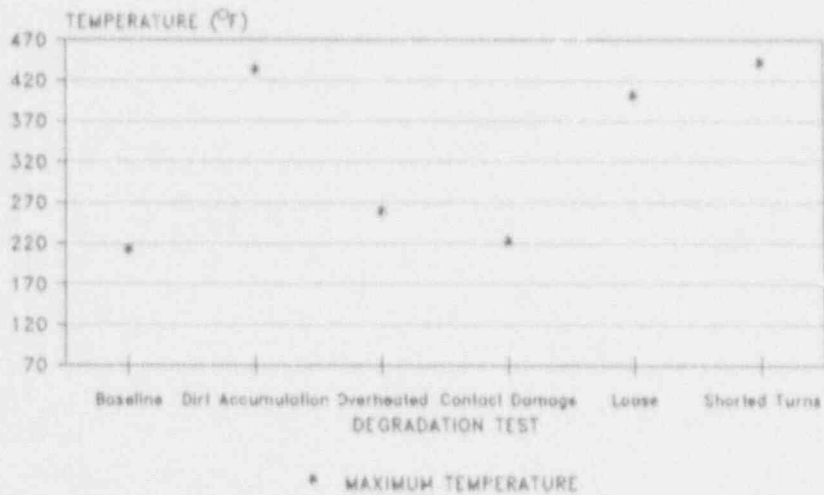
With the cover off, the degraded conditions of dirt accumulation, loose connections and shorted coil turns had caused temperature increases of approximately 200°F, Figure 4-55.

Figure 4-55. Infrared Pyrometry Comparison Auxiliary Relay MG-6 (Cover off)

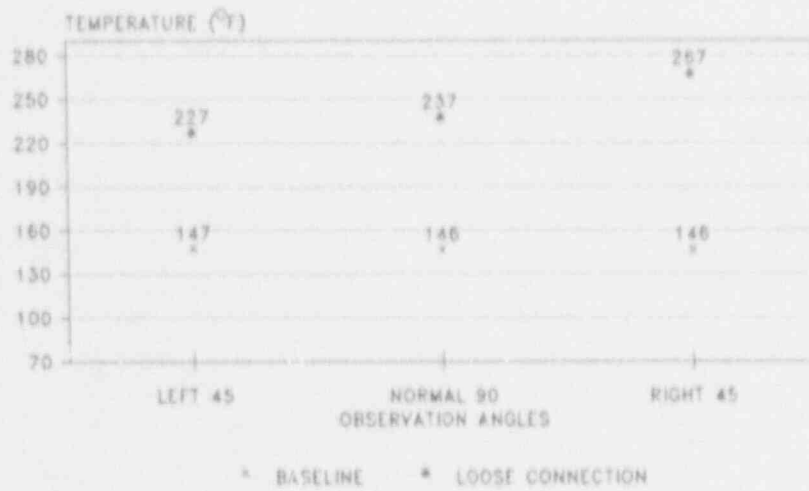
Also of interest on the MG-6 relay was the difference in temperature observed when different viewing angles were used. Figure 4-56 shows the three viewing angles of left 45°, normal to the relay (90°) and right 45°, with the cover on when the baseline temperatures were compared with the loose connection degradation. With the cover on, viewing angle had little effect during baseline measurements, but did show a difference of 40°F in the loose connection degradation. With the cover removed, Figure 4-57, viewing angle results in an almost 80°F difference in hot spot during baseline measurements and a 50°F difference during the loose connection degradation. Since dirt accumulation had caused a higher increase in maximum temperature, viewing angles were also compared. In Figure 4-58, viewing angle showed little difference with the cover on. With the cover off, a difference of 100°F was noted due to the viewing angle, Figure 4-59. The temperature of 472°F was found on a contact finger where the connection to the rear terminal post was made. This extreme temperature on the contact was due to the build up of foreign material on the contact surface, creating a poor electrical connection.

Figure 4-56. Infrared Pyrometry Comparison of Viewing Angles for MG-6 Baseline and Loose Connection: Cover on

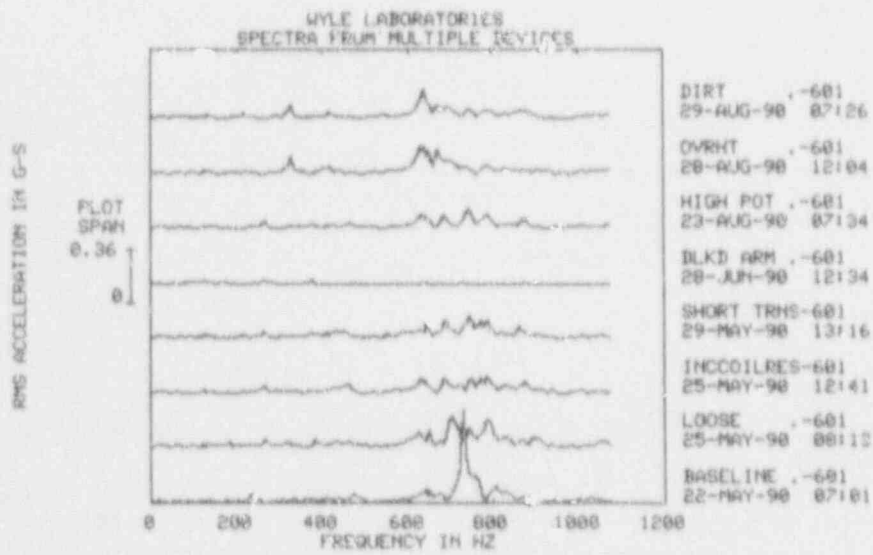
Vibration signature differences were caused by four of the ten degraded conditions for the HFA relay and six out of ten for the MG-6 relay. For the HFA relay, significant vibration signature differences were caused by loose connections, blocked armature, overheated and dirt accumulation, Figure 4-60. Loose connections caused a reduction in the peak at 731 Hz. Blocked armature resulted in significant signal reduction. Overheat caused re-characterization of the vibration signature by adding peaks at 328 and 630 Hz, even though the relay continued to pick-up and drop out. The degraded condition of dirt accumulation caused a narrowing of the peak at 630 Hz.

Figure 4-60. Vibration Signatures of
GE HFA Auxiliary Relays During Degraded Conditions

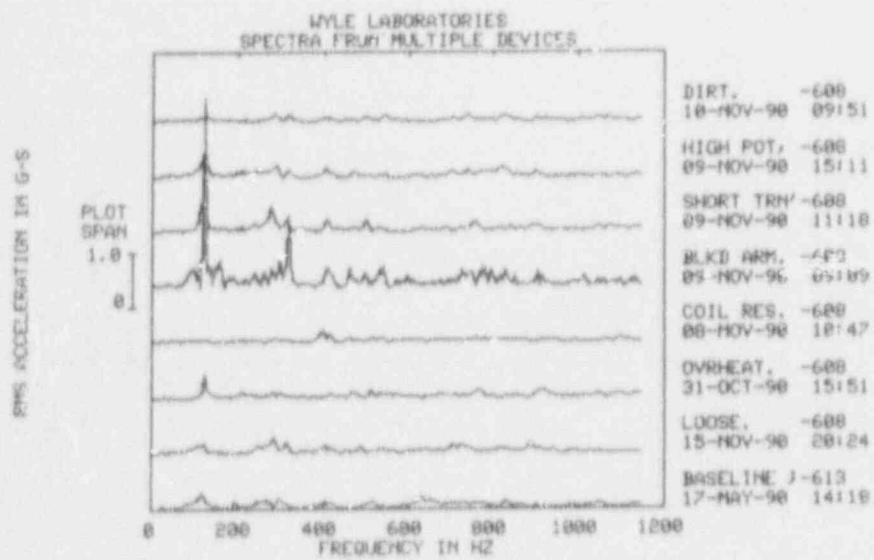
For the MG-6 relay, significant vibration signature changes were caused by loose connections, overheated, increased coil resistance, blocked armature, shorted coil turns and dirt accumulation. In the blocked armature degraded condition, excessive chatter and arcing of the contacts occurred as the relay attempted to close. This caused an extremely high vibration, Figure 4-6. Additionally, increased coil resistance caused a reduction in signal; loose connections caused a peak at 285 Hz; overheated resulted in narrowing the peak at 121 Hz; shorted coil turns caused a peak at 280 Hz and dirt accumulation reduced the peak at 121 Hz.

Figure 4-61. Vibration Signatures of Westinghouse MG-6 Auxiliary Relays During Degraded Conditions

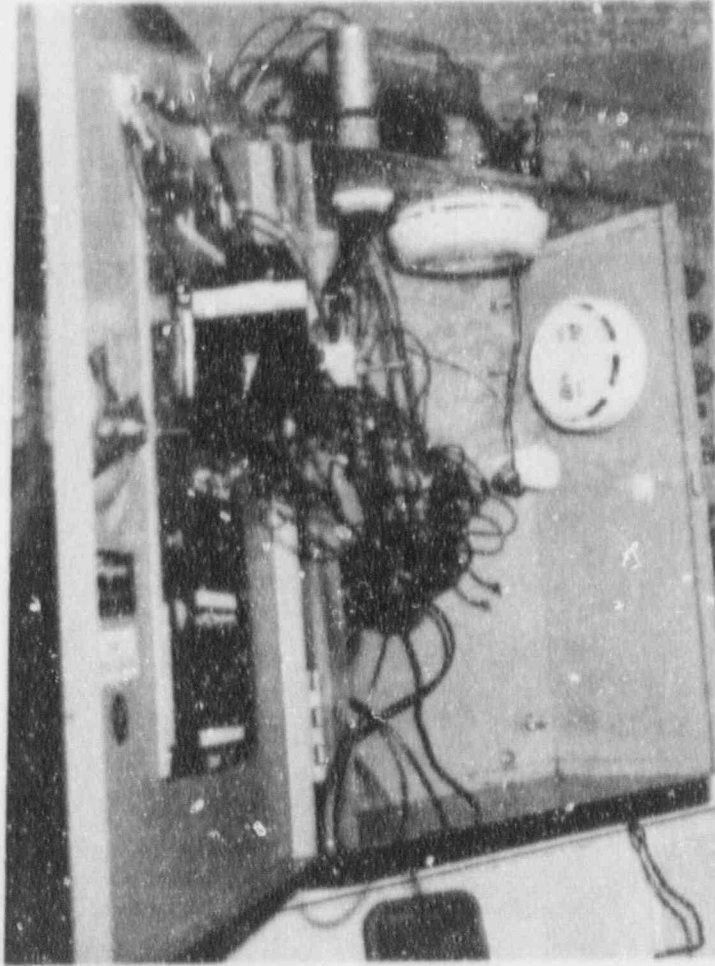
Visual inspection was effective in three of nine degraded conditions. They were dirt accumulation, overheated and loose connections. Since the contacts, coil and timing head are enclosed, visual inspection is limited to a few external observations. Figure 4-62 shows the setup for the degradation testing of the timing relay.

Figure 4-62. Timing Relay
Undergoing Degradation Condition Tests

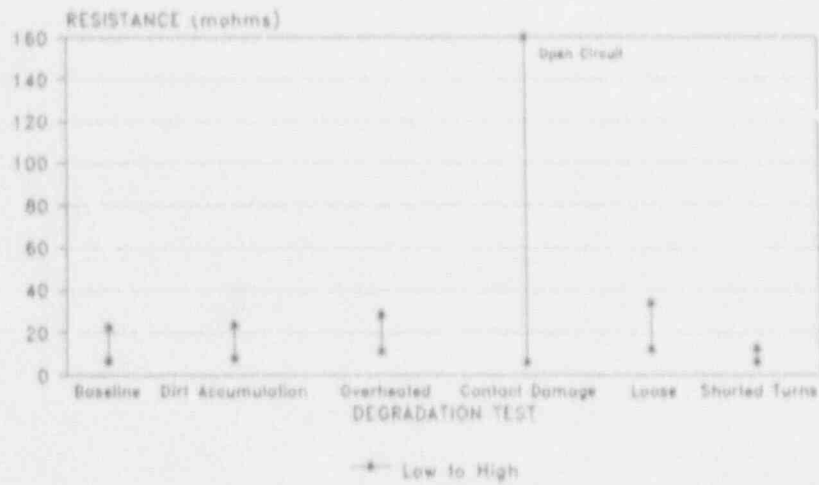
Contact resistance changed significantly in one out of the nine degraded conditions. The contact damage of soldering two contacts together caused an open circuit. Figure 4-63 shows the range of contact resistances for each contact set after each of the degraded conditions.

Figure 4-63. Contact Resistance Comparison Degradation Tests Timing Relays

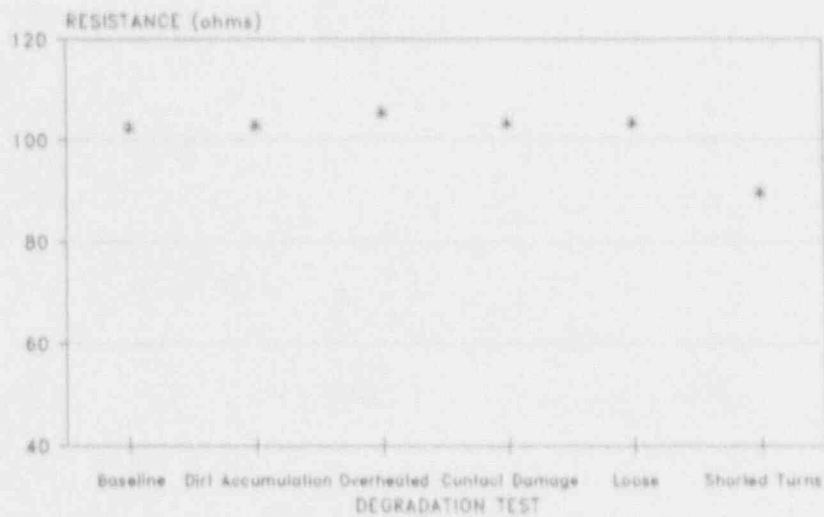
Coil resistance changed significantly in one out of the nine degraded conditions. Shorted coil turns caused a 15 % drop in coil resistance, Figure 4-64.

Figure 4-64. Coil Resistance Comparison Degradation Tests Timing Relays

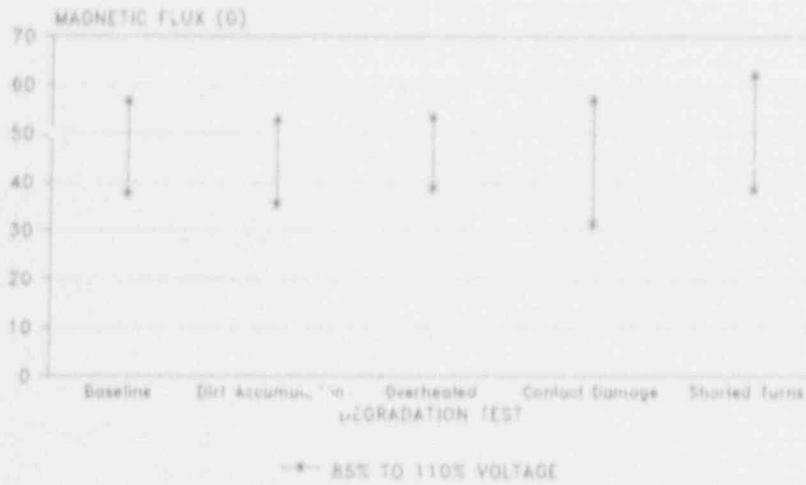
Magnetic flux changed significantly in two of the nine degraded conditions. Shorted coil turns caused the magnetic flux to increase at 110% voltage, Figure 4-65, and the overheated degradation caused a reduction.

Figure 4-65. Magnetic Field Comparison Degradation Tests Timing Relays

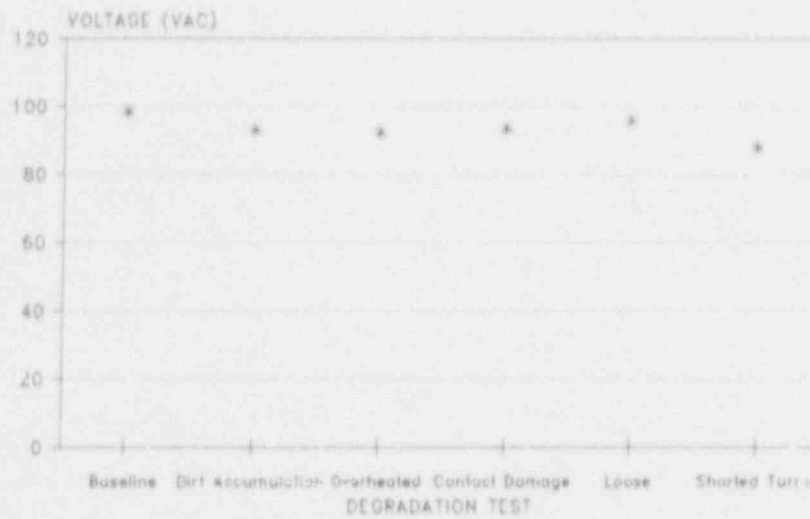
The significance of the pick-up voltage results was that none of the degraded conditions caused the pick-up voltage to increase. Thus, pick-up voltage did not indicate the presence of any of the degraded conditions. Pick-up voltage only changed, a reduction, in one out of the nine degraded conditions, and this would normally be misinterpreted as an improvement. Shorted coil turns caused a 10% reduction in pick-up voltage, Figure 4-66.

Figure 4-66. Pick-Up Voltage Comparison Degradation Tests Timing Relays

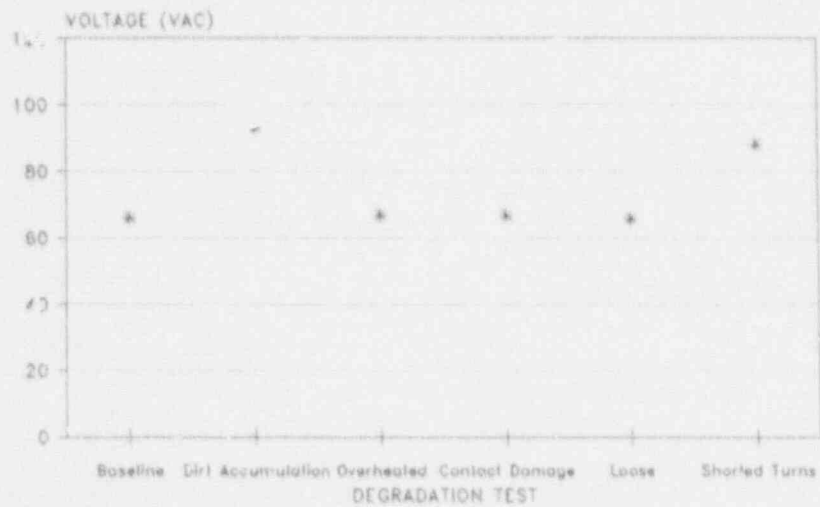
Drop-out voltage changed in two of the nine degraded conditions, Figure 4-67. Both the dirt accumulation and shorted coil turns degraded conditions caused drop out voltage to increase approximately 50%.

Figure 4-67. Drop Out Voltage
Comparison Degradation Tests
Timing Relays

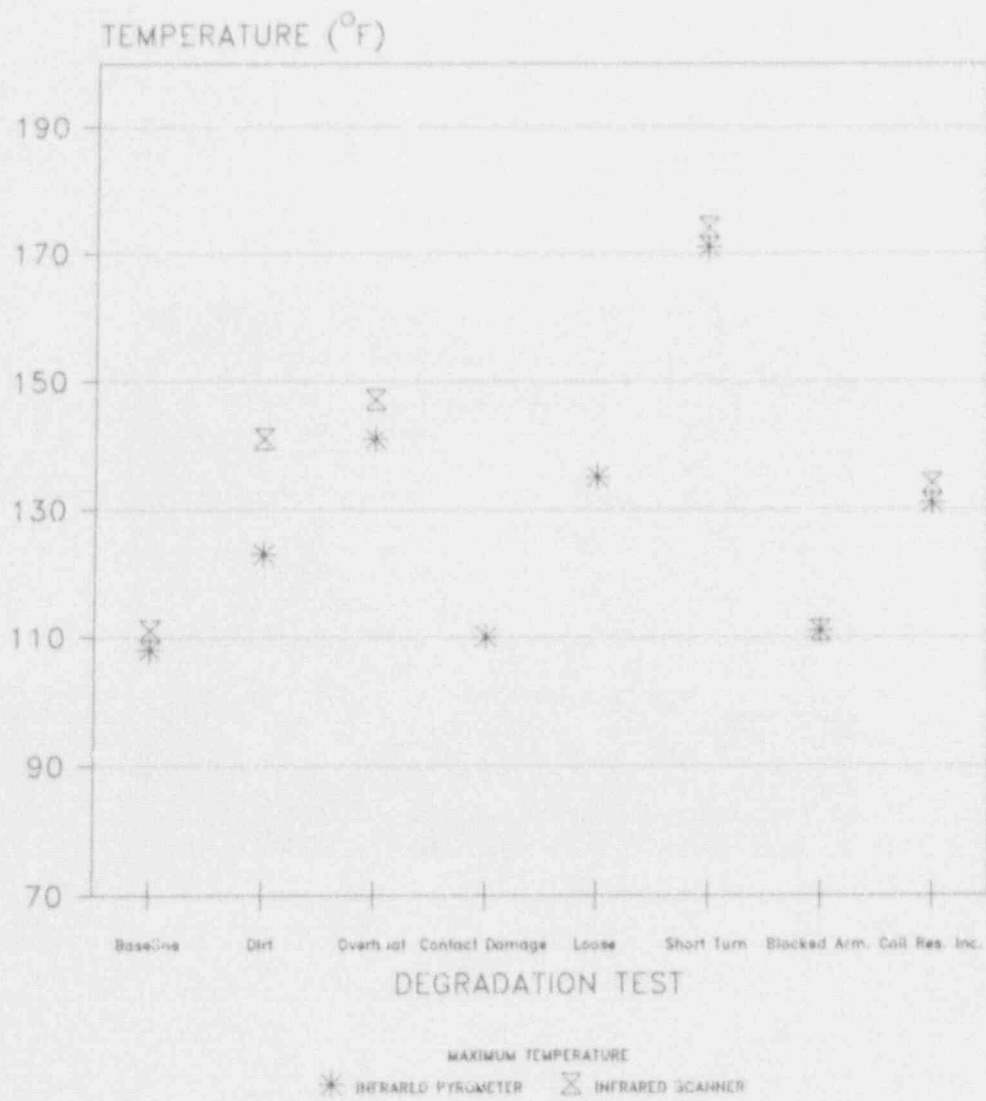
Figure 4-71. Temperature Comparison Degradation Tests Timing Relays

Infrared pyrometry showed temperature changes in five out of nine degraded conditions, Figure 4-71. An increase in temperature of 10°F was caused by the degraded condition of dirt accumulation. The degraded conditions of overheated, loose connections and increased coil resistance caused an increase in temperature of 20 to 30°F . The degraded condition of shorted coil turns caused an increase in temperature of approximately 60°F . These increased temperatures would be expected to reduce the life of the timing relays. When an Arrhenius relationship is used to calculate expected life, a temperature increase of 30°F would be expected to result in an expected life of approximately 25% of the original expected life. A temperature increase of 60°F would result in an expected life of less than 6% of the original life.

Infrared scanning showed temperature changes in four out of the seven degraded conditions in which it was measured, Figure 4-71. The equipment was unavailable for the degradations of contact damage and loose connections. Infrared scanning showed higher temperatures than the pyrometer since it could better pinpoint the hottest spot, as shown in thermograph of Figure 4-72, which was taken with the Inframetrics Thermal Imaging System 600. It showed the same trend as the infrared pyrometer.

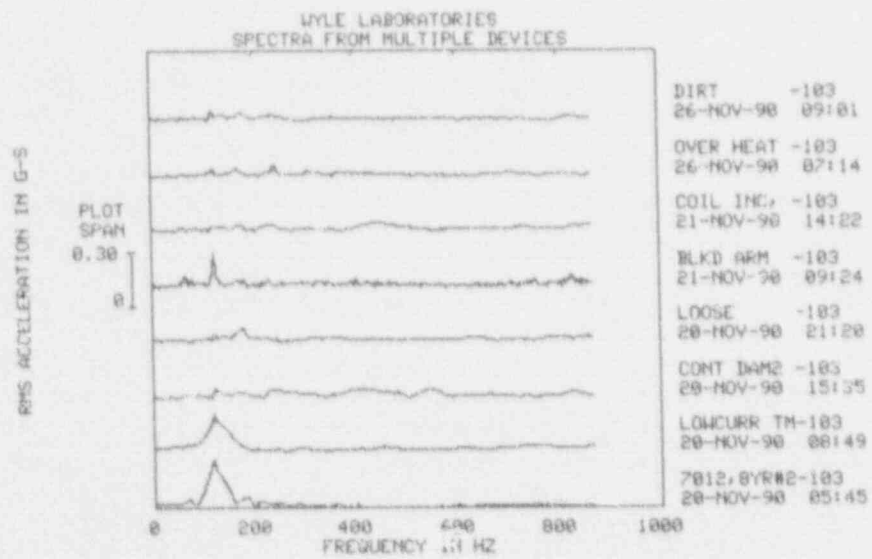
Figure 4-73. Vibration Signatures of Timing Relay During Degradation Condition Tests

Vibration signature differences were caused by six of the nine degraded conditions for the timing relays. Significant vibration signature differences were caused by contact damage, loose connections, blocked armature, increased coil resistance, overheated and dirt accumulation, Figure 4-73.

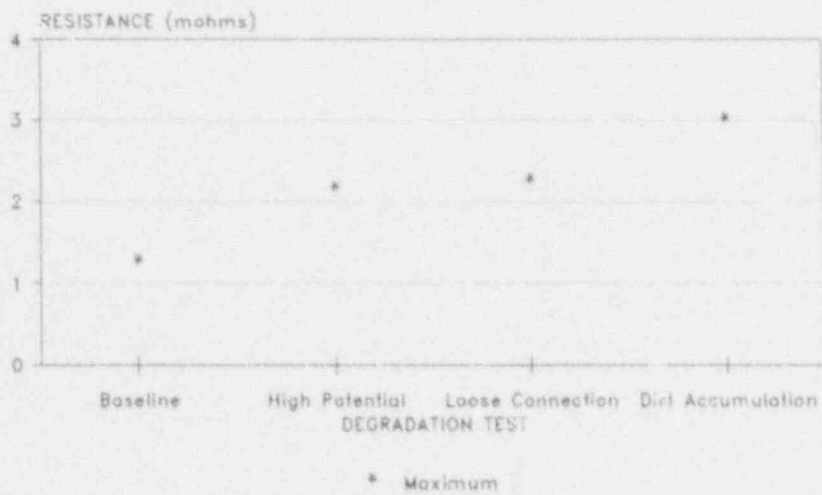
Figure 4-75. Pole Resistance Comparison Degradation Tests Molded Case Circuit Breakers

Pole resistance changed significantly in all three degraded conditions. Figure 4-75 shows that the pole resistance increased almost 200% due to high potential testing and loose connections and increased almost 300% due to dirt accumulation.

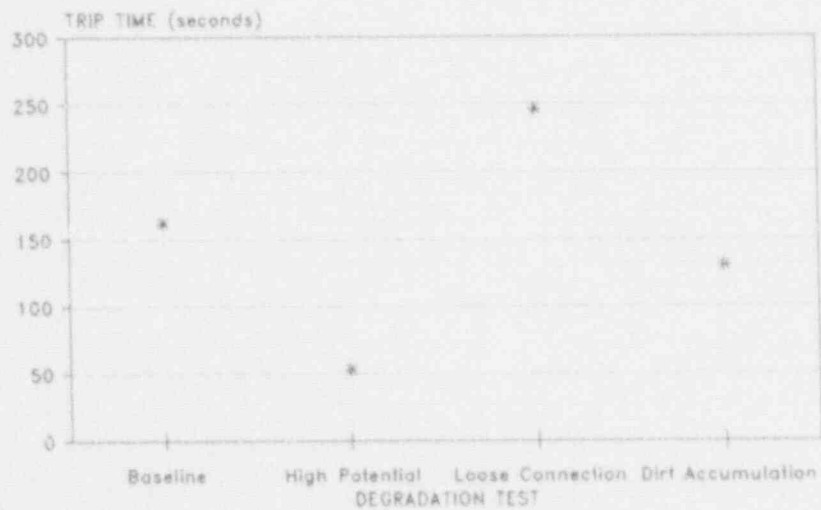
Figure 4-76. Trip Time Comparison at 135% Rated Current, Degradation Tests Molded Case Circuit Breakers

The trip time, when 135% rated current was applied, changed in all three degraded conditions, Figure 4-76. The trip time significantly decreased after the high potential tests and slightly decreased after dirt accumulation. The loose connection degradation caused a 35% increase in trip time.

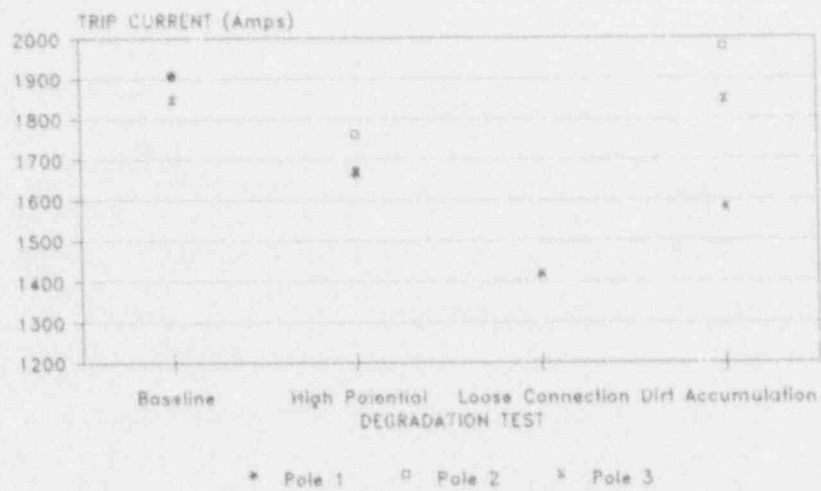
Figure 4-77. Instantaneous Trip Comparison, Degradation Tests Molded Case Circuit Breakers

The instantaneous trip current changed significantly in all three degraded conditions, Figure 4-77. The degradations of high potential and loose connections caused a decrease in the current necessary to cause an instantaneous trip. The degraded condition of dirt accumulation caused the instantaneous trip current of pole

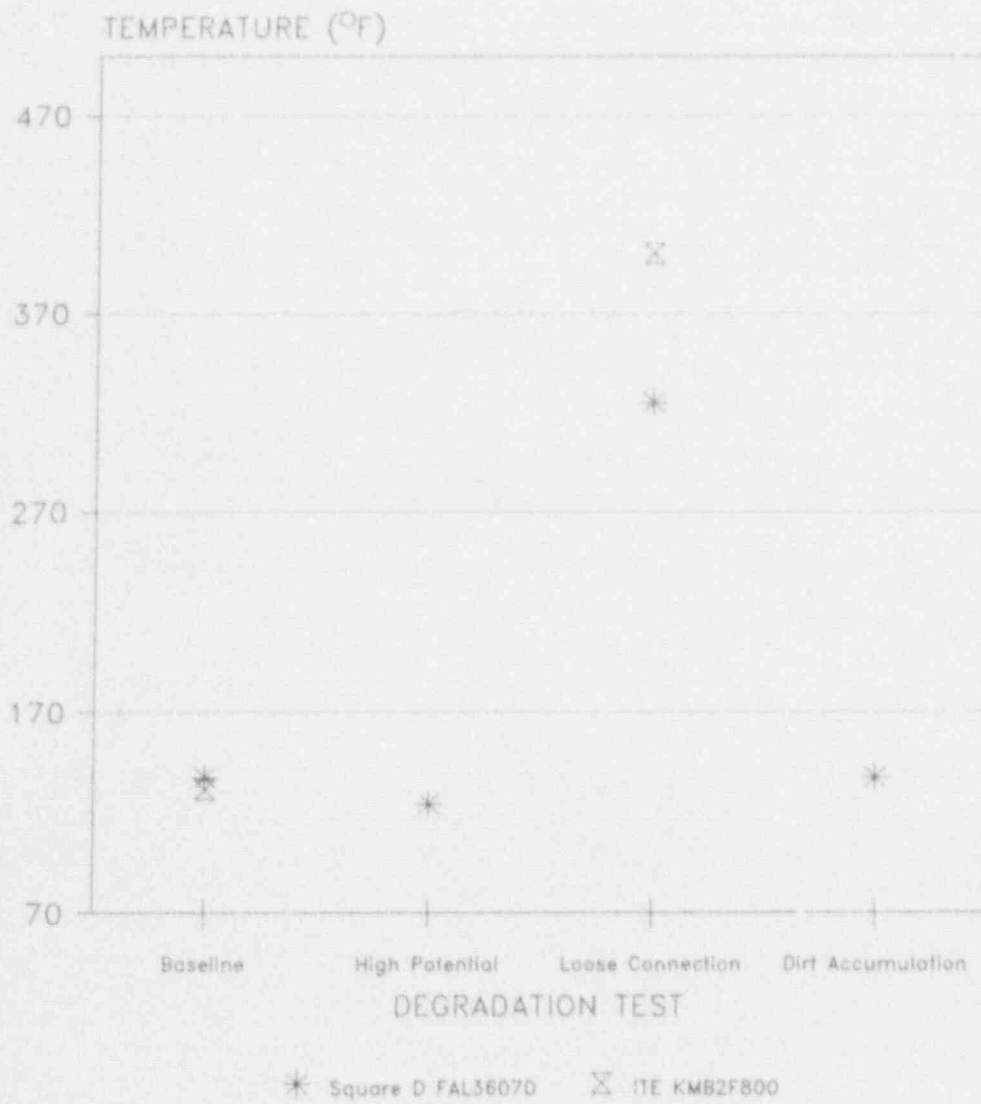
Figure 4-78. Infrared Pyrometry Comparison Degradation Tests Molded Case Circuit Breakers

Infrared pyrometry showed temperature changes in one out of three degraded conditions, Figure 4-78, for the Square D FAL36070. An increase in temperature of almost 200°F was caused by the loose connection degraded condition. For the ITE KMB2F800 circuit breaker, the loose connection degradation caused an increase in temperature of approximately 260°F, noted by the infrared scanner and pyrometer, Figure 4-78.

Infrared scanning was available only during the degradation conditions for the ITE KMB2F800 circuit breaker. It showed the significant temperature increase, to approximately 400°F, caused by the loose connections degradation.

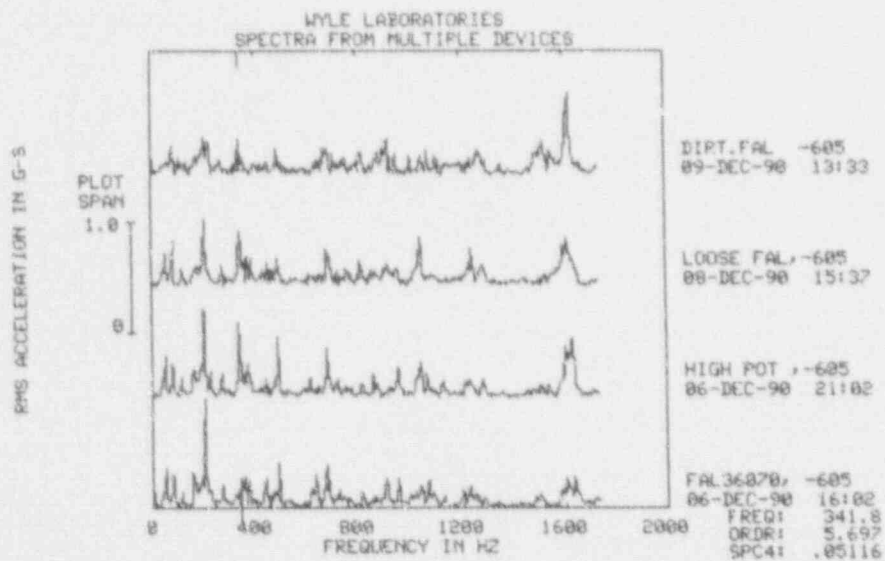
Figure 4-79. Square D FAL36070 Molded Case
Circuit Breaker Vibration Signatures
During Degraded Conditions

Vibration signature differences were caused by all three of the degraded conditions for the Square D FAL36070 molded case circuit breaker, Figure 4-79. Significant vibration signature differences were caused by the degraded condition of high potential by adding a peak at 340 Hz, by the degraded condition of loose connections by reduction in amplitude at 500 Hz and by the degraded condition of dirt accumulation by reducing the amplitude at several frequencies, most notably 203 Hz.

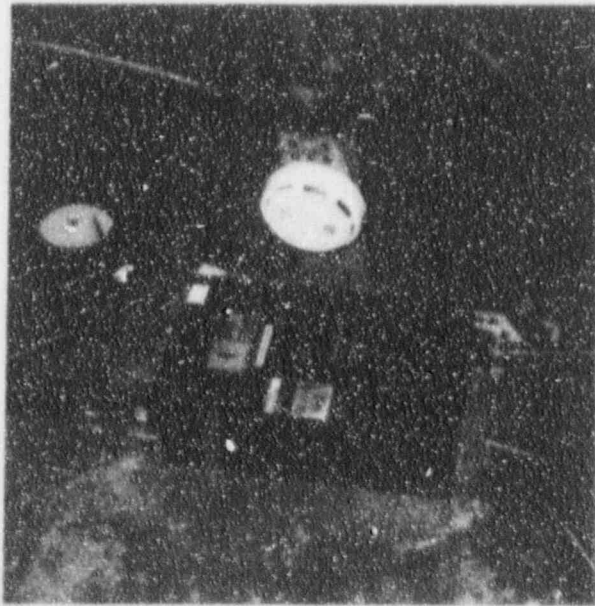
The ITE KMB2F800 was too large to mount in the panel and accommodate the proper cable size and lengths without becoming a personnel hazard, so it was tested outside a panel, with the ion detector suspended over the breaker. Figure 4-81 shows the relative position of the ion detector, approximately six inches above the breaker. When smoke evolved from the circuit breaker and cable, air currents prevented sufficient concentration of smoke at the ion detector and the ion detector did not alarm.

Figure 4-81. Loose Connection Degraded Condition on
ITE KMB2F800 Molded Case Circuit Breaker,
Note Ion Detector over Breaker

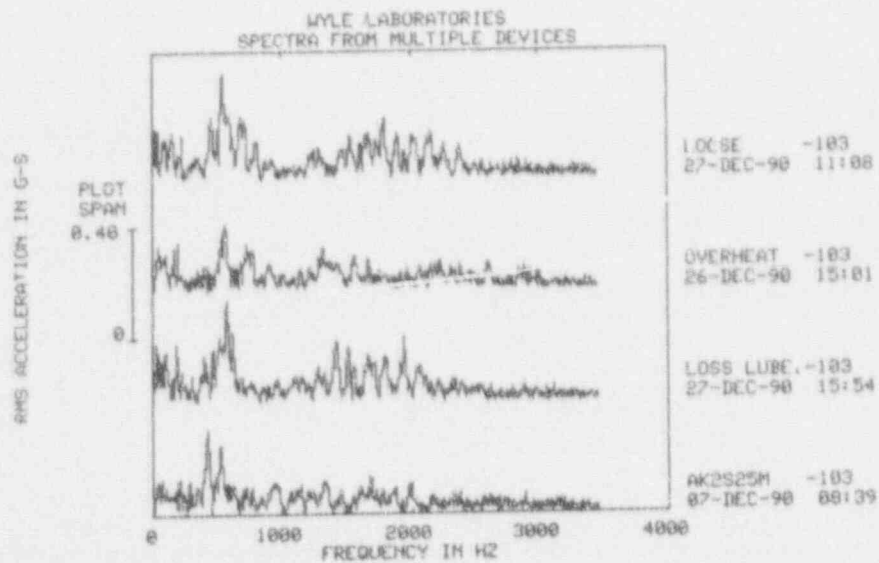
Figure 4-85. Vibration Signatures of Metal Clad Circuit Breakers During Degraded Conditions

Vibration signature differences were caused by all three of the degraded conditions for the GE AK-2S-25-M metal clad circuit breaker, Figure 4-85. Significant vibration signature differences were caused by the degraded condition of loss of lubricant by adding peaks at 180 Hz and below and between 1430 and 1950 Hz, as well as a change in the spectrum at 530 Hz. The degraded condition of overheat caused additional peaks at 730 to 780 Hz. The loose connections degradation caused additional vibration from approximately 1500 to 2400 Hz.
