NUREG/CR-5762
WYLE 60101

Comprehensive Aging Assessment of Circuit Breakers and Relays

Wyle Laboratories

Prepared for
U.S. Nuclear Regulatory Commission

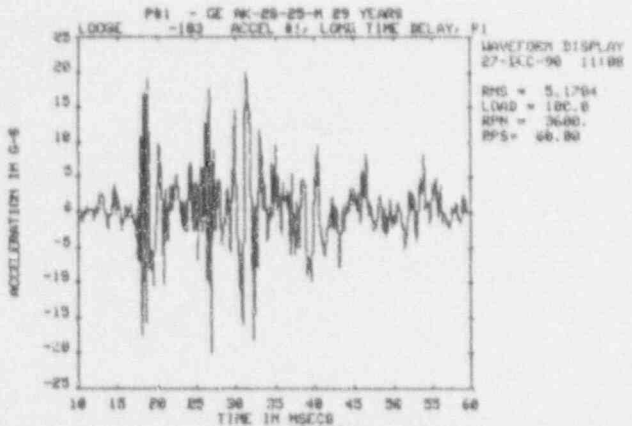
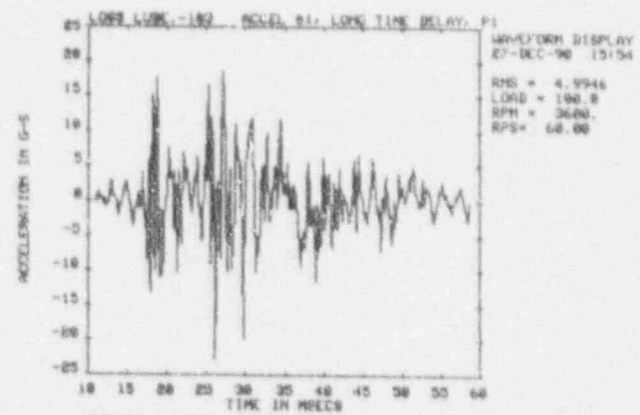
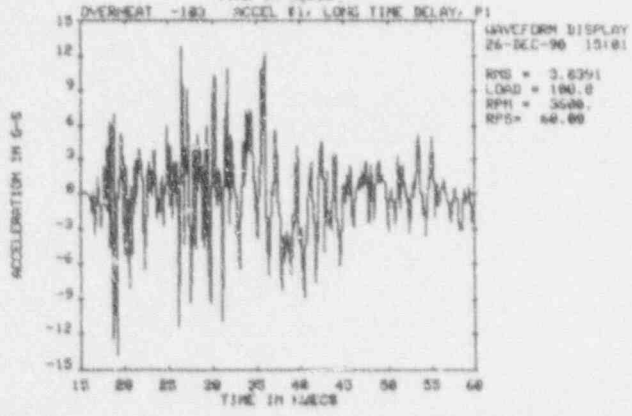
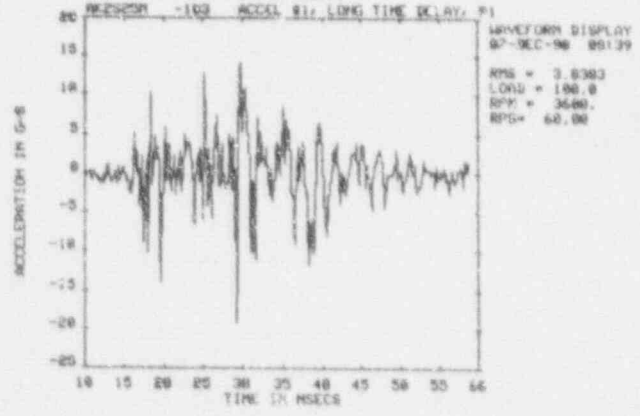
Figure 4-86. Vibration Time History Signatures of Metal Clad Circuit Breakers During Degraded Conditions

The time history of the vibration signatures also exhibited changes caused by the degraded conditions. Figure 4-86 shows the time history vibration signatures for the AK-2S-25-M breaker in the as received condition and after the degraded conditions. The as received condition is on the bottom and in ascending order, the degraded conditions of loss of lubrication, overheated and loose connections. Significant differences were noted in the number of peaks, highest amplitude and time between peaks. For instance the number of peaks which exceed 6 g were 12, 32, 13 and 24 for the

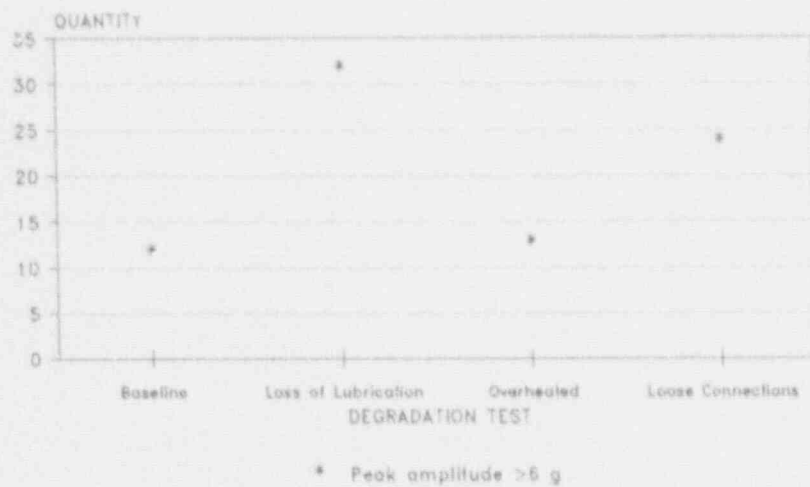
Figure 4-87. Analysis of Vibration Signatures, Quantity of Peaks Metal Clad Circuit Breakers

conditions , as received, loss of lubricant, overheated, and loose connections, respectively, Figure 4-87. Increases in the maximum amplitude were caused by the degraded conditions of loss of lubrication and loose connections, Figure 4-88, and the timing between the first through fourth highest peaks was most effected by the degraded condition of overheated, Figure 4-89.

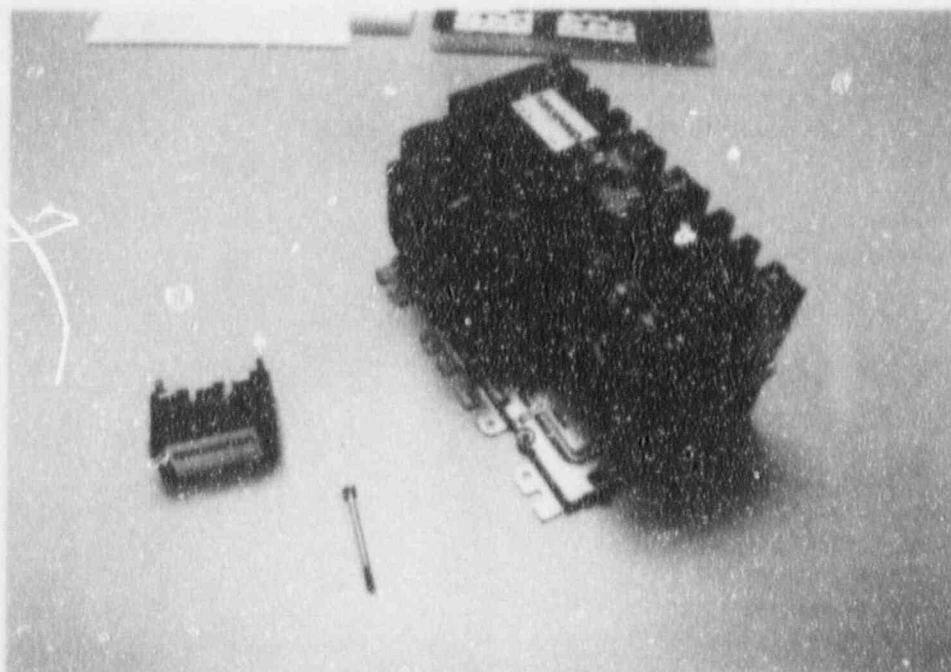
The Catawba staff then inspected 35 MCCs which contained 7 to 60 of the suspect relays and found 28 with loose screws. The corrective action was to change out the original screws with self locking screws which had a nylon patch applied to the screw to

Figure 4-98. Sylvania Relay Showing Contact Carrier and Self-Locking Screw with Nylon Patch

preclude the screw from loosening. Figure 4-98 shows the relay and the new screw.
