FAILURE ANALYSIS OF THE TYPE 304 STAINLESS STEEL 4-in.
RECIRCULATION BYPASS LINES OF THE MONTICELLO BWR POWER PLANT*

ARGONNE NATIONAL LABORATORY
9700 South Cass Avenue
Argonne, Illinois 60439
Materials Science Division

April 1976

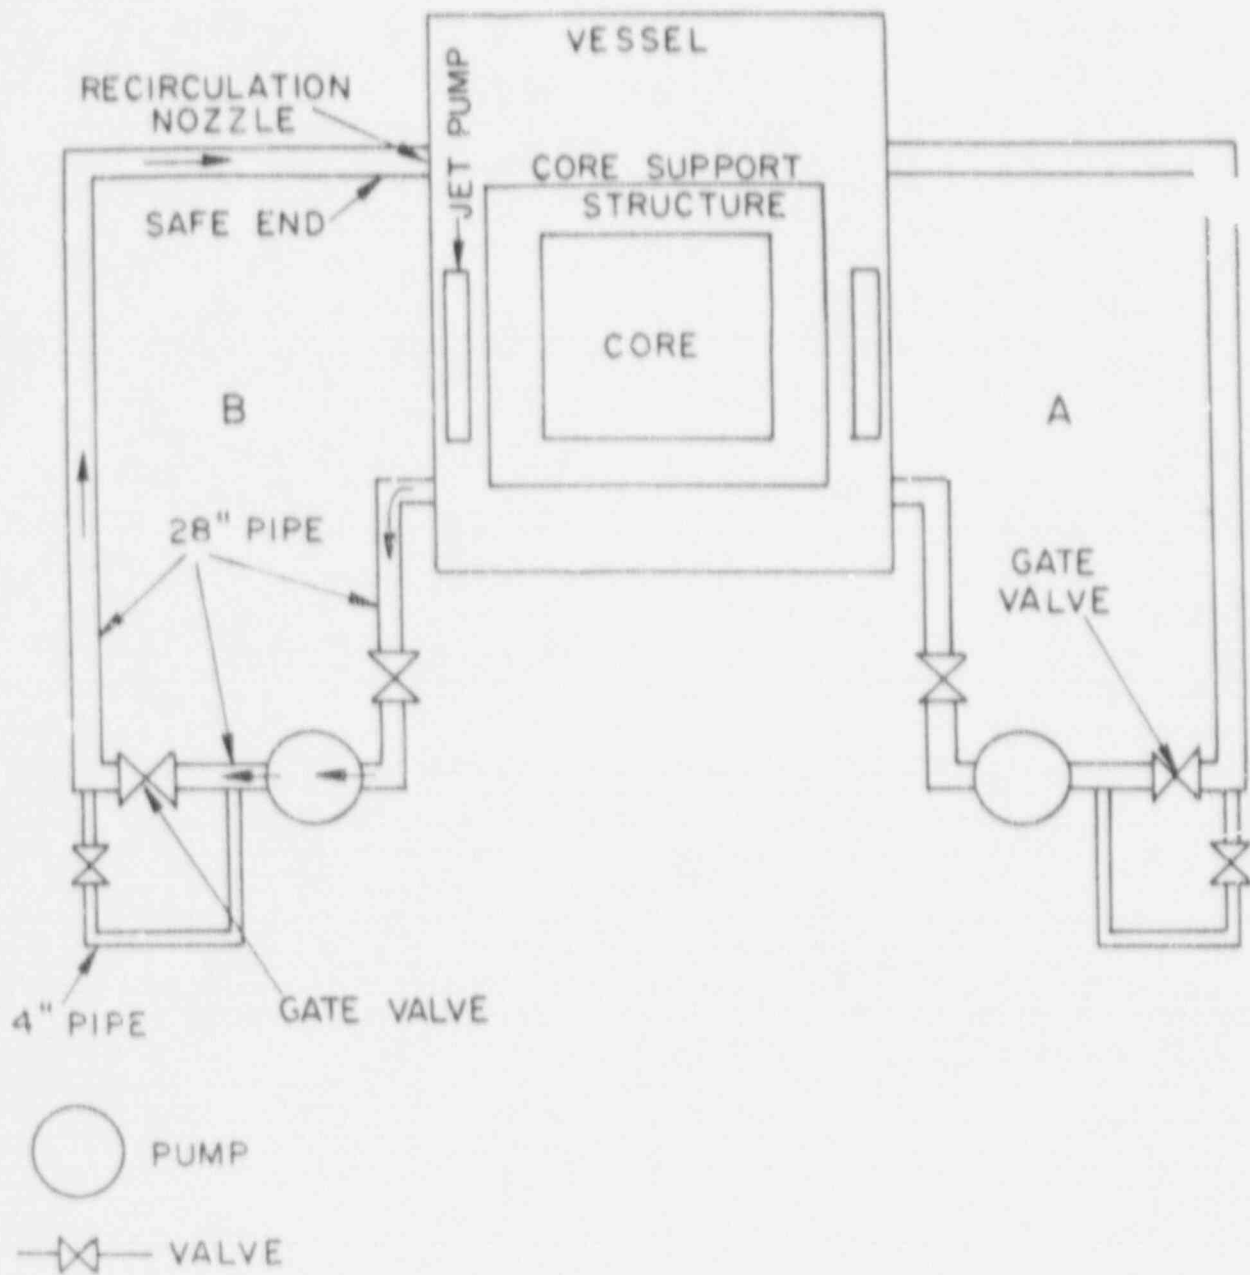
Fig. 1. Schematic showing the BWR water loop system. The 4-in. lines are indicated along with the gate valves and water flow direction.

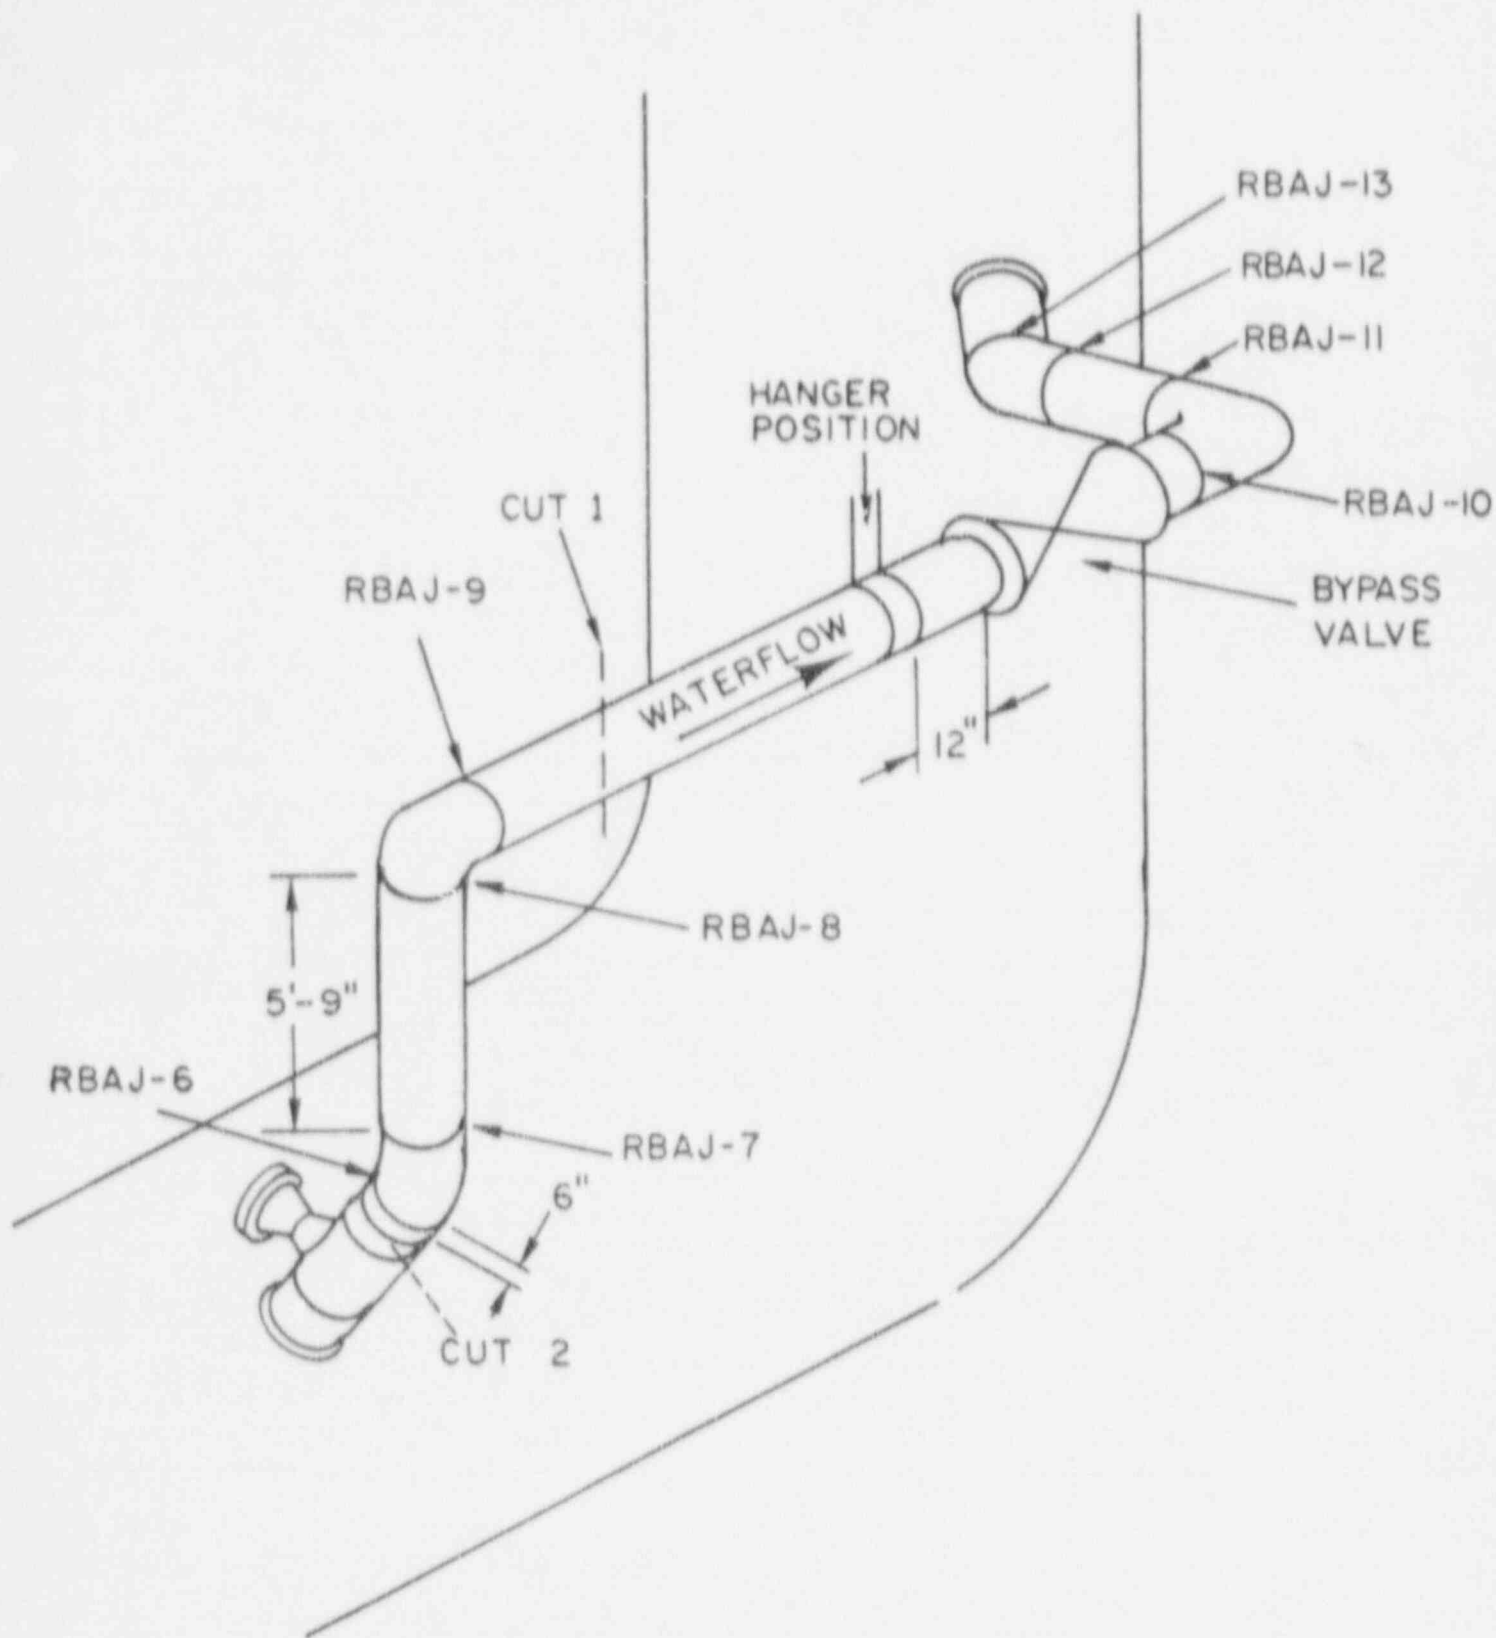
the 28-in. line. Detailed schematics of the 4-in. bypass lines of the Monticello plant are shown in Figs. 2 (Loop A) and 3 (Loop B). The bypass valves shown in these figures remained open during reactor operation, contrasting with the Dresden and Quad Cities plants, which operated with the bypass valves closed. The weld locations are noted in the figures and are labeled, e.g., RBAJ-9. The water flow proceeds as indicated. The welds suspected of having defects are RBAJ-8, RBAJ-7, RBAJ-6, and RBBJ-10. The hanger positions are also labeled.

Fig. 2. Loop A of the 4-in. recirculation bypass line. The weld locations and bypass valve are indicated. Water flow proceeds as shown. The cuts are also shown along with the hanger location and cold springing.

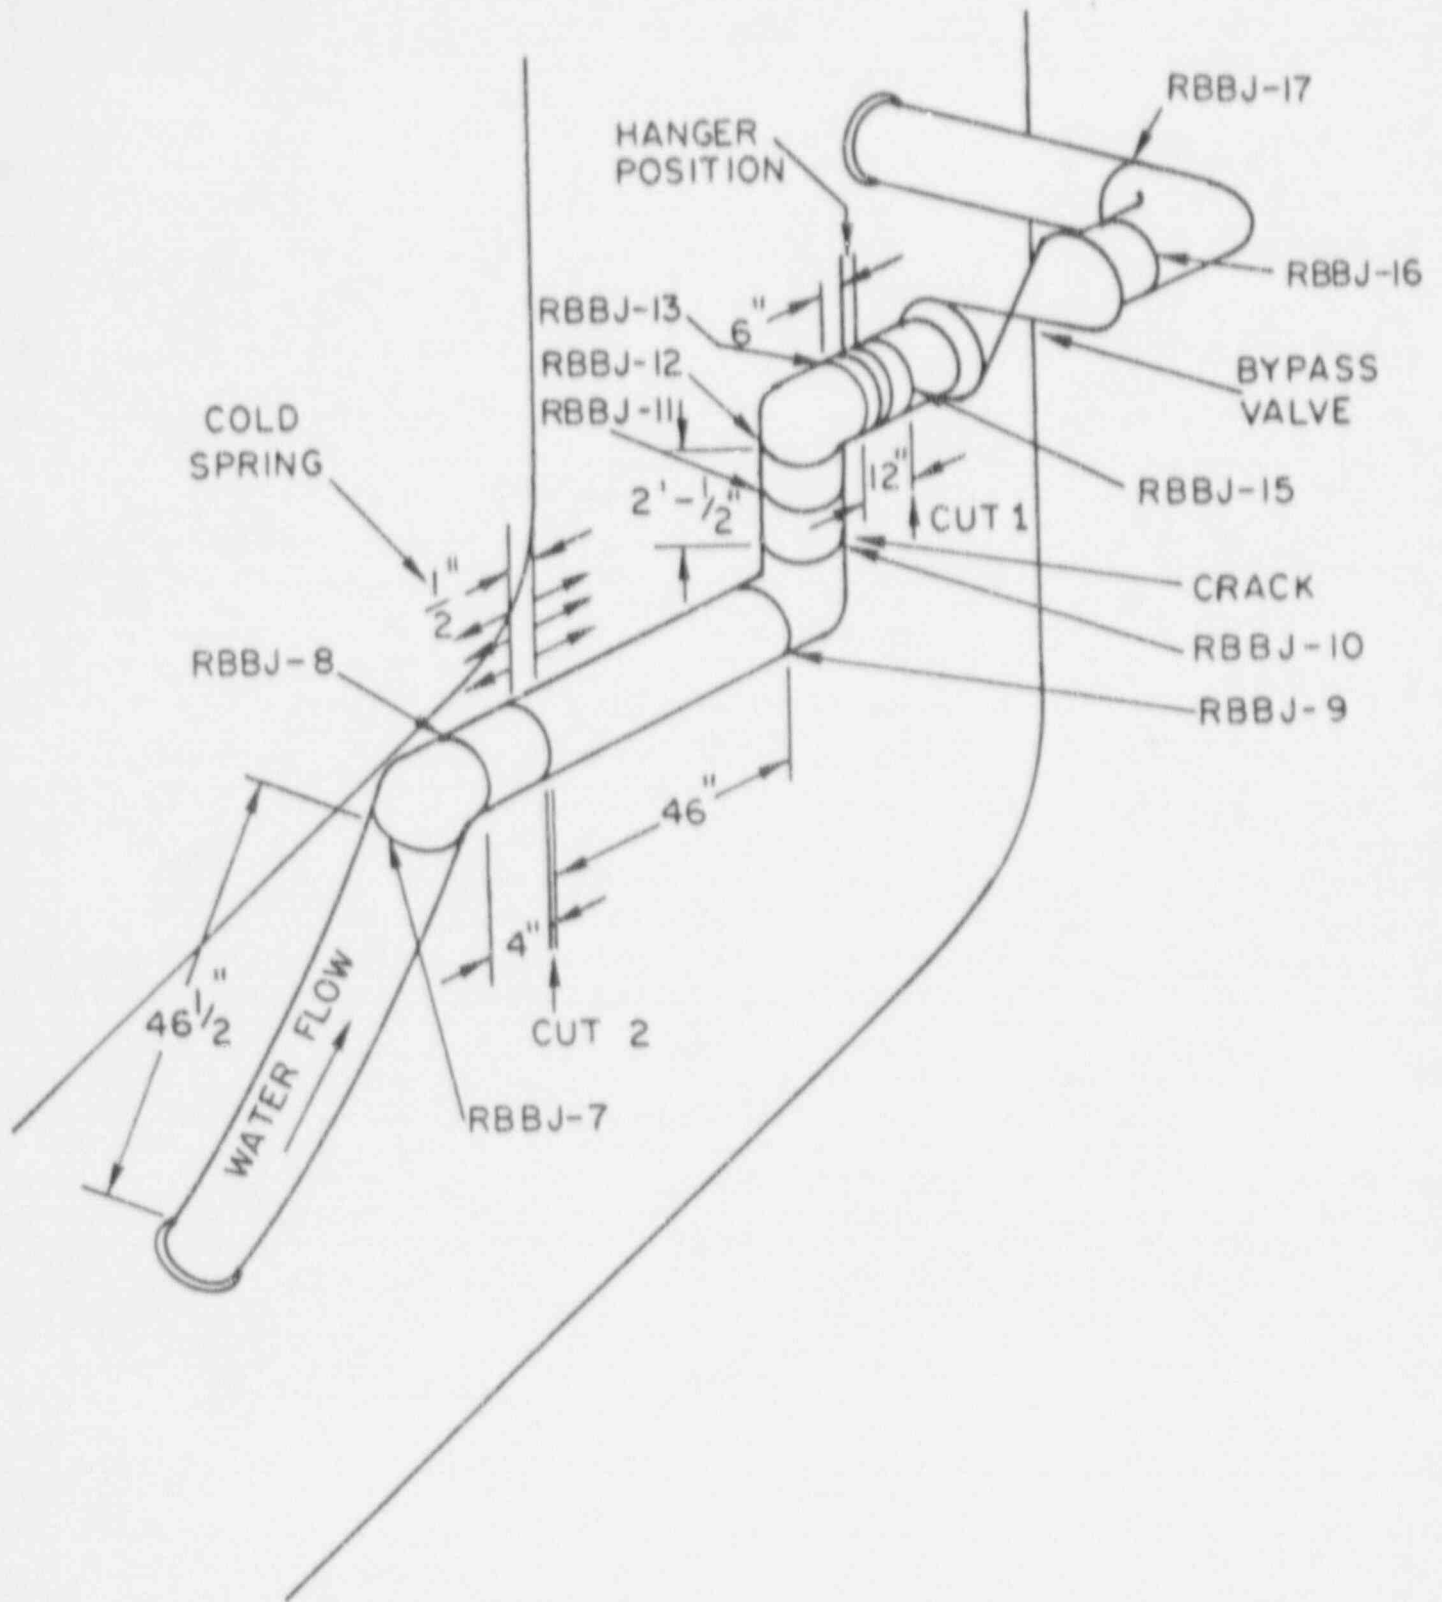
Fig. 3. Loop B of the 4-in. recirculation bypass line. The weld locations, bypass valve, and water flow are shown. The cuts are shown along with the hanger location and cold springing.

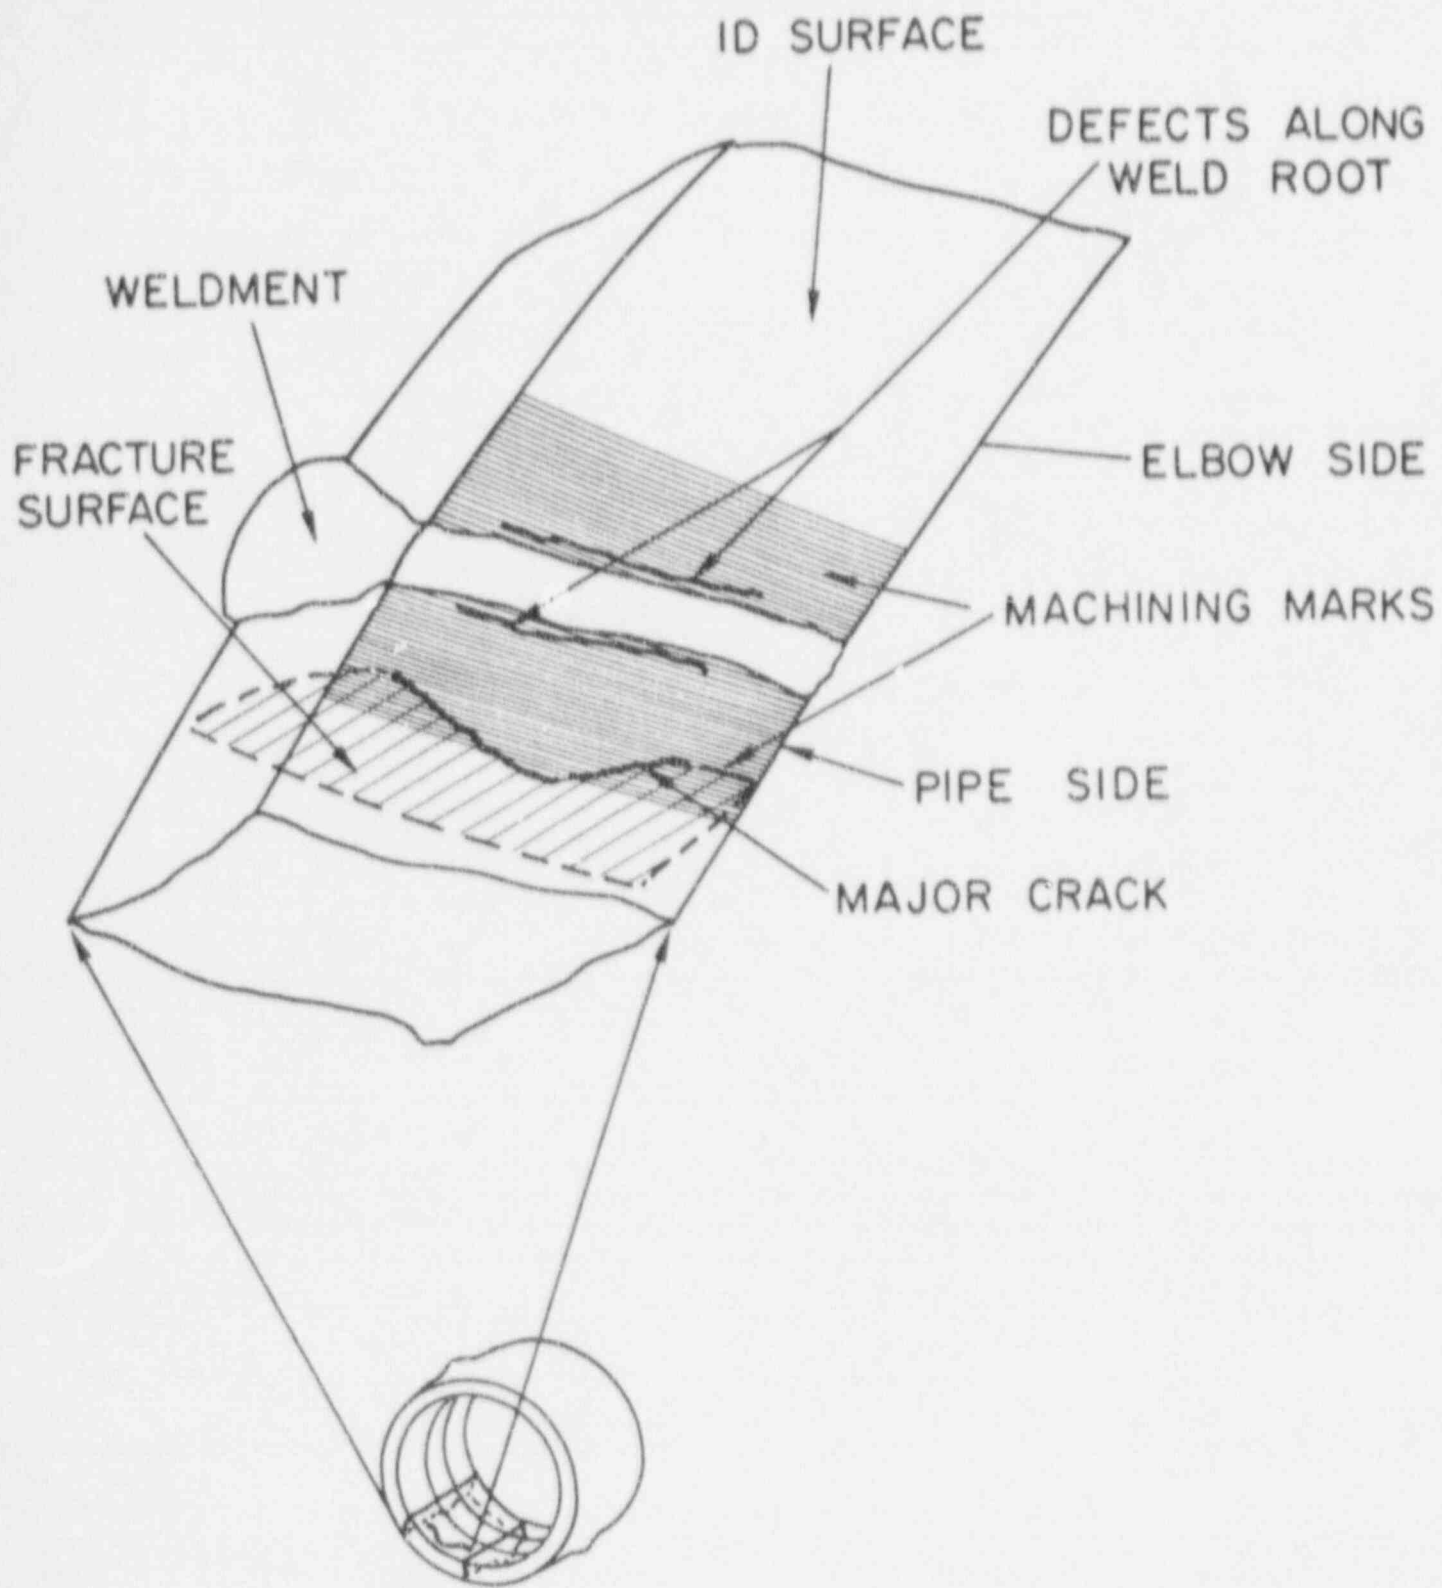
The weld was sectioned as shown in Fig. 8, and the crack was opened to reveal the fracture surface. Figure 12 shows a three-dimensional schematic with the sectioning geometry and major crack location. Figure 13 shows the two mating pieces after the major crack shown in Fig. 12 had been opened. The regions labeled A and B were cut using a cutoff wheel with a silicon carbide blade. The crack front separates the high contrast region from the intergranular cracked region. Care was exercised not to disturb the crack front such that, after sawing, the sample was cooled to liquid nitrogen temperatures and the crack was opened by impact fracture.

Fig. 12. Schematic diagram showing the orientation of the surface defects and major crack in relation to the pipe geometry. The fracture surface to be examined with the SEM is shown.

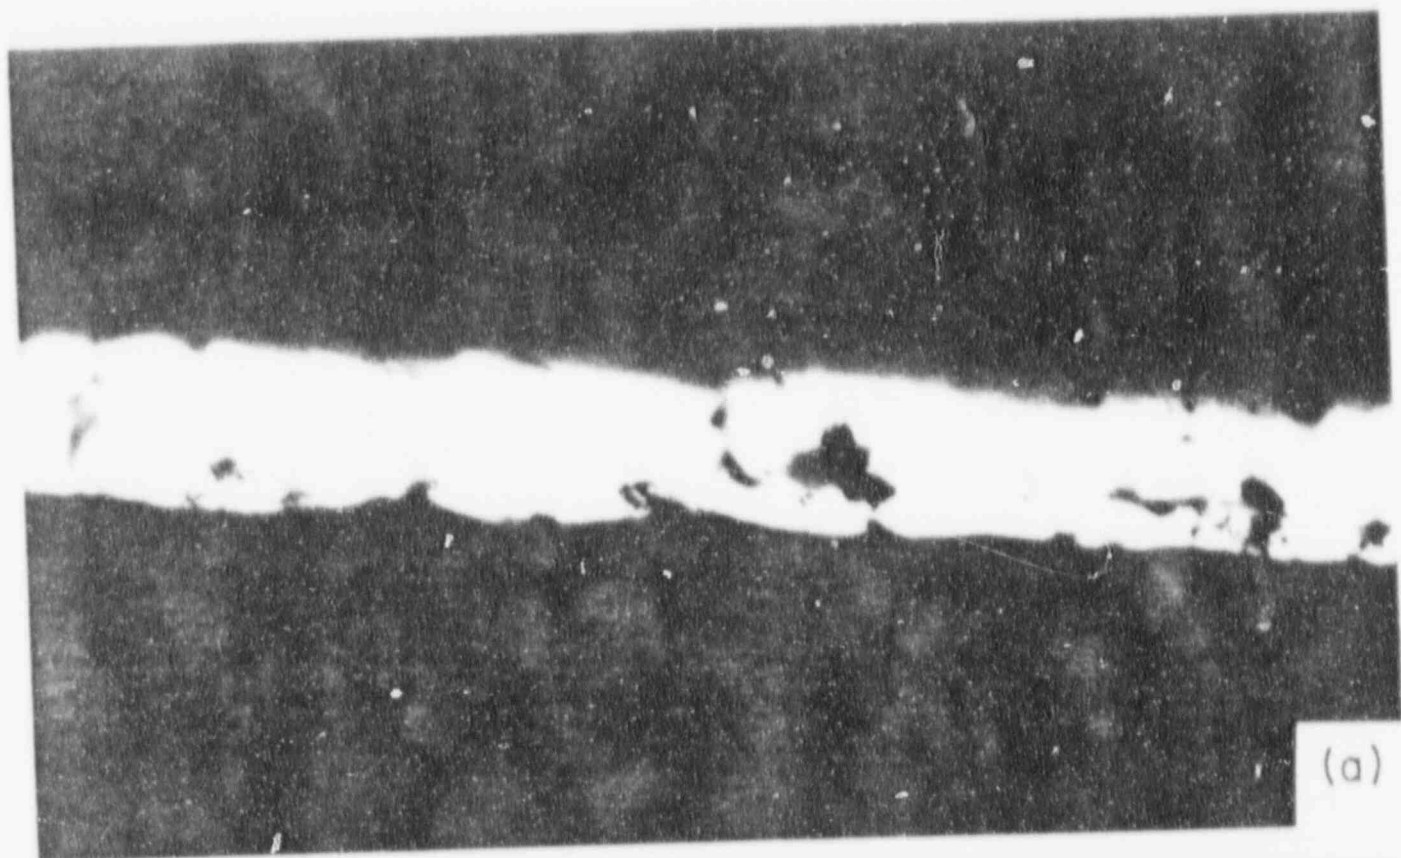
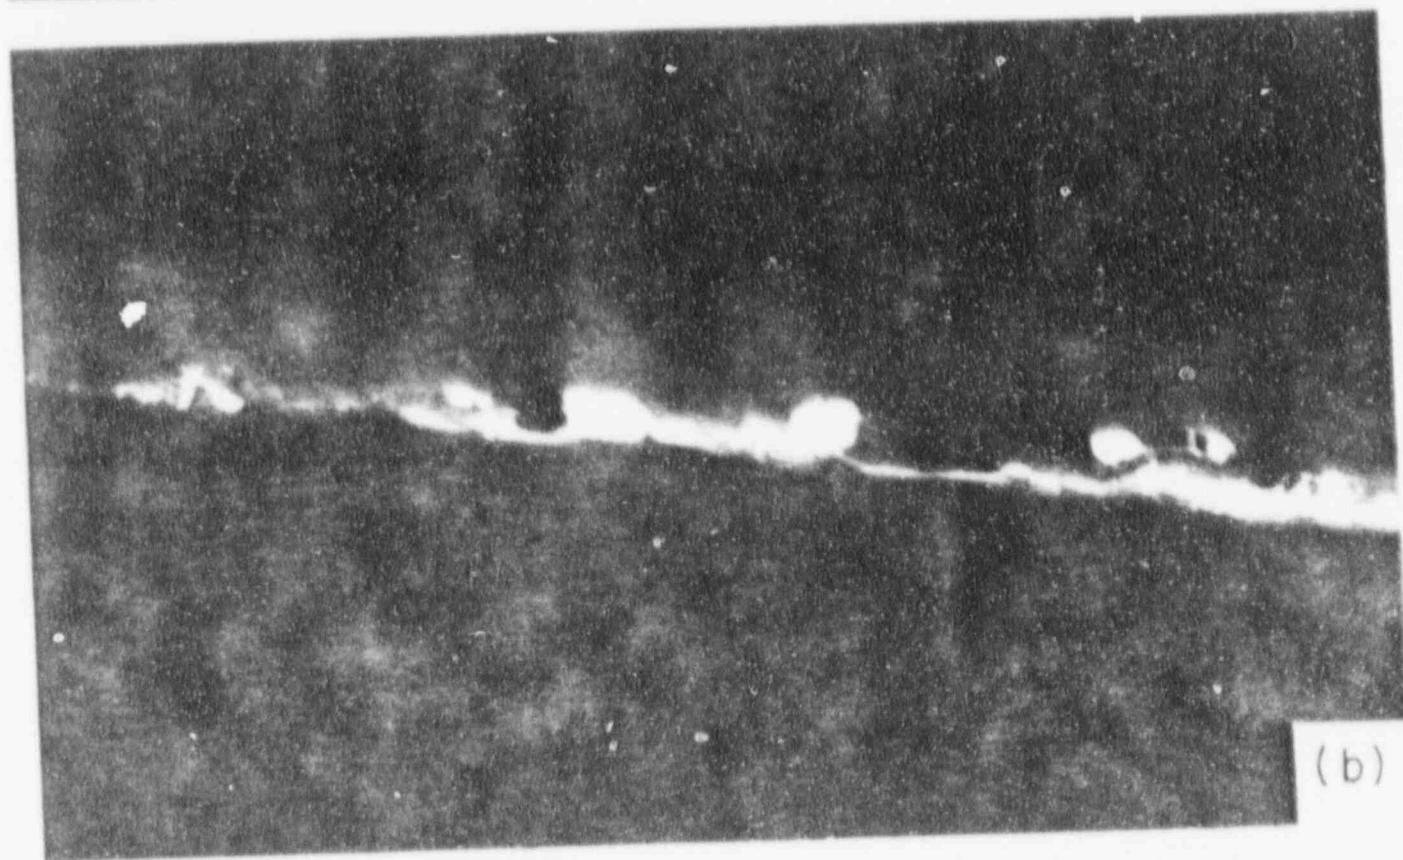
Fig. 22. Bright-field (a) and dark-field (b) TEM of a grain boundary of region 1 of Fig. 21. A grain boundary with precipitates (bright areas) is shown in (b).

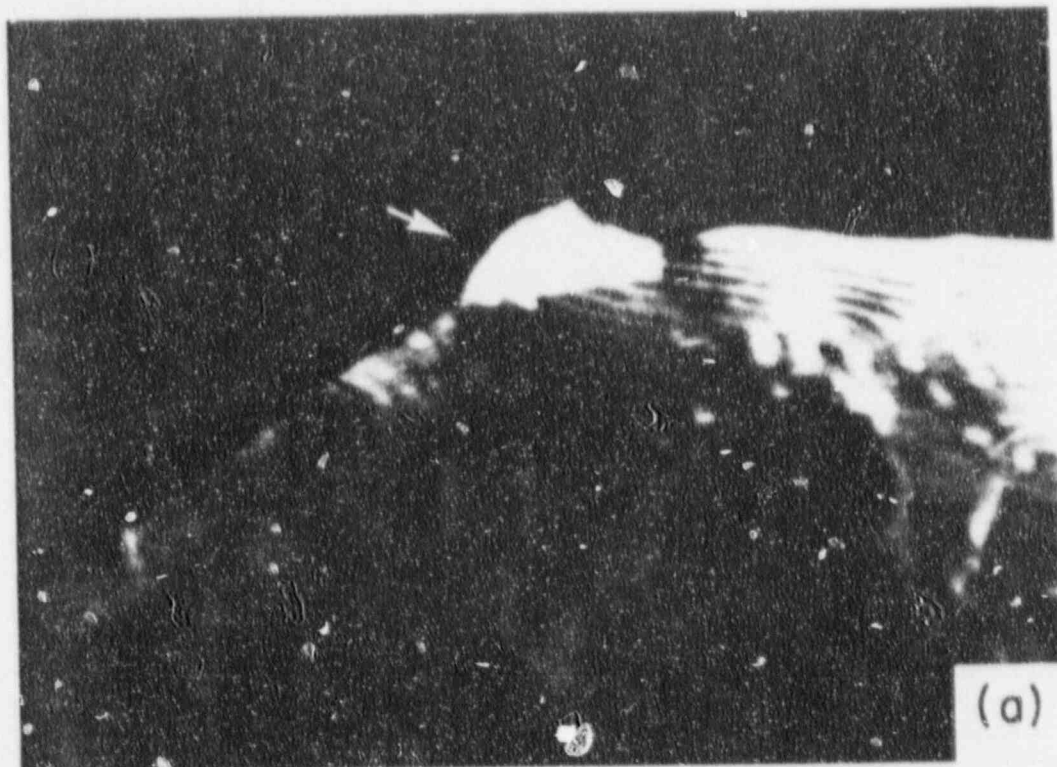
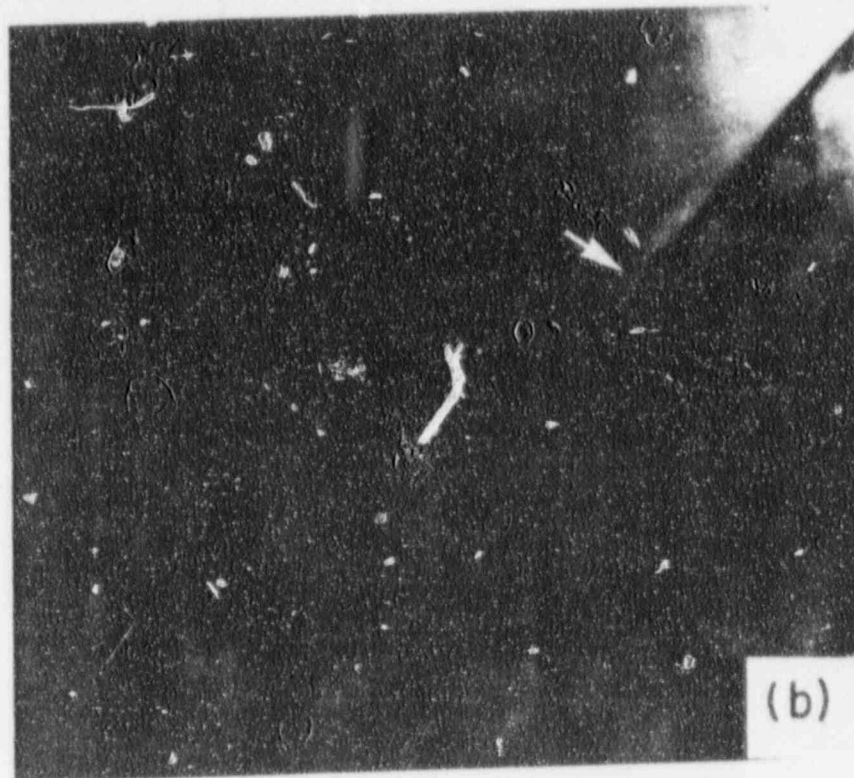
Fig. 23. Dark-field (a) and bright-field (b) TEM of a grain boundary (arrow) of region 3 of Fig. 21. Precipitates (bright areas in the grain boundary, (a)) are seen.

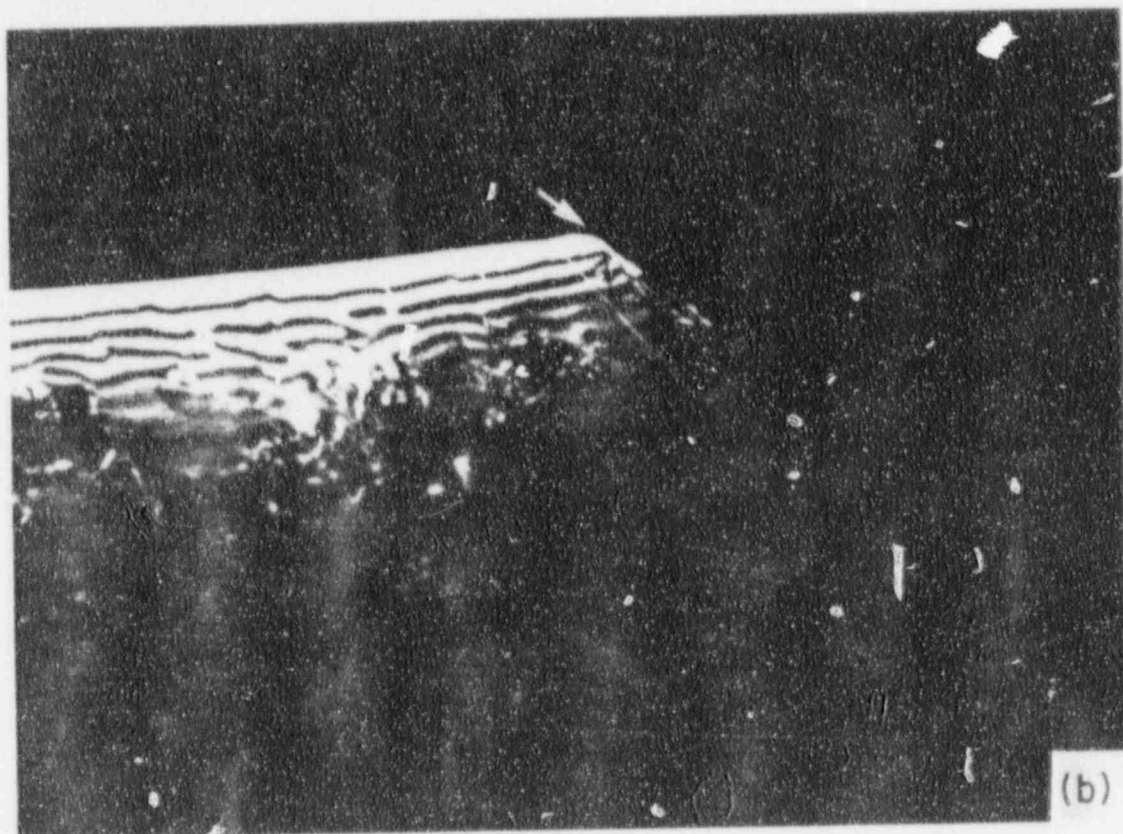
Fig. 24. Bright-field (a) and dark-field (b) TEM of a grain boundary (arrow) of region 4 of Fig. 21.

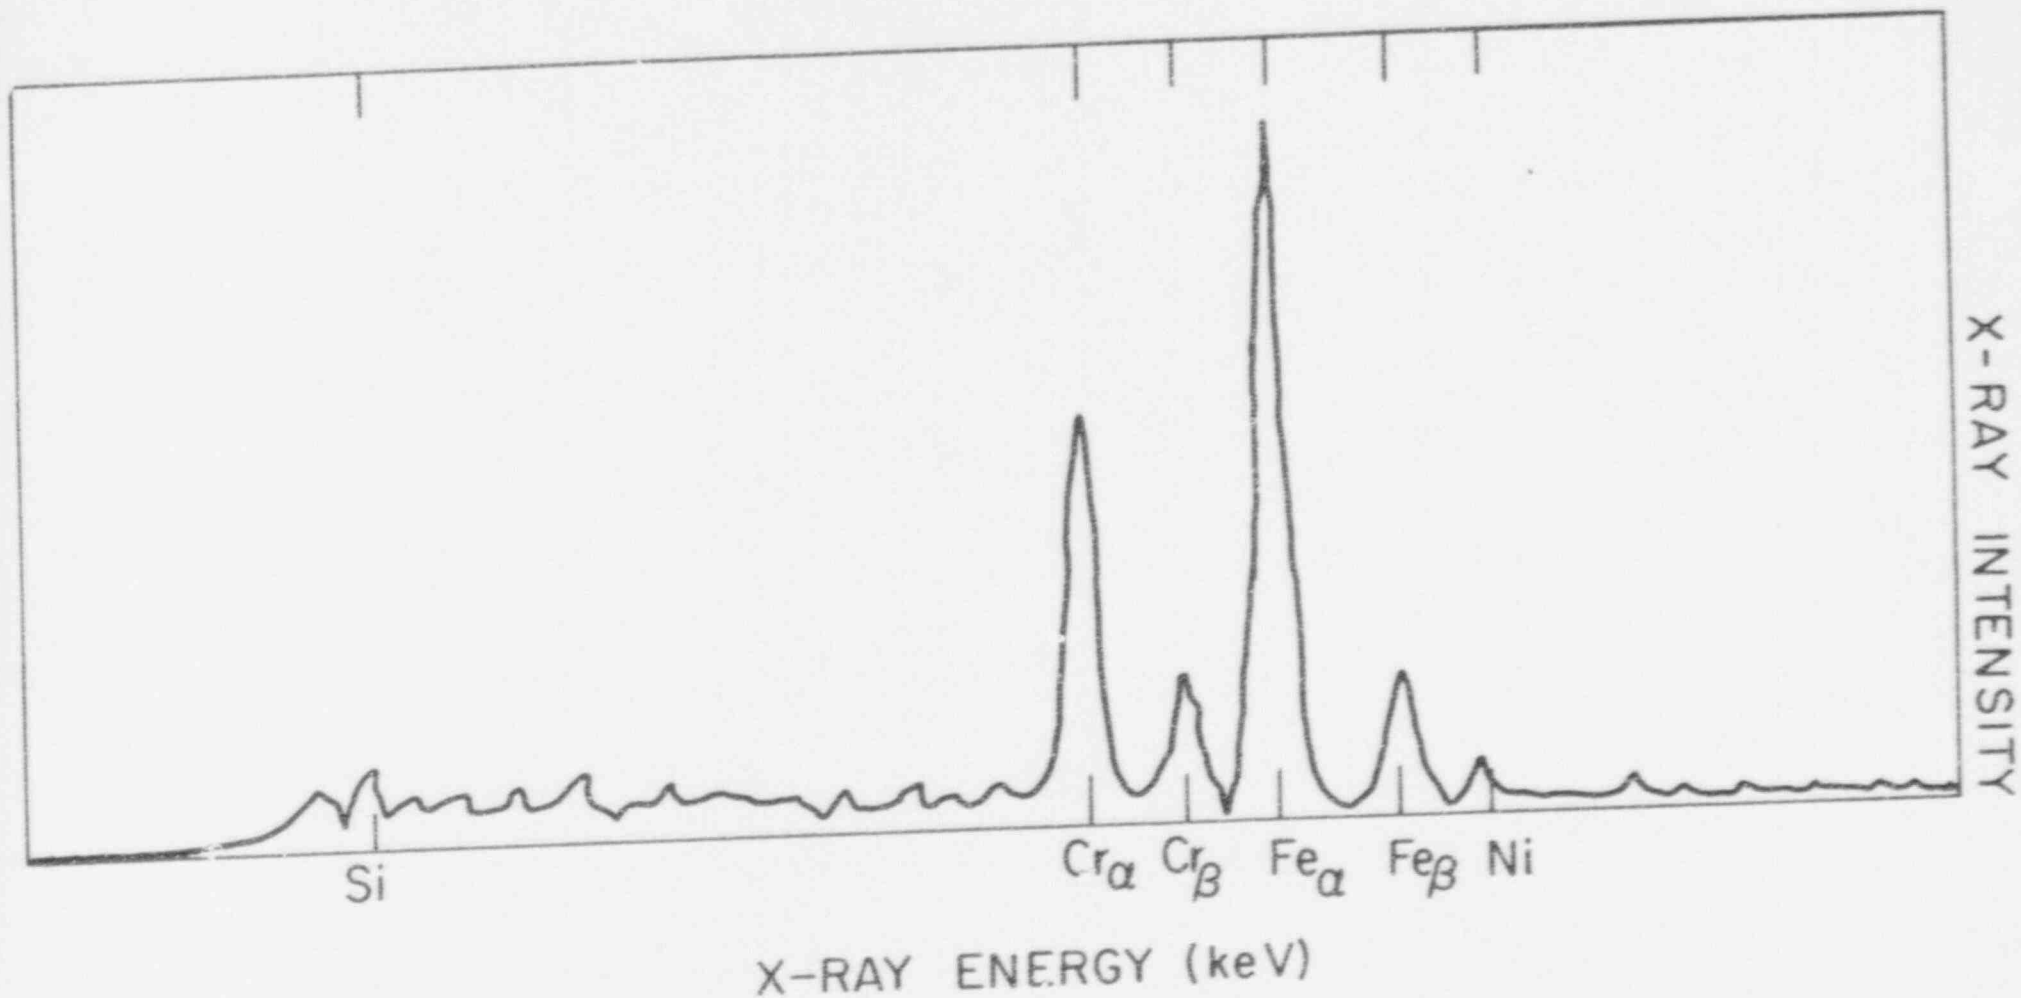
X-ray-dispersive analysis was performed on the precipitate particles and substrate material. The x-ray intensities (CuK α radiation) are shown in Figs. 25 and 26. Chromium, iron, nickel, and silicon are present in both the precipitate and substrate; however, sulfur is observed only in the precipitate. Differences in peak height are readily seen and have previously been attributed to oxide spinels.⁸

Fig. 25. X-ray fluorescence yield of the grains at the fracture surface. Si, Cr, Fe, and Ni peaks are observed. The relative magnitude of the peaks shows that the material is stainless steel.

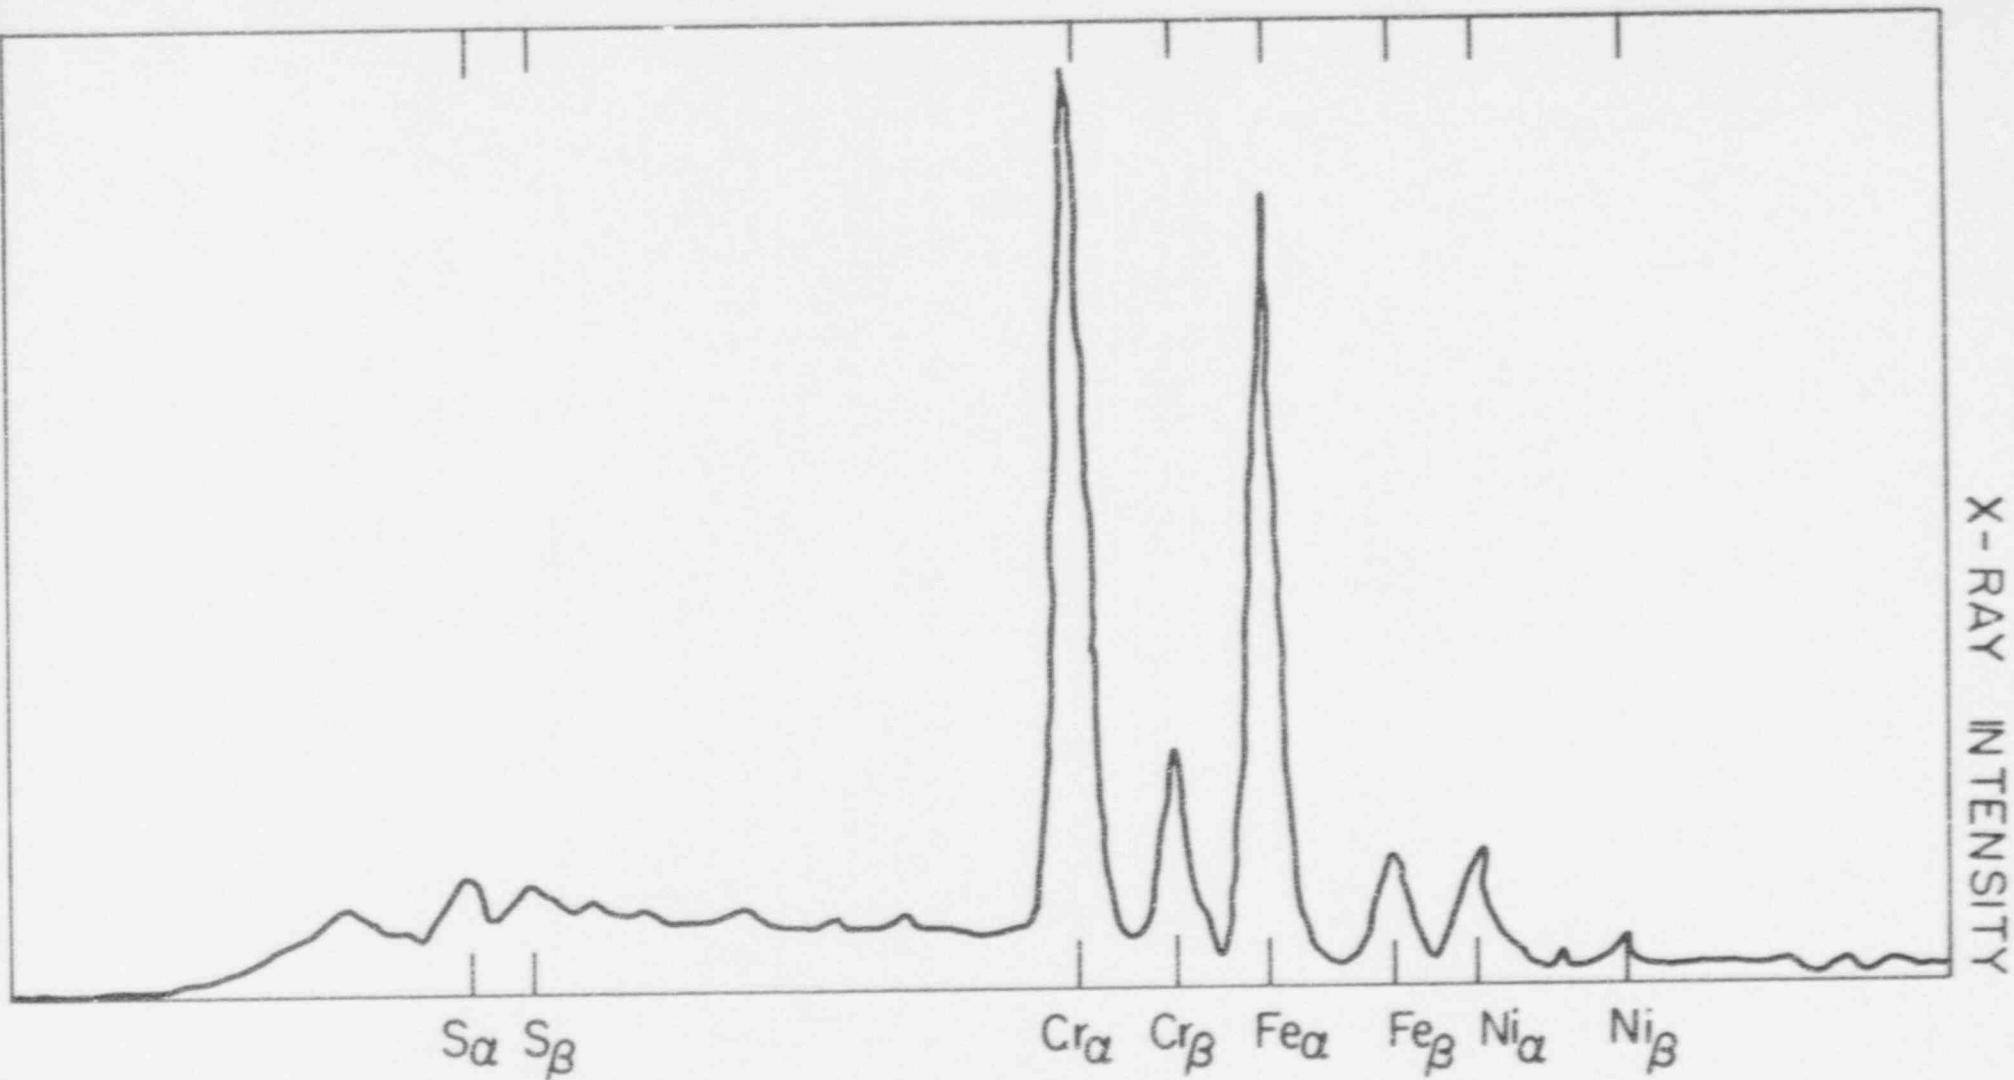
Fig. 26. X-ray fluorescence yield of a precipitate embedded in a grain boundary at the fracture surface. S, Cr, Fe, and Ni peaks are observed. The relative magnitude of the peaks (compare with Fig. 25) suggests that the particle is made of a chromium-rich spinel.

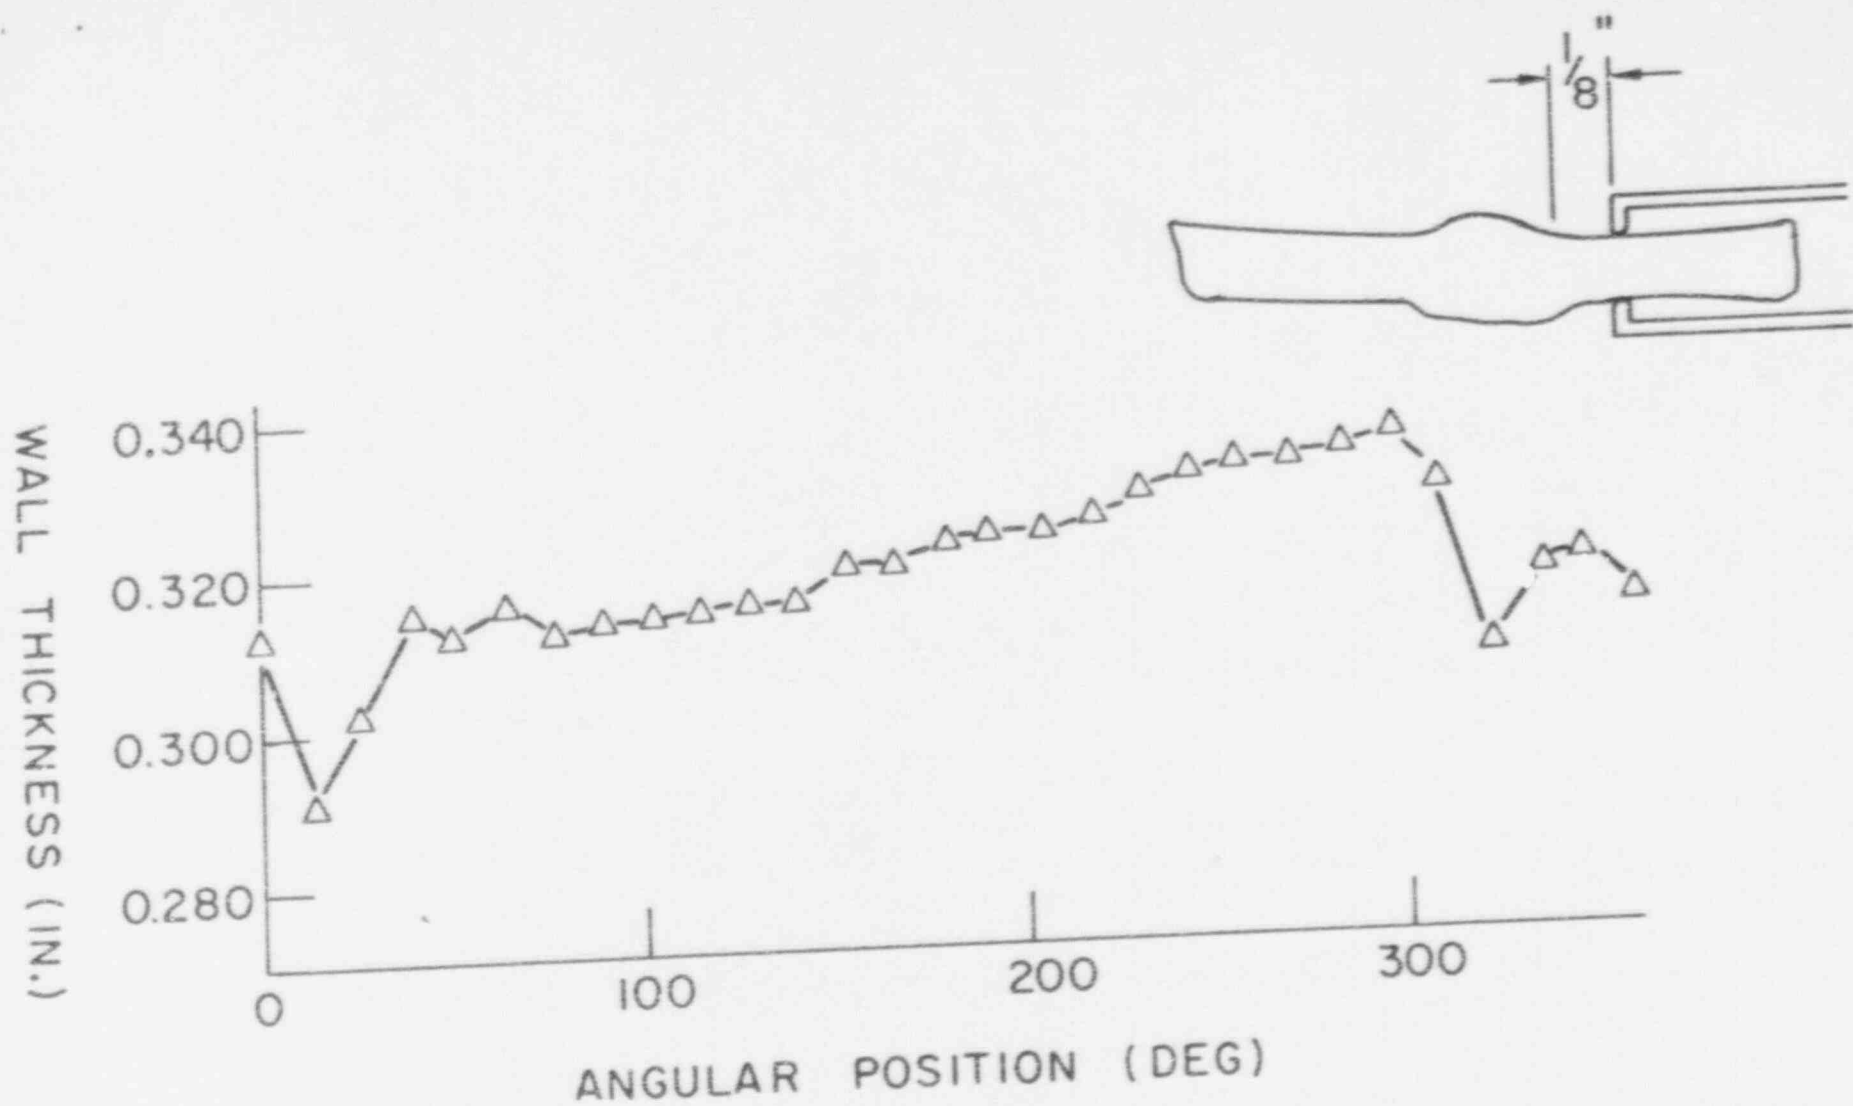
Wall-thickness measurements around the circumference were taken 1/8 in. from the fusion line of weld RBAJ-7. The results, shown in Fig. 29, are plotted as wall thickness versus angular position. It is apparent that significant thickness changes, which could lead to stress concentrations, may be present in the HAZ as a result of weld shrinkage. Weld shrinkage may also lead to cold cracks due to tensile stresses. It may be assumed that measurements for the other welds will show similar variations in thickness.

Fig. 29. Circumferential wall thickness vs angular position. The circumferential wall-thickness measurement was accomplished for weld RBAJ-7 as shown in the upper right corner of the figure. The data were obtained 1/8 in. from the weld root.

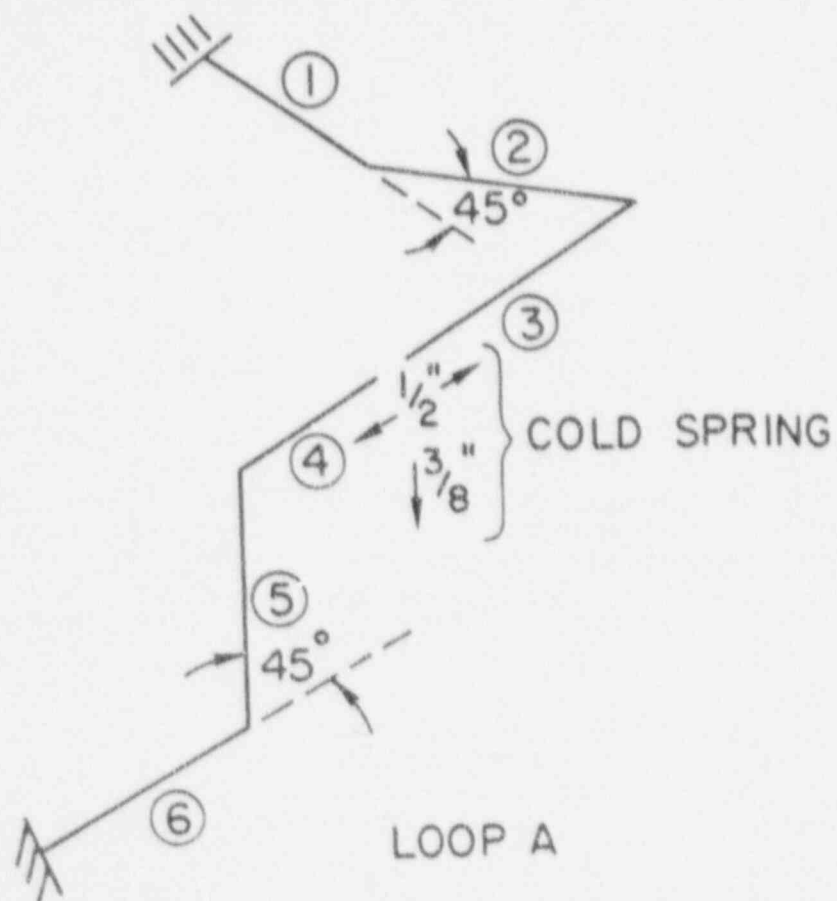
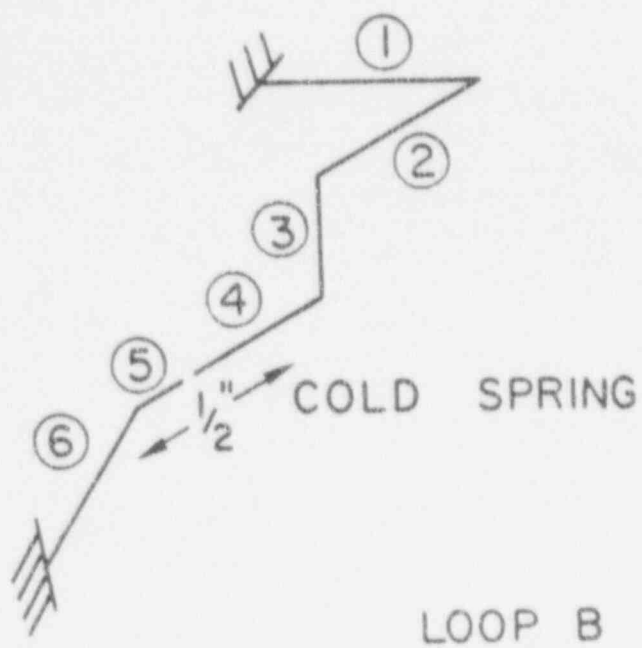
cold springing of both loops is shown in Fig. 30, with numbers indicating straight-line pipe segments (elements). Loop A was severed at the junction of elements 3 and 4, and the measured separations were 1/2 in. along the pipe axis and 3/8 in. perpendicular to the axis. The cold springing of Loop B, measured at the junction of elements 4 and 5, was 1/2 in. along the pipe axis. The stresses were calculated assuming a three-dimensional beam analysis, with the flexibility of the elbows being neglected. Also, the 4-in. pipe section was assumed to be connected at both ends to immovable supports. The analysis is done by inputting the geometry and external constraints into the SAP IV Pipe Bend Element Code. The output of this code is fed into the IBM SSP subroutine SIMQ, where the unknown loads are calculated. The stresses are computed by dividing the loads by the moment areas. The results of the analysis, considering cold bending alone, are shown in Tables III and IV, which include maximum bending stress (σ_B), uniform axial stress (σ_T), and shear stress due to torsion (τ). The beam-type loads due to pressure have been neglected because of their small value. Since the bypass valve on both 4-in. lines was in the open position, the temperature difference between the 4- and 28-in. line is assumed small; consequently, stresses imposed by thermal expansion have also been neglected. The results listed in the tables show that (a) high stresses are present at the connection between the 4- and 28-in. lines and are distributed through a weld-on-let and (b) the stresses are distributed through the other welds, with certain welds showing higher stresses than others. For example, welds RBBJ-9, RBBJ-10, and RBBJ-11 show a relatively higher stress than the other welds in Loop B.

Fig. 30. Schematic of cold-spring measurements.
