SUBJECT: EVALUATION OF THE LANDSMAN CONCERNS FOR MIDLAND

SUBJECT: EVALUATION OF LANDSMAN'S CONCERNS REGARDING
DIESEL GENERATOR BUILDING AT MIDLAND

Midland NPP Diesel Generator Building Review

Structural Evaluation of the Diesel Generator Building

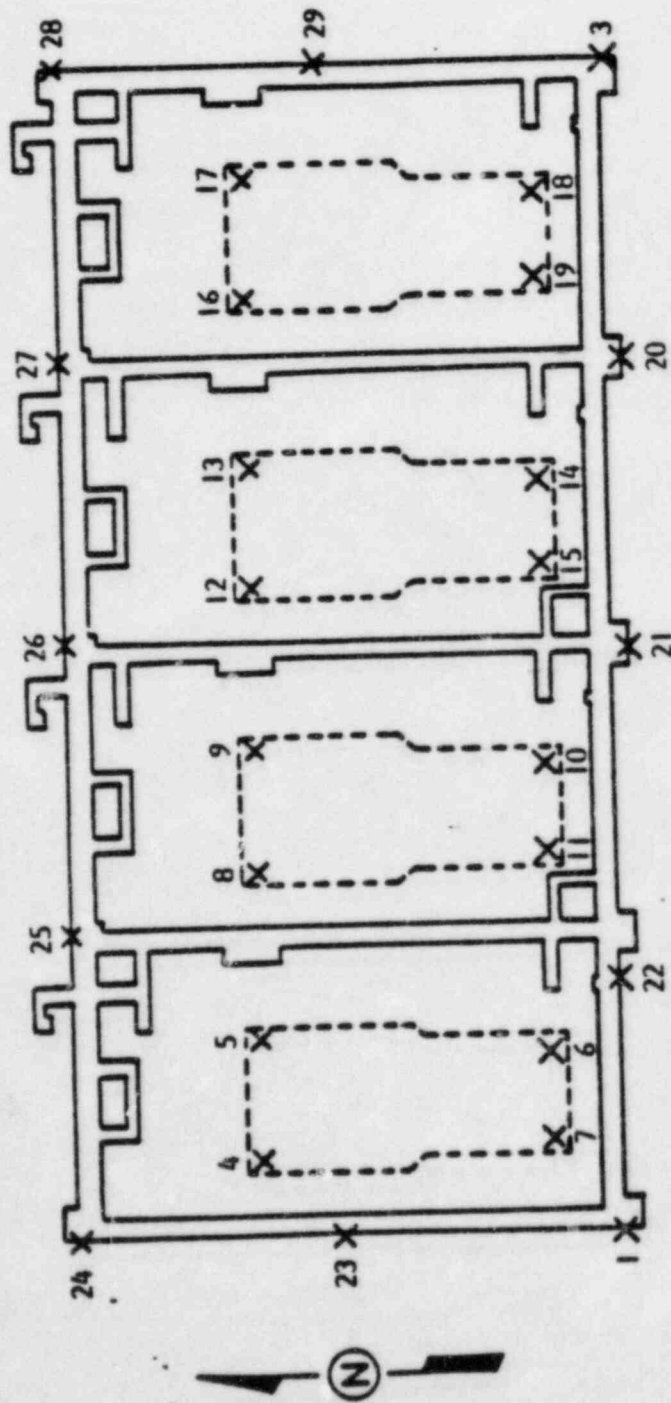
FIGURE 6-2
DIESEL GENERATOR BUILDING
SETTLEMENT MARKER LOCATIONS

The building settlements have been monitored at close intervals during the construction period and thereafter. Figure 6-2 presents the location of the settlement markers indicating where survey measurements are taken. The data spans over a period of 5 years with measurements taken approximately every other week. This large amount of data allows one to follow the settlement history through the stages of construction, duct bank isolation, surcharge period, dewatering, and up through the present. It also provides a means of assessing potential random and systematic errors in the measurements. The Midland project has concluded that significant errors exist in the measurements due to a variety of circumstances. A study of these data is presented in the following section.

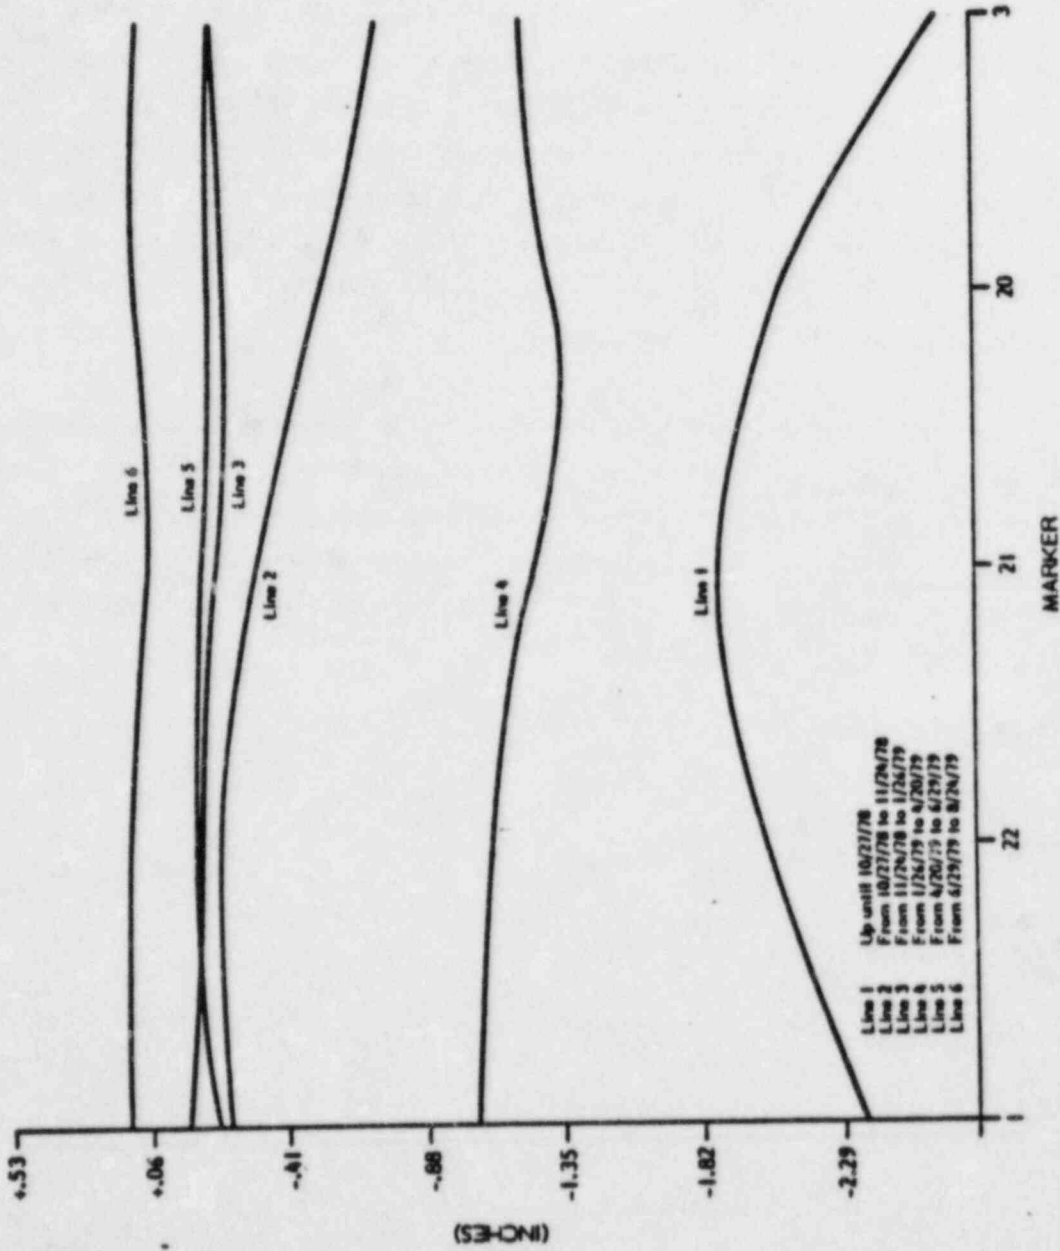
FIGURE 6-3
DIESEL GENERATOR BUILDING
SOUTH WALL
SETTLEMENT INCREMENT

Figure 6-3 shows the incremental settlement for 6 time periods between July 1978 and August 1979 for the south wall of the DGB. The first three measurements show large differential deformations and introduction of curvature in the wall. The latter ones show stabilization of differential settlements implying that the wall is still settling but as a rigid unit, introducing little additional in-plane bending. For more recent recordings the stabilizing trend is even more noticeable. Study of the foundation curvature variation and deformation of the building with respect to its rigid body motion point toward the same trend. This is supported by an evaluation discussed in reference 4, where it was noted that the settlements occurring during the time periods represented by lines c and d (reference 4, figure DGB-7), were those that are expected of a rigid body. In figure DGB-7, line c represents settlement during the surcharging period (1/79 - 8/79) and line d represents estimated settlement during the post-surcharge period (9/79 - 12/2025). The point here is that the early cracking occurred when the building was only partially completed. Upon completion, the five sided (four walls and a roof) structure is now responding as a stiffer, essentially rigid body as would be expected.

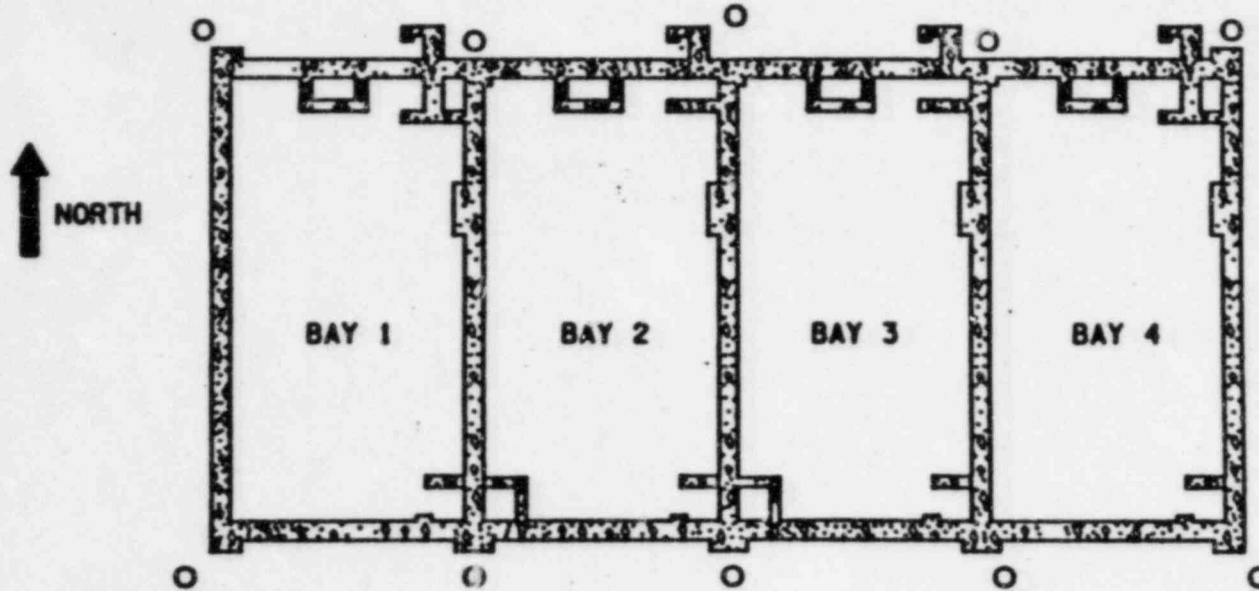
FIGURE 2

3. Para. 92: The settlement of the D.G.B. after the release of the duct banks is not uniform as claimed by the Applicant in the last sentence of this paragraph. As shown in Attachment No.-2 (Fig-2) of the testimony of Mr. H. N. Singh, there has been considerable differential settlement after the release of the duct banks.

The effects of the remedial measures taken can be observed from the amount of settlement which the DGB has gone through as indicated in Figure 2 and also from the crack sizes and crack patterns of the walls as shown in Figure 3. Details of both settlement and cracking issues are discussed in the following sections.

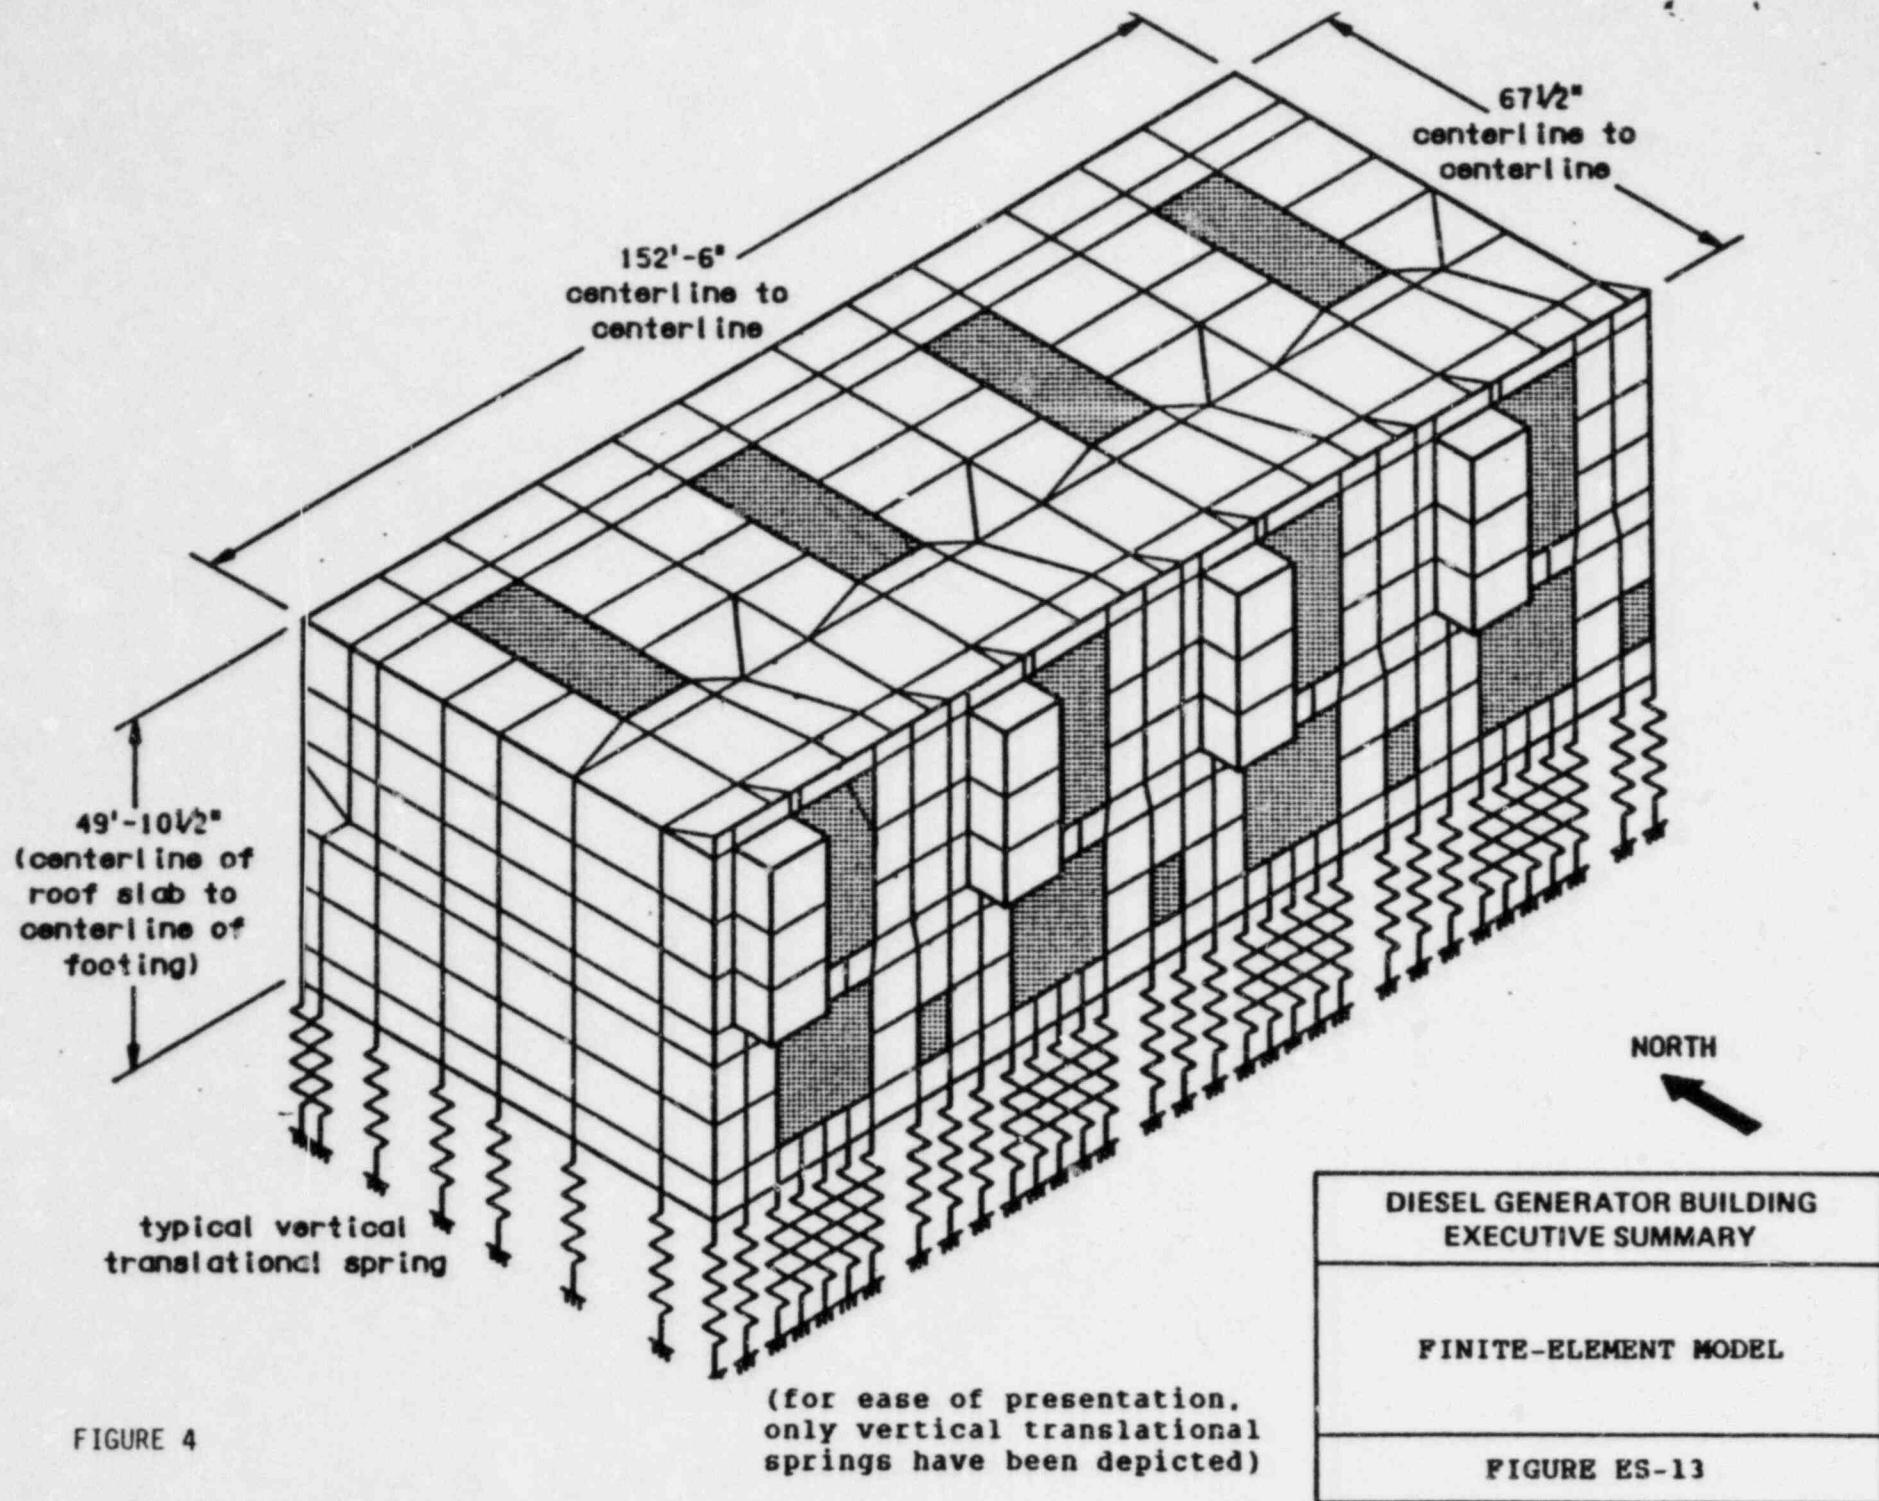
FIGURE 4

shown in Figure 2. With the exception of Case 1A which was analyzed by long hand computation and by idealizing the partially completed DGB as a series of individual beams, the other three cases were analyzed by computer through the discretion of the DGB into a number of finite elements as exemplified in Figure 4. Case 1A was accomplished by passing deflection curve through any three measured neighboring settlement points and selecting the one with the largest curvature for moment computation, and eventually, stress determination. This calculation indicated that the measured displacements would result in a maximum rebar stress of 11 ksi. For the other three settlement cases, individual finite-element models were used. For settlement Case 1B, the finite-element model represents the structure as built to el. 662 f 0 in.
