SUBJECT: POTENTIAL CORE SHROUD CRACKING AT BOILING WATER REACTORS

NRC INFORMATION NOTICE 93-79: CORE SHROUD CRACKING AT BELTLINE REGION WELDS
IN BOILING-WATER REACTORS

CORE SHROUD CRACKING
PRELIMINARY SAFETY ASSESSMENT

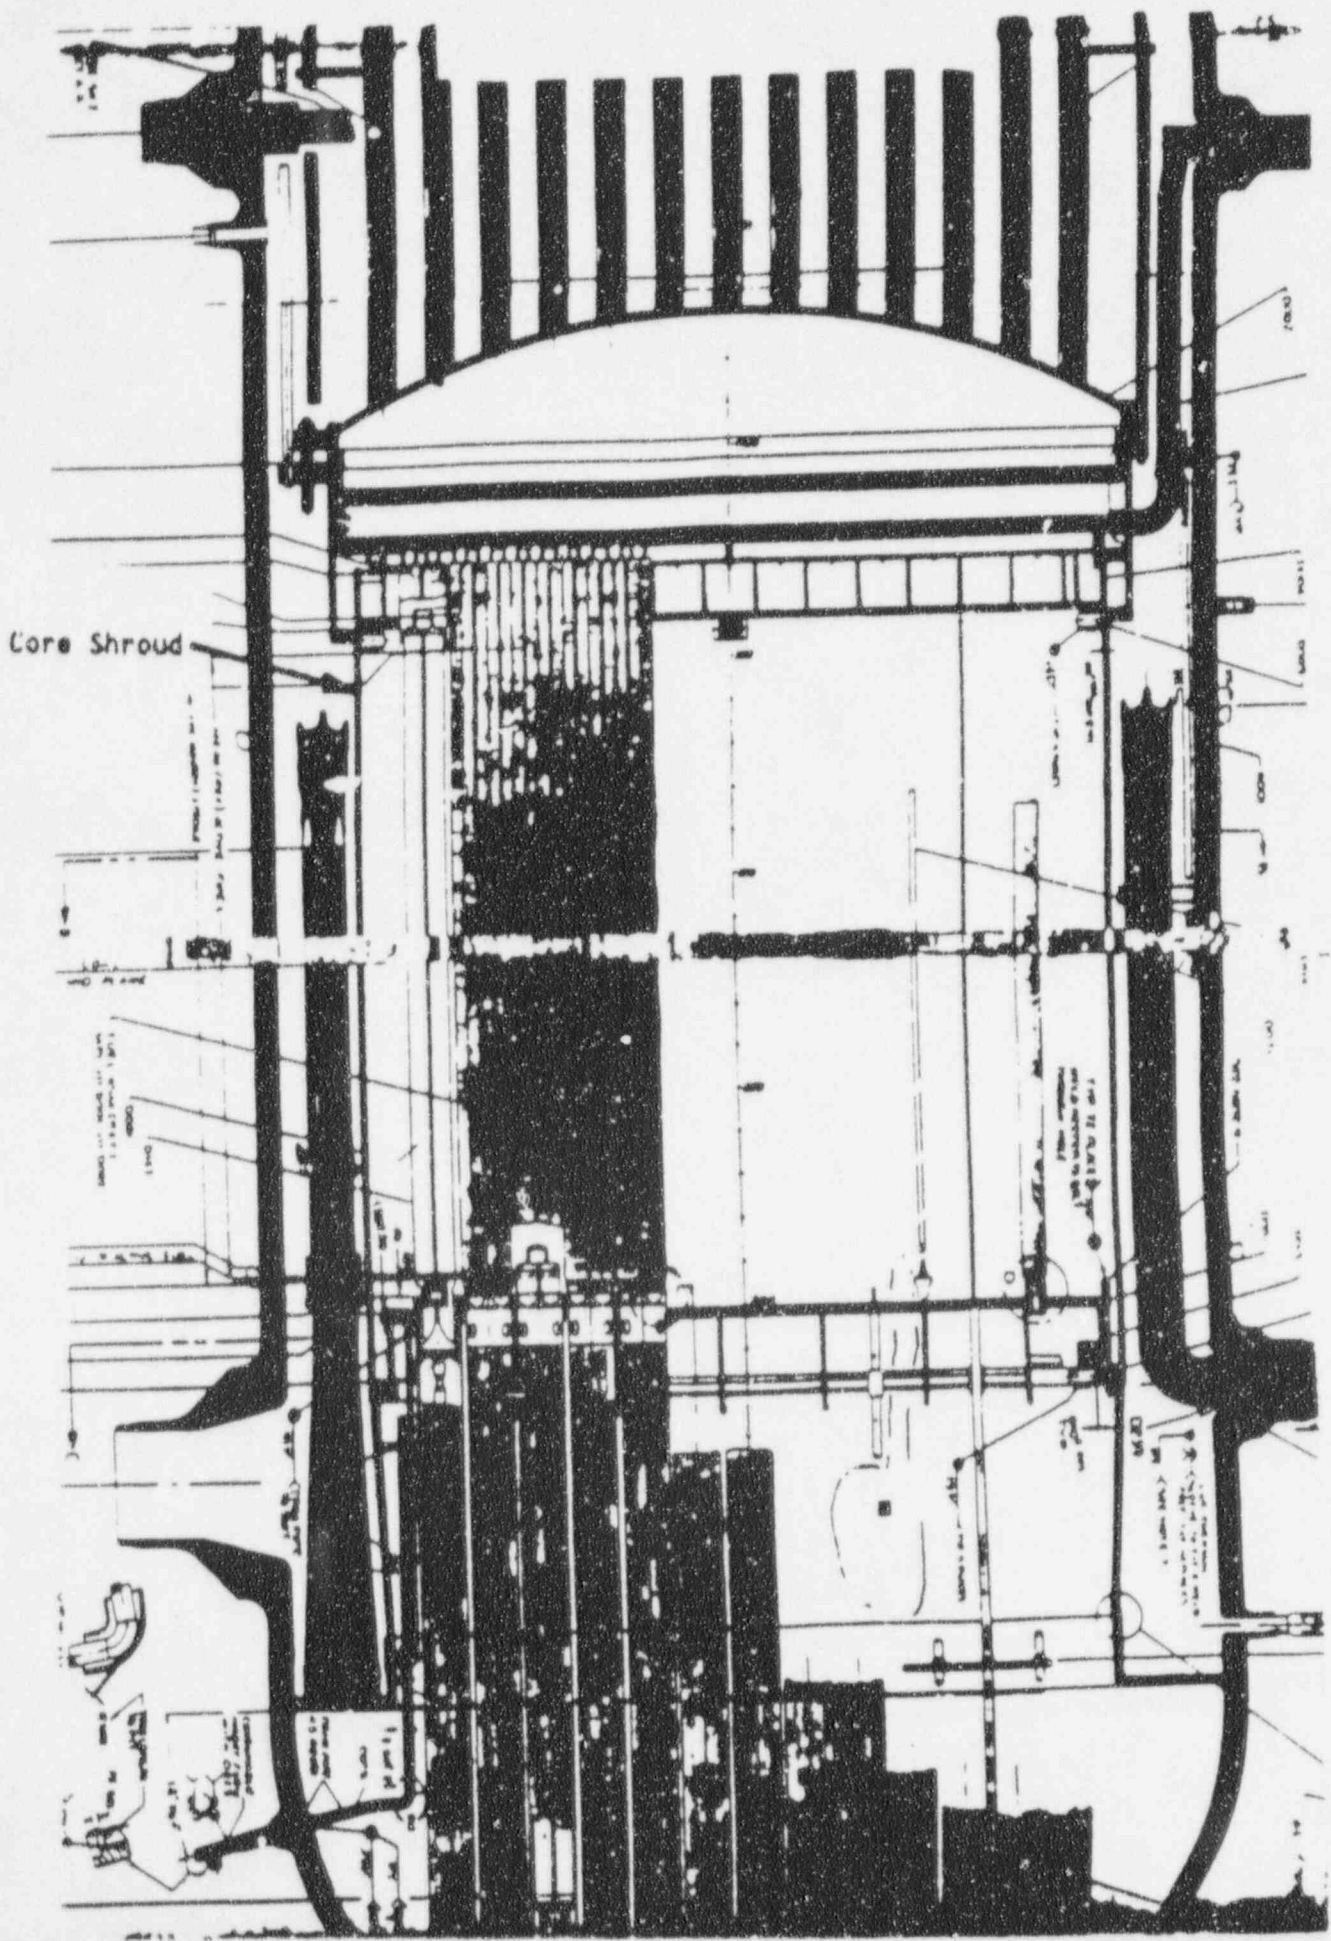
FIGURE 1
BWR REACTOR VESSEL

The core shroud is illustrated in Figure 1. The core shroud separates the core region from the downcomer annulus, which contains the jet pumps, and assures that feedwater flow is directed down the downcomer annulus, through the jet pumps, through the lower plenum, and up through the core region. From the core region, the exiting two-phase flow is directed through the steam separators and dryers and the steam then exits the vessel through the steam lines while the liquid is recirculated to the downcomer annulus. The core shroud is welded at the bottom to the ledge at the bottom of the downcomer annulus upon which the jet pumps sit. The shroud is further supported by 14 pedestals welded to the bottom head of the reactor vessel. The steam separators and the dryers are mechanically attached to the core shroud at the ledge region near the top of the core above the core spray spargers. The core top guide structure, which provides lateral support for the fuel assemblies and assures that the core geometry is maintained to allow for control rod insertion, is supported by a second ledge below the core spray spargers. The spray header for the high pressure and low pressure core spray systems is contained within and supported by the core shroud and the connecting piping enters through the vertical portion of the core shroud above the top guide support ring (ledge).
