REPORT ON THE REVIEW OF THE
DIESEL GENERATOR BUILDING AT MIDLAND

OCTOBER, 1983

Structural Engineering Section B
Structural and Geotechnical Engineering Branch
Division of Engineering, ONRR

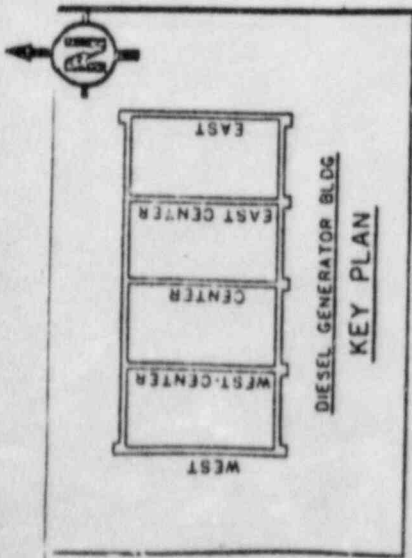
CENTER WALL - EAST SIDE
LOOKING WEST

CENTER WALL - WEST SIDE
LOOKING WEST

1. CRACKS SHOWN WERE MAPPED PRIOR TO PLACING THE PRELOAD. (12-15-78 TO 12-18-78).
2. NORTH & SOUTH WERE NOT MAPPED SINCE NO SIGNIFICANT CRACKS WERE OBSERVED.
3. IN GENERAL, ALL CRACKS WERE MAP LINED WITH SOME CRACKS WITH A THICKNESS OF 28 MILS AS OF 2-2-79.

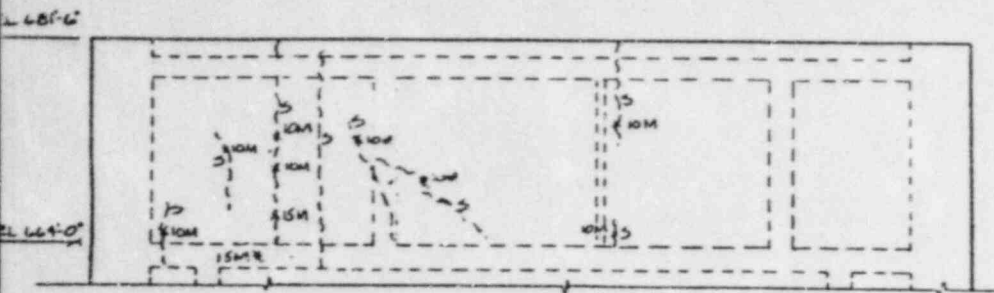
EAST WALL - EAST SIDE
LOOKING WEST

1. IN GENERAL ALL CRACKS MAPPED IN DEC 1978 WERE HAIRLINE. SOME CRACKS HAD A THICKNESS OF 28 MILS AS OF 2-2-79.
2. FOR CRACK MAPPING OF WALLS FROM EL. 664'-0" TO EL. 631'-6" SEE FIS. 28-3
3. CRACKS LESS THAN 10 MILS IN SIZE ARE NOT SHOWN.

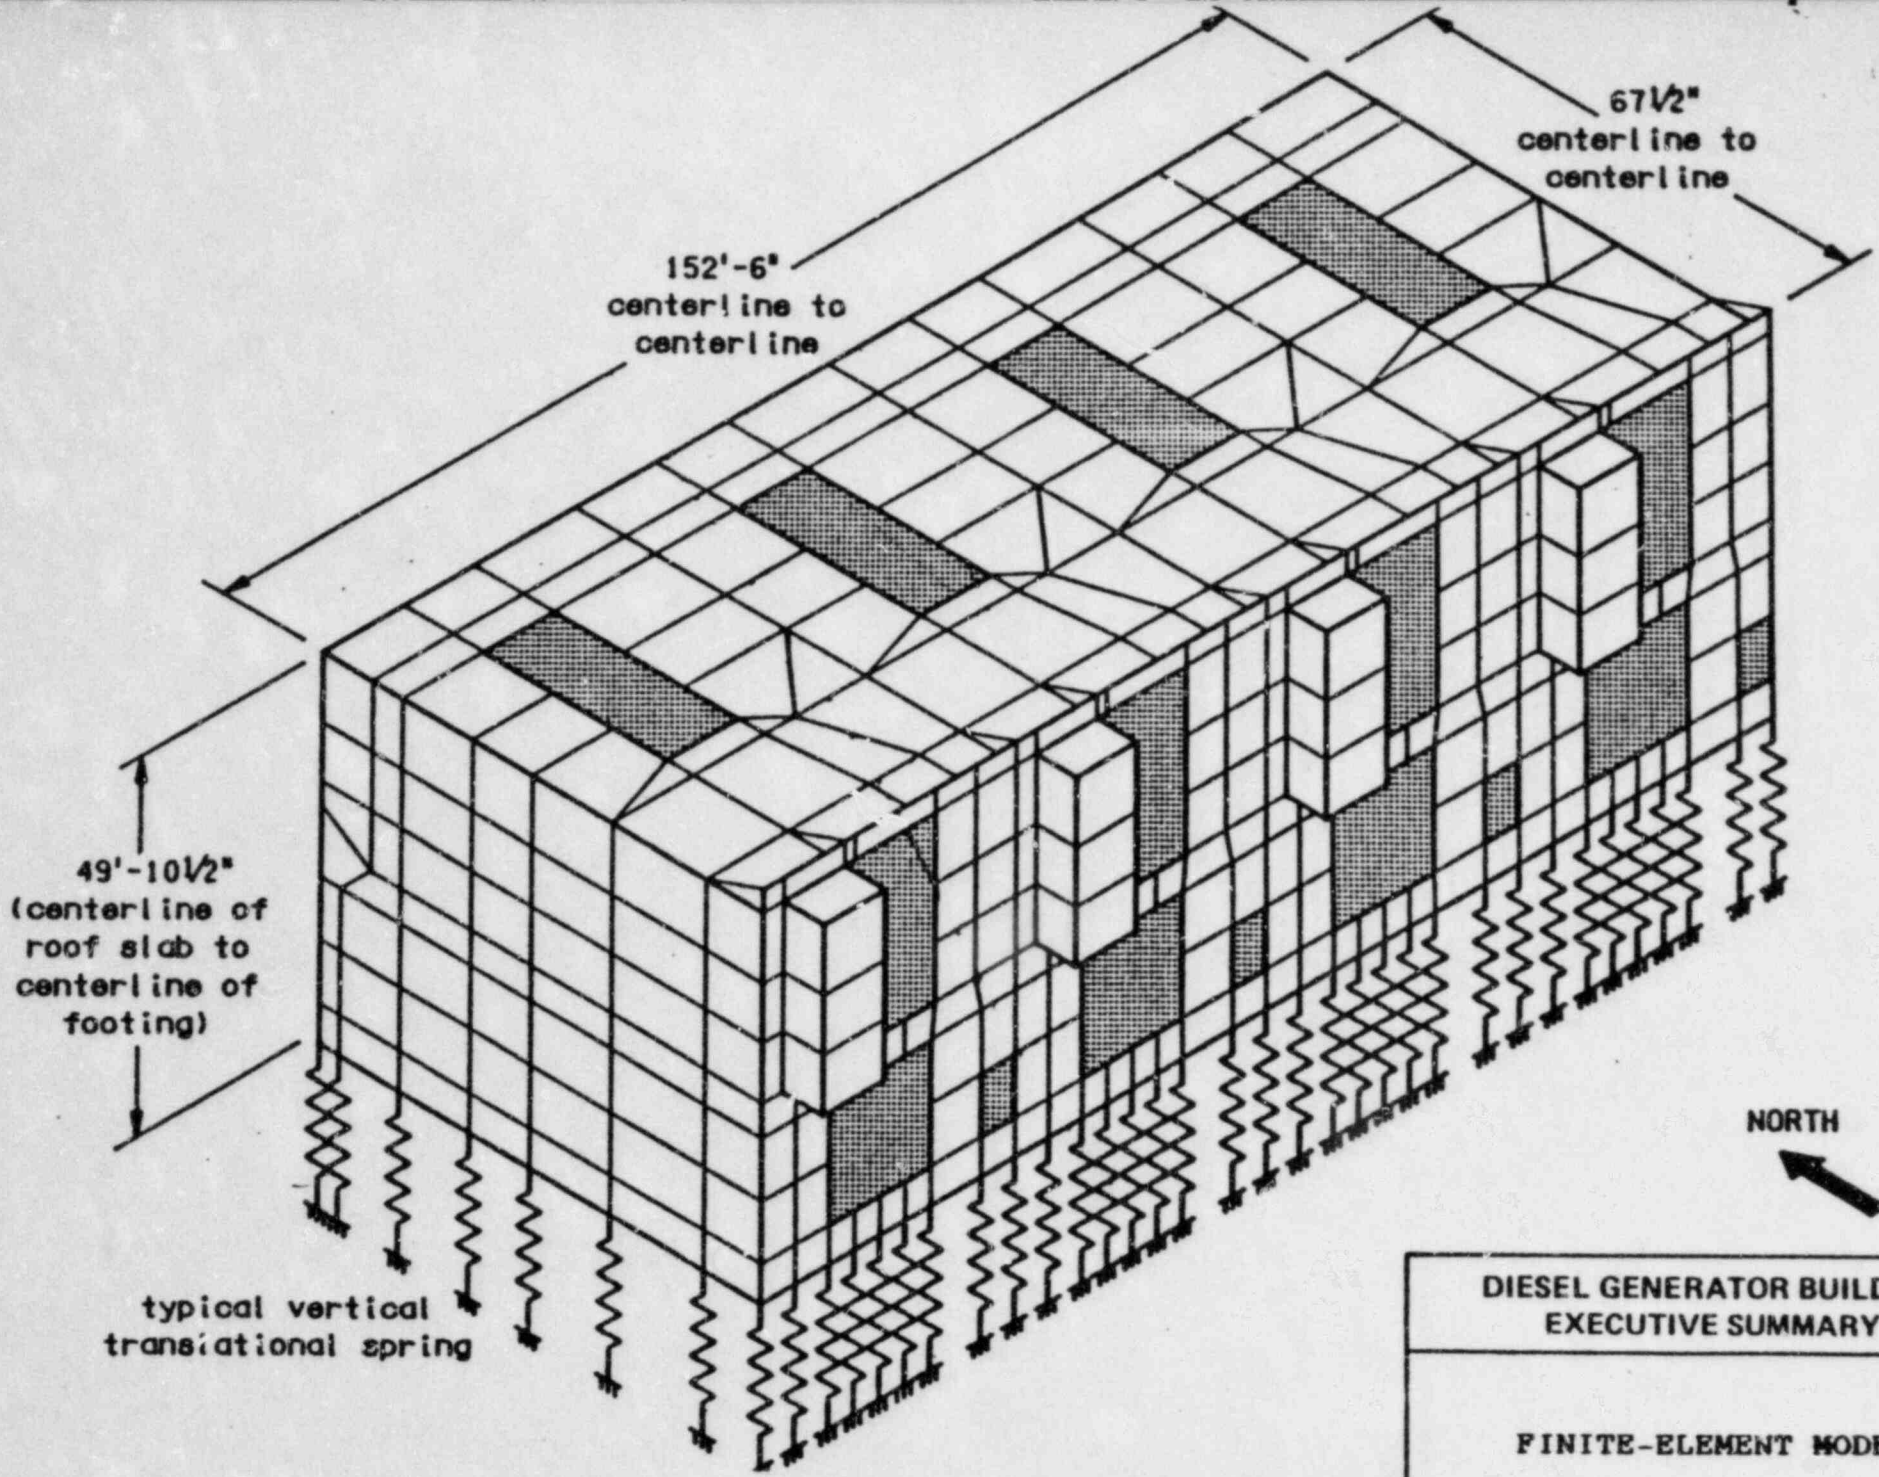
FIGURE 4

shown in Figure 2. With the exception of Case 1A which was analyzed by long hand computation and by idealizing the partially completed DGB as a series of individual beams, the other three cases were analyzed by computer through the discretion of the DGB into a number of finite elements as exemplified in Figure 4. Case 1A was accomplished by passing deflection curve through any three measured neighboring settlement points and selecting the one with the largest curvature for moment computation, and eventually, stress determination. This calculation indicated that the measured displacements would result in a maximum rebar stress of 11 ksi. For the other three settlement cases, individual finite-element models were used. For settlement Case 1B, the finite-element model represents the structure as built to el. 662 f 0 in.
