APPENDIX J

DIESEL GENERATOR FAILURE REVIEW AND ANALYSIS

This appendix describes the scope and results of the licensee's investigation to determine the causes for the unexpected 1A emergency diesel generator shutdowns during the incident. It describes the maintenance performed on the emergency diesel generator during the refueling outage before the event, the post-incident review and troubleshooting efforts, and the sensor testing program to determine the root cause of the sensor malfunctions.

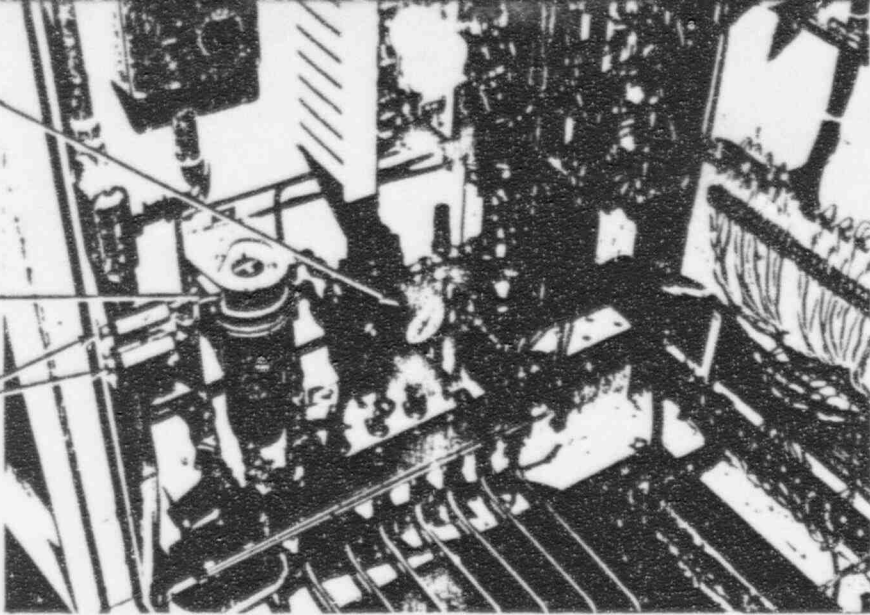
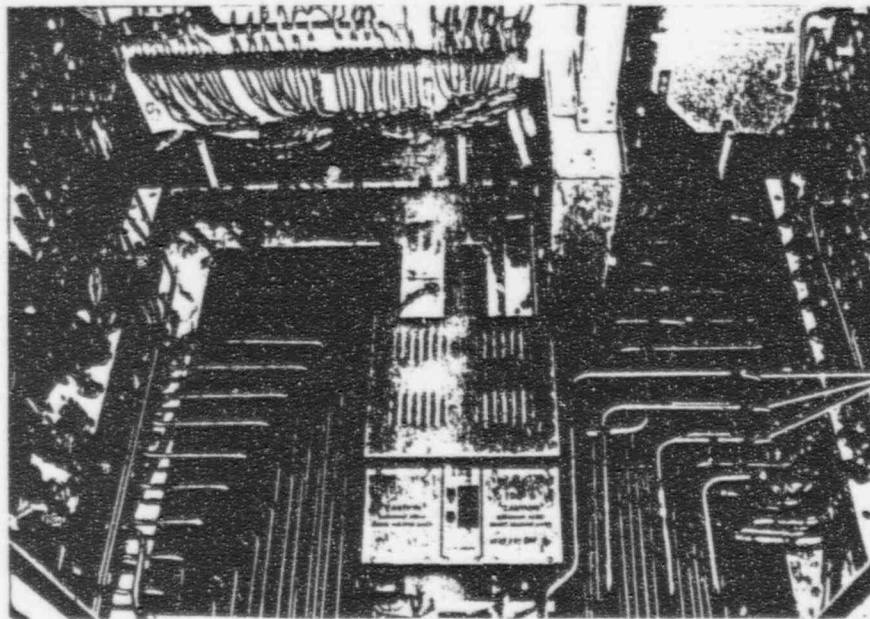
Figure J.4 Diesel Generator Trip Circuitry:
Bottom Views

Air supply
5 micron filter

Check valves
from redundant
air start systems
to pneumatic trip
circuits

Bubble test
rig connection
point
