GEORGIA POWER
POWER GENERATION DEPARTMENT
VOGTLE ELECTRIC GENERATING PLANT

TITLE: LOSS OF CLASS 1E ELECTRICAL SYSTEM NUMBER: LO-LP-60323-01

TITLE:	LOSS OF POWER CASE STUDY	NUMBER:	LO-HO-60991-00-001
PROGRAM:	LICENSED OPERATOR TRAINING	REVISION:	0
AUTHOR:	L. FITZWATER	DATE:	6/24/88
APPROVED:	<i>Robert J. Brown</i>	DATE:	7/26/88
REFERENCES:

This case study material focuses on the cooldown transient experienced at Rancho Seco on December 26, 1985. The material includes an event description that covers major operator actions and equipment failures related to the event. In addition, some instructor aids are provided to assist the instructor.

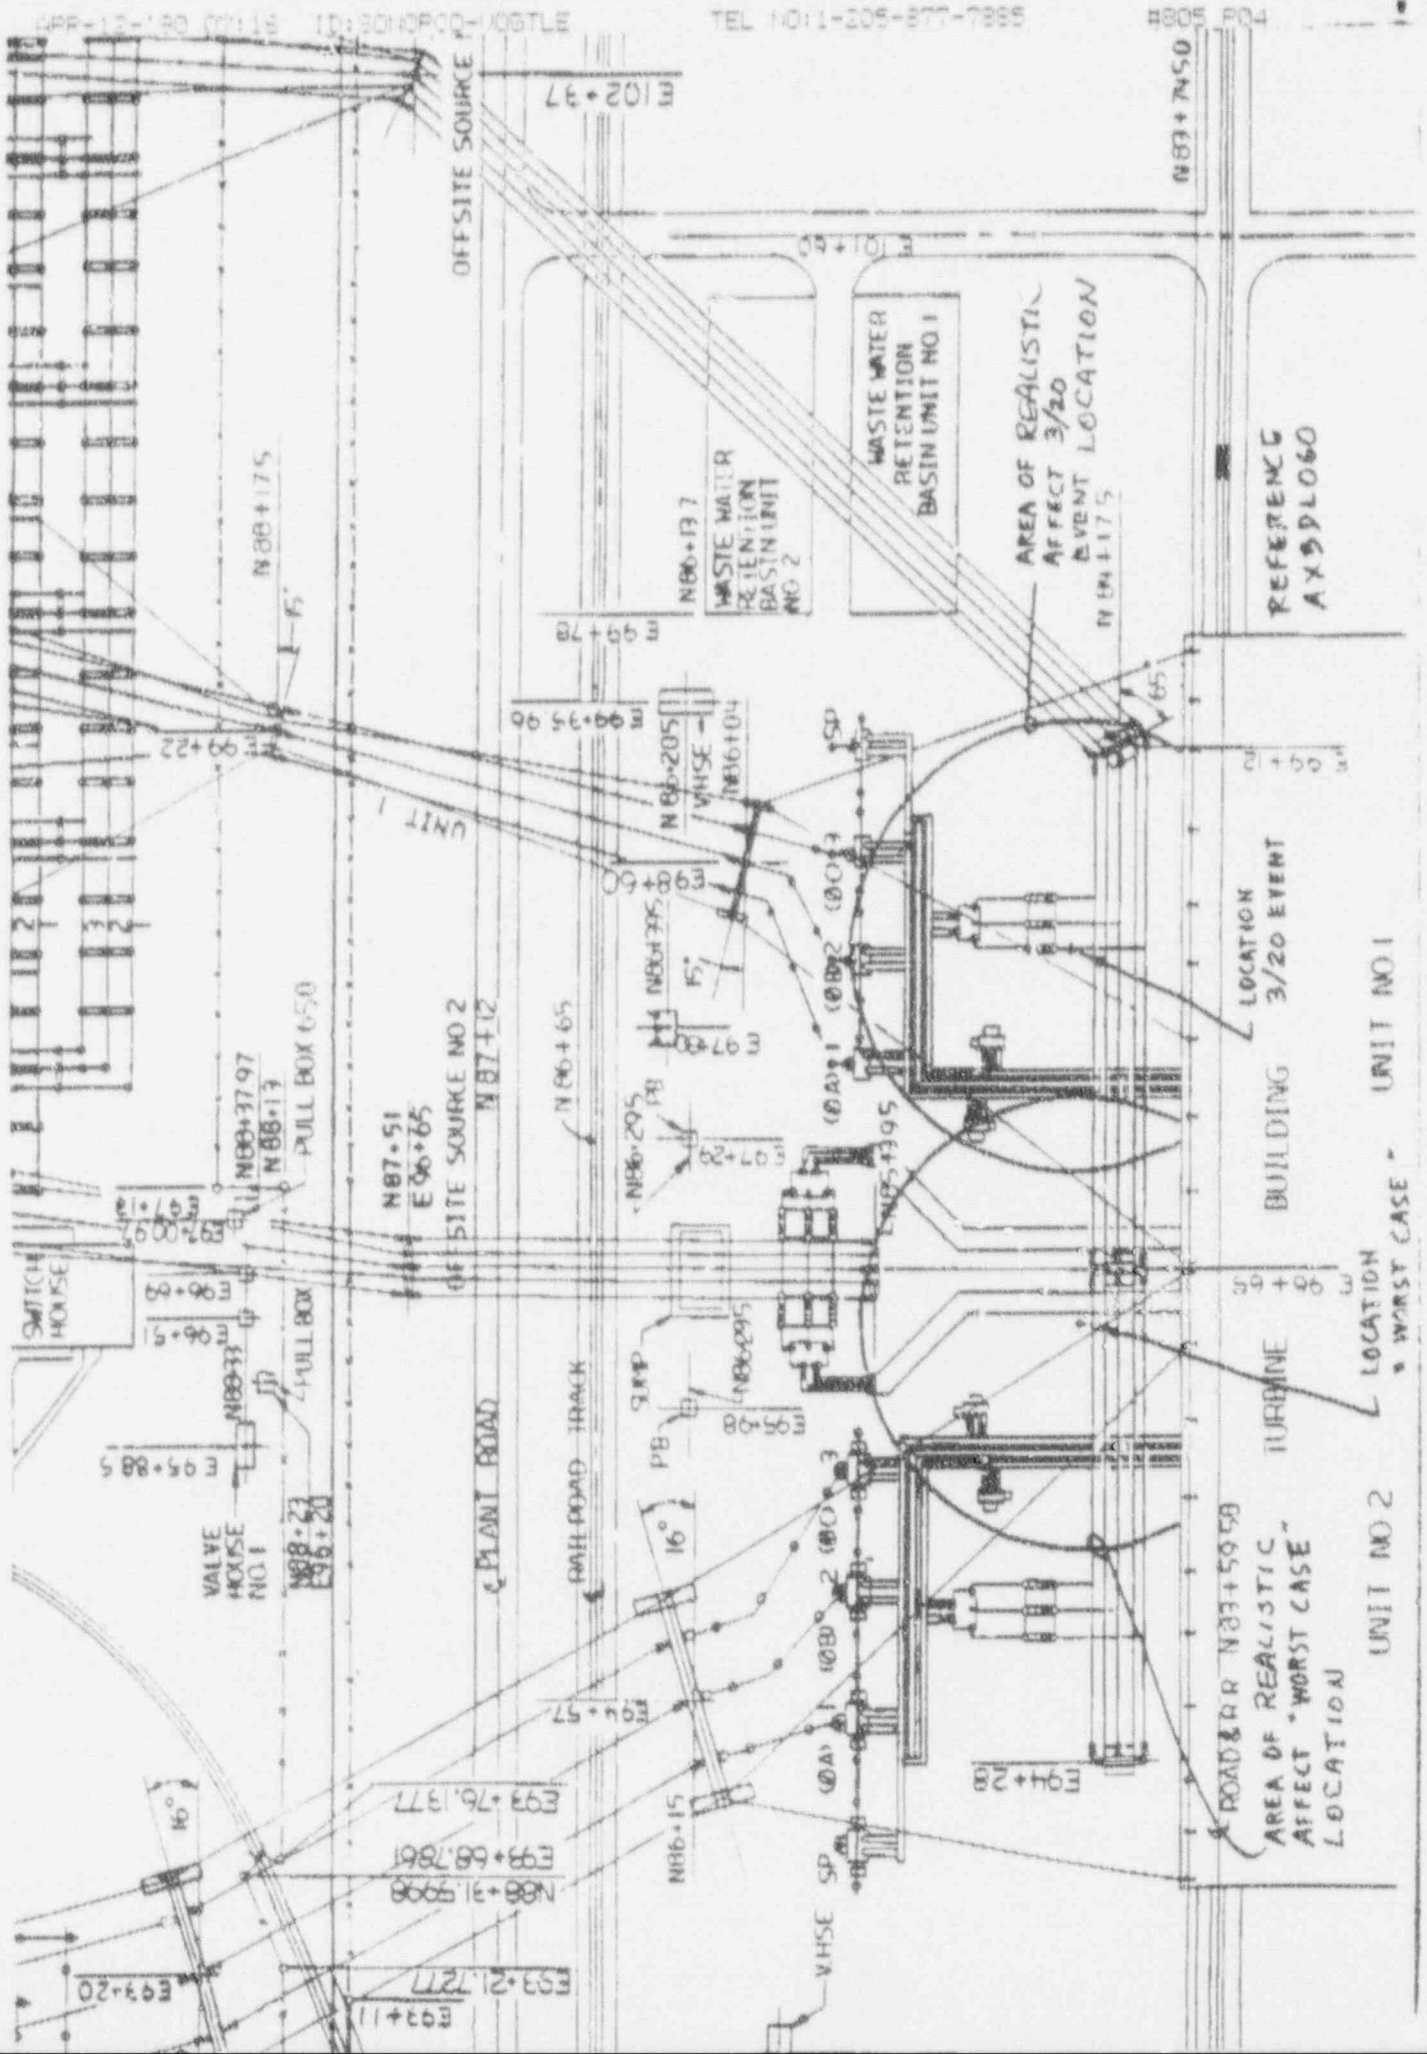
SKETCH 2

- Typical vehicle located at site of March 20, 1990 event (see sketch #2)
- Combustible material quantities are assumed to be actual vehicle inventories described in attachment #1
- 5 gallon gasoline spill vaporized locally
- Sparks from damaged cables ignite vaporized gasoline in a local free air explosion and fire involves remaining combustible materials on the vehicle
- Combustible materials, except 5 gallons of spilled gasoline, is assumed to oxidize on location
- Safe standoff distances are derived from NUREG/CR-2462, Capacity of Nuclear Power Plant Structures to Resist Blast Loadings, September 1983

- Offsite source 1 which feeds reserve auxiliary transformers (RAT) 1NXRA and 2NXRB is located within the safe standoff distance and is thus considered damaged resulting in loss of off-site power source #1 to Units 1 and 2.

- Reserve Auxiliary transformers (RAT) 1NXRA, Unit Auxiliary transformers (UAT) 1NXAA and 1NXAB, and Main Step-up transformers (MST) numbers 1, 2, and 3 are located within the safe standoff zone and are assumed damaged resulting in the loss of service of this equipment

- The total BTUs released from fire = 103,451,800
- Phase 3 conductor is approximately 16 feet above truck bed (fire base). Full effect of heat from fire will be radiated to conductor/insulator. (Flame height approximately 28 feet based on data presented for gasoline in the Handbook of Fire Protection Engineering by the SFPE.) This conductor is assumed to fail due to the fire.

- Offsite source #1 lines are approximately 50 feet above truck bed (fire base) and would be effected by heat from fire. The offsite source #1 is assumed to fail due to heat and/or arcing to ground through combustion gases
