AFFIDAVIT

I, Charles C. Stokes, am providing this statement of my own volition in response to various Pacific Gas and Electric (PG&E) submittals to the NRC. This is intended to follow up on issues which I have raised in prior statements to the Commission and which I feel must still be addressed in detail by PG&E Diablo Project management before Unit 1 is allowed to go beyond 5% power. In some cases my comments suggest necessary methodological steps to obtain adequate correction action on my allegations, largely confirmed by Mr. Yin. In other cases, my comments expose false or misleading statements by PG&E in their response to Mr. Yin's inspection report.

In response to PG&E letters on the subject of **Tube Steel Radius and Flare-Bevel Welds** as addressed in the April 7, 1984 and April 11, 1984 to the members of the Appeal Board, and PG&E letter No.: DCL-84-083, DCL-84-164, DCL-84-166, and DCL-84-190.

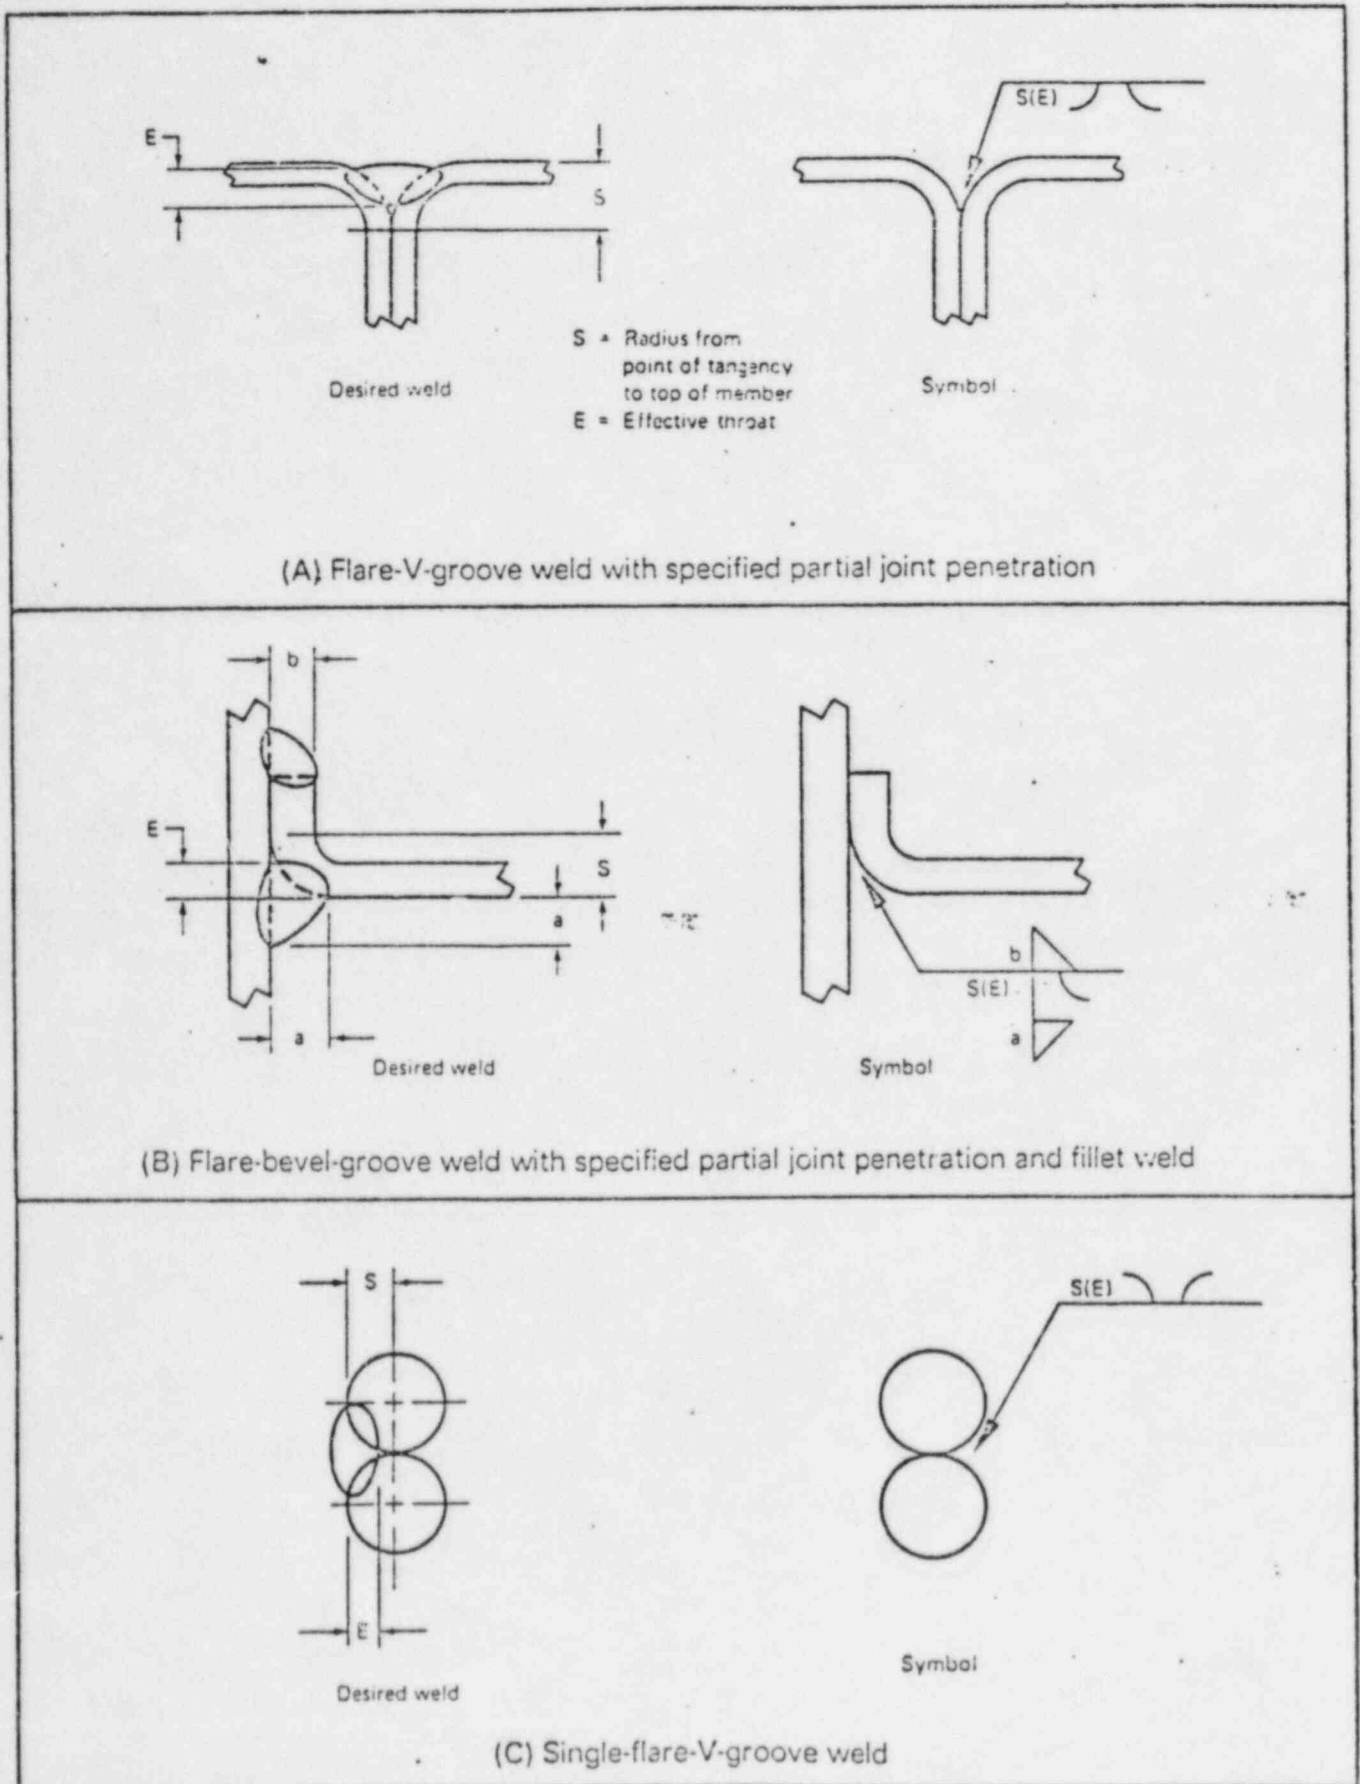
ATTACHMENT 2, a

"Flare-groove welds. The dimension S of flare-groove welds is considered as extending only to the tangent points indicated below by dimension lines. (See Fig. 32)" (See Attachment 2, 2 pages)

Fig. 32—Application of flare-bevel- and flare-V-groove weld symbols
