Condition of 44-Year **Naturally Aged** Cable

Pyrotrol III, Raychem Flamtrol, and RSCC **Firewall III** Cable (15 years)

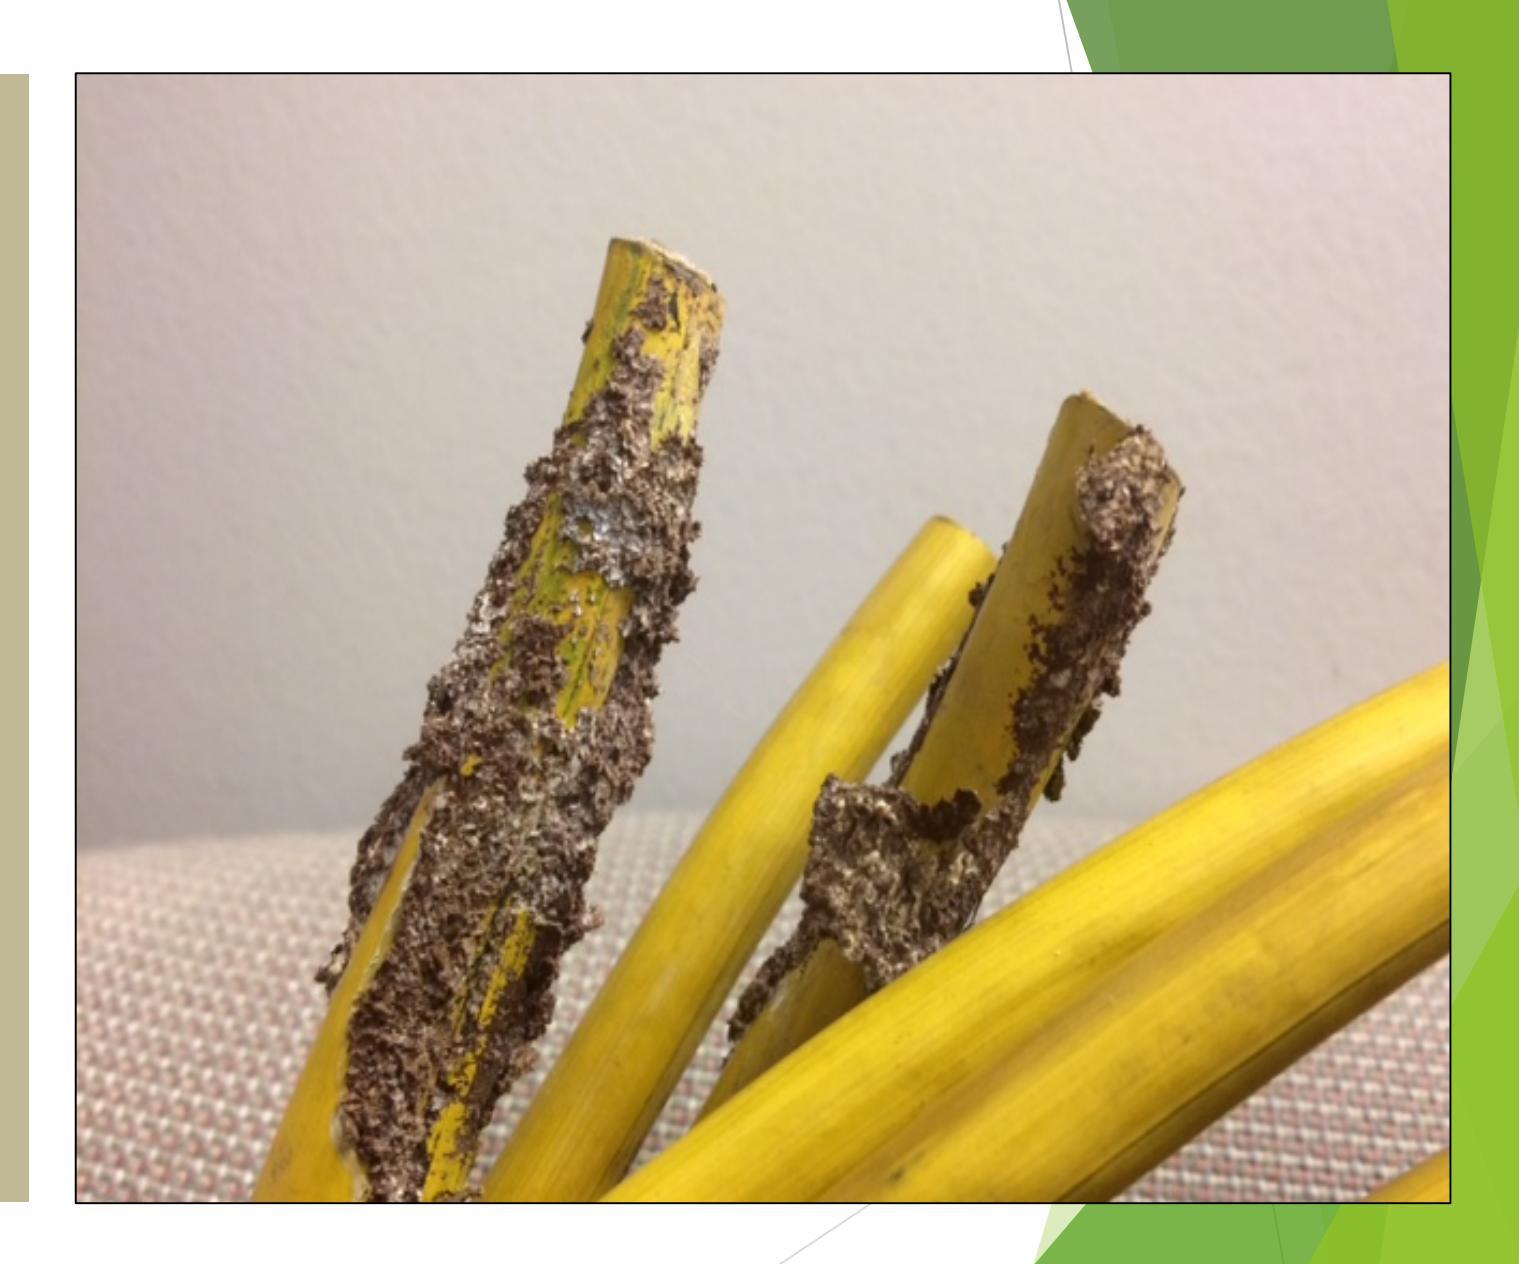
BALANCE OF CABLES PULLED IN 2018.

More precisely, their Elongation-At-Break and Insulation **Resistance** would likewise have been about the same as the 2016 cables.

The remaining life of 15-years for the Pyrotrol III cable and 5-years for the Raychem Flamtrol Cable is based on a minimum of 50% EAB as determined by AMS.

CNS conservatively chose to replace the Pyrotrol III Cables

... because the remaining life also has to account for any HELB accident.

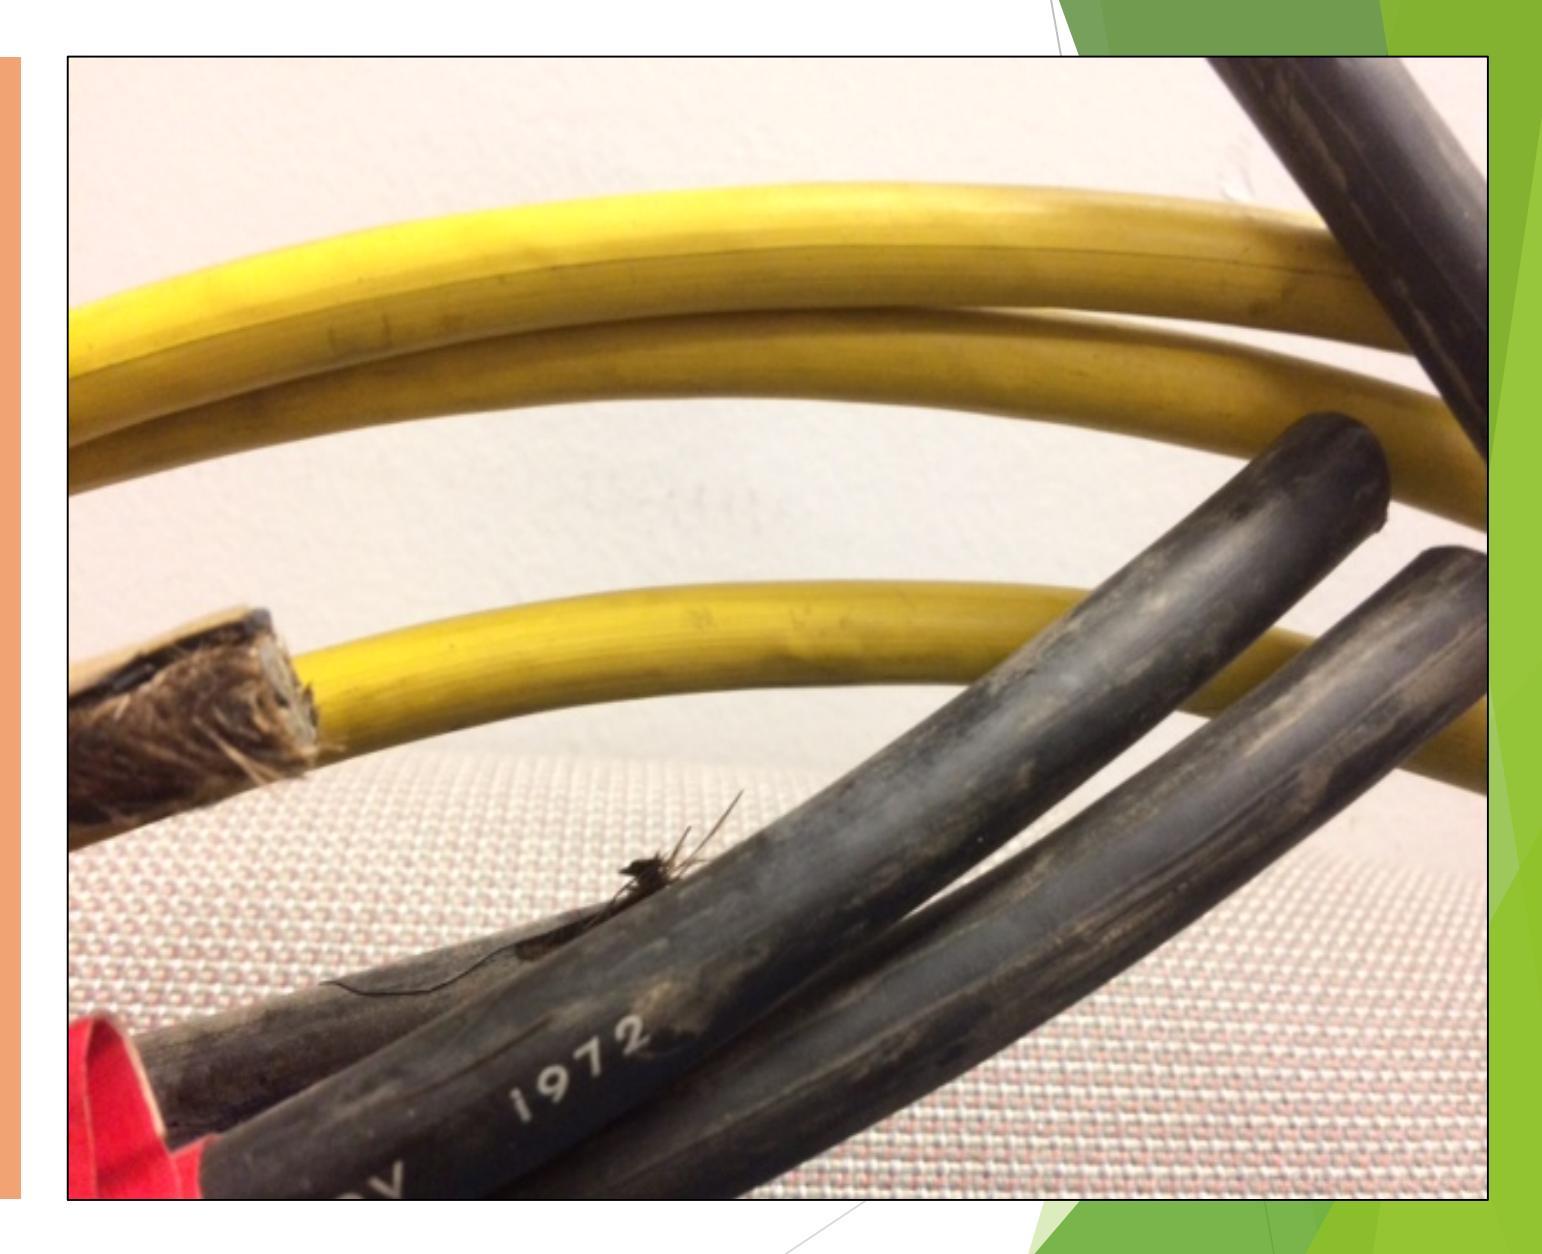
SAMPLES OF CABLE LENGTHS PASSED OUT FOR YOU TO LOOK CLOSELY

The four packages are from the 2018 cable pull. They represent the vintage, manufacturer, and condition.

One yellow cable shows a transition from being in very good condition to being severely degraded within about a foot. This suggests that the load or nearby equipment was extremely hot at one end.

The conductors, however, are still in good condition and flexible.
