REVISION 1 TO THE DETAILED CONTROL ROOM DESIGN REVIEW SUMMARY REPORT FOR SNUPPS

Wolf Creek Plant - Kansas Gas and Electric Co. Docket No. STN 50-482

Callaway Plant - Union Electric Company Docket No. STN 50-463

> In Response To: NRC Generic Letter 82-33 Supplement 1 to NUREG 0737

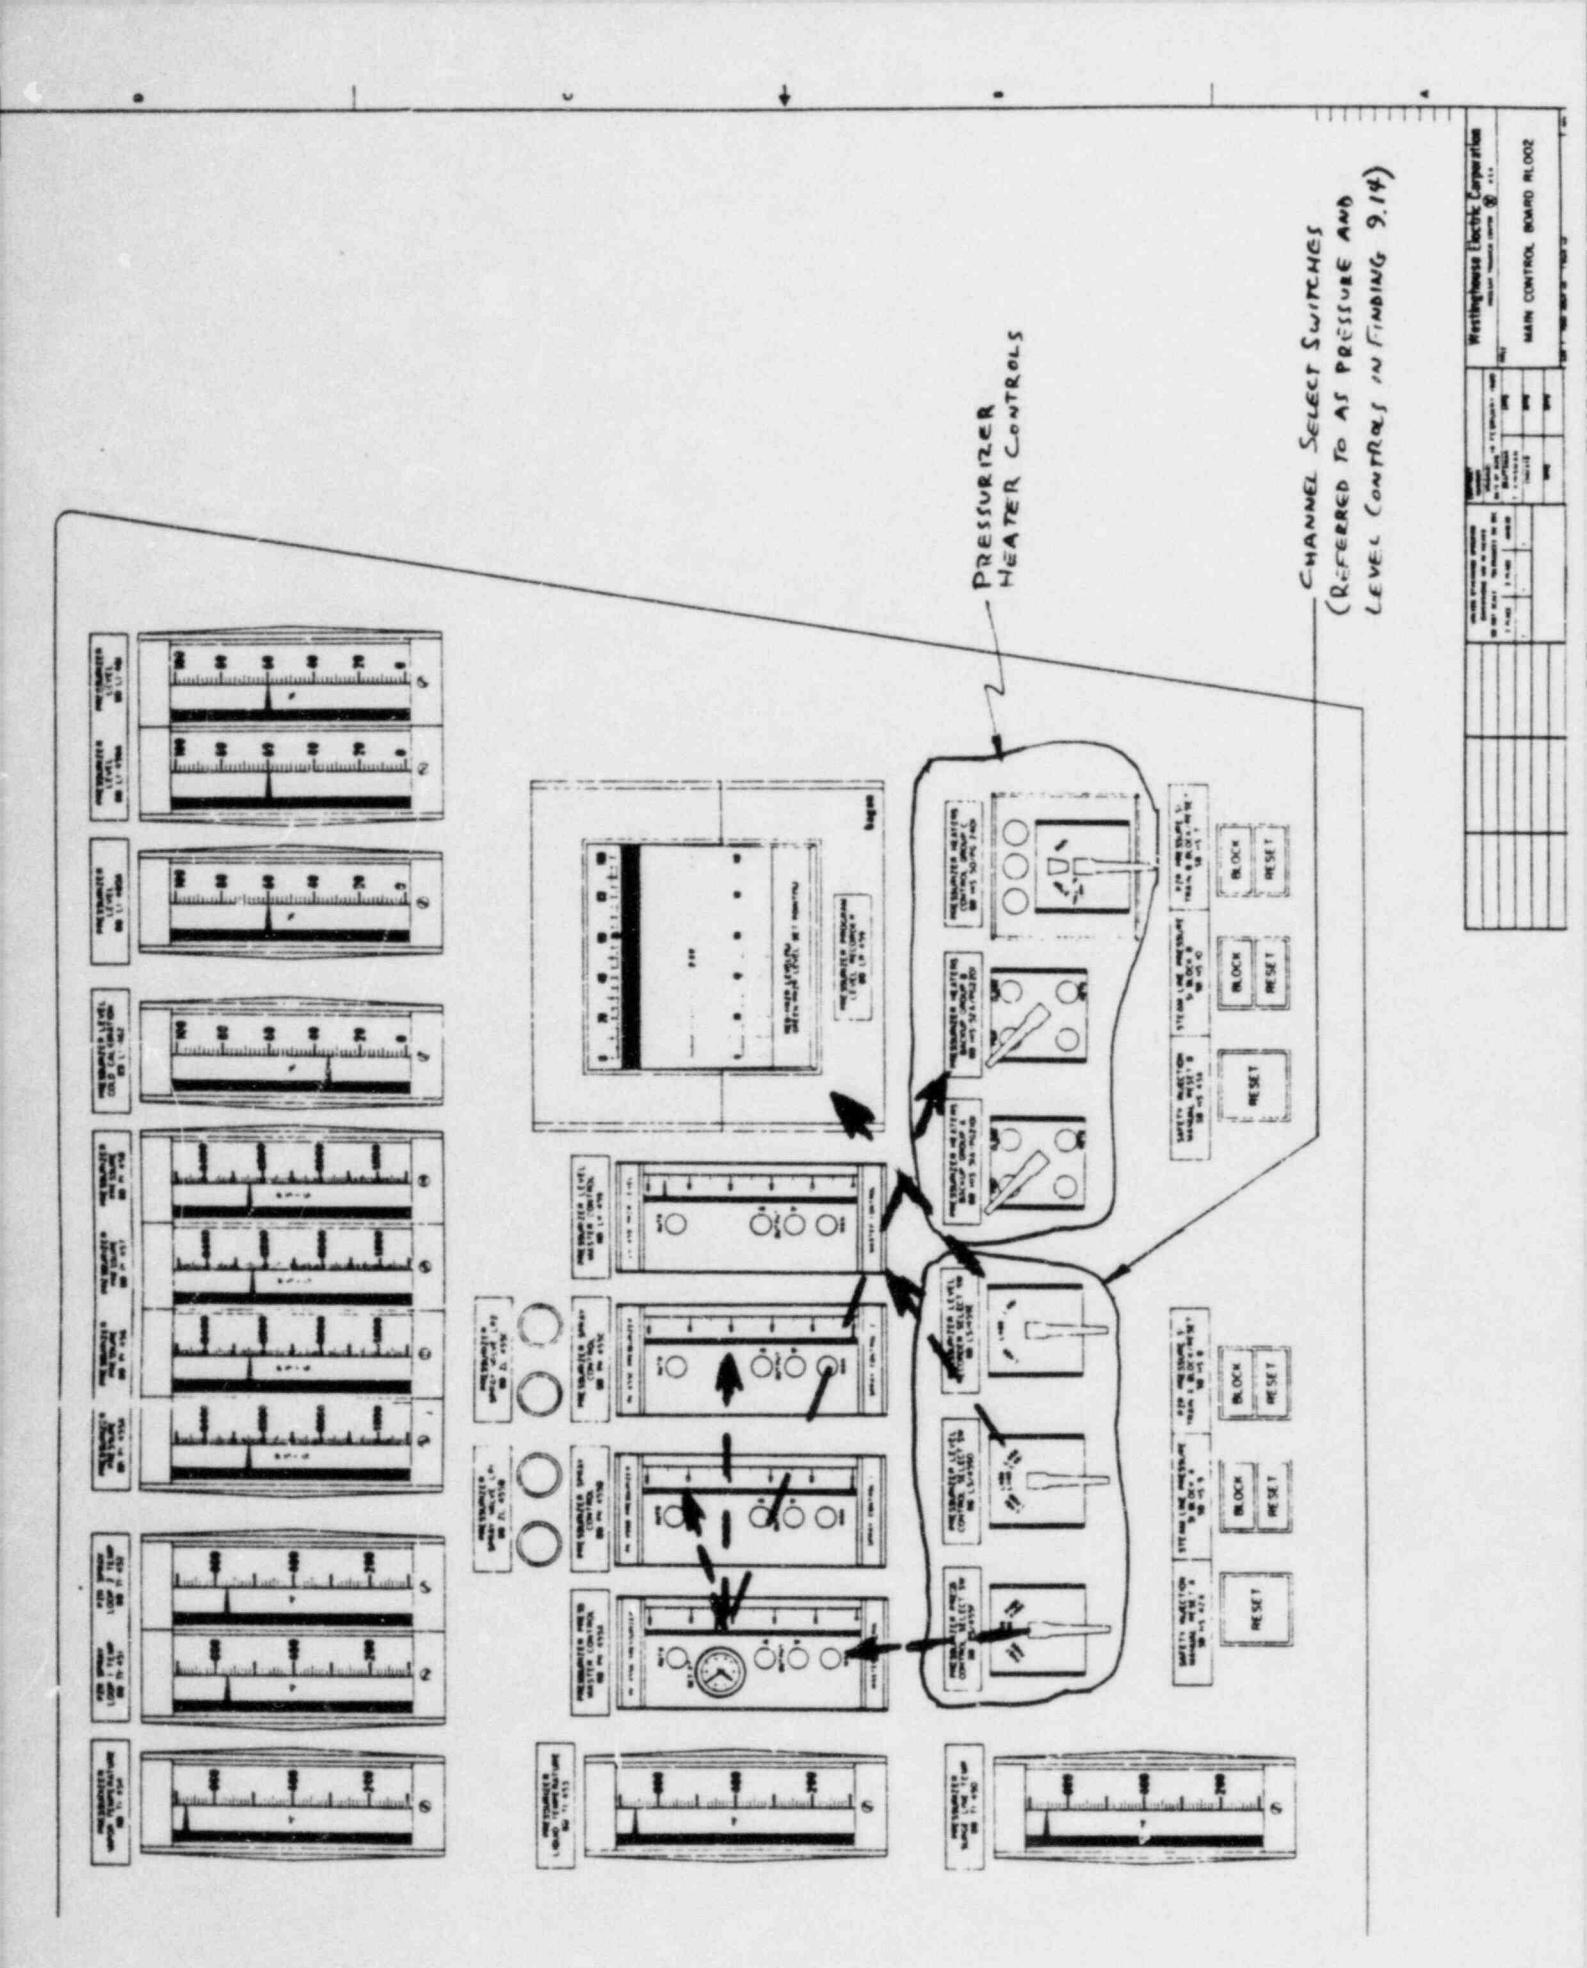
- The channel select switches are logically located with respect to the Process Controllers that they affect. See the drawing for signal relationships.

- 5. Normal operation of the Pressure Control System is completely automatic, and does not involve any Operator manipulation of these switches. Manual operation uses the push buttons on the Process Controllers, and again, does not involve these switches.
