UNITED STATES
NUCLEAR REGULATORY COMMISSION
WASHINGTON, D. C. 20555

Docket Nos. 50-329
and 50-330 OM, OL

APPLICANT: Consumers Power Company
FACILITY: Midland Plant, Units 1 and 2
SUBJECT: SUMMARY OF OCTOBER 6-7, 1981 MEETING ON UNDERGROUND PIPING

MIDLAND PROJECT
MIDLAND DOCKET NOS 50-329, 50-330
EVALUATION REPORT FOR THE FEEDWATER ISOLATION VALVE PITS
FILE 0485.16 SERIAL 15493
ENCLOSURES: (1) EVALUATION OF FEEDWATER ISOLATION
VALVE PITS AT MIDLAND PLANT
(2) FEEDWATER ISOLATION VALVE PIT
CRACK MONITORING PROGRAM

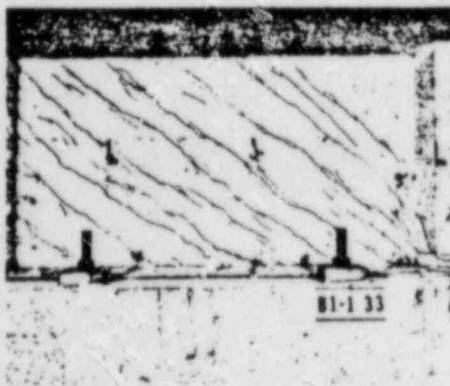
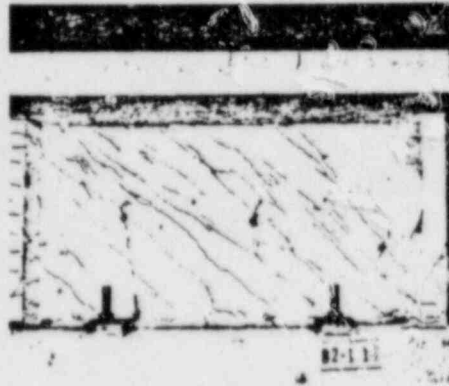
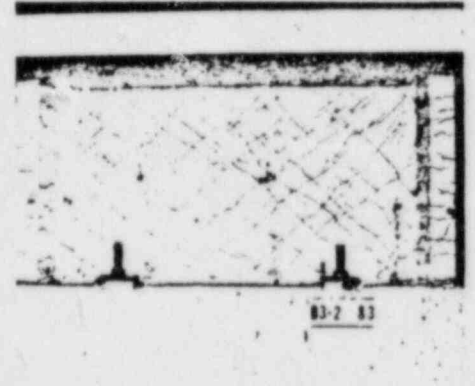
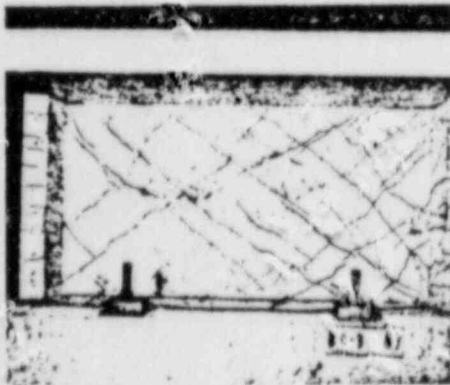
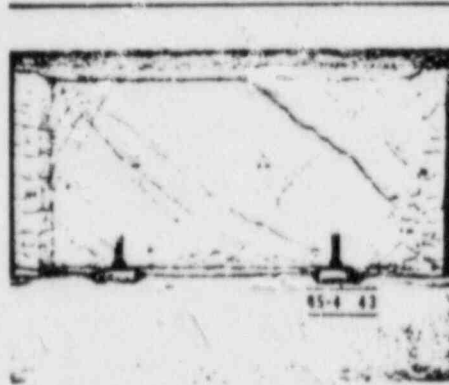
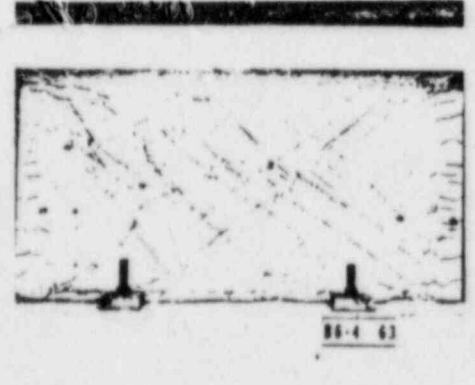
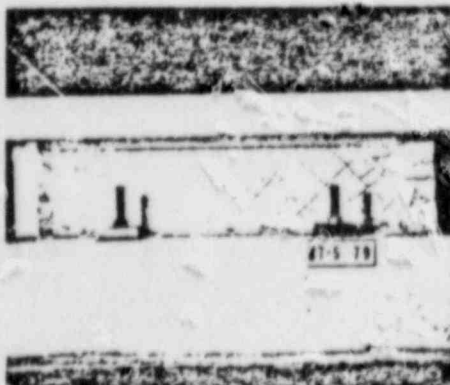
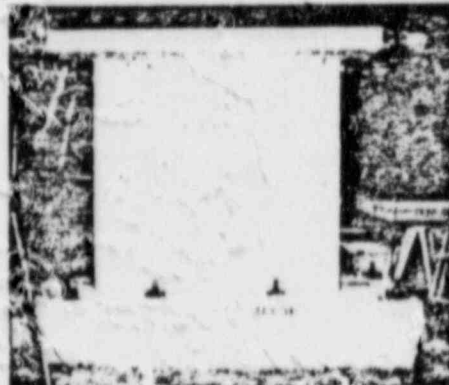
Fig. 2 "Low-Rise" Wall Test Specimens at Ultimate Load (1)

Principal test results for the eight walls are shown in Table 1. For all specimens, except B5-4, the maximum nominal shear stress in the wall exceeded the stress at first observed shear cracking by a factor of at least 2.4. For Specimen B5-4, which contained no vertical reinforcement in the diaphragm, the maximum nominal shear stress exceeded the stress at first shear cracking by a factor of 1.5. The ratio of maximum nominal shear force to first shear cracking even exceeded 2.5 for Specimen B4-3 which contained no horizontal reinforcement. For each of the "low-rise" walls tested, measured capacity exceeded

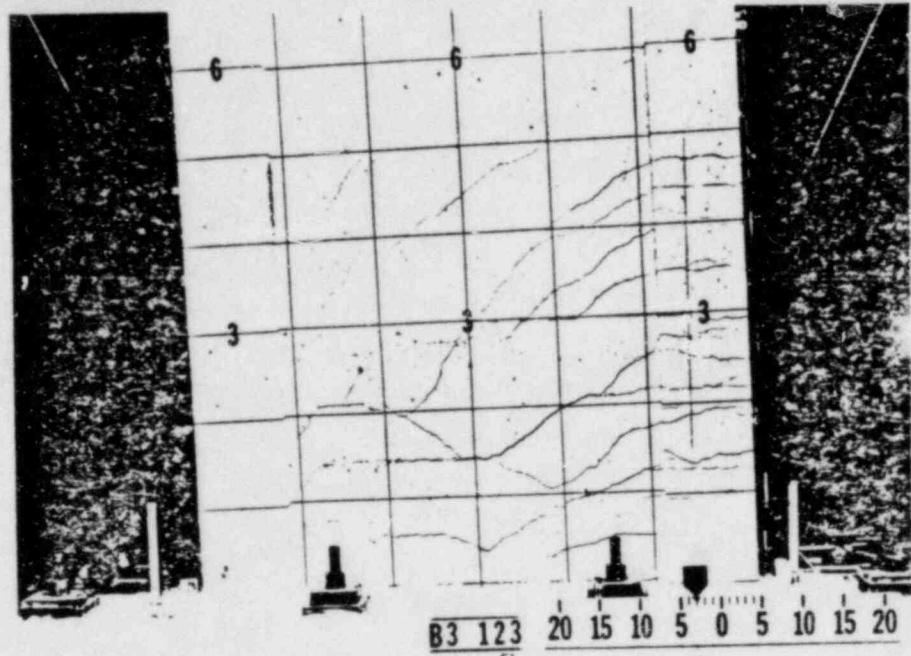
Fig. 7 Specimen B3 at Load Stage 123

After Load Stage 117 was reached, the wall was unloaded and pushed in the opposite direction until Load Stage 123 was reached. Figure 7 shows the condition of Specimen B3 at Load Stage 123. At this load stage, the maximum crack width measured in the tension column was approximately 0.07 in. and the maximum measured crack width in the wall web was 0.16 in. When the wall was again unloaded, to Load Stage 125, the crack pattern shown in Fig. 8 resulted. It is clearly evident from the behavior of Specimen B3 (and from other specimens tested) that the presence of cracks did not prevent the walls from maintaining their structural integrity and developing their nominal strength.

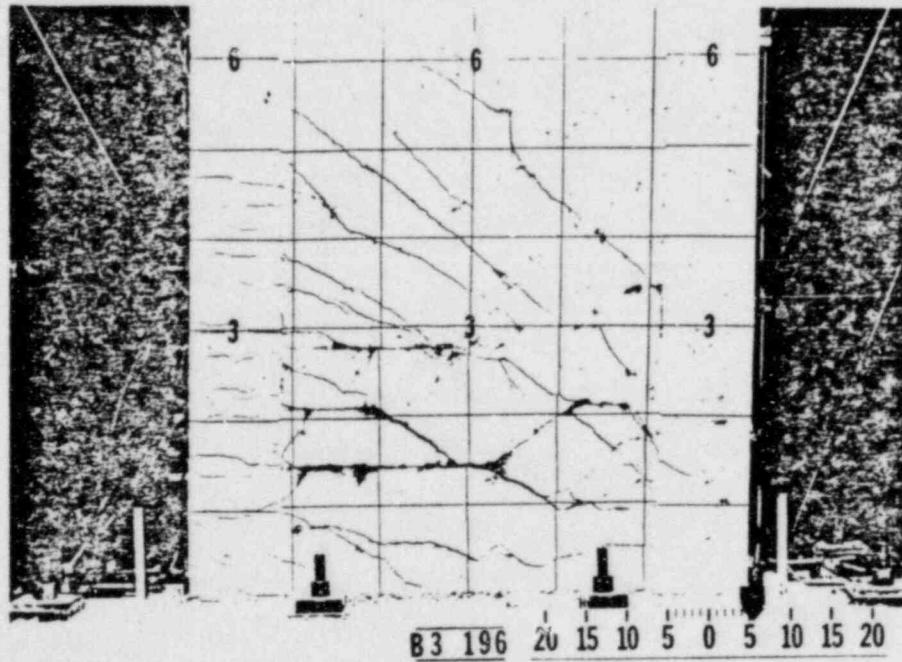
Fig. 9 Specimen B3 at Load Stage 196

Figure 9 shows Specimen B3 at Load Stage 196. This load stage is also indicated in Fig. 4. The cracking pattern in Fig. 9 is indicative of severe distress in the member, yet at this stage the wall carried its maximum load which corresponded to approximately $3.1\sqrt{f'_c}$. For purposes of comparison, the design strength this member calculated in accordance with the American Concrete Institute Building Code is $2.3\sqrt{f'_c}$.

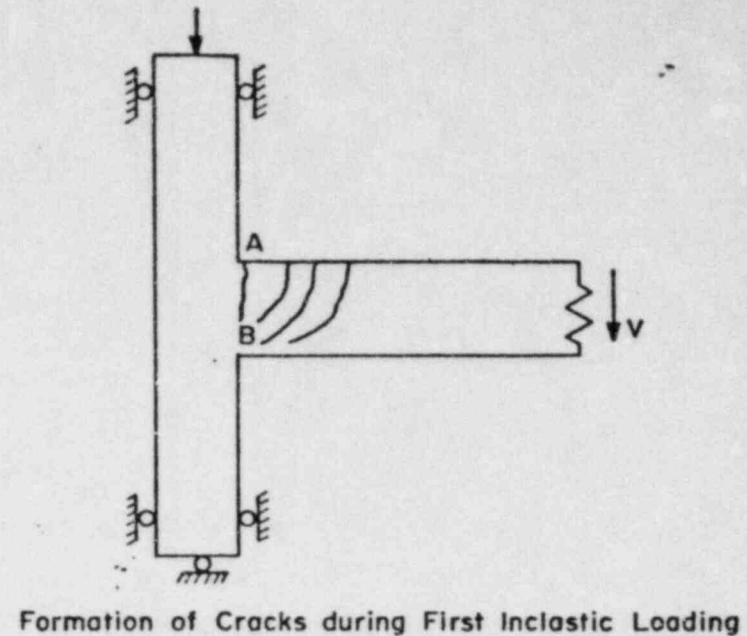
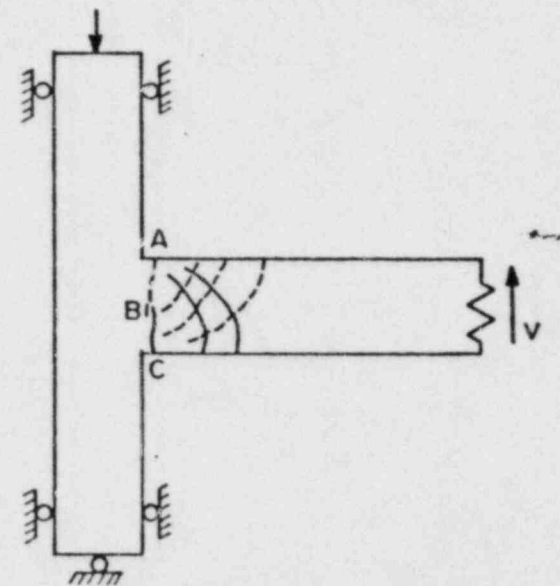
Fig. 11 Crack Pattern (After Ref. 5)

Figure 11 illustrates crack patterns that developed during the first inelastic loading and during subsequent load reversals. As increasing numbers of load cycles were applied, the entire beam moment at the face of the column was carried by a force couple between the top and bottom layers of longitudinal steel. Thus, applied moments were primarily resisted by the positive and negative longitudinal reinforcement.

Under load reversals a complete crack plane, labeled A-B-C in Fig. 11, formed through the beam. This crack plane did not prevent the beam from transferring load. During the final stages of the test, increasing numbers of inelastic load reversals caused concrete near the face of the column to abrade and eventually disintegrate. This resulted in a "slip plane" along the beam at the face of the column. The significance of such a slip plane is related to the number of inelastic load reversals and the level of shear stress on the beam. The existence of

the crack plane did not become significant until repeated numbers of inelastic cycles were applied.
