EVALUATION OF THE OPERATIONAL AND
MAINTENANCE HISTORY OF, AND RECENT
MODIFICATIONS TO, THE MAIN ENGINES IN THE
M.V. COLUMBIA

SES Report No. 123-01

April 1983

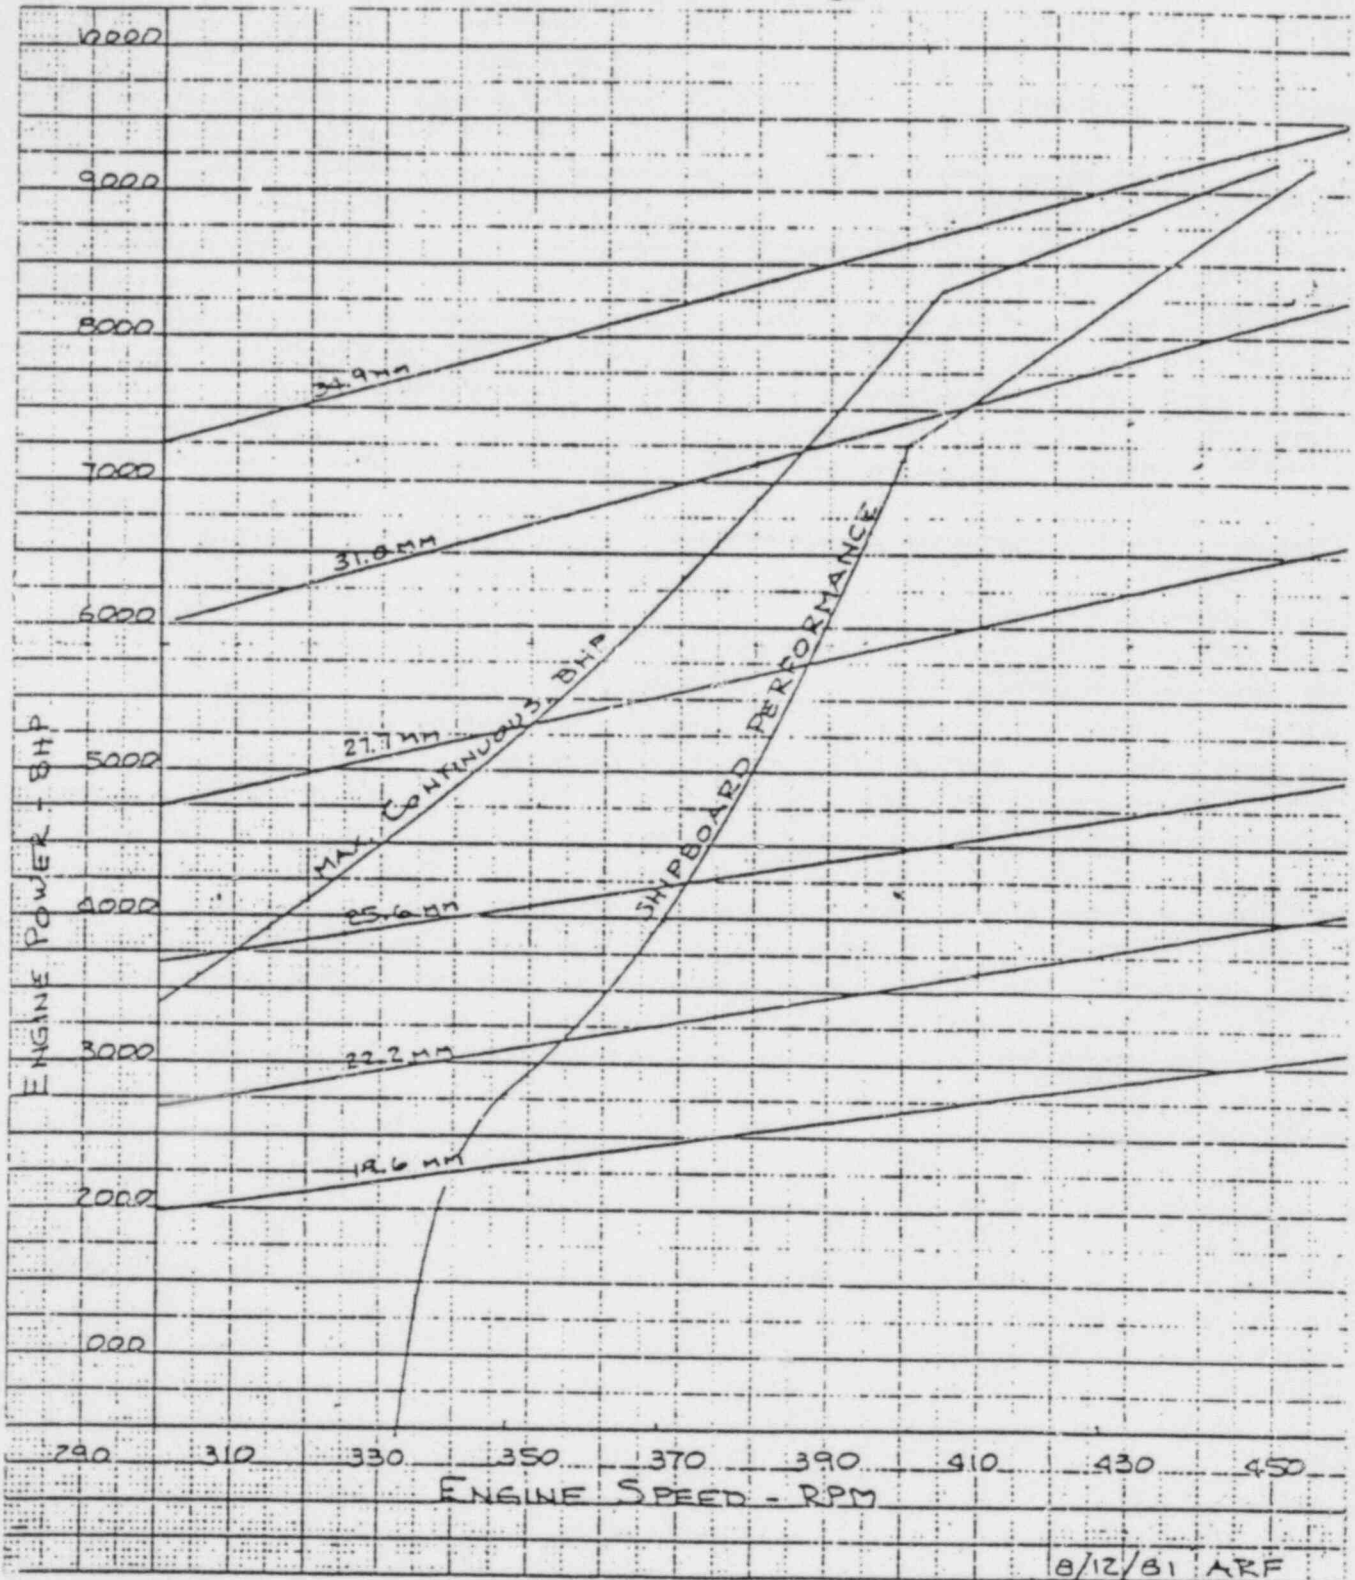
BMEP's for various COLUMBIA voyages were computed from log book ERPM and rack settings per the July 1981 sea trial load curve for the original engine rating shown in Figure 2.4 and taken from Reference No. 3. A comparison of BMEP's shown indicates the following. First, it appears that the engine has been operated full away at combinations of ERPM, propeller pitch and BHP which result in BMEP's ranging from approximately 175 to 200

PSI as can be best determined utilizing Figure 2.4. (However, it should be noted that frequent changes in the pitch program portion of the throttle control system, as reported, make it difficult to conclude that the load curve shown in Figure 2.4 is 100% representative of engine load profile from delivery in 1974 up until de-rating in early 1983.) Secondly, from Tables 2.3 and 2.4, operation at ERPM's and BHP's, as shown from the COLUMBIA and Halter Marine engine test stand data, which are somewhat similar to the predicted de-rated engine load profile, should produce BMEP's which are ten (10) to twenty (20) percent lower at the projected maximum continuous rating of 6164 BHP for the de-rated engines. Operation at the new Design Service Rating of 5284 BHP/385₈ ERPM should result in a reduction of from twenty (20) to thirty (30) percent in BMEP's compared to past operating loads.

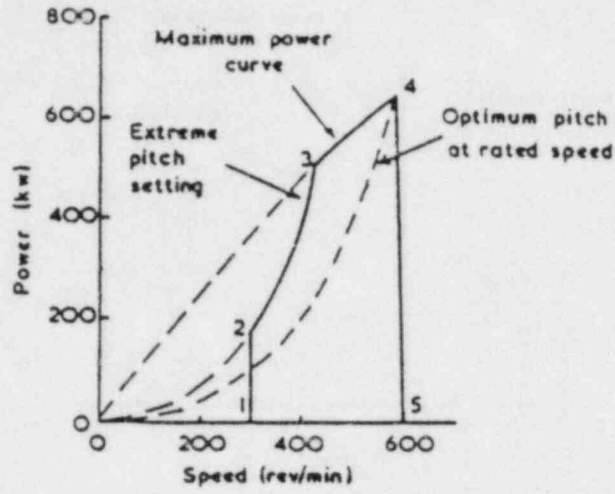
Another contributing factor is the match of the DE-17-123 turbos capable of an output that would satisfy the air requirements of the original 9200 BHP rating of the engine. If, in fact, these are the same units in terms of capacity, they have ended up operating in a situation depicted by Figures 2.8 and 2.9, taken from Reference No. 5. Figure 2.8 shows the speed, pitch and power relationship for a generic four-cycle engine fitted with a CRP wheel. Extreme pitch seating is applied from point

(2) to (3), building up to the maximum power portion of the curve from (3) to (4) as speed is increased. If this same pitch curve is overlaid on a compressor map for a unit matched for the engine's maximum output, as shown in Figure 2.9, the following can occur. Operation at maximum engine output, points (3) to (4), places the compressor well away from surge and close to maximum turbo efficiency. However, as load is reduced, essentially by lowering speed, while maintaining a maximum pitch setting, points (3) to (2), the extreme pitch setting line comes very close to the surge line. This situation is further aggravated by the "waist" or dip in the surge line characteristic of operating a highly rated turbo at lower outputs, as shown. Thus, for an engine fitted with a CRP, it is the extreme pitch setting curve and not maximum engine/propeller speed which determines the surge margin and related matching requirements. Referring back to the data plotted in Figure 2.6, extrapolation of these operating lines to a higher compressor output shows the slope carrying them into a more stable (further from surge) and efficient area on the compressor map. As indicated by the dotted lines of decreasing pitch setting in Figure 2.9, a reduction in pitch setting will move the engine curve away from surge which is exactly the experience reported on the initial voyage of the COLUMBIA.

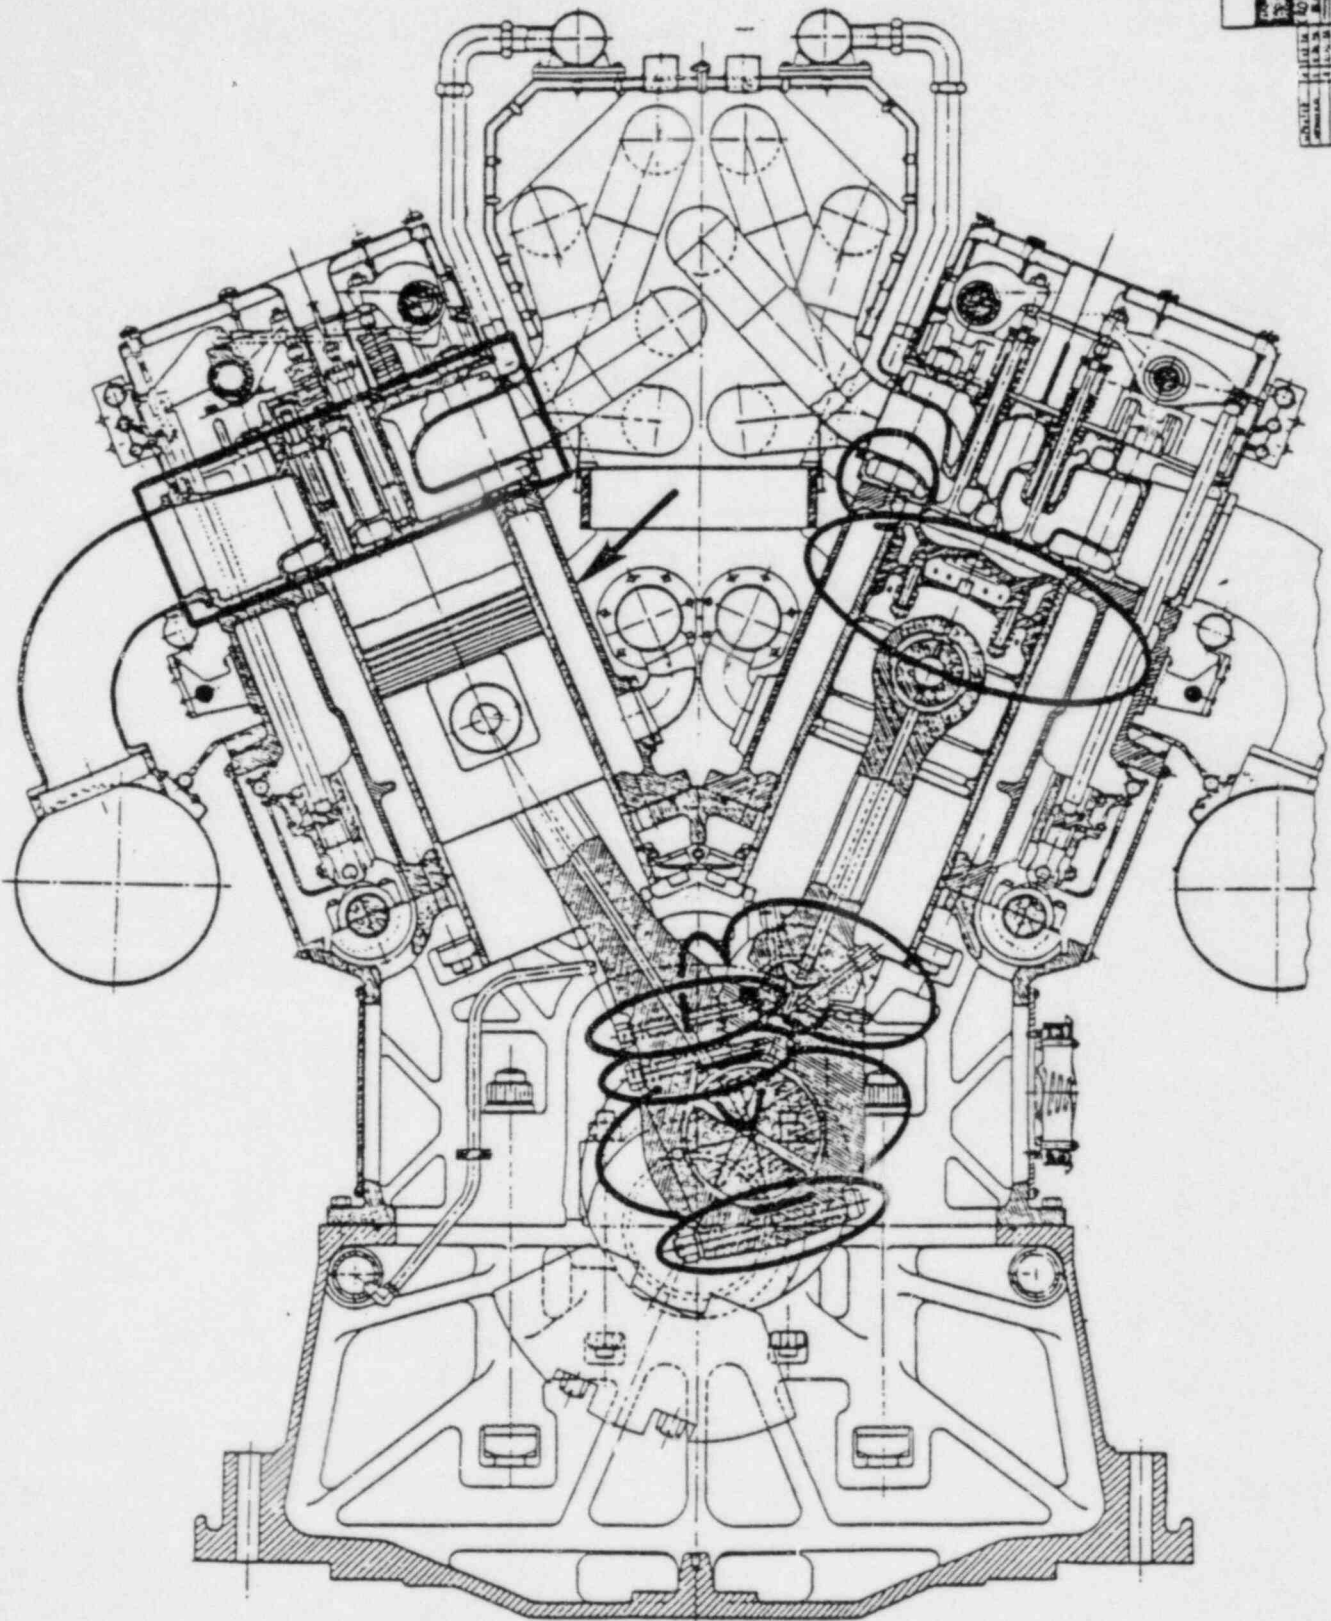
DMRV-16-4 High Corrective Maintenance Areas

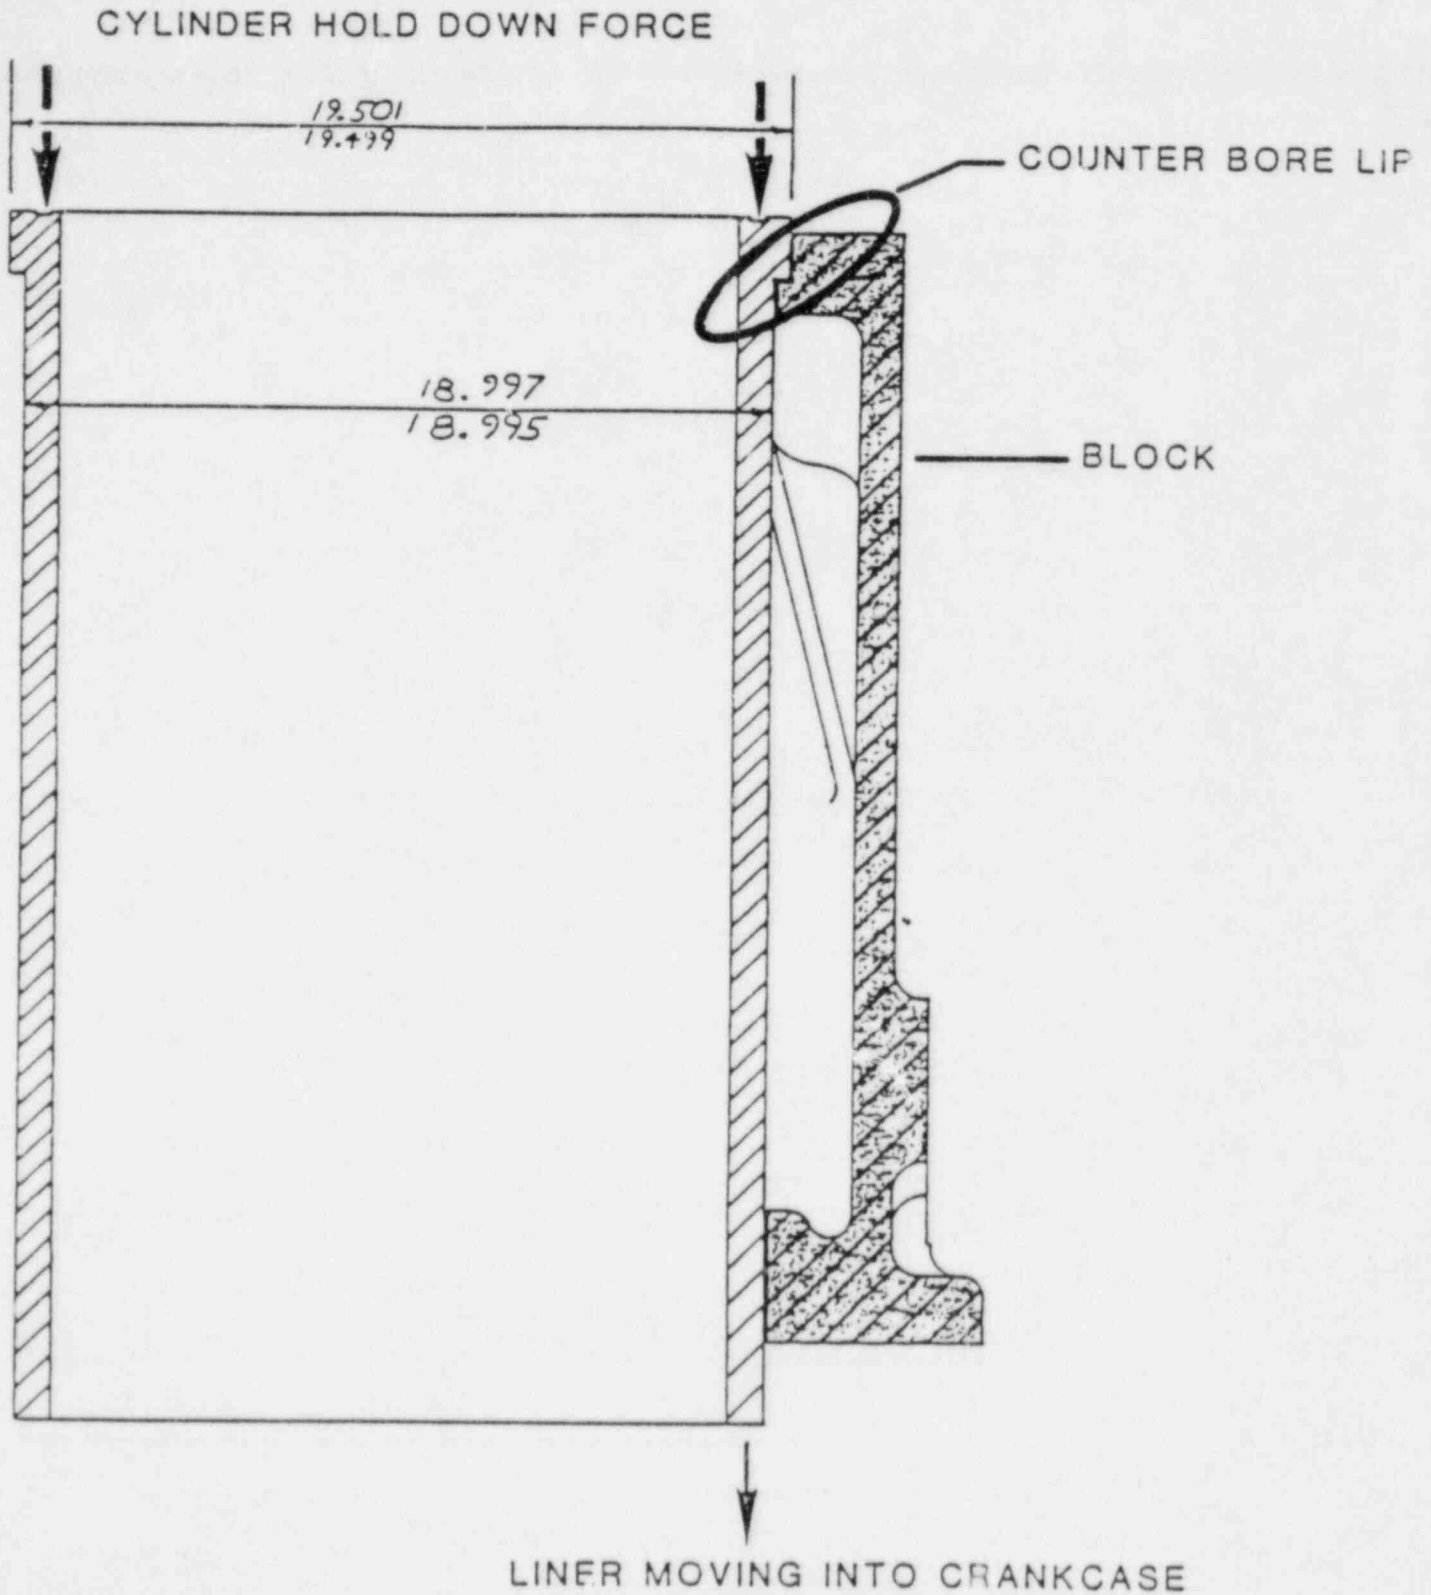
Figure 3.6

Table 3.1A lists the scrapping of four (4) cylinder blocks. The reasons for replacing these blocks were based primarily on two basic documented observations. The following narrative is a summary from the "Engine Rebuild Report", by Jon O. Jacobson, March 31, 1981. The first observation was the deformation or lowering of the cylinder liner block counterbore lip, as illustrated in Figures 3.6 and 3.7. The mechanism by which this was happening is illustrated in Figures 3.8 and 3.9, wherein the counterbore lip was cracking under the high stress of the cylinder head hold down force. Non-destructive testing was employed to determine the extent of the cracking in both engines. The results are presented in Figures 3.10 and 3.11. The magnitude of the cracking, the extent of the cracking, and the potential for the liner "dropping" into the crankcase, with the ensuing catastrophic results, provided a strong case for block renewal.
