ENGINE REBUILD REPORT

Motor Vessel Columbia

State of Alaska

January 30, 1981

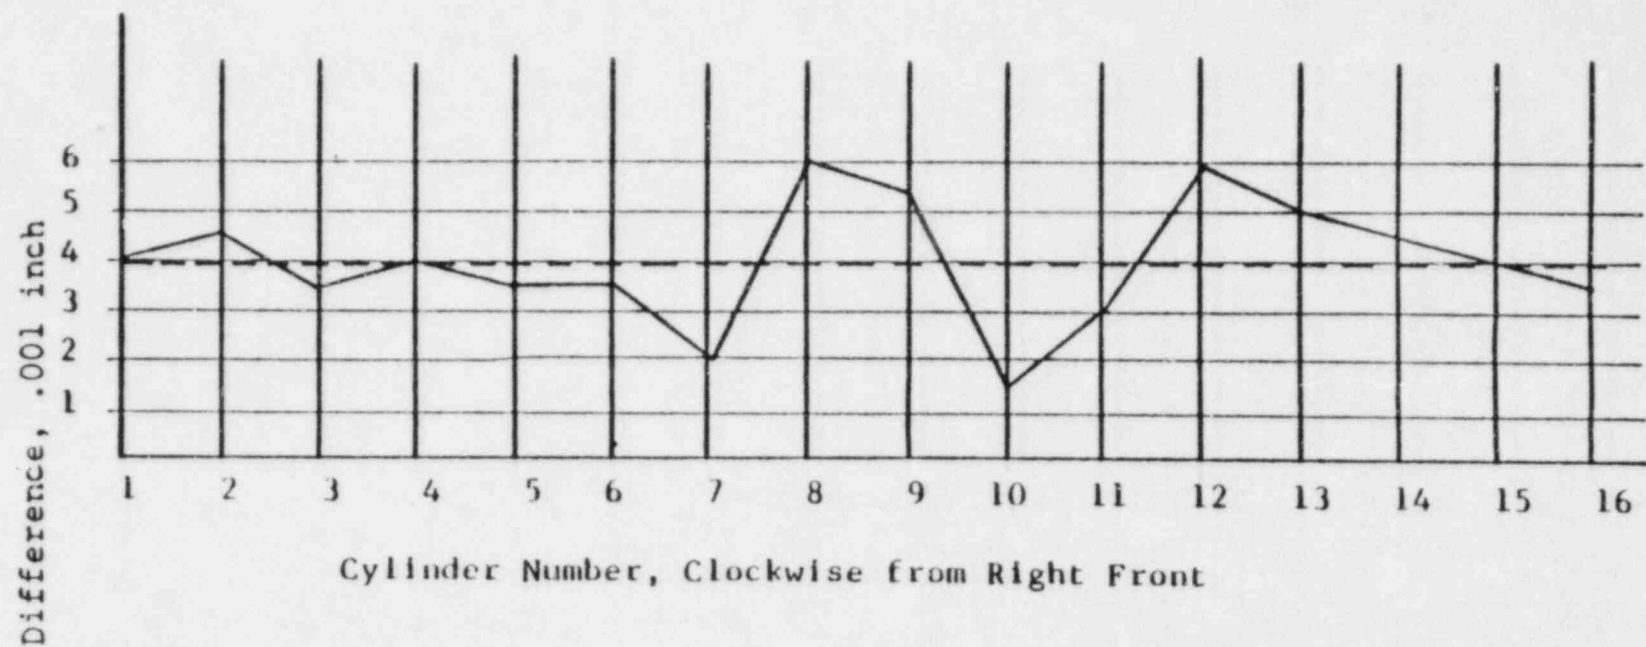
Figure 10

Average Difference between the Block and the Liner Bore Diameter

The average clearance between the liner and the block has increased .005 inch. The clearance difference explains why it was easier to remove the liners when they were cold. Under operating conditions, the effects of internal pressure and temperature gradient from the interior of the cylinder to the water jacket produces liner expansion to where it deforms to follow the shape of the block. Initial calculations indicate that during operation in the firing cycle, the cylinder-to-block compression force will be 27,000 psi.

Non-destructive testing was performed on all cylinders about the circumference of the bore at the top of the block. Figures 10 and 11 show the results of these studies. Radial cracks were found on one or more cylinders in all four blocks. These cracks are a result of the creep and fatigue at the top of the block. These cracks are radial extending outward from the cylinder bore and are generally either between the cylinder bore and a smaller block drilling such as head stud, or water-jacket passage. These openings will have produced local stress concentrations and, hence, the resulting fractures from creep and fatigue stresses.

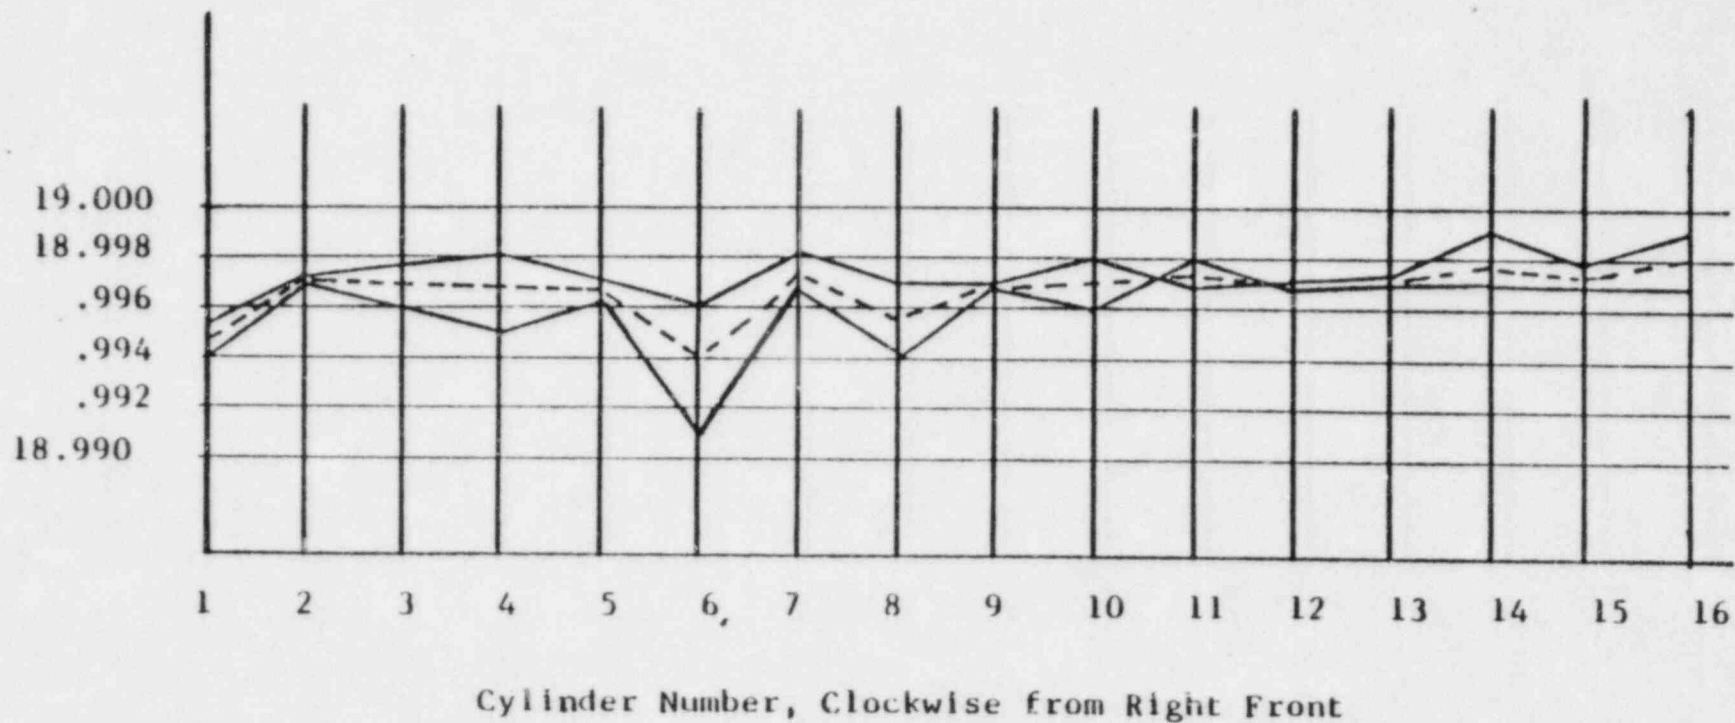
Figure 15

Laminar fractures outward from the root of the counterbore in cylinders 3 and 4 of the left bank of the starboard engine (Figure 15).

Confirmation of the extent of the above fractures by showing their entrance at the metal surface in the roots of the counterbore in cylinders 3 and 4 of the left bank of the starboard engine.

5. The laminar fracturing of the left block of the starboard engine has rendered it unserviceable; it or the entire engine must be replaced.
6. Because the remaining three blocks have been shown to have radial cracks about several of the cylinders, this condition must be closely monitored to observe the cylinder diameter growth in an attempt to perform corrective maintenance before major problems occur.
7. Plan to replace the remaining three blocks in the near future.
8. Consider redesign of the upper portion of the block for replacement to alleviate observed block failure.
