METALLURGICAL EVALUATION  
OF  
DIESEL GENERATOR TURBOCHARGER  
GUIDE VANE HOLD DOWN BOLTS  
AT  
GRAND GULF NUCLEAR STATION - UNIT 1

PREPARED FOR: NUCLEAR PLANT ENGINEERING  
MISSISSIPPI POWER & LIGHT COMPANY  
PORT GIBSON, MISSISSIPPI 39150

PREPARED BY: J. S. BRIHMADESAM  
NUCLEAR ENGINEERING DEPARTMENT  
MIDDLE SOUTH SERVICE, INC.  
NEW ORLEANS, LOUISIANA 70112

JULY, 1984

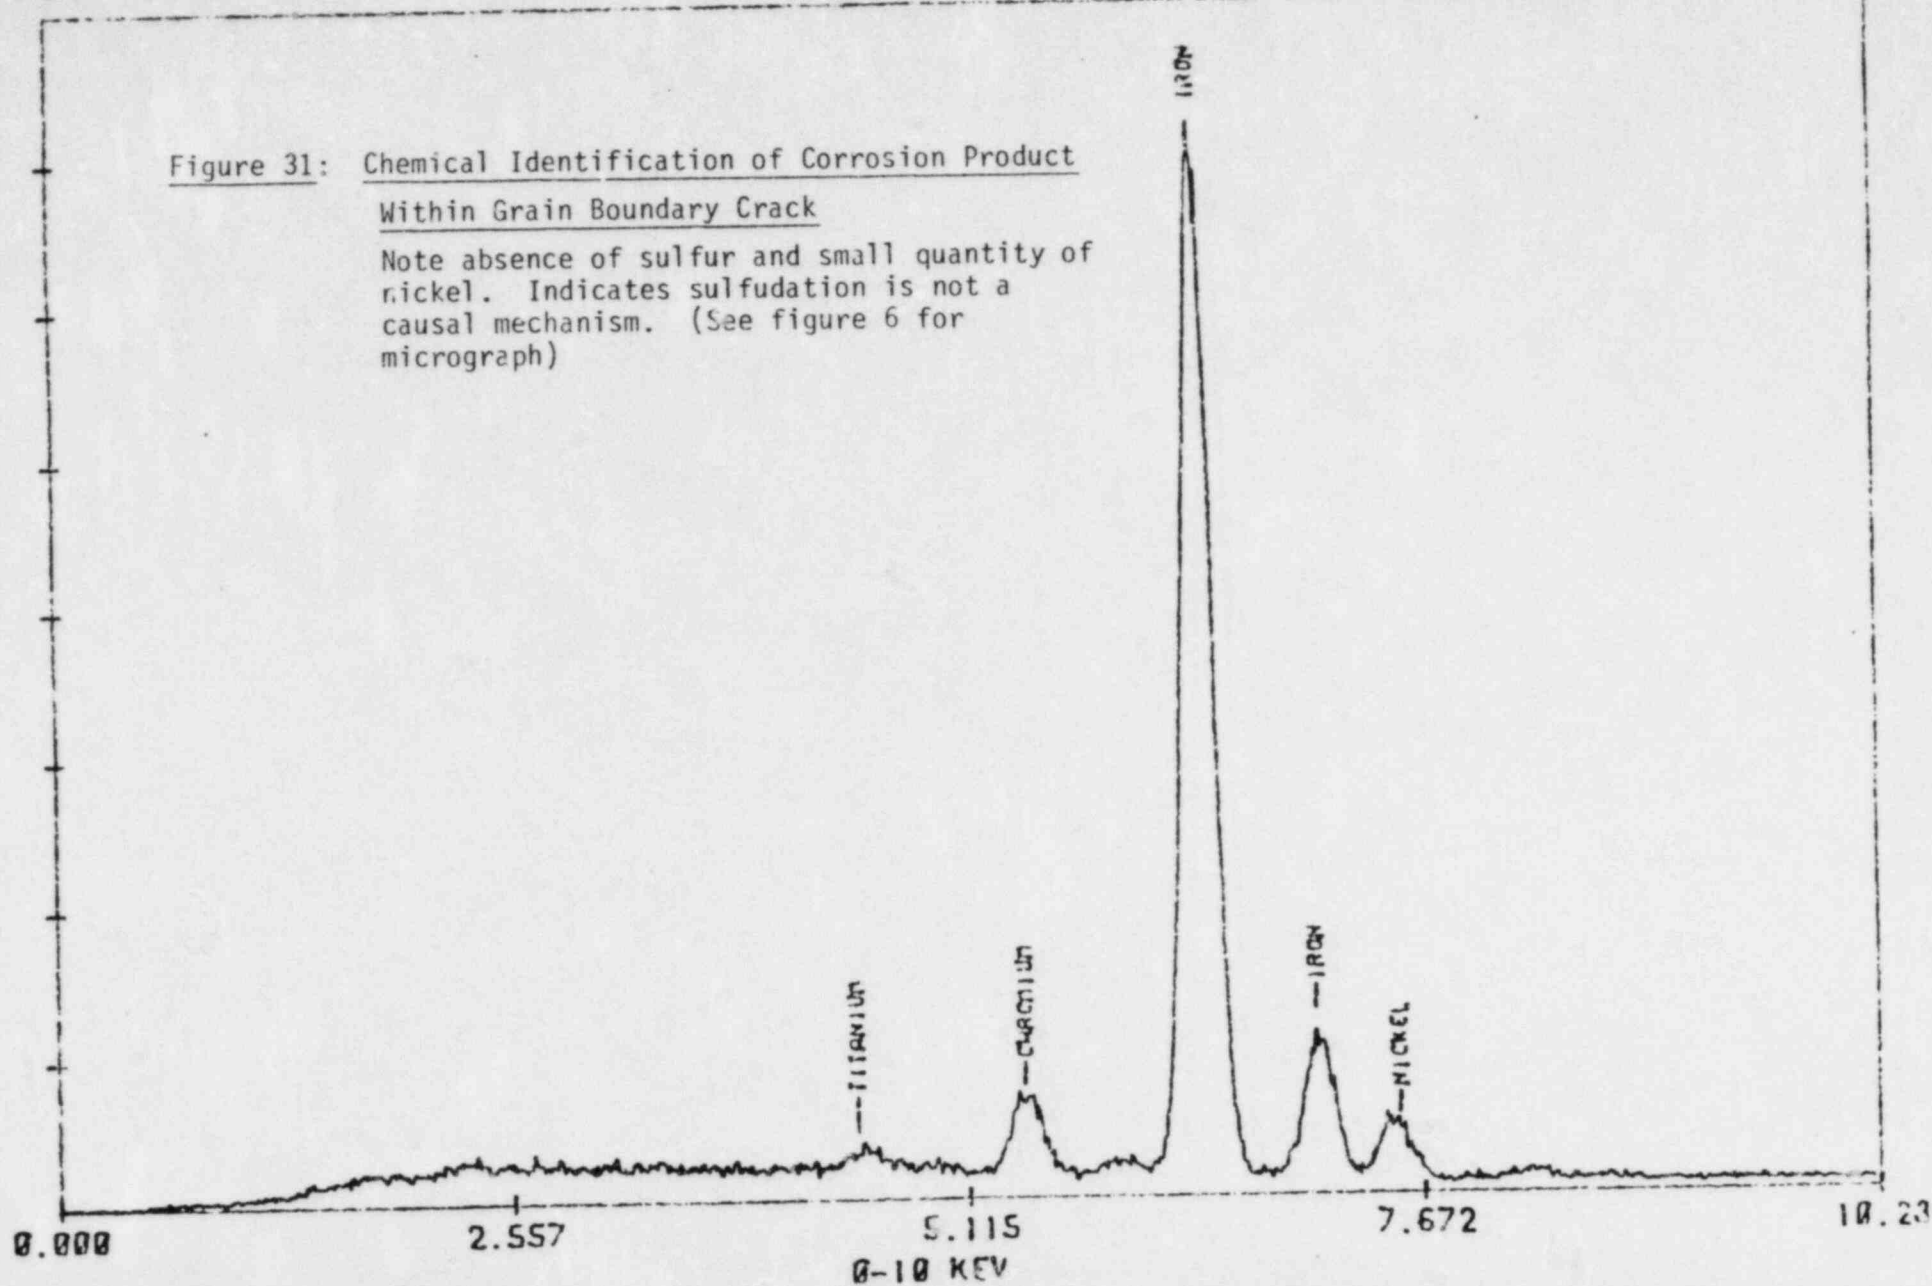
Figure 31: Chemical Identification of Corrosion Product  
Within Grain Boundary Crack

Note absence of sulfur and small quantity of  
nickel. Indicates sulfuration is not a  
causal mechanism. (See figure 6 for  
micrograph)

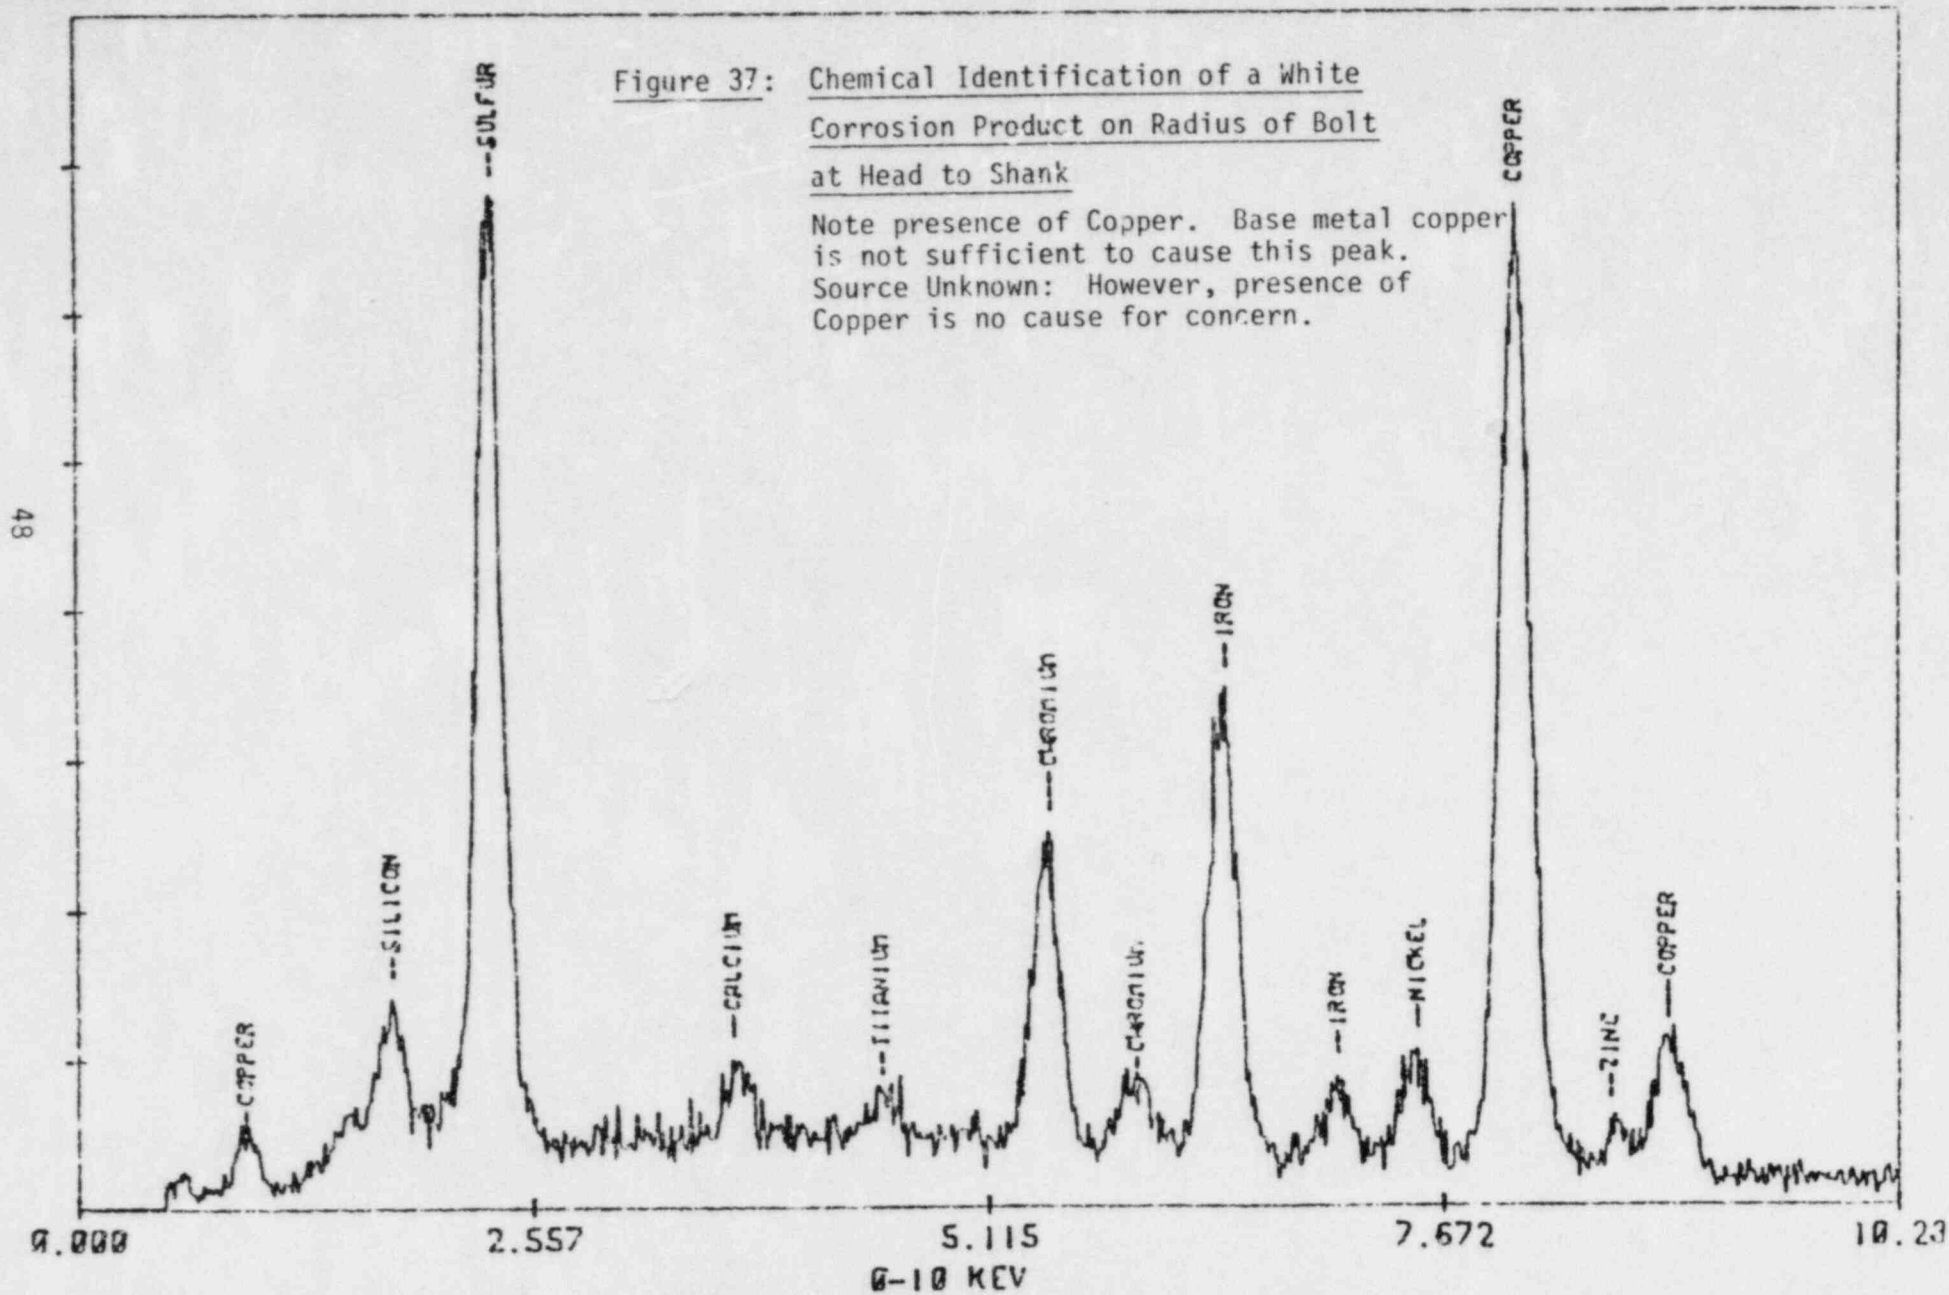
Figure 37: Chemical Identification of a White Corrosion Product on Radius of Bolt at Head to Shank

The corrosion products observed on the bolts and the washers were analyzed. The corrosion product on the washer was a beige colored deposit and the identification of species is provided in Figure 35. The species indicate that these are products of combustion of the fuel oil. The brown colored deposits on the head of the bolt is identified in Figure 36 and this spectrum is similar to the one from the washer. Comparing these two to that from the fracture surface (Figure 30) it is clear that the fracture surface did not contain the quantities present on the exposed surfaces. On one of the bolts, R-1 of Division II, a white deposit was observed in the fillet region between the shank and head of the bolt. Identification of this product is provided in Figure 37. This product had a significant quantity of copper. The amount of copper in the base metal (0.06 wt%) is not sufficient to show such a large peak. The presence of copper on this bolt's surface is unknown. However, the bolt did not show any evidence of pitting or cracking underneath this product. Therefore, the occurrence of copper in this deposit is not a cause for concern.

Note presence of Copper. Base metal copper is not sufficient to cause this peak. Source Unknown: However, presence of Copper is no cause for concern.
