FACILITY: Pilgrim Nuclear Power Station

SUBJECT: MEETING ON JUNE 15, 1984 WITH BOSTON EDISON COMPANY  
REGARDING CRACKS IN INCONEL WELD MATERIAL AT THE  
PILGRIM NUCLEAR POWER STATION

NRC MEETING  
PILGRIM SAFE END REPAIRS  
6/15/84

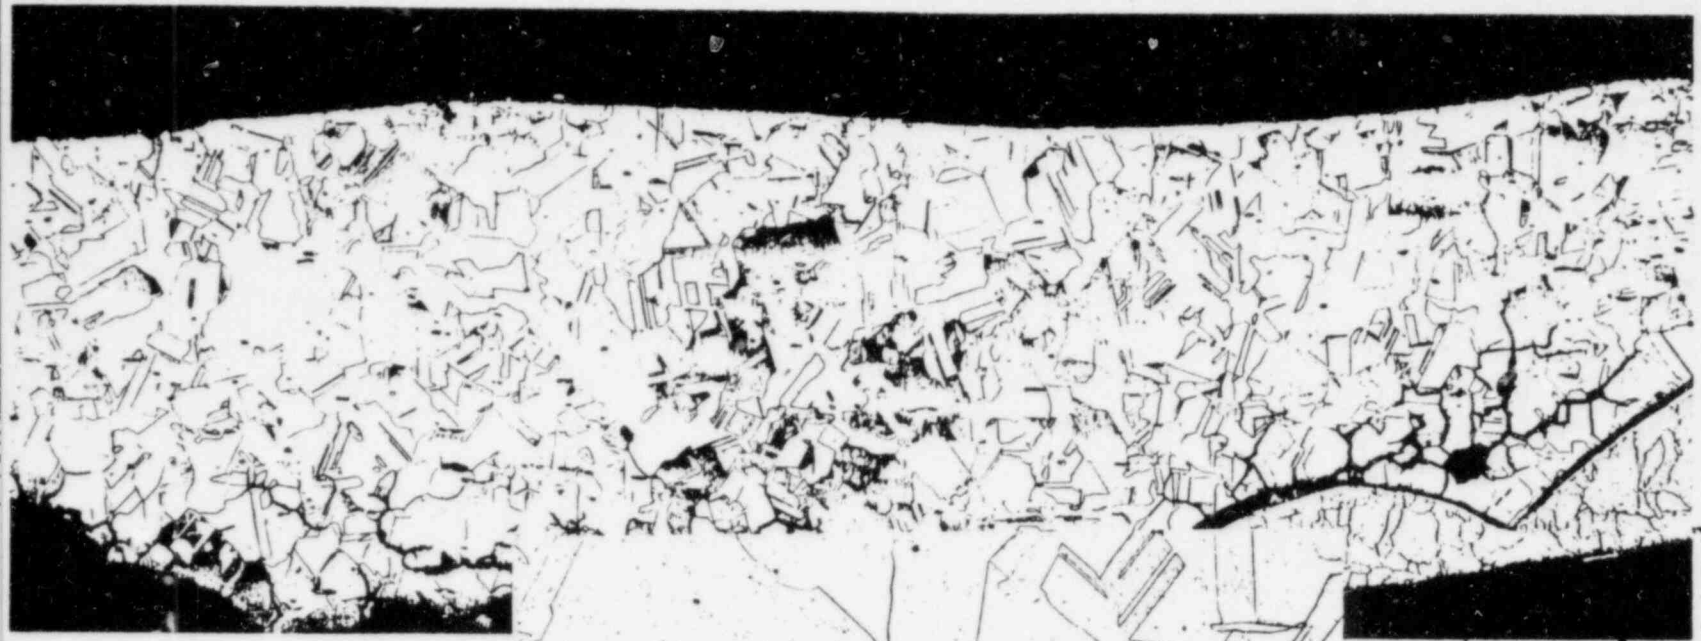
INTERGRANULAR CRACKING IN INCONEL 182 BUTTER

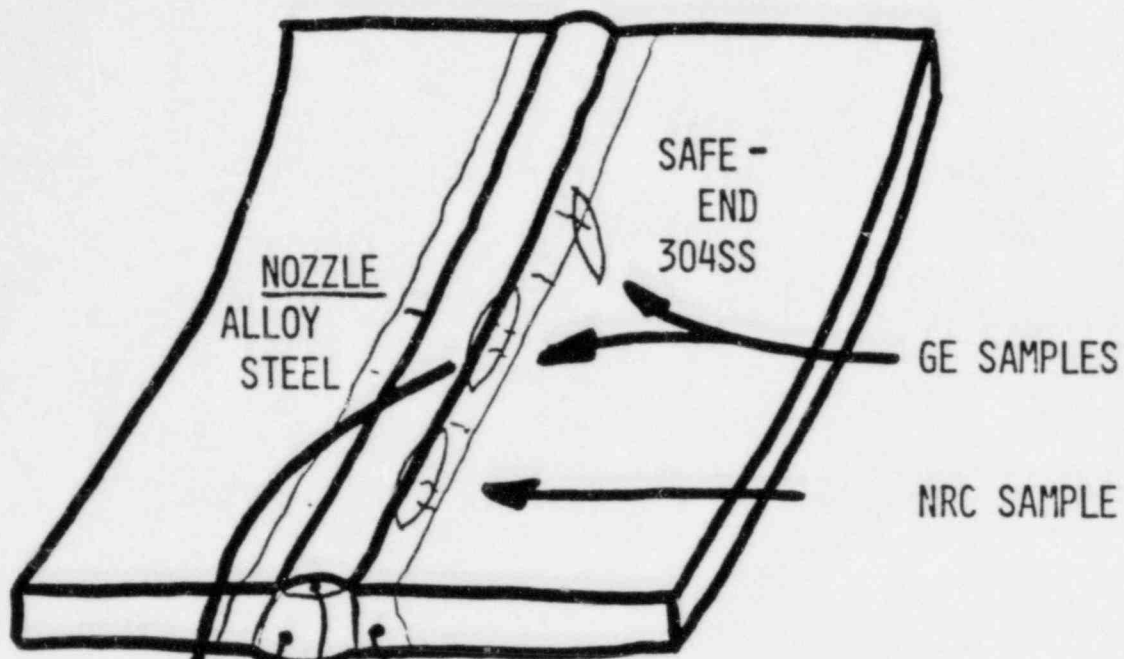
PILGRIM NOZZLE N1-B

CIRCUMFERENTIAL  
INTERGRANULAR CRACKING  
AT INCONEL 182/304SS  
SAFE END INTERFACE

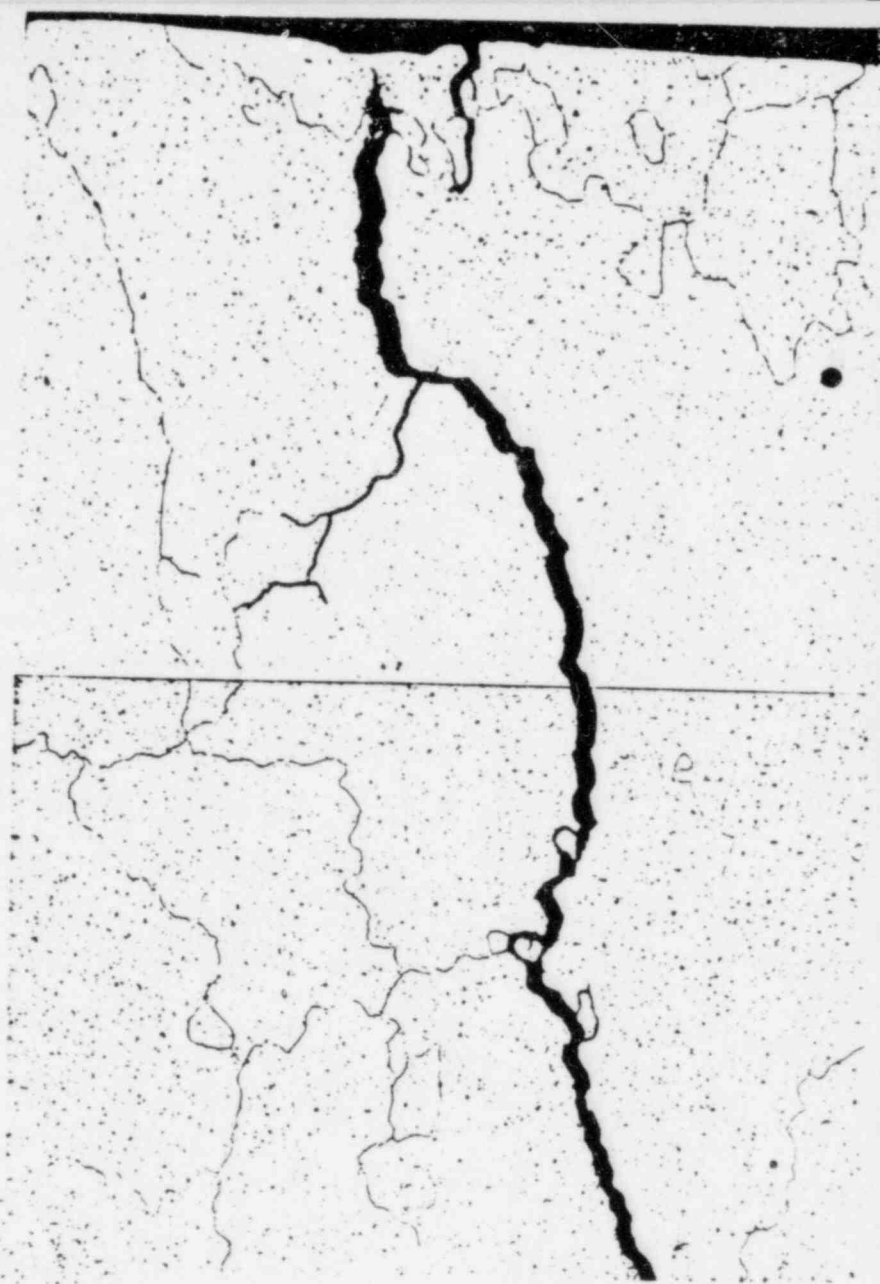
PILGRIM NOZZLE N1-B

AXIAL INTERDENDRITIC CRACKING IN INCONEL 182 BUTTER ADJACENT TO WELD ROOT ON SAFE END SIDE  
CRACK IN CENTER OF PHOTO INITIATION IN INCONEL 182 BUTTER ON THE NOZZLE SIDE OF THE WELD.

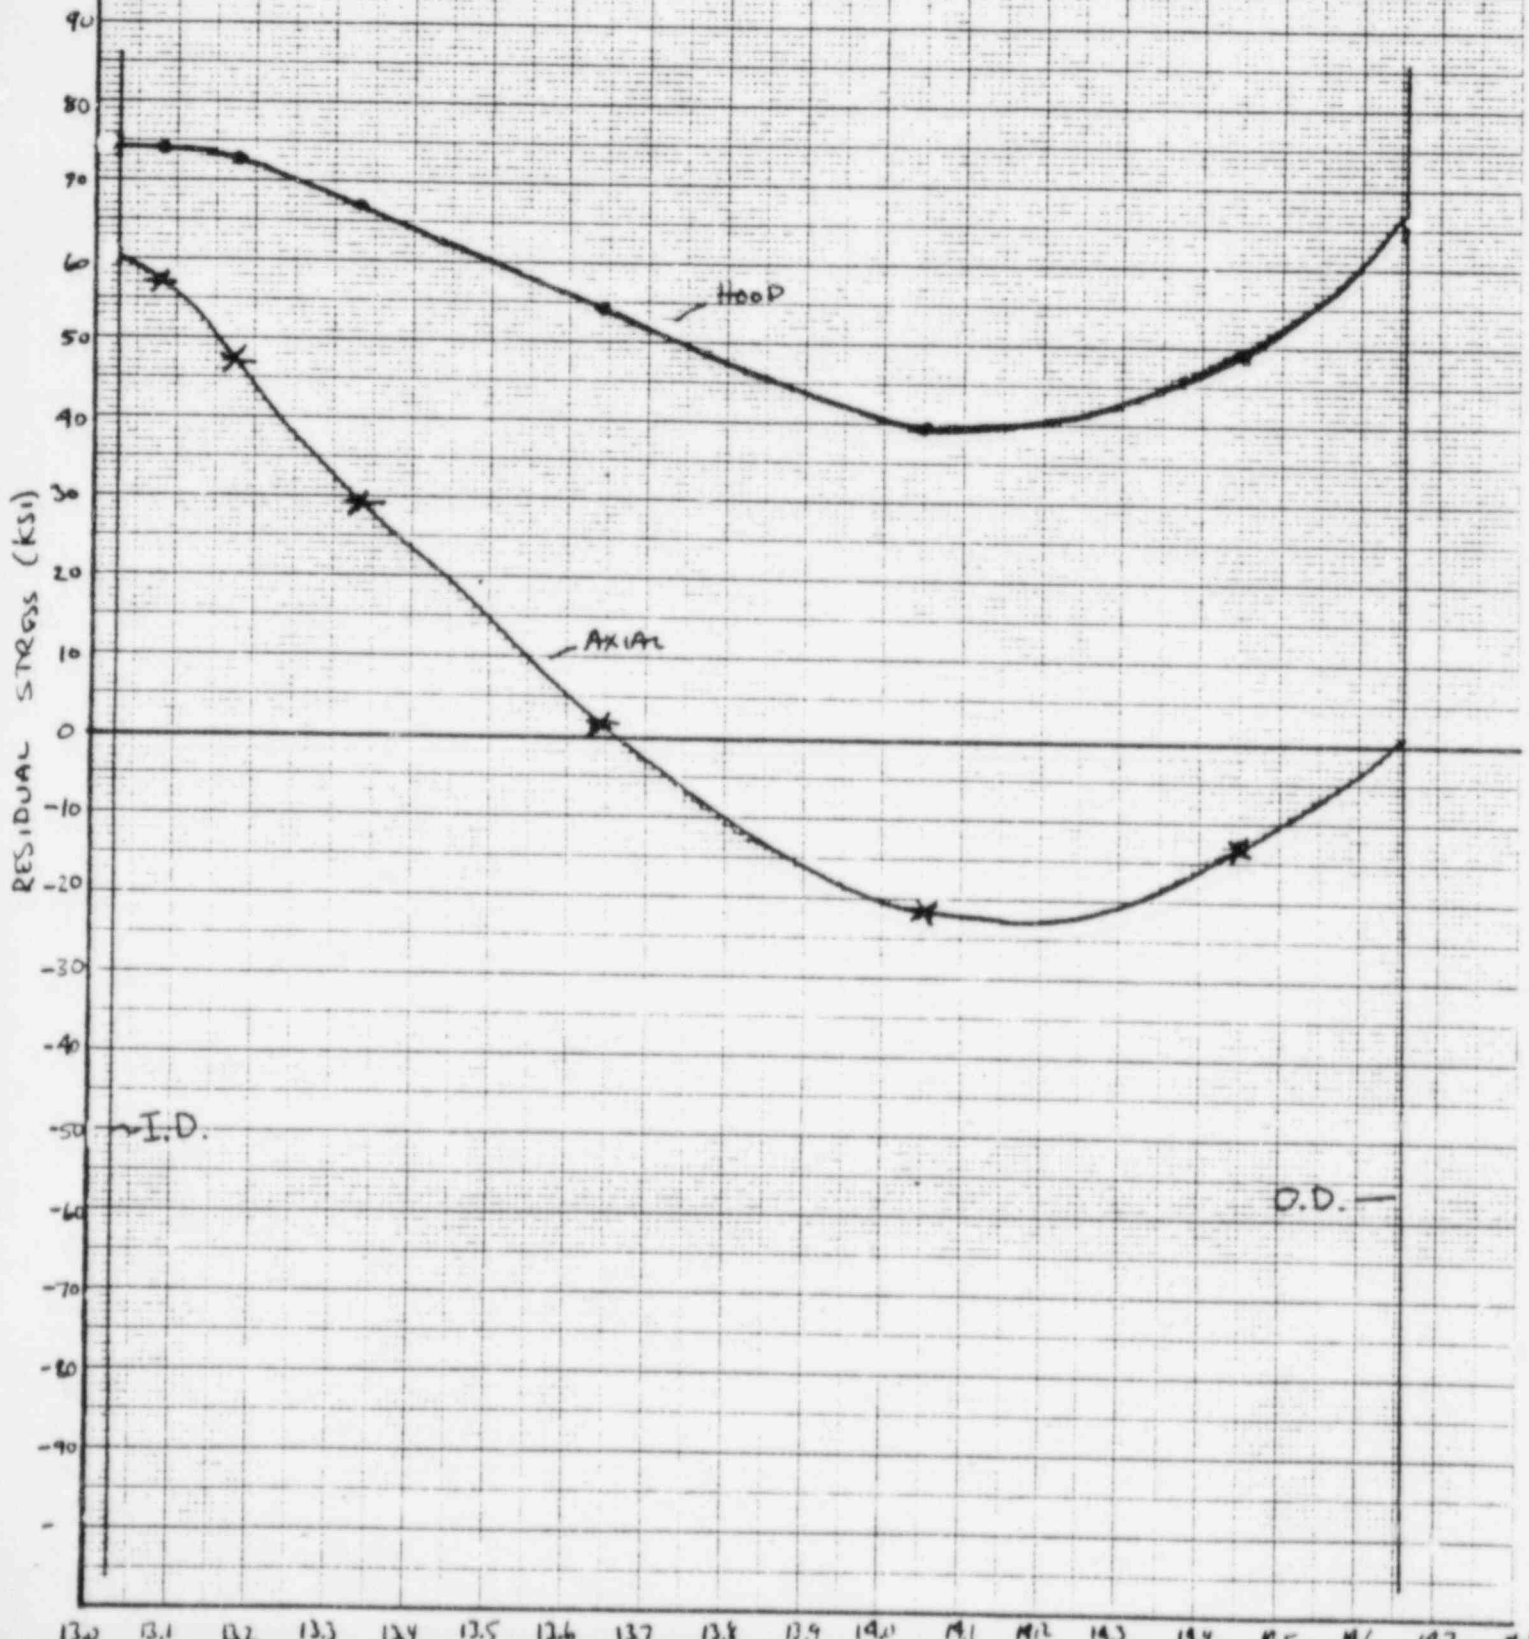
PLUGFLOW RECIRCULATION  
 OUTLET NOZZLE  
 RESIDUAL STRESS ANALYSIS  
 THROUGHWALL RESIDUAL  
 STRESS

- PRIMARY HOOP STRESS DUE TO PRESSURE 10 KSI
- WELD RESIDUAL STRESS 50 - 70 KSI
- CIRCUMFERENTIAL STRESSES SUFFICIENT TO EXPLAIN THE OBSERVED CRACKING
- PREDOMINANT AXIAL CRACKING DUE TO HIGHER PRESSURE STRESS AND WELD RESIDUAL STRESS

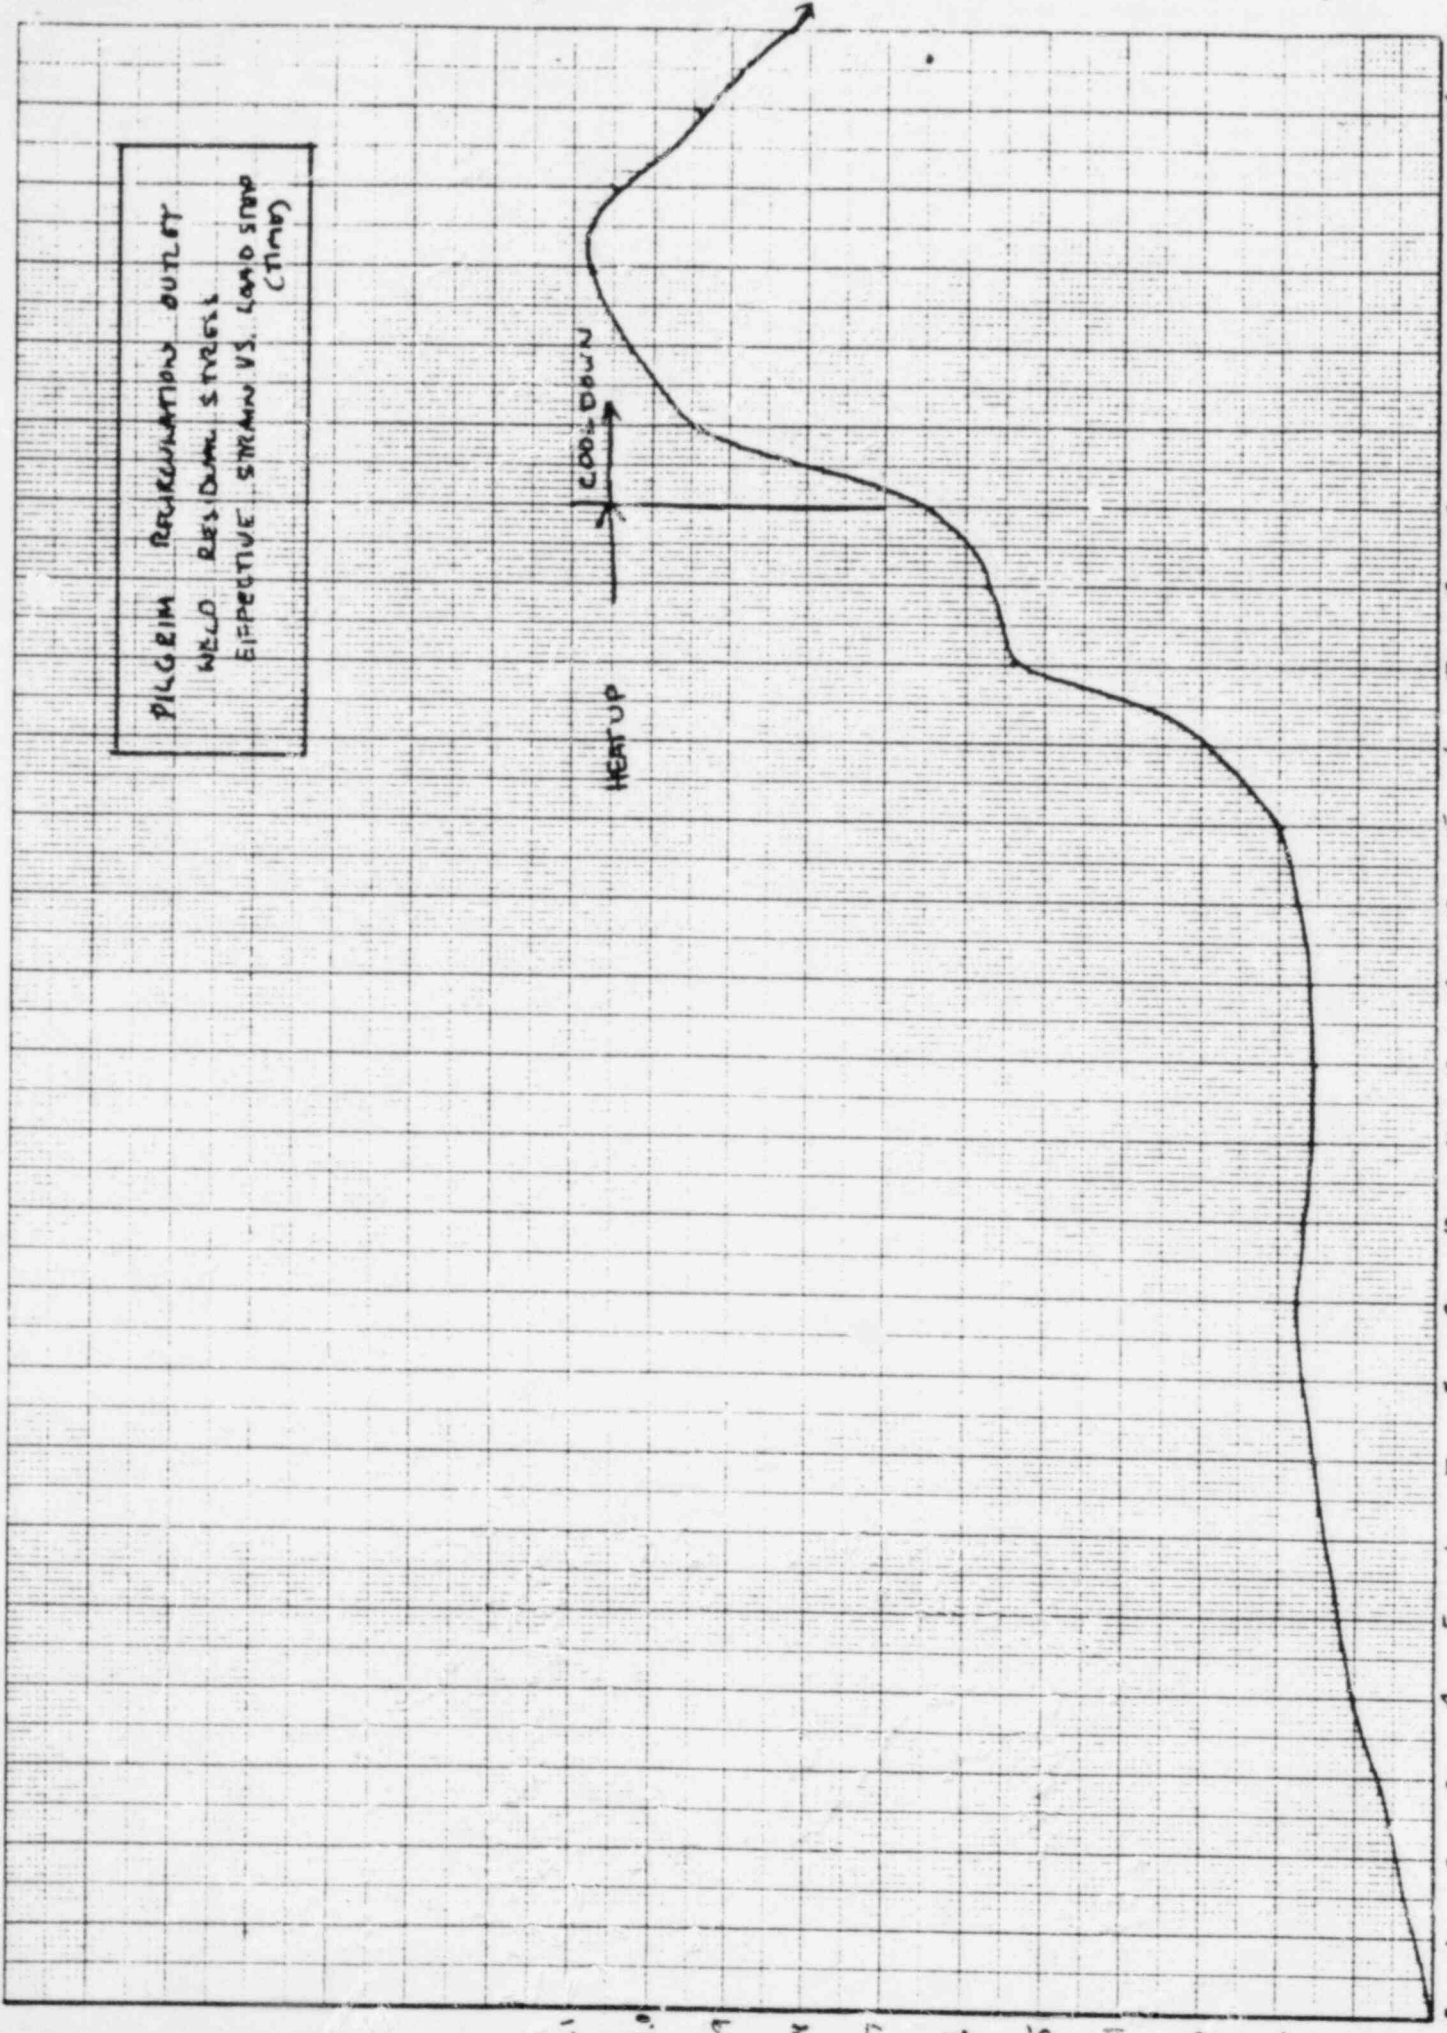
PILGRIM REGULATION OUTPUT  
 WELD RESIDUAL STRESS  
 EFFECTIVE STRAIN VS. LOAD STEP  
 (TIME)

- FINAL WELD PRODUCES EXTENSIVE YIELDING IN THE WELD BUTTER AND THE SURROUNDING LOW ALLOY STEEL MATERIAL
- THE PLASTIC YIELDING IS SUFFICIENT TO OVERWHELM PREVIOUS RESIDUAL STRESSES
- STUDIES ON IHSI HAVE CONFIRMED THE ROLE OF PLASTICITY IN ELIMINATING PREVIOUS STRESS STATE
- FINAL STRESSES IN THE WELD AND SURROUNDING MATERIAL ARE ESSENTIALLY SAME AS DIFFERENT THAN THAT IN A WELD WITHOUT HALF BEAD REPAIR
