TMI-1 REACTOR COOLANT PUMP SHAFT FAILURE ANALYSIS

RESEARCH AND DEVELOPMENT DIVISION
LYNCHBURG RESEARCH CENTER

SPONSORED BY
GENERAL PUBLIC UTILITIES

Lynchburg Research Center Report
RDD:84:5183-06:01

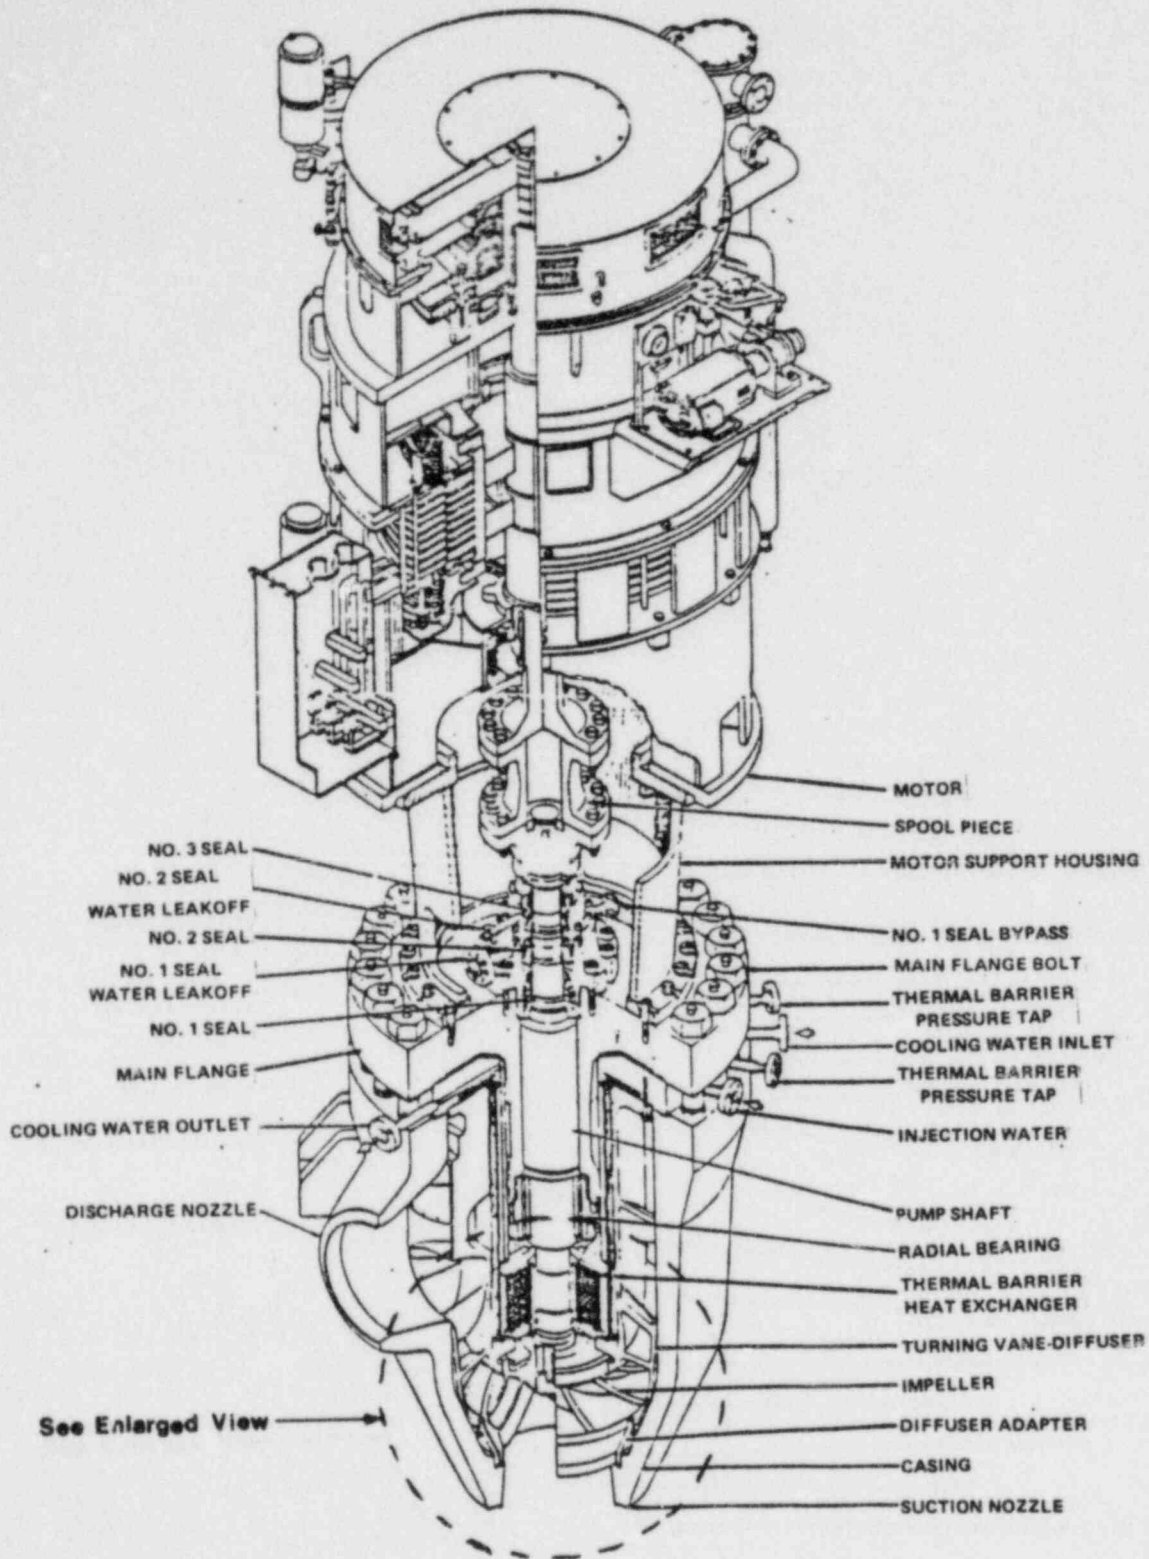
Figure 1.2-1. Schematic of Westinghouse Model 93 A Reactor Coolant Pump

RCP-1B is a Westinghouse Model 93A pump of which 82 are in use in the United States and in foreign reactors. A cutaway view of this pump is shown in Figure 1.2-1. The area of interest relative to the TMI-1 pump shaft failure is circled in Figure 1.2-1 and enlarged in Figure 1.2-2. In Figure 1.2-2 the location of the TMI-1 pump shaft crack and two other pump shaft failures, Surry-1² and Prairie Island Unit-2 (PI-2)³, are shown. The Surry-1 failure was opposite the upper thermal barrier labyrinth, just below the radial bearing. The Surry-1 shaft had a shrunk-fit thermal sleeve in place near the crack. Both the PI-2 and TMI-1 failures occurred opposite the lower thermal barrier labyrinth. Both PI-2 and TMI-1 shafts had shrunk-fit thermal sleeves over the area of cracking. Figure 1.2-3 provides an overall view of the shaft configuration associated with the Surry-1 failure (type A shaft) and the PI-2 and TMI-1 failure (type B shaft.) The type B shaft reflects design changes in the area of the Surry-1 failure. These changes⁴ include elimination of 1) the shrunk-on thermal sleeve just below the radial bearing, 2) a groove in the shaft below the bearing, and 3) anti-rotation pins, lock-welded near the site of the Surry-1 failure.

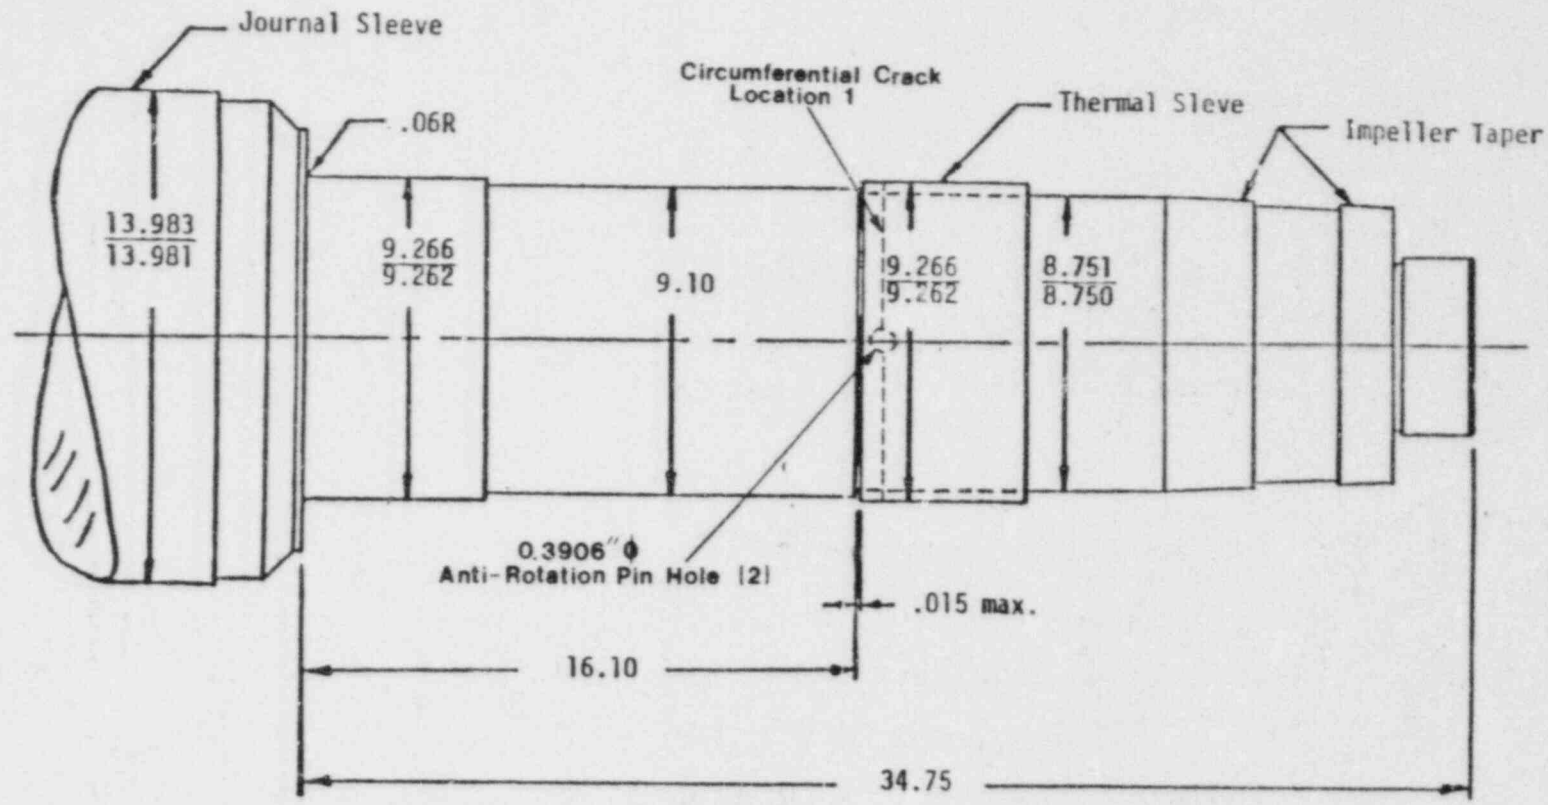
Figure 1.2-4. Geometry of Type B Shaft in Failure Area

The geometry of the lower end of type B shaft used in TMI-1 RCP-1B is shown in Figure 1.2-4. The majority of the crack in RCP-1B was found by GPU to exist under the thermal sleeve near the shaft diameter step change from 8.750 inches to 9.10 inches. Near this diameter change are two blind holes 180° apart on the shaft. Each of these holes are 0.3906 inches in diameter and extend to a maximum depth of 0.455 inch. Figure 1.2-5 shows the design detail of these holes, the thermal sleeve, and shaft in this area. The holes position the anti-rotation pins which are welded to the thermal sleeve.

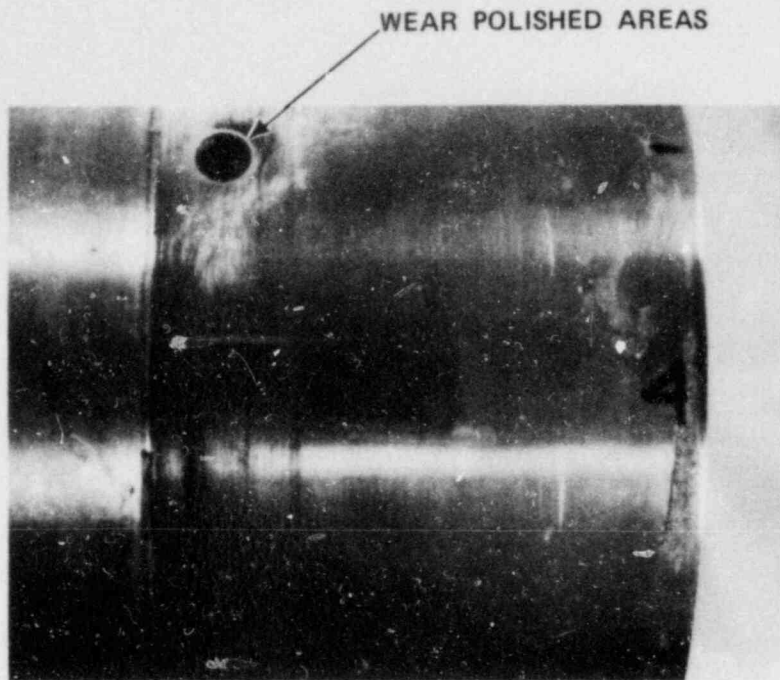
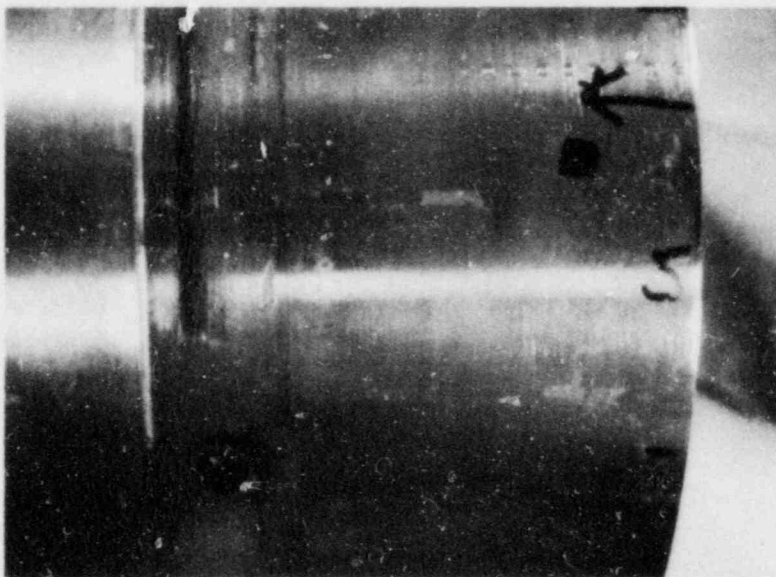
Figure 3.1-3. Enlarged Views of Pin Holes. A, B, and C Shot at Different Angles or Different Illumination at Cracked Pin Hole. D and E Shot at Uncracked Pin Hole

Both pin holes had worn or polished areas around their circumference which disrupted the local pattern of deposits as shown in Figure 3.1-3. The crack can be clearly seen to intersect the pin hole at the border of the #1 and #8

octants (Figure 3.1-3a-c). The crack shown in Figure 3.1-3 can only be discerned near the #1-#8 pin hole (views a and c) where the crack was bordered on one side by a bright metallic worn area and a linear streak of deposits on the other.

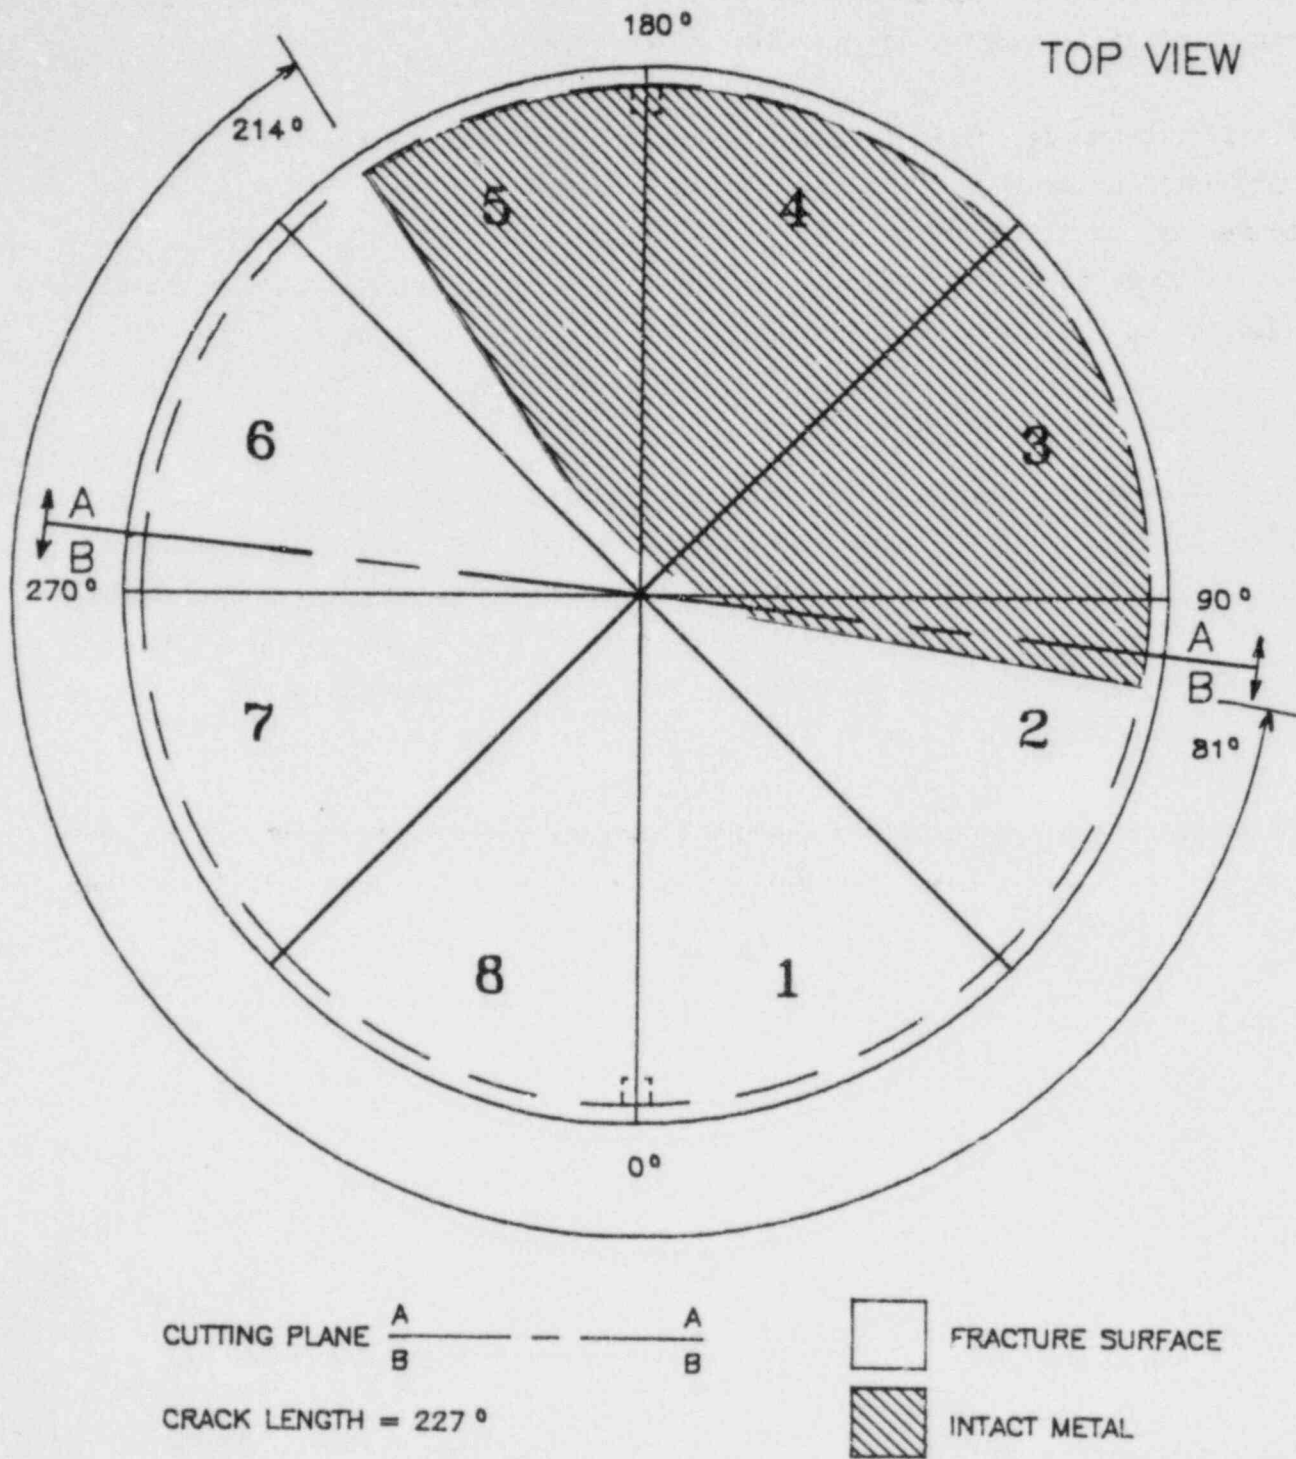
Figure 3.2-1. Initial Section of the Pump Shaft,
Viewed from the Motor End

Initially the shaft was longitudinally sectioned in half as shown in Figure 3.2-1 and labeled "Piece A" and "Piece B". Piece B was selected for fracture morphology since it contained the thermal sleeve pin hole through which the crack intersected and the smaller amount of uncracked material. To precisely determine the amount of intact or uncracked material on Piece B, an ultrasonic inspection was performed and is described in Section 3.2.1. To reveal the crack surfaces, hydraulic pressure was used to separate Piece B along the crack as shown in Figure 3.2-2. The two halves of Piece B were labeled Piece B1 and B2, with B1 containing the outer diameter (OD) step reduction. After photography, the entire fracture surface was removed from Piece B1 in sample B1A. Sample B1A was then subdivided into three smaller specimens labeled B1A1, B1A2, and B1A3 according to Figure 3.2-3. Notches, to use as reference points, were placed on one edge of Specimen B1A1 every 1/4-inch beginning at the shaft OD. Scanning electron microscopy and metallographic specimens were sectioned from Specimen B1A1 as shown in the figure, with the identification numbers on the individual specimens corresponding to the 1/4-inch notch locations.

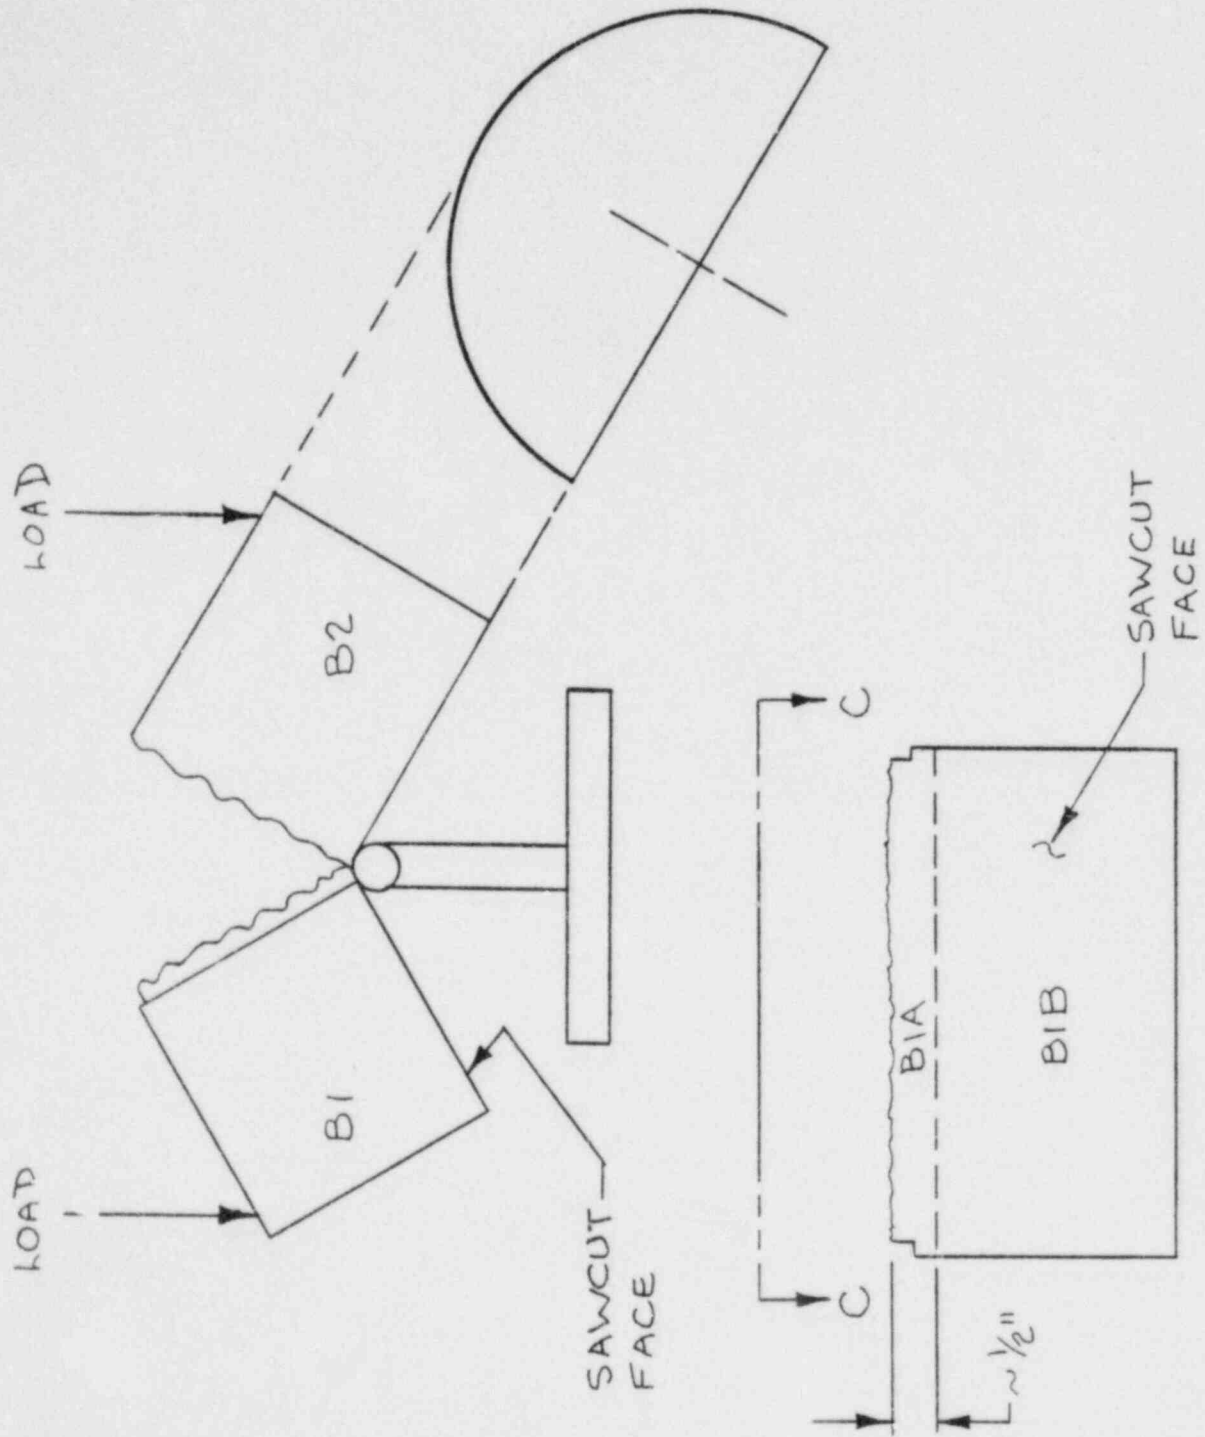
Figure 3.2-2. Separation of the Fracture in Section B

To prevent possible damage to the crack surface during separation, it was decided to bend Piece B as described in Section 3.2 rather than pull the halves apart.

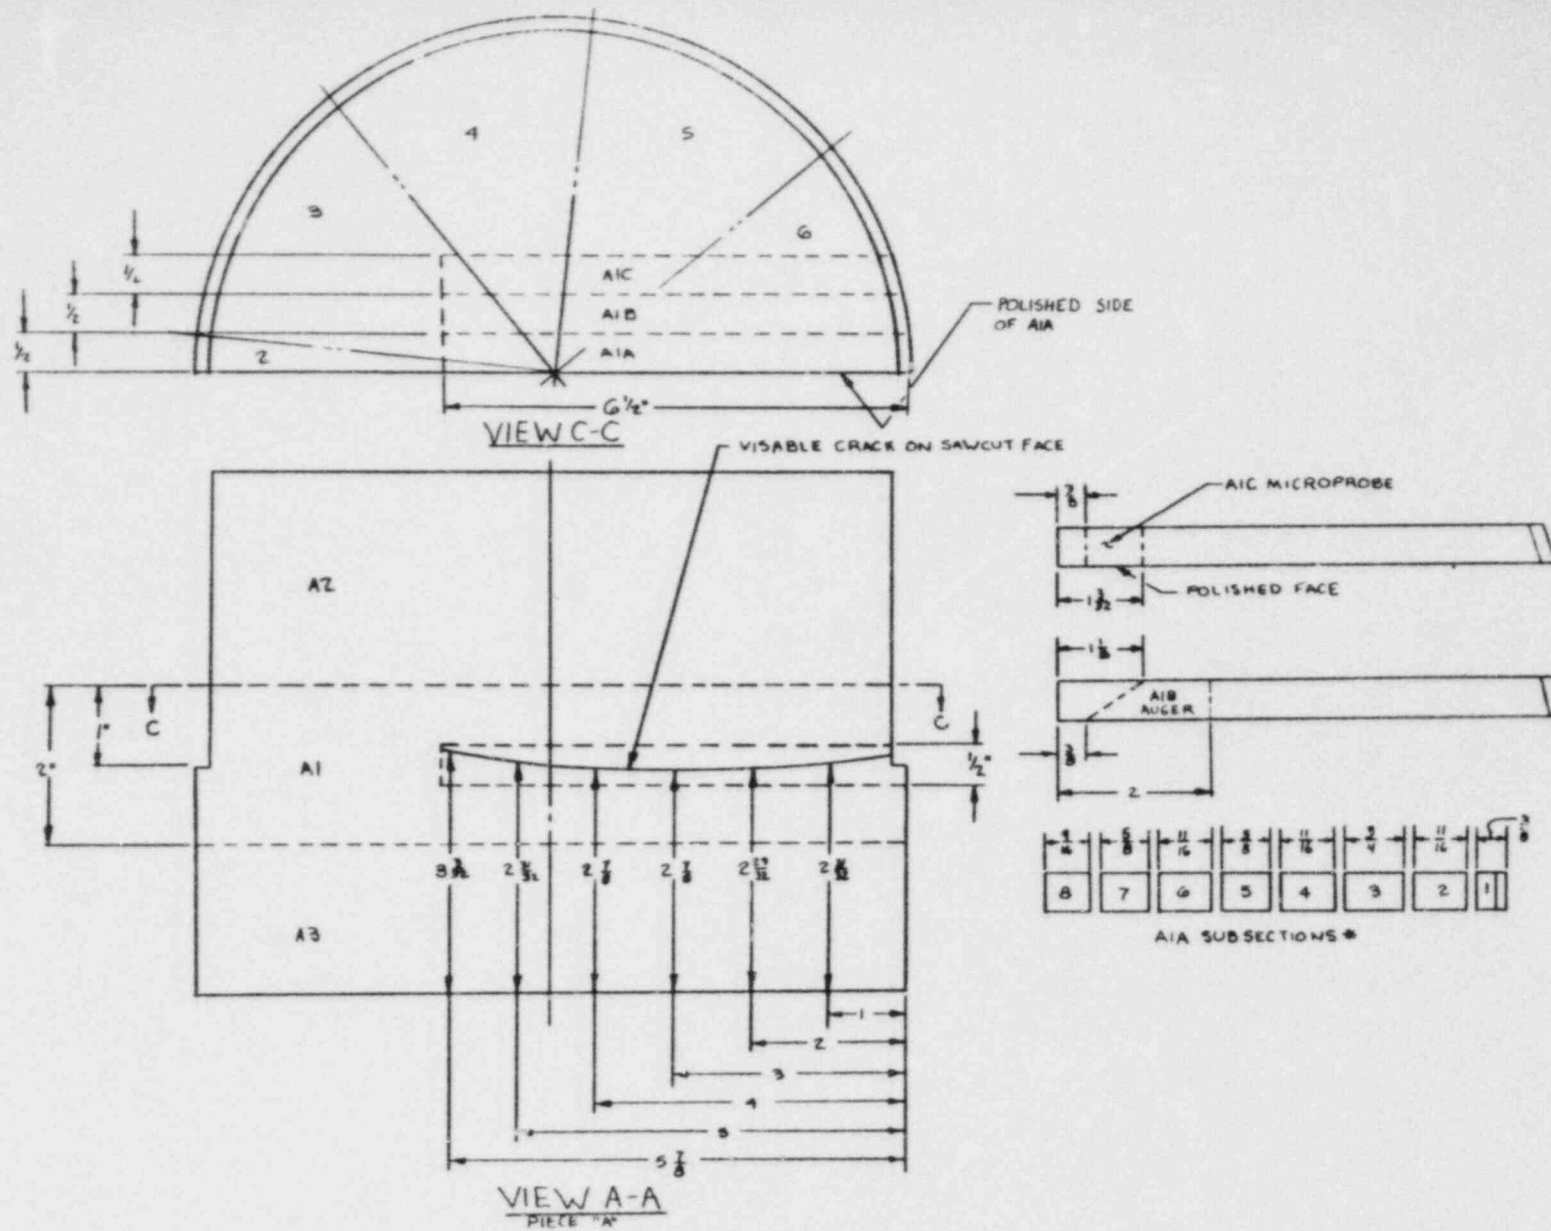
Figure 3.2-4. Subdivision of Section A Into Specimens for Metallographic, Auger, and Electron Microprobe Examinations

Piece A was sectioned into three specimens according to Figure 3.2-4 and labeled A1, A2, and A3. From Specimen A1 was sectioned three 1/2-inch wide strips, A1A, A1B, and A1C. Since the crack extended nearly the entire length of strip specimen A1A, holes were drilled approximately every 1/4-inch through which bolts were inserted to hold it together. Metallographic specimens A1A-1 through A1A-8 were then sectioned. Specimens for Auger electron spectroscopy

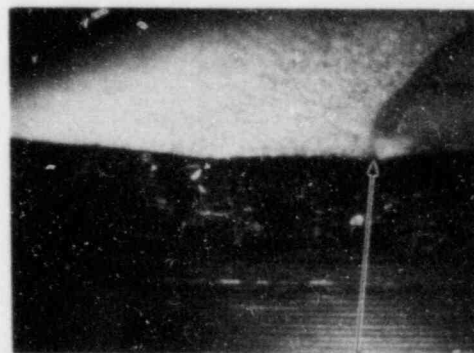
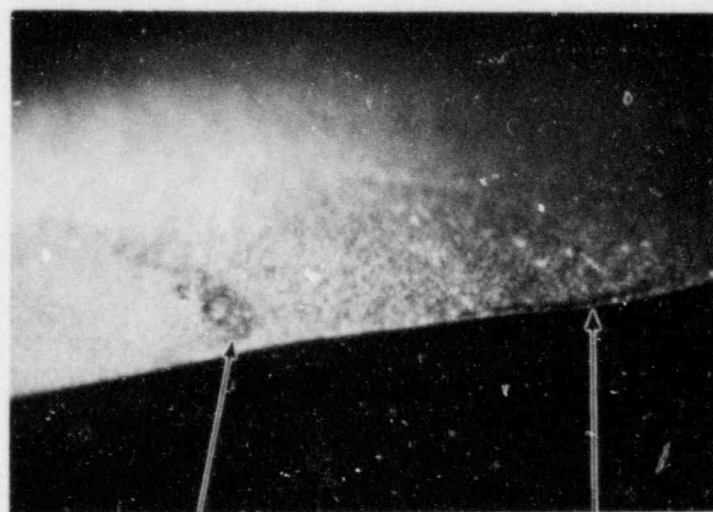
Figure 3.3-4. Views of Crack Path Changes Relative to Fracture Surface Beachmarks

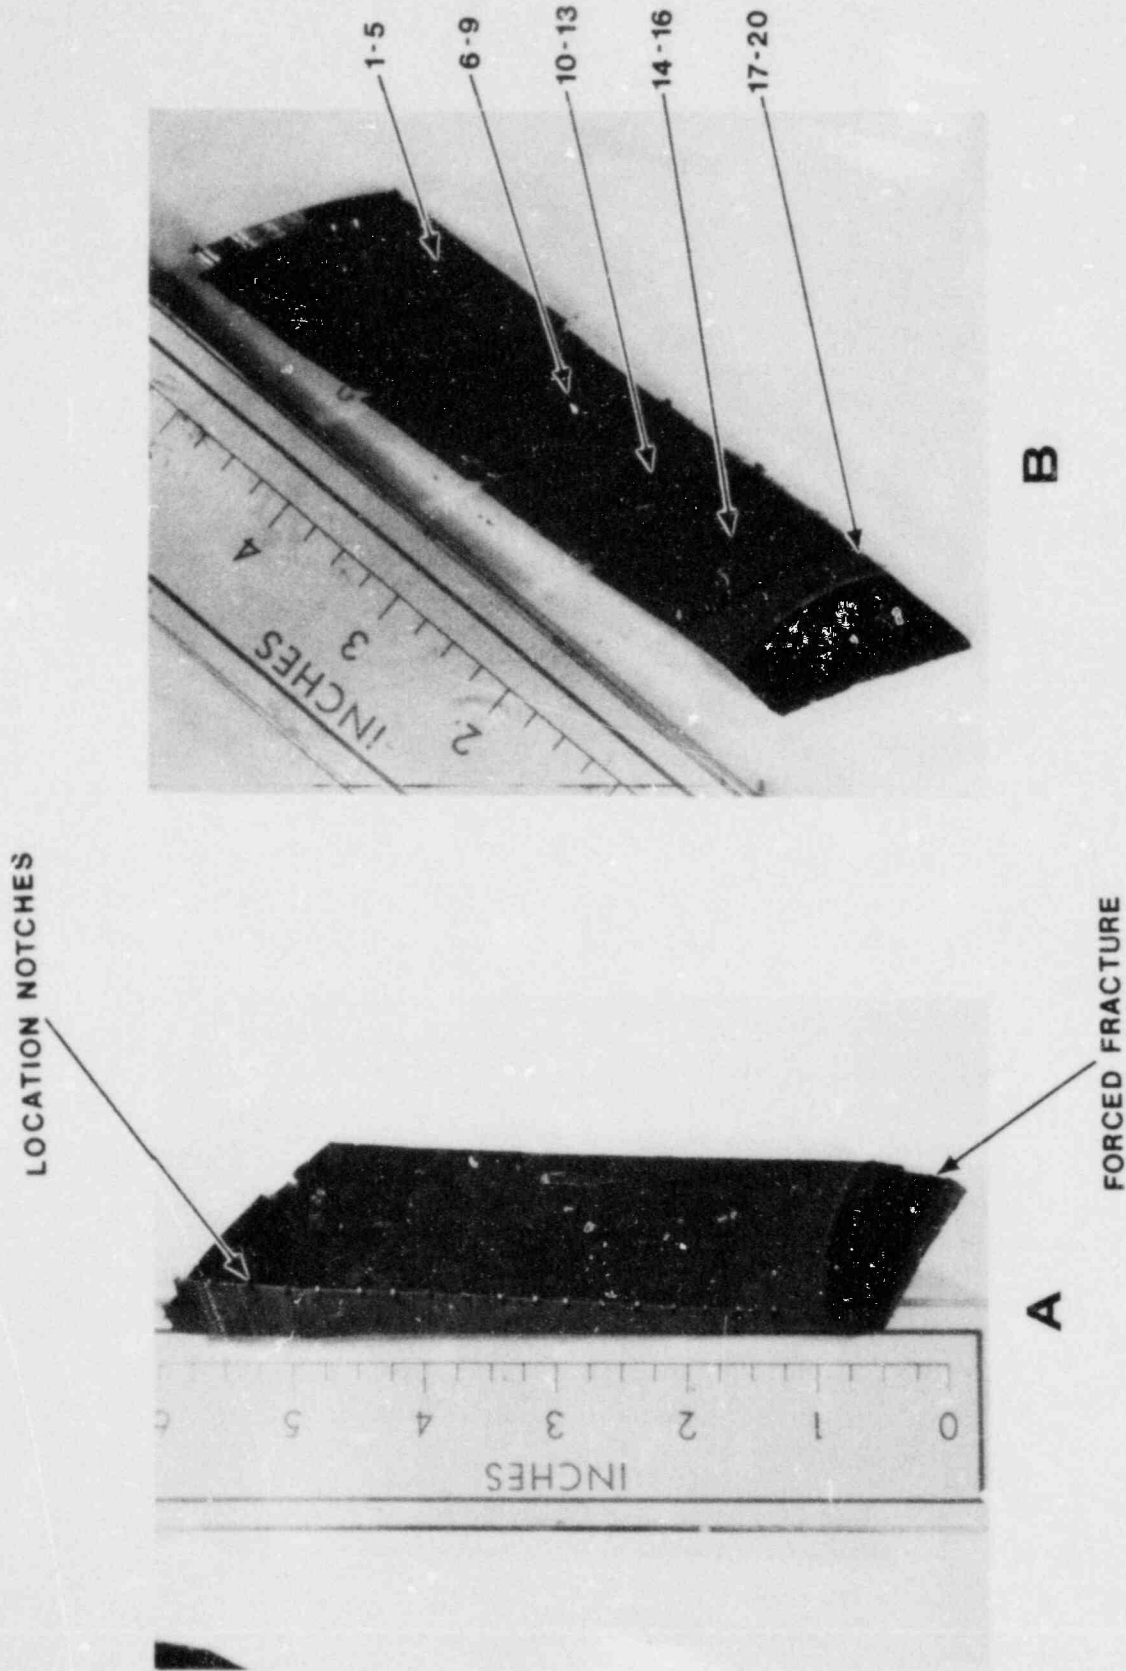
Figure 3.3-5. Specimen BIAI Preparation for Examination
A. Notches Placed Every $\frac{1}{4}$ " at Edge
B. Subdivision Into Fractography Specimens

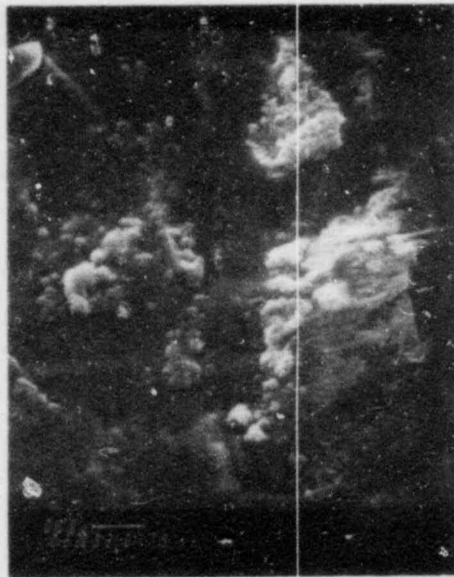
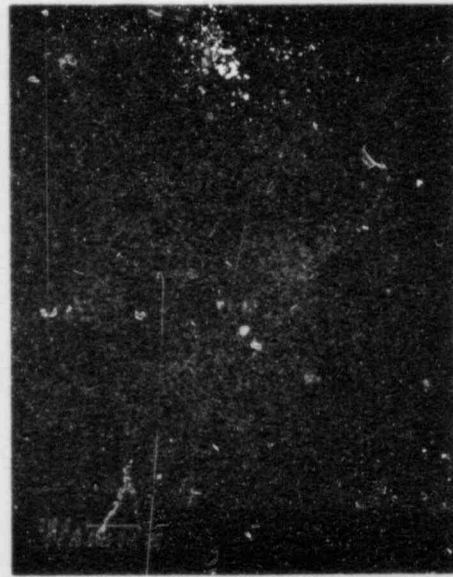
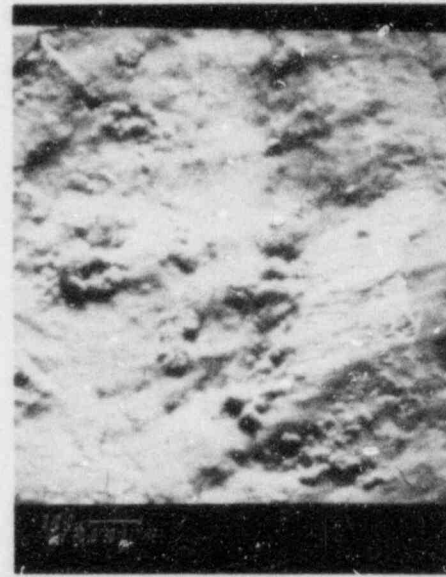
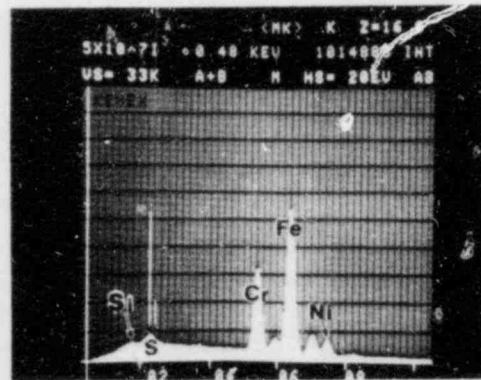
Figure 3.3-7. Typical Surface Film Structure in Specimen 1-5
A. Secondary Electron Image, B. Sulphur Dot Map
C. Backscatter Electron Image, D. EDS Spectrum of Film

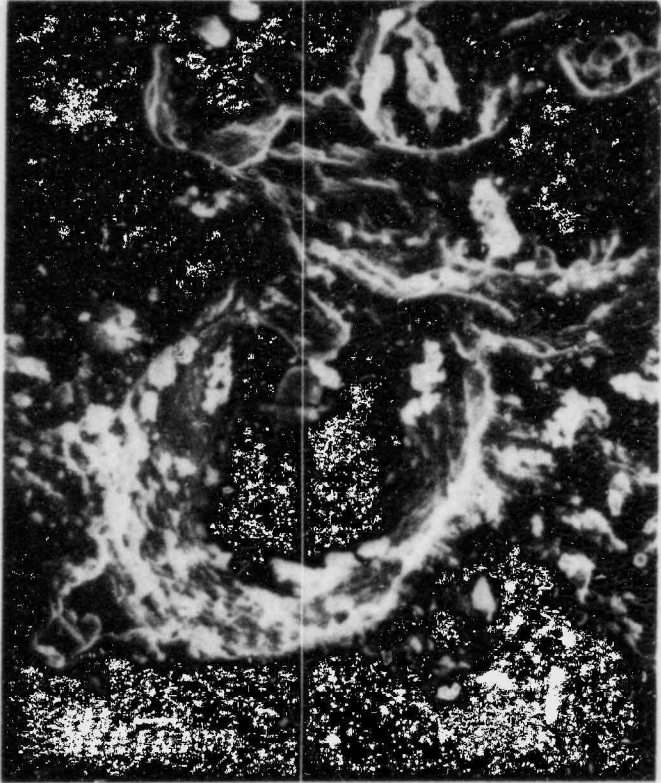
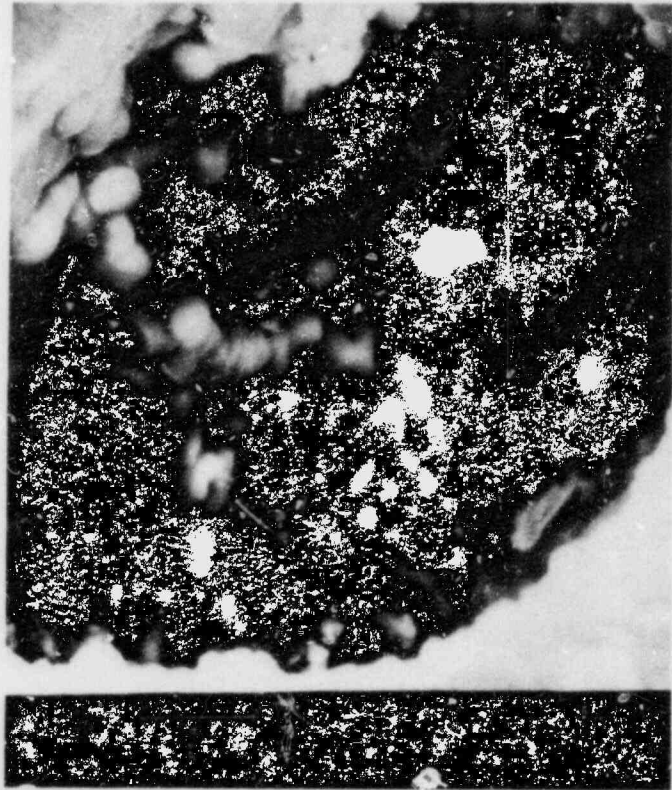
Figure 3.3-9. Appearance of Pits at Beachmark #15 Prior to Cleaning

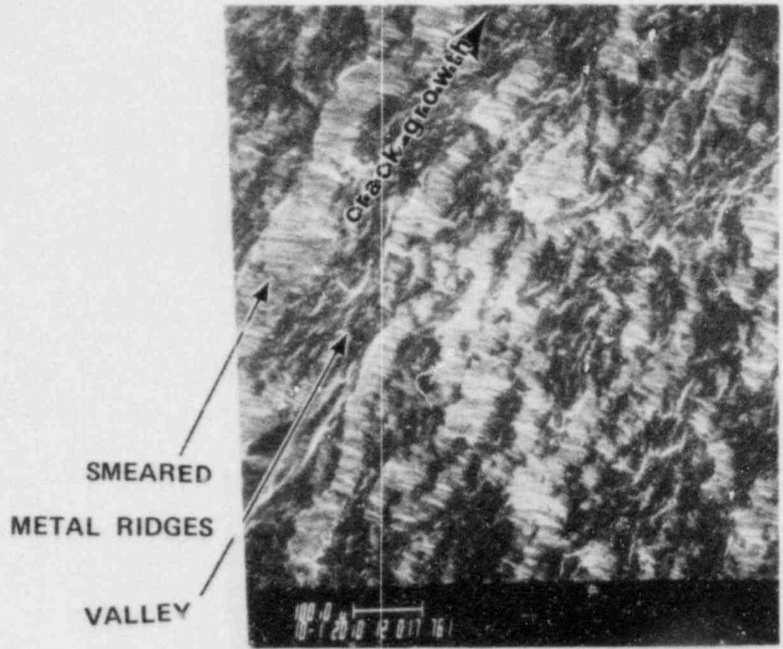
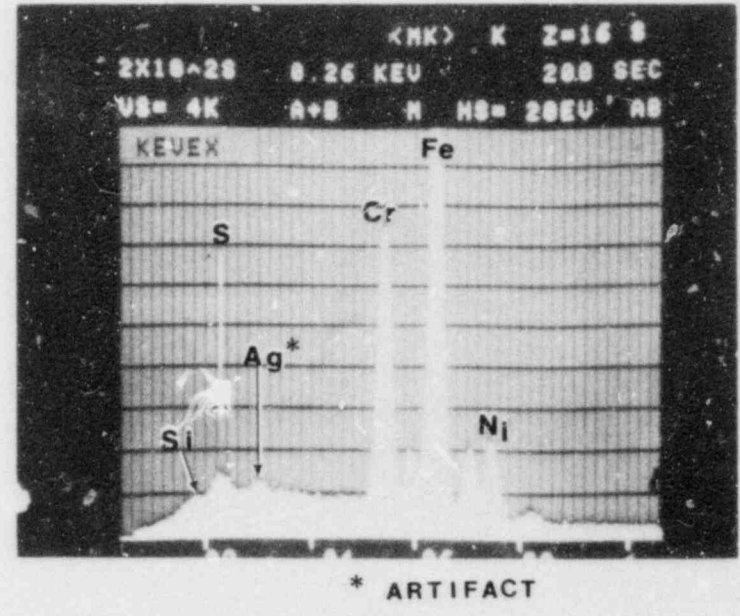
Figure 3.3-10. Ridge and Valley Structure on Specimen 6-9. Examination Prior to Cleaning, Overall EDS Spectrum Showing Sulphur

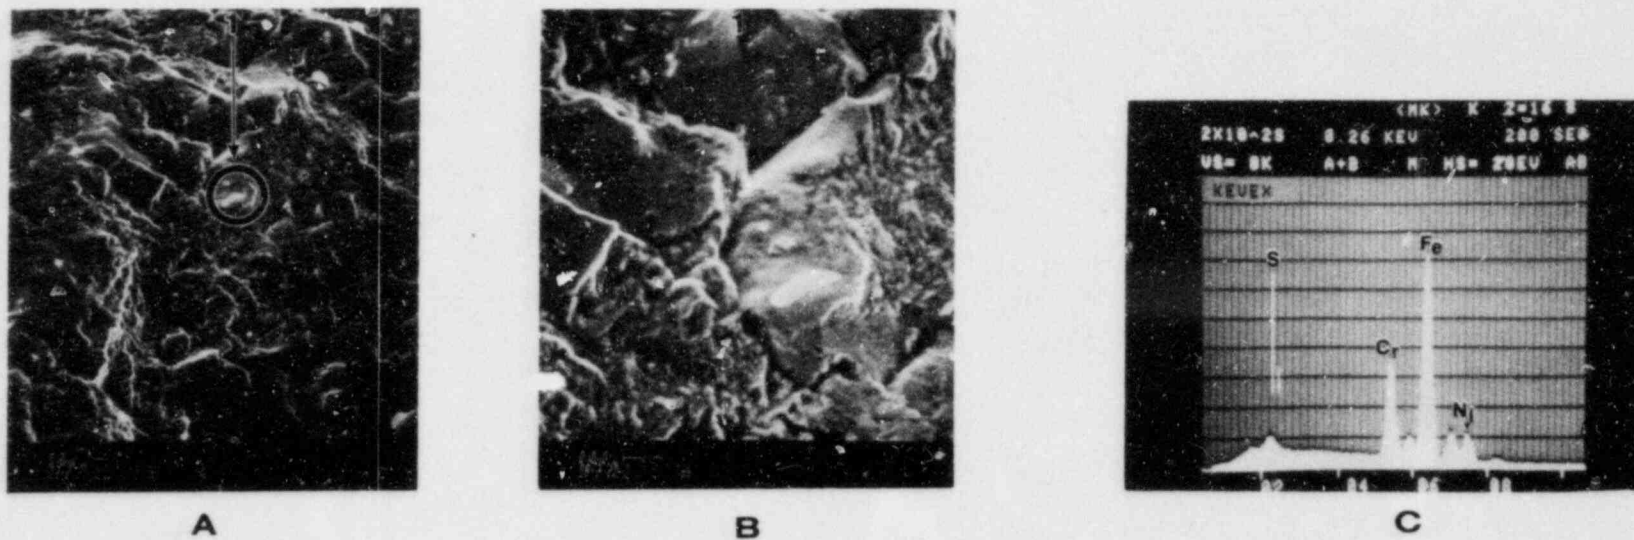
2.553	10-13-1	Fracture Detail A	18-020 to -025 Montage	17-916 to -919 Detail	0.12-0.15	Generally same topography as in 6-9, but less smearing and possibly less relief. Some fine feathery fractography at high magnification.

2.672	10-13-2	Fracture Detail B	18-026 to -030 Montage	17-920 to -925 Detail	0.12-0.16	Same as A above in 10-13-1. Also beginning to see signs of large cleavage facets or grain faces in with feathery fracture.

Figure 3.3-11. Faceted Structure in Fractographic Features of Specimen 10-13
A. General View of Facet Islands, B. Enlarged View at 1
C. EDS at Spectrum Location 1

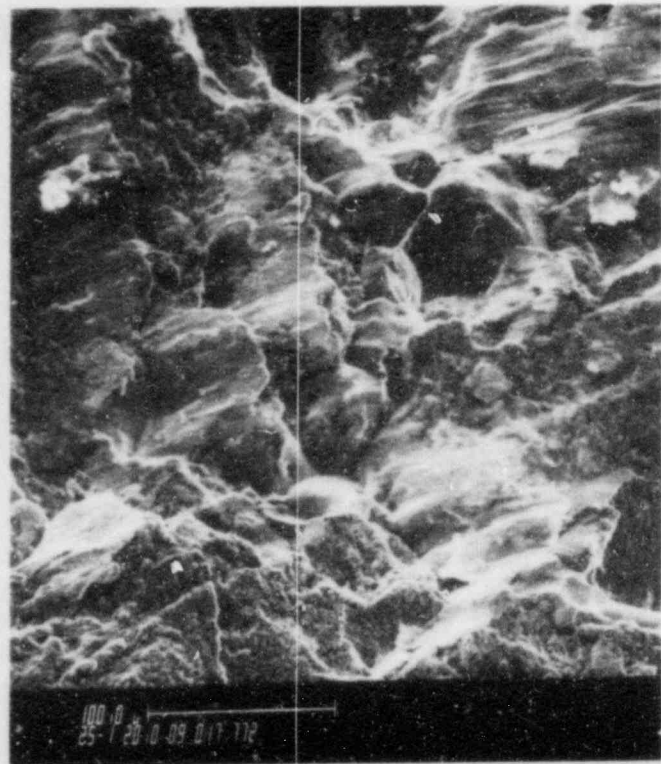
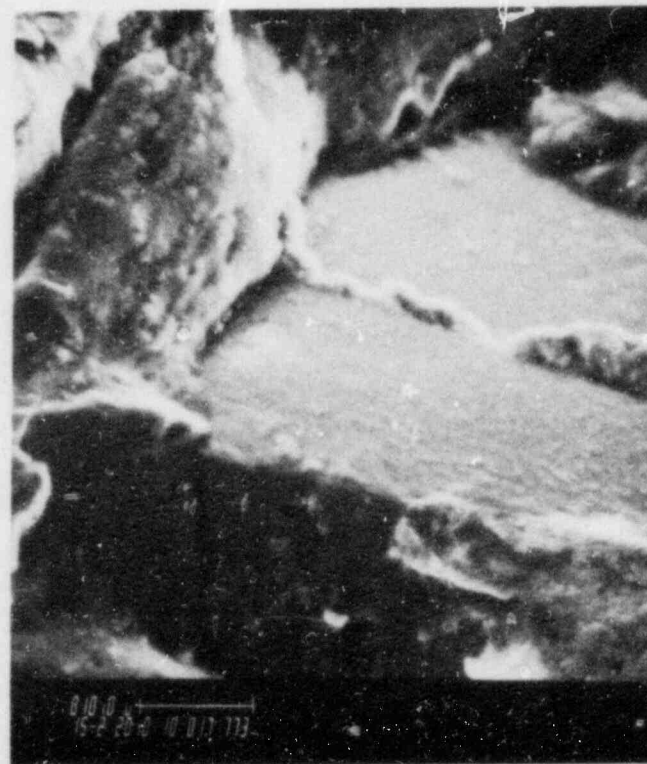
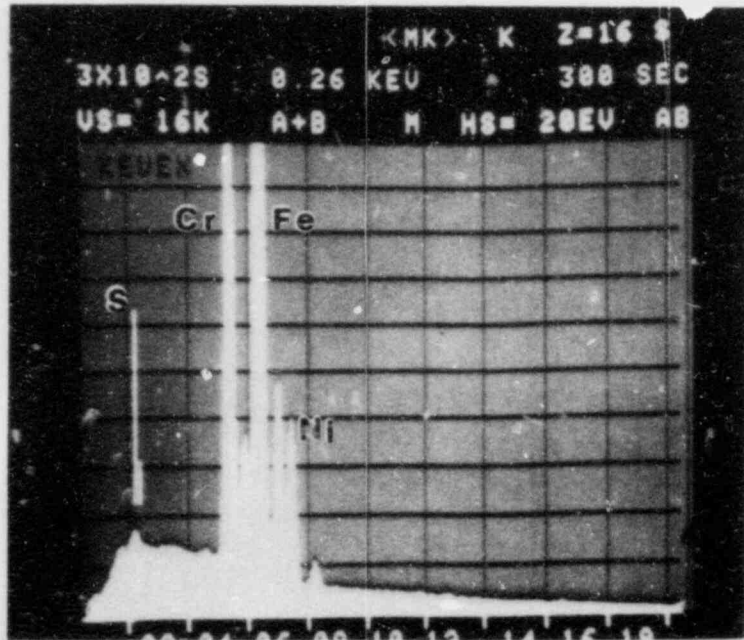
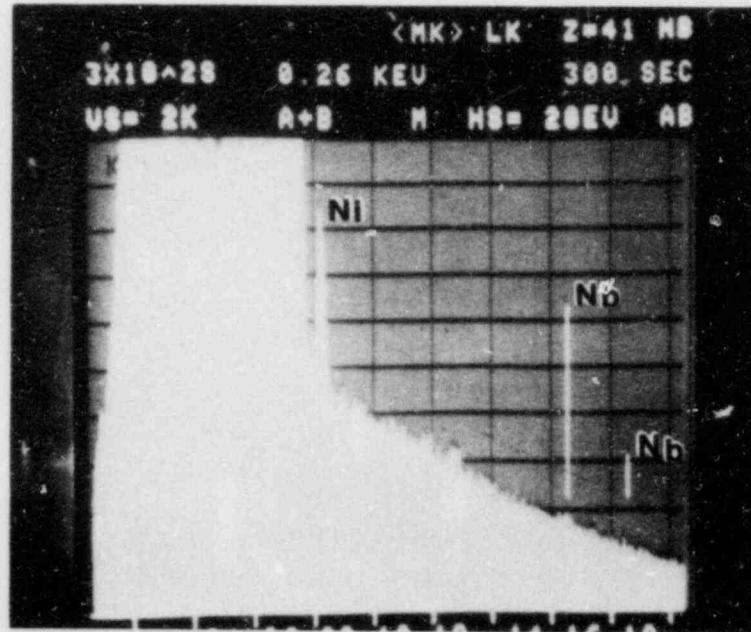
3.448	14-16	Fracture Detail A	17-898 to -900 No Montage	--	Island of IG fracture involving 9 grains. Some secondary IG cracking. Surrounded by feathery structure. Some smearing at elevated grain boundary corners. One face has coarse linear markings with a spacing of 0.6 μ . Generally more IG showing up than on 10-13.

Figure 3.3-12. Typical Faceted Structure on Specimen 14-16 Prior to Cleaning. A and B are General Views. C and D are EDS Spectra of B

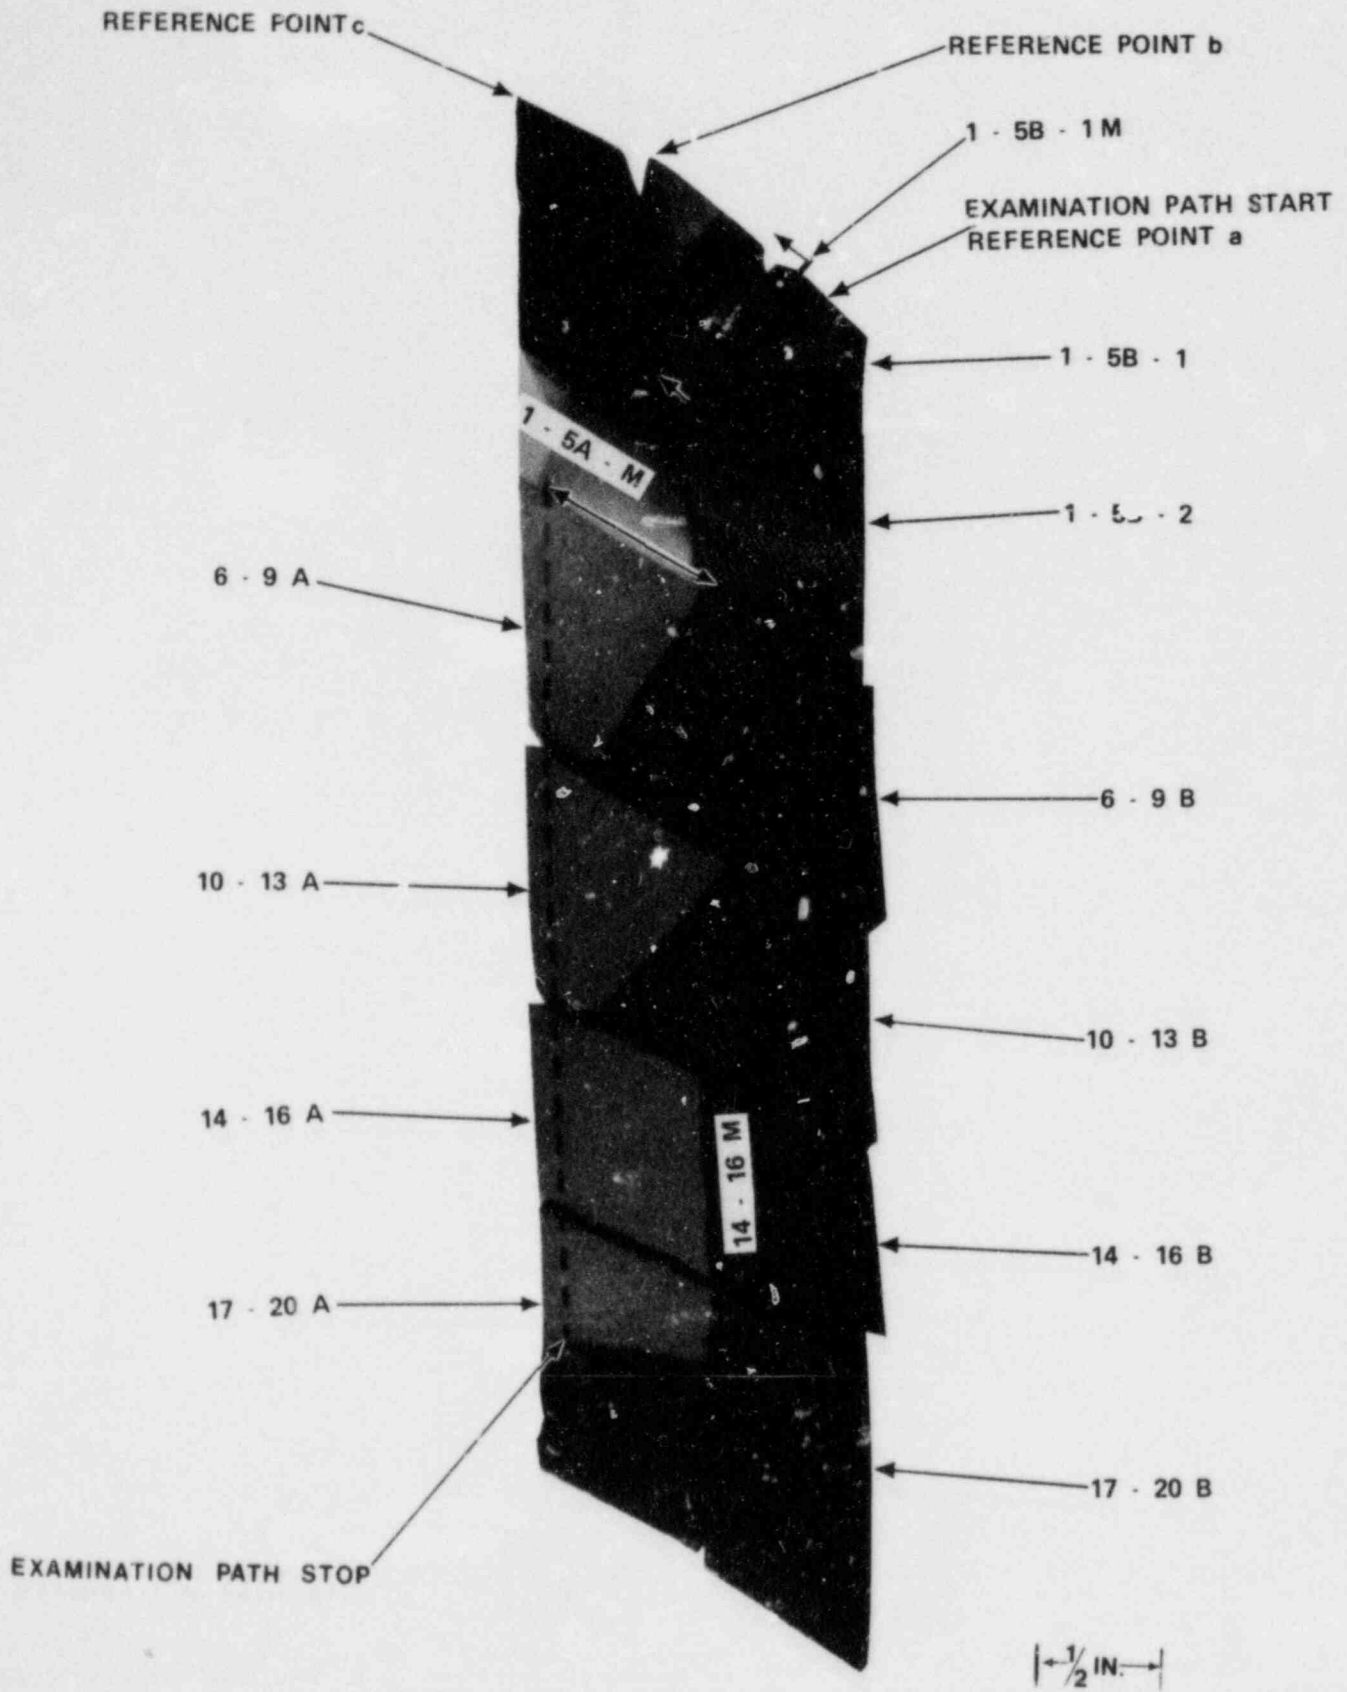
Figure 3.3-14. Section B1A1 Reconstructed From Individual Specimens

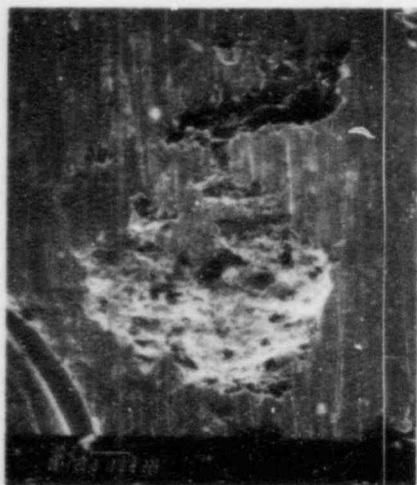
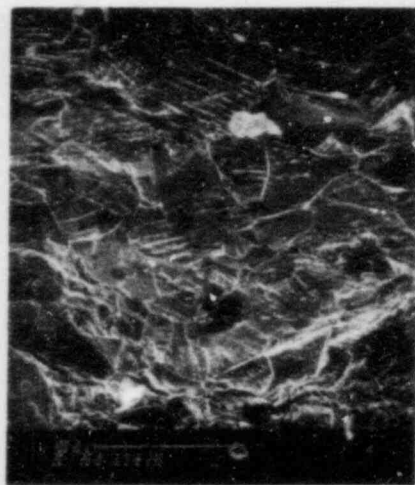
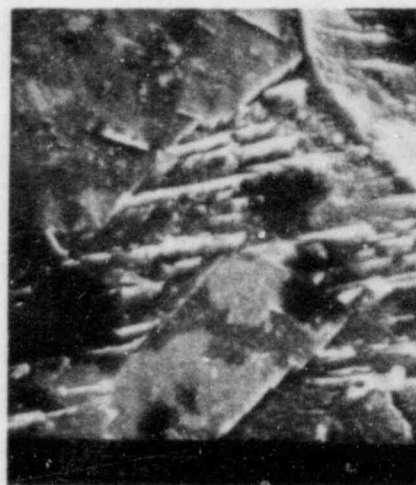
Figure 3.3-16. Typical Pit Structure Seen Near Cracked Pin Hole on Shaft Outer Surface. Views A, B, C Show Structure at Increasing Magnification

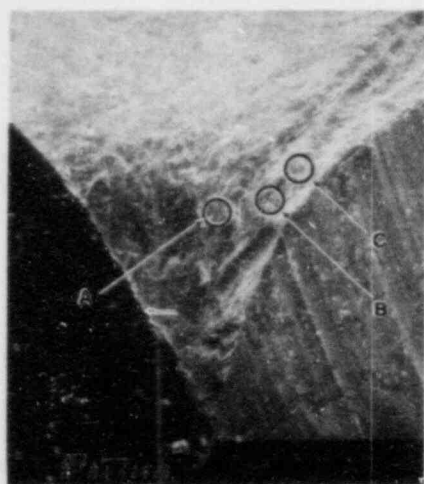
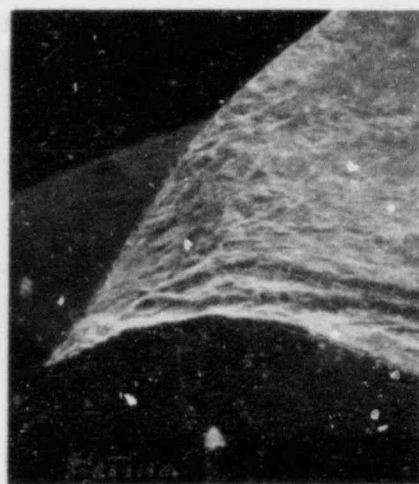
Figure 3.3-18. SEM Photomicrographs of Initiation Site from Different Angles
