TMI-1 REACTOR COOLANT PUMP SHAFT FAILURE ANALYSIS

RESEARCH AND DEVELOPMENT DIVISION
LYNCHBURG RESEARCH CENTER

SPONSORED BY
GENERAL PUBLIC UTILITIES

Lynchburg Research Center Report
RDD:84:5183-06:01

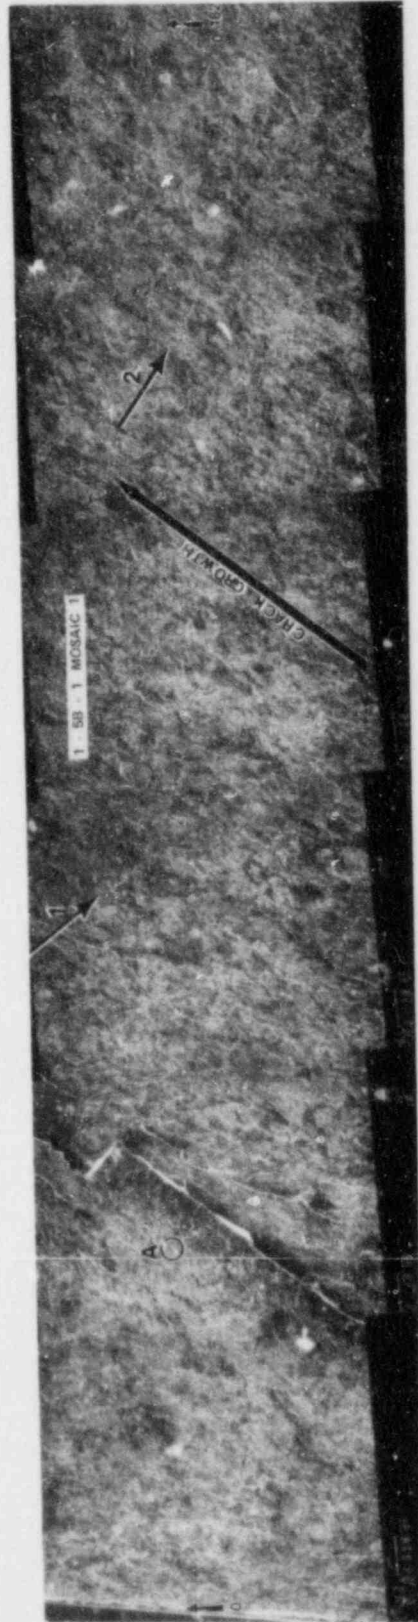
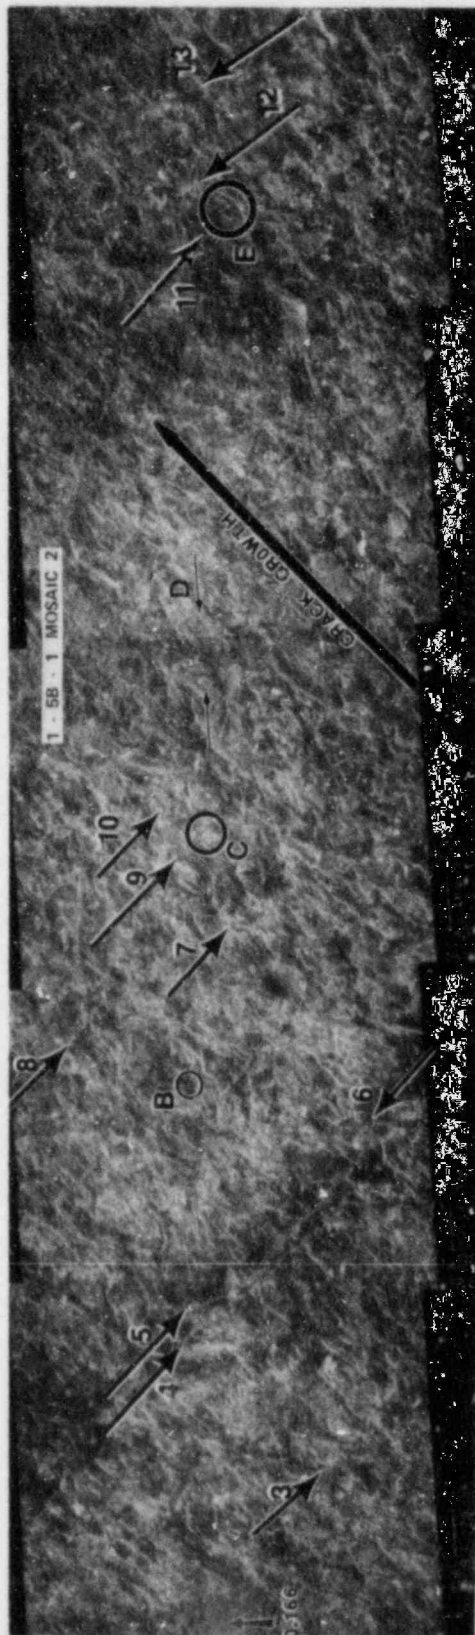
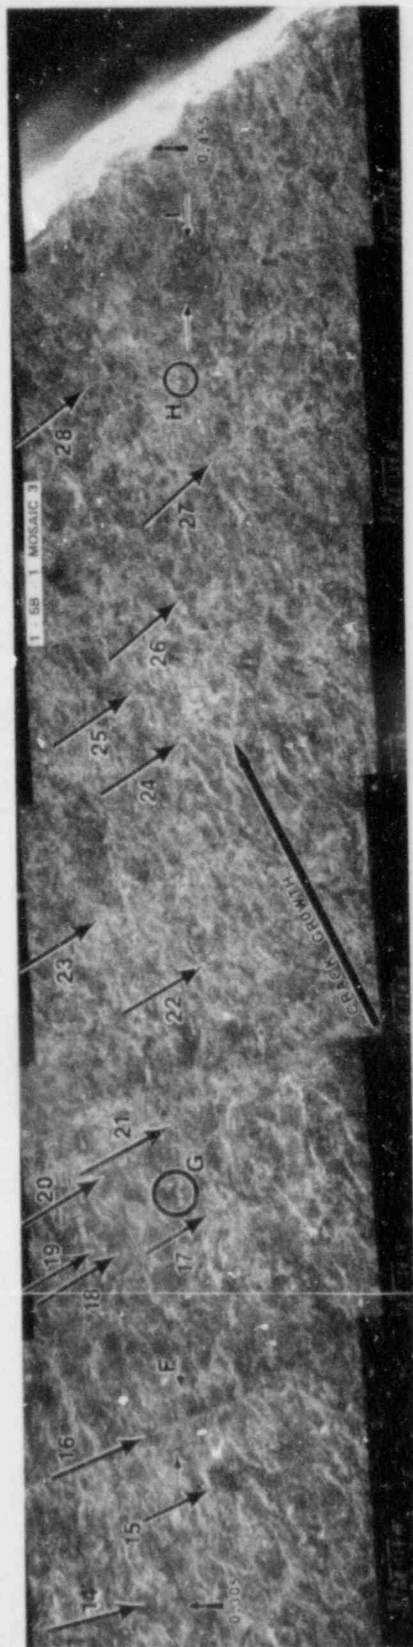
Distance From Surface Reference Points, inches	Specimen	Fracture Surface Feature			Striation Spacing, μ	Comments
		Type	Label	Photo		
1.514	1-58-1	Beachmark	#61	18-263, -264	--	Corresponds to beachmark #19 on light microscopy color montage (initiation). Fracture becomes somewhat finer, smearing and much less corrosion product adherence.

Figure 3.3-21. SEM Photomontage of Specimen 1-58-1

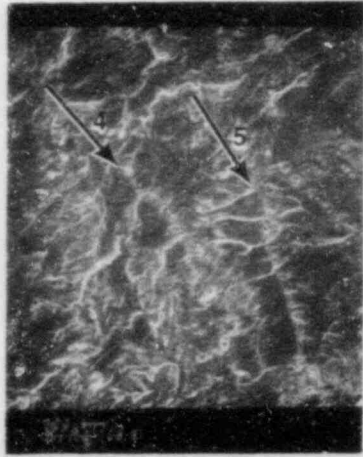
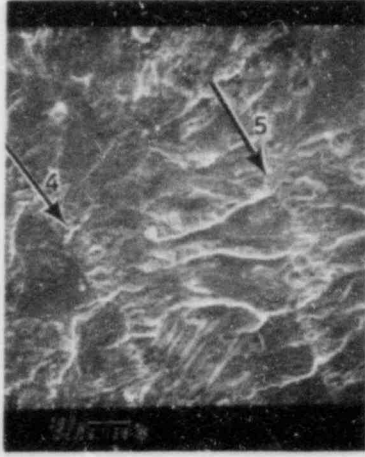
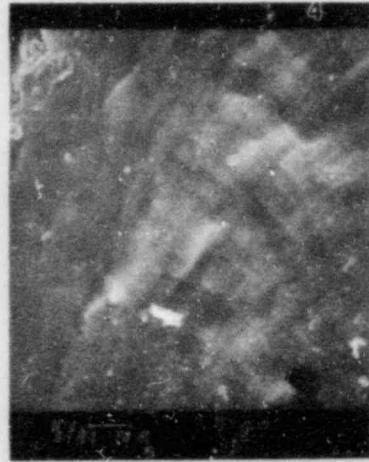
Figure 3.3-22. Typical Fractography Features on Specimen 1-5B-1. Letters and Numbers on Photomicrographs Refer to Previous SEM Montage

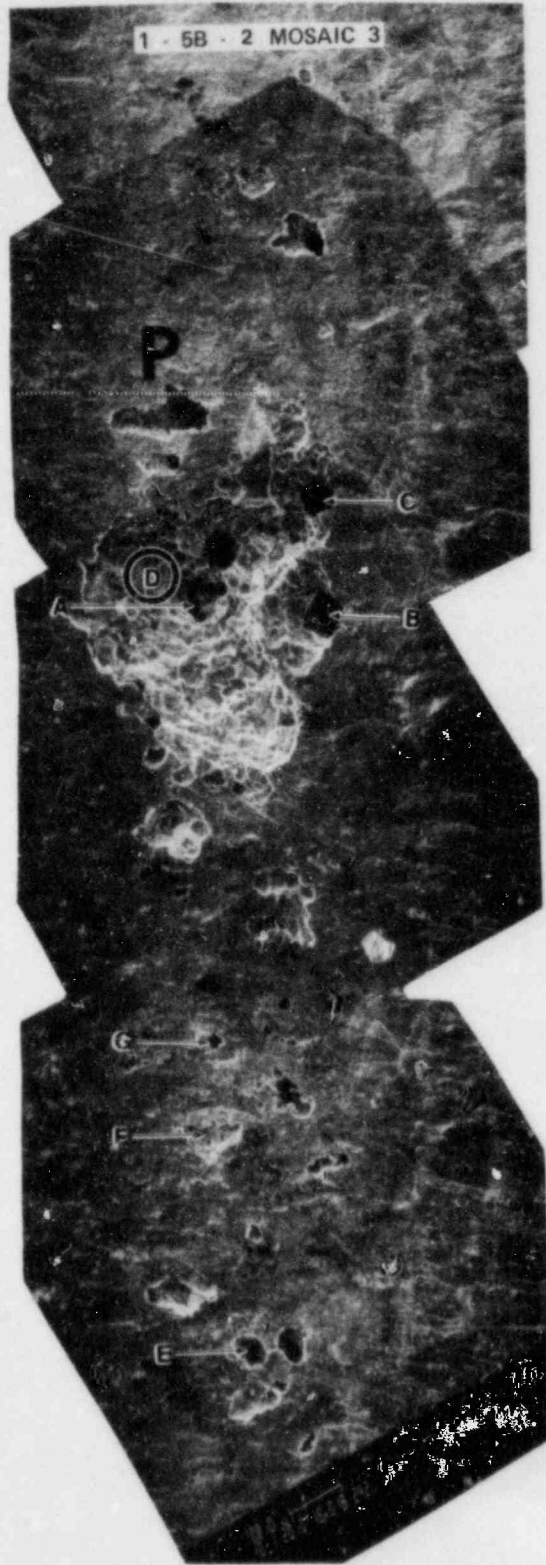
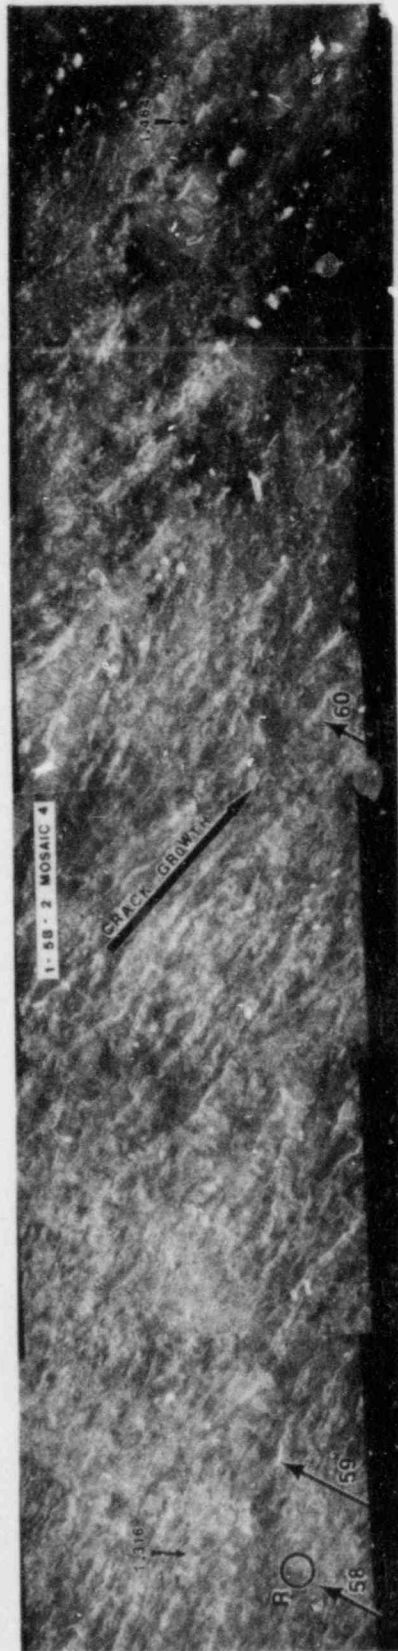
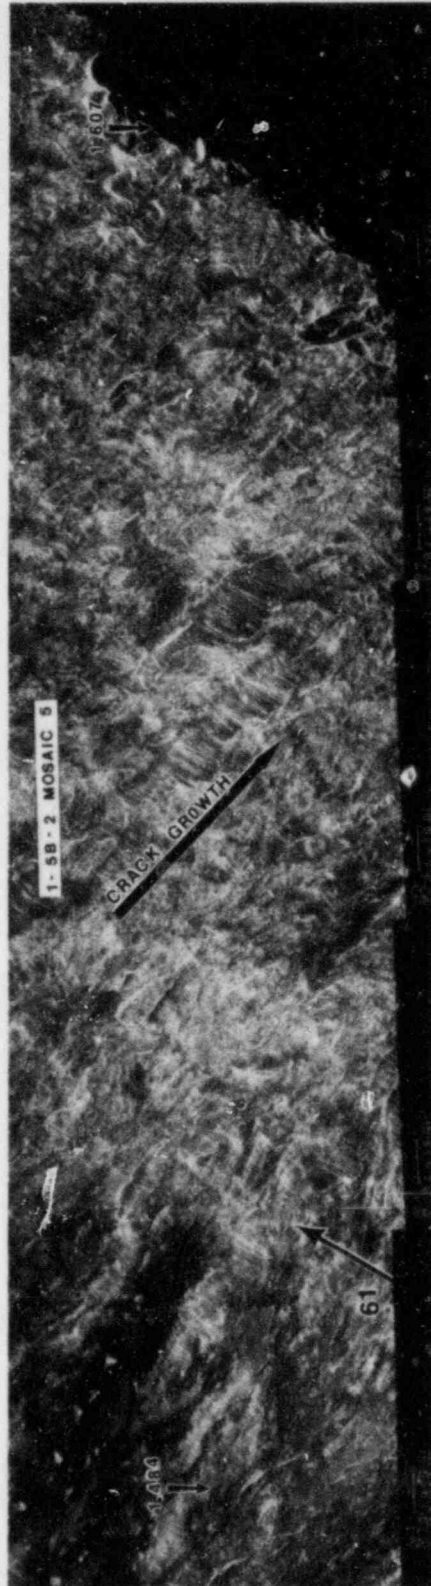
Figure 3.3-24. SEM Photomontages of Fracture Along Line M-M on Specimen 1-5B-2
A. Montage 1, B. Montage 2, C. Montage 3, Pitting Near P on Montage 2, D. Montage 4, E. Montage 5

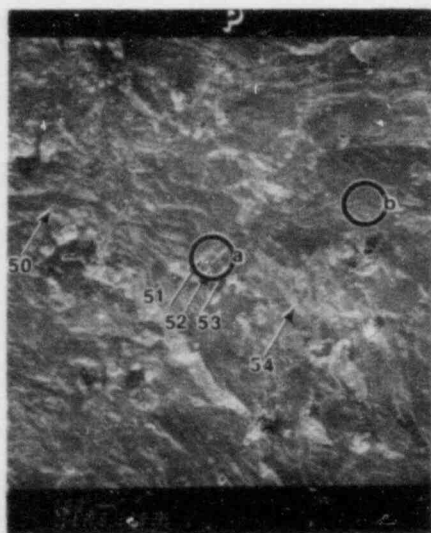
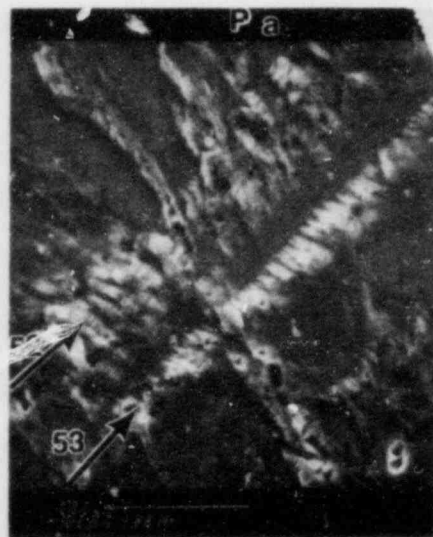
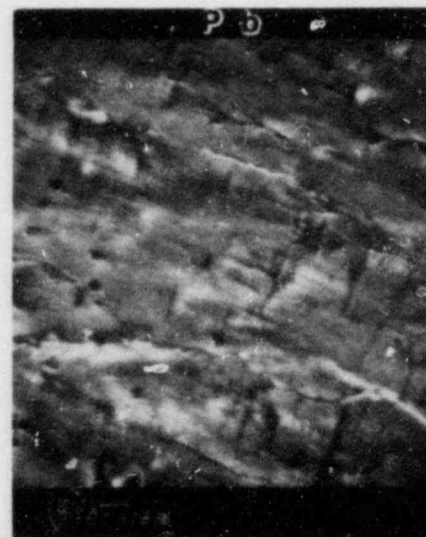
Figure 3.3-25. Typical Fracture Features
in 1-5B-2 at Location P

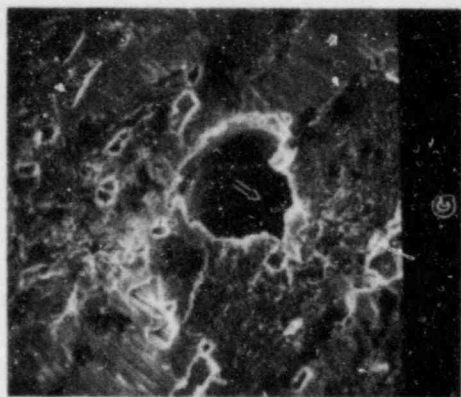
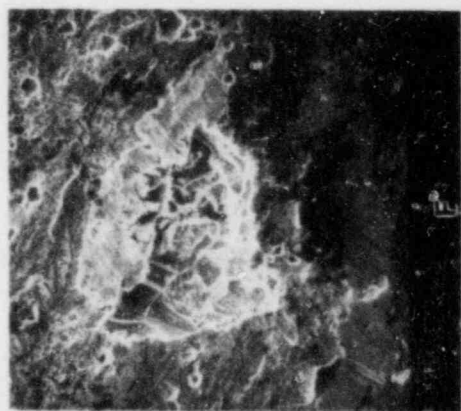
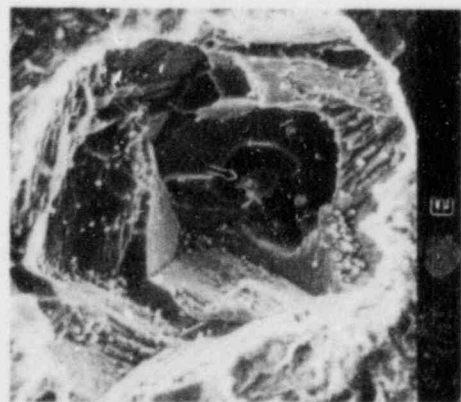
Figure 3.3-26. Typical Structure Inside Pits in Specimen 1-5B-2.
Arrows Show Inclusions or Inclusion Sites

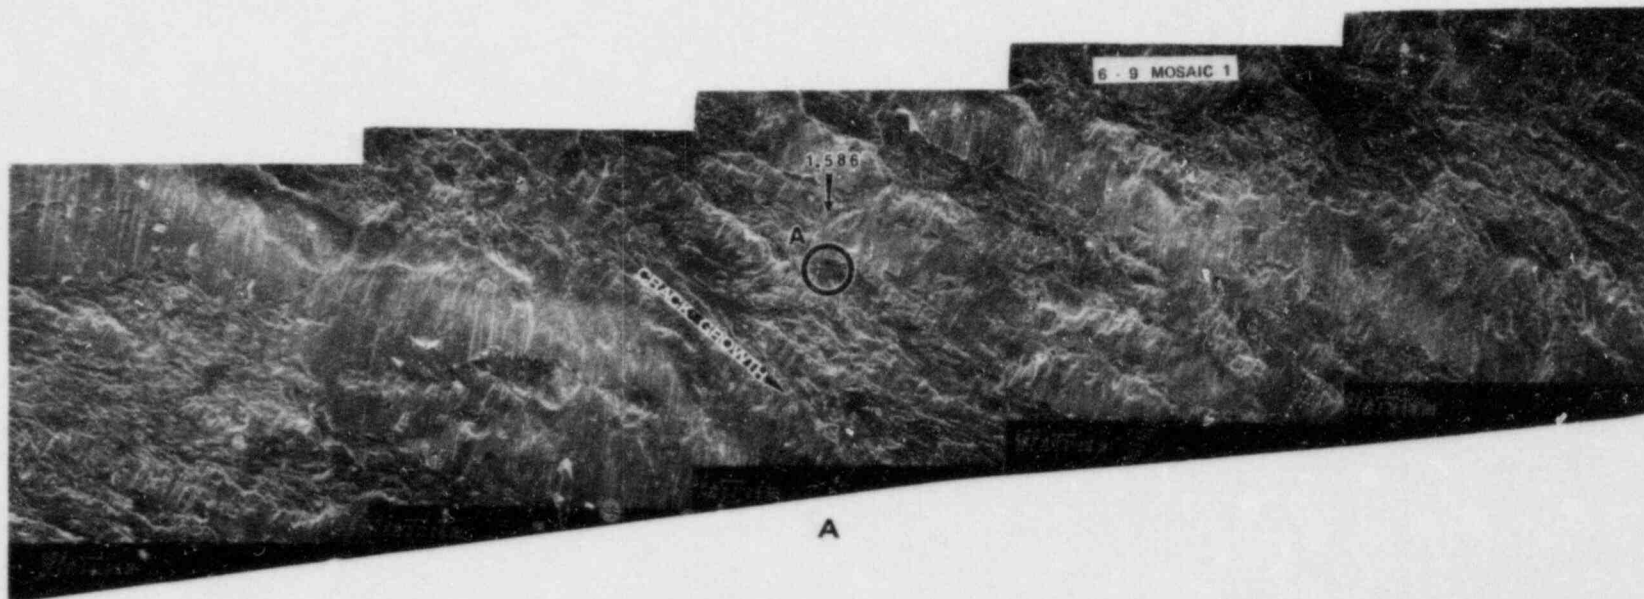
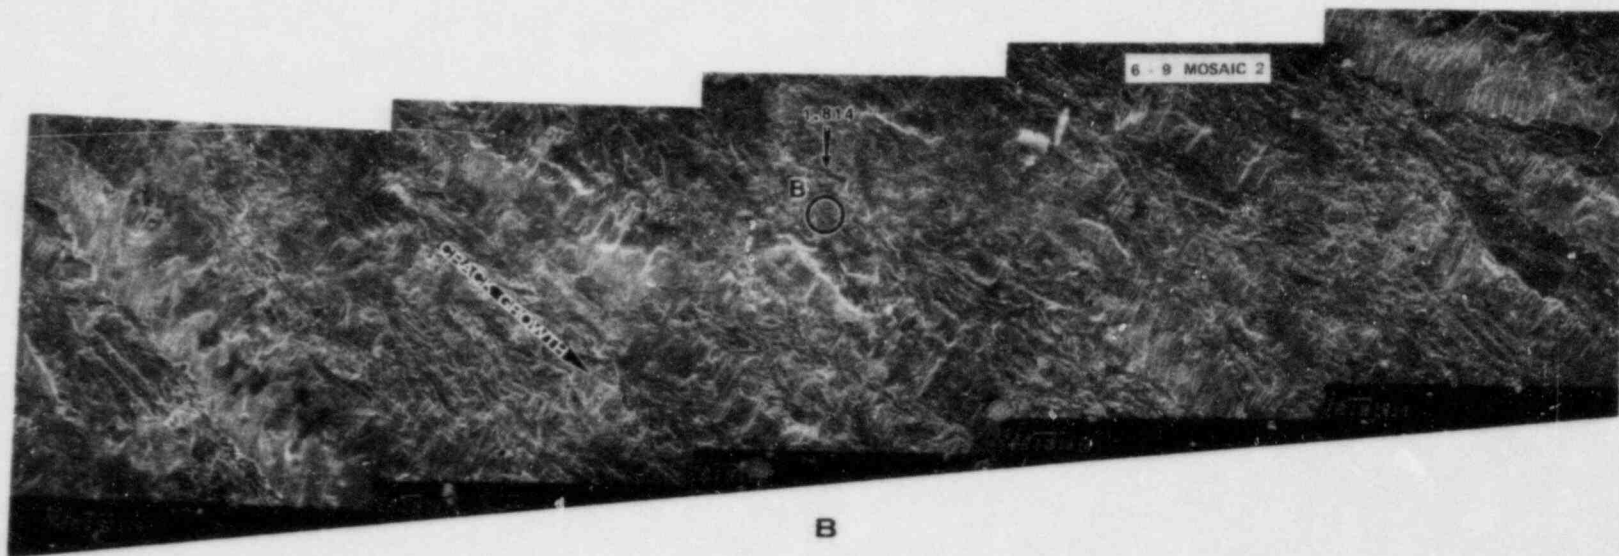
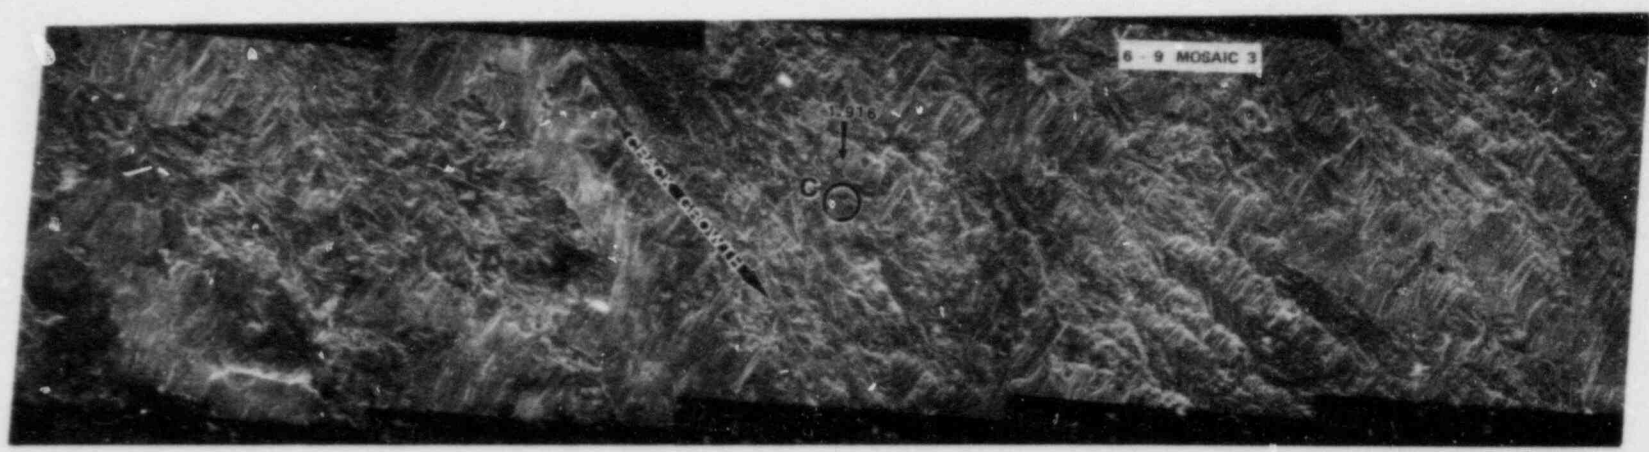
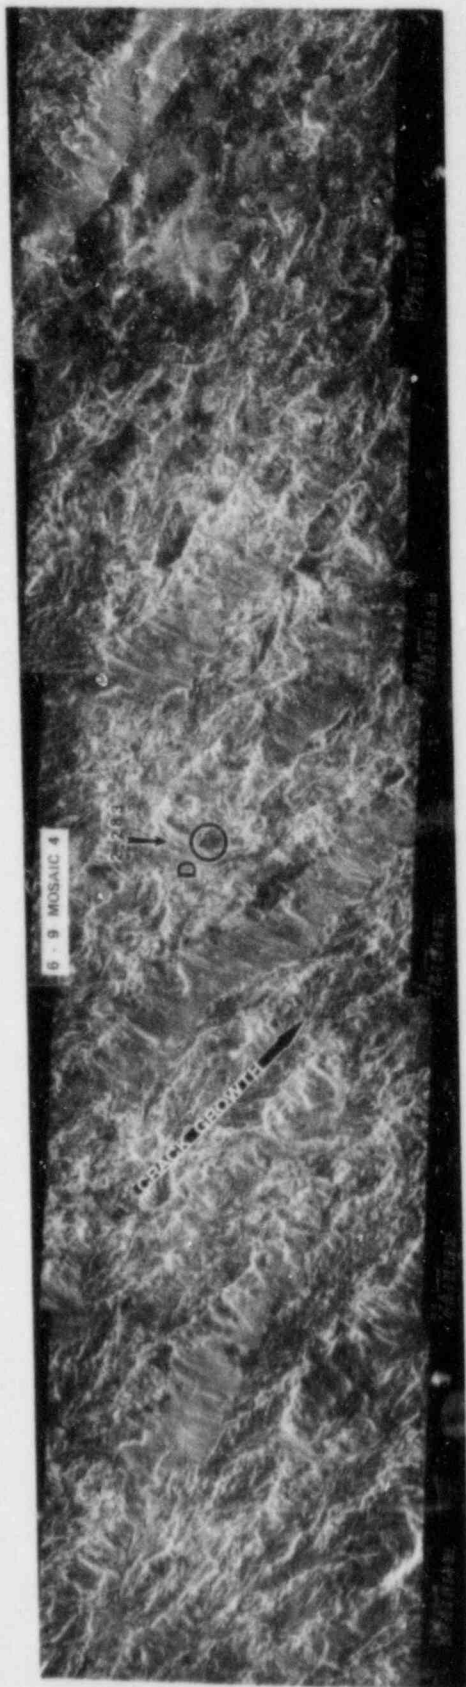
Figure 3.3-27. SEM Photomontages of Typical Fracture Structures Observed on Specimen 6-9
A. Montage 1, B. Montage 2
C. Montage 3, D. Montage 4

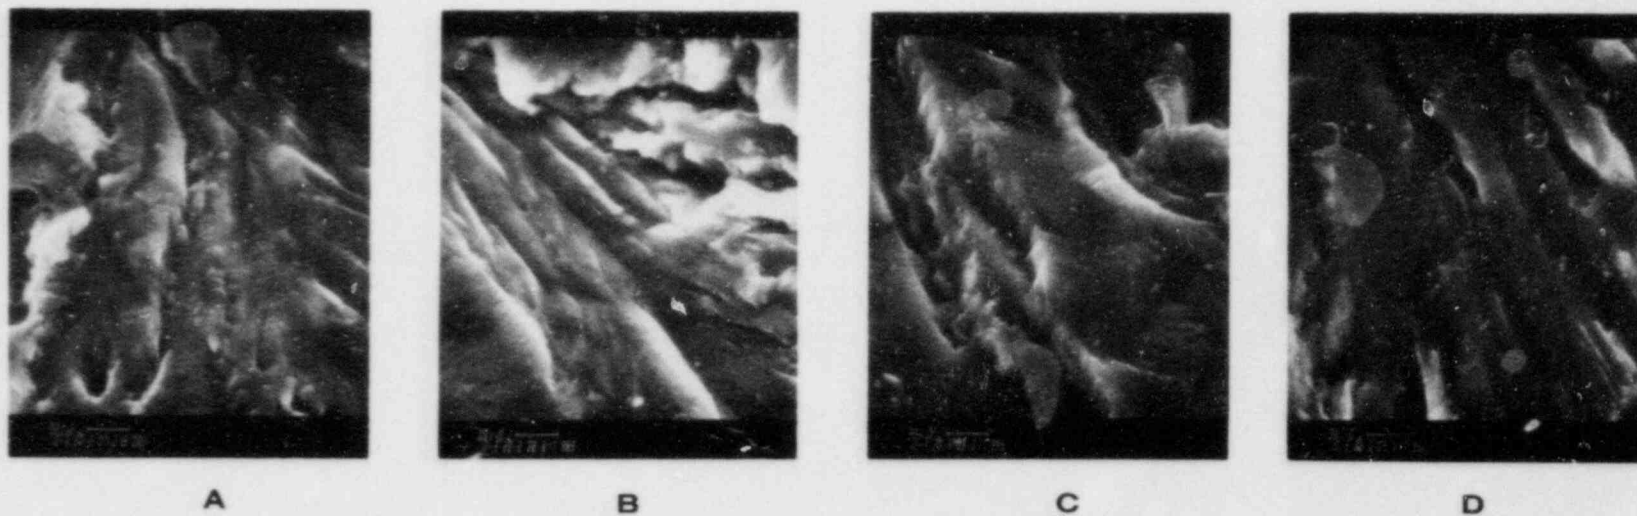
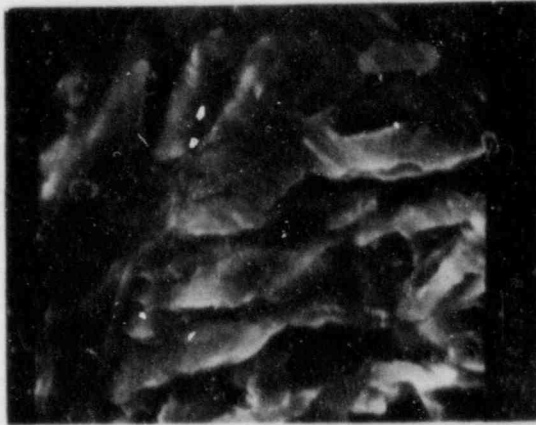
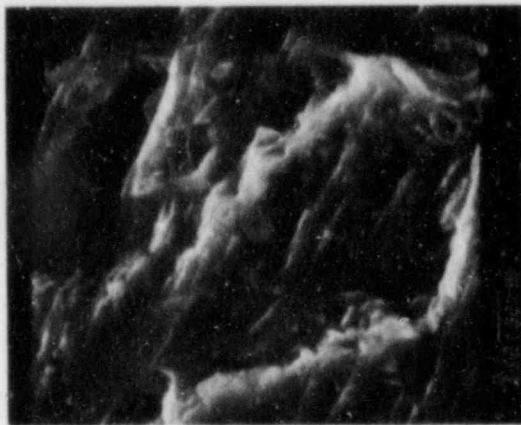
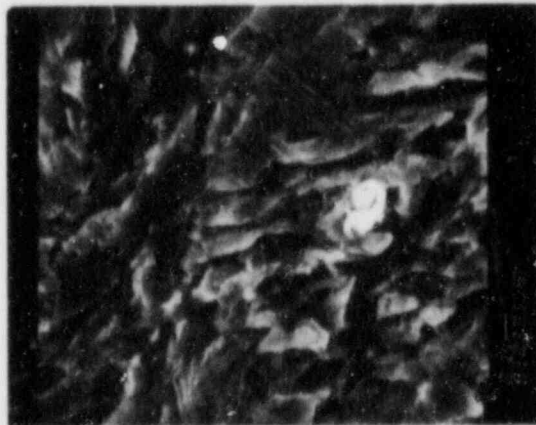
Figure 3.3-28. Typical Fractographic Features of Specimen 6-9 Viewed at High Magnification. Views A Through D Are Located on Previous Lower Magnification Montage of Specimen 6-9

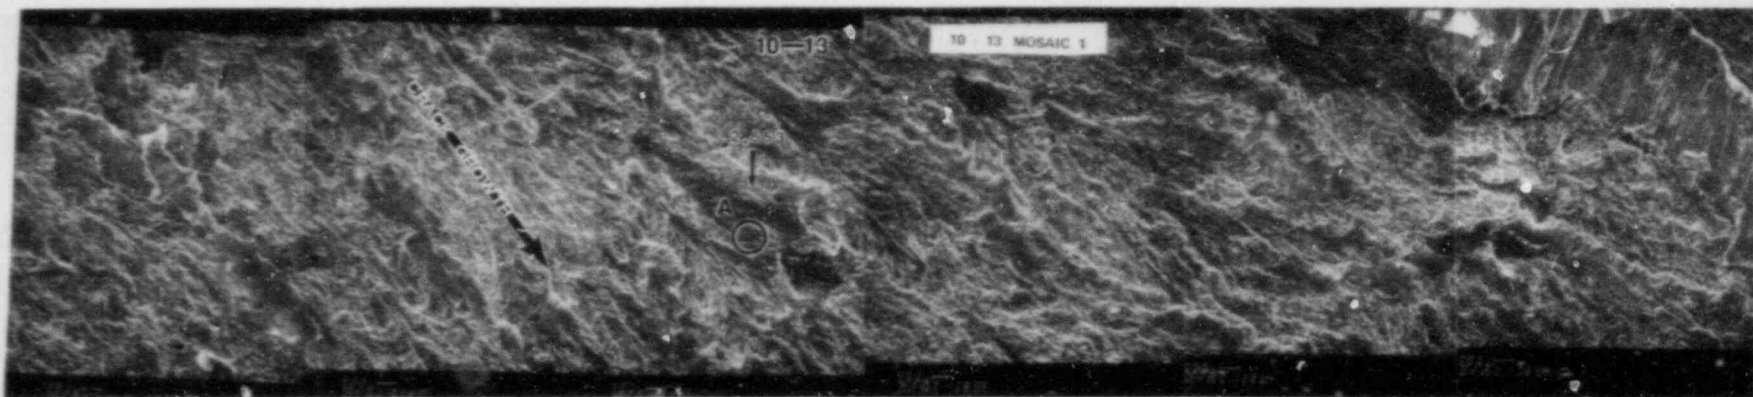
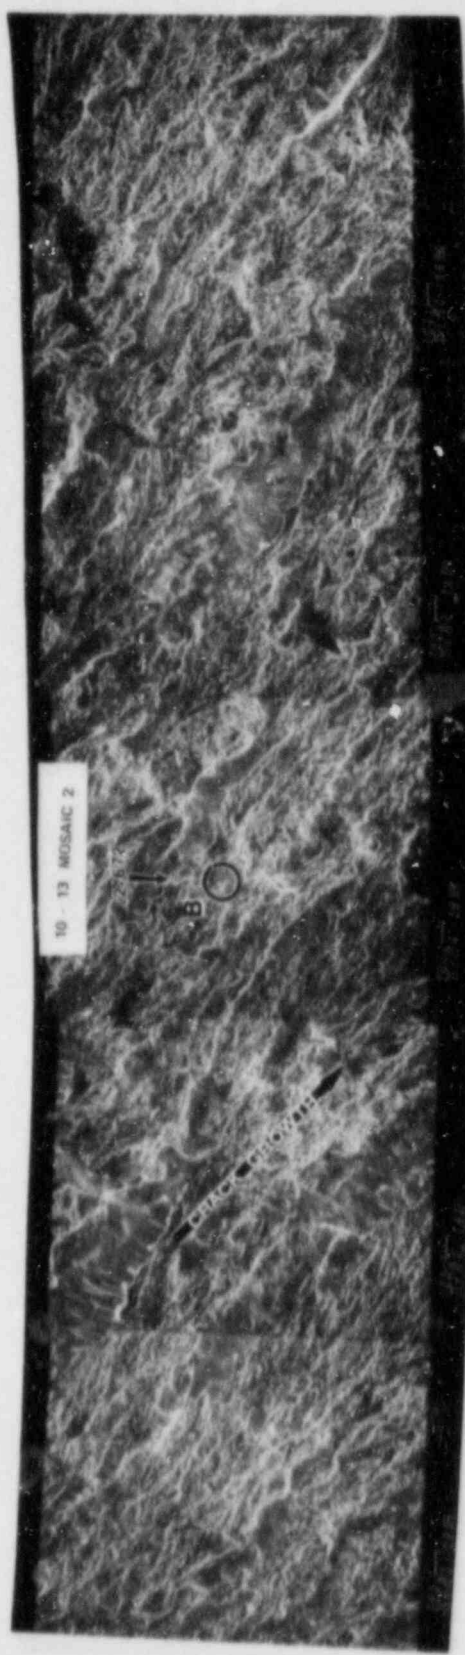
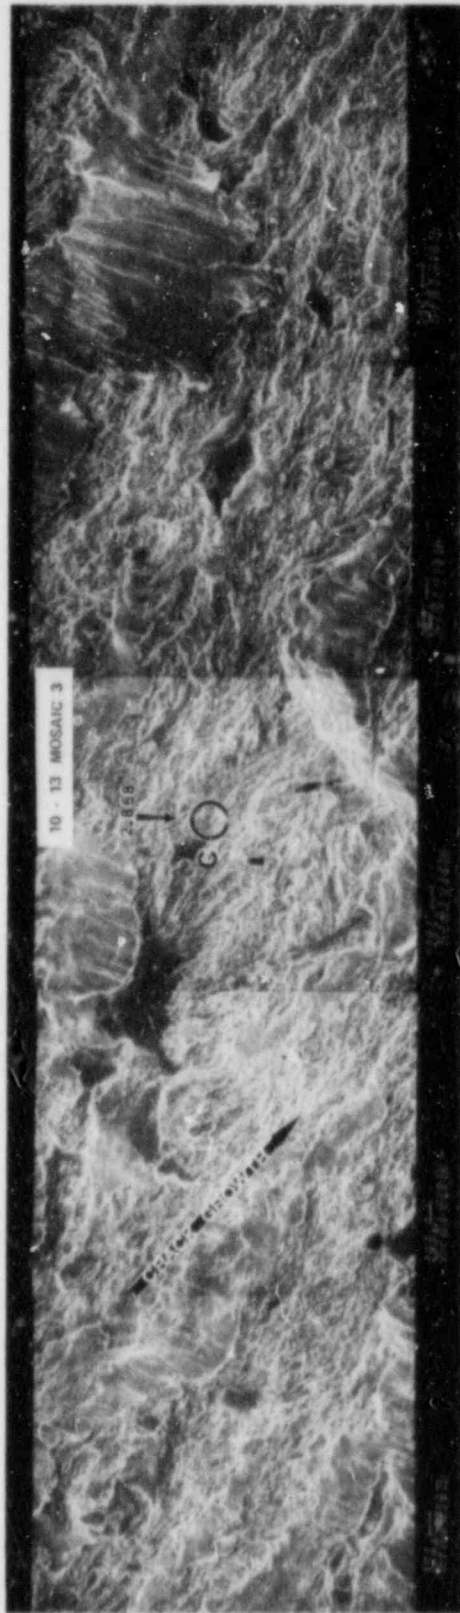
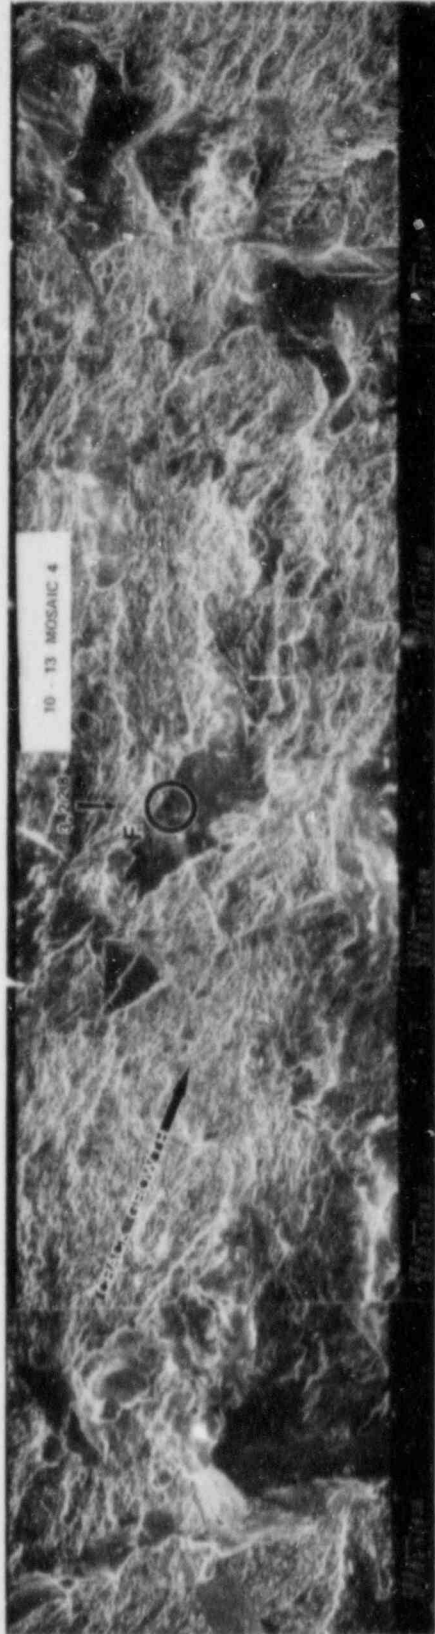
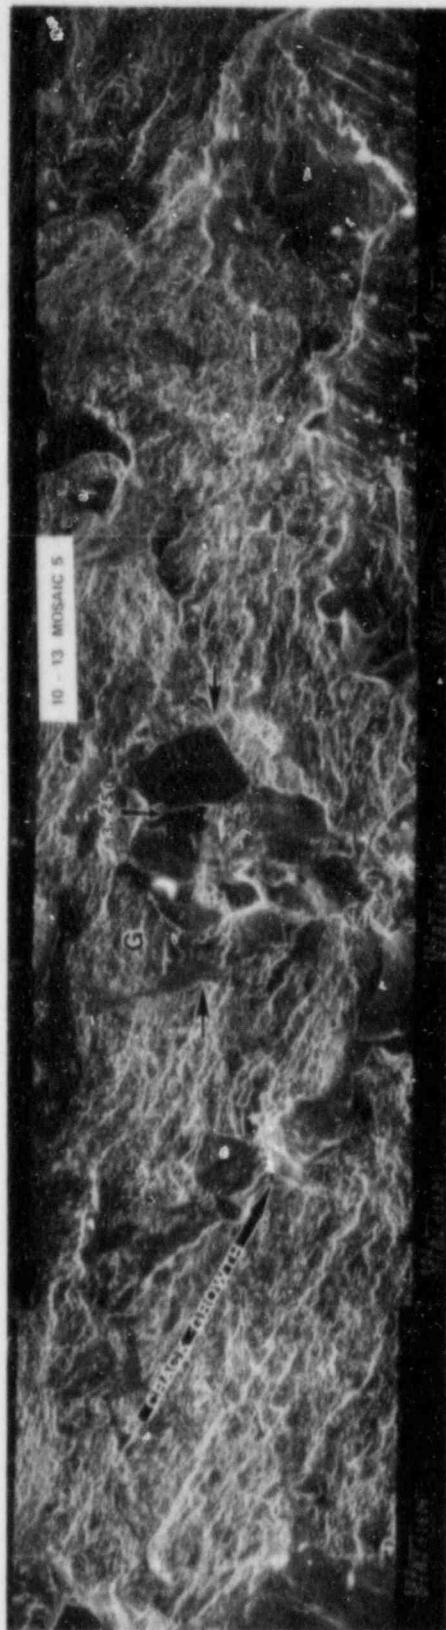
Figure 3.3-29. SEM Photomontages of Typical Fracture Structure Observed on Specimen 10-13
A. Montage 1, B. Montage 2
C. Montage 3, D. Montage 4
E. Montage 5

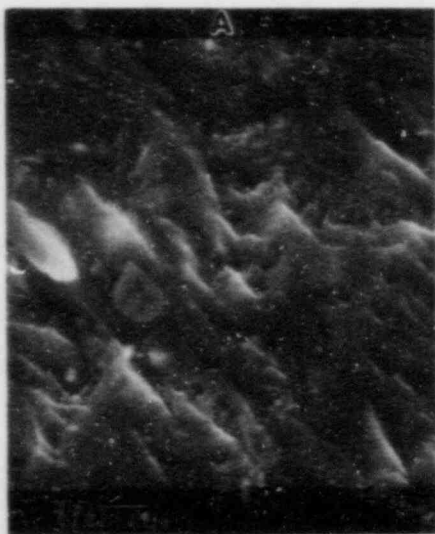
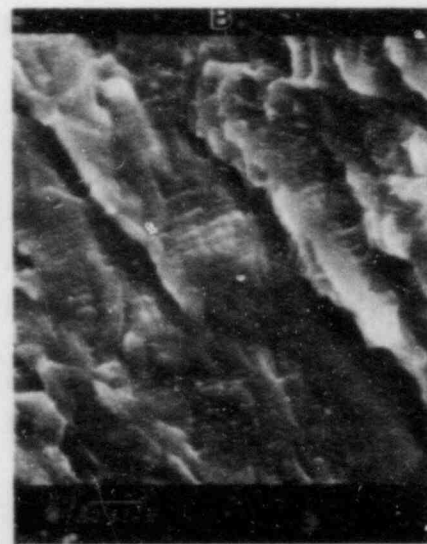
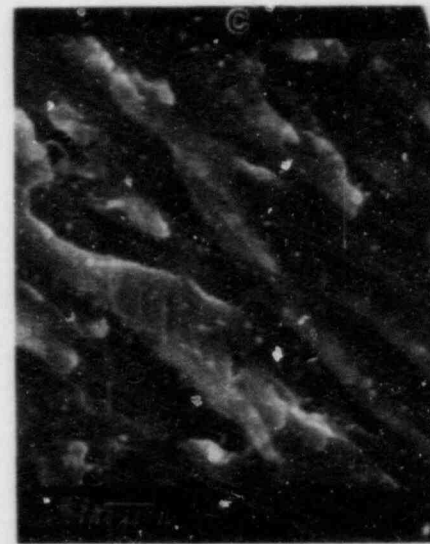
Figure 3.3-30. High Magnification SEM Photomicrographs of Fine Transgranular Fracture With Faint Striations in Specimen 10-13. Views Are at Locations A, B, and C of Previous Mosaic

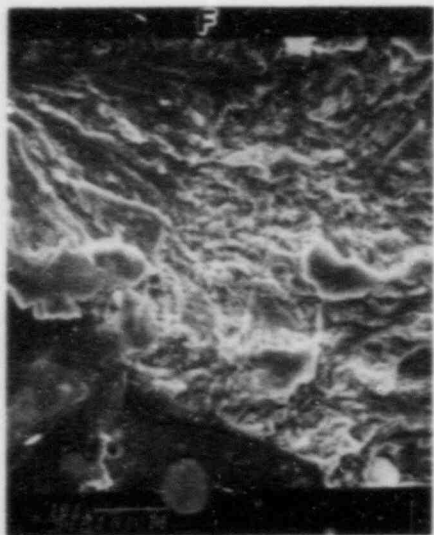
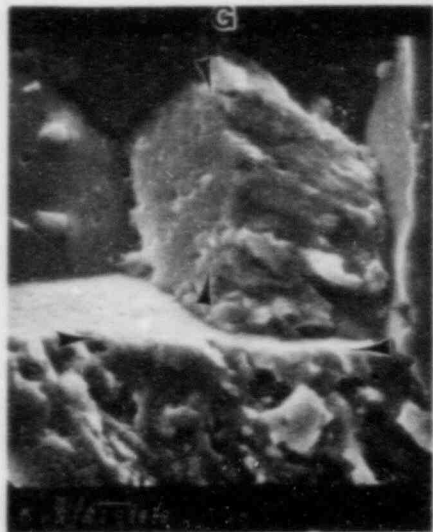
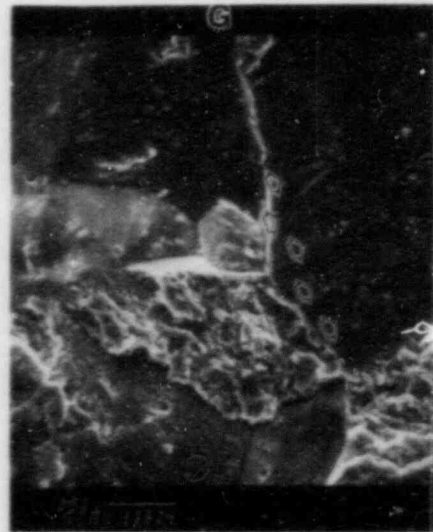
Figure 3.3-31. Typical Mixed Mode Fractography Seen on Specimen 10-13. Letter at Top of Photo Refer to Location on Previous Montage). Cleavage and Intergranular Separation Facets Occur in Colonies Surround by a Fine Transgranular Structure. A. Intergranular Separation, Enlarged in B, C. Intergranular Separation, Enlarged in D

E,F. Intergranular, Plus Some Cleavage
G. Enlarged View of F Showing Possible
Crack Arrest Points on Facet Surface
(Arrows)

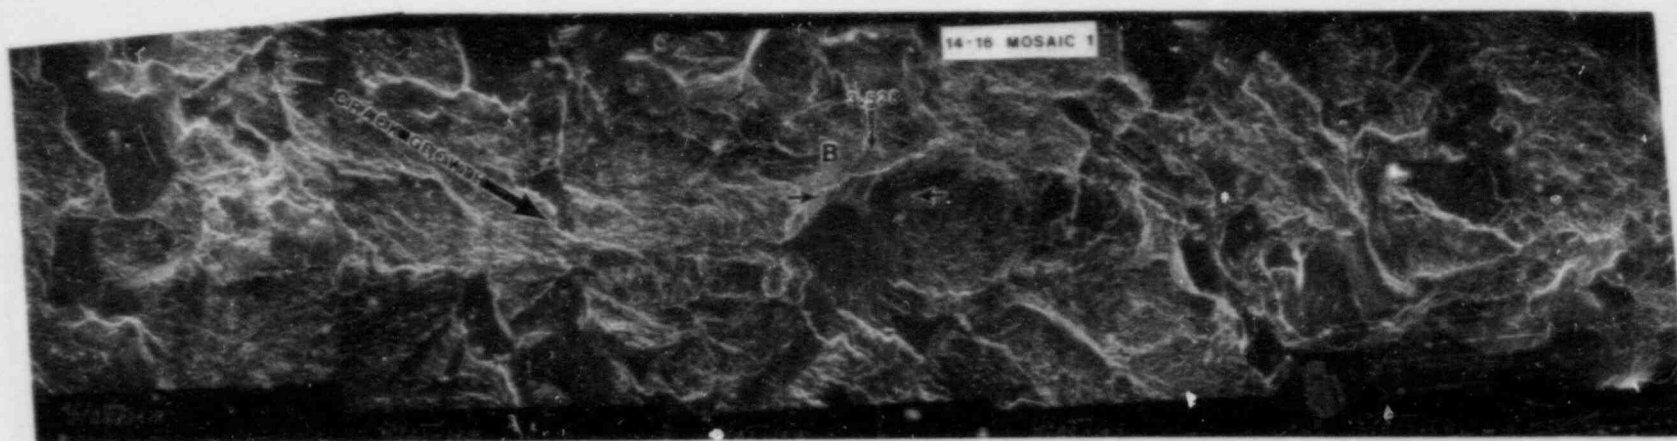
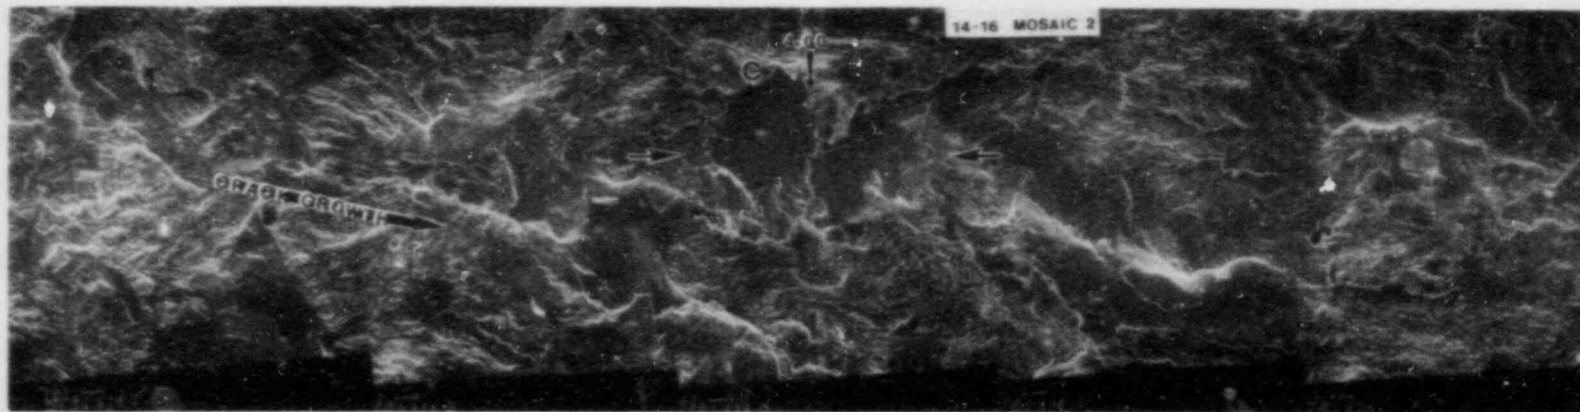
Figure 3.3-32. SEM Photomontage From Specimen 14-16
A. Montage 1, B. Montage 2

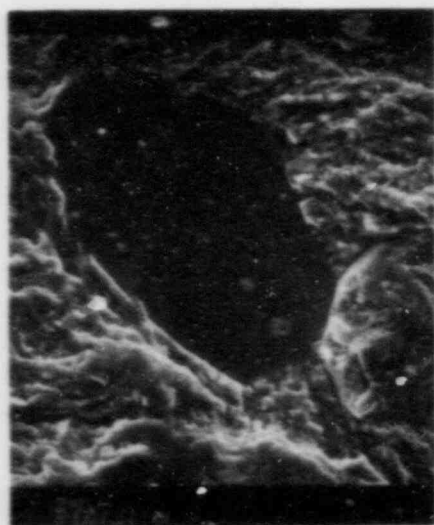
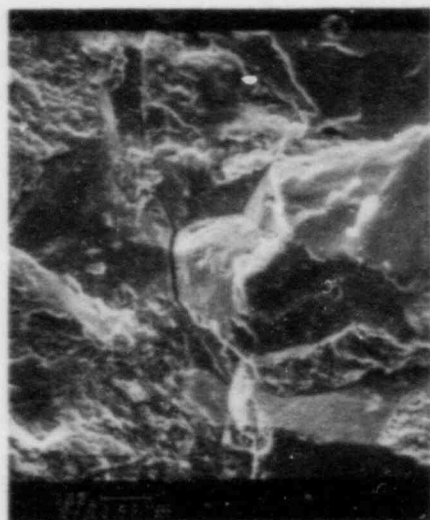
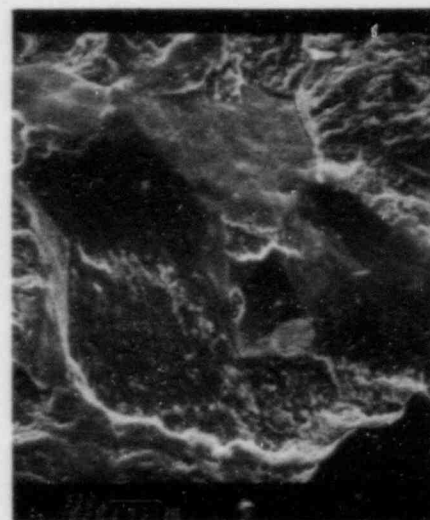
Figure 3.3-33. Typical Examples of Faceted Structure in Specimen 14-16.

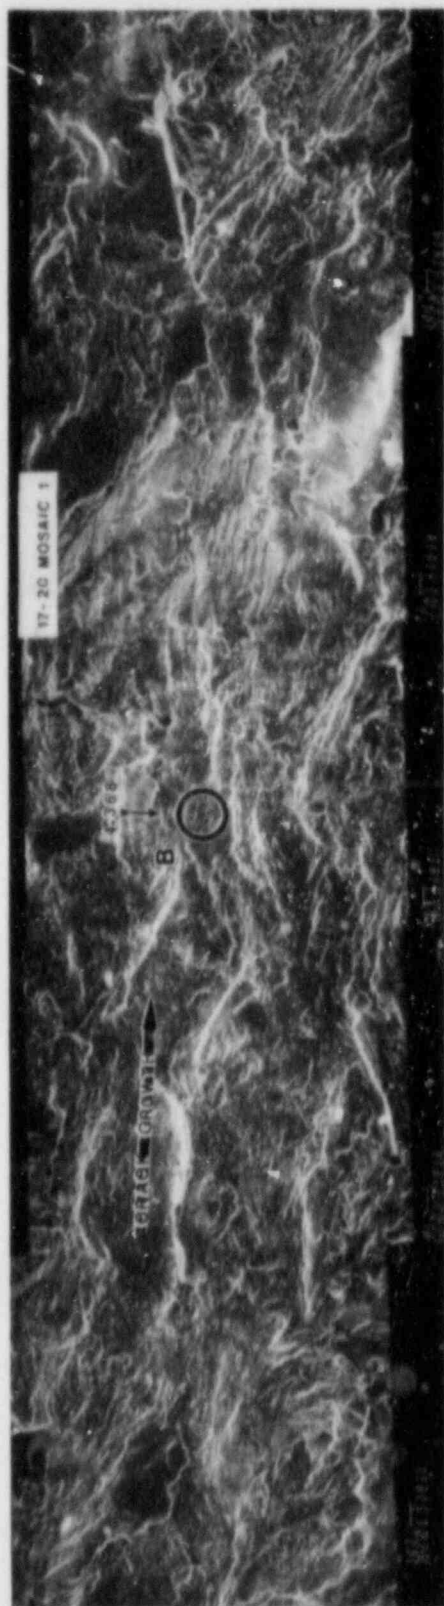
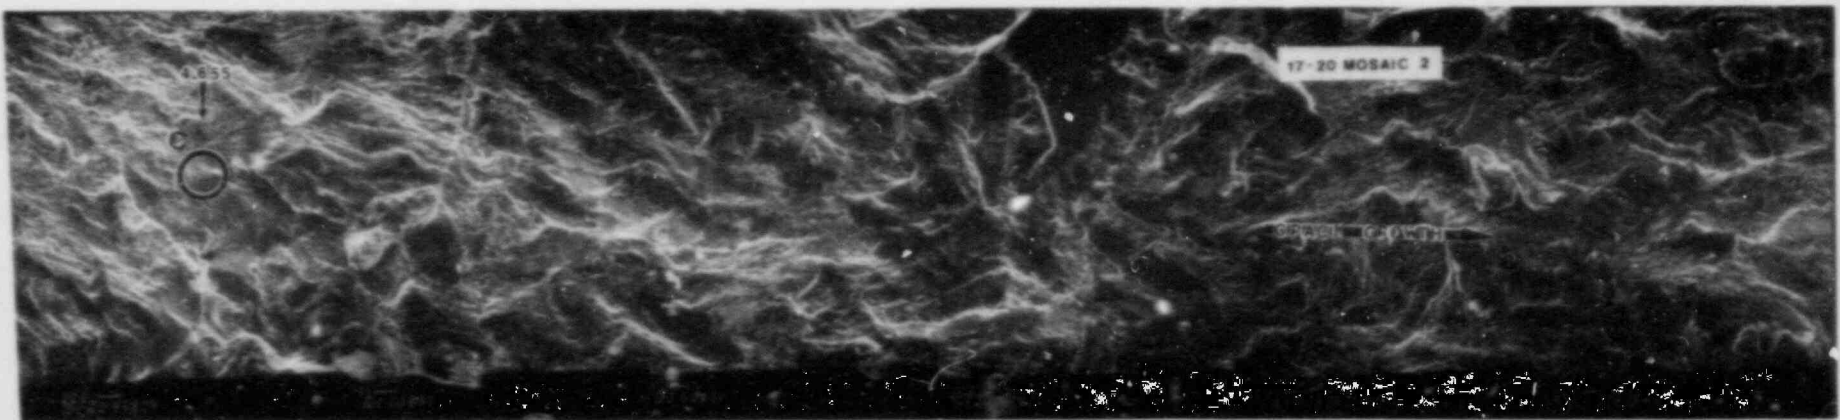
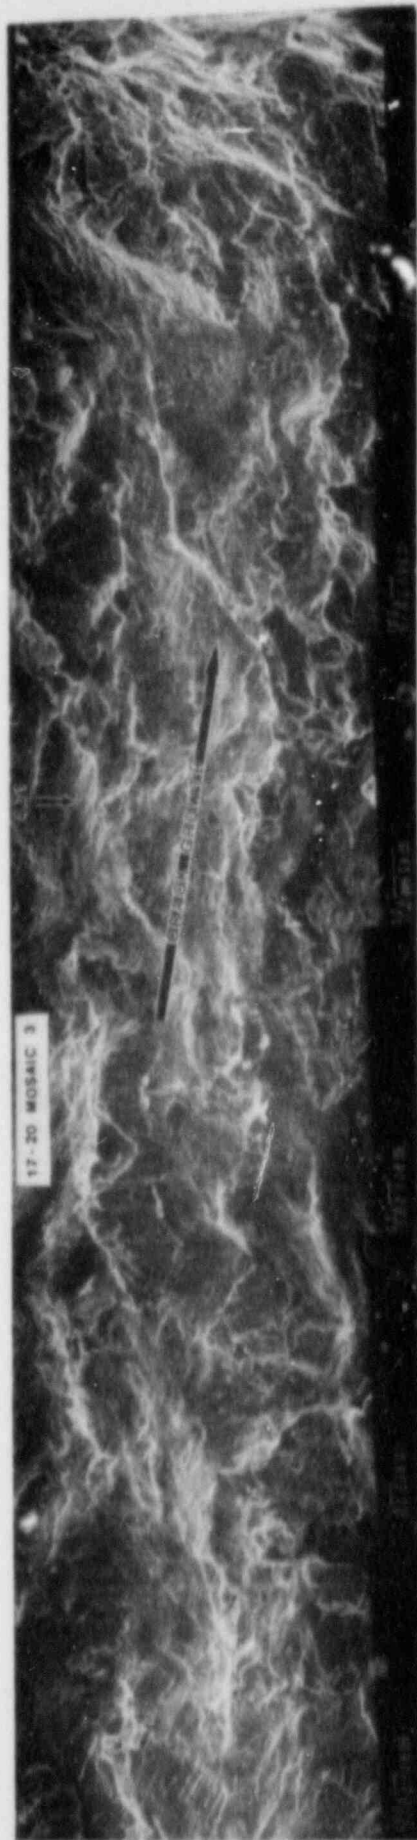
Figure 3.3-34. SEM Photomontage from Specimen 17-20
A. Montage 1, B. Montage 2, C. Montage 3

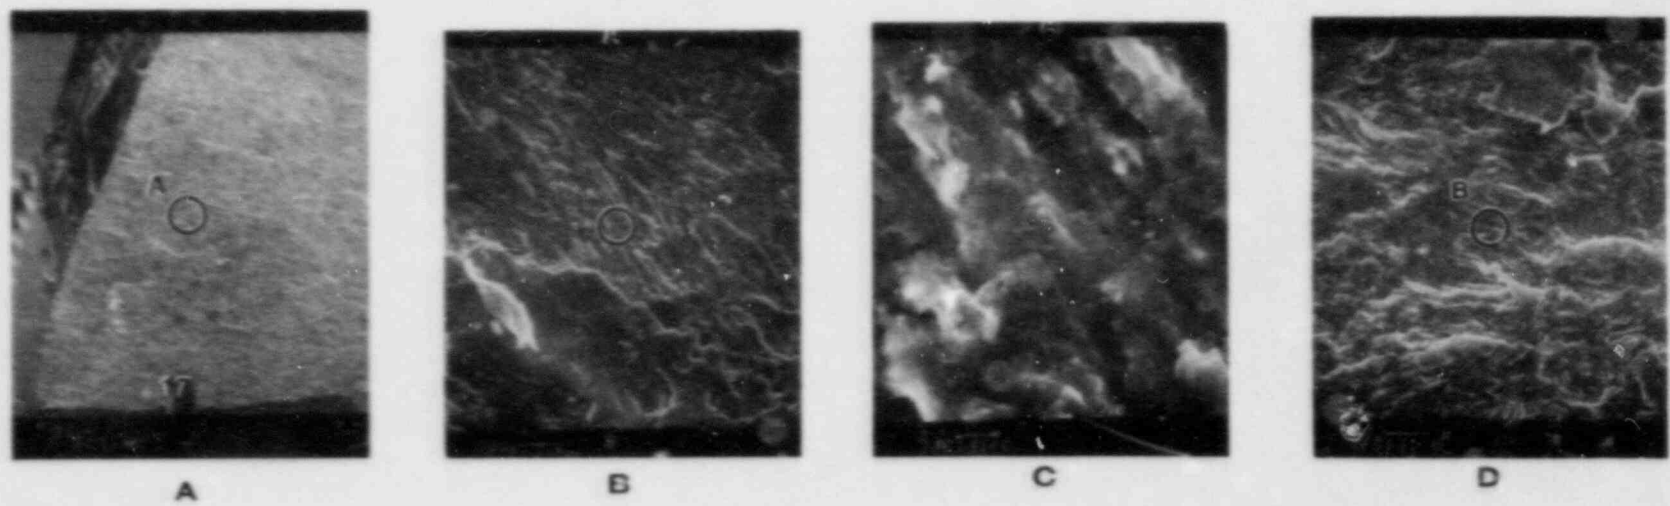
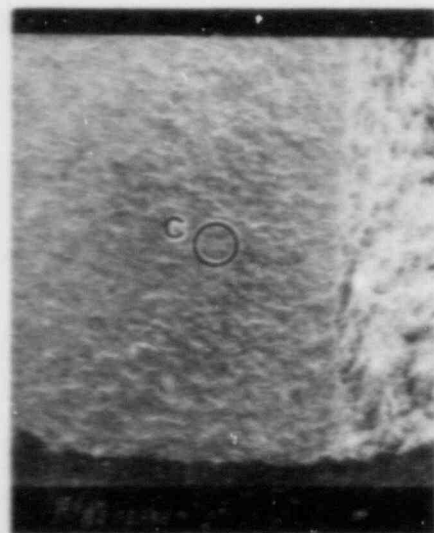
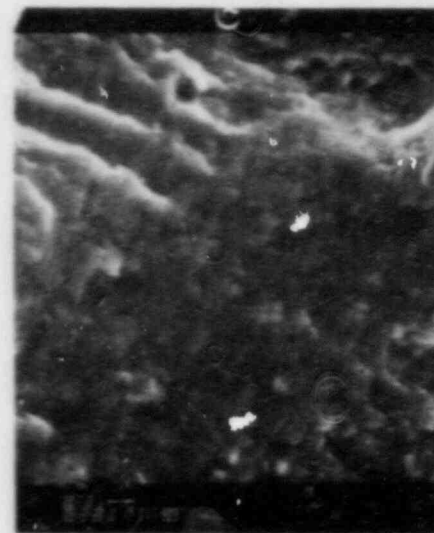
Figure 3.3-35. Higher Magnification Views of Fracture Surface Structure on Specimen
Views B and C Taken at Location A. Views D and E Taken at Location
B Shown on Previous Montage. Views F and G Taken at Location C.
