TMI-1 REACTOR COOLANT PUMP SHAFT FAILURE ANALYSIS

RESEARCH AND DEVELOPMENT DIVISION
LYNCHBURG RESEARCH CENTER

SPONSORED BY
GENERAL PUBLIC UTILITIES

Lynchburg Research Center Report
RDD:84:5183-06:01

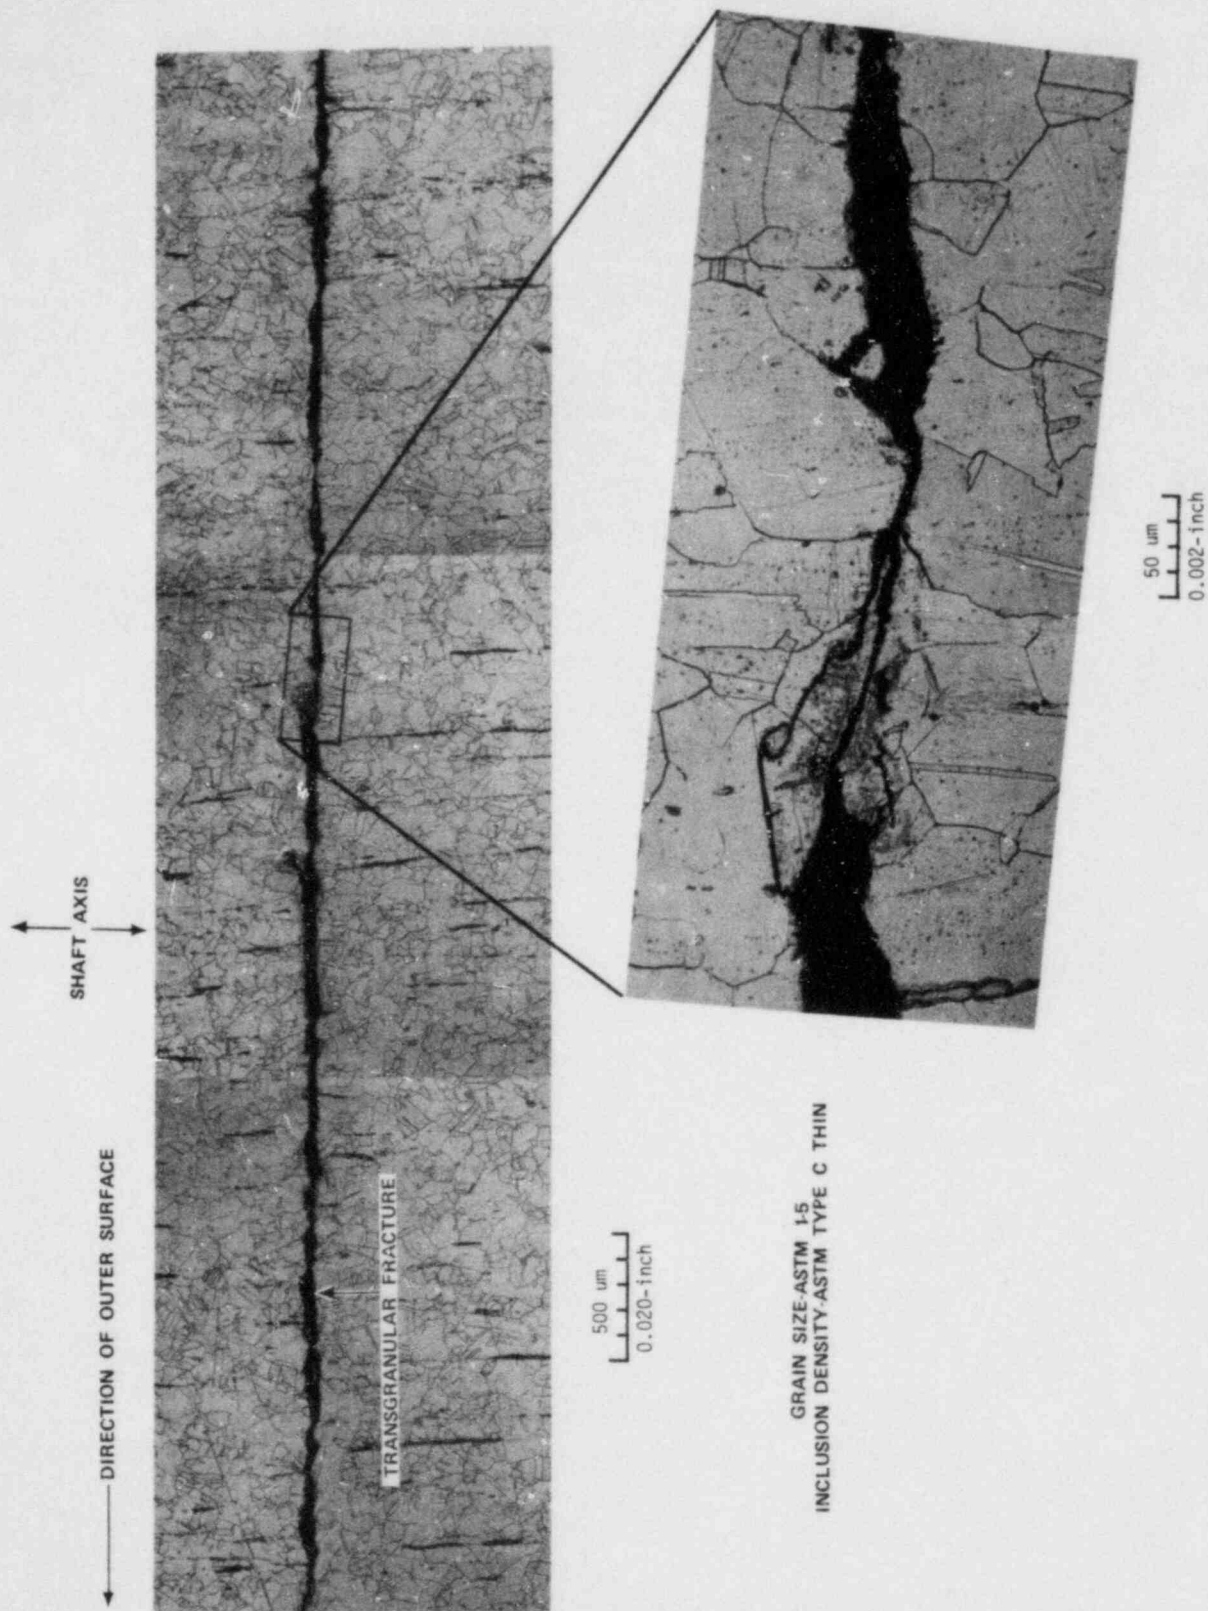
Figure 3.3-37. Longitudinal View of Specimen A1A-4

GRAIN SIZE-ASTM 15
INCLUSION DENSITY-ASTM TYPE C THIN

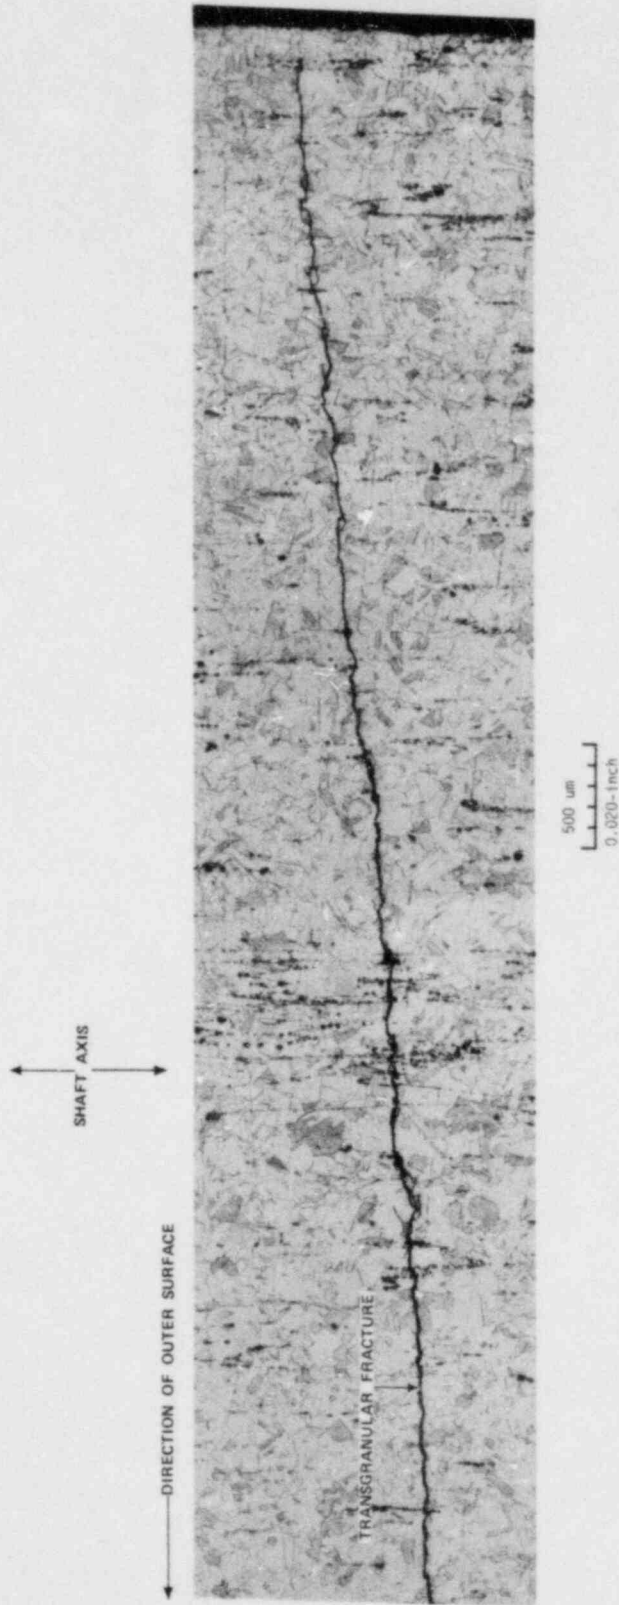
Figure 3.3-38. Longitudinal View of Specimen AIA-8

GAIN SIZE-ASTM 4.5
INCLUSION DENSITY-ASTM TYPE C HEAVY

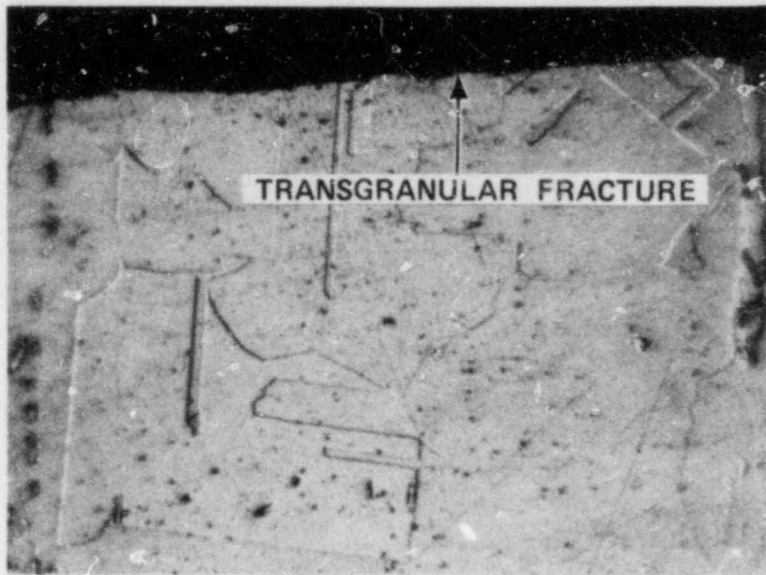
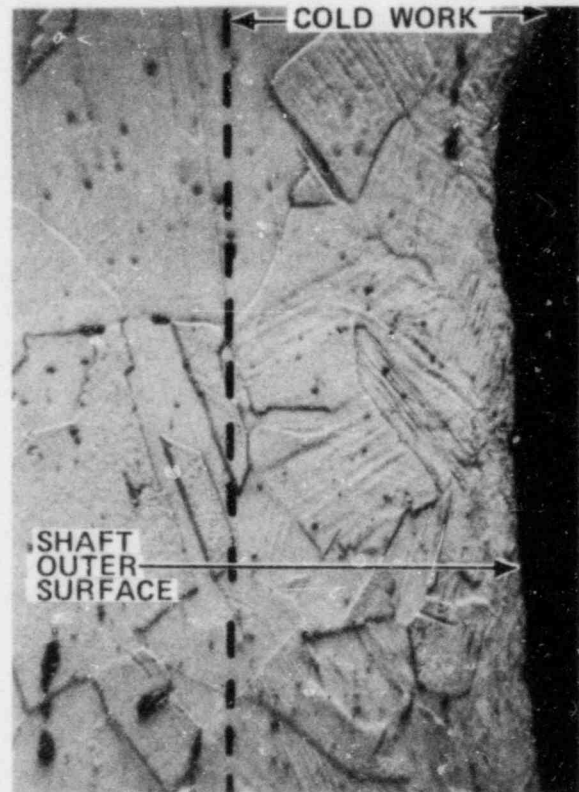
Figure 3.3-41. Longitudinal Views of Specimens B1A1 1-5B-1

GRAIN SIZE-ASTM 4-5
INCLUSION DENSITY-ASTM TYPE C THIN

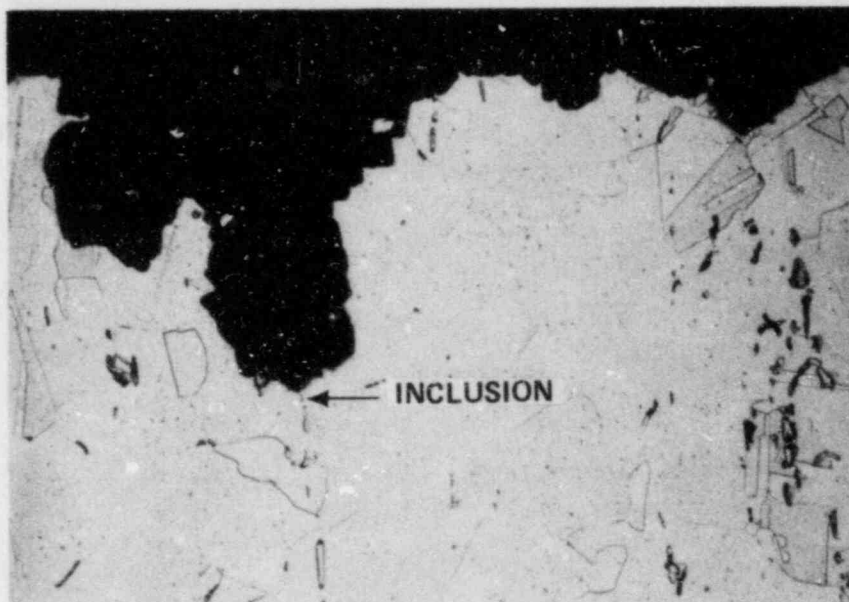
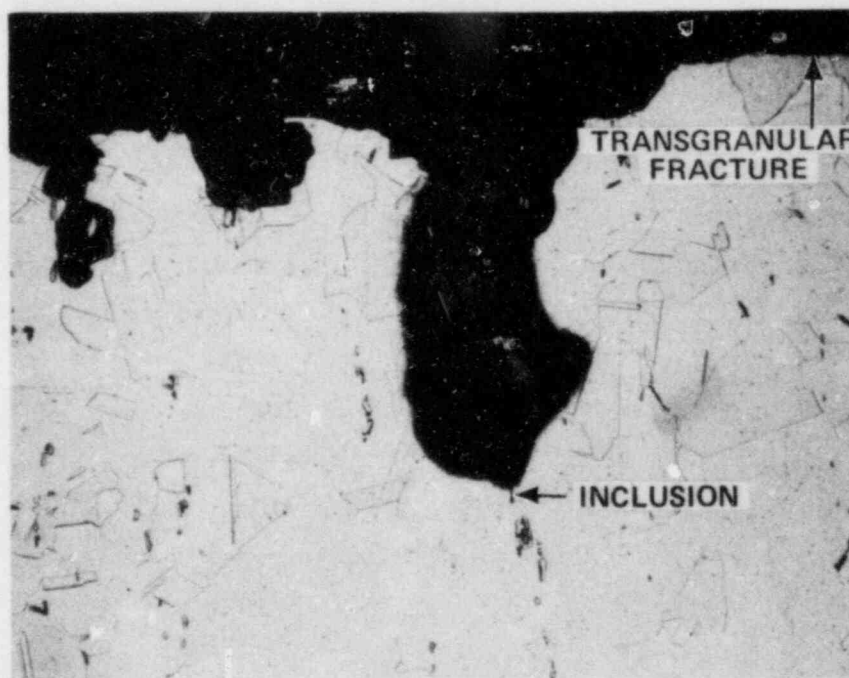
GRAIN SIZE-ASTM 4-5
INCLUSION DENSITY-ASTM TYPE C THIN

Figure 3.3-42. Longitudinal Views of Specimen B1A1, 1-5A-M Pit Region

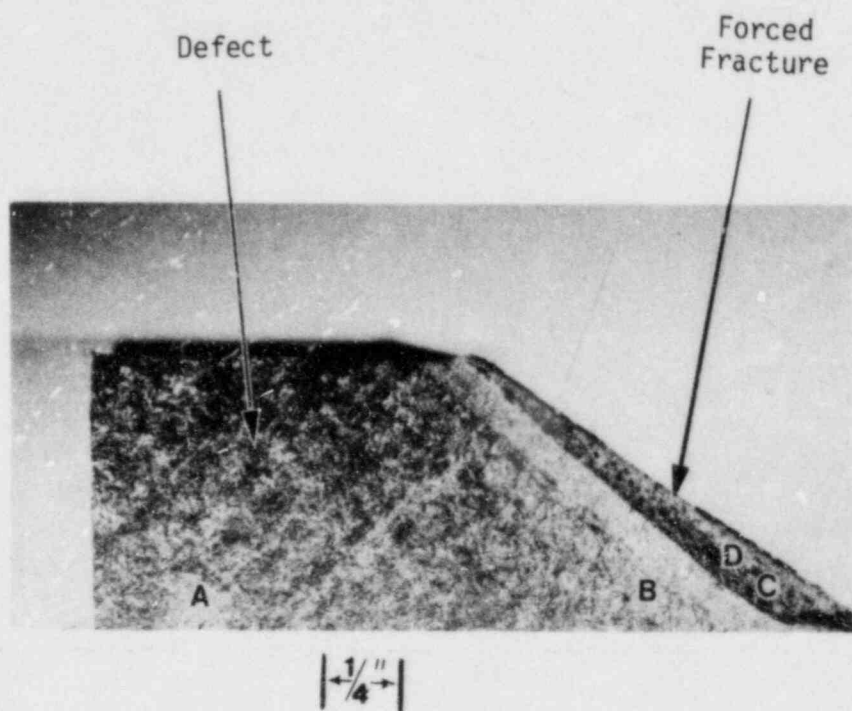
Sputter depth profiling was done at four locations, two on the failure area and two on the forced fracture as shown in Figure 3.4-1. The concentration in atomic percent of the elements found along with the depths at which they were detected are recorded in Table 6.

Figure 3.4-1. View of Fracture Surface on Specimen A1B Which Was Used for Auger Analysis

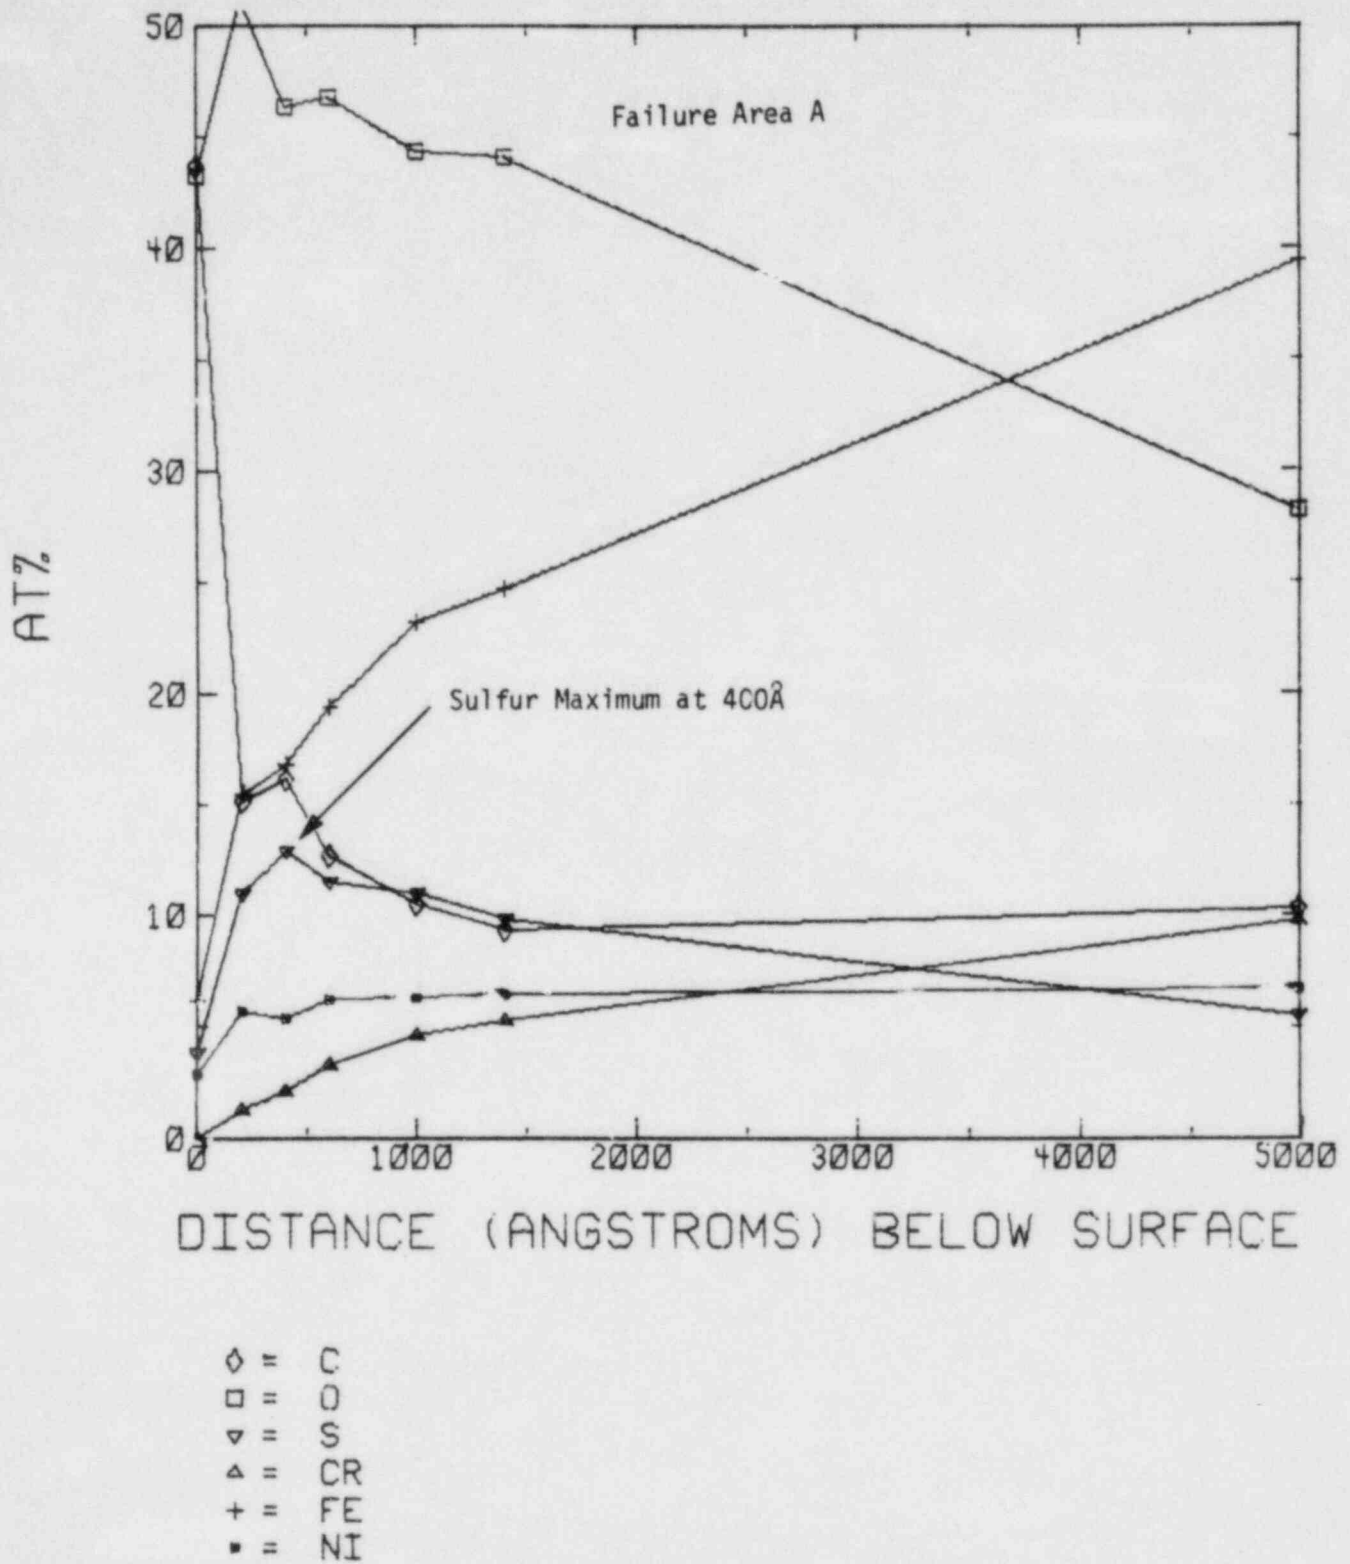
The graph seen in Figure 3.4-2 represents the sputter depth profile of the major elements to a depth of 5000Å taken at Location A on the surface as viewed in Figure 3.4-1. The sulphur concentration reaches a maximum of 13 atomic percent at 400Å and then decreases to 3.6 atomic percent at 9500Å. This indicates a film that was significantly enriched in sulphur when compared to the sputter depth profile of the forced fracture Area C. The sulphur concentration was highest at the surface (5.9 atomic percent) in the forced fracture region and decreased slightly at the 100Å and 200Å levels to 4 atomic percent.

Figure 3.4-2. Auger Analysis Sputter Depth Profiles on the Fracture Surface in Figure 3.4-2

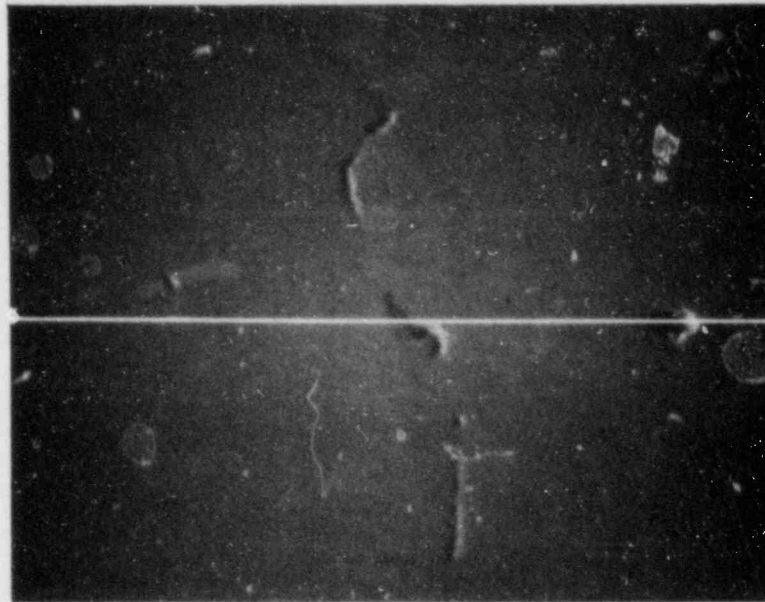
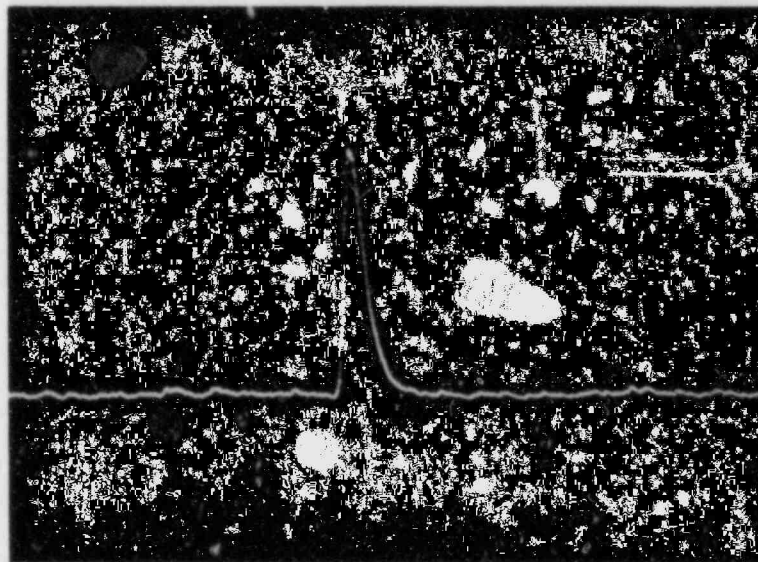
An SEM photomicrograph of the polished defect cross section can be seen in Figure 3.4-3. The crack was very tight and microanalysis along this plane only revealed occasional oxide patches. The white line in Figure 3.4-3a indicates the location of a beam traverse for oxygen while Figure 3.4-3b is the associated oxygen profile to illustrate the presence of oxides. No sulphur enrichment could be detected along the defect line in this sample orientation.

Figure 3.4-3. Specimen A1C Used for Microprobe Analyses.
A. SEM View of Crack, B. Oxygen Profile
Corresponding to the Beam Traverse Location
Shown by White Line in View A

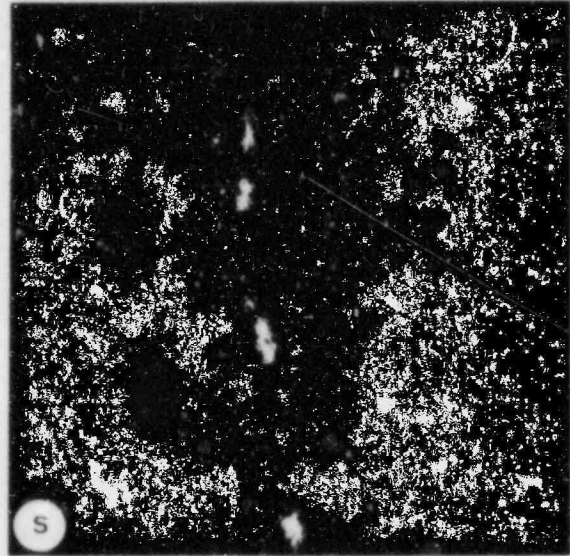
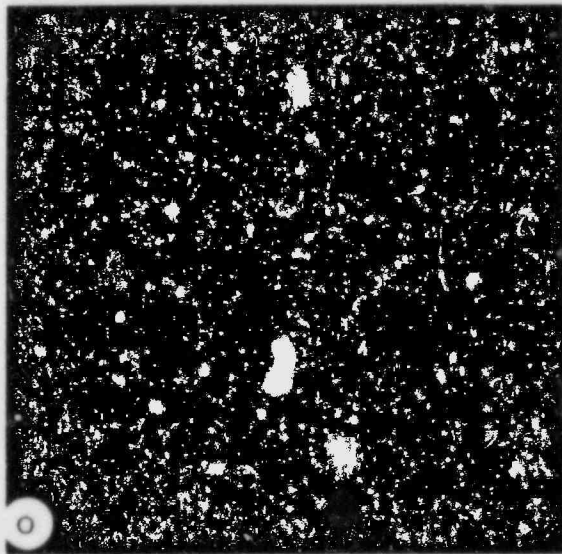
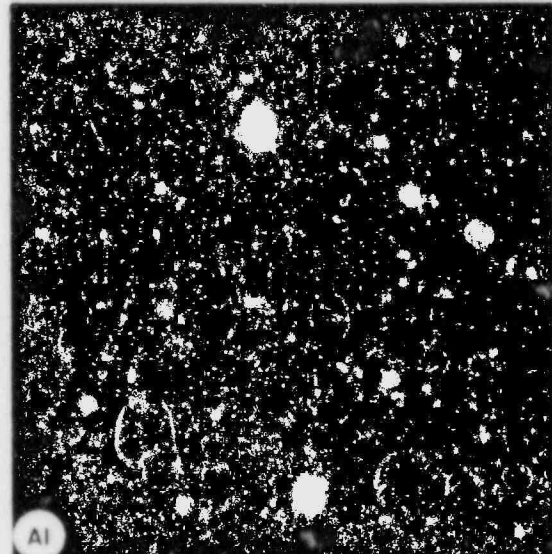
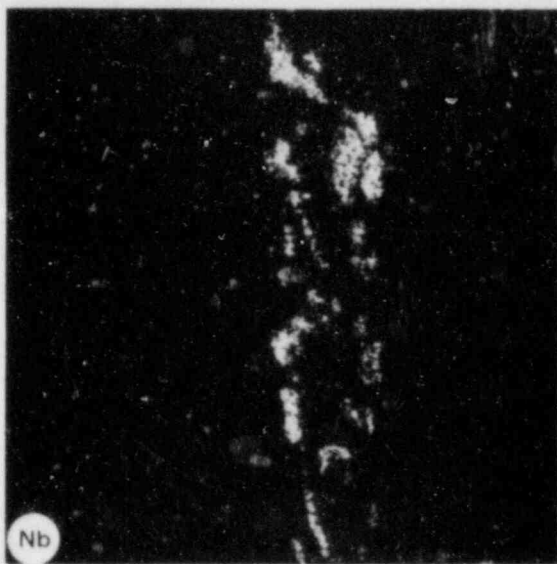
Several stringered inclusions were observed in the sample orientation analyzed. Elemental dot mapping was done on several inclusions for the following elements: C, N, Ta, S, O, Mn and Nb, and Al. It was observed that the majority of the inclusions were of the form Nb (C, N). Figure 3.4-4 displays an SEM photomicrograph and several associated element dot maps of a typical cluster of inclusions seen in the sample. The white appearing inclusions were niobium rich. The carbon and nitrogen maps were abnormally faint, most likely because material had smeared over during polishing. The surface was in the unetched condition. The grayish inclusion was identified by mapping as Al_2O_3 . MnS had precipitated out around this and other observed oxide inclusions. MnS inclusions were also found separately in clusters with oxides and Nb (C, N) as well as isolated in the matrix. Sulphide inclusions were found much less frequently than Nb (C, N) inclusions throughout the sample.

Figure 3.4-4. SEM Photomicrograph and Associated Element Maps of a Typical Stringer Formation Found in the 347SS Pump Shaft Material

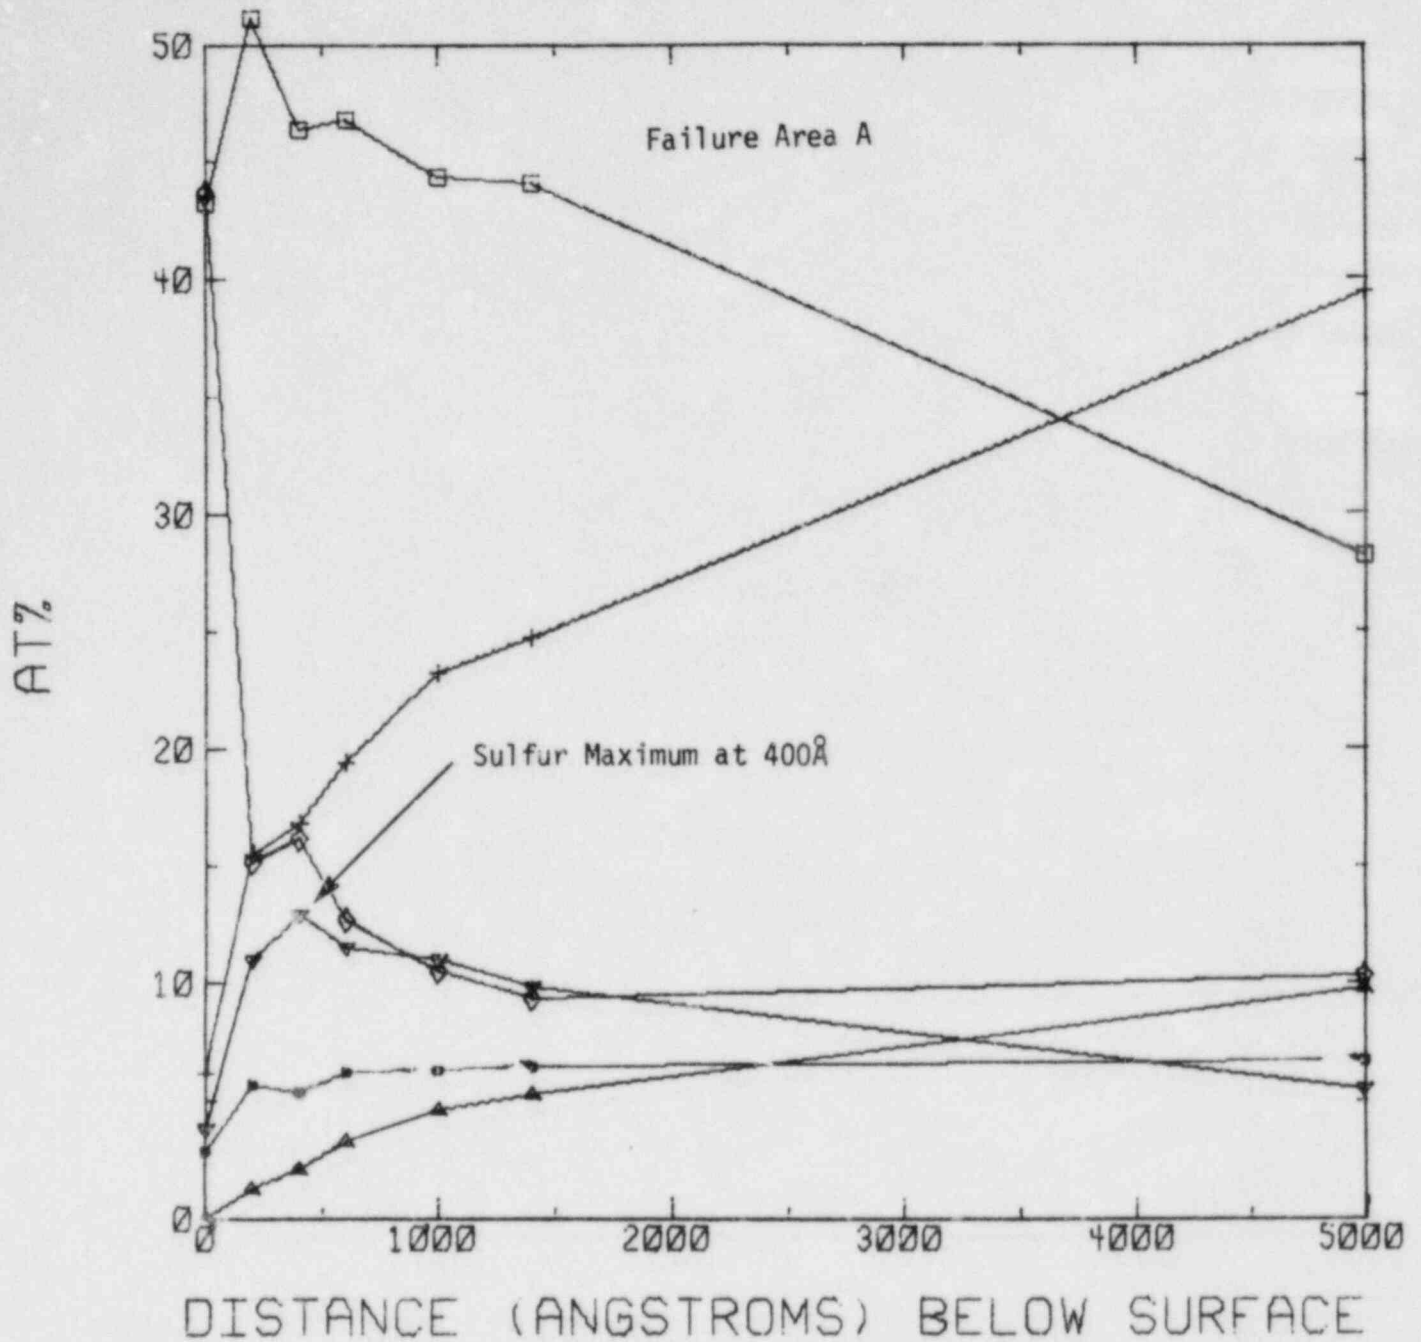
The graph seen in Figure 2 represents the sputter depth profile of the major elements to a depth of 5000Å taken at Location A on the surface as viewed in Figure 3. The sulfur concentration reaches a maximum at 400Å (13 atomic %) and then decreases to 3.6 atomic % at 9500Å. This indicates a film that is significantly rich in sulfur when compared to the sputter depth profile of the forced fracture Area C. The sulfur concentration is highest at the surface (5.9 atomic %) in the forced fracture region and has decreased slightly at the 100Å and 200Å levels to 4 atomic %.

Figure 2. Auger' Analysis Sputter Depth Profiles on the Surface seen in Figure 3.

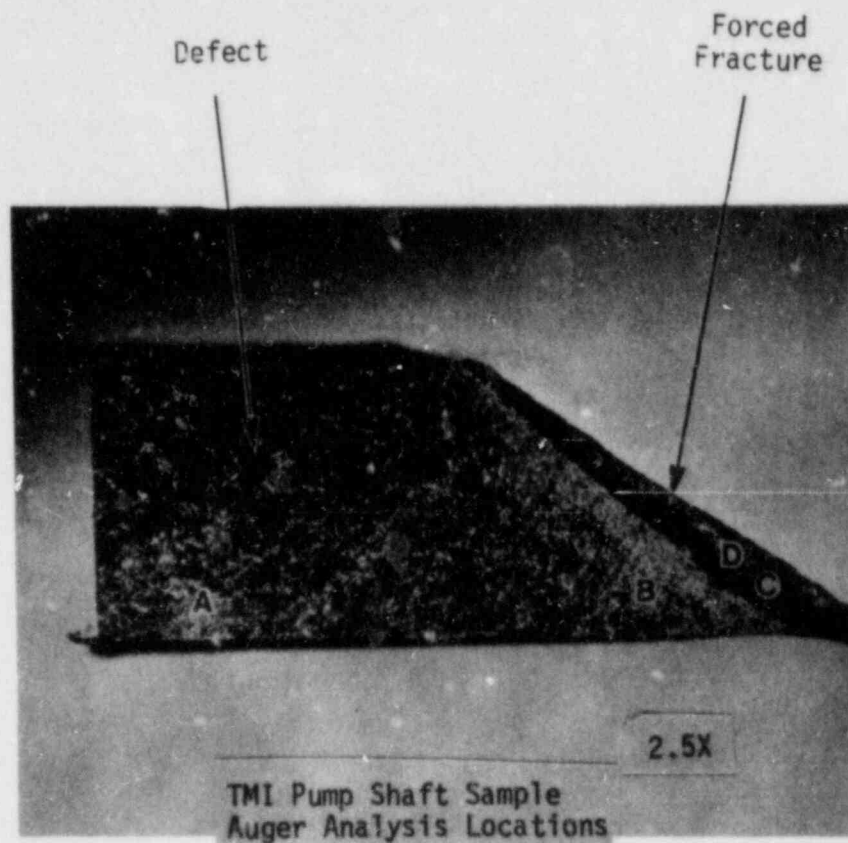
Based on the results of the Auger analysis, the following elements were included in the microprobe analysis: Cr, Mn, Fe, Ni, Nb, S, and O. The piece which was analyzed is the mating surface to the Auger sample (see Figure 3). The results of the quantitative analysis are given in Table 2. Four randomly chosen locations were analyzed on the surface away from the forced fracture. The readings were compared to normal base metal on a piece taken adjacent to the Auger sample such that a plane perpendicular to the defect surface was analyzed. Fracture surface readings were taken, but the surface roughness proved to be too great to achieve good quantitative results. A beam search for sulfur revealed high sulfur in rough surfaces adjacent to the forced fracture but again surface roughness made quantification impossible.

Figure 3. Defect Surface Examined by Auger Analysis. The Mating Face was Used for the Microprobe Analysis.

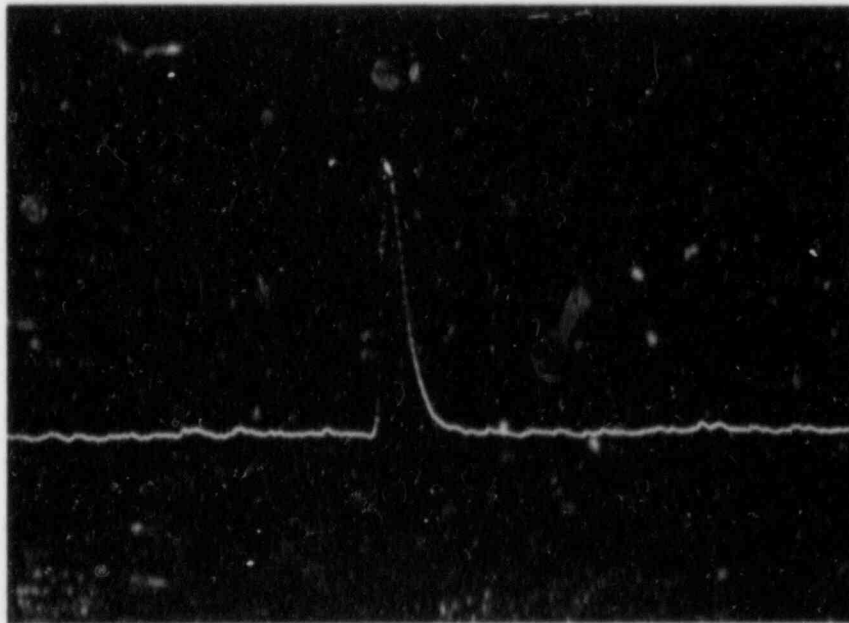
An SEM micrograph of the defect surface prior to opening can be seen in Figure 4a. The crack is very tight and microanalysis along this plane only revealed occasional oxide patches. The white line on Figure 4a indicates the location of a beam traverse for oxygen while Figure 4b is the associated oxygen profile to illustrate the presence of oxides. No sulfur enrichment could be detected along the defect line in this sample orientation.

Figure 4b. Oxygen Profile Corresponding to the Beam Traverse Location (White Line) seen in Figure 4a.

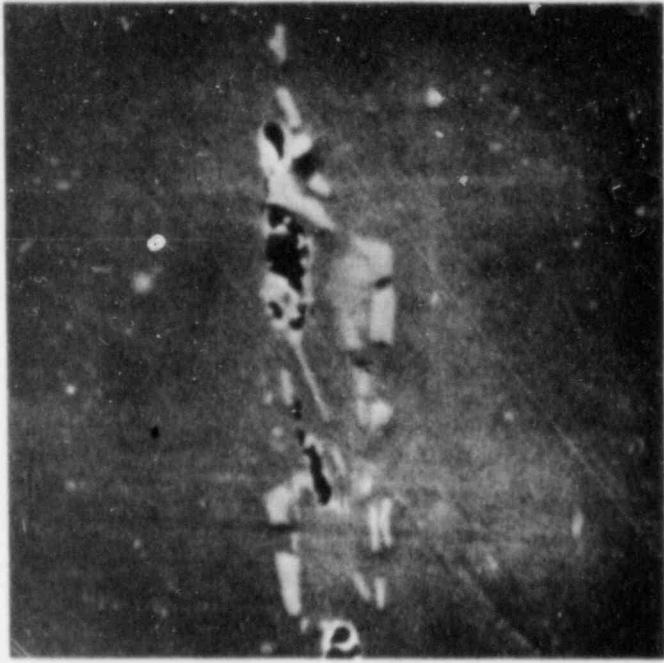
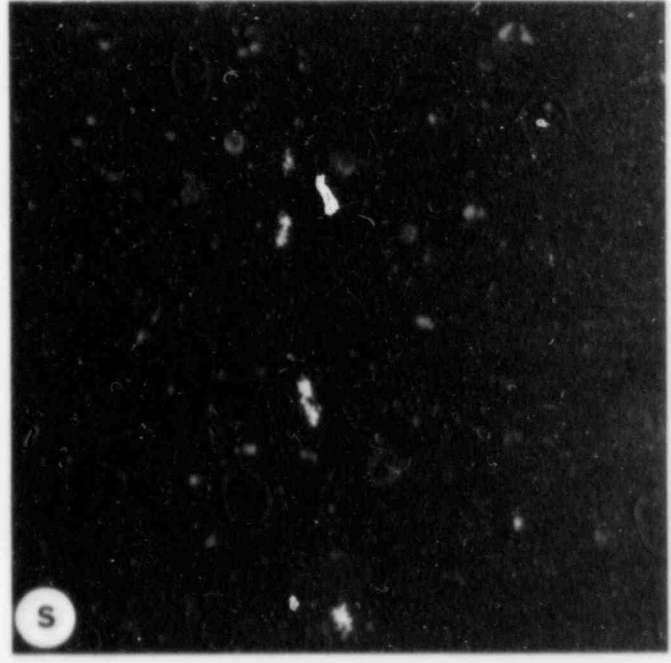
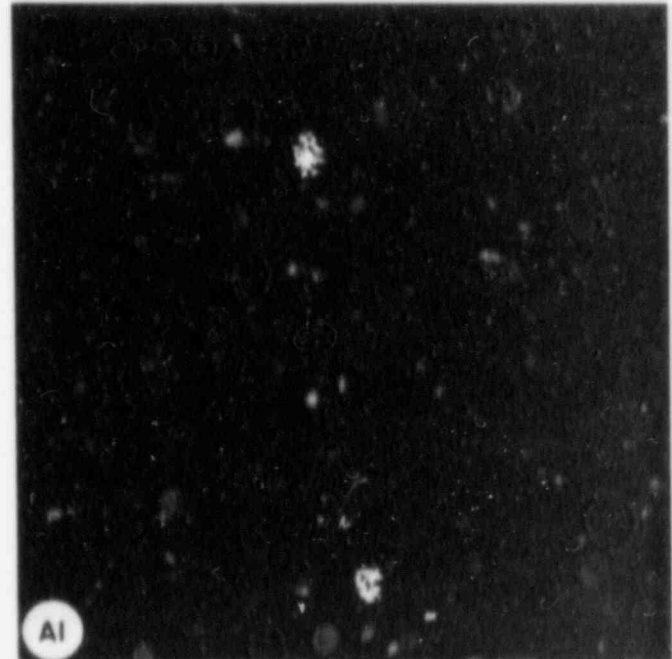
Elemental dot mapping was done on several inclusions for the following elements: C, N, Ta, S, O, Mn and Nb, and Al. It was observed that the majority of the inclusions are of the form Ti (C, N). Figures 5a through 5g display an SEM micrograph and several associated element maps of a typical cluster of inclusions seen in the sample. The white inclusions are niobium rich. The carbon and nitrogen maps were abnormally faint, most likely because material had smeared over during polishing. The surface is in the unetched condition. The grayish inclusion can be identified by mapping as Al_2O_3 . MnS has precipitated out around this and other observed oxide inclusions and MnS inclusions can also be found separately in clusters with oxides and Nb (C, N) as well as isolated in the matrix. Sulfide inclusions were found much less frequently than Nb (C, N) inclusions throughout the sample.

1000X
Figure 5. SEM Micrograph and Associated Element Maps of a Typical Stringer Formation Found in the 347SS Pump Shaft Material.

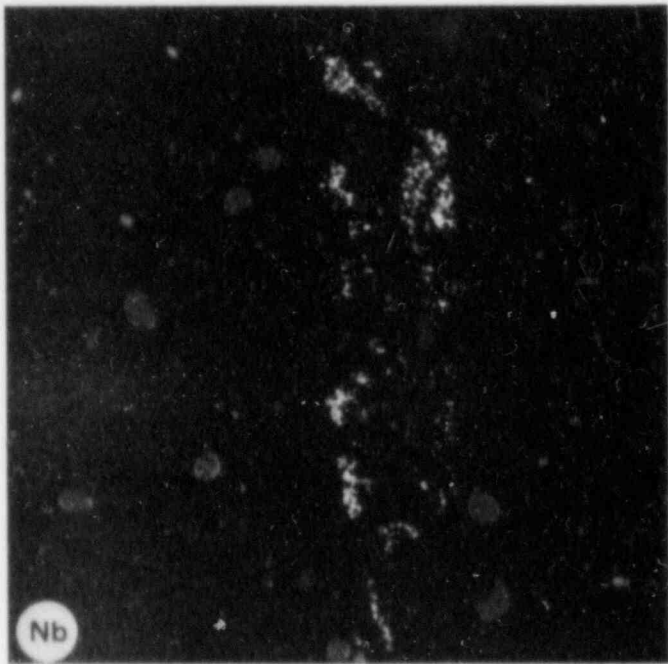
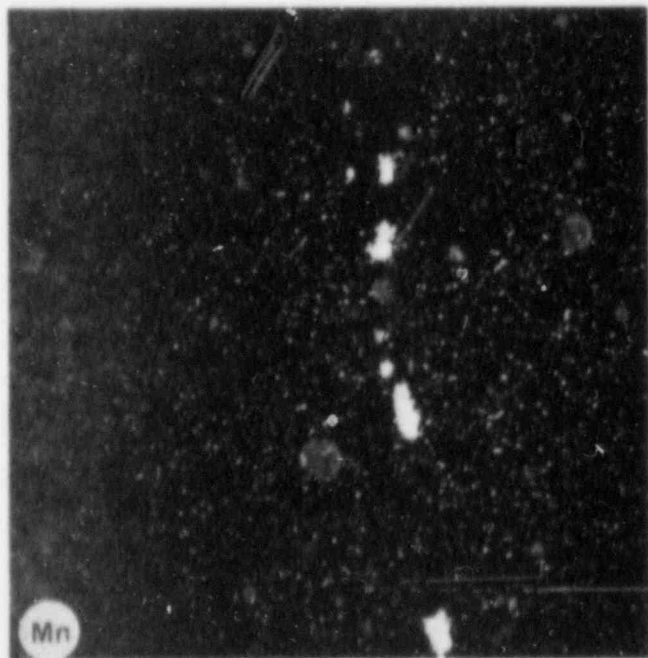
Figure 5 continued.

Several inclusions were seen to be in stringer formations in the sample orientation analyzed. Because sulfide inclusions may play a part in a proposed failure mechanism, the inclusions were analyzed to determine if the inclusions were sulfides.
