U.S. NUCLEAR REGULATORY COMMISSION
REGION I

Report No. 50-443/84-12
50-444/84-06

Facility Name: Seabrook Station, Unit 1 and 2

Inspection Summary: Inspection on August 13-17 and 27-31, 1984 (Inspection Report 50-443/84-12 and 50-444/84-06)

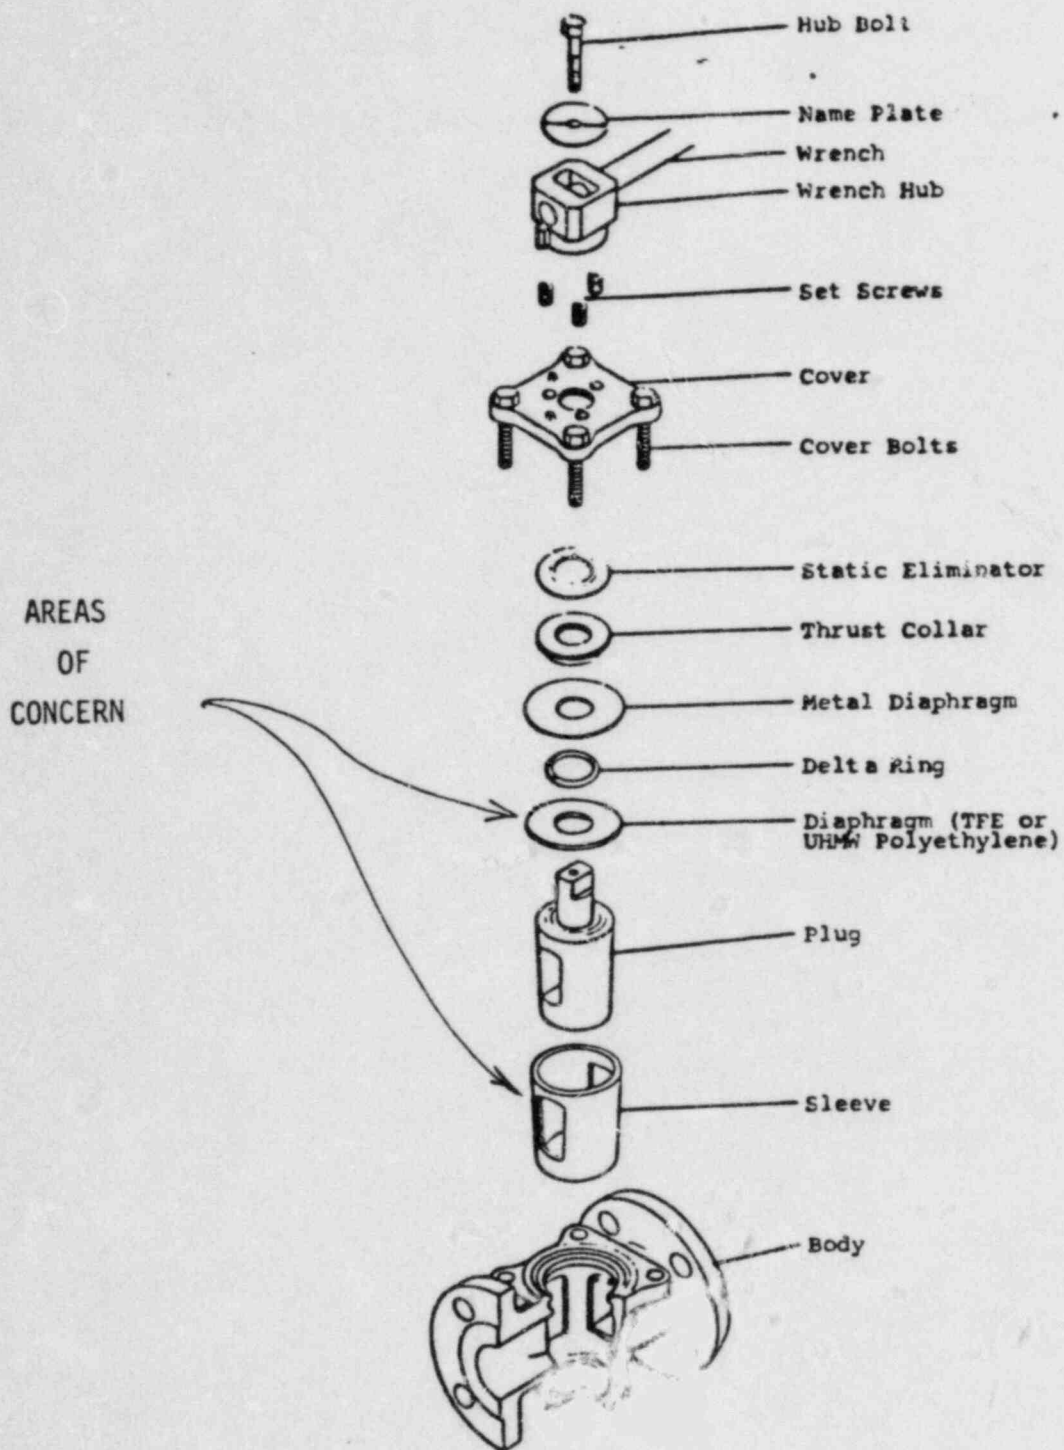
FIGURE 12-1

The teflon seat valves are Tufline valves manufactured by the XOMOX Corporation. The valves have one or more plastic parts which could be affected by excess welding heat input, which are shown on Figure 12-1 an exploded view of a representative Tufline valve. Figure 12-2A shows a typical installed valve. These valves inspected are utilized in non-safety related systems.

EXPLODED VIEW OF TYPICAL TUFINE VALVE
