UNITED STATES
NUCLEAR REGULATORY COMMISSION

FACILITY: Three Mile Island Nuclear Station, Unit 1 (TMI-1)

SUBJECT: SUMMARY OF OCTOBER 12, 1995, MEETING WITH GPU NUCLEAR CORPORATION
REGARDING FUEL CLADDING DISTINCTIVE CRUD PATTERNS AT THREE MILE
ISLAND NUCLEAR STATION, UNIT 1 (TMI-1)

**TMI-1 Fuel Assembly Degradation
NRC/GPUN/BWFC Meeting - October 12, 1995**

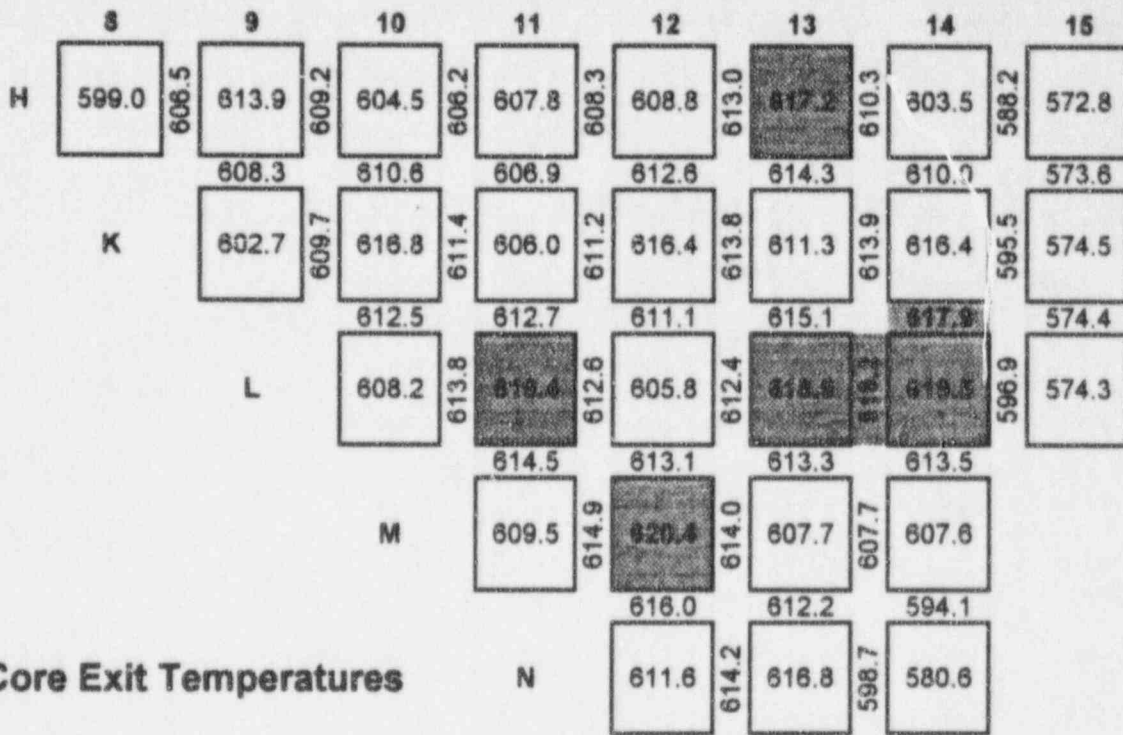
TMI-1 Cycle 10 at 0 EFPD

- Thermal-Hydraulic Evaluation
 - ▶ Core-Wide Analysis Shows Temperatures Slightly Higher in Outer Ring Fresh Fuel Locations
 - ▶ Local Conditions Analyses Show Clad Surface Temperatures Among Highest in Core; Local Velocities Lower in Peripheral Channels than in Bundle Interior
 - ▶ Both Core-Wide and Local Conditions are Similar to or Bounded by Those in Other Similar Cores
- Correlates to High Temperature, Low Velocities but These Conditions Would Not in Themselves Lead to Fuel Degradation

Highlighted regions with temperatures > 617 F.
