NYN-95 084

October 25, 1995

Subject: Supplement to Relief Request From ASME Code Section XI Requirements and Results of Augmented Inspections

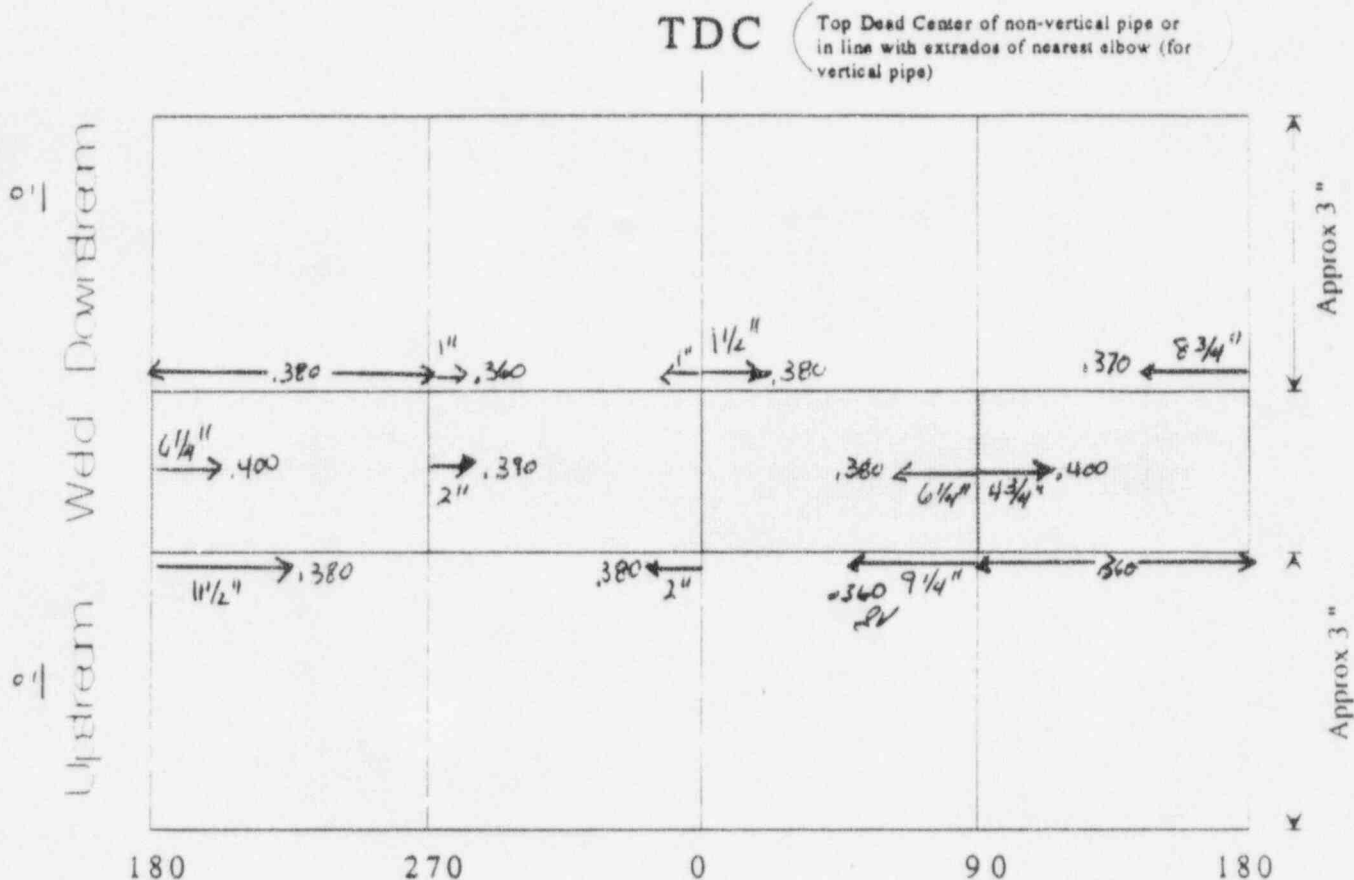
Line 1802 Weld No. F1003 Date 10-23-95

The location of the N/A Lowest (thinnest) reading does does not coincide with previous lowest reading (within 1")

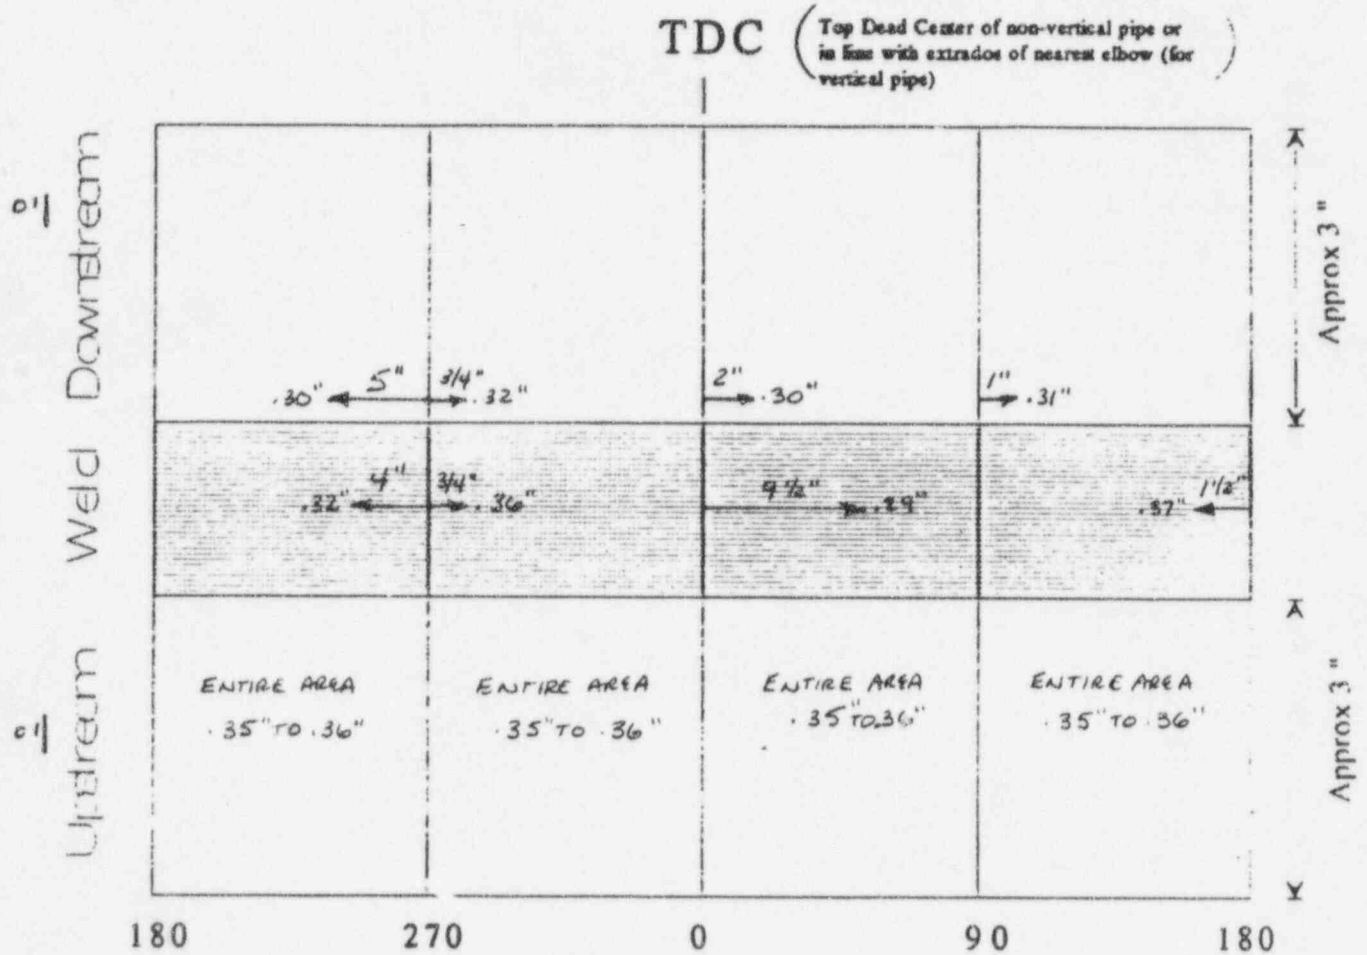
Line 1802 Weld No. F060Z Date 10/23/95

The location of the Lowest (thinnest) reading does N/A coincide with previous lowest reading (within 1")

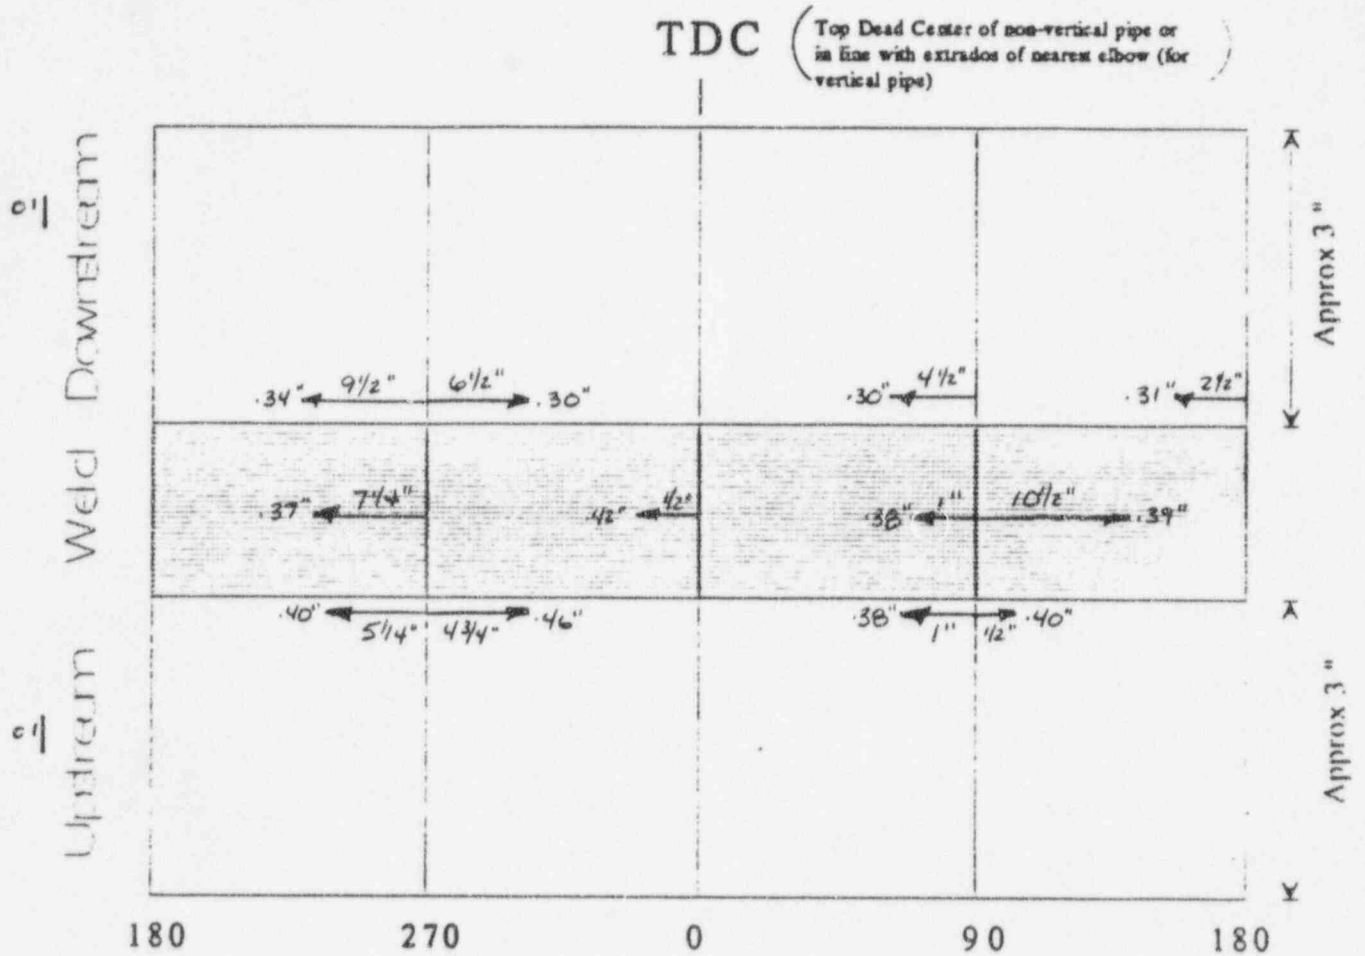
Line 1802 Weld No. F0601 Date 10/23/95

The location of the Lowest (thinnest) reading does does not coincide with previous lowest reading (within 1")

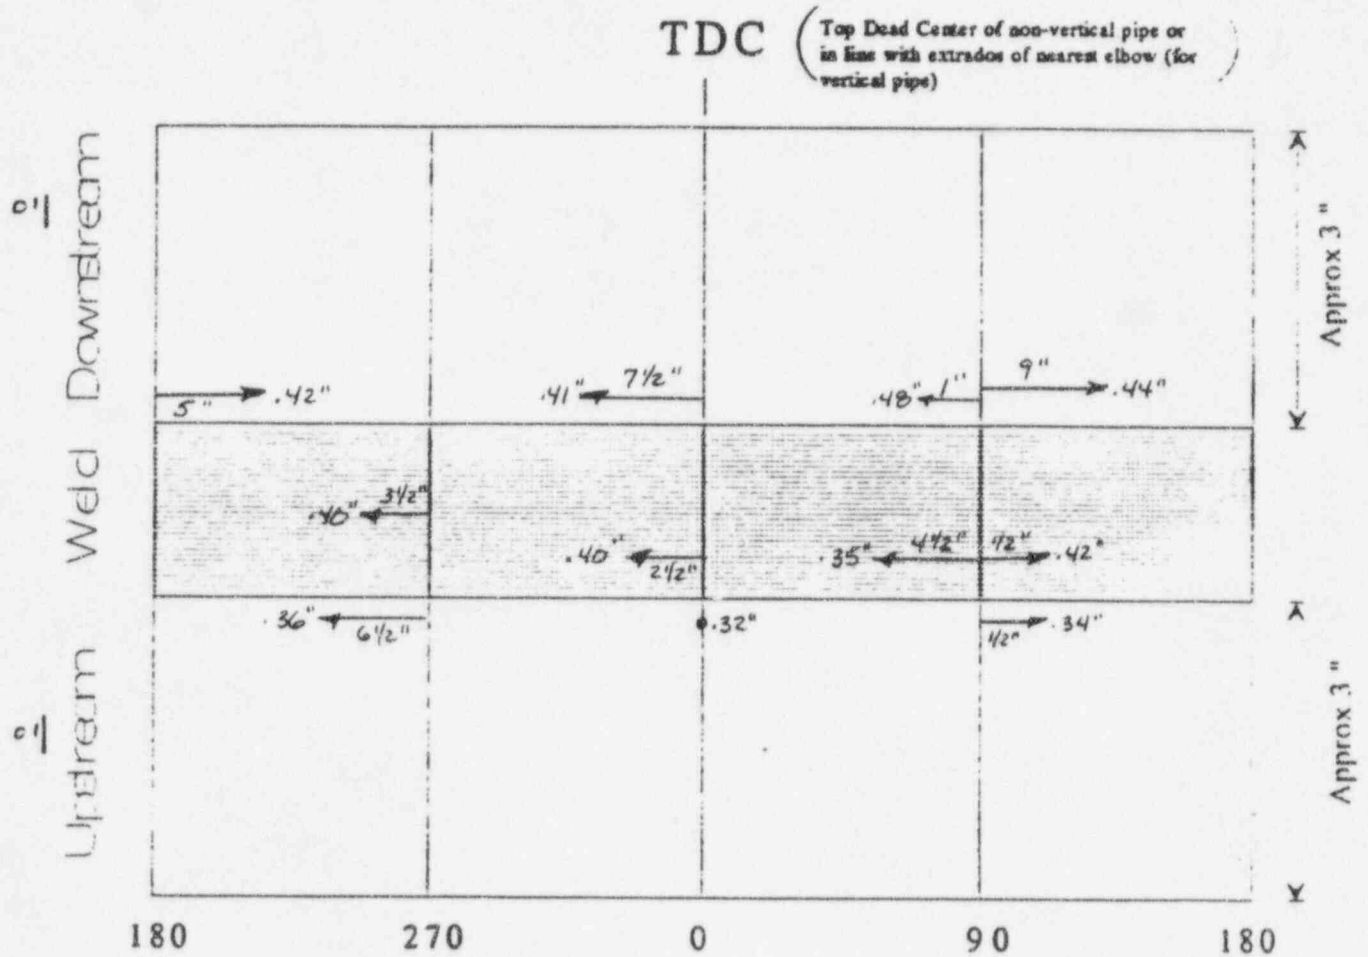
Line 1812 Weld No. F1001 Date 10/23/95

The location of the Lowest (thinnest) reading does ^{N/A} does not coincide with previous lowest reading (within 1")

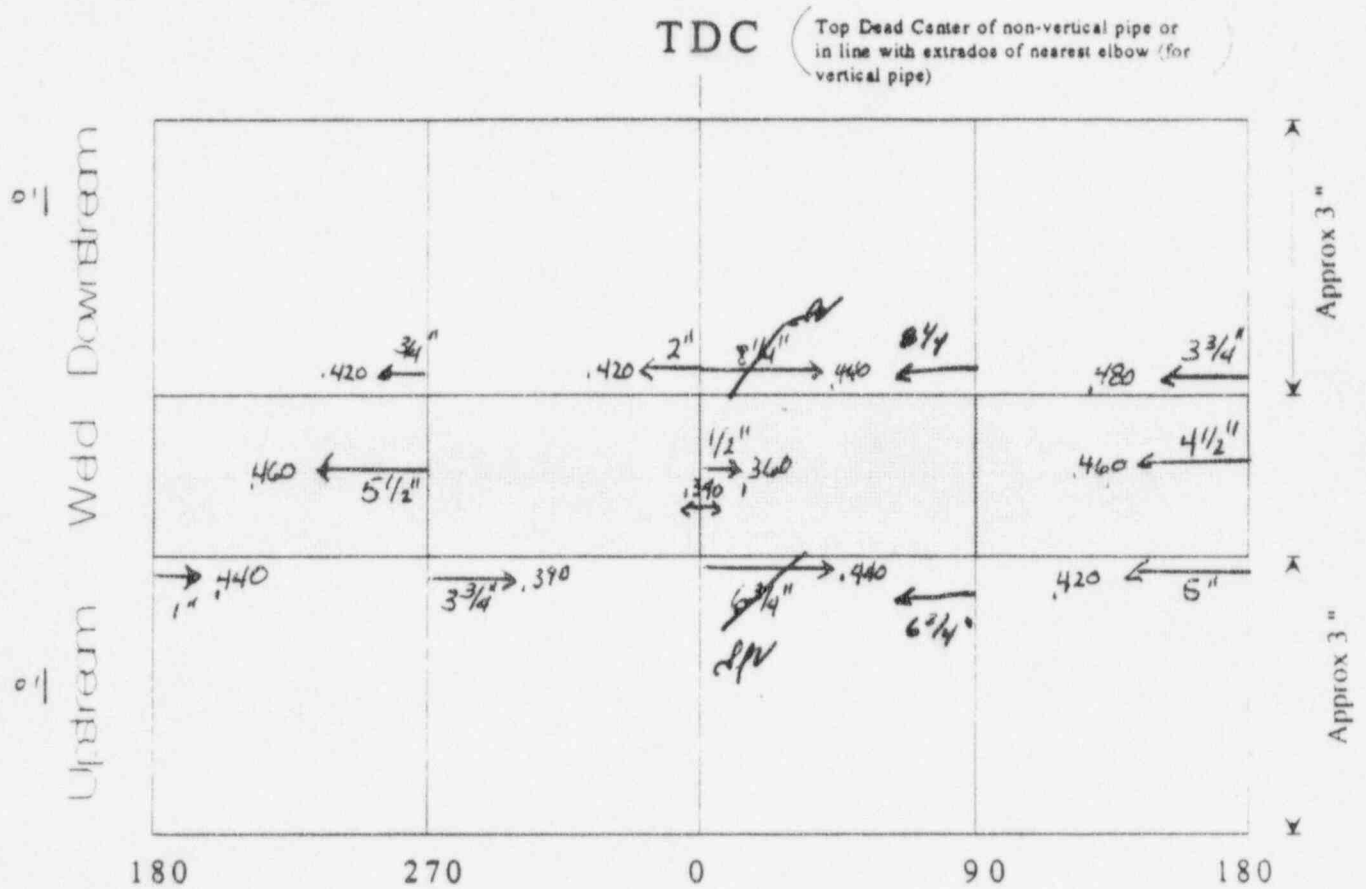
Line 181-Z Weld No. F0903 Date 10-23-95

The location of the N/A Lowest (thinnest) reading does does not coincide with previous lowest reading (within 1")

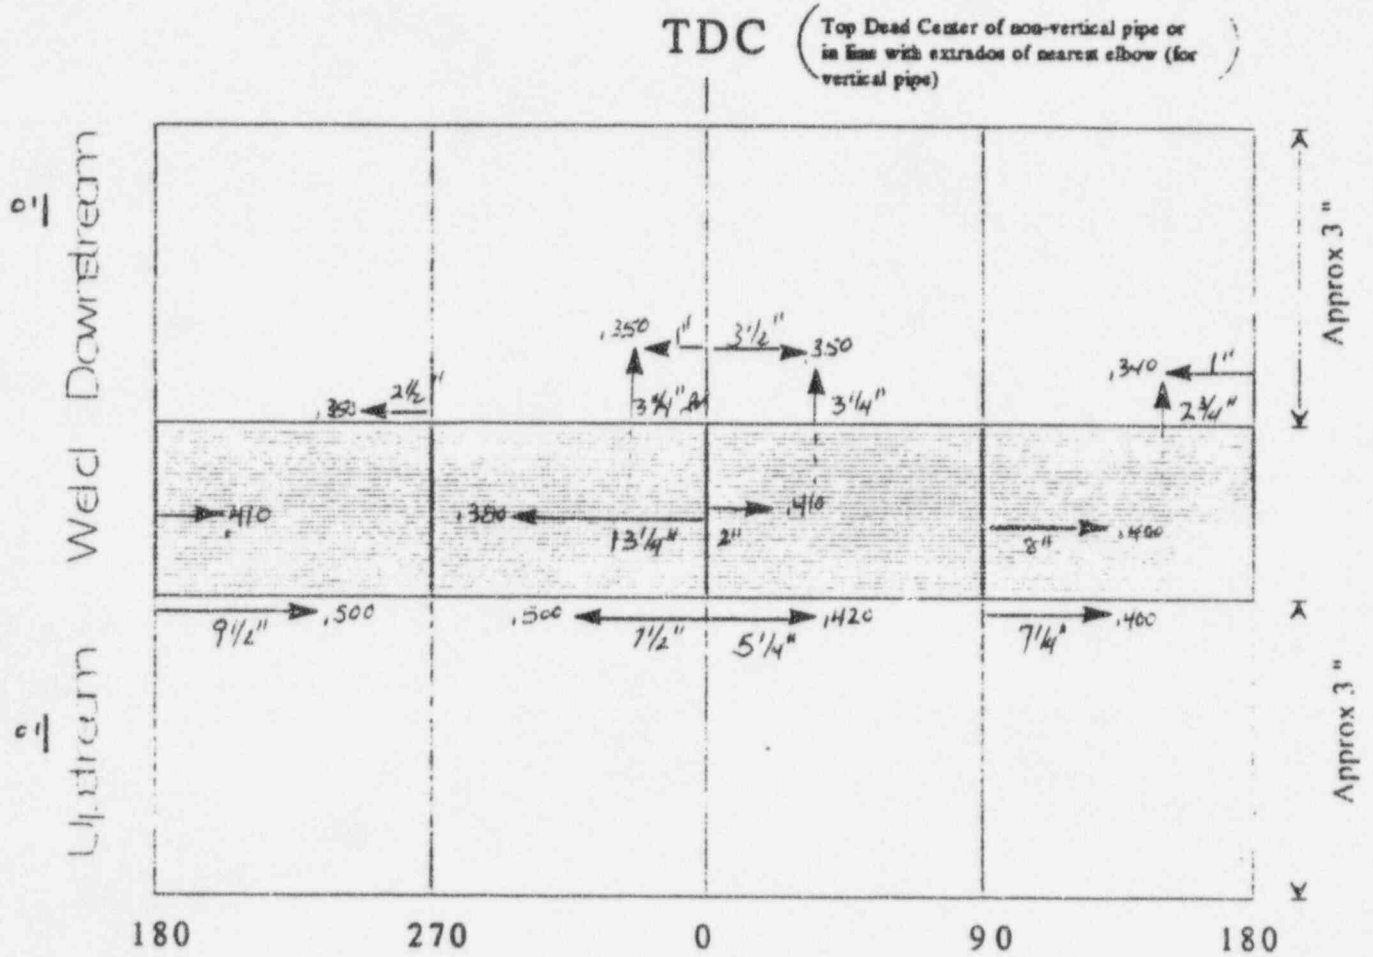
Line 1802 Weld No. F0902 Date 10-20-95

The location of the Lowest (thinnest) reading does N/A does not coincide with previous lowest reading (within 1")

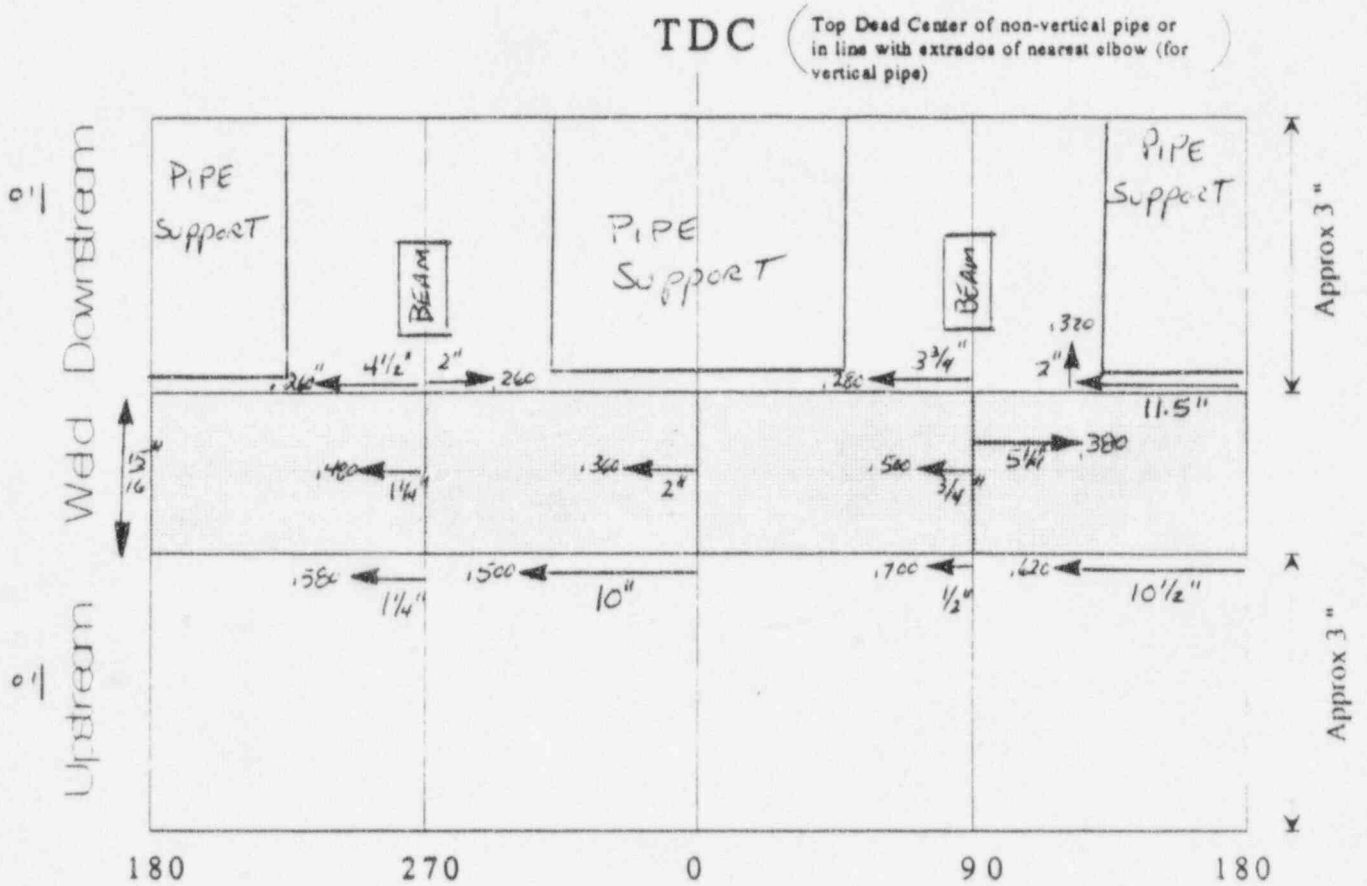
Line 1812 Weld No. F1002 Date 10-18-95

The location of the N/A
Lowest (thinnest) reading does does not coincide with previous lowest reading (within 1")

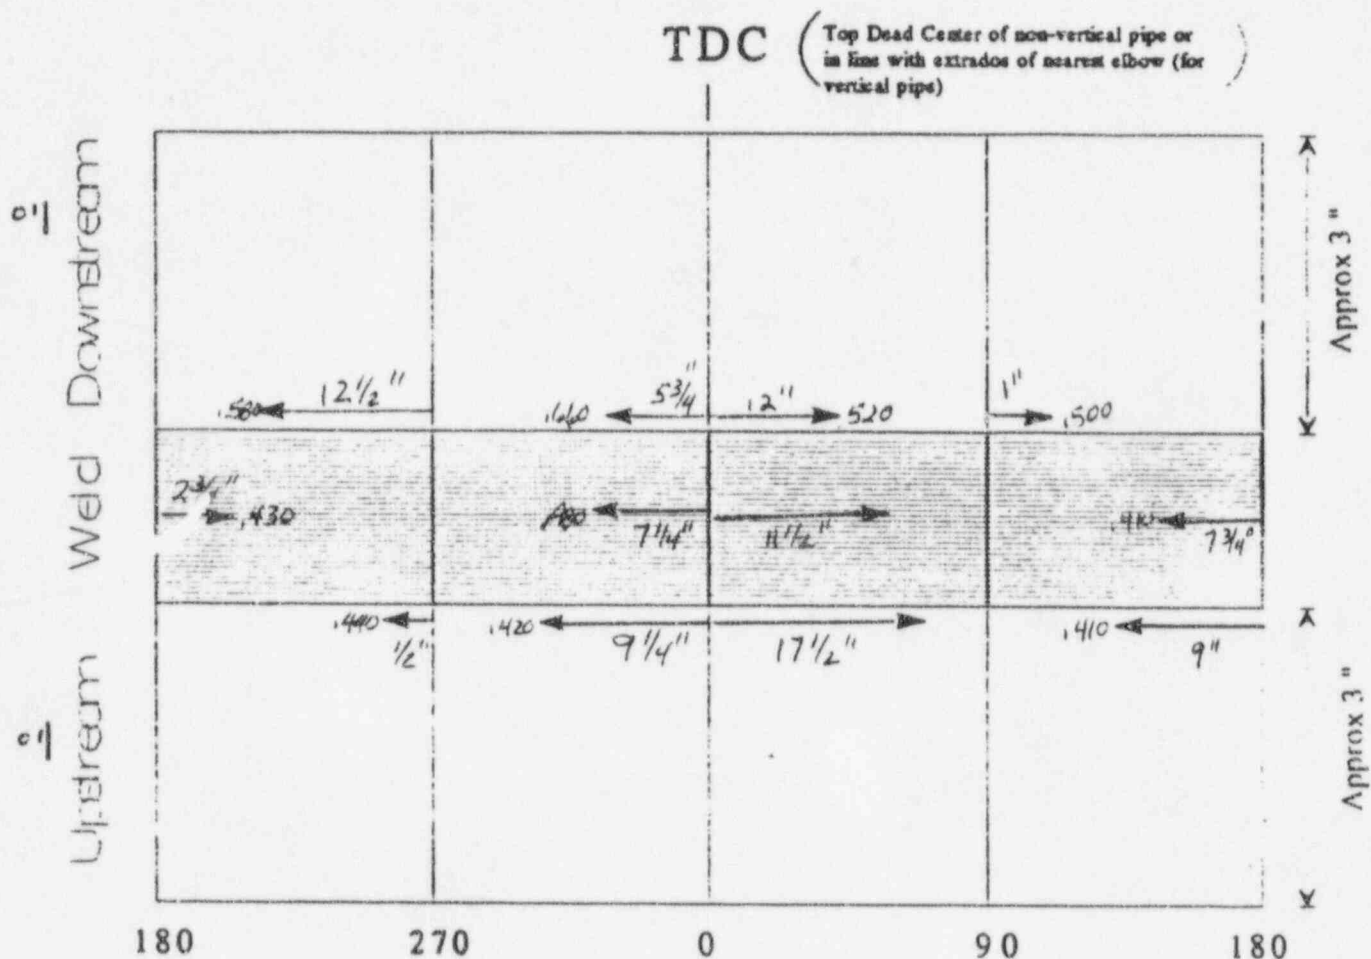
Line 1802 Weld No. F0701 Date 10-20-95

The location of the N/A Lowest (thinnest) reading does does not coincide with previous lowest reading (within 1")
