Docket No. 50-346

Toledo Edison Company
ATTN: Mr. Donald Shelton
Vice President
Nuclear
Edison Plaza
300 Madison Avenue
Toledo, OH 43652

SUBJECT: ADDITIONAL PROTECTION FOR LIGHTNING STRIKES AT NUCLEAR POWER
GENERATING STATIONS

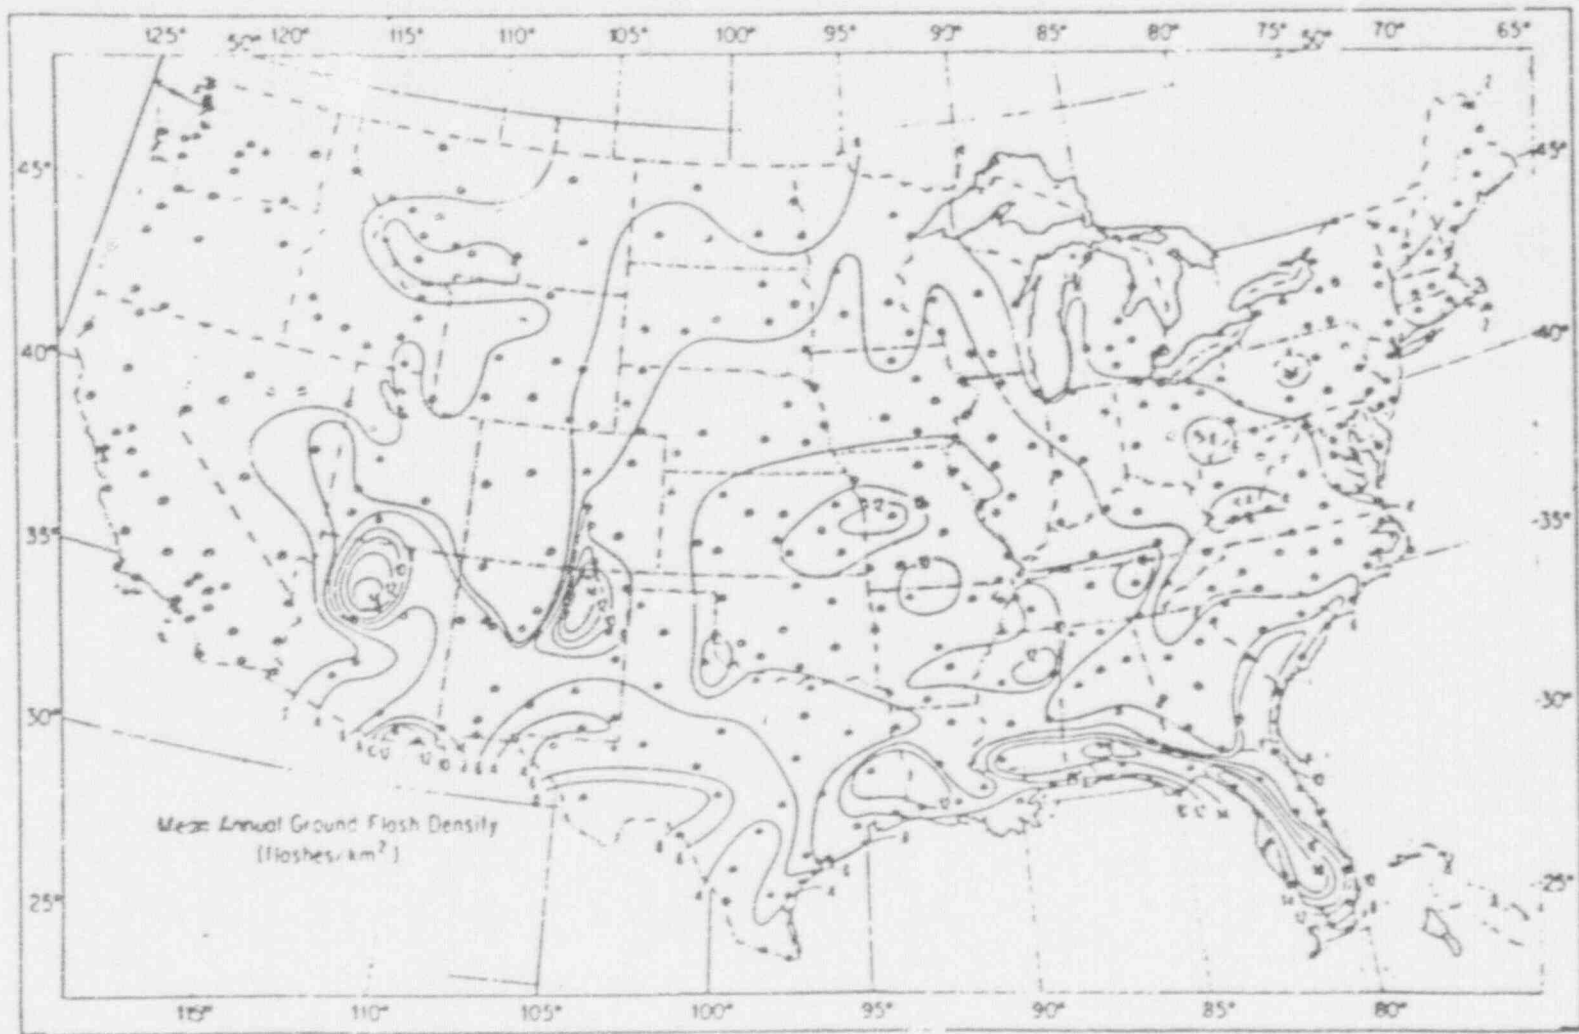
Figure 2 . Contour map of mean annual lightning strike density.

As seen on Figures 1 and 2, Byron is located in a region of medium lightning activity (6 flashes/square-km.). As such, is not expected to be subjected to many lightning strikes. However, because of the damage sustained during this strike, the licensee modified the lightning protection system of the containment structure to minimize the effect of any future strikes. To ensure that lightning strike currents are carried directly to ground, the containment lightning protection grid has been isolated from structural steel and new conductors have been routed from the grid to the station ground mat. These corrective actions should improve the protection provided to the safety-related instrumentation systems and equipment at Byron 1.
