SUBJECT: PROPOSED INFORMATION NOTICE ON THERMOLAG FIRE RETARDANT
MATERIAL

NRC INFORMATION NOTICE NO. 91- : FAILURE OF THERMOLAG FIRE BARRIER MATERIAL
TO PASS 3-HOUR FIRE ENDURANCE TEST

Subject: TSI's Response To The NRC Information Notice No. 91-47
"Failure of THERMO-LAG Fire Barrier Material To Pass Fire
Endurance Test"

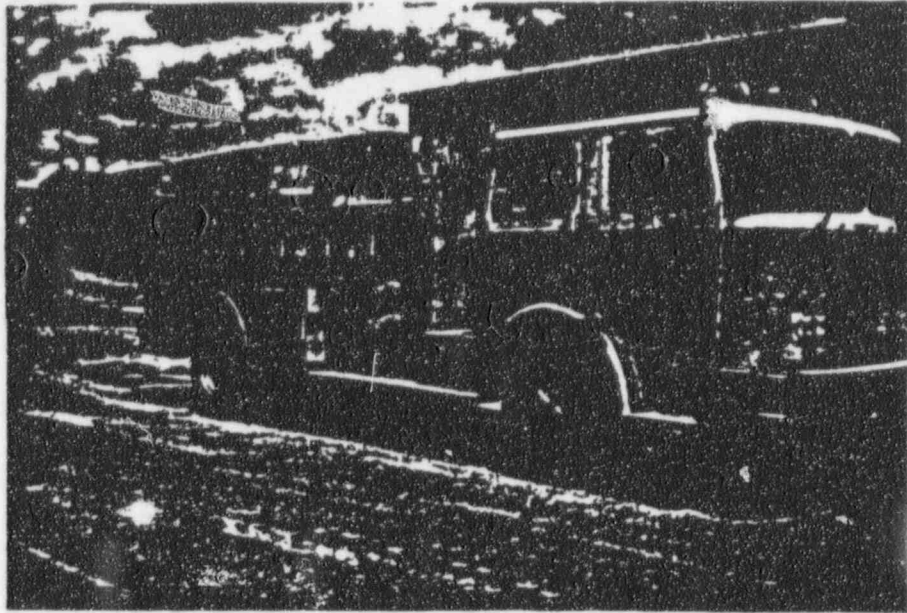
3. After 45 minutes of fire exposure, slight 'cracking' was observed in the Thermo-Lag 330-1 Subliming Coating Envelope System "CHAR FORMATION" on the air drop envelope and the upper horizontal leg envelope. These observations were made through the viewing windows of the Test Facility. Such cracking in the char formation is normal and has been repeatedly observed by the Author in other Thermo-Lag 330-1 Subliming Coating fire tests on Plates, Beams, etc.

Such char formation cracking usually occurs long after sublimation of the coating and is felt to be due to continued heating of the char and the resultant expansion of the char, a normally expected sequence of events. Figure 10 presents a photograph of the Cable Tray Test Specimen after the removal from the ASTM-E-119 Fire Simulation Facility. The char formation cracking, or checking, can be observed in the outer areas of the Thermo-Lag 330-1 Subliming Coating Envelope. However, it is important to note that the depth of this cracking or checking is limited to the char. This cracking or checking does not penetrate into the un-sublimed lower layers of the envelope system, as will be shown later in this report.

CRACKING IN CHAR FORMATION

FIGURE 10: PHOTOGRAPH OF CABLE TRAY AND AIR DROP TEST ASSEMBLY AFTER 65-MINUTES OF EXPOSURE TO THE TSI ASTM-E-119 FIRE SIMULATION FACILITY
