In the Matter of  
DUKE POWER COMPANY, ET AL.  
(Catawba Nuclear Station, Units 1 and 2)  
Docket Nos. 50-413 and 50-414 *OK*

REVIEW AND EVALUATION  
OF TRANSAMERICA DELAVAL, INC.,  
DIESEL ENGINE RELIABILITY AND  
OPERABILITY - CATAWBA NUCLEAR  
STATION UNIT 1

August 1984

Pacific Northwest Laboratory  
Richland, Washington 99352

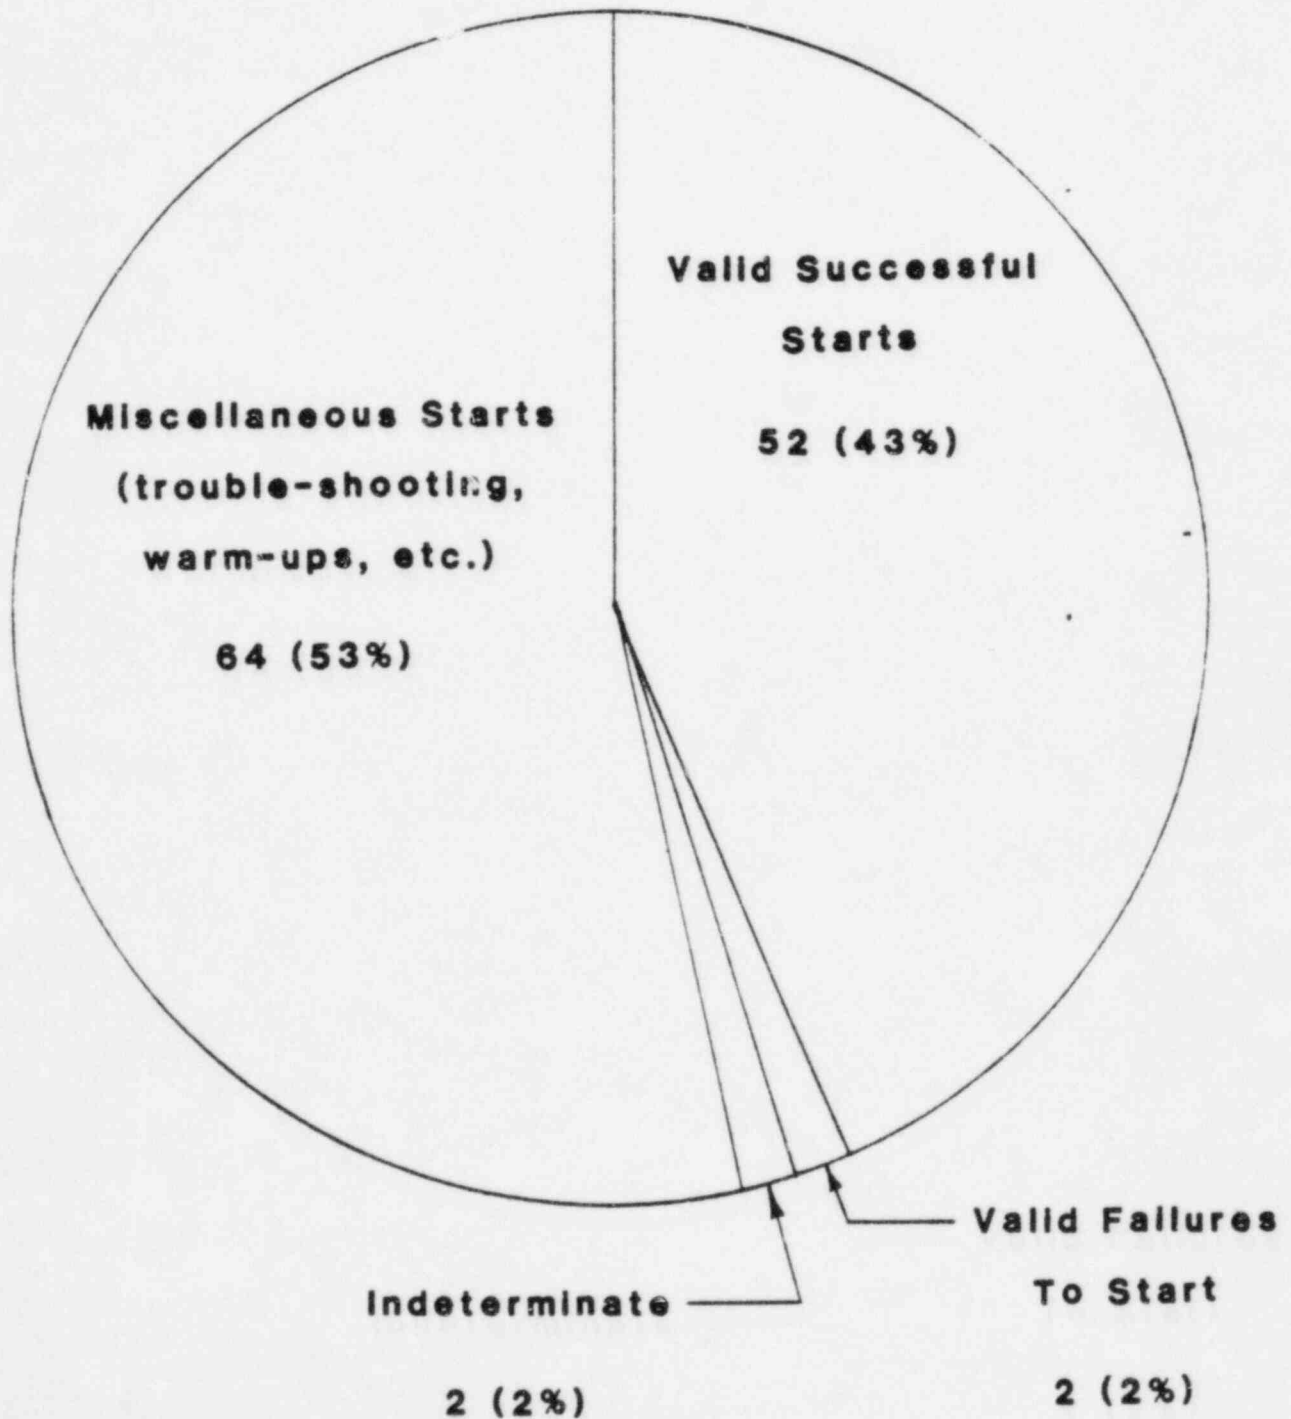
Fig. 1.

The Catawba Unit 1 diesels have been through a combines total of 361 documented attempts to start, of which there have been 7 valid failures to start (2%). (See Section 3.0 for definitions.) A summary of the starts for the 1A and 1B diesel engines are shown graphically in figures 1 and 2. The valid failures to start are addressed in section 4.0. It should be noted that there are no invalid failures to start for both the 1A and 1B diesels.

# Diesel Generator 1A

Total Start Attempts 120

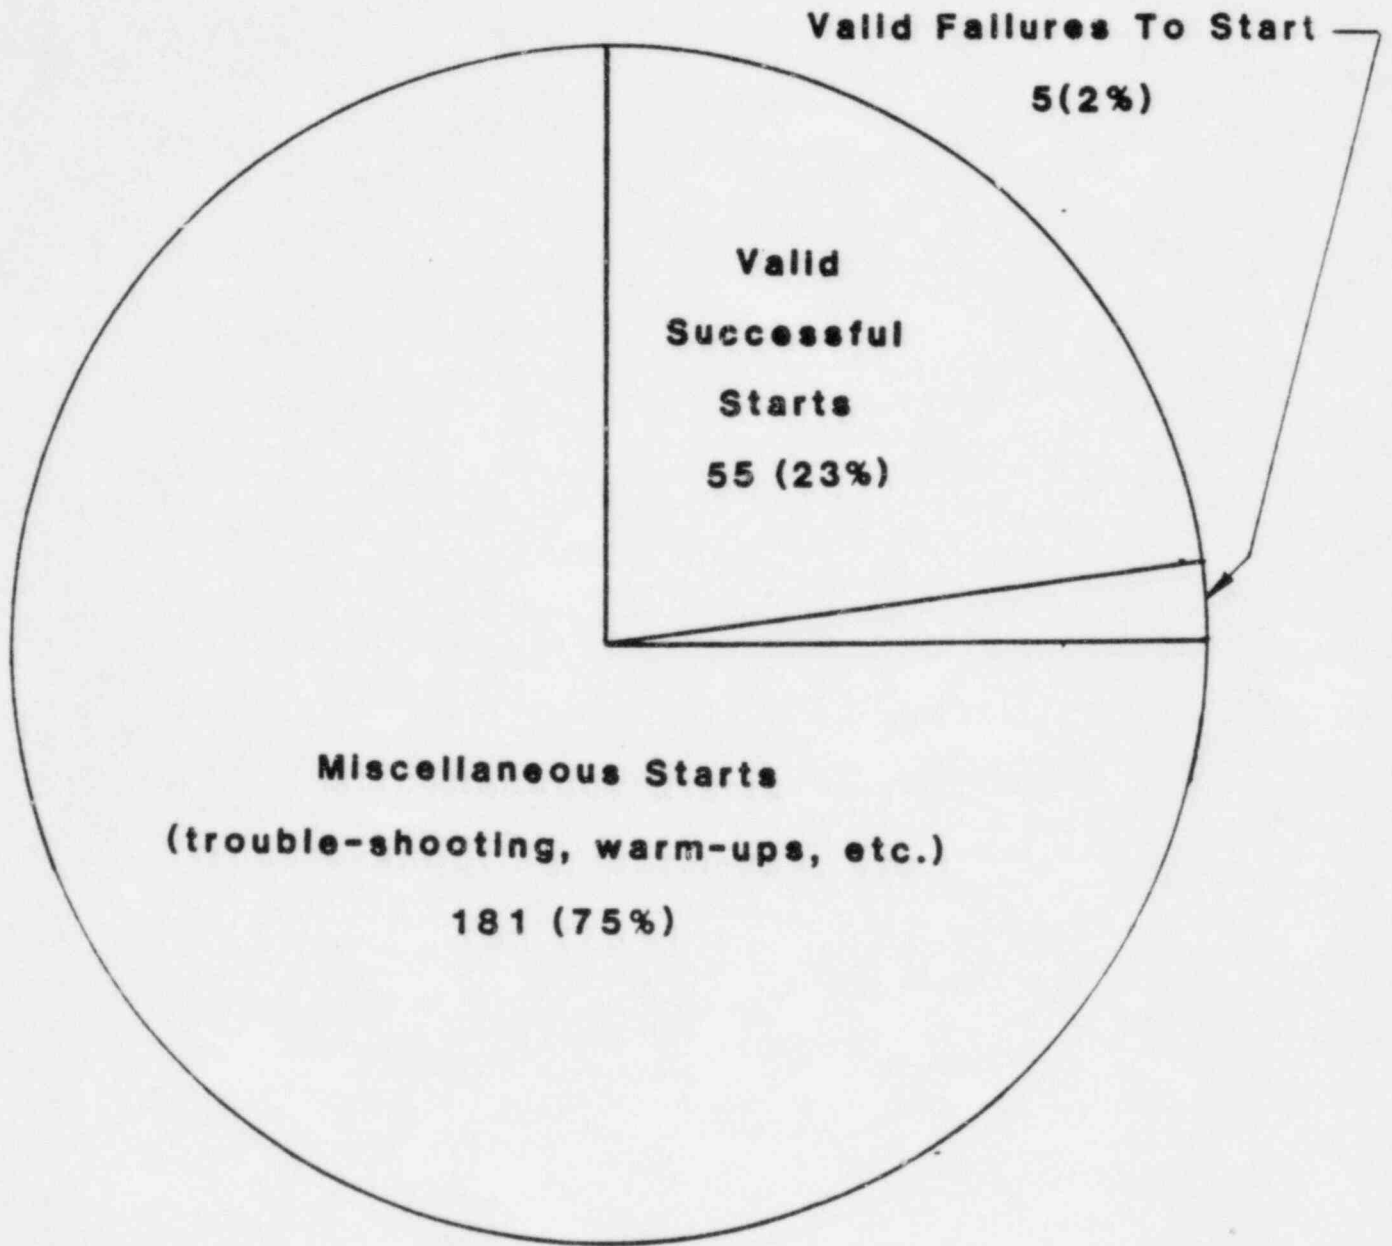
Fig. 2.

# Diesel Generator 1B

Total Start Attempts 241

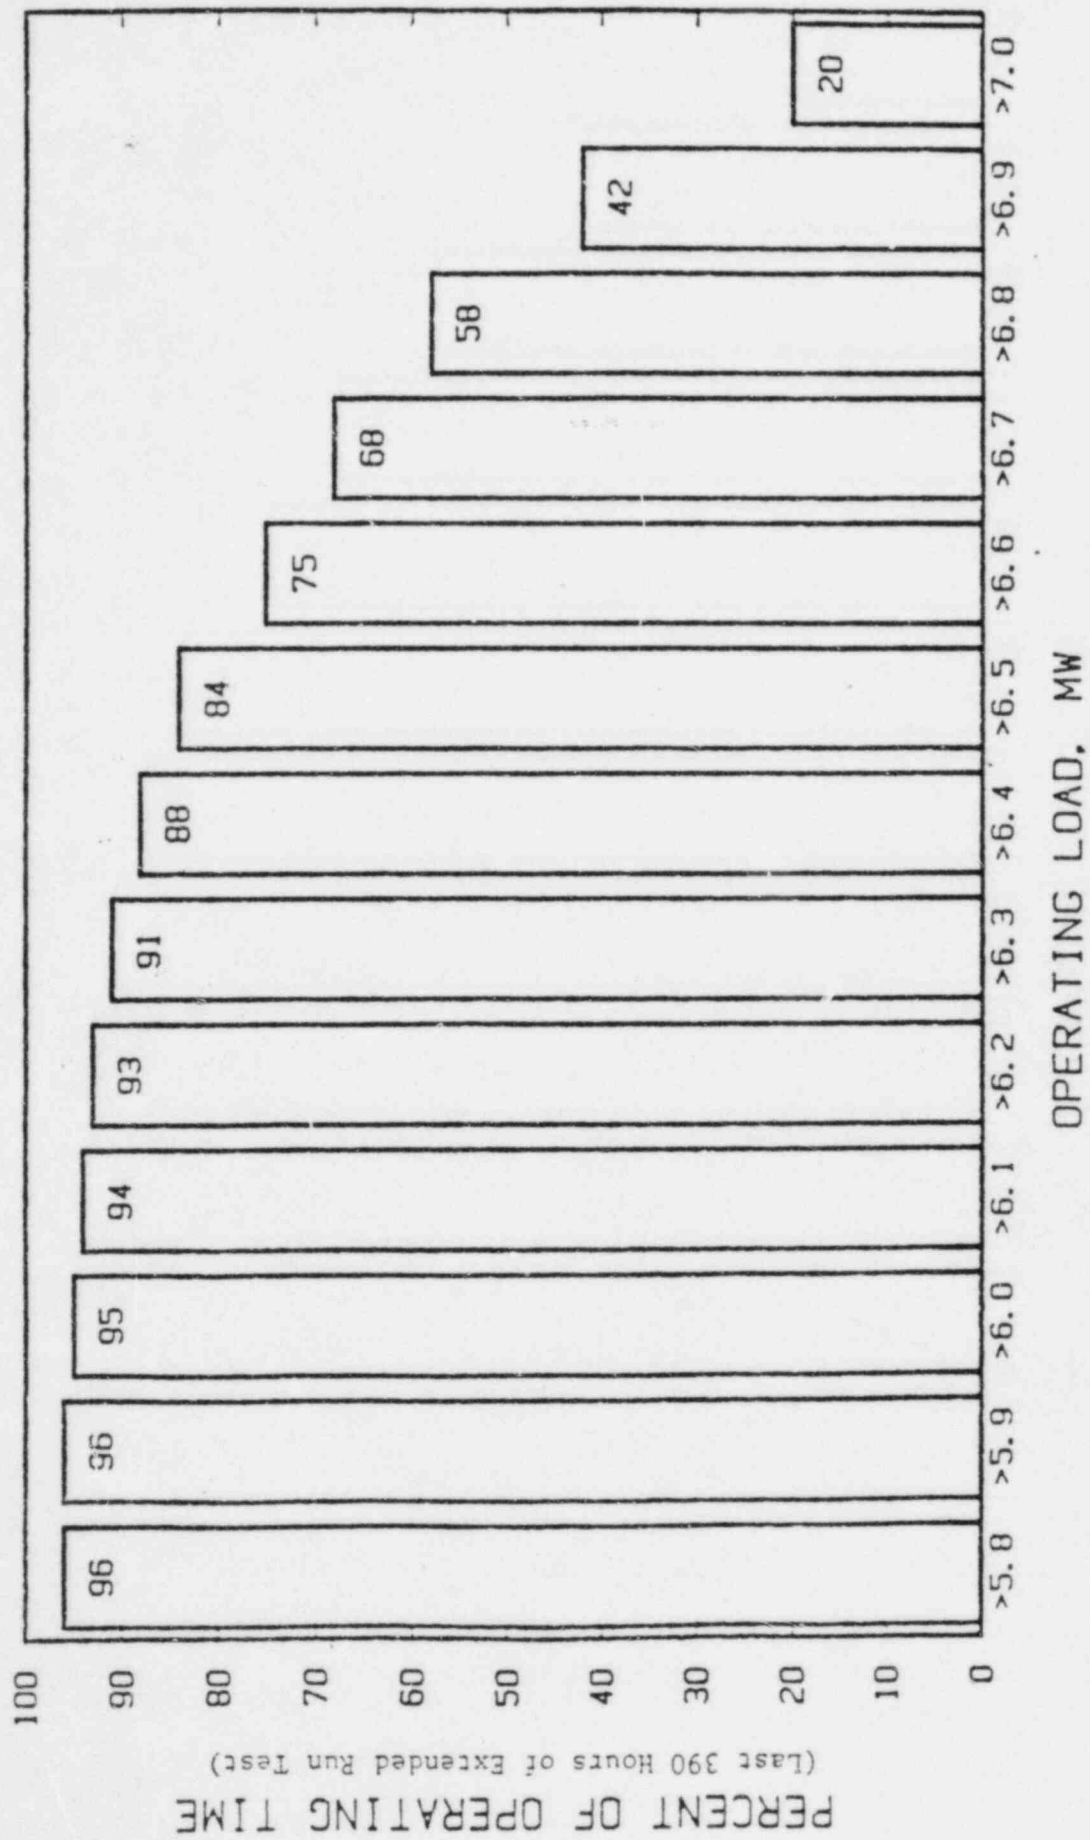
FIGURE 4-1

The Catawba TDI DSRV-16-4 diesels have a rated load of 7000kw. The maximum calculated emergency diesel generator load under blackout conditions is 5714kw (the engines have about a 18.4% margin in load capability). During the extended operation test, the engine was operated at loads in excess of the required 5714kw approximately 97% of the test period. Specifically, during the last 390 hours of documented extended run test period the generator load was in excess of 5800kw 96% of the operating time. Figure 4-1 illustrates, for the last 390 hours, the diesel 1A operating profile with a bar chart that indicates the percent of diesel operating time the diesel generator load was in excess of the specified load. The diesel load was calculated based on generator volts, amps and power factor.

CATAWBA NUCLEAR STATION  
 DIESEL GENERATOR 1A

PERCENT DIESEL OPERATING  
 TIME VS. DIESEL  
 GENERATOR LOAD
