U.S. NUCLEAR REGULATORY COMMISSION
OFFICE OF INSPECTION AND ENFORCEMENT
REGION III

Report No. 050-329/78-20; 050-330/78-20

Subject: Consumers Power Company
Midland Nuclear Power Plant, Units 1 and 2
Midland, Michigan

Settlement of the Diesel Generator Building

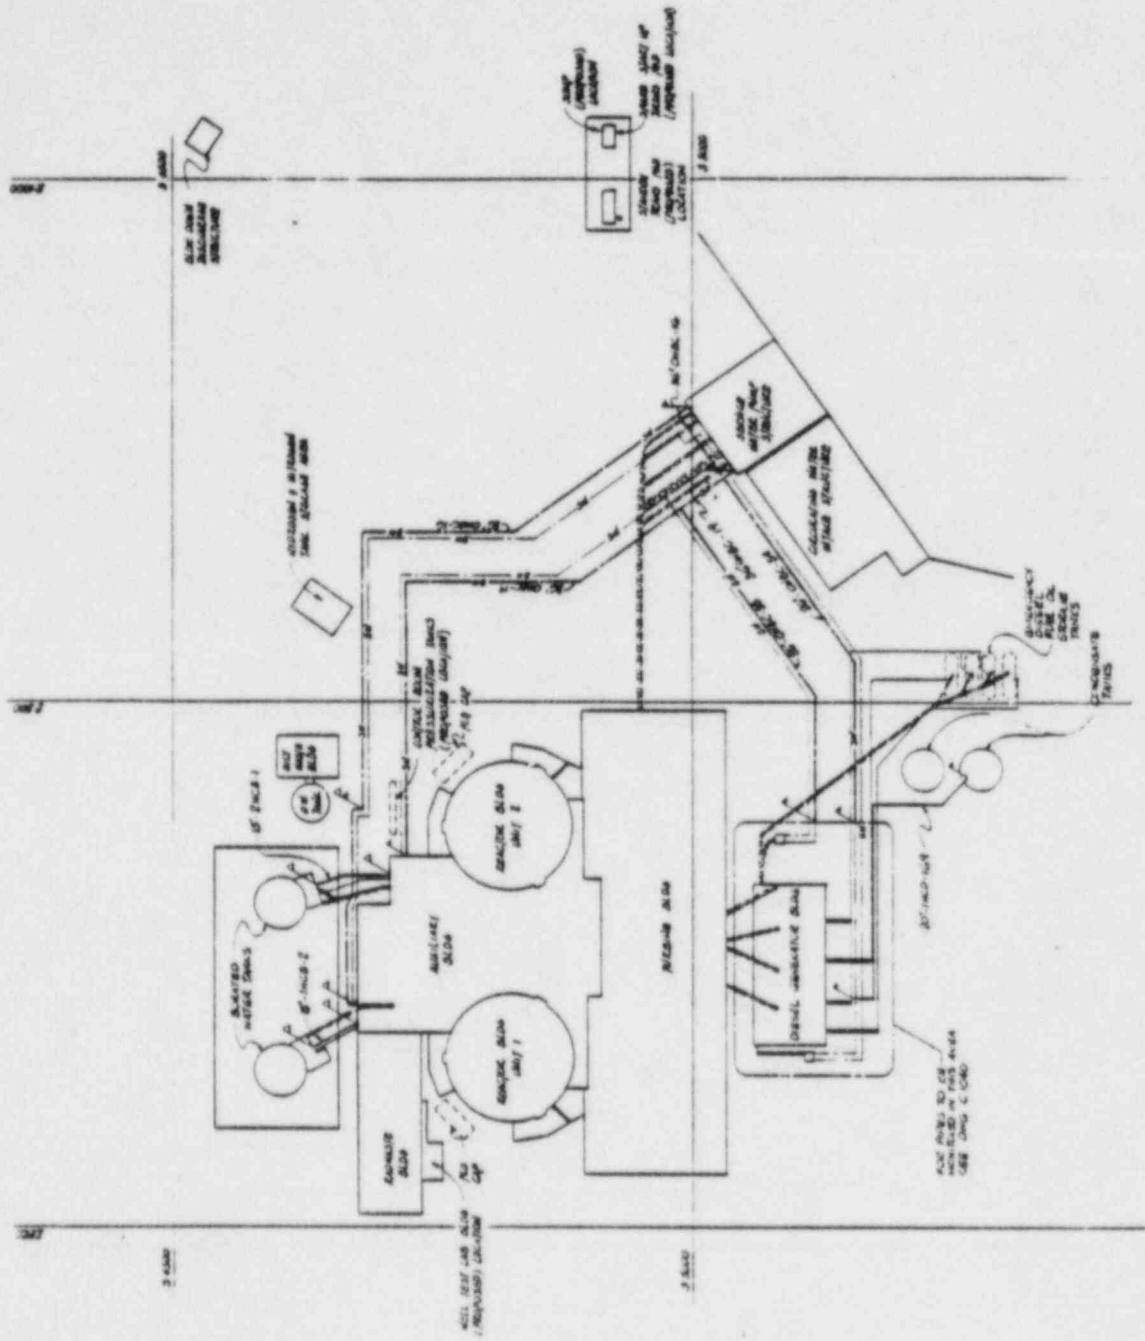
Fig. 6

The underground facilities that will be discussed are Seismic Category I piping and electrical duct banks. Figure 6 shows safety-related piping, namely Service Water Lines, from the auxiliary building to the service water structure and from the diesel generator building to the service water structure, borated water lines from the auxiliary building to BWST, and diesel oil lines from the diesel oil storage tanks to the diesel generator building. Also shown are electrical duct banks.

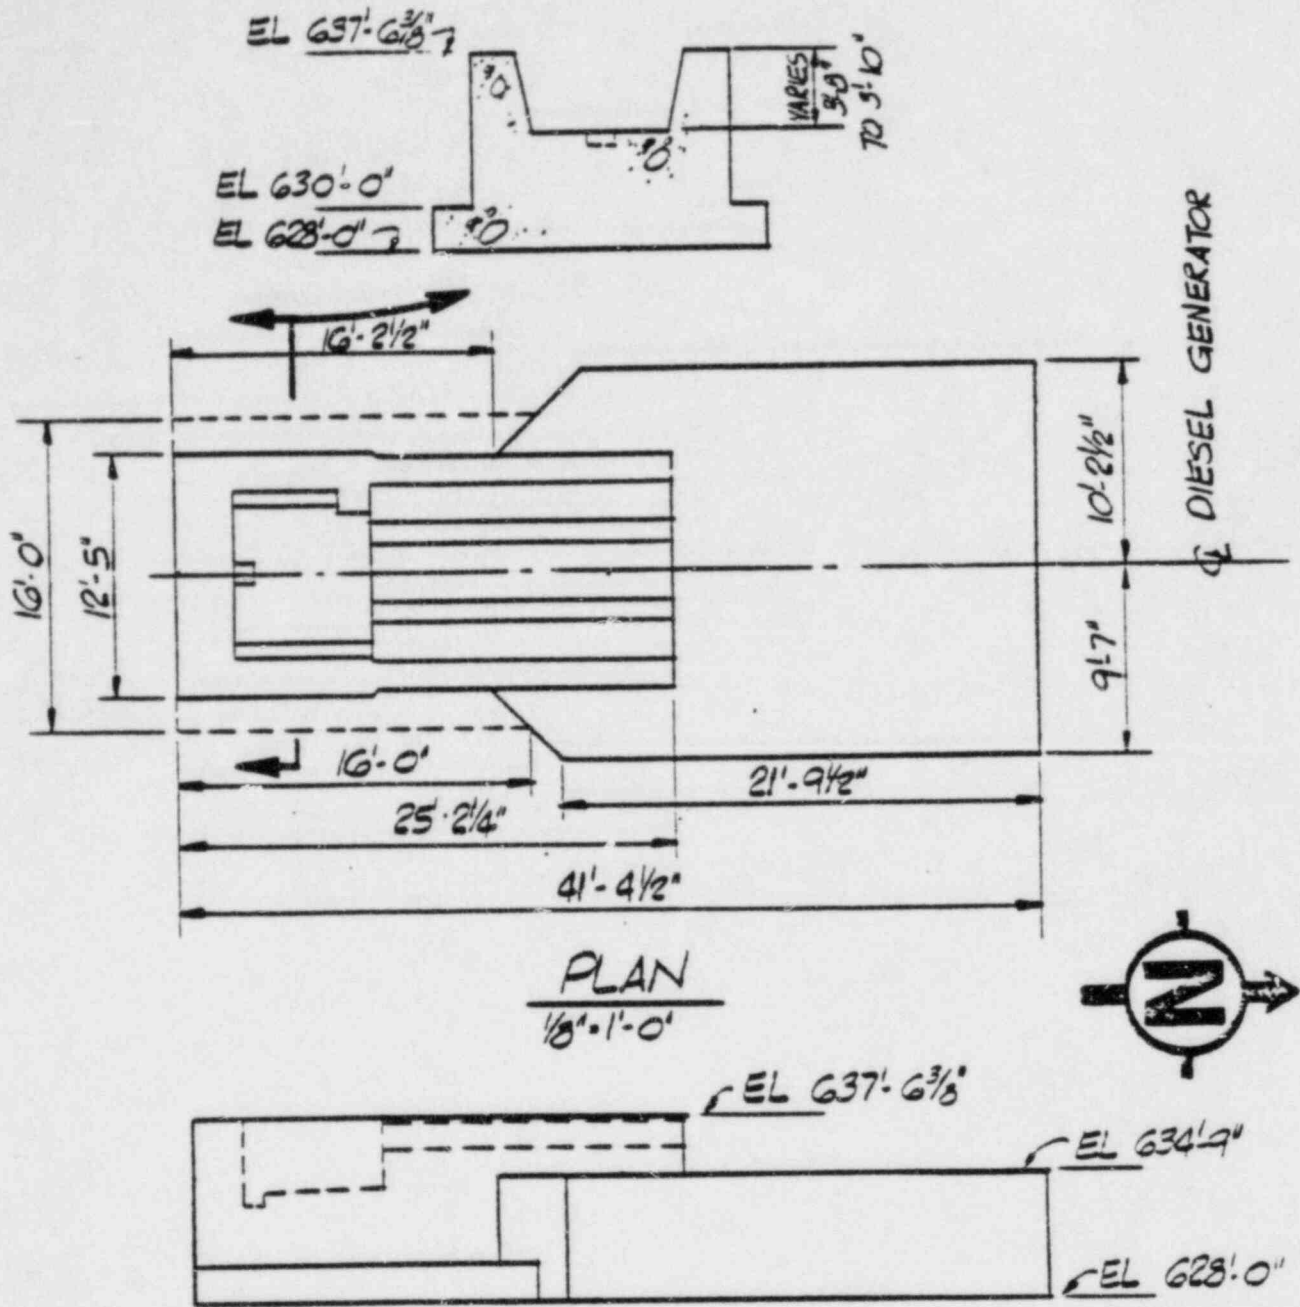
FIG. 17

Figure 17 shows plan and cross-sectional elevations of a typical diesel generator pedestal. This is a reinforced concrete structure having a minimum compressive strength of 4000 psi. The fill beneath the pedestals have also consolidated resulting in differential settlement. Differential settlement of the pedestals will have no effect on alignment of the engine and the generator because they are both mounted on the same foundation. Furthermore, because of the enormous stiffness of the pedestal, no significant warping is expected and the top of the pedestal will generally lie within one plane. The diesel generator will be set in a level position irrespective of the amount of differential settlement between the corners of the pedestal. It will be achieved either by a suitable layer of grout on the pedestal or by chipping a few inches of the top concrete and refinishing it to the required level.

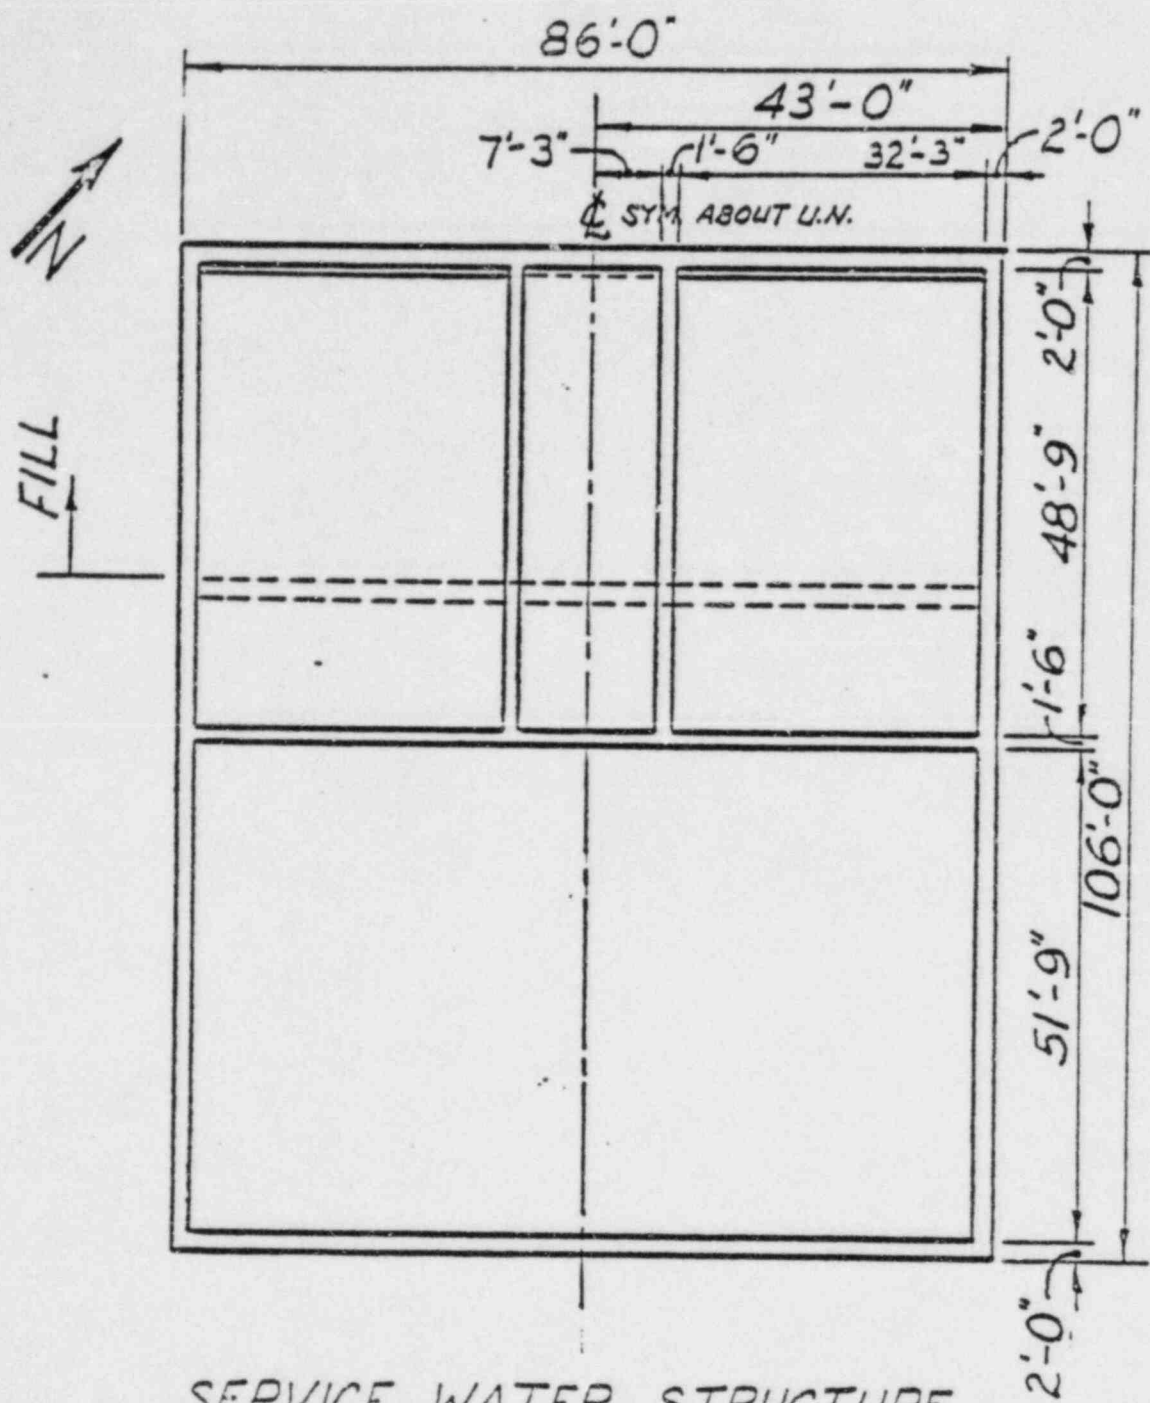
FIG. 18

The service water pump structure is located in the southeast end of the power block area adjacent to the cooling pond. (See Figure 6.) Figure 18 shows a plan view of the structure. The cooling pond is on the southern side. The major portion of the structure is founded on natural soil material except for the northern portion which is founded on fill. Figure 19 shows a cross-sectional view of the structure. As mentioned earlier, the northern section, which is cantilevered off the main building, is founded on backfill material. As a follow-up to the investigation of all Class I structures on fill, several borings were taken in this area. The borings indicated that the backfill consists of soft to very stiff clay and loose to very dense sand. The conclusion was that some areas of the fill material under the northern part of the structure were not sufficiently compacted. However, no significant settlement of the structure has been noted. The reason for this is that the existing dead loads from this portion are being partially supported by the rest of the structures through cantilever action. The remedial measure chosen is to support the north wall on piles driven to hard glacial till. The choice of piles is an economical and expedient solution with minimal impact on the schedule.

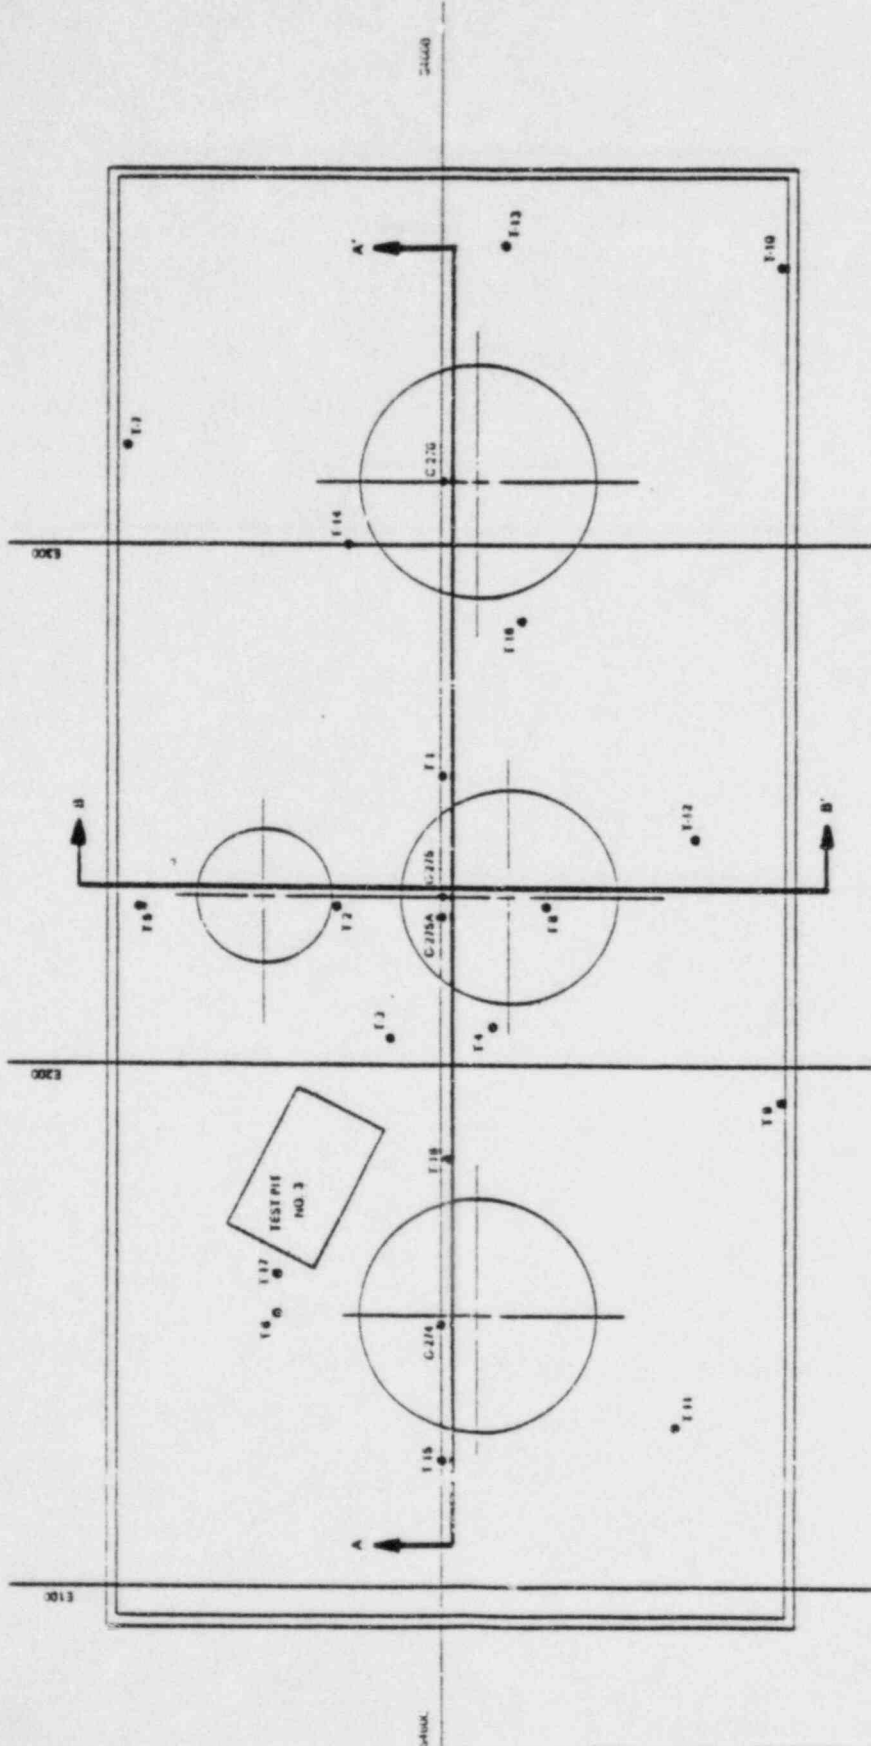
FIG.23

Figure 23 shows the tank farm in plan. There are two borated water storage tanks (BWST), a utility tank and a primary storage tank. Of these, only the BWSTs are safety-related. Each BWST has a capacity of 500,000 gallons and is 52 feet in diameter and 32 feet in height.

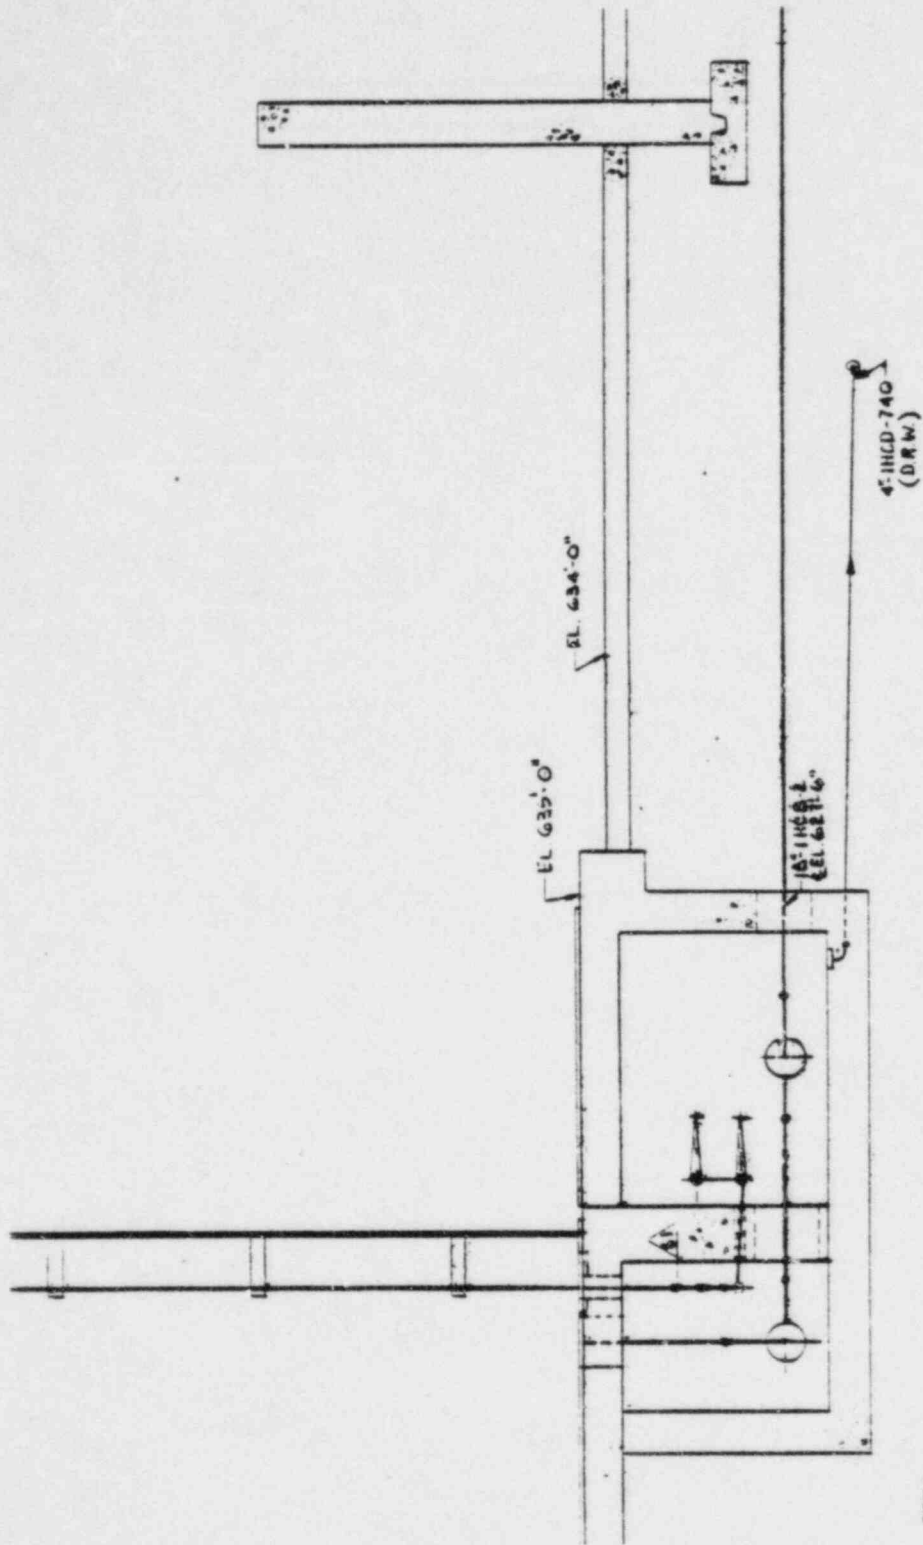
FIG. 24

As shown in Figure 24, a short concrete ring girder foundation with a strip footing is provided for each BWST. The tank is supported on the ring girder and the soil within the foundation. The tank by itself is quite flexible.

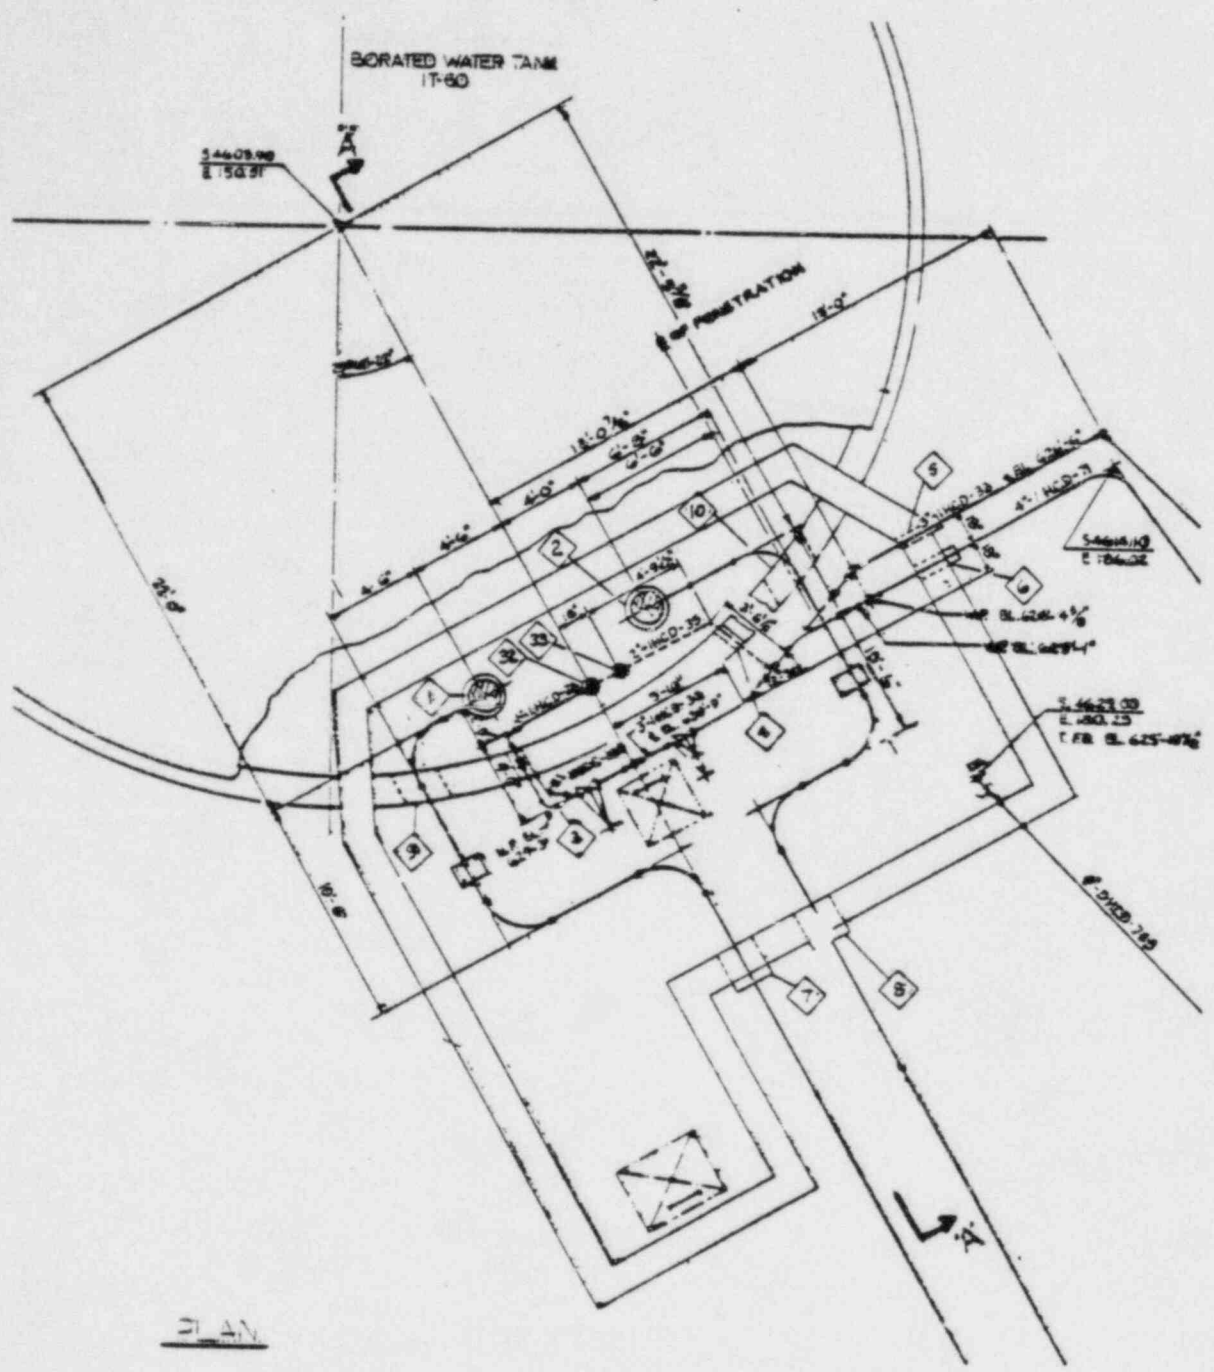
FIG. 25

Figure 25 shows the layout of borated water lines entering the tank through the valve pit. The piping connections are being made to allow startup, flushing, filling and testing of the tank. Selected points on the piping between the BWSTs and the auxiliary building will be monitored for settlement during construction phase. Any differential settlement measured will be analyzed in accordance with established procedures.

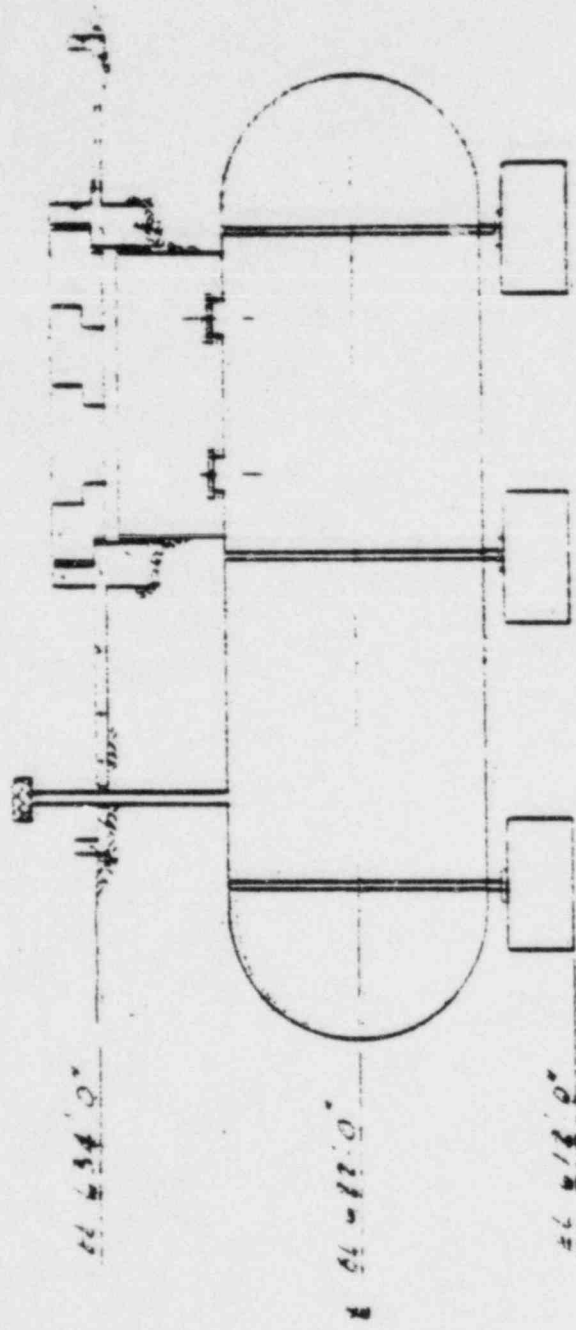
FIG. 26

Figure 26 shows a cross-sectional view of a tank. There is six feet of earth covering each tank. The tanks are supported at three points anchored to concrete pedestals. The tanks are founded on backfill and results of the boring program indicated that the tanks are supported on medium to stiff sandy clay backfill. This soil condition is adequate to support the tanks. Moreover, the weight of the tanks is approximately equal to the fill that it replaced. In order to verify that the fill is satisfactory, these tanks have been filled with water and settlements are being monitored. It has been three months since the tanks have been filled with water and no appreciable settlements have been noted yet. Therefore, the backfill is considered adequate and no remedial measures are anticipated.

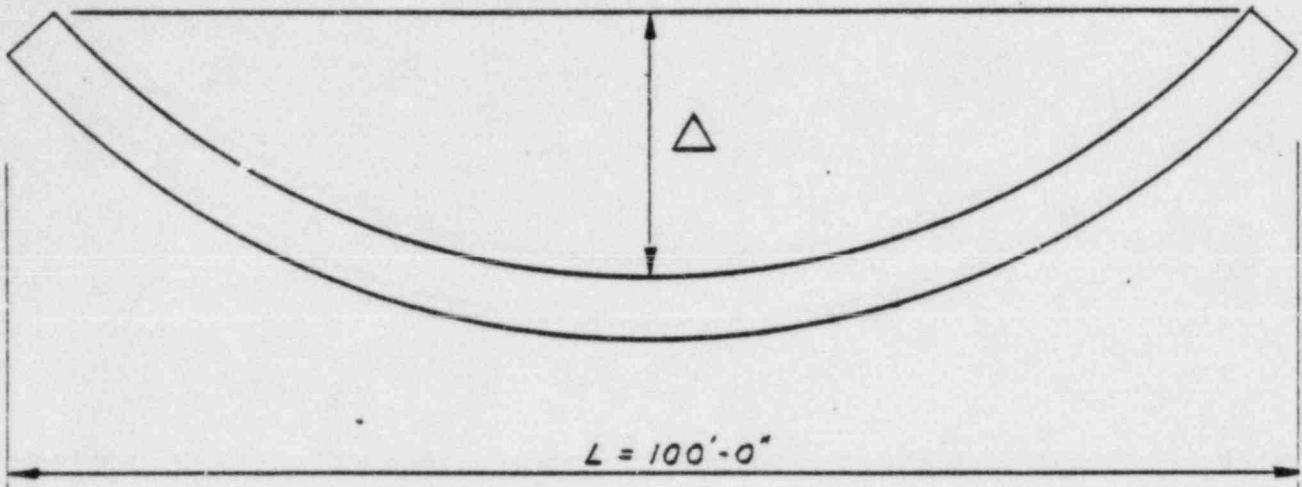
FIG.28

As shown in Figure 28, a preliminary calculation indicated that a typical duct bank of 100 feet in length can undergo a maximum of 12" of central deflection in pure bending at ultimate load.

FOR A DUCT BANK 54" x 35" DEEP
 Δ WHEN STEEL YIELDS = 15"

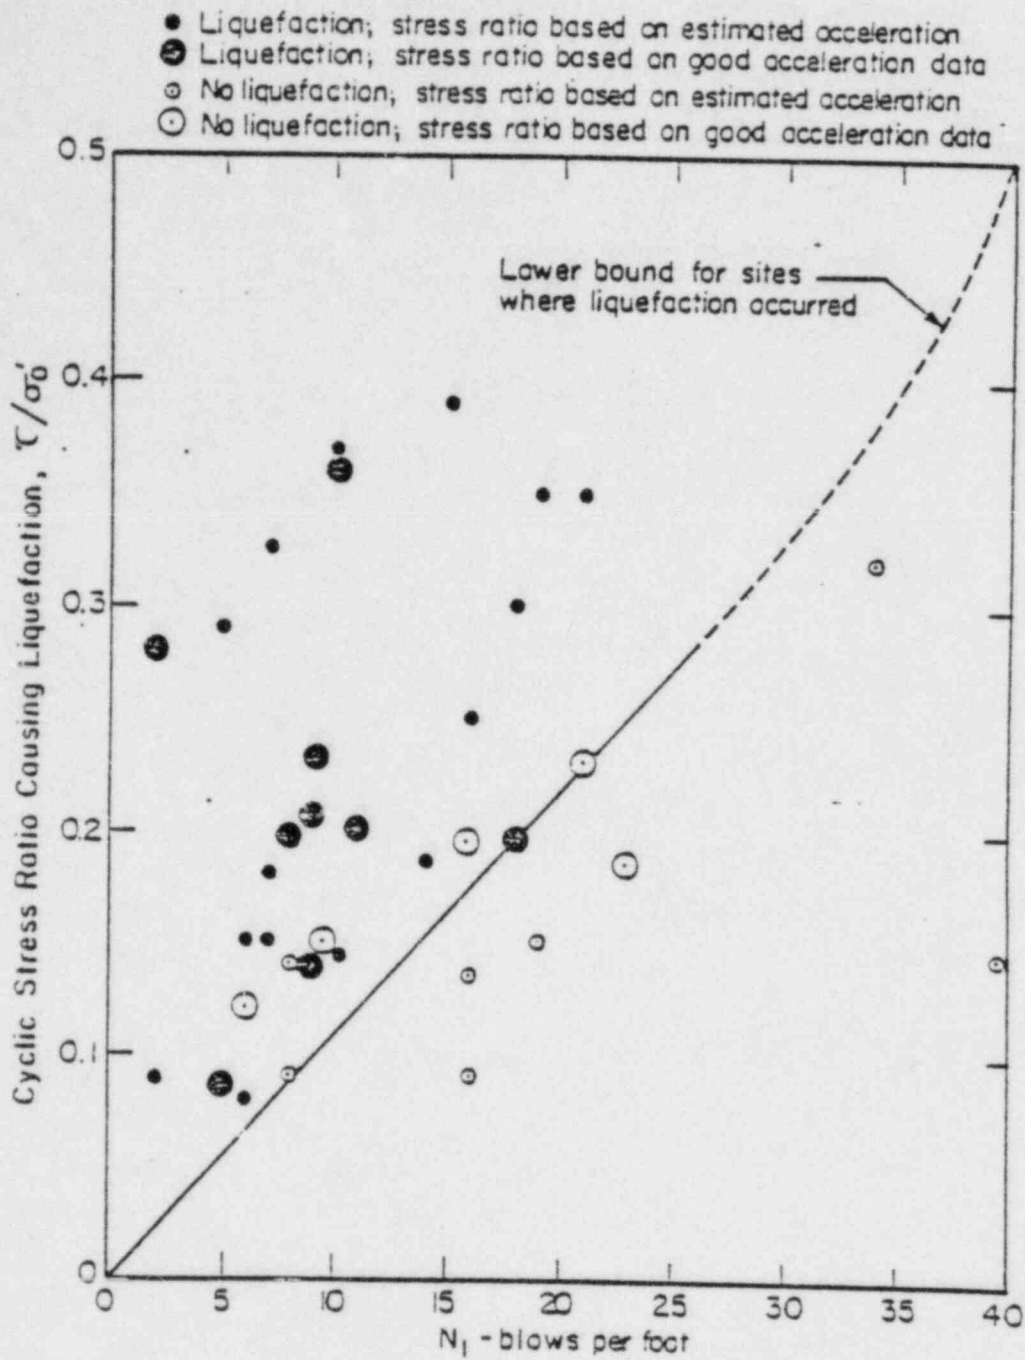
FIGURE 35

Figure 35 is a plot of the cyclic shear stress ratio causing liquefaction versus the standard penetration blowcount corrected to an equivalent overburden pressure of 2,000 pounds per square foot. The figure correlates the shear stress causing liquefaction in the field and the penetration resistance of the sand. Utilizing this figure, if the standard penetration resistance is known at a certain site along with other pertinent information regarding the soil column, the structure and ground surface acceleration, a point can be plotted on this graph. The horizontal coordinate of this point will be the standard penetration resistance after correction to an equivalent overburden pressure of 2,000 psf and the vertical coordinate will be the shear stress ratio induced during the earthquake. If the point falls below the line, this will indicate liquefaction would not occur. On the other hand, if the point plots above the line, this would indicate that liquefaction is possible. This can be illustrated in terms of factor safety as follows.

The liquefaction evaluation was based on ground water table at elevation 627 and ground surface acceleration of 0.12g and did account for surcharge from the structure. It is noted that figure 35 is based on data for magnitude 7.5 earthquake which constitutes a very conservative basis for evaluation of liquefaction at Midland.

CORRELATION BETWEEN STRESS RATIO CAUSING LIQUEFACTION IN THE FIELD AND PENETRATION RESISTANCE OF SAND. (after Seed et al)

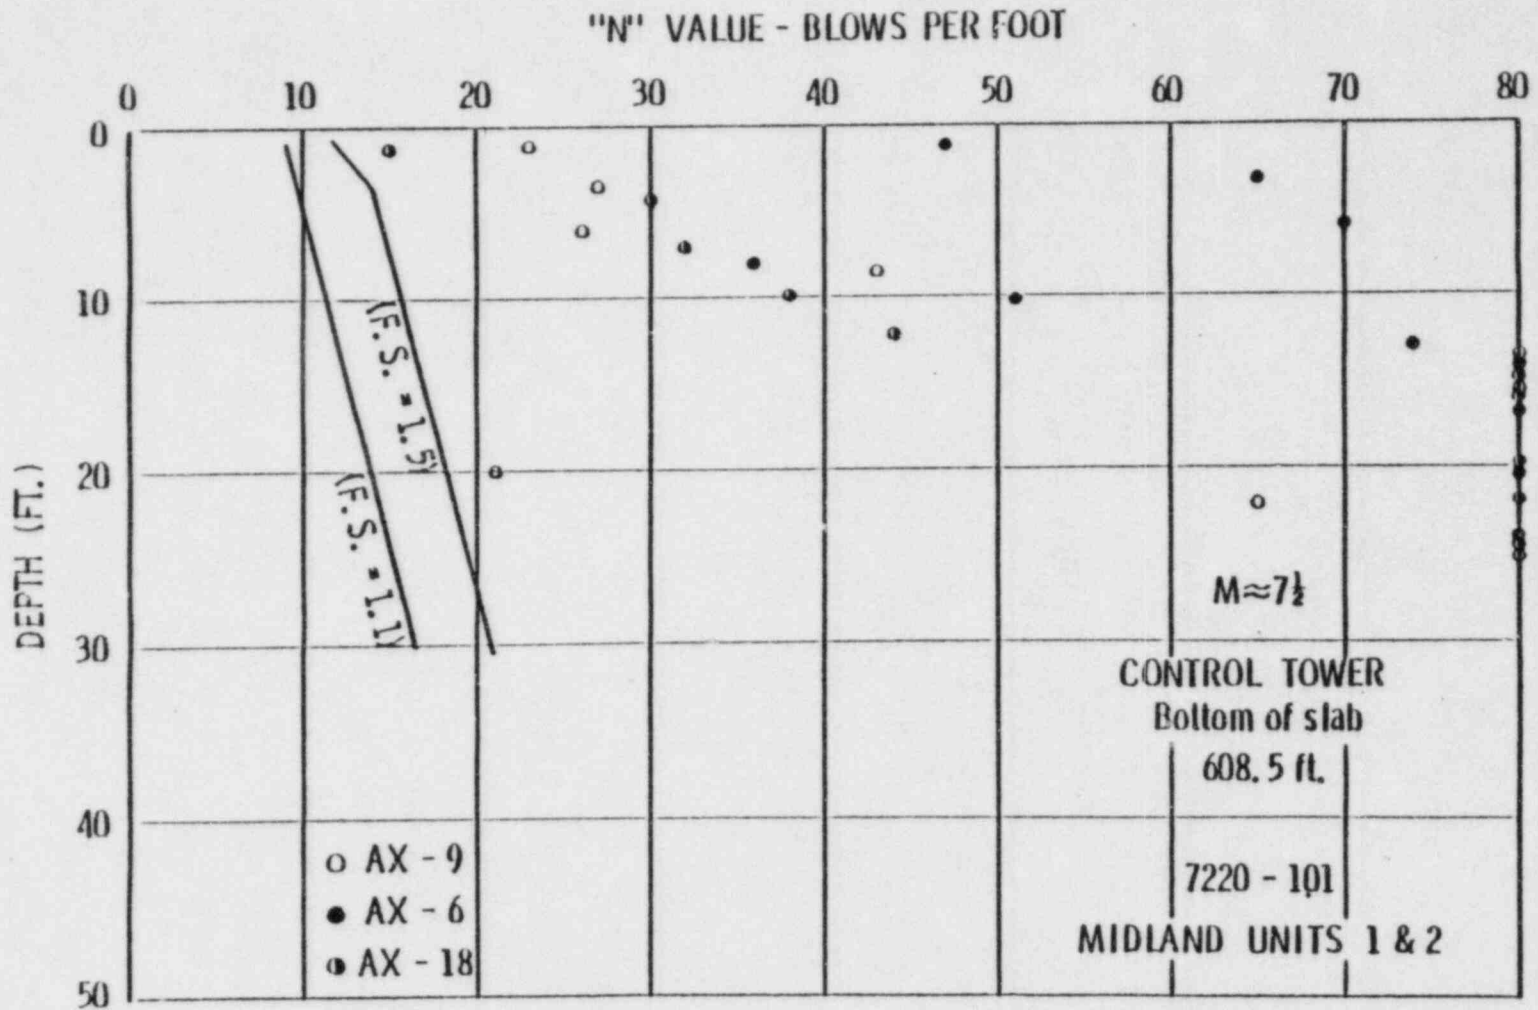
FIGURE 39A

Figure 39A illustrates that the standard penetration blowcounts from boring AX-9, AX-6 and AX-18 under the control tower indicate a factor of safety in excess of the required 1.5 in all cases. Figures 39B, C and D show the relationship between standard penetration resistance, relative density, and effective overburden pressure for the three areas indicated.

STANDARD PENETRATION BLOWCOUNT VERSUS
DEPTH FOR AUXILIARY BUILDING CONTROL TOWER

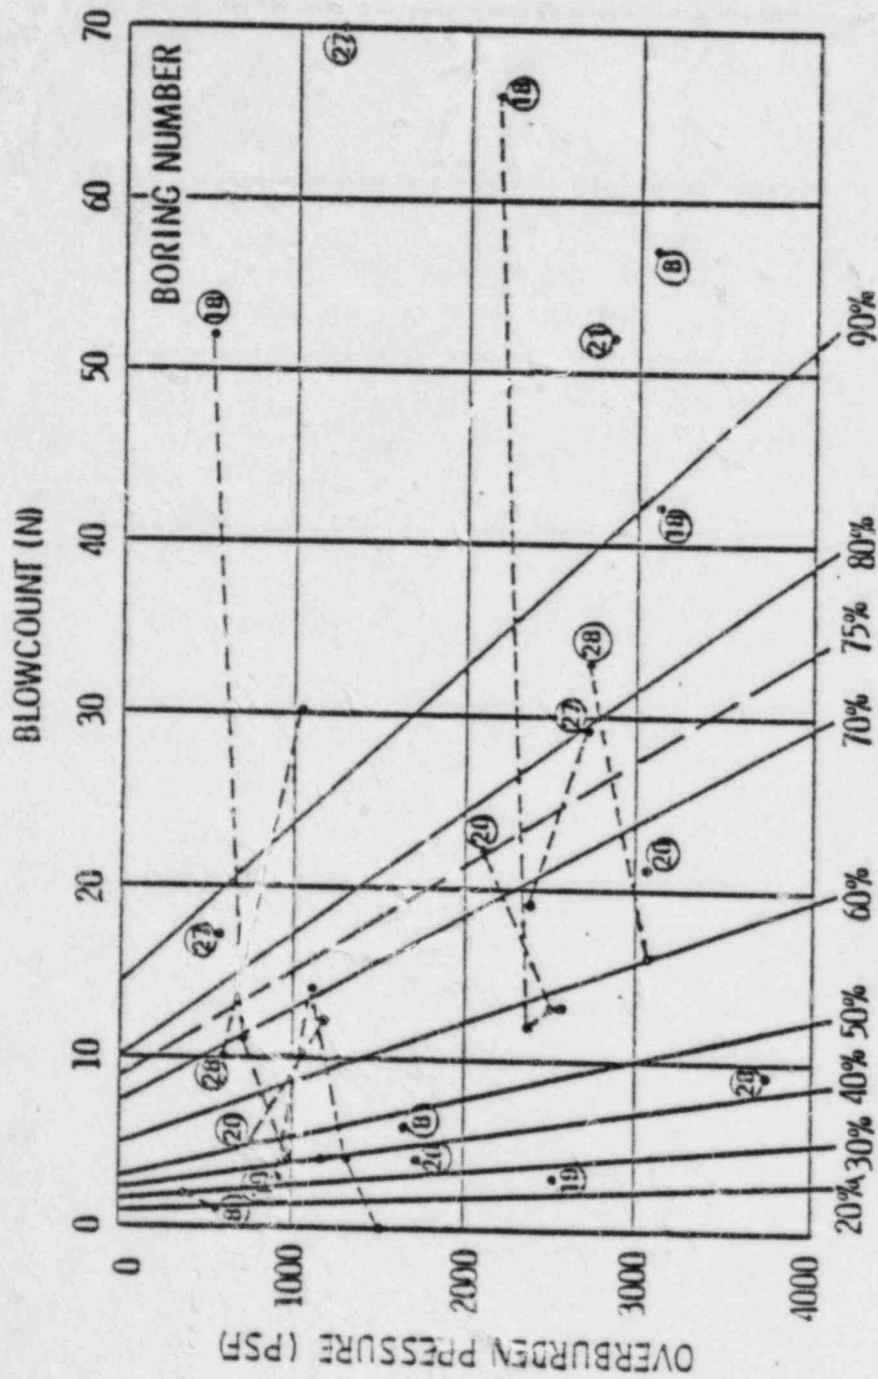
FIGURE 39B

MIDLAND - DIESEL GENERATOR BUILDING

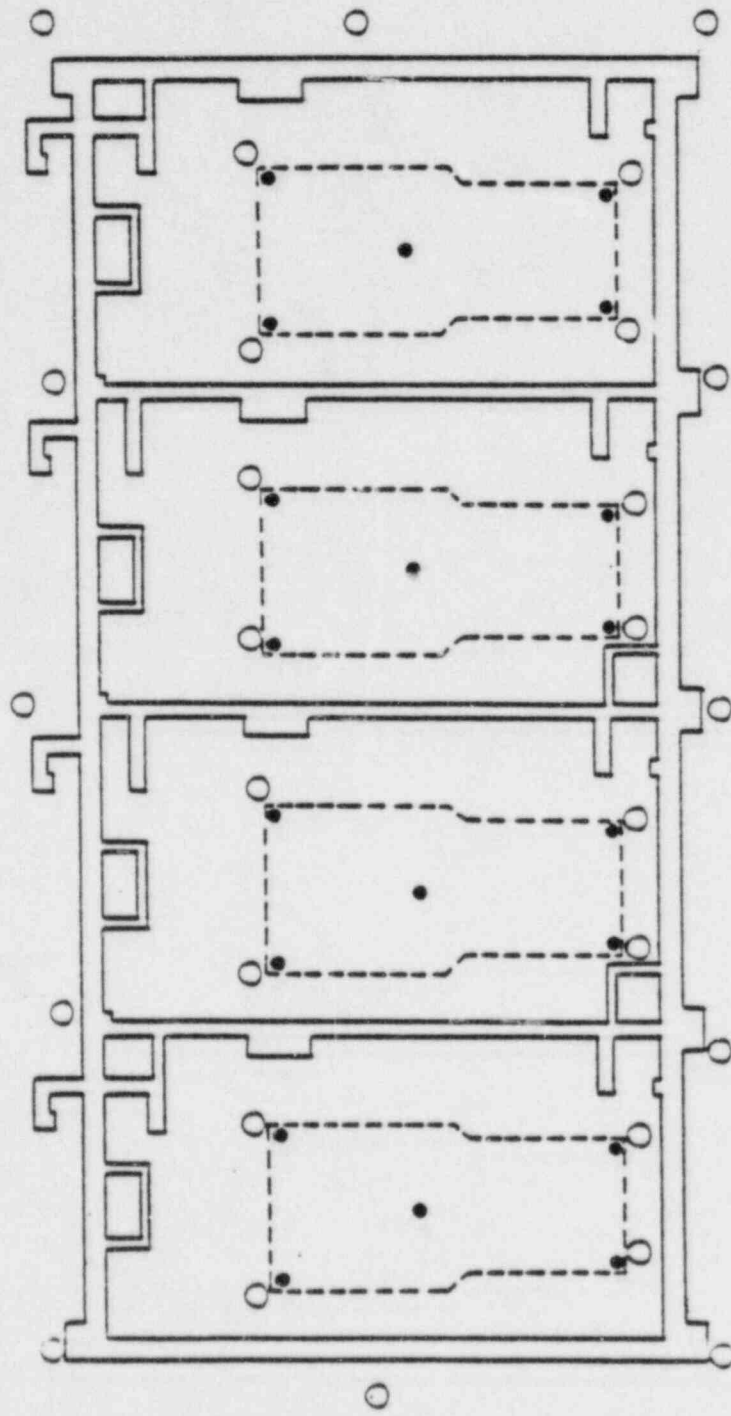
Figures 50 through 53 illustrate locations of the various instruments associated with the preload program. Figure 50 shows the locations of building survey settlement markers and pedestal settlement rods. Figure 51 shows the location of surface settlement plates and borros anchors installed in the fill primarily at three different elevations to monitor the movement of the soil as a result of the surcharge. The figure also shows locations of 4 deep (elev 535) borros anchors installed for use as reference points for the precise measurements during secondary compression where the movement has subsided to a very small rate. Figure 52 illustrates locations of piezometers installed primarily at three different elevations below the building to monitor the dissipation of pore water pressure during consolidation. Figure 53 illustrates the locations of Sondex instruments intended for measuring soil rebound in order to estimate the modulus of elasticity below the building to check the range used in dynamic analysis.

BUILDING AND PEDESTAL MOVEMENT
MONITORING EQUIPMENT
DIESEL GENERATOR BUILDING

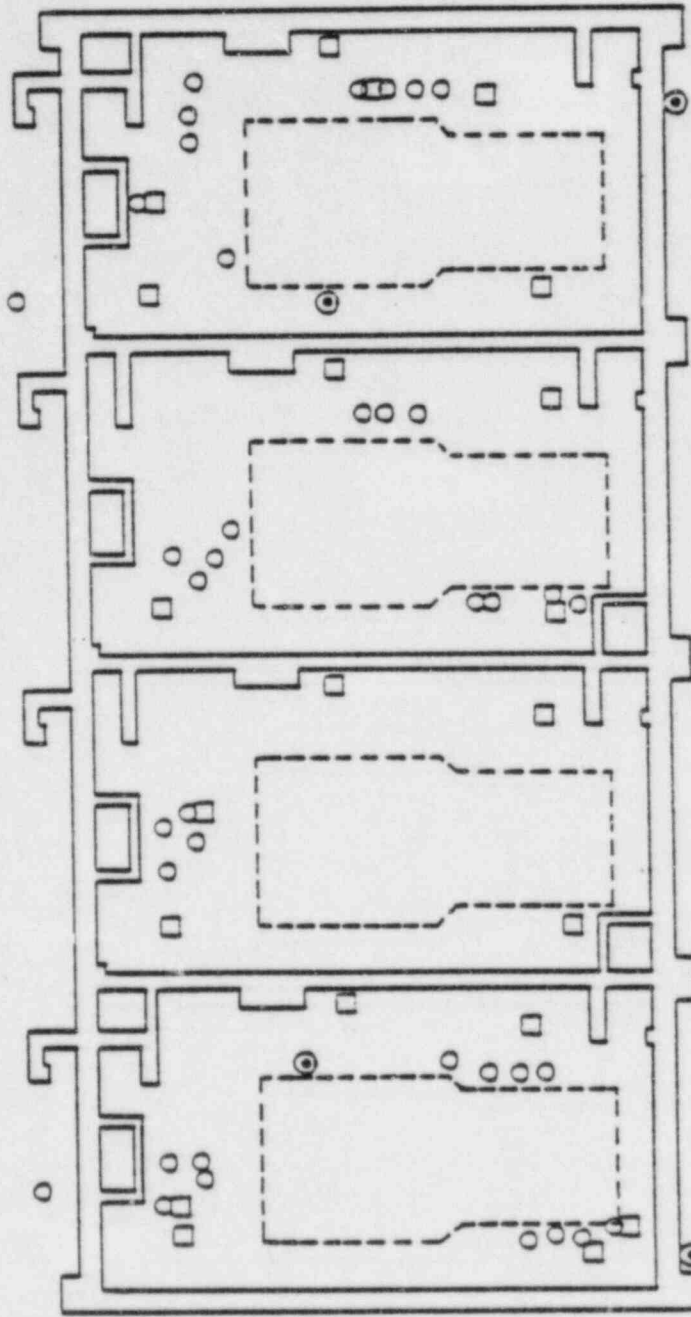
SOIL SETTLEMENT MONITORING EQUIPMENT
□ DIESEL GENERATOR BUILDING

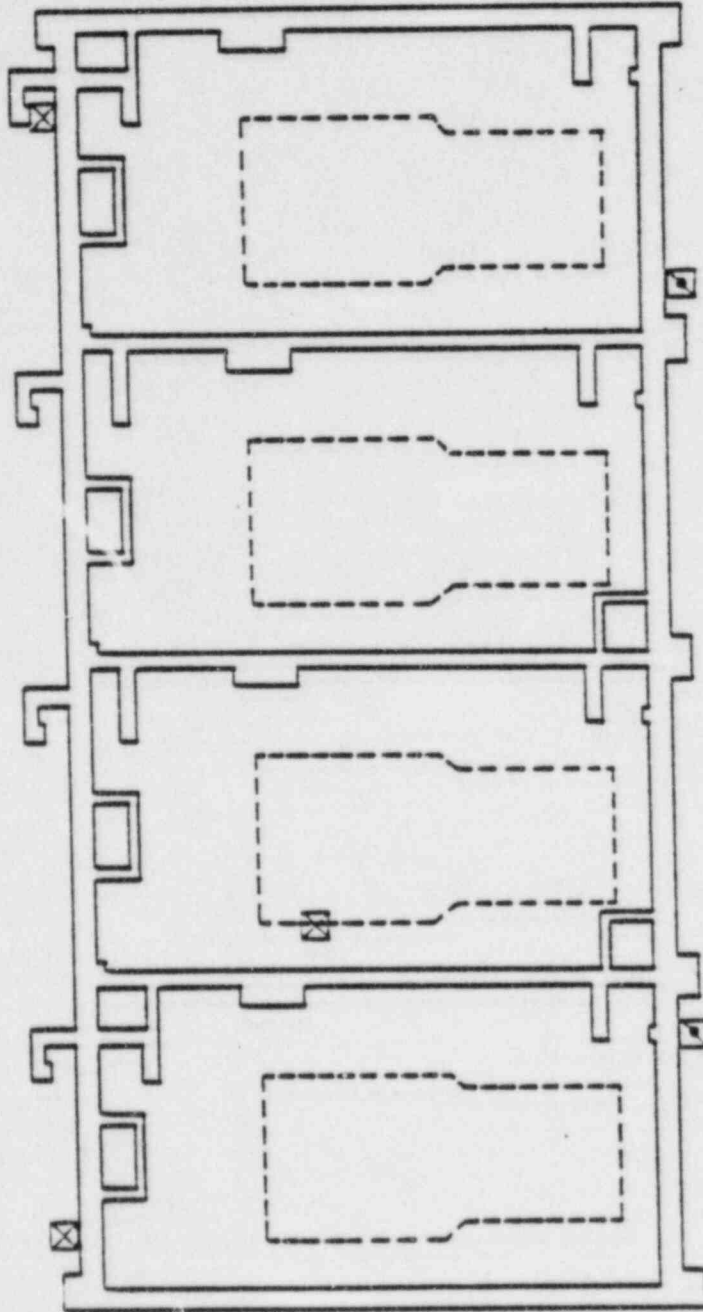
FIGURE 53

SOIL REBOUND MONITORING EQUIPMENT
DIESEL GENERATOR BUILDING

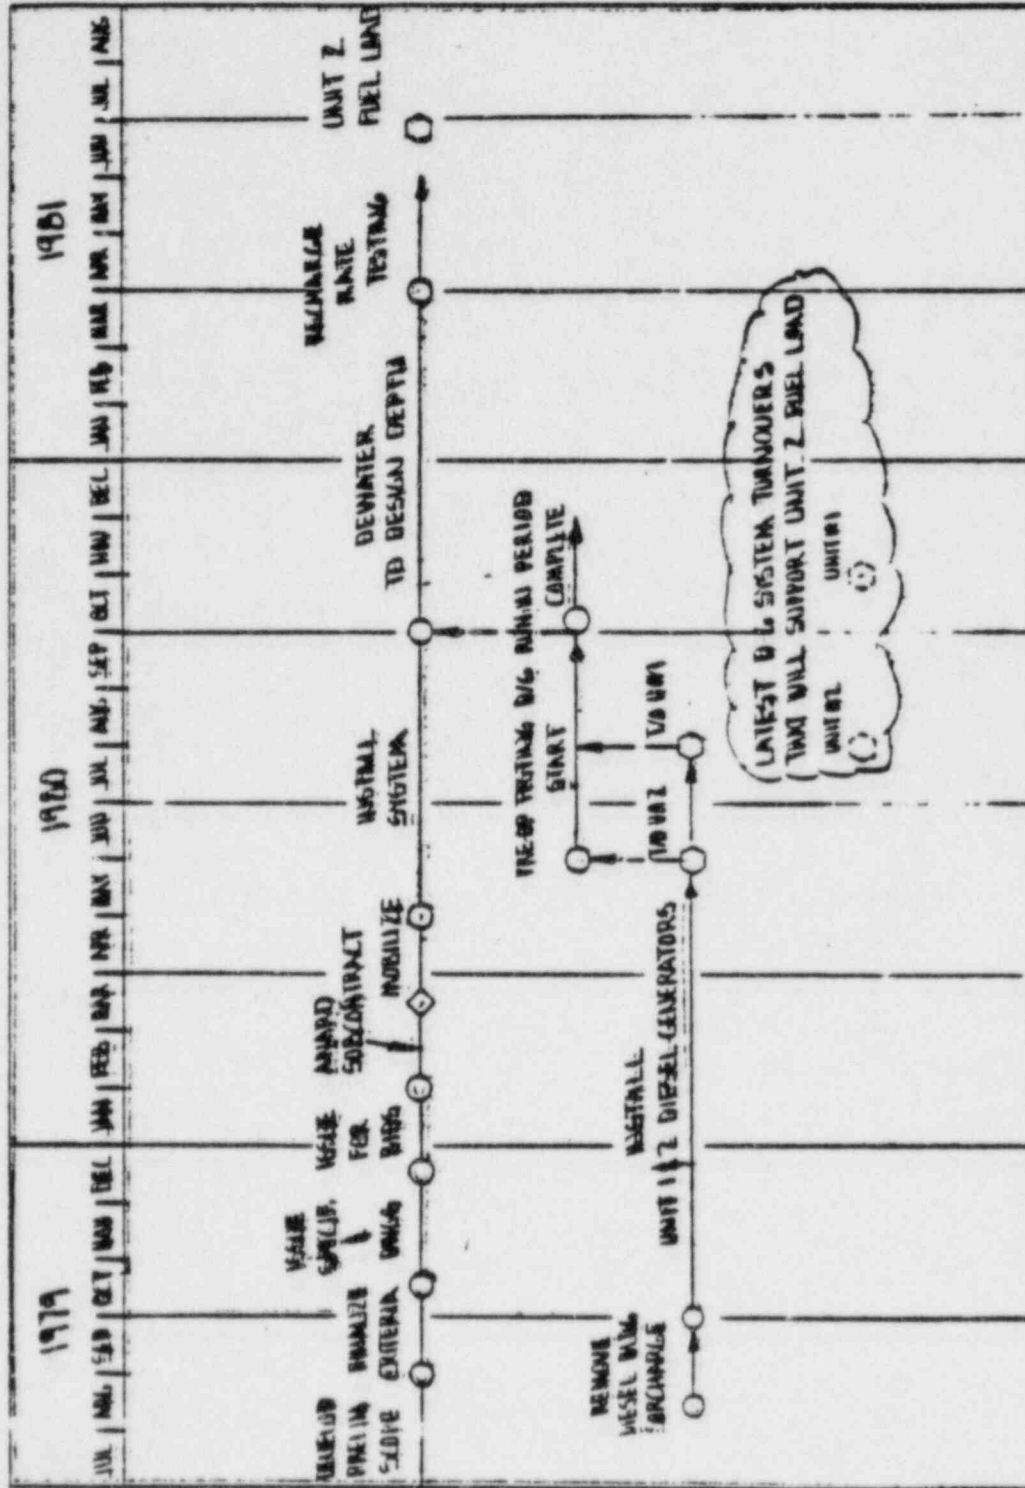
FIGURE 60

PERMANENT PLANT DEWATERING SYSTEM

Figure 60 shows the permanent plant dewatering system. We had previously informed the NRC that because of the preloading activities there could be an overall impact of two months on the project schedule. At this time, because of a revised testing philosophy, the Unit 1 and 2 Diesel Generator turnovers need not take place until November of 1980 and August of 1980 respectively. This actually allows some float time in the schedule.
