To T.E. Johnson
Subject Problem Alert
Large Settlements Due to
Incorrectly Placed Backfill
Copies to K. Wiedner
J. Milandin

Subject: Large Settlements Due to Incorrectly Placed Backfill

MIDLAND PLANT UNITS 1 & 2
CONSUMERS POWER COMPANY
SEVERAL DATA
TIME RATE

TIME/RATE SETTLEMENT OF DIESEL GENERATOR BUILDING

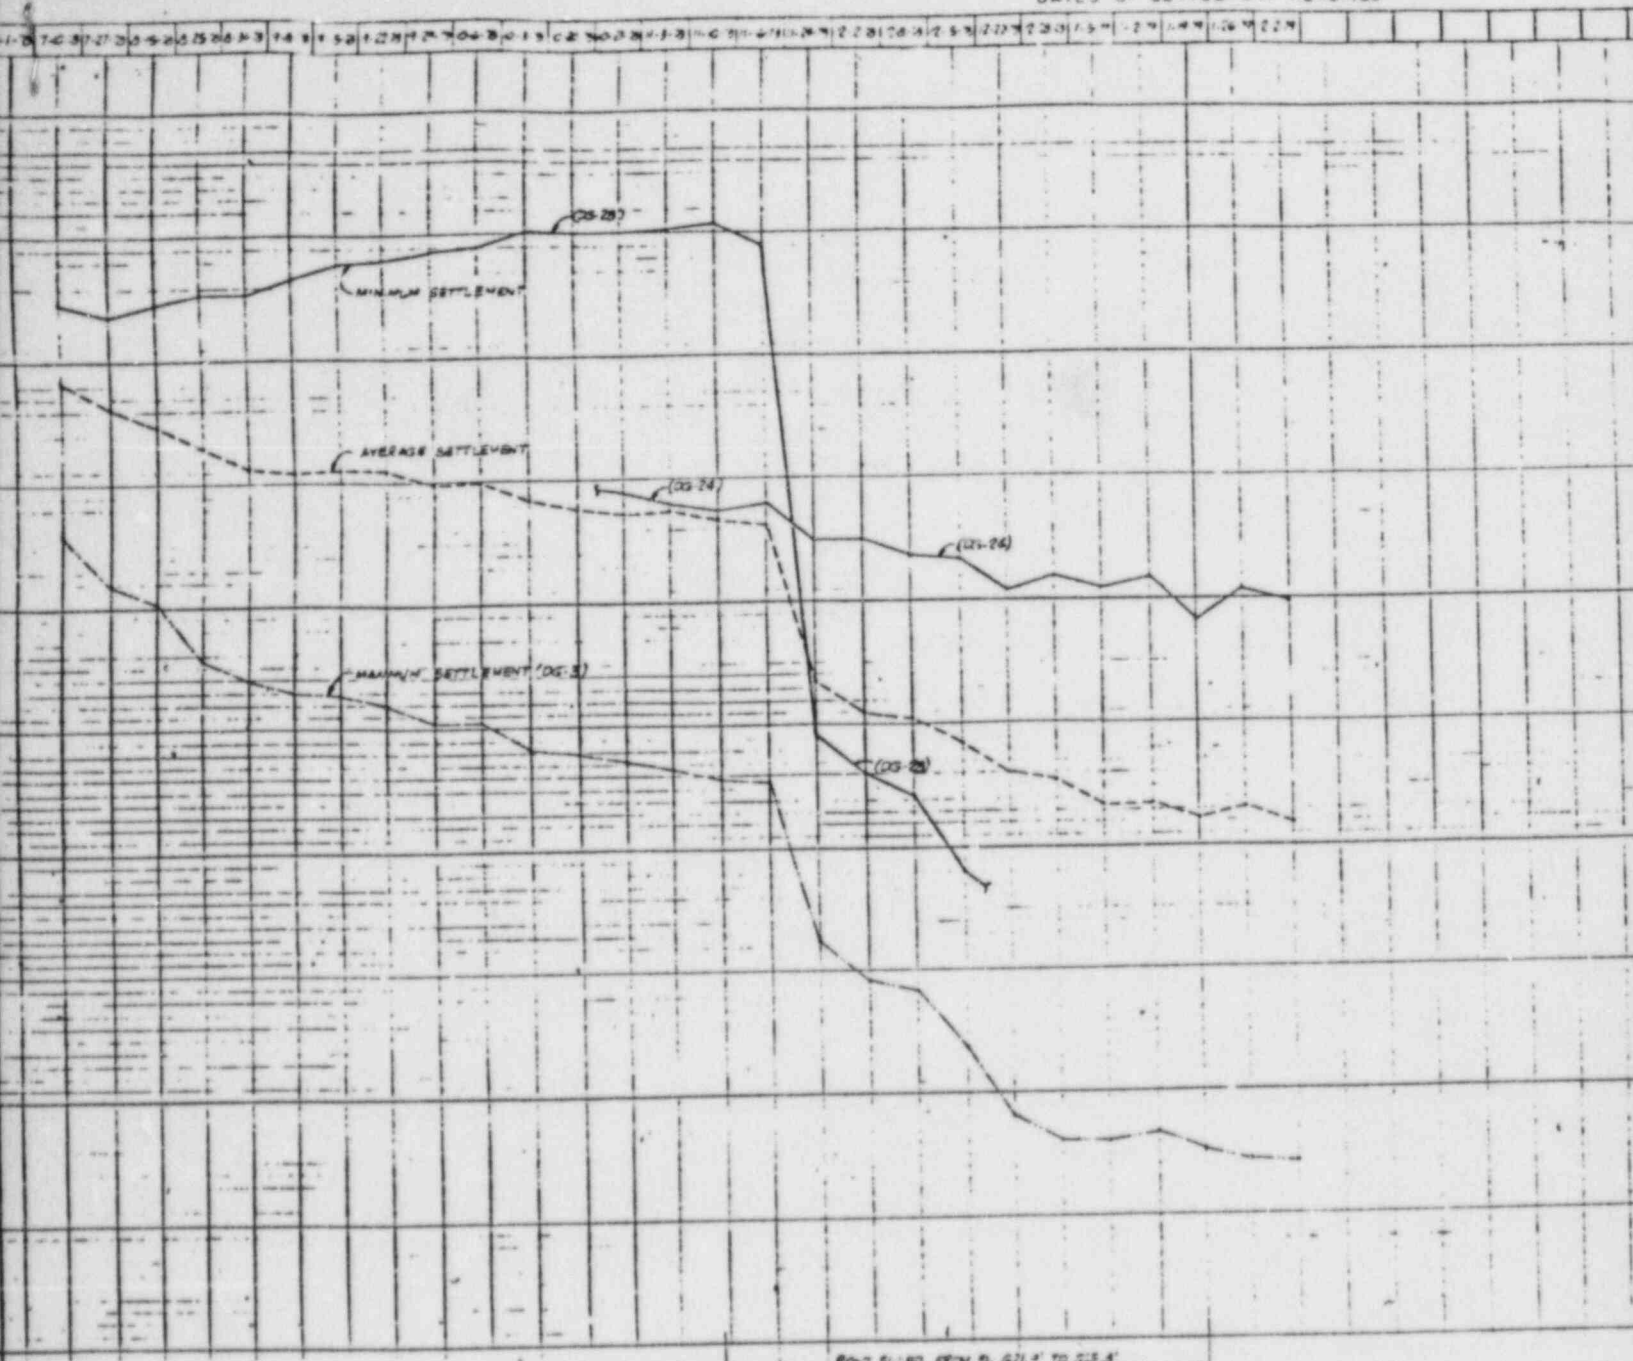
POU PILED FROM EL. 214' TO 215.5'

SETTLEMENT MEASURED BY SLEEVES SETTLEMENT MEASURED BY MARKERS

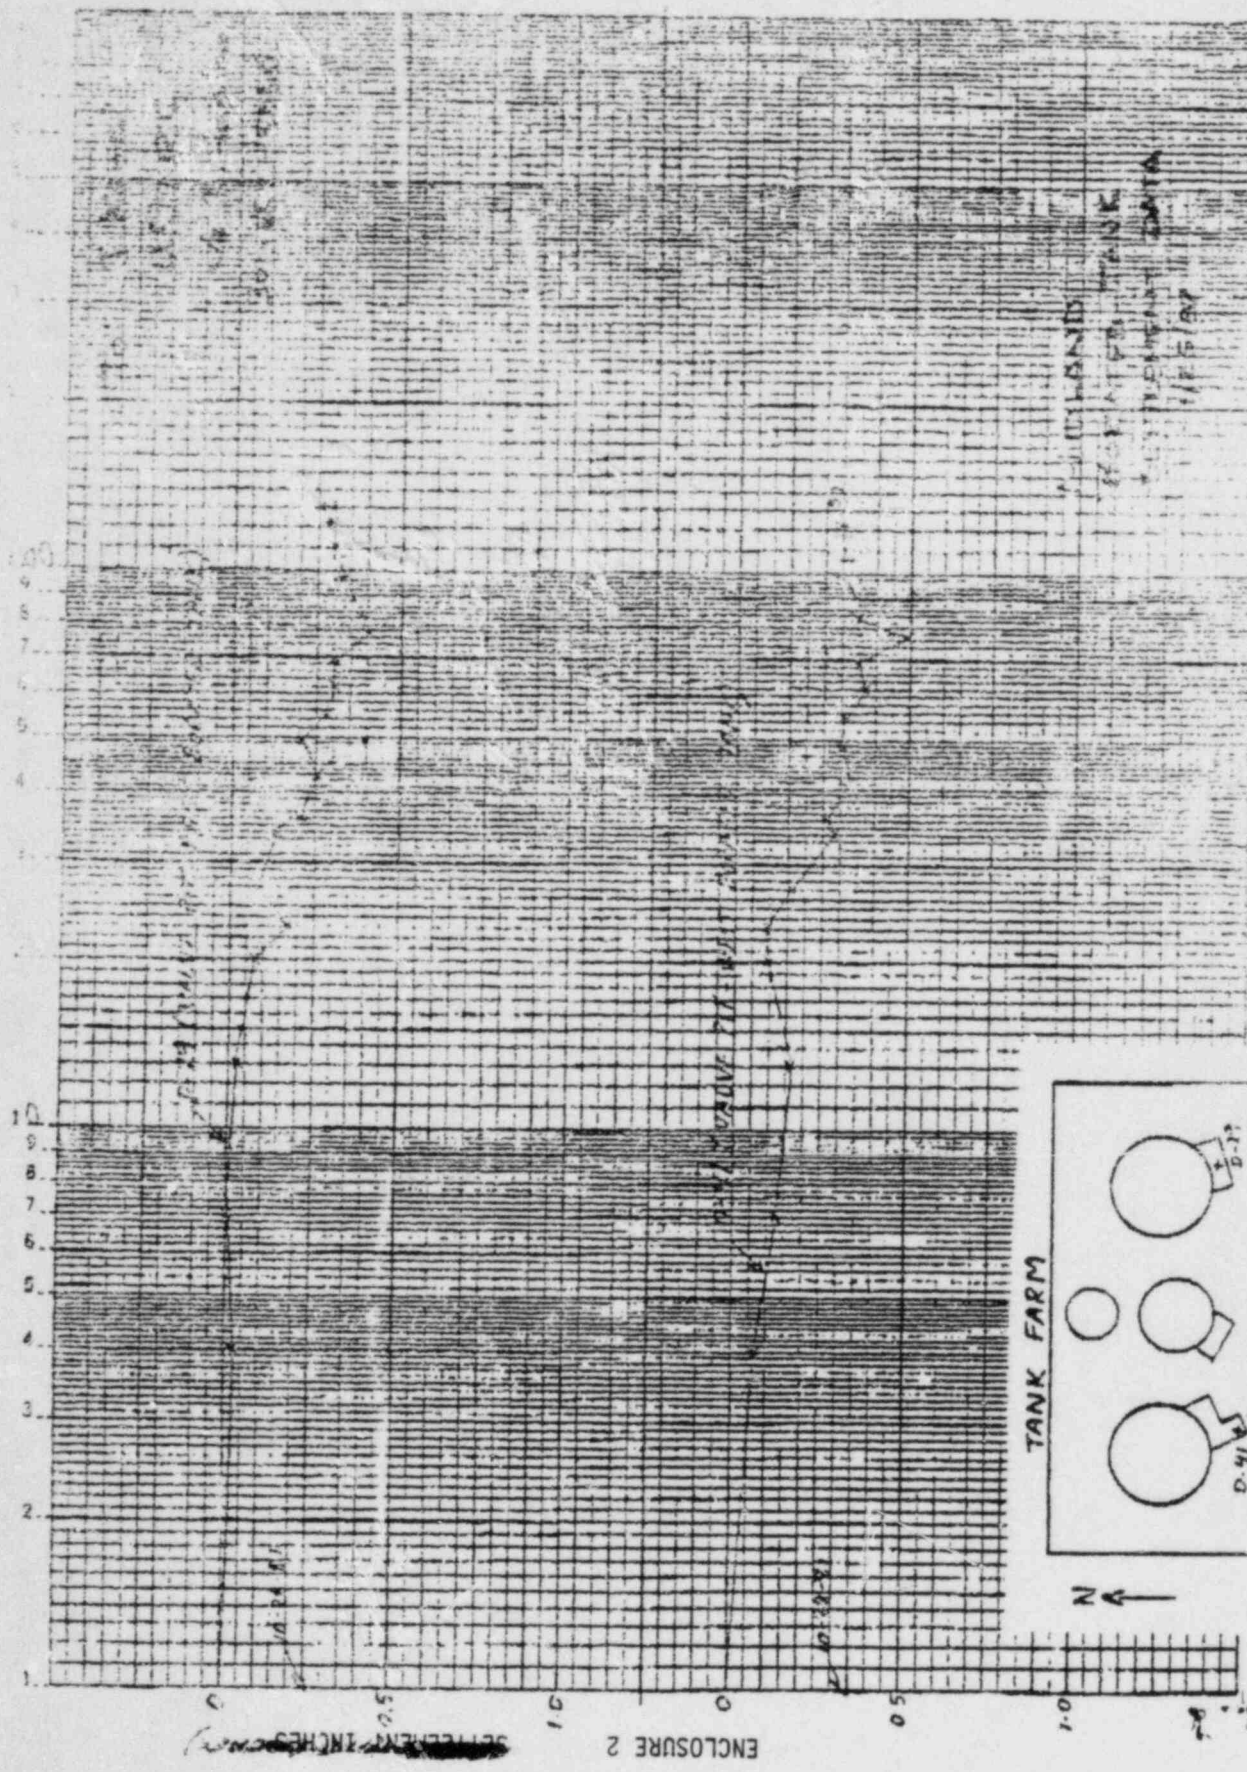
MIDLAND
 BORATED TANK
 SETTLEMENT DATA
 1/25/02

1. The criteria for maximum settlement is 0.5". Although the curve for marker U-41 on January 12, 1982 reads 0.5", Consumers does not consider this to be an accurate reading, as demonstrated by the January 18, 1982 reading which shows about 0.4".
2. Other measured points also show the dip which occurred on January 12, 1982. Consumers speculates that survey inaccuracies may be at fault for the January 12, 1982 readings.
3. Consumers feels the current data demonstrate that the fill beneath the BWST foundations is now in secondary consolidation. The secondary consolidation rate for the tanks has been estimated to be 1/2" per decade.

Mr. Kane replied that the settlement data for markers U-29 and U-41 do not clearly indicate that the foundation soils beneath the valve pit are in secondary consolidation. If the questionable readings of January 12, 1982 are excluded, and average smooth settlement curve through the plotted points could be drawn since November 24, 1981 (the date for placing the third and final surcharge load increment) which would indicate the foundation soils are still in primary consolidation. Mr. Kane requested that the settlement data for the other markers be provided for review.
