WCAP-12872
Revision 2

J. M. Farley Units 1 and 2
SG Tube Plugging Criteria for
ODSCC at Tube Support Plates

Westinghouse Energy Systems

February 1992

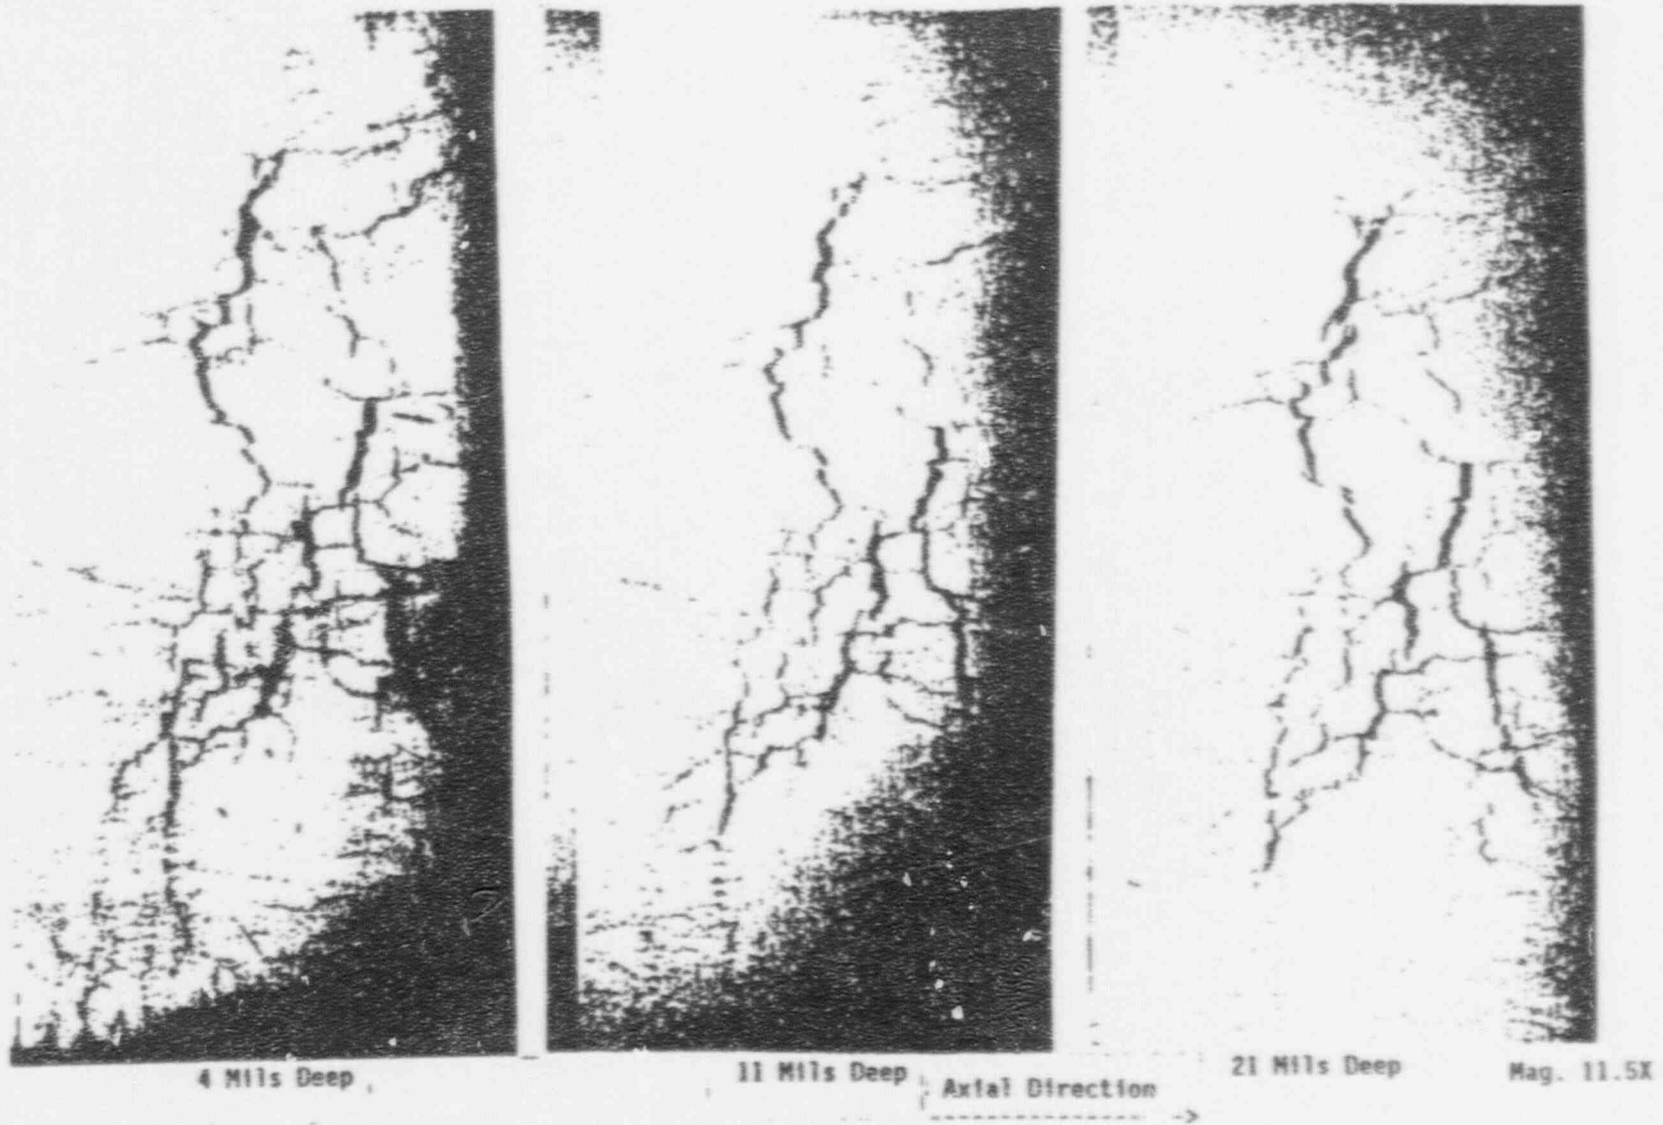
Figure 4-4 Photomicrographs of radial metallography performed on a region with axial and circumferential degradation on tube R16-C74, support plate 1. Cellular IIA was found with little change in the cell shape and cell wall thickness at depths of 4, 11 and 21 mils below the OD surface. Note that the cut section was flattened, preferentially opening the circumferential wall of the cells.

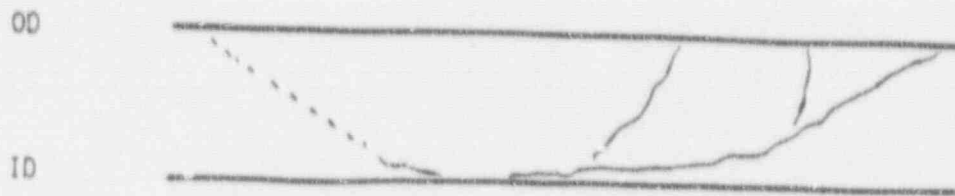
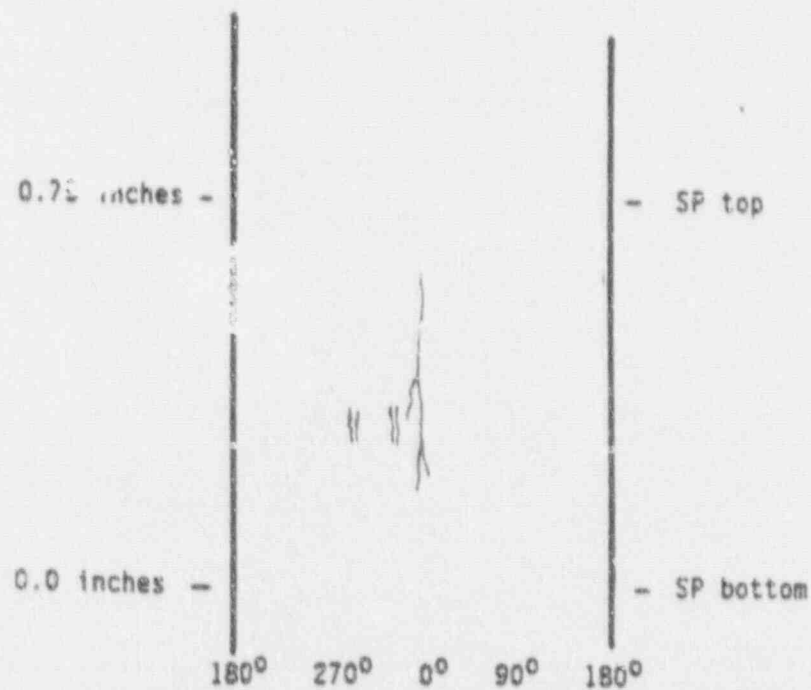
Sketch of Burst Crack

Macrocrack Length = 0.52 inch

Number of Microcracks = at least 3

Morphology = IGSCC with moderate IGA components

Figure 4 - 5. Summary of crack distribution and morphology observed on the first support plate cravice region of tube R31-C46, Farley Unit 2.

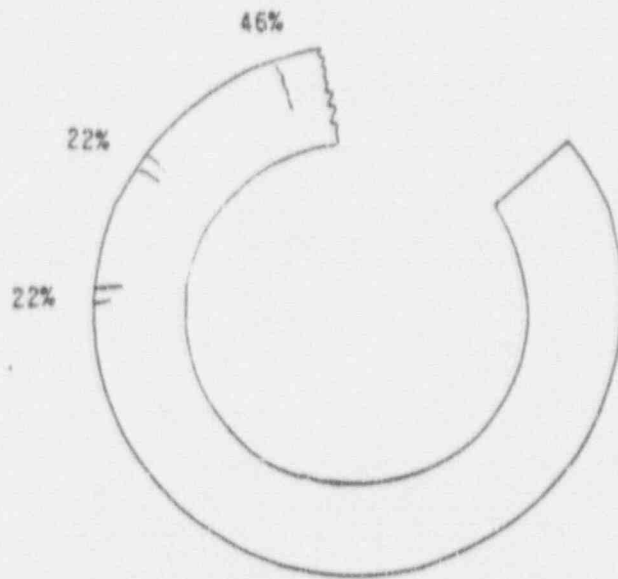
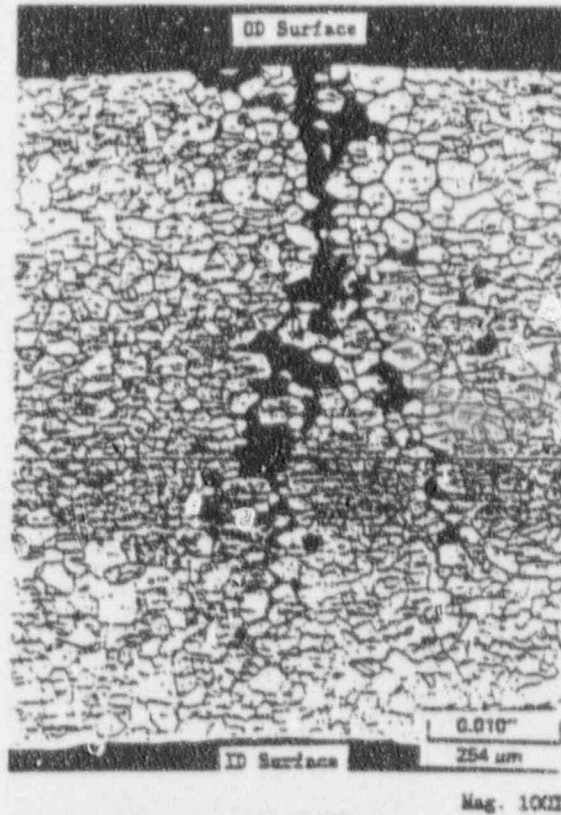
Figure 4 - 6. Secondary crack distribution and a photomicrograph of one of the cracks in a transverse metallographic section of the first support plate crevice region of tube R31-C46. The crack morphology is that of IGSCC with moderate IGA components.

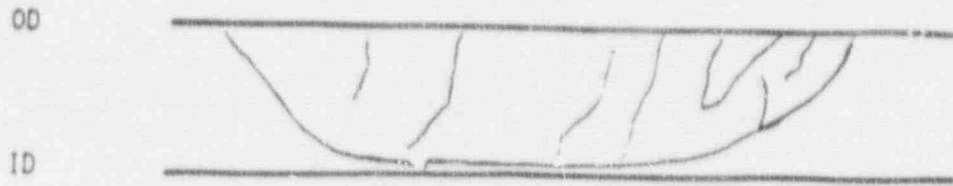
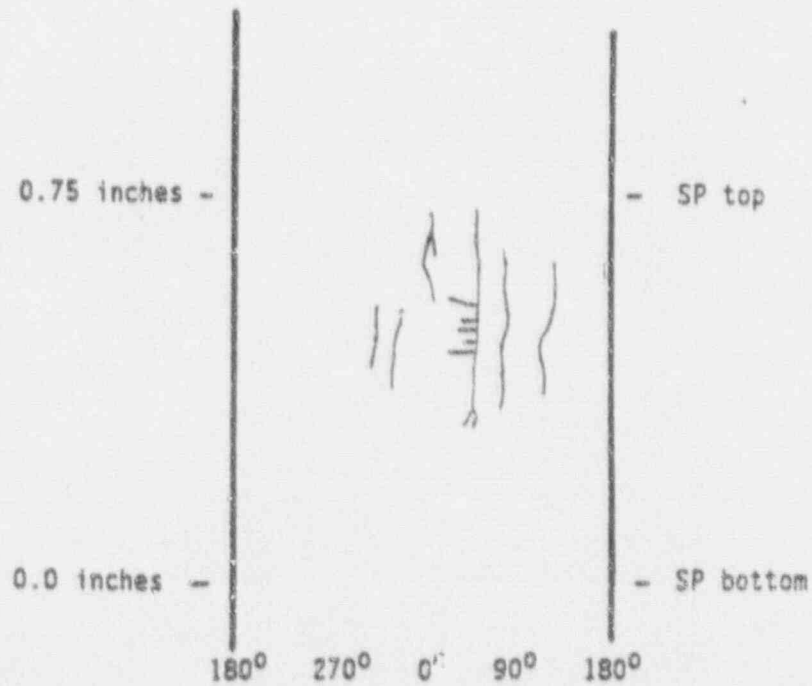
Macrocrack Length = 0.4 inch

Number of Microcracks = 7 (all ligaments have predominantly intergranular features)

Morphology = IGSCC with some IGA aspects (circumferential cracking has more IGA characteristics)

Figure 4 - 7. Description of OD origin corrosion at the fifth support plate crevice region of tube R4-C61, Plant B-1

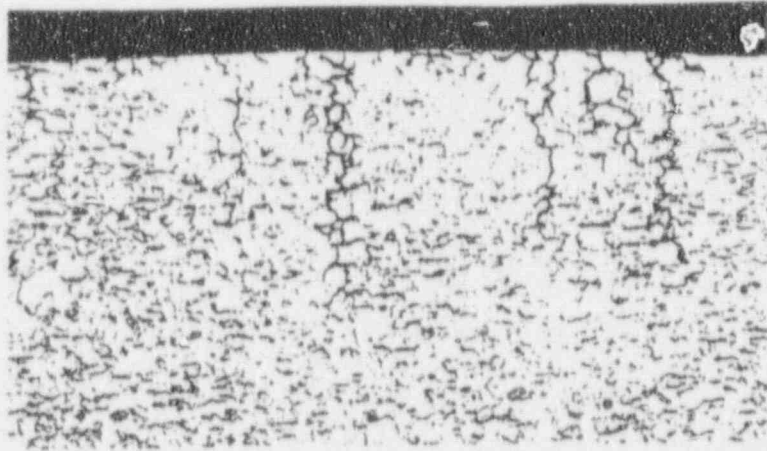
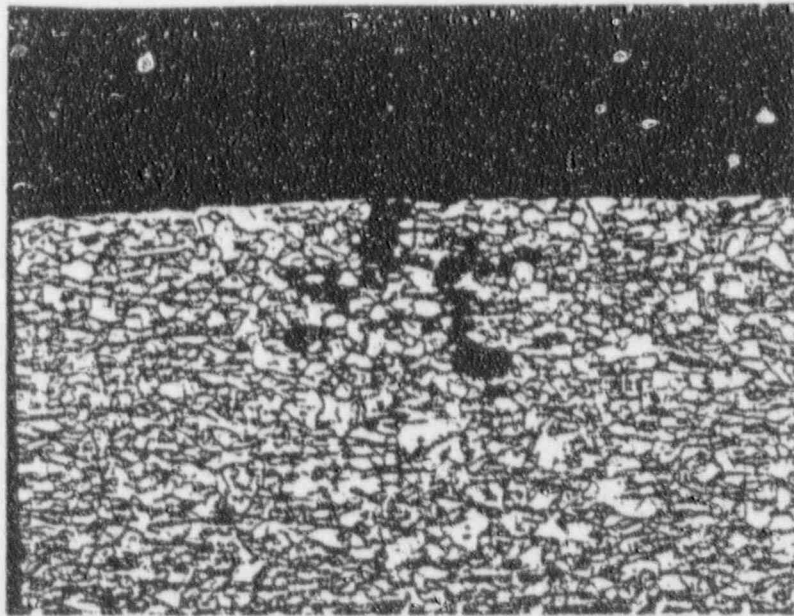
Figure 4 - 8. Photomicrographs of tube R4-C61 corrosion degradation. Top photo shows axial crack morphology (transverse section) at the eighth support plate location (no transverse metallography was performed at the fifth support plate region). Bottom photo shows circumferential crack morphology (axial section) at fifth support plate region.

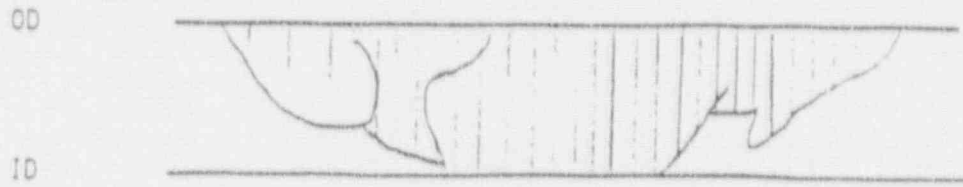
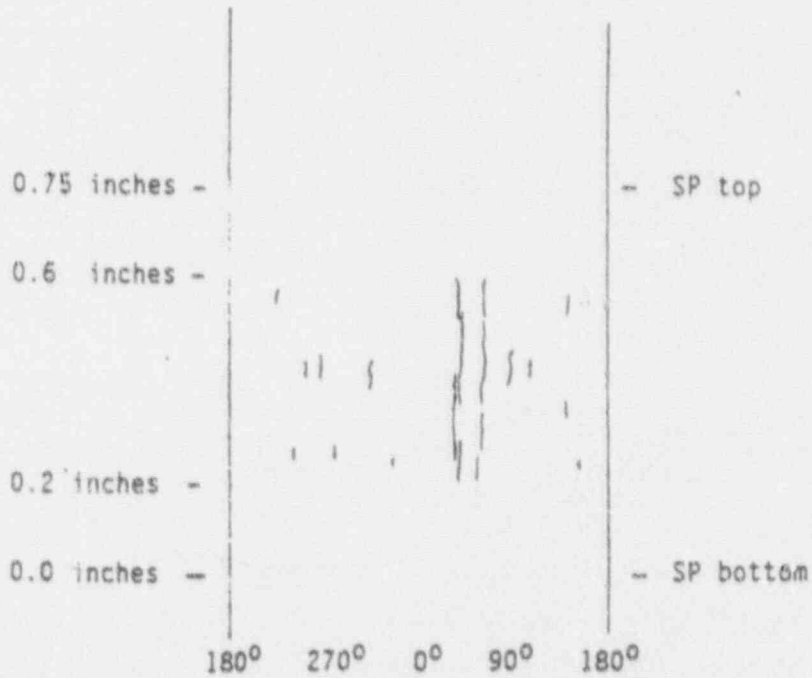
Macrocrack Length = 0.42 inches

Number of Microcracks = 4 (all ligaments with intergranular features)

Morphology = Intergranular SCC with some IGA characteristics (width of IGA 0.012 inches)

Figure 4 - 9. Description of OD origin corrosion at the first support plate crevice region of tube R4-C73.

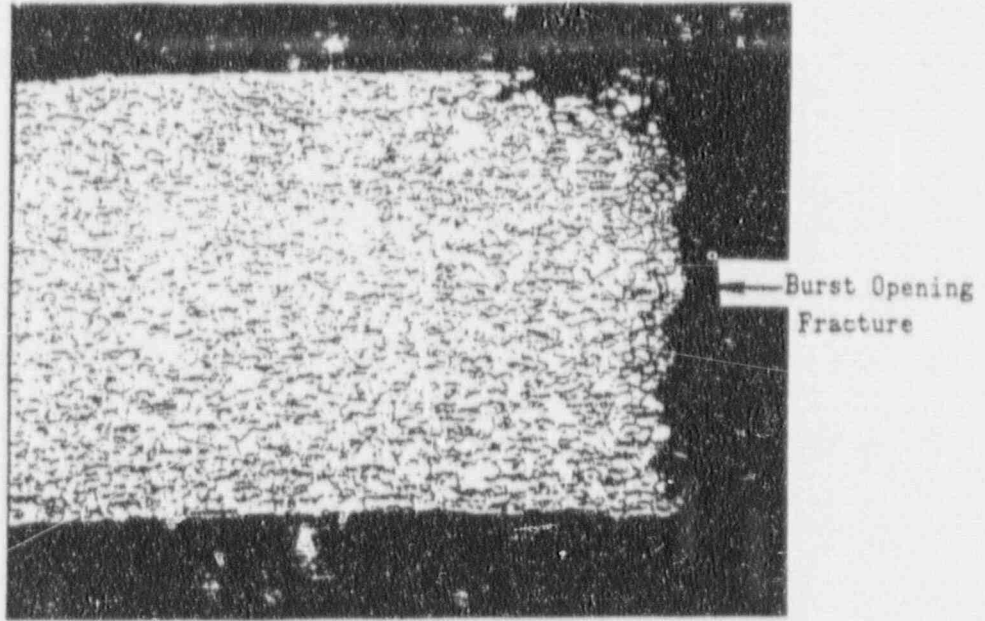
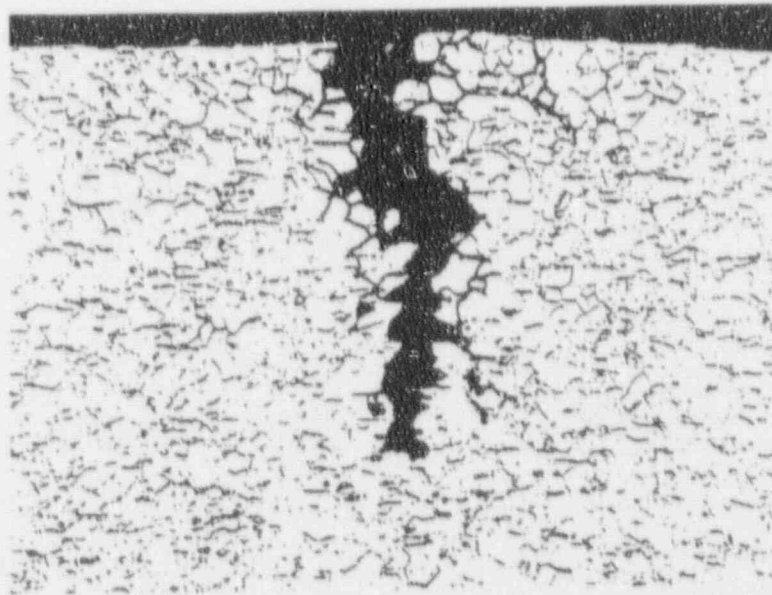
Figure 4 - 11. Top photomicrograph is from a transverse section through one half of the main burst crack. The crack morphology is that of IGSCC with some IGA characteristics (width of IGA is 0.006 inch on one side of the crack). Bottom micrograph is from a transverse section through a typical crack located near the burst crack. The morphology is that of IGSCC with only minor IGA characteristics. (Note: crack is opened wide by tube deformation).

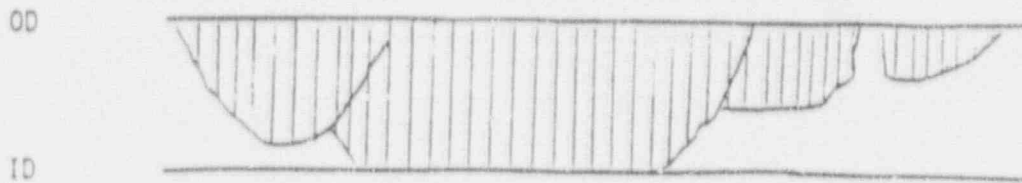
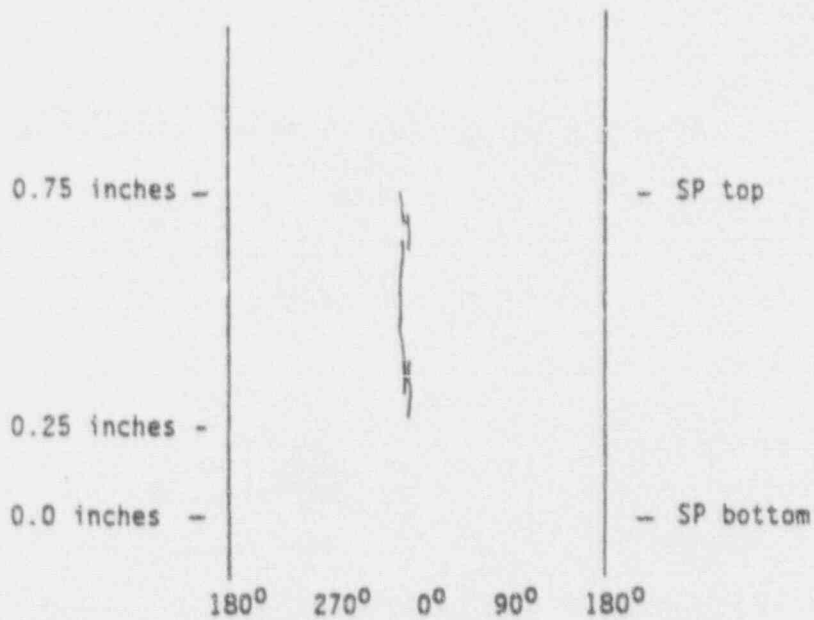
Macrocrack Length = 0.50 inches

Number of Microcracks = 4 (two ligaments with intergranular features, one with ductile overload features)

Morphology = Intergranular SCC with significant IGA characteristics (width of IGA 0.030 inches)

Figure 4 - 12. Description of OD origin corrosion at the first support plate crevice region of tube R21-C22.

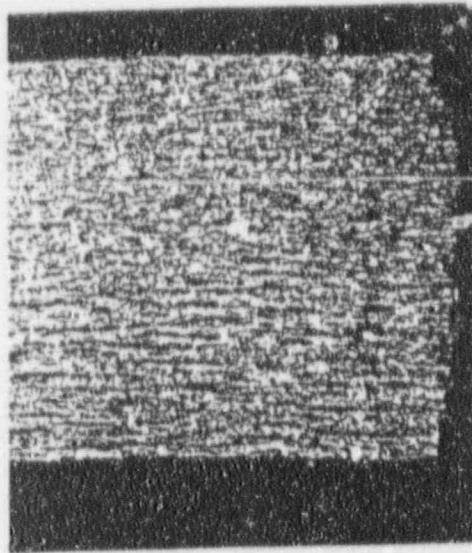
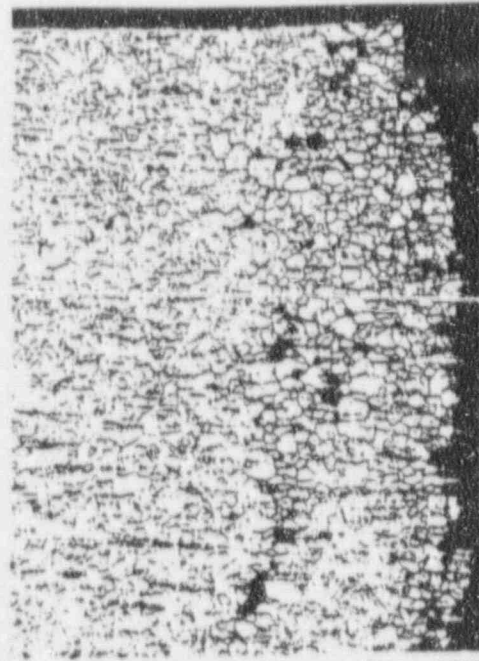
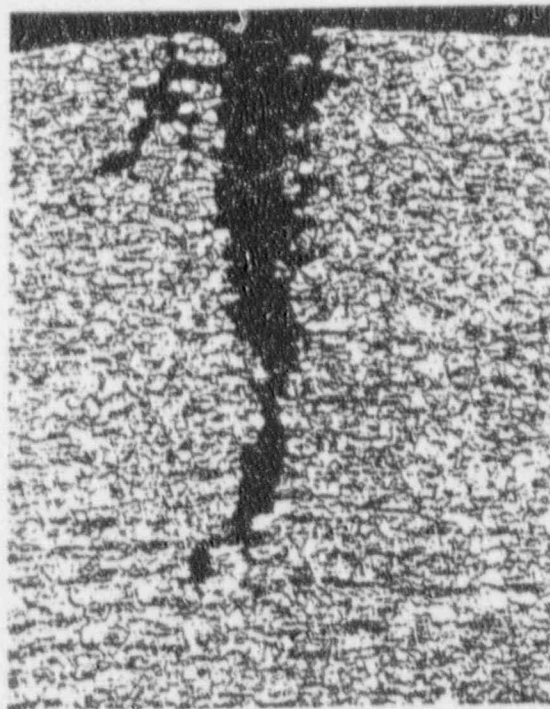
Figure 4 - 14. Top micrographs are from a transverse section through one half of the main burst crack. The morphology is that of IGSCC with significant IGA characteristics (width of IGA is 0.015 inch on one side of the crack). Bottom micrograph is from a transverse section through the only other crack found in the crevice region. Its morphology is more that of IGSCC. (Note: crack has been opened wide by tube deformation).

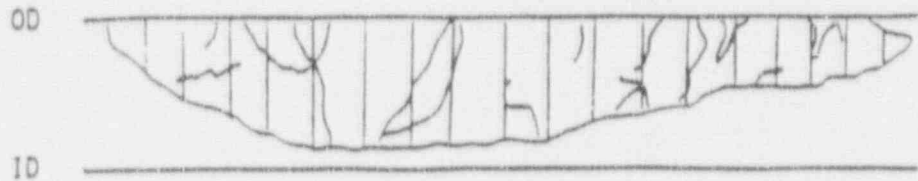
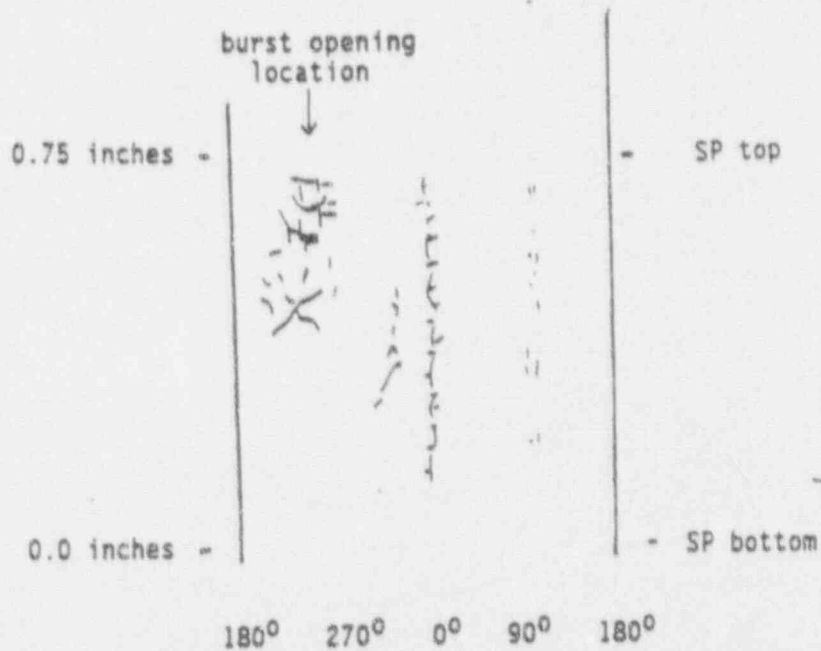
Figure 4-15 shows a sketch of the SEM fractographic observations on the burst fracture face of the first support plate region of tube R38-C46. A 0.37 inch long, OD origin, axial macrocrack was observed. The intergranular crack was up to 78% through wall and was contained within the support plate crevice region. The macrocrack was composed of numerous microcracks which had an unusual spatial distribution. They had orientations which ranged from axial to circumferential generating a spider-like crack distribution. It is believed that this local network had a cellular IGA/SCC morphology similar to that on tube R16-C74 from Plant L presented in Figure 4-4. Three other crevice locations had less deep but significant intergranular crack distributions. Their locations are also shown in Figure 4-15. Figure 4-16 shows the crack distribution and depth as determined by transverse metallographic examinations. Figure 4-17 shows photomicrographs of cracks in transverse sections obtained from within the crevice region. The cracks are opened wide by tube deformation. The morphology of the cracks is that of IGSCC with minor to moderate IGA components ($D/W = 14$ to 28).

Macrocrack Length = 0.37 inches

Number of Microcracks = numerous (ligaments have intergranular features)

Morphology = Intergranular SCC with minor IGA features
(Unusual spider-shaped crack distribution)

Figure 4 - 15. Description of OD origin corrosion at the first support plate crevice region of tube R38-C46.

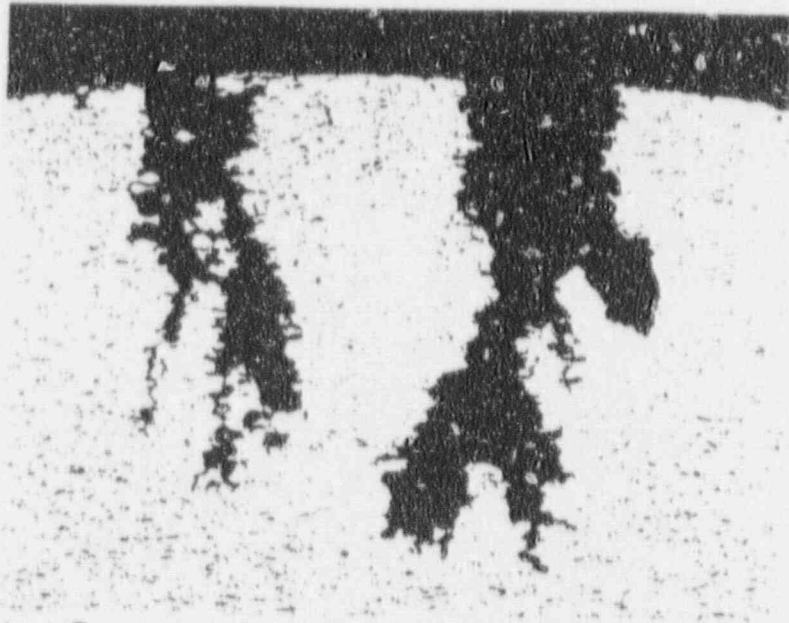
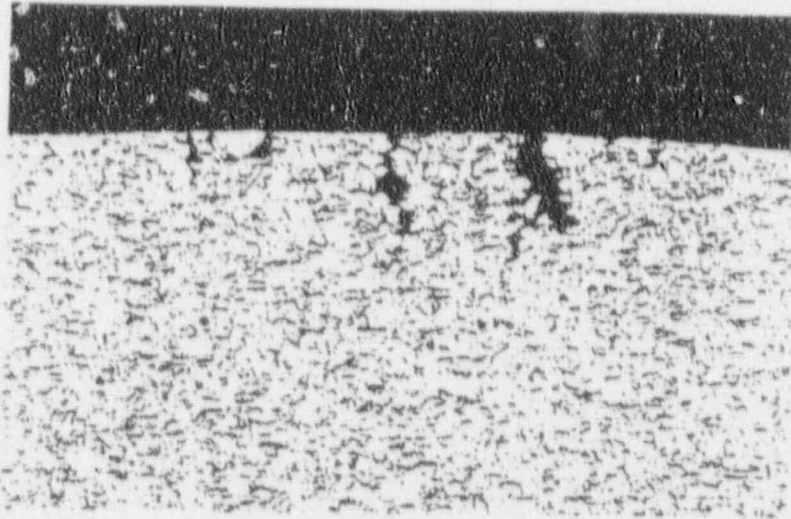
Figure 4 - 17. Photomicrographs of a transverse metallographic section through the first support plate crevice region of tube R38-C46. The crack morphology is that of IGSCC with minor IGA characteristics. Mag. 100X.

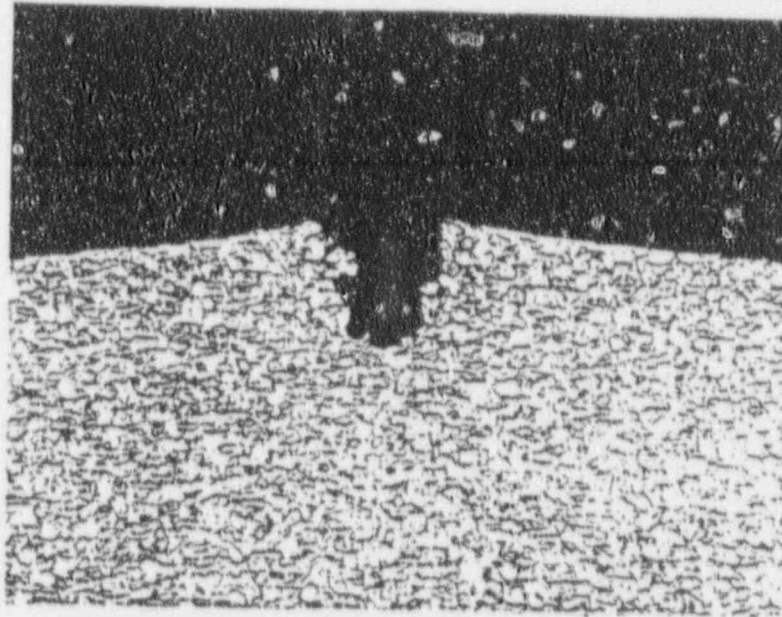
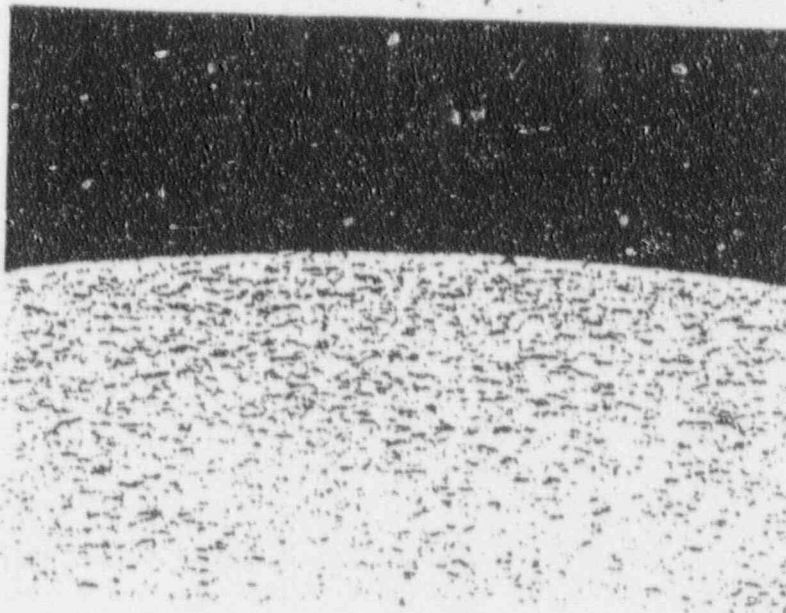
Figure 4 - 18. Cracks at the OD surface of Farley-2 tube R16-C50 at the first tube support plate crevice. Mag. 100X.

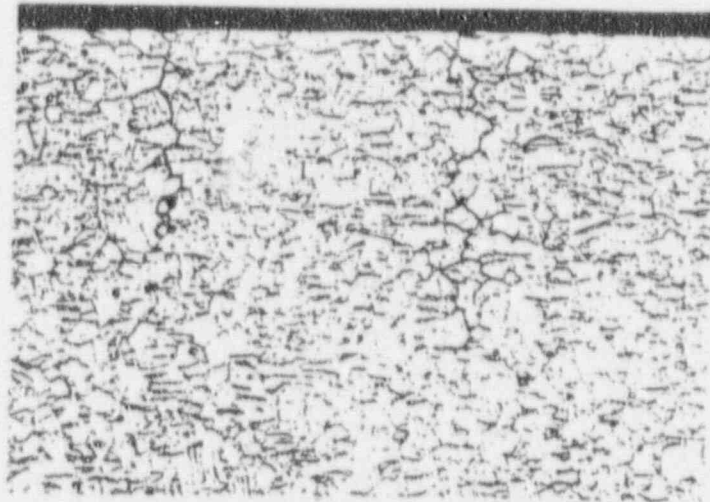
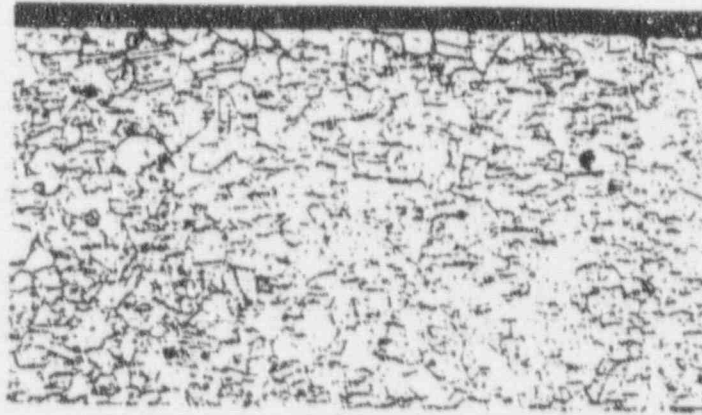
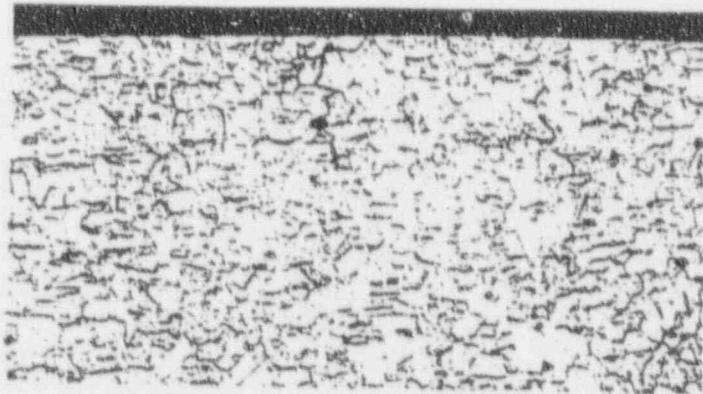
Figure 4 - 19. Photomicrographs of a transverse section from the first support plate crevice region of tube R16-C53. Mag. 100X.

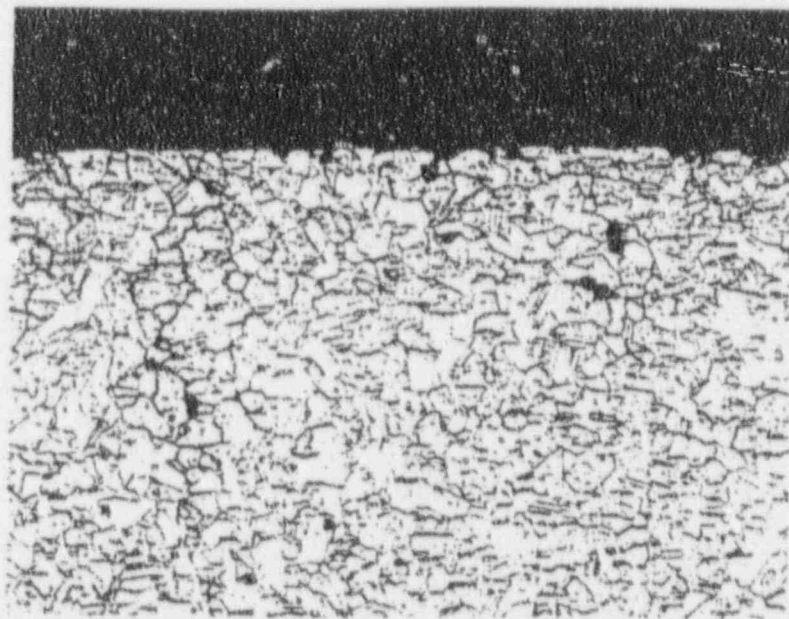
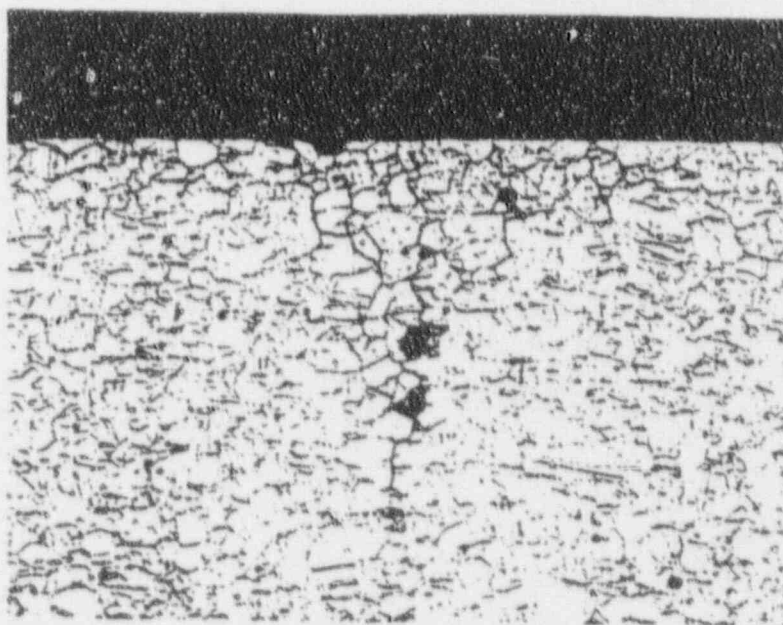
Figure 4 - 20. Additional micrographs from the same transverse section shown in Figure 4-15, tube R16-C53. Mag. 100X.

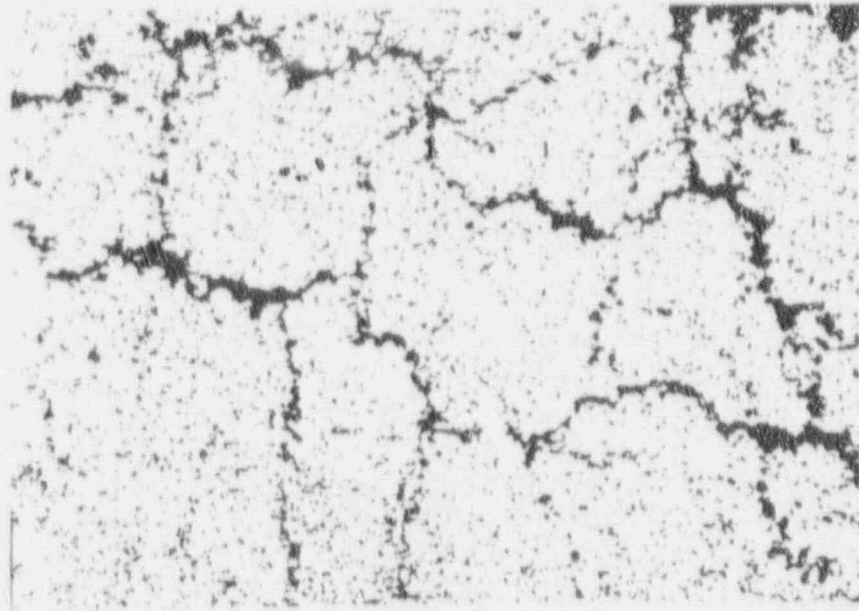
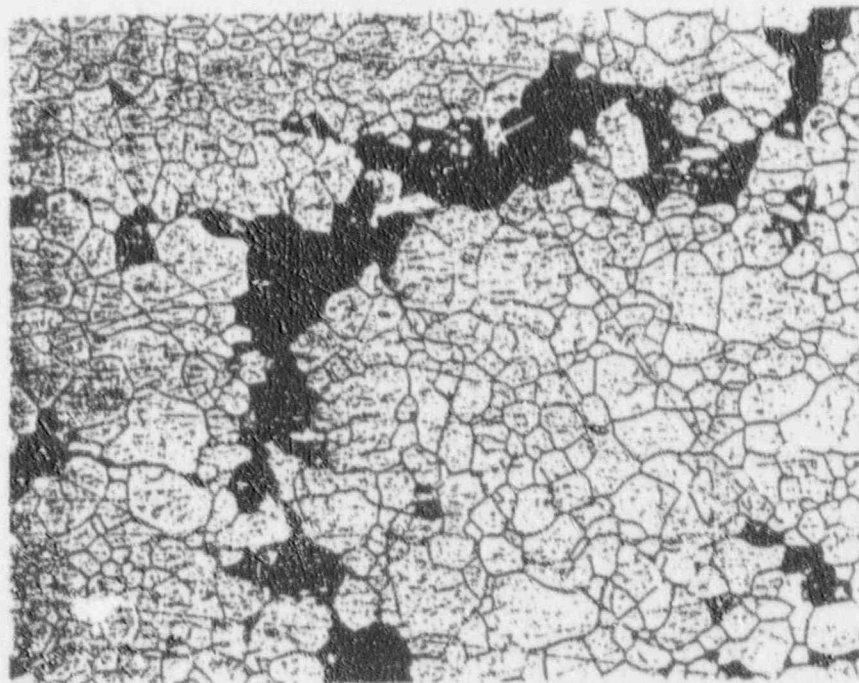
Figure 4 - 27. Higher magnification photomicrographs of the radial section shown in the previous figure. Top photo 50X, bottom 200X

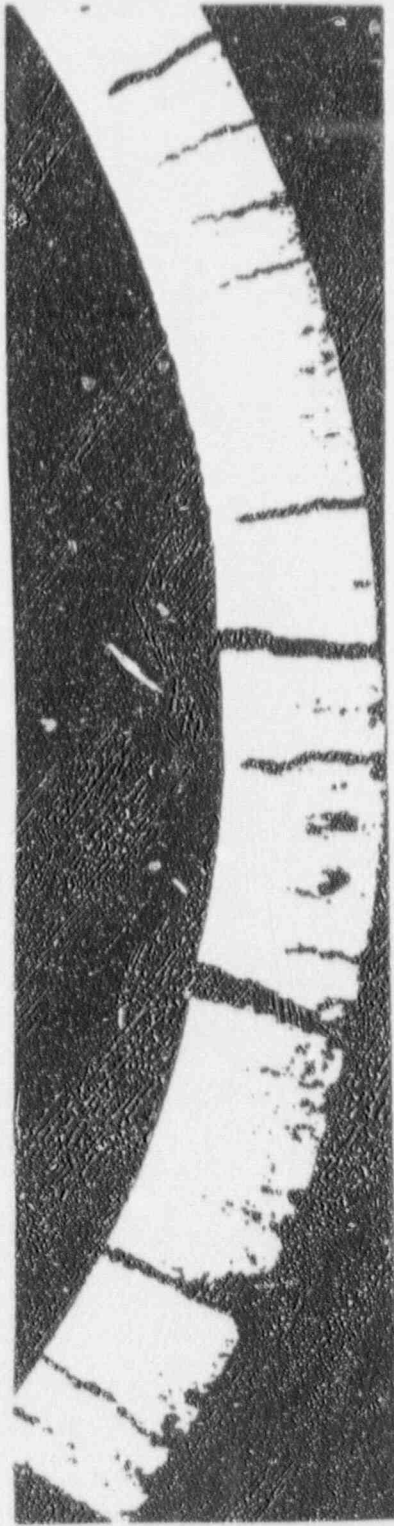
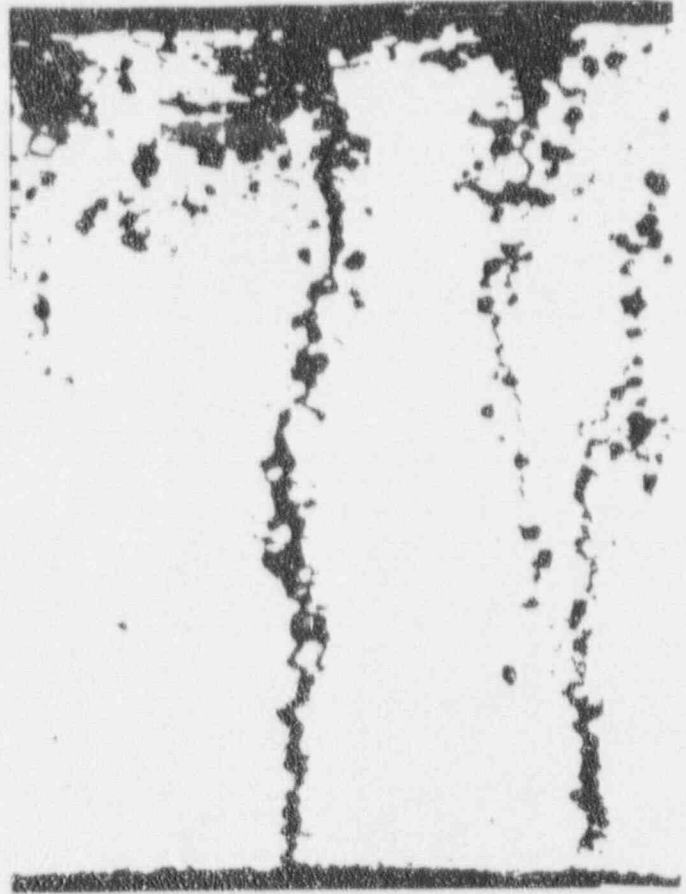
Figure 4 - 31. Transverse photomicrographs of intergranular corrosion at the first support plate region of tube L8-C74 from Plant J-1

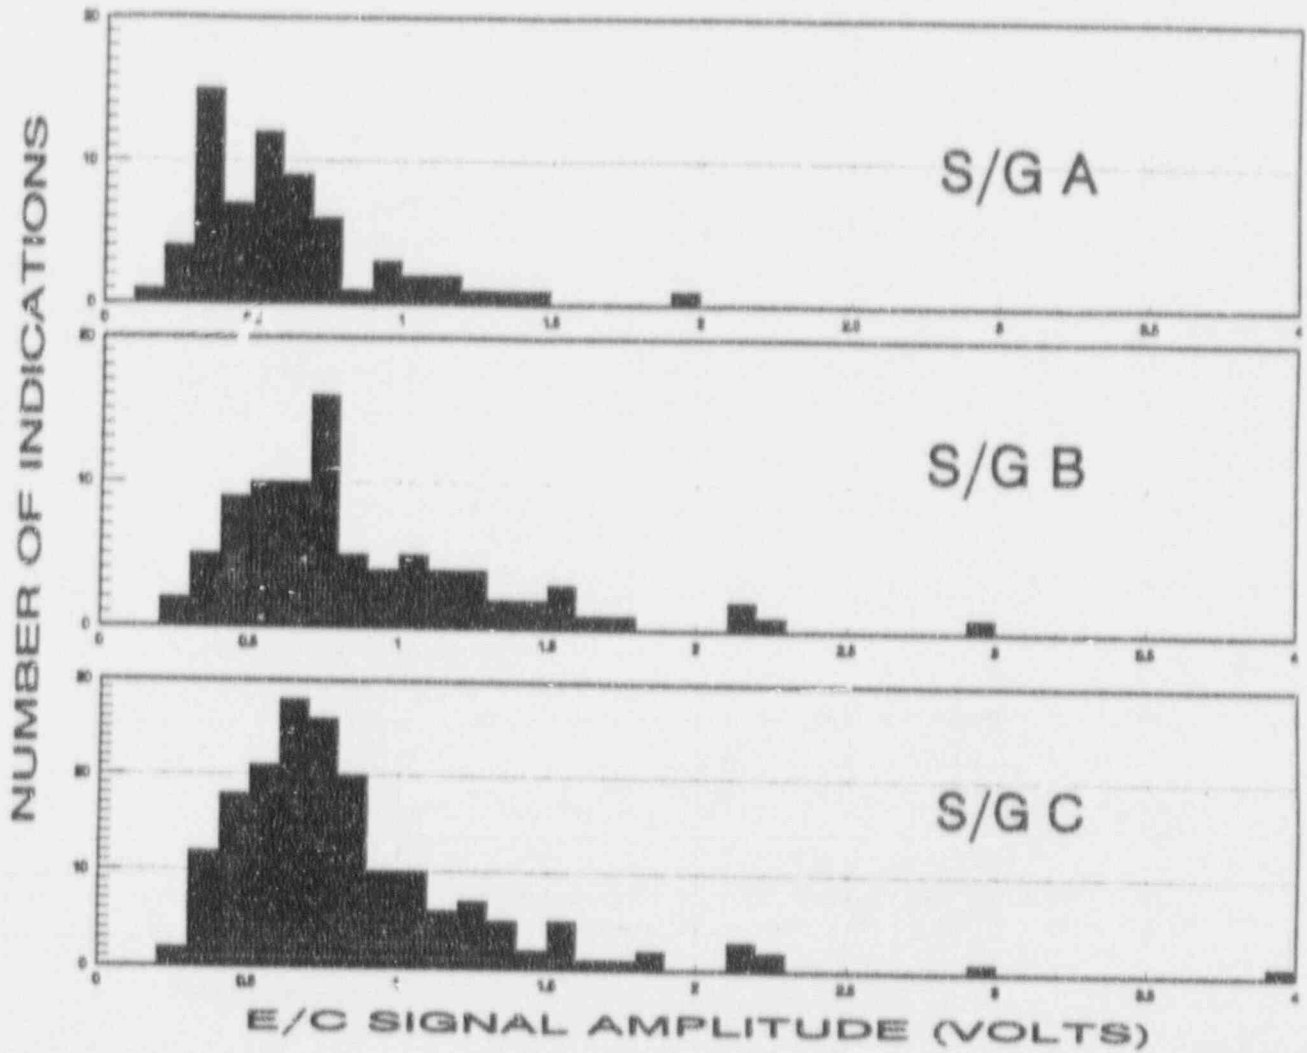
Figure 5-5 displays the voltage levels recorded for all TSP indications in Farley-2. A discussion of voltage growth is given in Section 5.3.

Distribution of TSP Indication Amplitudes in Farley-2 S/Gs (October 1990)

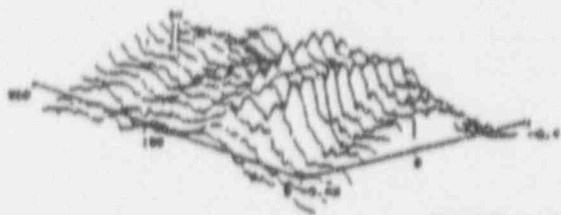
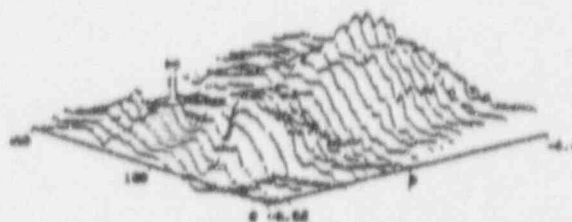
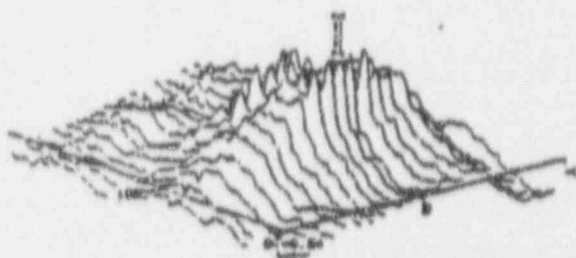
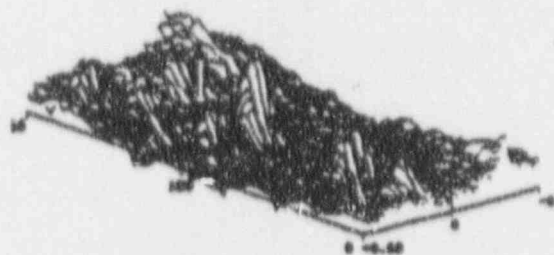
Figure 5-8

Farley-1 RPC Characterization (November 1989)

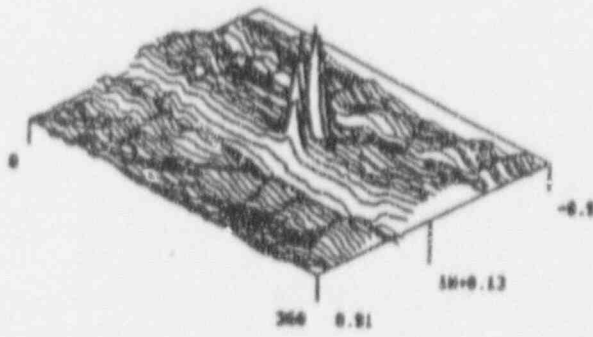
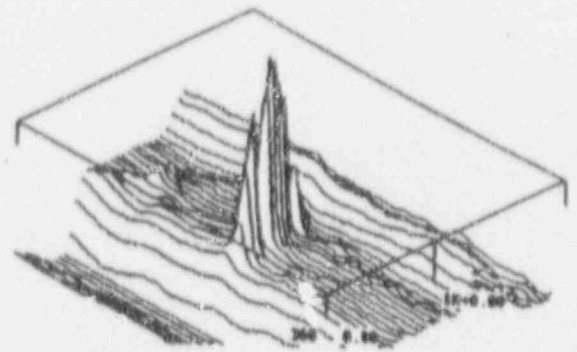
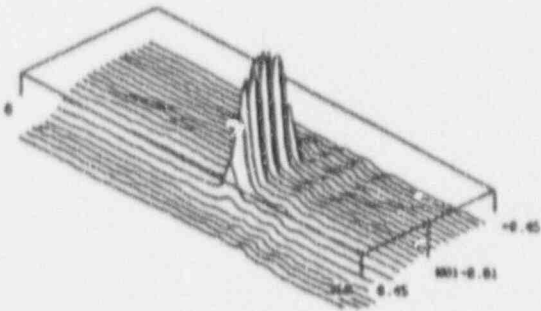
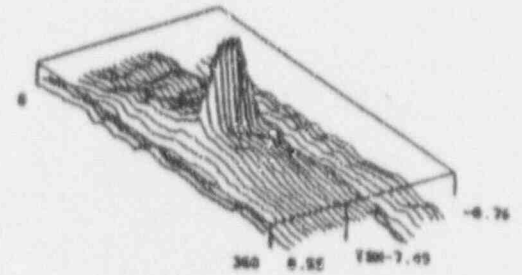
Figure 5-9

Although TSP/ODSCC indications detected by the bobbin coil tend to exhibit complex lissajous patterns in the Farley steam generators, characterization of the degradation at these locations with the rotating pancake coil probe (RPC) often clarifies the dimensions and distribution of the major crack features. A selection of four (4) such RPC characterizations from each unit are provided in Figures 5-8 and 5-9. For Farley-1 the figure exhibits the data for the pulled tube (SG-C: R20-C26) and the tubes plugged for TSP/ODSCC in November 1989, SG-B: R12-C3 and SG-B: R31-C50; similarly the Farley-2 examples include two tubes pulled in November 1990 SG-B: R4-C73 and SG-B: R21-C22 as well as two with large bobbin signal voltages plugged during the same outage (SG-C: R38-C65 and SG-C: R40-C43).

Farley-2 RPC Characterization (November 1990)

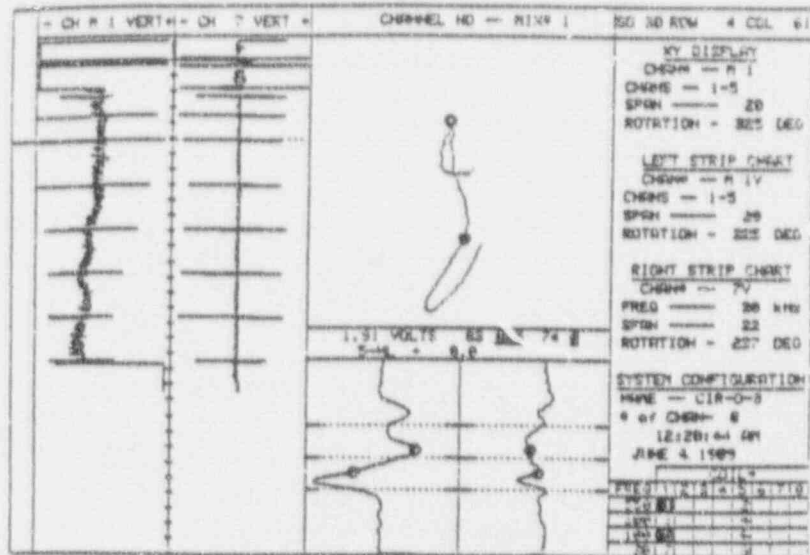
Figure 6-3

Field bobbin probe data for Plant B-1, tube R4-C61 at TSP 5, using 550/100 kHz differential mode mix. A 1.91 volt indication with 74% depth is observed.

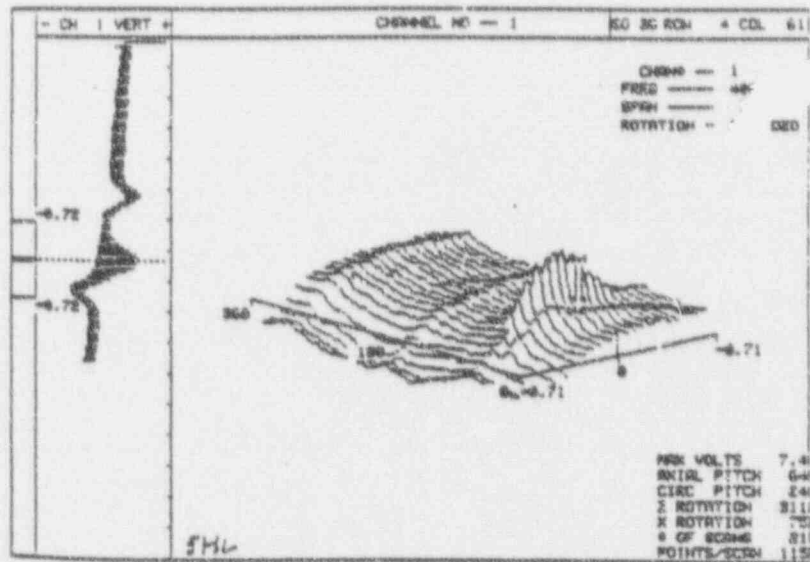
Field RPC data for Plant B-1, tube R4-C61 at TSP 5. A 0.4 inch long axial indication is observed.

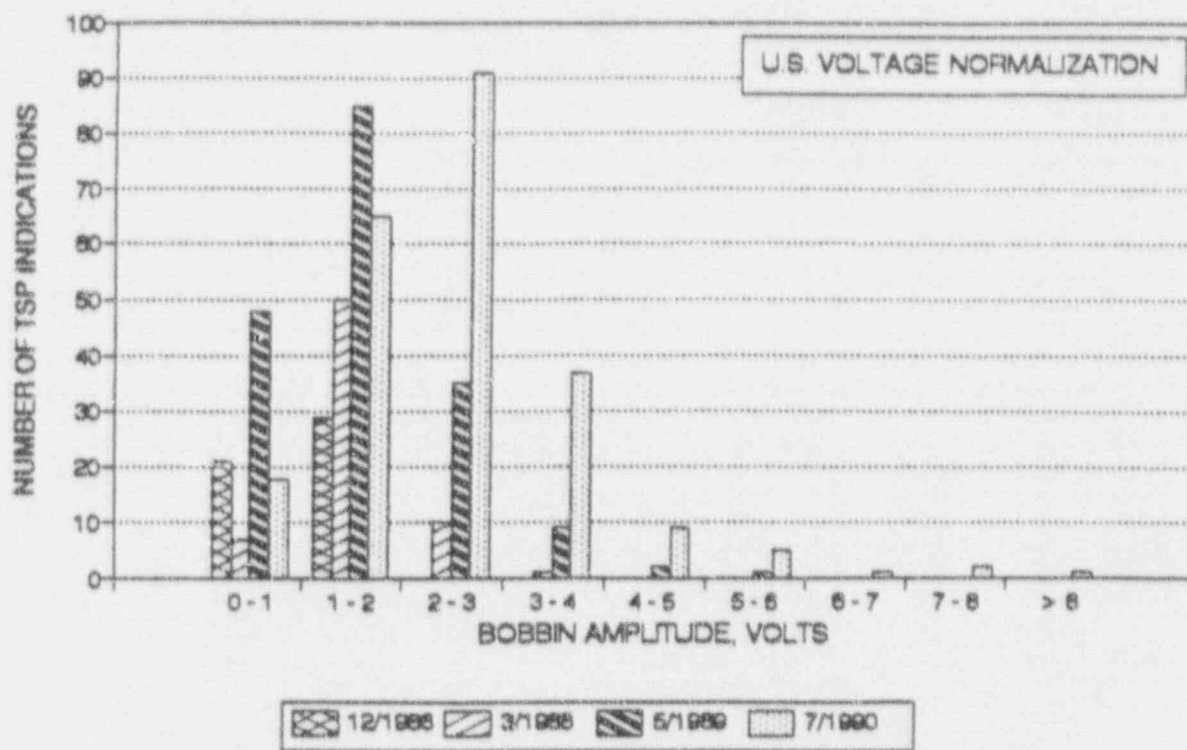
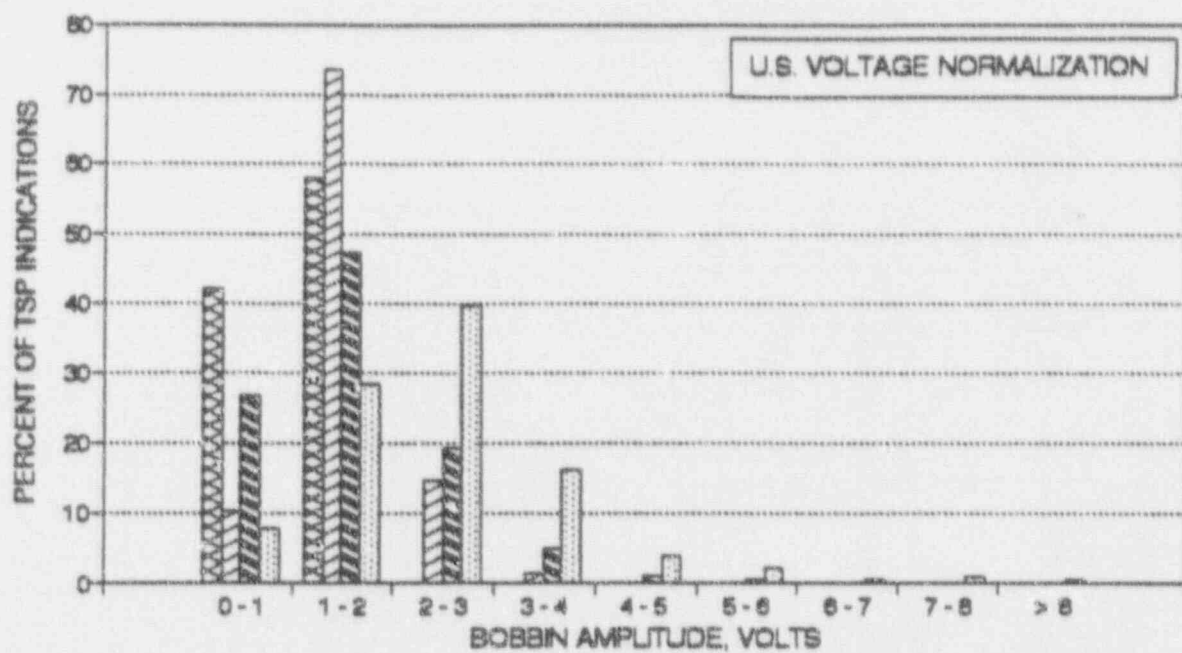
Figure 6-6

Data for ODSCC at TSPs for French Unit H-1, SG-1 are available for four successive inspections with no tube plugging as shown in Figure 6-6. The upper figure shows the number of indications versus voltage amplitude while the lower figure shows the percentage distribution of indications within each outage. Without tube plugging to eliminate the larger indications, the distribution becomes more heavily weighted at the larger indications with increasing operating time.

Distribution of TSP Indications for Plant H-1 (1986 to 1990)
