WCAP-12872
Revision 2

J. M. Farley Units 1 and 2
SG Tube Plugging Criteria for
ODSCC at Tube Support Plates

Westinghouse Energy Systems

February 1992

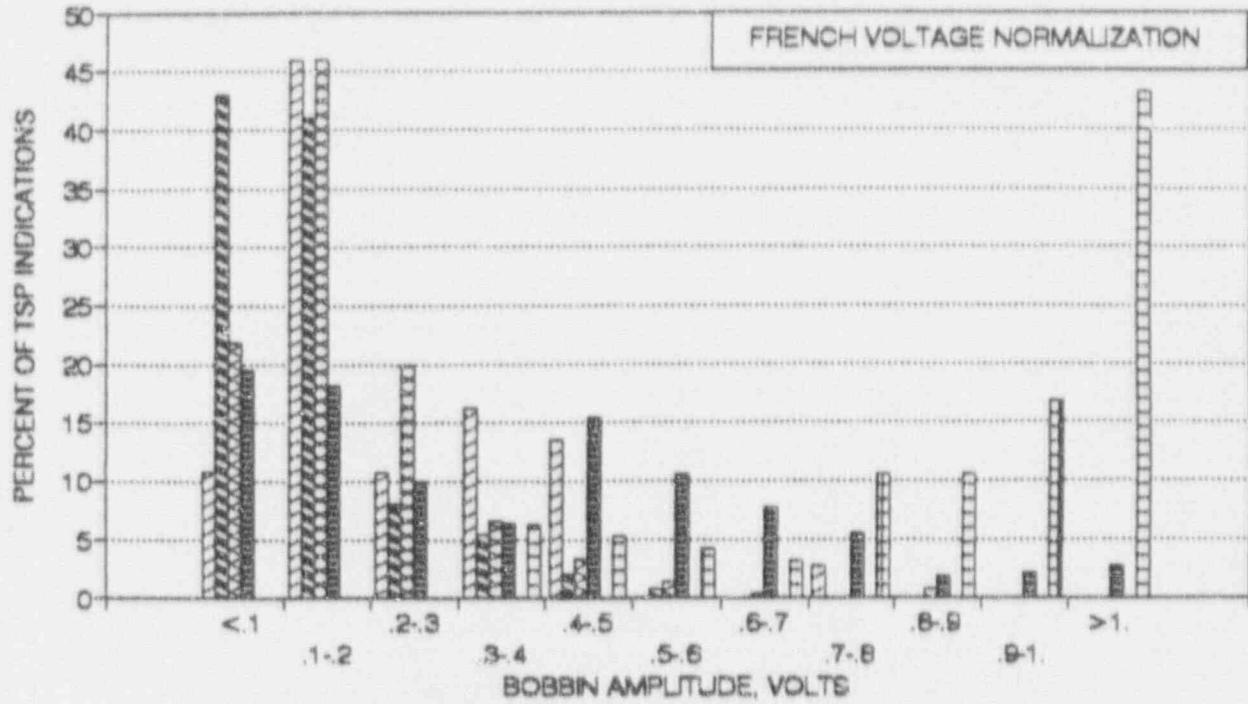
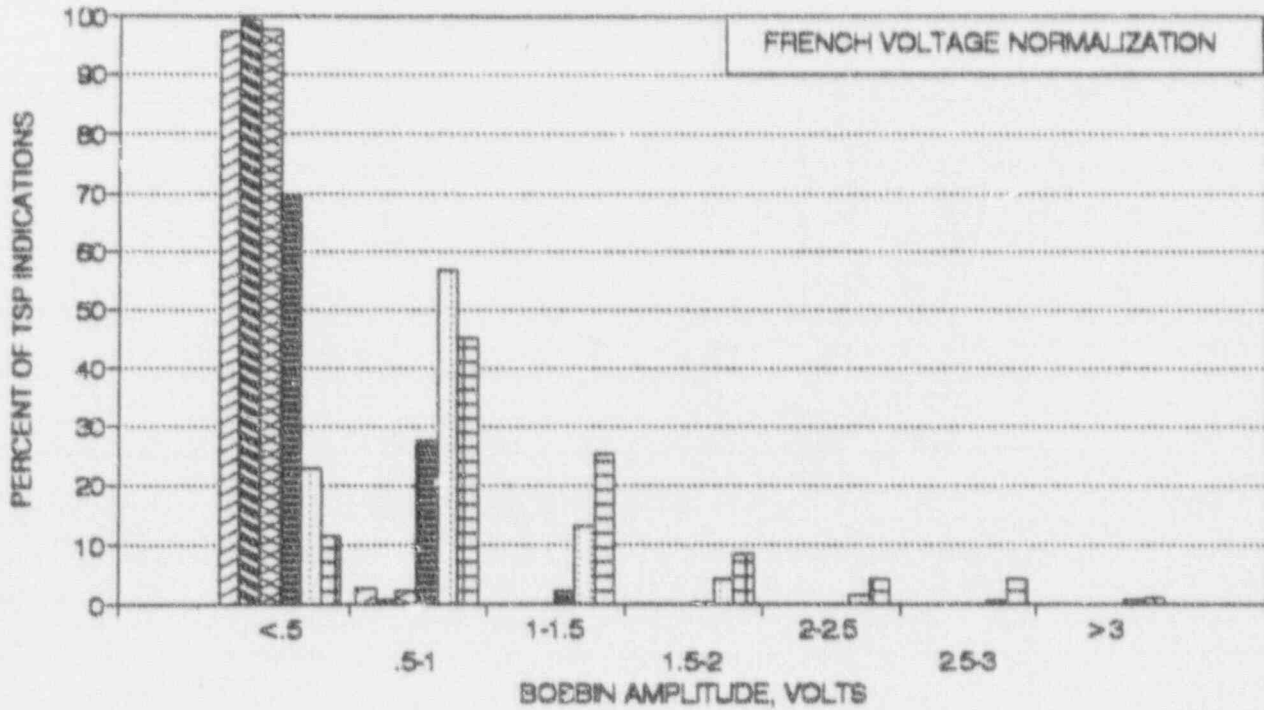
European data is currently available for French Units H-1 and J-1 and Belgian Unit K-1. It is useful to compare the percentage voltage distributions for these units with the Farley-2 data and another domestic unit, Plant F. This is shown in Figure 6-7. The lower figure is scaled to include all available data while the reduced scale of the upper figure is included to emphasize the small voltage range of the U.S. data compared to the European data. Plant J-1 was excluded from the upper figure since breakdown of the data into small ranges was not available. It may be noted that over 97% of the domestic data falls below 0.5 volts when normalized to the French procedure and none of this domestic plant data falls above 1 volt. The French and Belgian data, on the other hand, extends above 3 volts.

The European units of Figure 6-7 with higher equivalent voltages have operated with no identifiable operating leakage. This result indicates that operating leakage due to ODSCC at TSPs is expected to be insignificant. This is supported by the fact that only 3 cases of small operating leakage, as shown in Table 6.3, have been identified to date.

Comparison of Voltage Indications at TSPs Between U.S. and European Plants

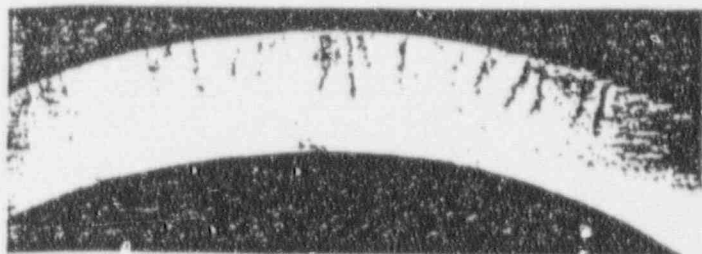
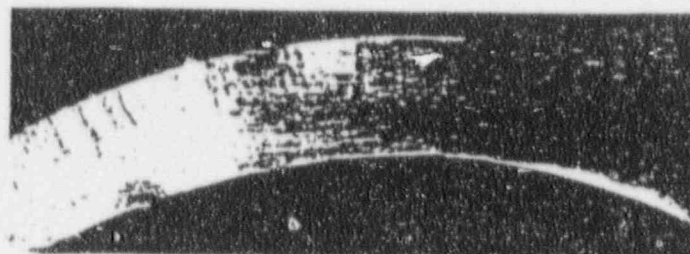
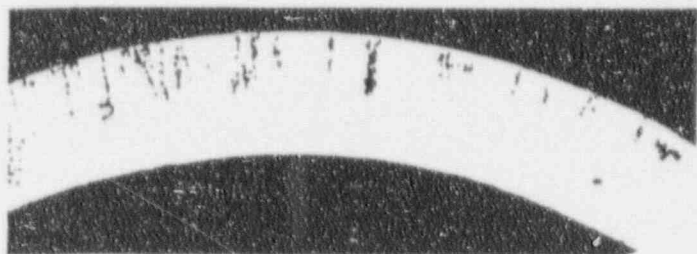
Fourteen tubes have been removed from French units with destructive examination results currently available. Figure 6-8 shows the crack morphology for a tube with a 0.7 volt (~3.7 U.S. volts) indication. The tube exams indicate many axial cracks of comparable depth around the tube circumference. The cracks are dominantly ODSCC with somewhat more IGA participation than seen in most domestic pulled tube data such as the Farley data. The multiple crack networks would be expected to increase bobbin coil voltage compared to one or only a few deep cracks as typical of the domestic data.

Crack Morphology for Pulled Tube from French S/G

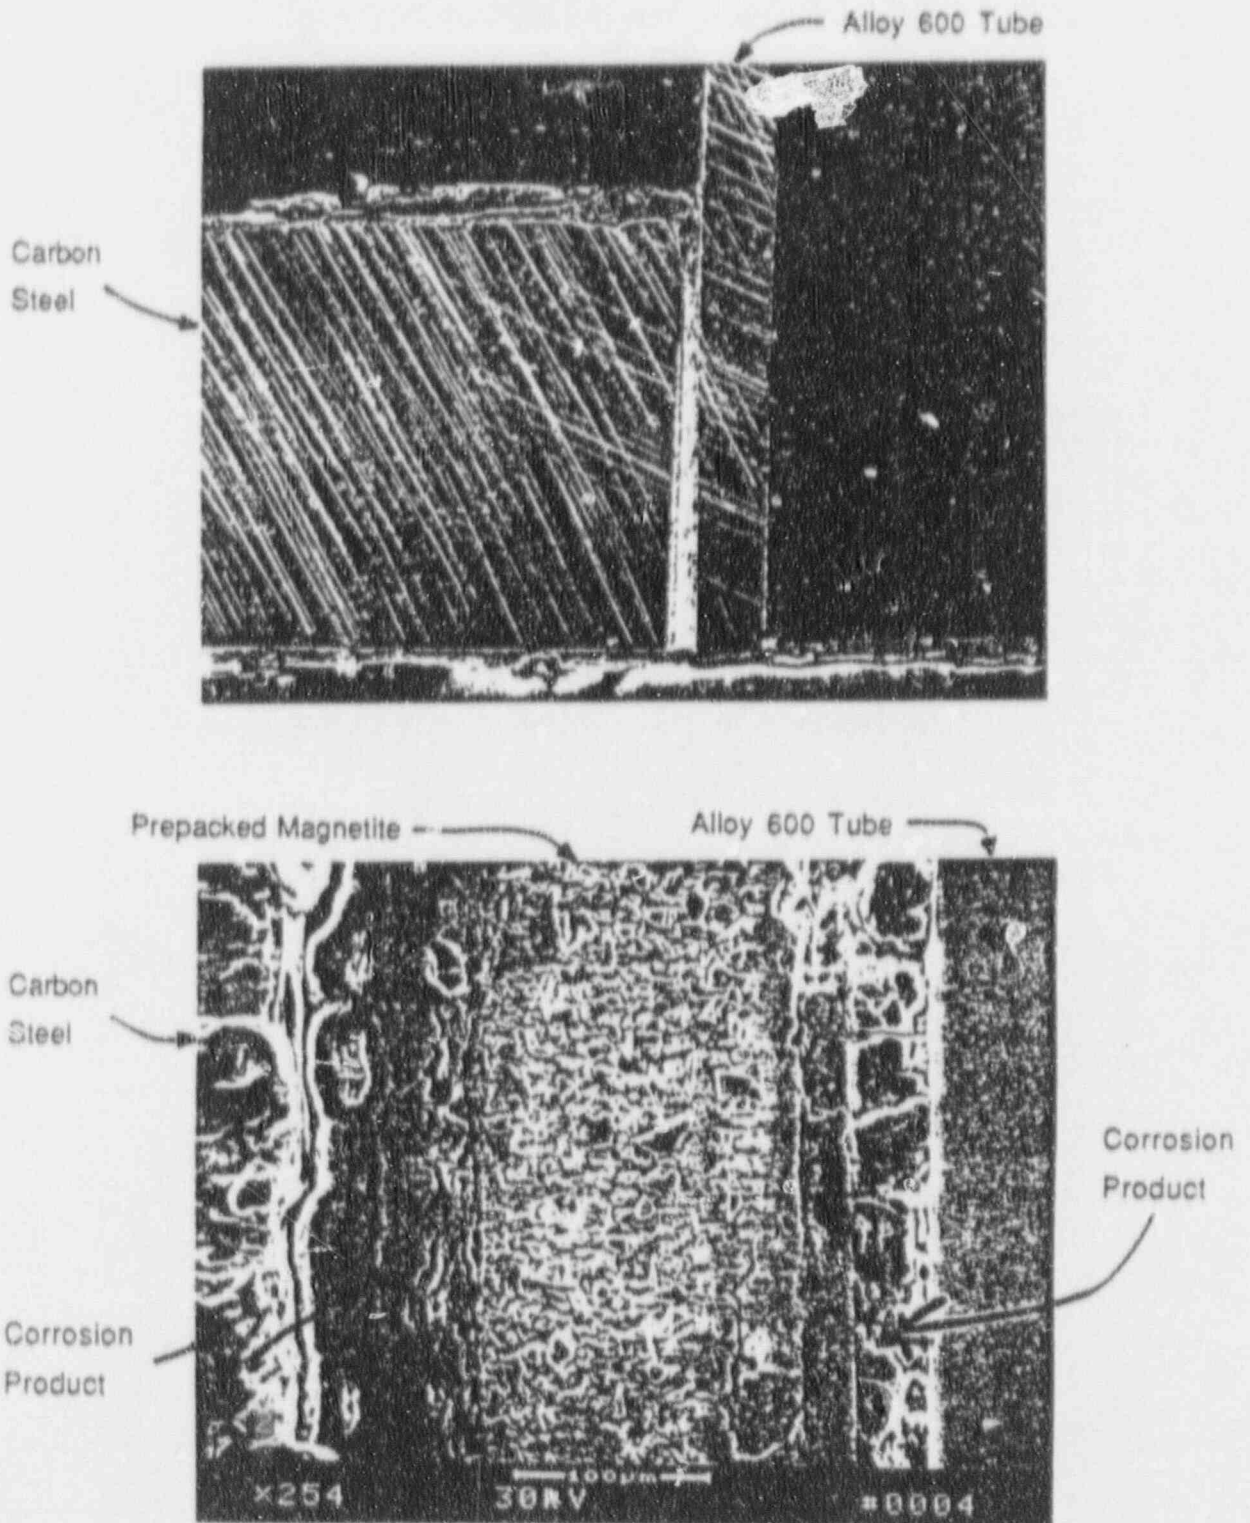
Figure 7-3. Section Through a Dented Tube Support Plate Intersection

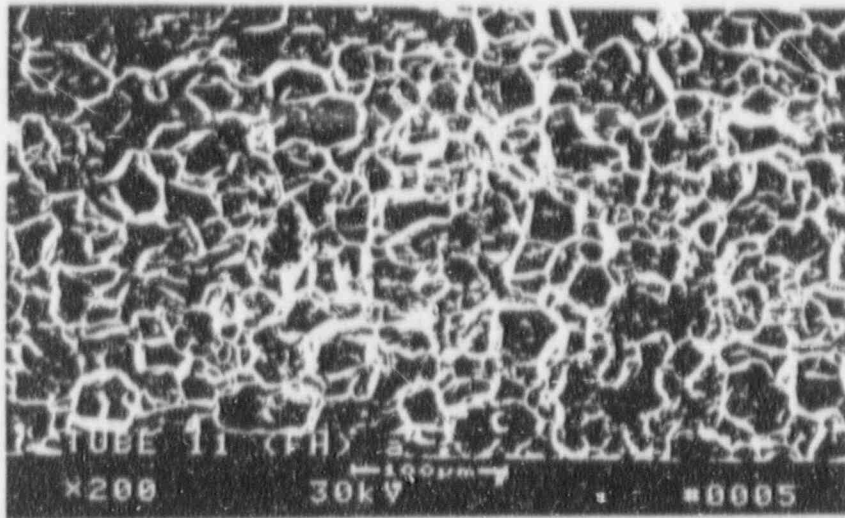
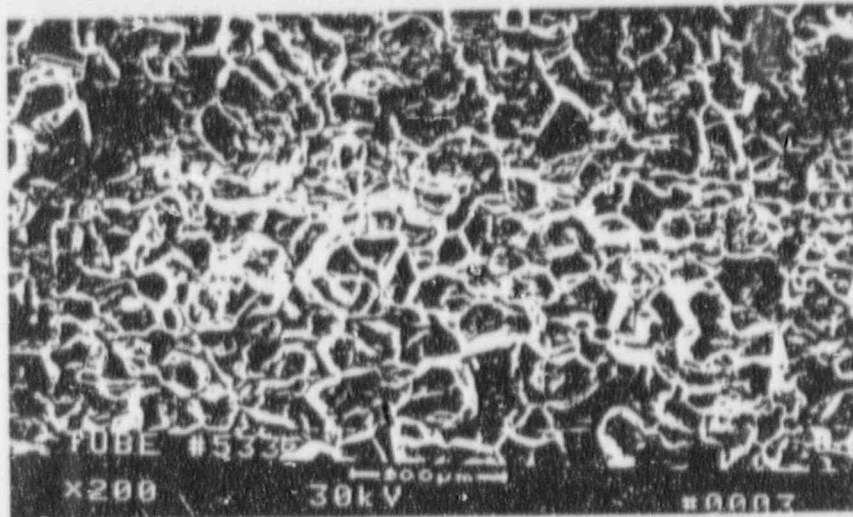
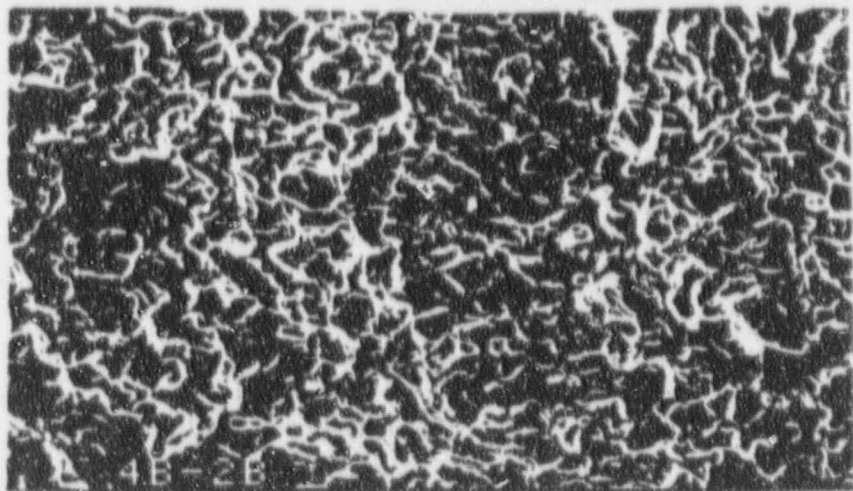
Figure 7-5. SEM Fractographs of Cracks in Doped Steam Specimen,
Model Boiler Specimen and Service Tube

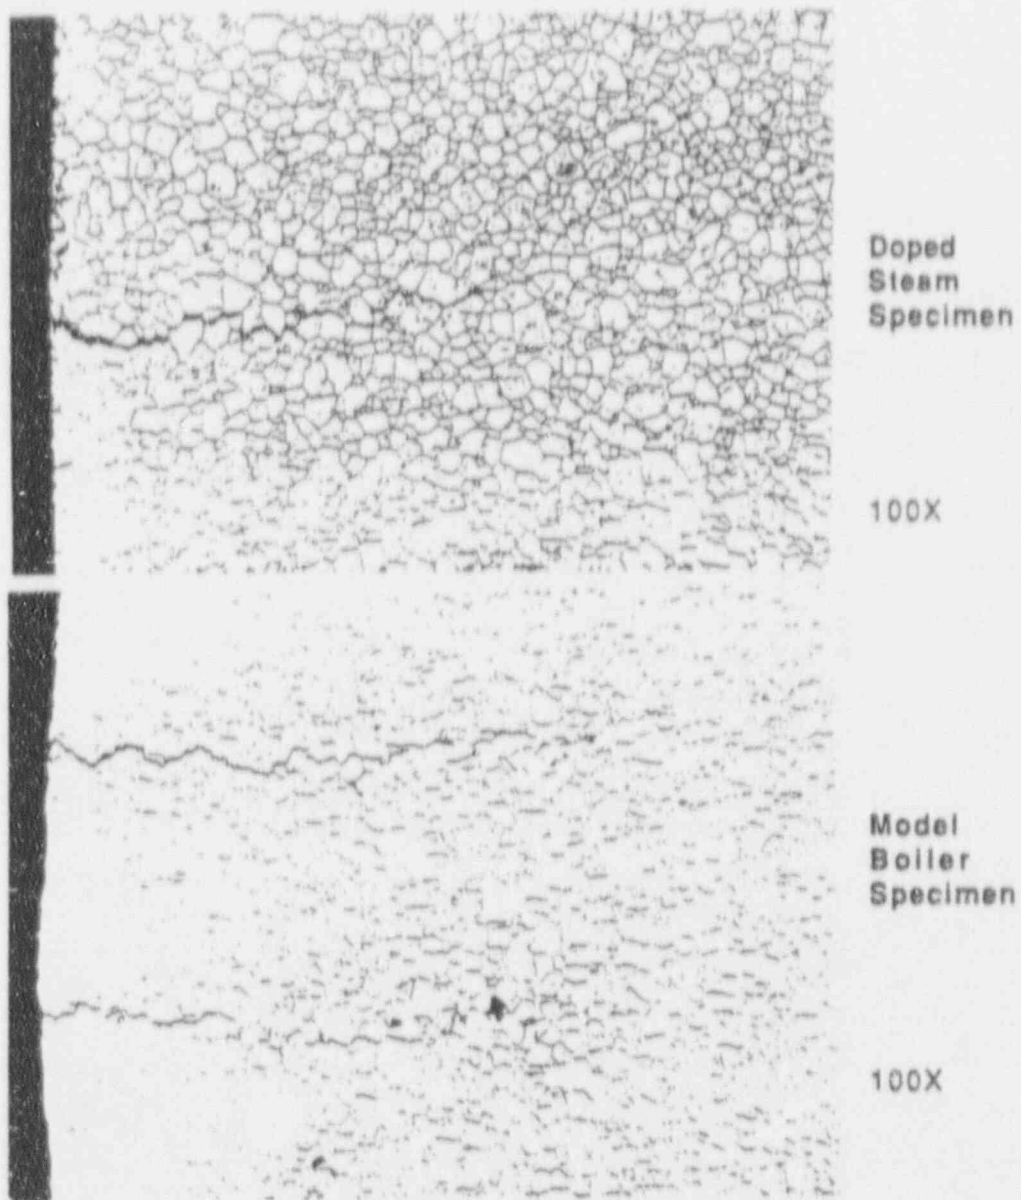
Figure 7-6. Metallograph of Cracked Specimens

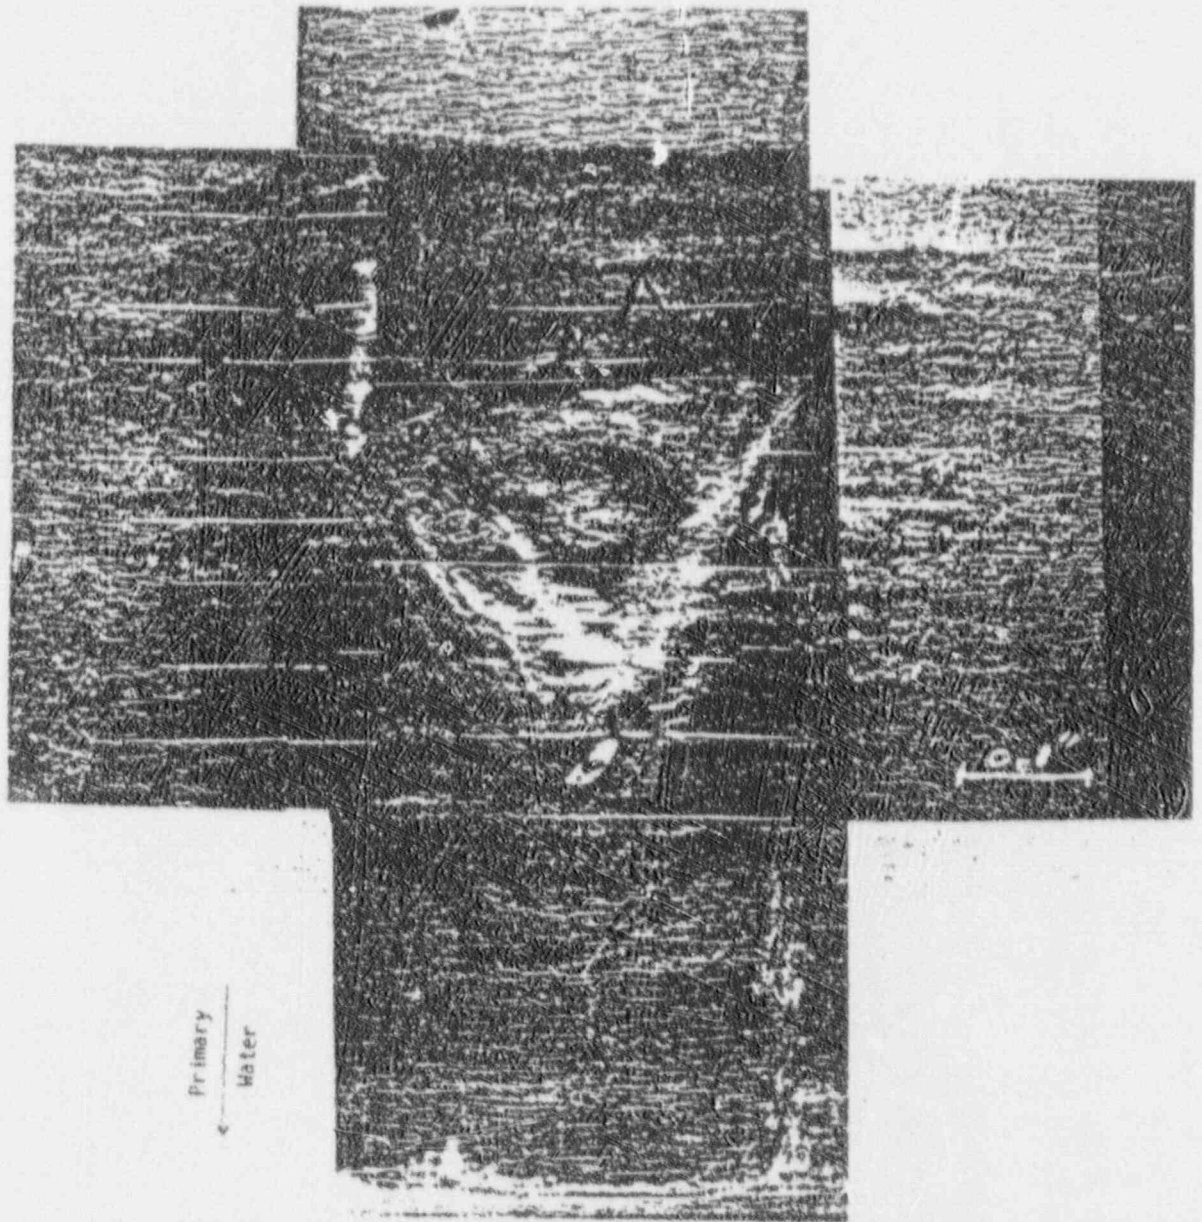
- Cold Leg Thinning:** Pulled tube data from two different plants with cold leg thinning were reviewed and are summarized as follows. In one case, a flaw at the second TSP in the cold leg with a maximum wall penetration of 48% had a bobbin amplitude of 4 volts. Figure 8-11 shows a photograph of the OD surface at the degraded location. In the second example, which was also at the second TSP in the cold leg, a maximum wall penetration of 59% yielded a bobbin amplitude of 4.9 volts. Examination of the pulled tubes showed no cracks in these tubes and the degradation was identified as "cold leg thinning."

Photograph of the OD Surface of a Pulled Tube With Cold Leg Thinning

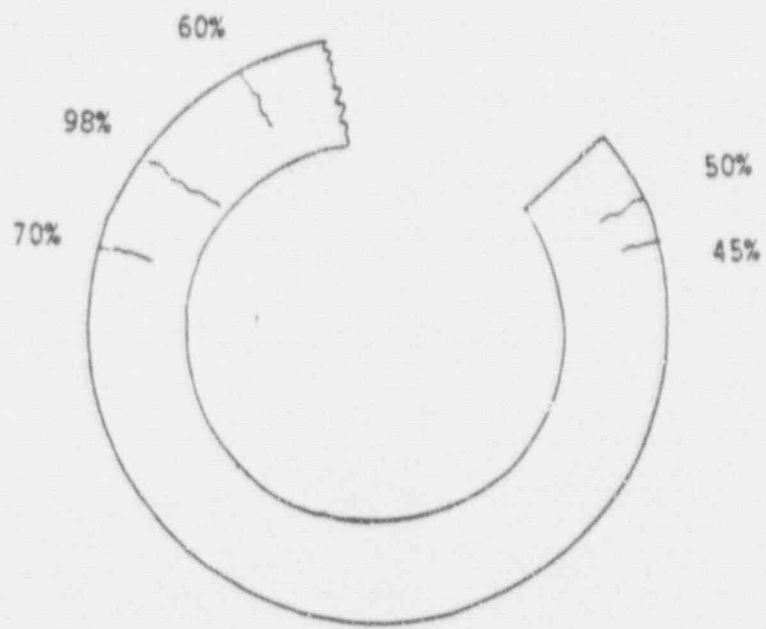
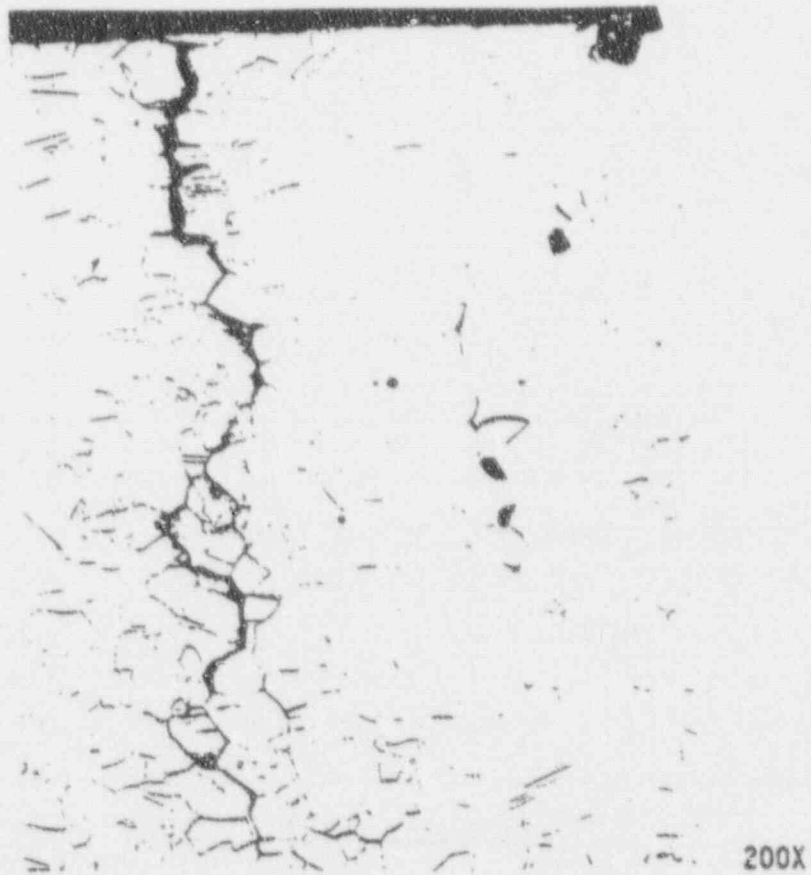
Figure 10-1 Sketch of a metallographic cross section through secondary support plate crevice cracks in Tube 543-4. A typical crack micrograph is also shown.

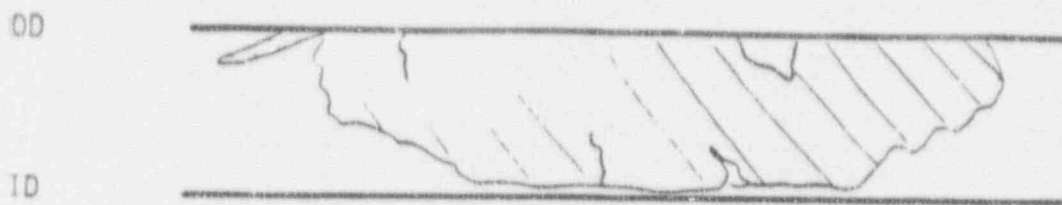
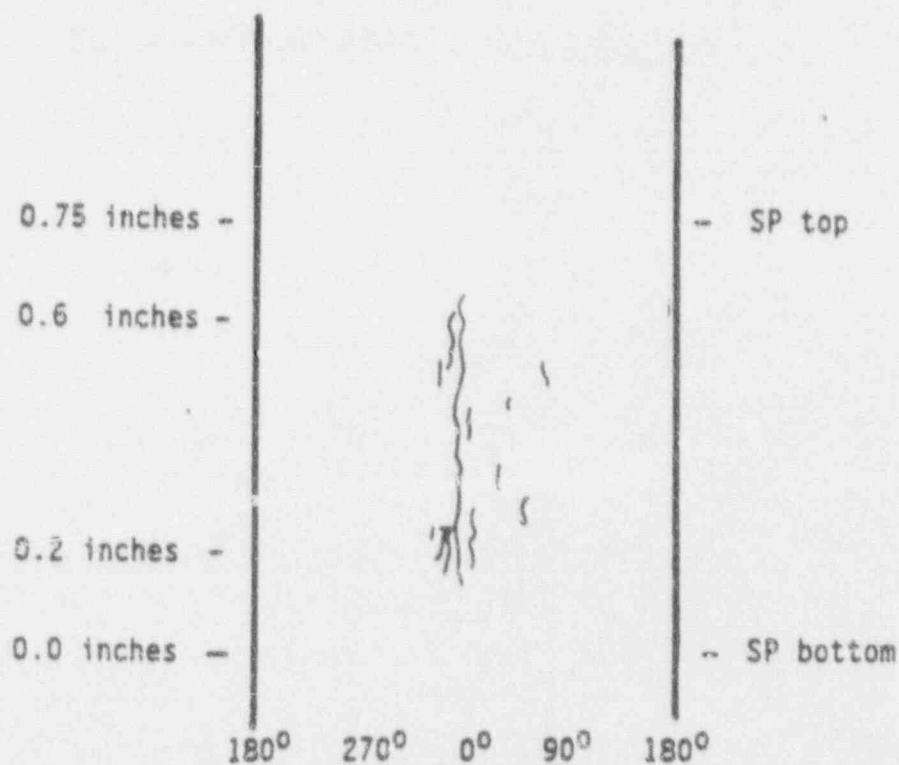
Figure 10-2 Summary of crack distribution and morphology observed on Tube 543-4.

Fractography of the burst crack showed that the environmental cracks were intergranular and typical of stress corrosion cracking (SCC). The macrocrack was 0.52 inch long and did not penetrate the ID wall although it was at many locations up to 98% through wall. The macrocrack was composed of at least six microcracks, all of which had joined together by intergranular SCC. A metallographic cross section through many of the secondary cracks observed on the circumference within the tube support plate intersection revealed five cracks with depths ranging from 45 to 98% through wall. A sketch of the location of these cracks relative to the burst fracture is shown in Figure 10-1. A typical crack morphology of a secondary crack is shown in this figure. A summary of the observed OD origin secondary cracks and morphology of the main crack are shown in Figure 10-7.

Macrocrack Length = 0.52 inches

Number of Microcracks = 6 (all ligaments with intergranular features)

Morphology = IGSCC

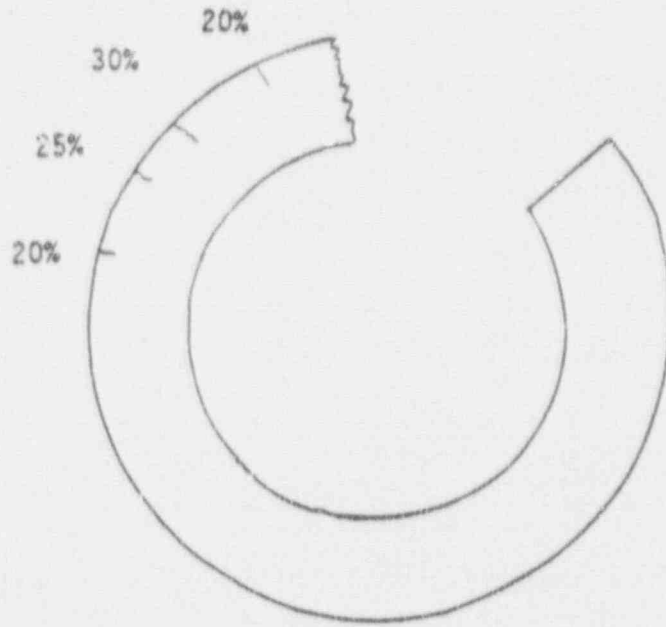
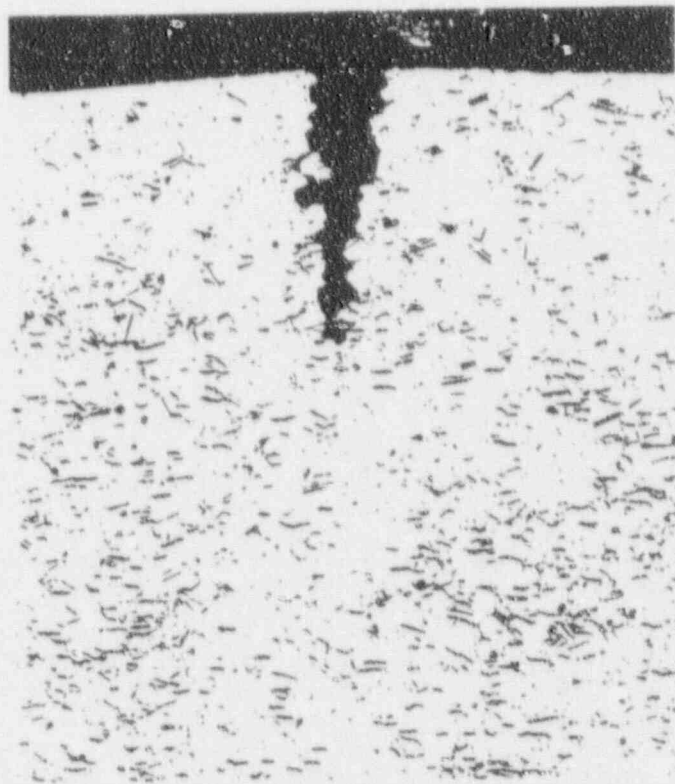
The burst crack was relatively short (0.16 inch long) but deep, 95% through wall. The secondary cracks were all short and axially orientated. A summary of the shape, morphology and distribution of cracks found in Tube 525-1 is presented in Figures 10-3 and 10-4.

Figure 10-3 Secondary crack distribution in a metallographic cross section of Tube 525 in the support plate crevice region. A micrograph of one of the cracks is also shown.

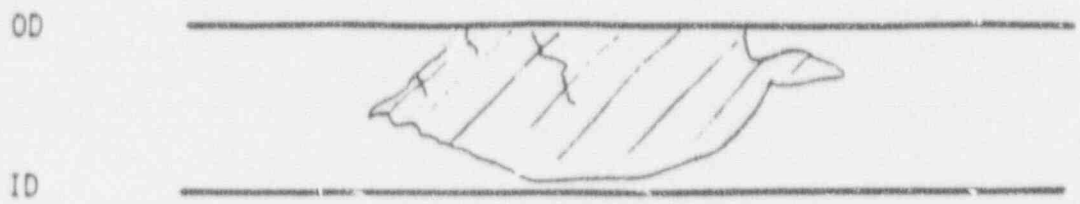
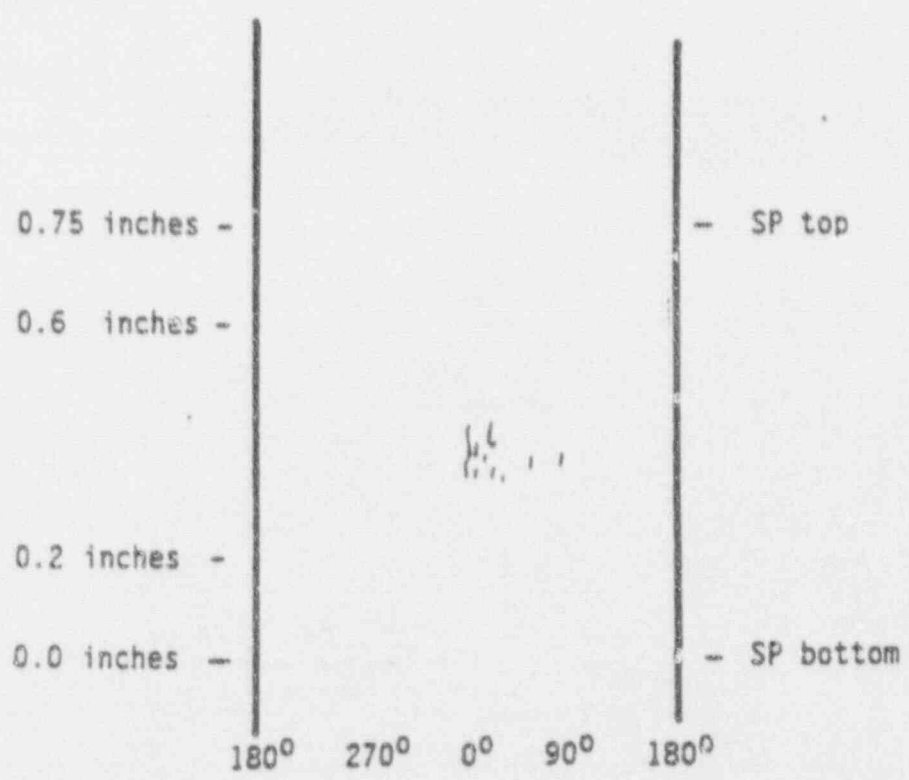
Figure 10-4 Summary of crack distribution and morphology observed on Tube 525.

Macrocrack Length = 0.16 inches
 Throughwall Length = 0 (95% throughwall)
 Number of Microcracks = 3 (all ligaments with intergranular features)
 Morphology = IGSCC

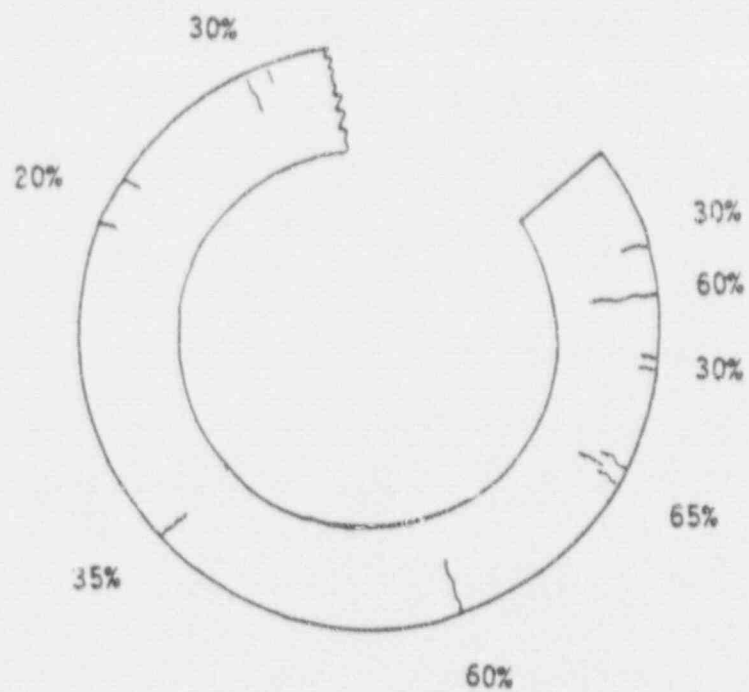
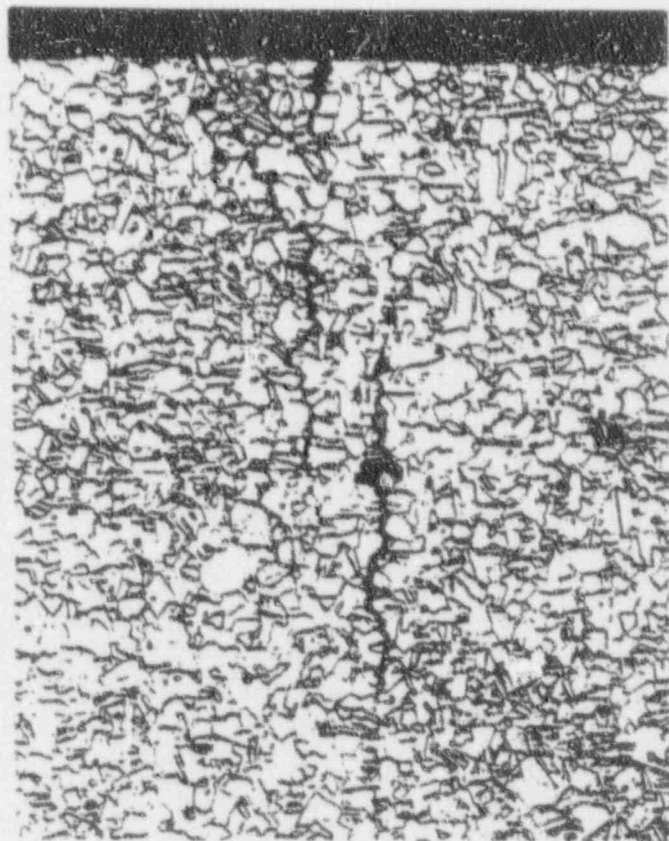
Figure 10-5 Secondary crack distribution and a micrograph of one of these cracks in a metallographic cross section of Tube 533-4.

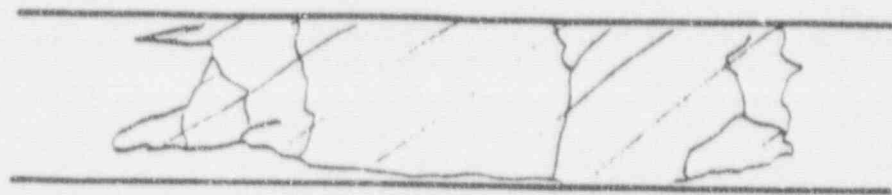
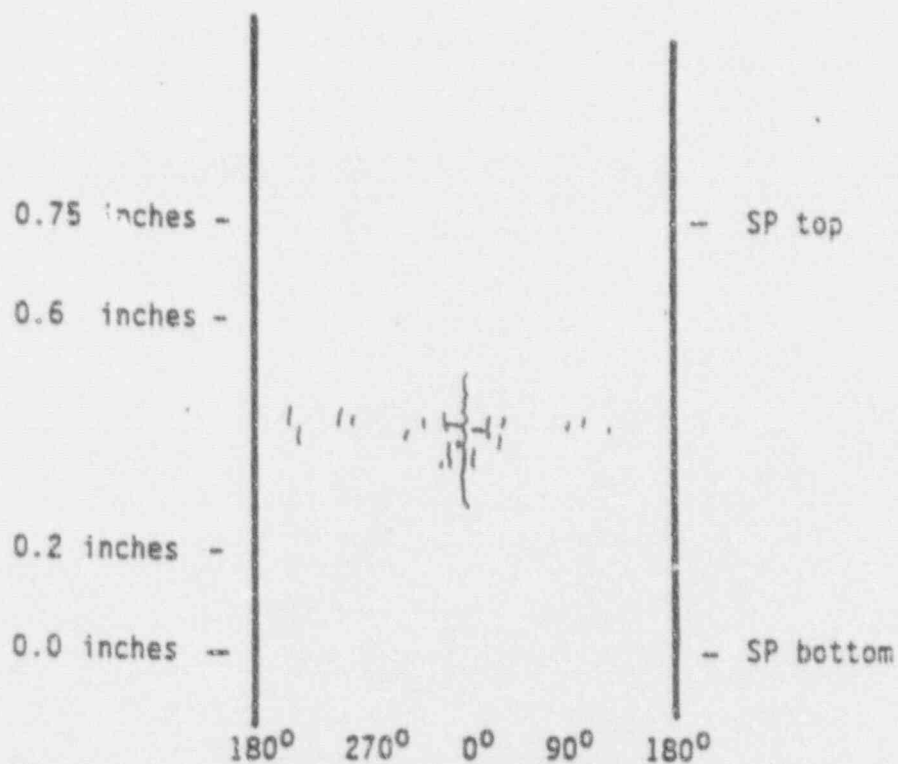
Figure 10-6 Summary of crack distribution and morphology observed on Tube 533-4.

A network of axial and circumferential secondary cracks was observed near the burst crack. The axially orientated burst crack was composed of at least five microcracks which joined to form the macrocrack. Joggles separating these microcracks showed partially ductile features (shear dimples) while the crack face was entirely intergranular. The OD origin major crack was 0.34 inch long and penetrated the ID wall for a length of 0.14 inch. The secondary crack distribution found in the metallographic cross section is shown in Figure 10-5, and a summary of the cracks observed in the support plate region of the tube is presented in Figure 10-6.

Macrocrack Length = 0.34 inches

Number of Microcracks = 5 (3 ligaments have ductile features)

Morphology = IGSCC

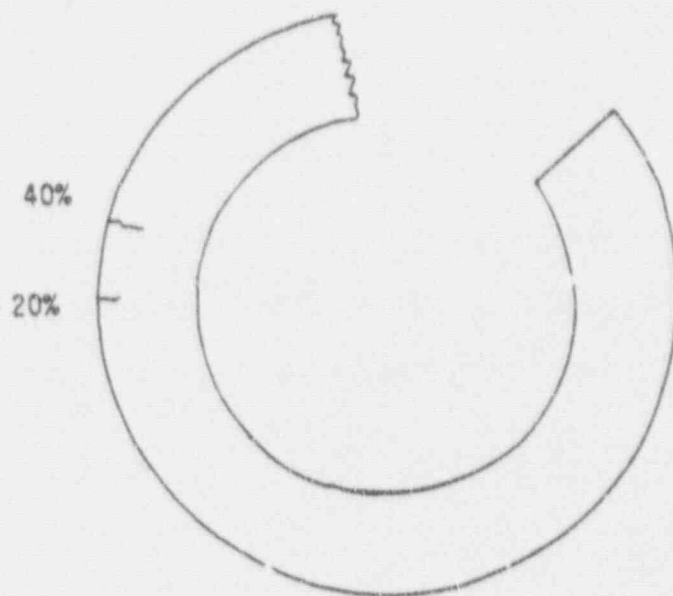
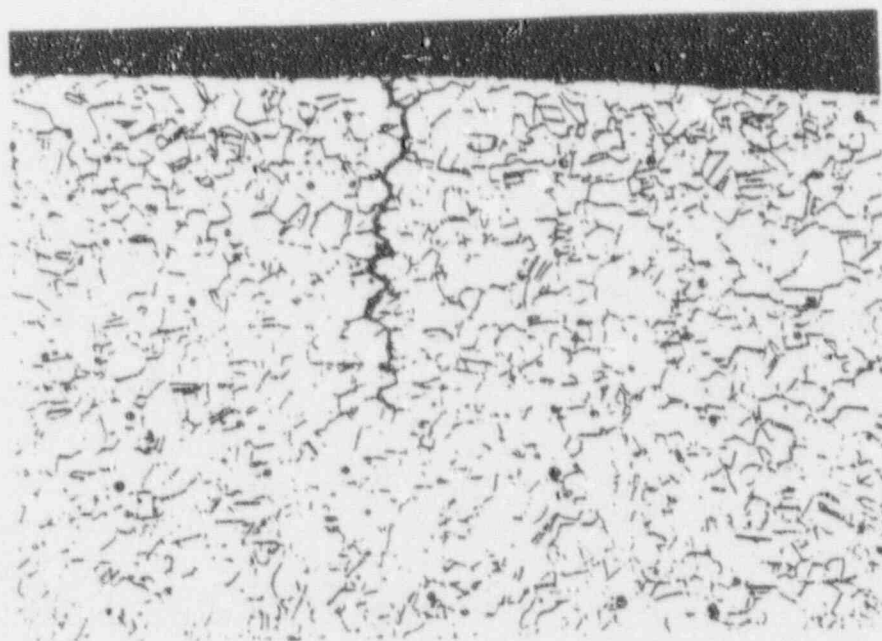
Figure 10-7 Secondary crack distribution and a micrograph of one of these cracks in a metallographic cross section of Tube 536-1.

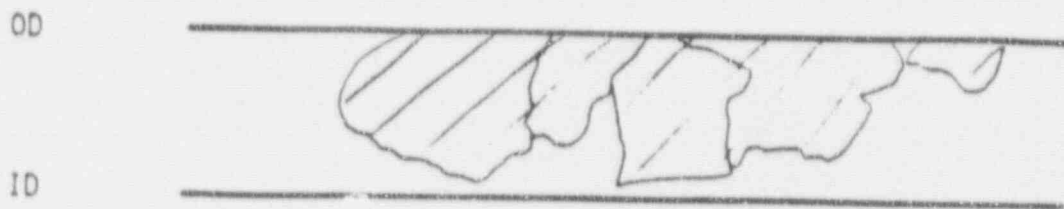
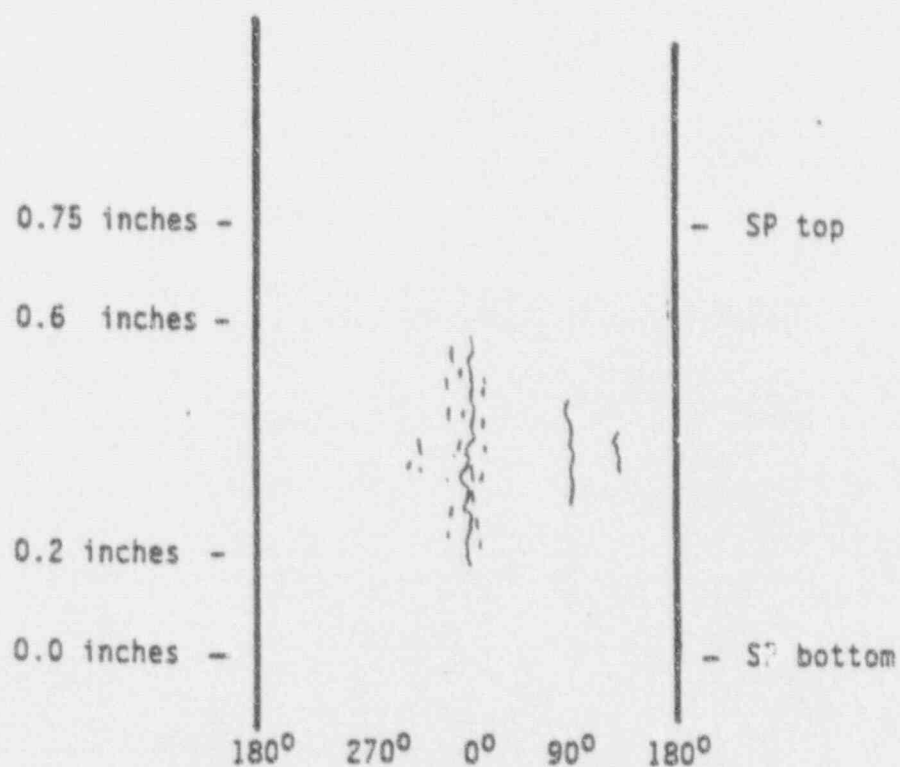
Figure 10-8 Summary of crack distribution and morphology observed on Tube 536-1.

Many secondary cracks were observed clustered around the burst opening. Other larger secondary cracks were found at a location 95 and 145 degrees from the burst opening. The main burst crack and the largest of the secondary cracks located at 95 degrees were opened and examined by SEM. In both cases the OD origin cracking morphology was intergranular and typical of SCC. The burst crack was 0.4 inch long and 90% through wall. The macrocrack consisted of at least five microcracks which joined to form the macrocrack. The largest secondary crack was 0.3 inch long and 95% through wall. It was also formed by several microcracks. A metallographic cross section through the remaining piece of the tube at the support plate intersection showed two intergranular OD origin stress corrosion cracks (Figure 10-7). The larger of these two cracks was 40% through wall. A summary of crack observations on Tube 536-1 is shown in Figure 10-8.

Macrocrack Length = 0.4 inches

Number of Microcracks = 5 (ligaments have mostly ductile features)

Morphology = IGSCC

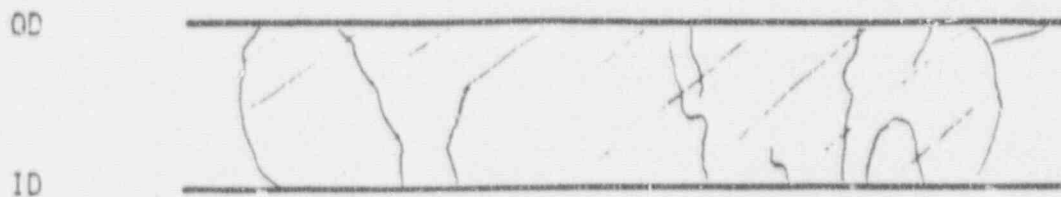
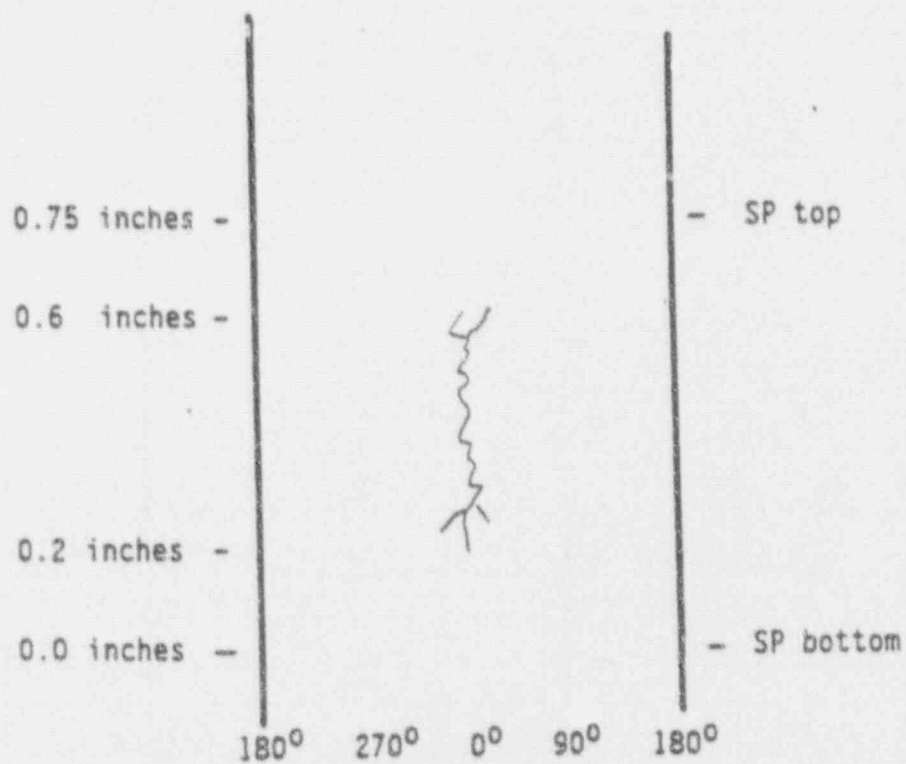
Figure 10-9 Summary of crack distribution and morphology observed on Tube 558-1.

Macrocrack Length = 0.4 inches

Number of Microcracks = 6 (ligaments have mostly intergranular features with some ductile features)

Morphology = IGSCC

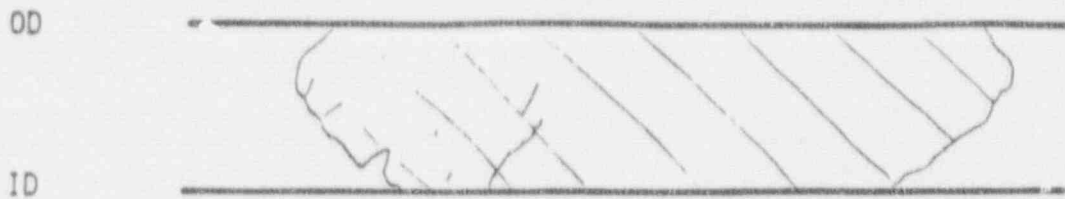
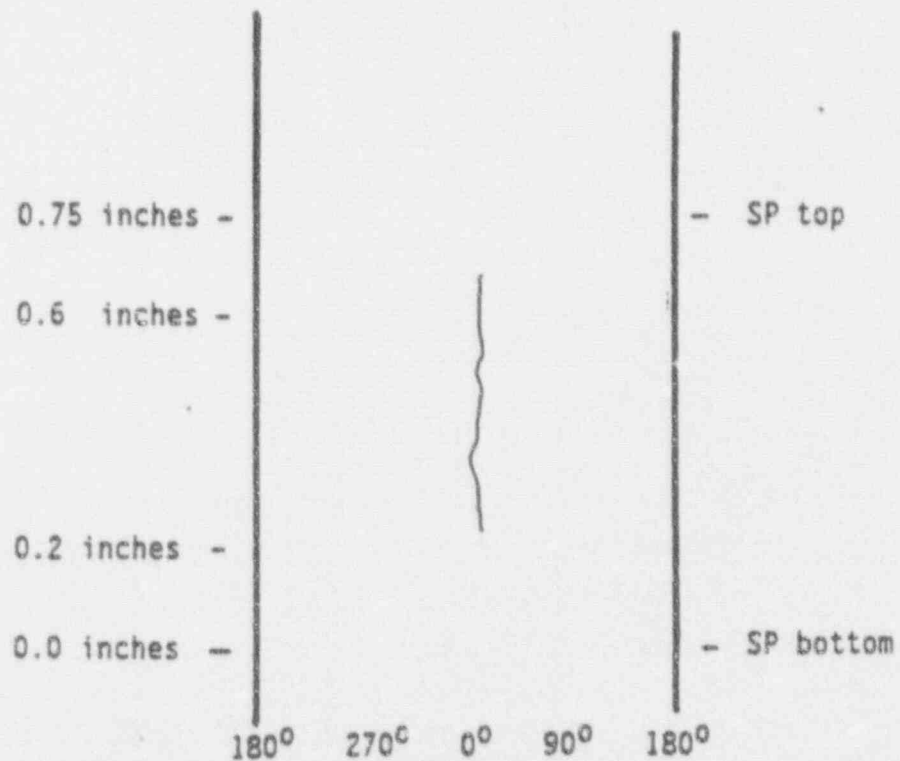
Figure 10-10 Summary of crack distribution and morphology observed on Tube 571-1.

Macrocrack Length = 0.44 inches

Number of Microcracks = 1 to 4

Morphology = IGSCC

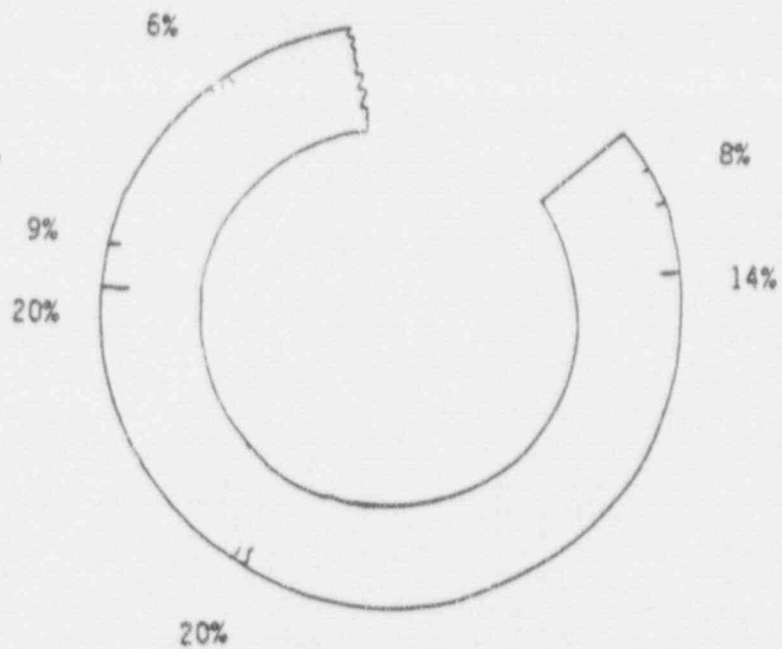
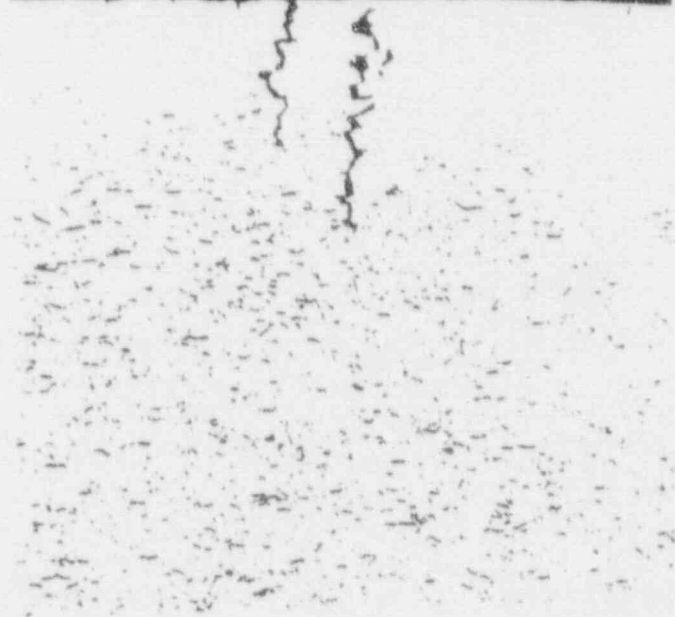
Figure 10-11 Secondary crack distribution and a micrograph of one of these cracks in a metallographic cross section of Tube 533-3 within the Teflon support plate region.

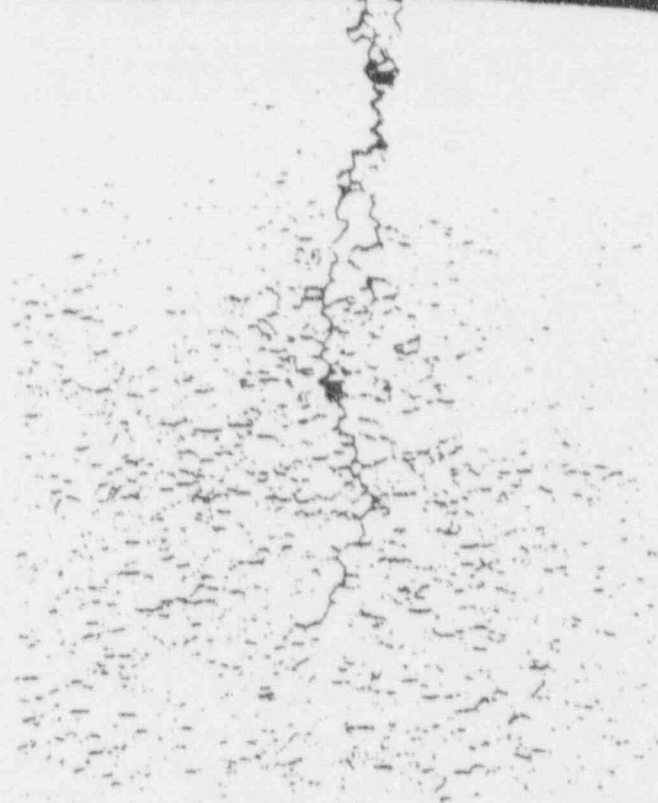
51% 51% 66%

Figure 10-12 Crack distribution and a micrograph of one of these cracks in a metallographic cross section of Tube 533-3 within the steel collar region.

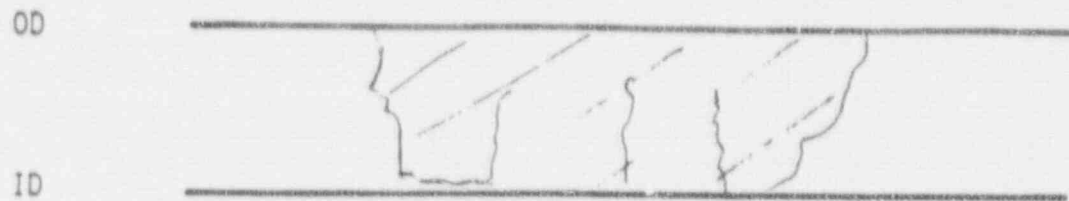
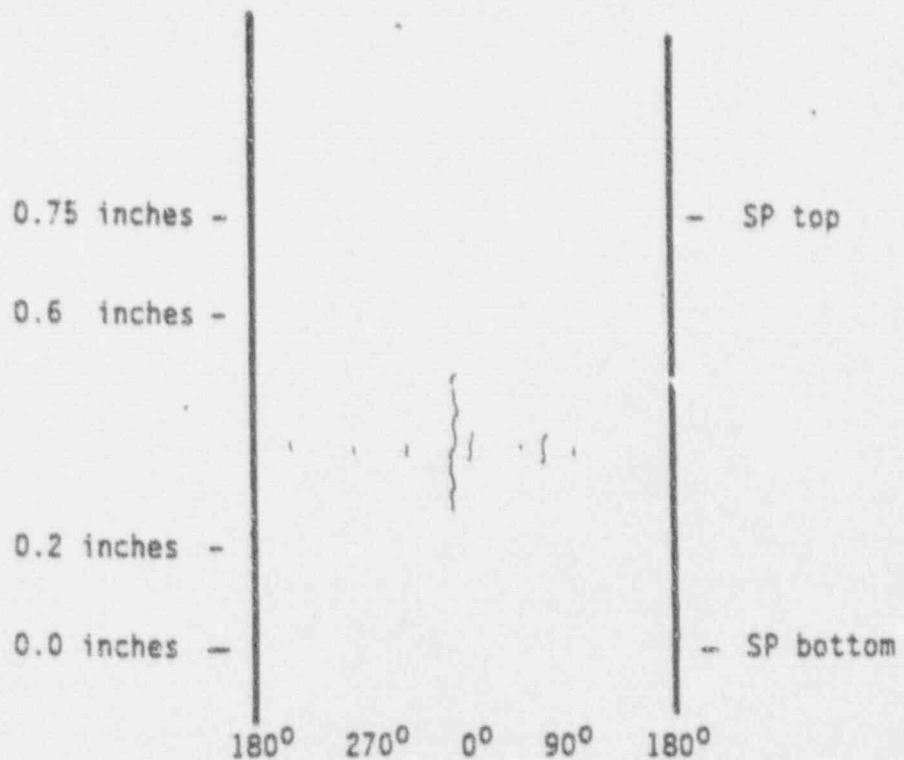
The collars of this model boiler specimen were removed. Several small axial cracks were observed at the support intersections. One was located under the Teflon collar and a few were located under the top steel collar. The crack within the Teflon collar intersection was opened and examined by SEM. The macrocrack face exhibited intergranular features with some ductile tearing on a ligament separating two microcracks. The macrocrack was 0.27 inch long and was composed of four microcracks. The OD origin crack penetrated the ID wall for a length of 0.17 inch. A metallographic cross section through the center of the Teflon collar intersection revealed numerous small intergranular stress corrosion cracks. The location (on the tube) and depth of these cracks is shown in Figure 10-11, together with one micrograph. A metallographic cross section through some of the cracks within the steel collar intersection revealed the crack distribution shown in Figure 10-12. The characterization of the through wall crack found under the Teflon collar and the crack distribution around the tube within the Teflon support is shown in Figure 10-13.

Macrocrack Length = 0.27 inches

Number of Microcracks = 4 (2 ligaments with intergranular features; 1 with ductile features)

Morphology = IGSCC

Figure 10-13 Summary of crack distribution and morphology observed on Tube 533-3 at the Teflon intersection.
