WCAP-12872
Revision 2

J. M. Farley Units 1 and 2
SG Tube Plugging Criteria for
ODSCC at Tube Support Plates

Westinghouse Energy Systems

February 1992

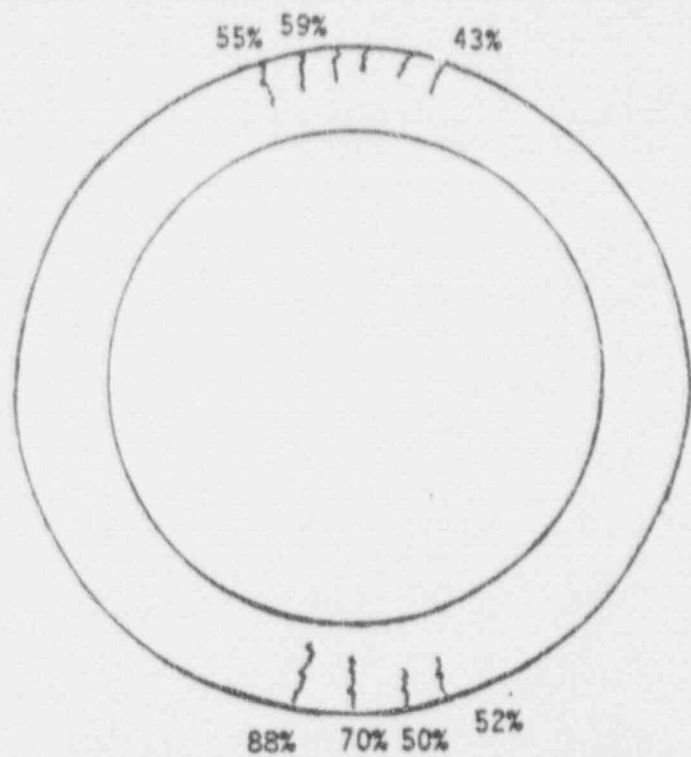
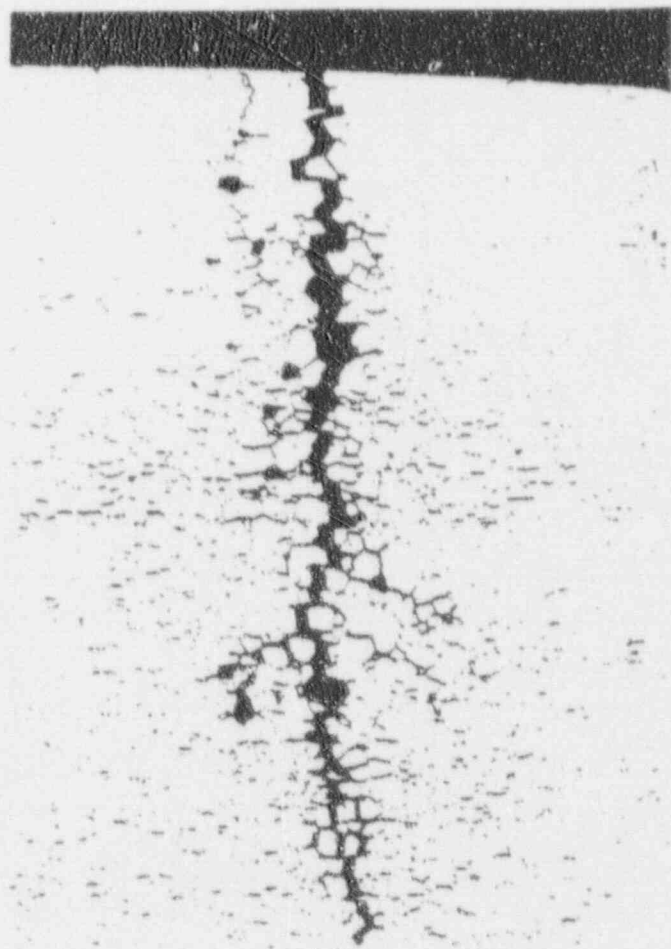
Doped steam specimen SL-FH-11 developed a large number of OD origin cracks. The largest agglomeration of these cracks was opened for fractographic examinations and cross sectional cuts made above (A) and below (B) the opened section of the macrocrack for metallographic examinations. The opened section of the tube showed an intergranular macrocrack, 0.37 inch long. The ligaments separating the 4 microcracks of the macrocrack had only intergranular features. The crack penetrated the ID wall for a length of 0.23 inch. The cross sectional cuts made through planes A and B produced the crack distributions and typical crack morphologies depicted in Figures 10-14 and 10-15. A summary of the crack observations made at this location is shown in Figure 10-16.

Figure 10-14 Crack distribution and a micrograph of one of these cracks in a metallographic cross section of Tube SL-FH-11 in Plane A.

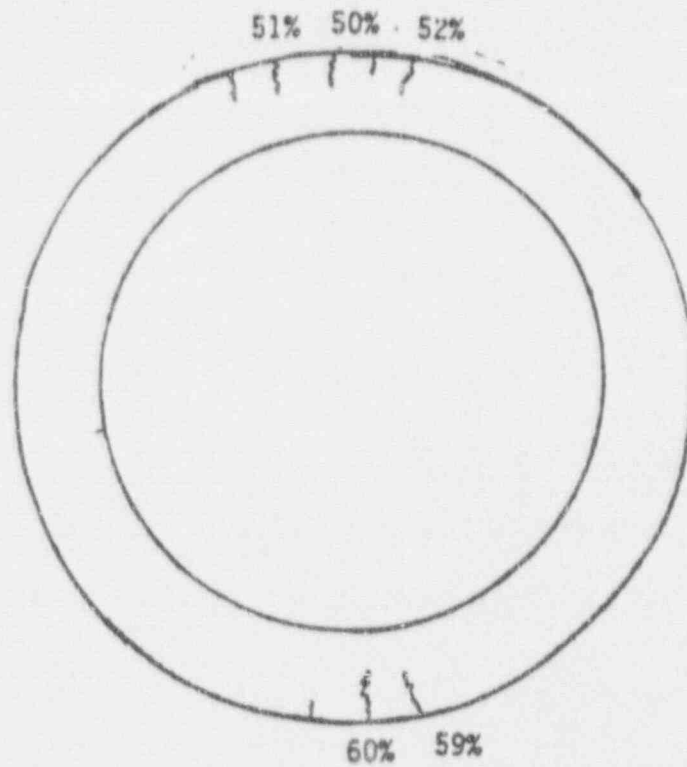
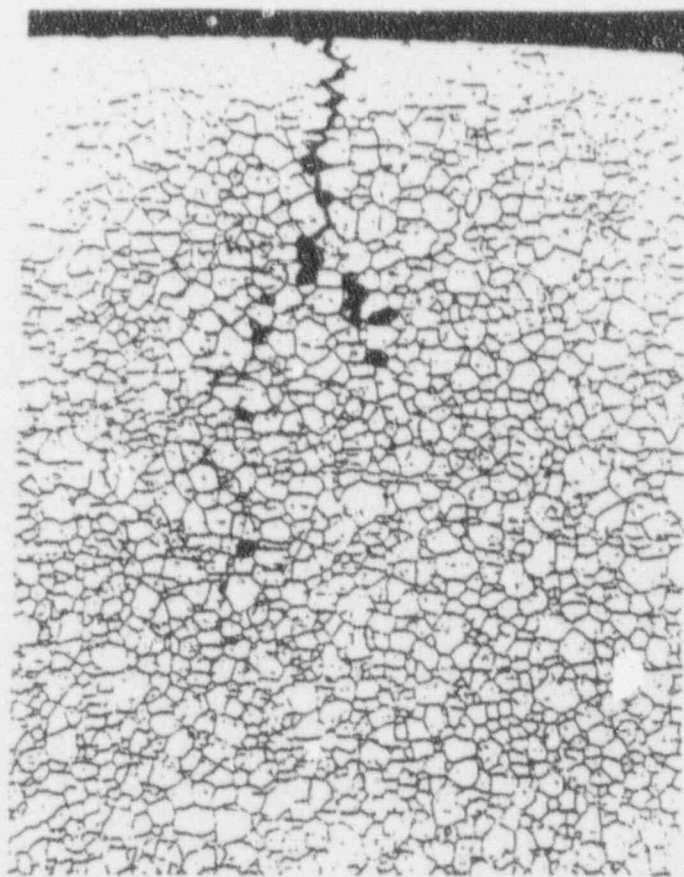
Figure 10-15 Crack distribution and a micrograph of one of these cracks in a metallographic cross section of Tube SL-FH-11 in Plane B.

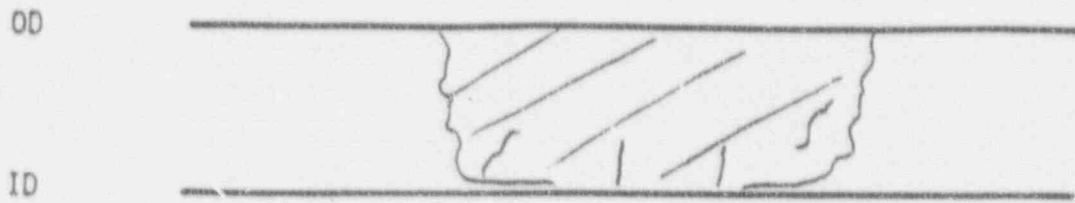
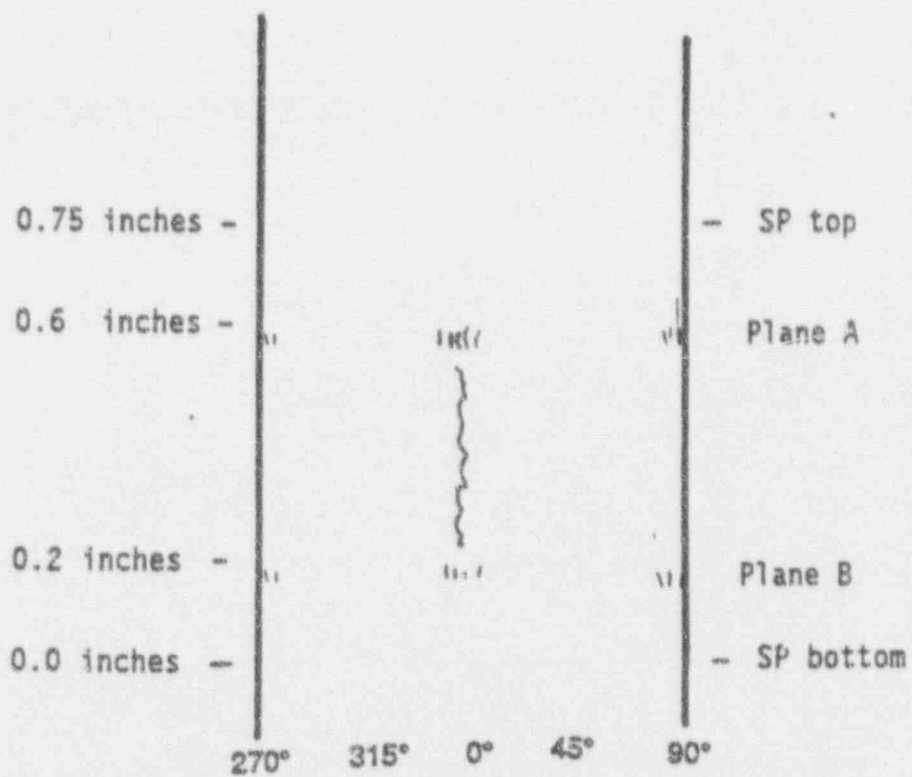
Macrocrack Length = 0.37 inches

Number of Microcracks = 4 (all ligaments with intergranular features)

Morphology = IGSCC

Figure 10-16 Summary of crack distribution and morphology observed on Tube SL-FH-11.

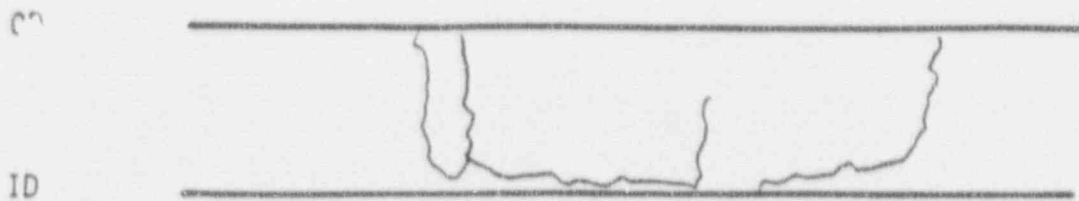
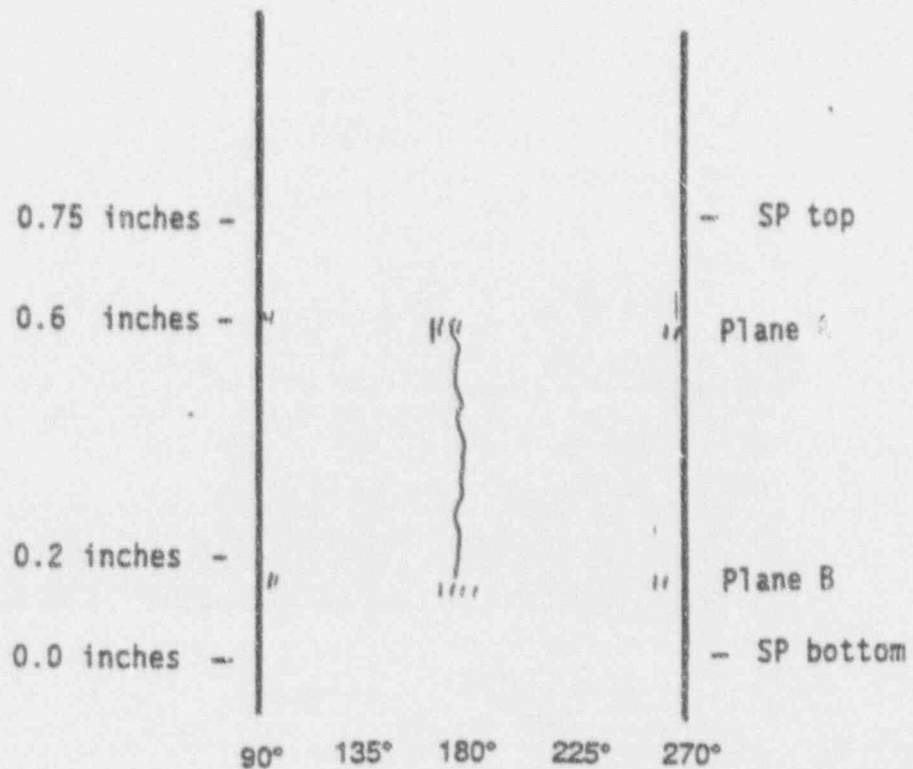
A longer but more shallow crack network was found on the opposite side of the tube from the crack described above. The crack network was opened and examined fractographically. The macrocrack was 0.46 inch long and was composed of at least three microcracks. It penetrated the ID wall locally for a length of only 0.03 inch. The crack morphology was intergranular with some ductile features at ligament locations. A summary sketch of the crack profile and character is shown in Figure 10-17.

Macrocrack Length = 0.46 inches

Number of Microcracks = 3 (ligaments have intergranular and ductile features)

Morphology = IGSCC

Figure 10-17 Summary of crack distribution and morphology observed on second crack opened in the laboratory on Tube SL-FH-11.

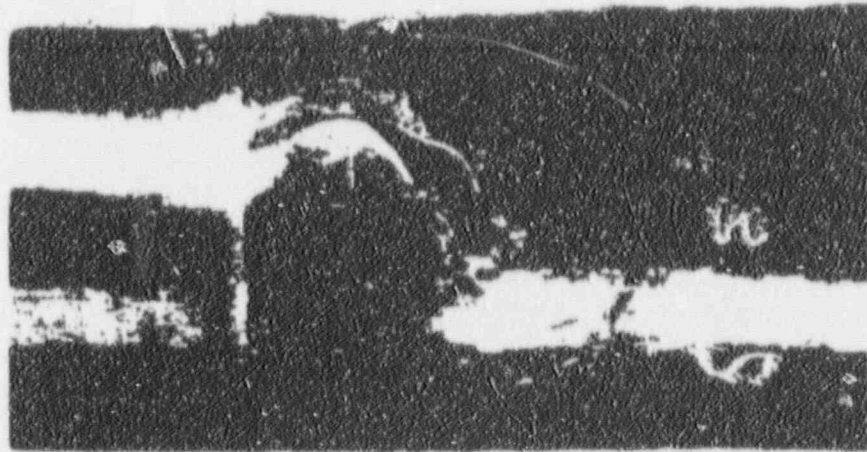
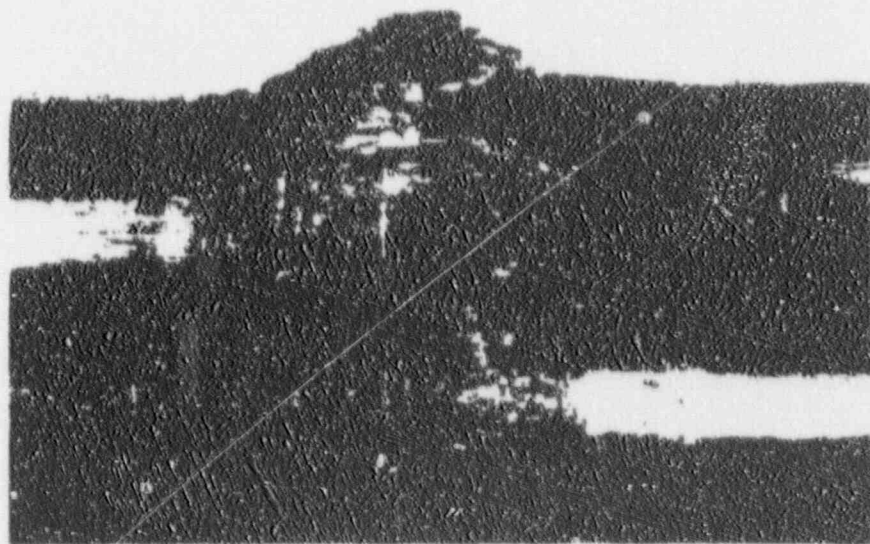
A grouping of many small, OD origin, axial cracks, interconnected by ligaments and by circumferential extensions, formed the curved major burst opening shown in Figure 10-18. Other small axial cracks with circumferential involvement were observed in other areas of the simulated tube support plate crevice region. Fractographic observations of the major burst opening revealed that the corrosion crack consisted of at least six microcracks with intergranular ligaments. These ligaments often ran in the circumferential direction. The combined length of the microcracks that formed the macrocrack was 0.67 inch. Through wall cracking extended for 0.50 inch. The morphology of the macrocrack was IGSCC with no to negligible IGA components, as shown in Figure 10-19. Circumferential, intergranular extension of the axial crack can be observed in this figure. Transverse metallography through the center of the crevice region revealed the crack distribution shown by a sketch in Figure 10-20. An example of the morphology of one of the secondary OD cracks is also shown in this figure; the morphology is again that of IGSCC with negligible IGA aspects. A summary of the major crack shape and corrosion morphology and the distribution of OD cracks observed within the crevice region of tube 528-2 is shown in Figure 10-21.

Figure 10-18 Appearance of the major burst crack opening on tube 528-2.

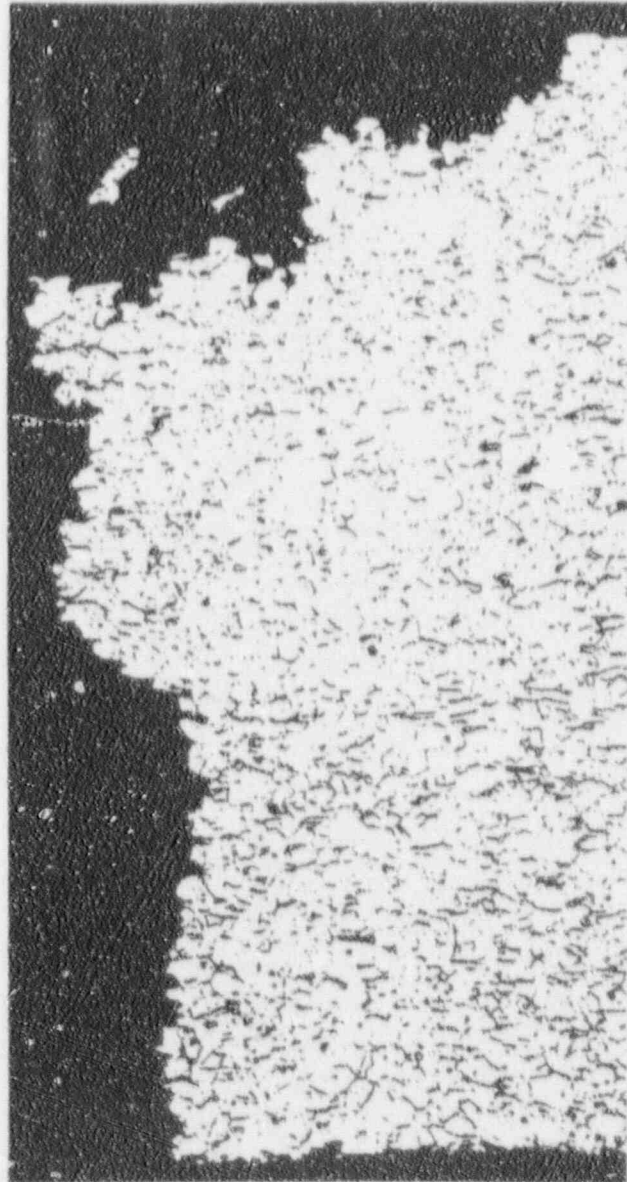
Figure 10-19 Crack morphology of the major burst opening crack (transverse section) showing it to be IGSCC with circumferential extension. Mag. 100X

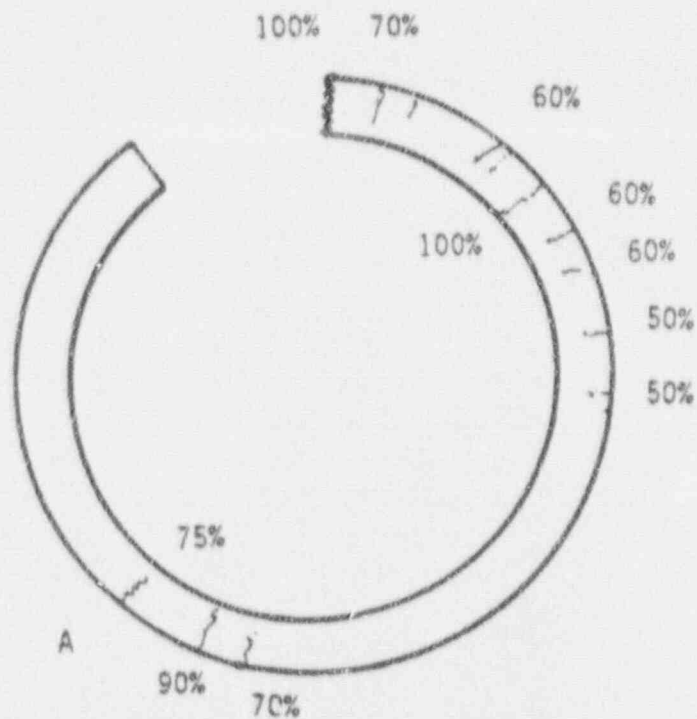
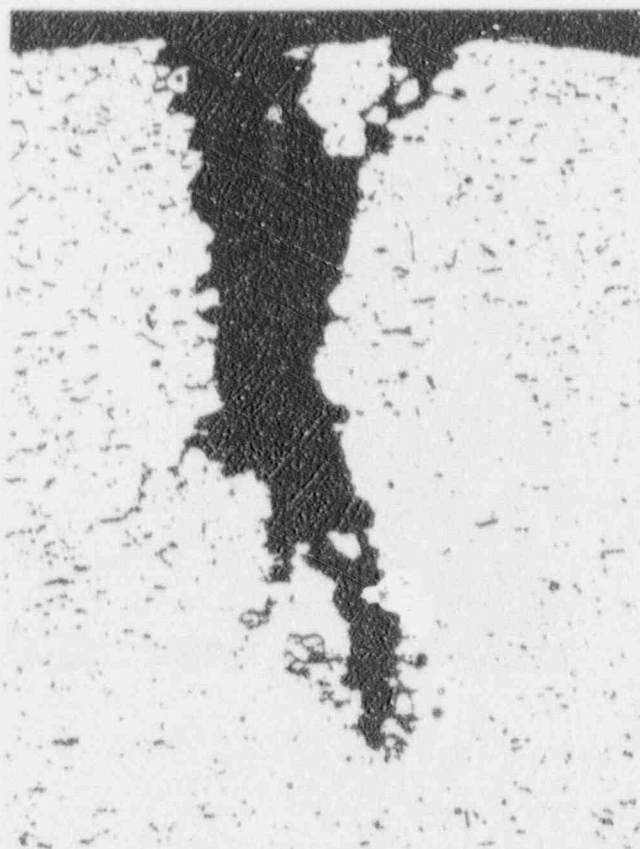
Figure 10-20 Crack distribution found by a metallographic cross section through the center of the crevice (top) and a photomicrograph of one of the secondary cracks (bottom) showing IGSCC with negligible IGA aspects. Mag. 100X

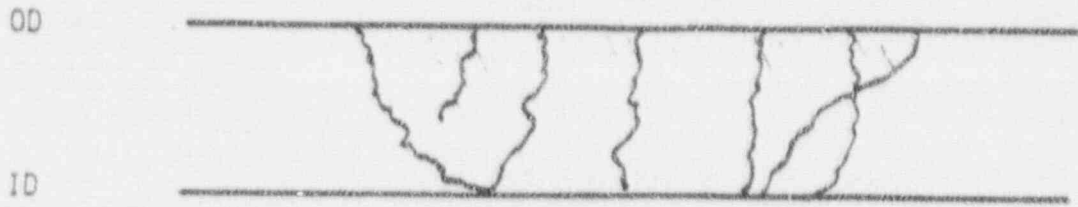
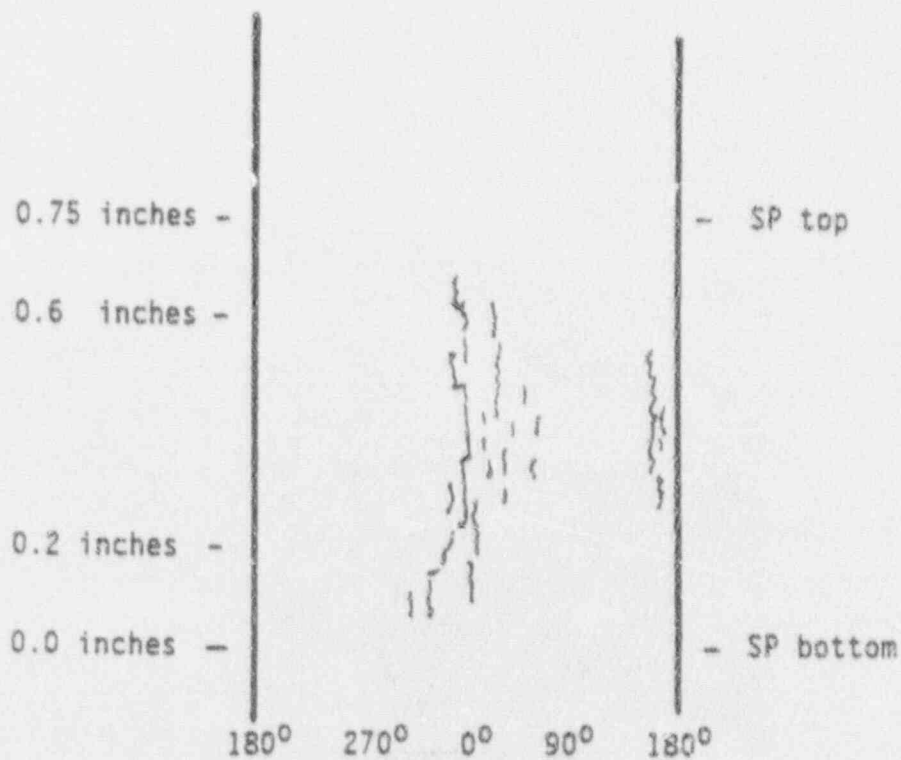
Macrocrack Length = 0.67 inch

Number of Microcracks = at least 6 (ligaments have intergranular features)

Morphology = IGSCC

Figure 10-21 Summary of overall crack distribution and morphology observed on tube 528-2.

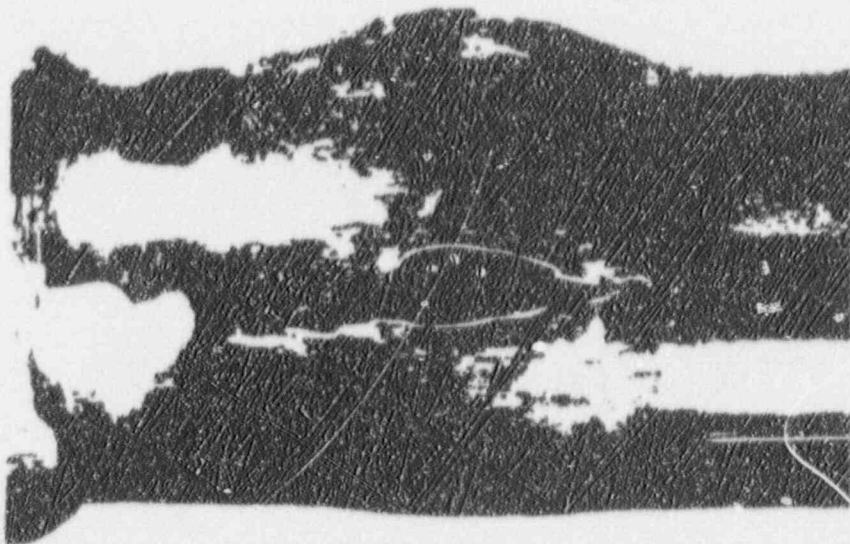
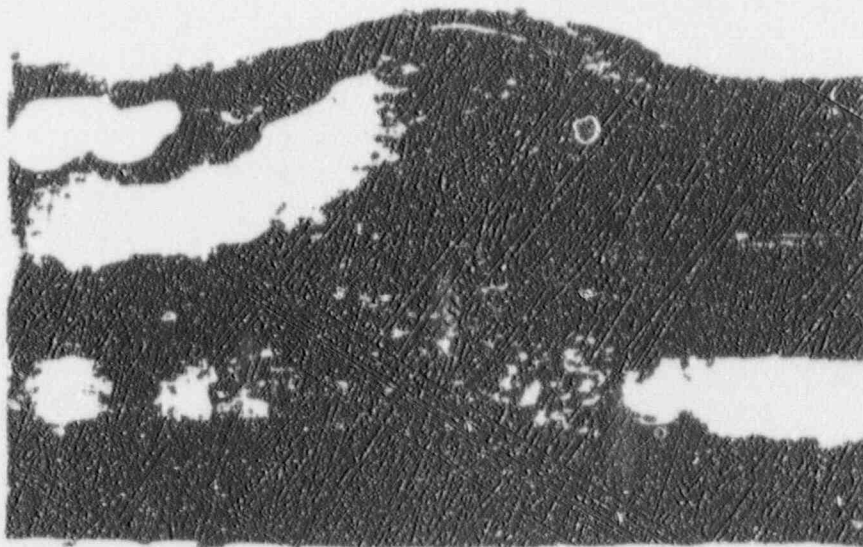
A large number of long and short, OD origin, axial cracks were observed in the simulated tube support plate crevice region of tube 532-1, many of which were through wall. Figures 10-22 and 10-23 show photographs of the burst tube and convey the extensive cracking around the tube within the crevice region. A grouping of small axial cracks combined to form two of the burst crack openings which were examined in some detail. The longer of the two was 0.70 inch long and was formed from five microcracks interconnected with ledges having intergranular features. The length through wall was 0.52 inch. The crack morphology was IGSCC. Cracks seen on a metallographic cross section through the center of the crevice are depicted in a sketch in Figure 10-24 together with two micrographs showing typical crack morphologies of secondary cracks. A summary of the major burst crack and its morphology together with a distribution of cracks seen the crevice region is shown in Figure 10-25.

Figure 10-22 Photographs of the longest burst opening and σ_1 nearby secondary cracks in tube 532-1 and 0 and 60° locations.

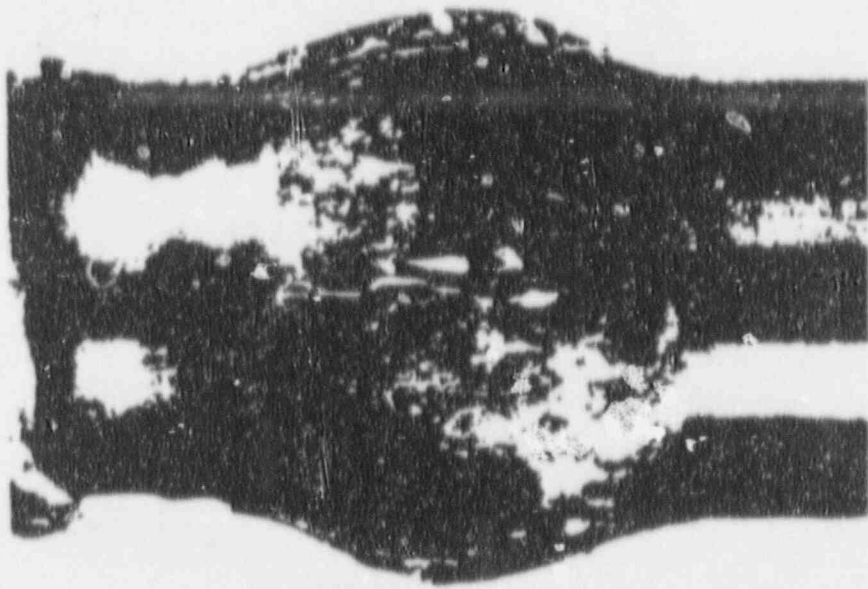
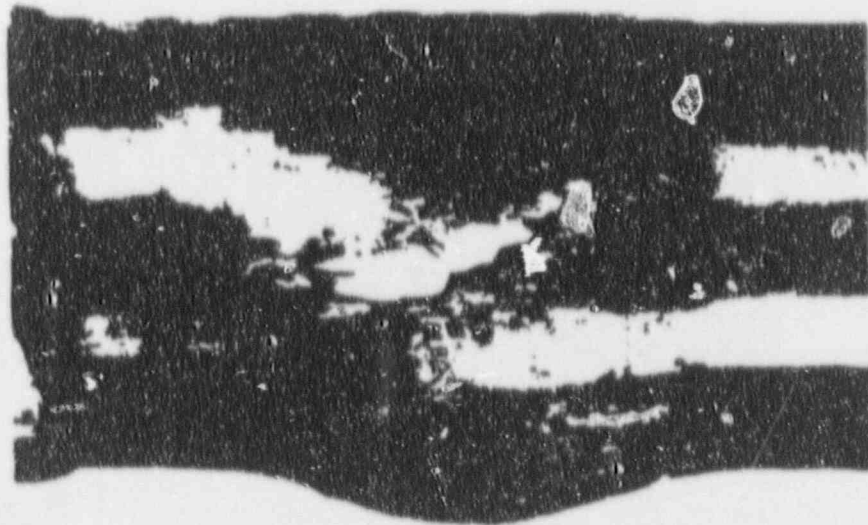
Figure 10-23 Photographs of additional secondary cracks and of a second major burst crack in the crevice region of tube 532-1.

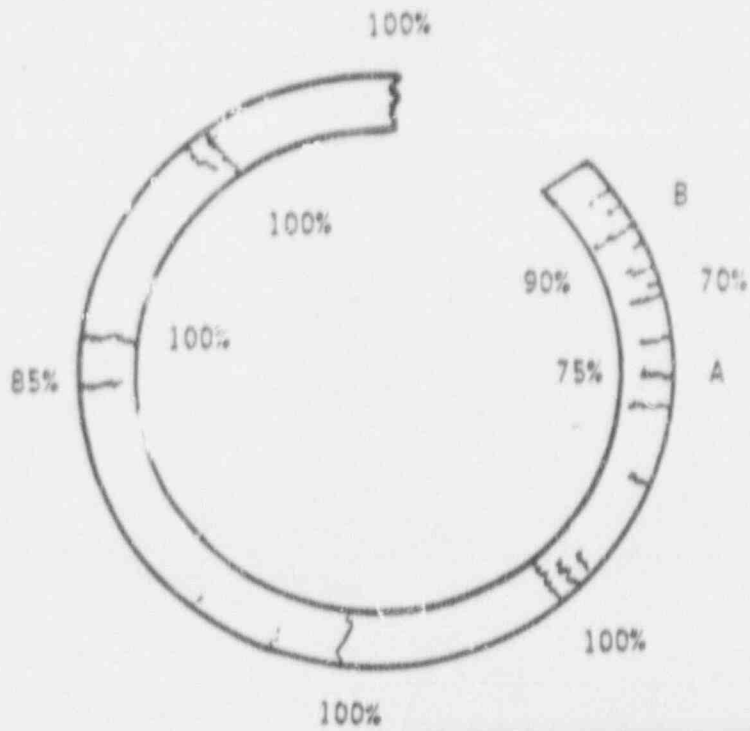
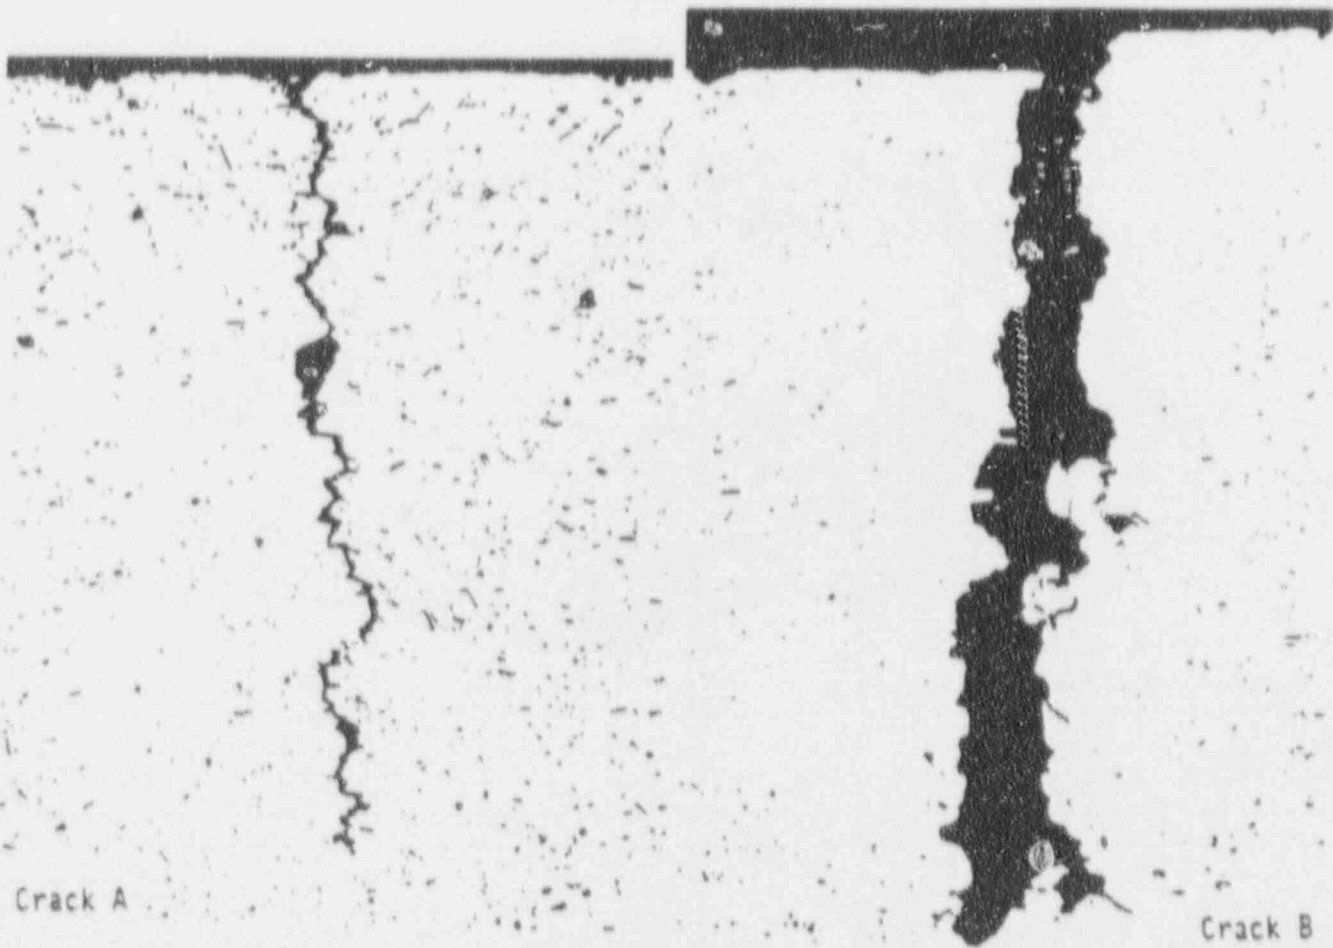
Figure 10-24 Sketch of crack distribution found by a metallographic cross section through the center of the crevice region of tube 532-1 and two photomicrographs of secondary cracks.
Mag. 100X

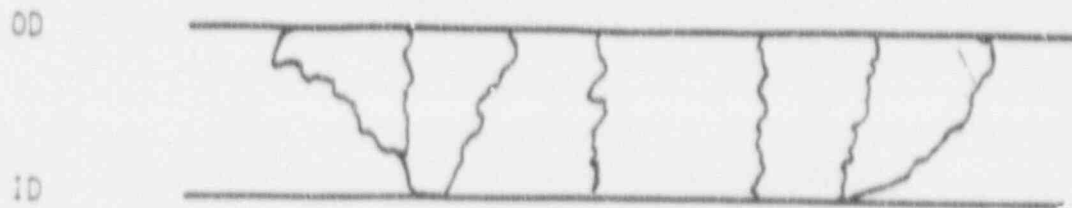
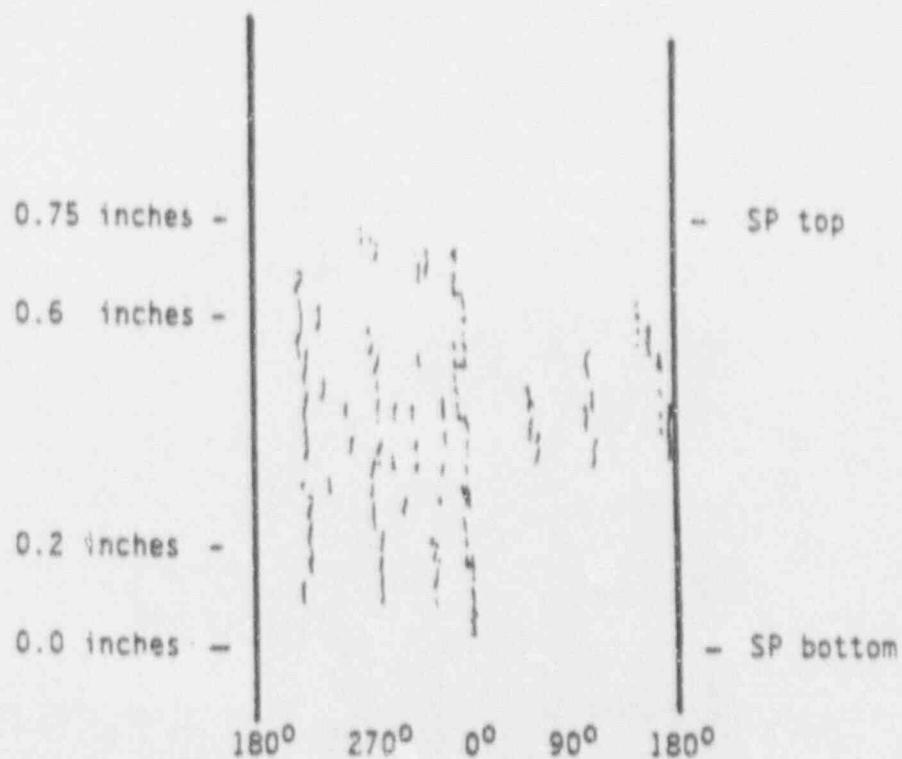
Macrocrack Length = 0.70 inch

Number of Microcracks = 5 (ligaments have intergranular features)

Morphology = IGSCC

Figure 10-25 Summary of overall crack distribution and morphology observed on tube 532-1.

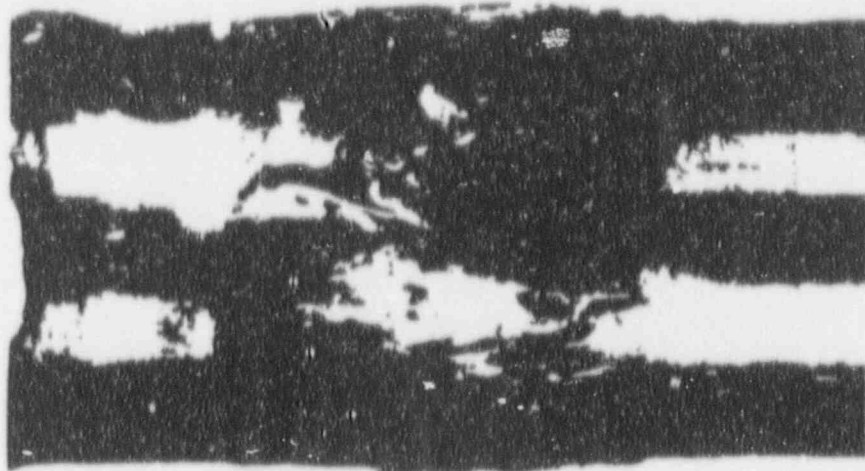
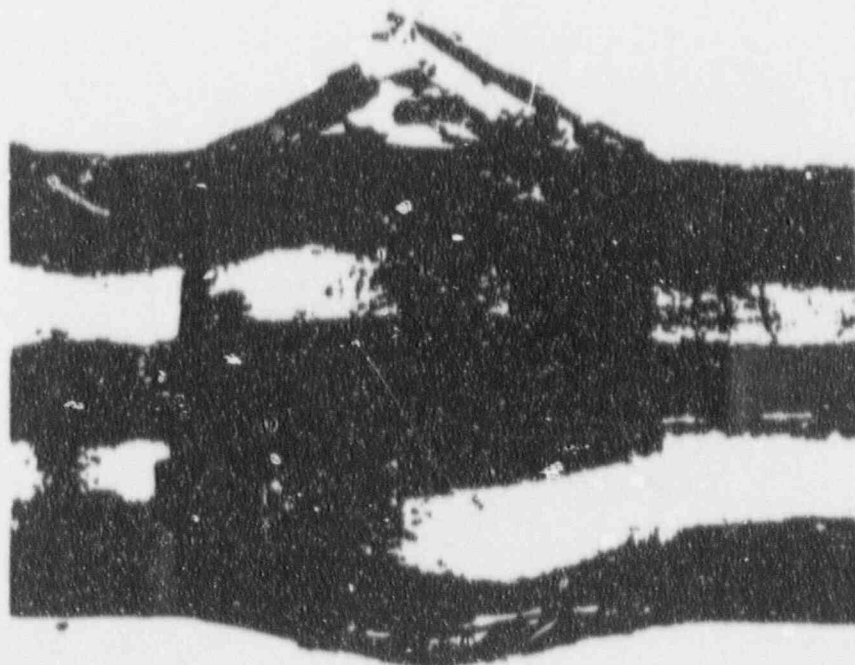
OD origin cracking within the simulated tube support plate crevice region of tube 532-2 can be seen in the post-burst test photographs of the tube in Figures 10-26 and

10-27. Many of the axial cracks were through wall. A group of many through wall microcracks formed the weakest area in the tube where the main burst fracture occurred. Fractography of this macrocrack showed at least six microcracks combined to form the main burst fracture. The total length of the macrocrack was 0.75 inch and it was through wall for 0.58 inch. While most ligament features were intergranular, occasional areas had ductile features, indicating that the ligaments had not completely interconnected by intergranular corrosion. The corrosion crack morphology of the main burst crack was that of IGSCC. A metallographic cross section through the center of the crevice region revealed many cracks shown by a sketch in Figure 10-28. Typical crack morphologies are also shown in photomicrographs for two secondary cracks in this figure. A summary of the main burst crack description, morphology, and crack distribution are given in Figure 10-29.

Figure 10-26 Photographs of the major burst opening and secondary cracks within the crevice region of tube 532-2 at 0 and 90°.

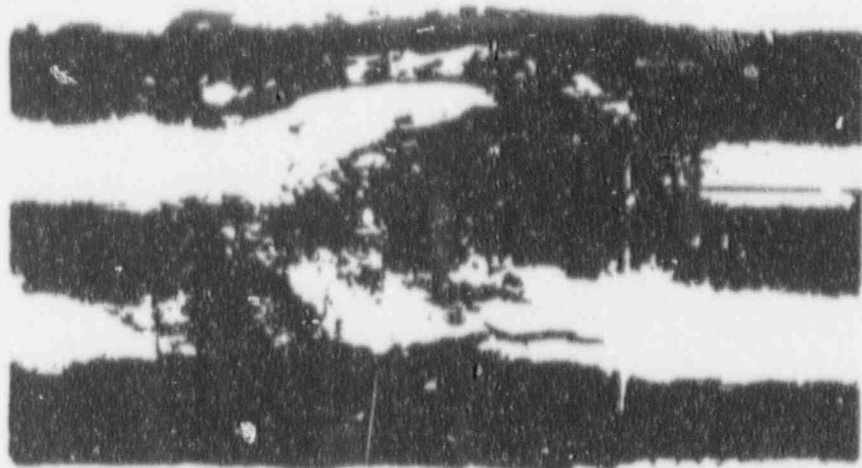
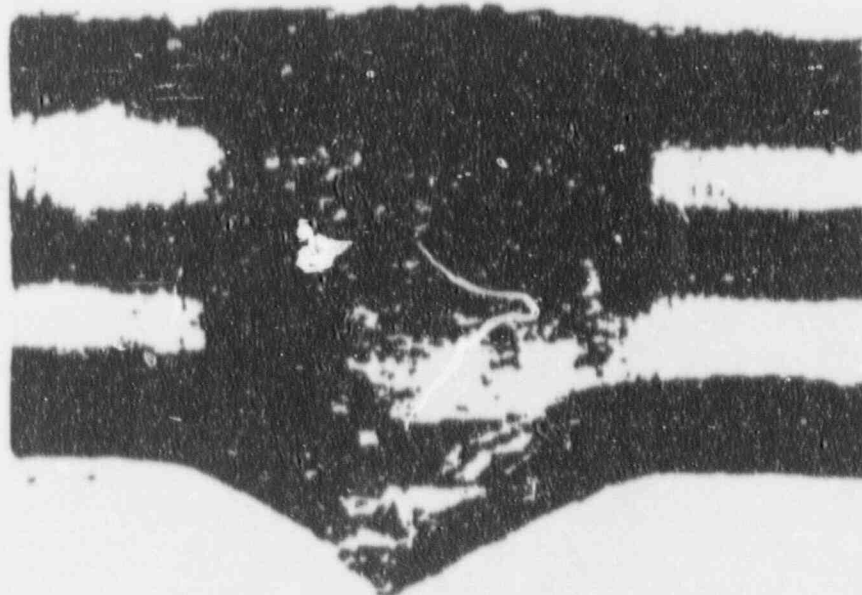
Figure 10-27 Additional photographs of secondary cracks in tube 532-2 at 180 and 270°.

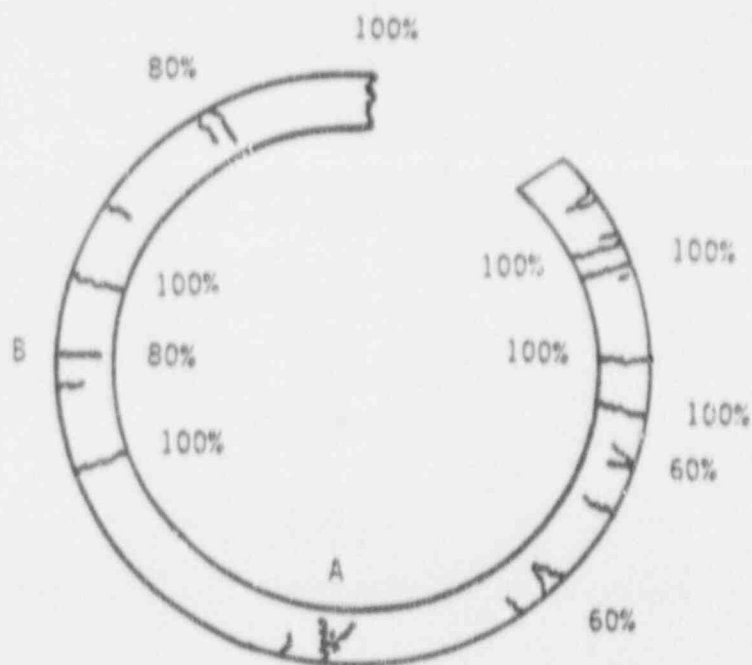
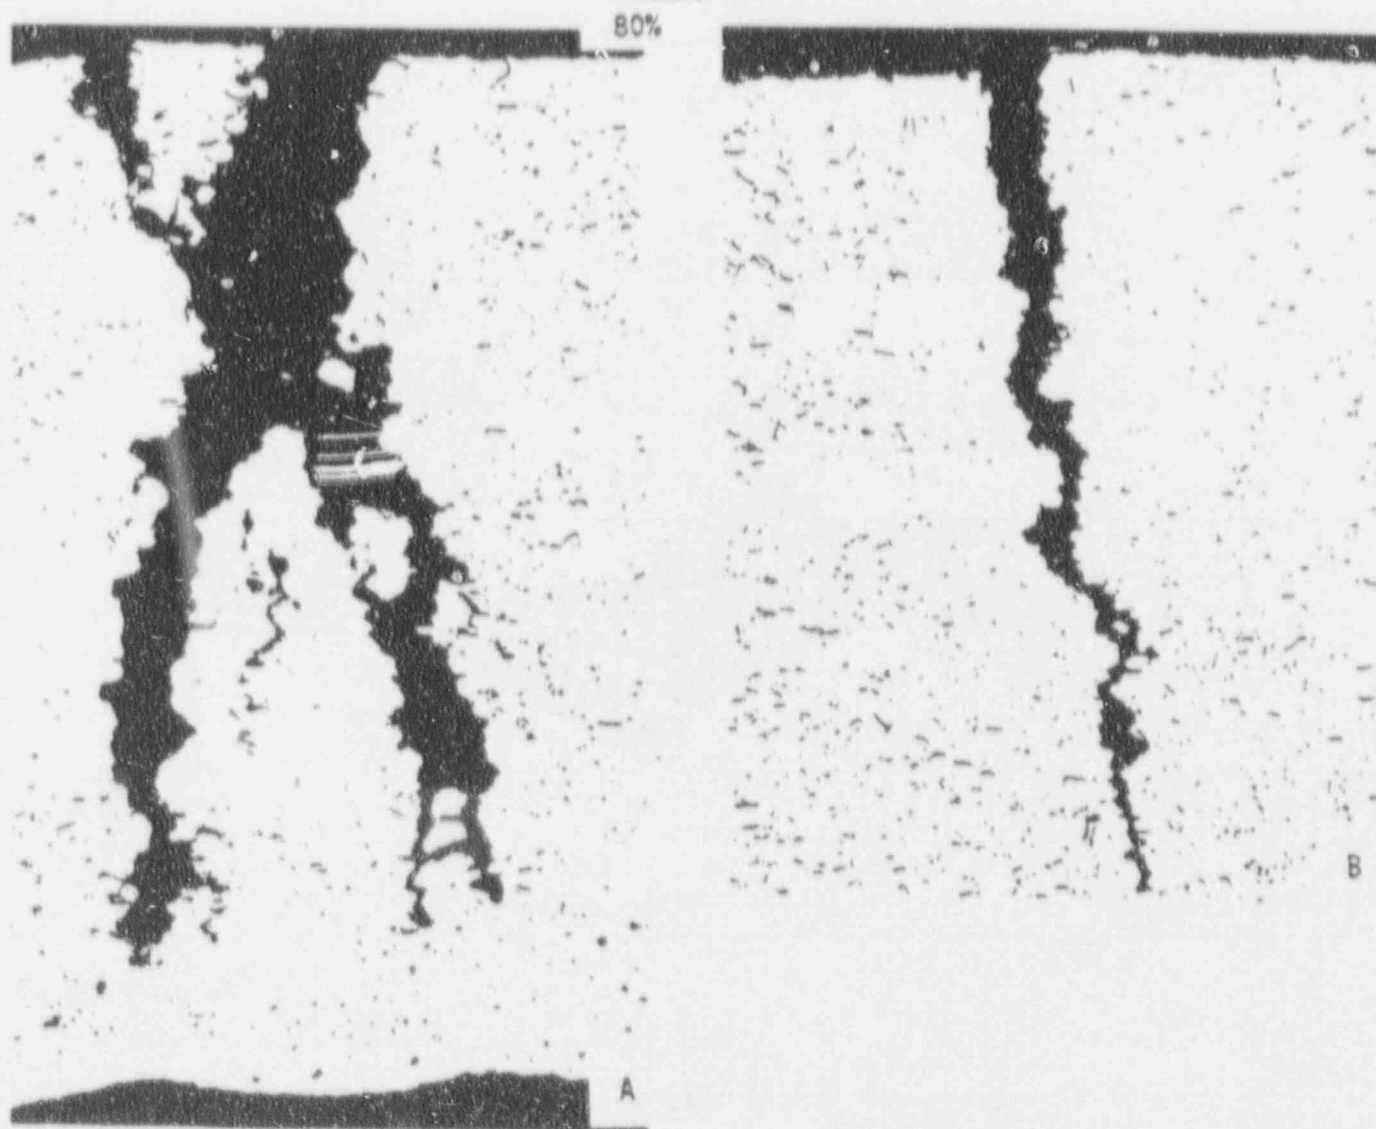
Figure 10-28 Crack distribution as revealed by a metallographic cross section through the center of the crevice of tube 532-2 and photomicrographs of secondary cracks A and B. Mag. 100X

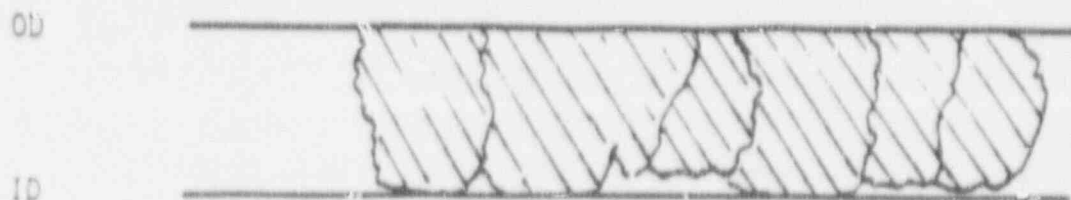
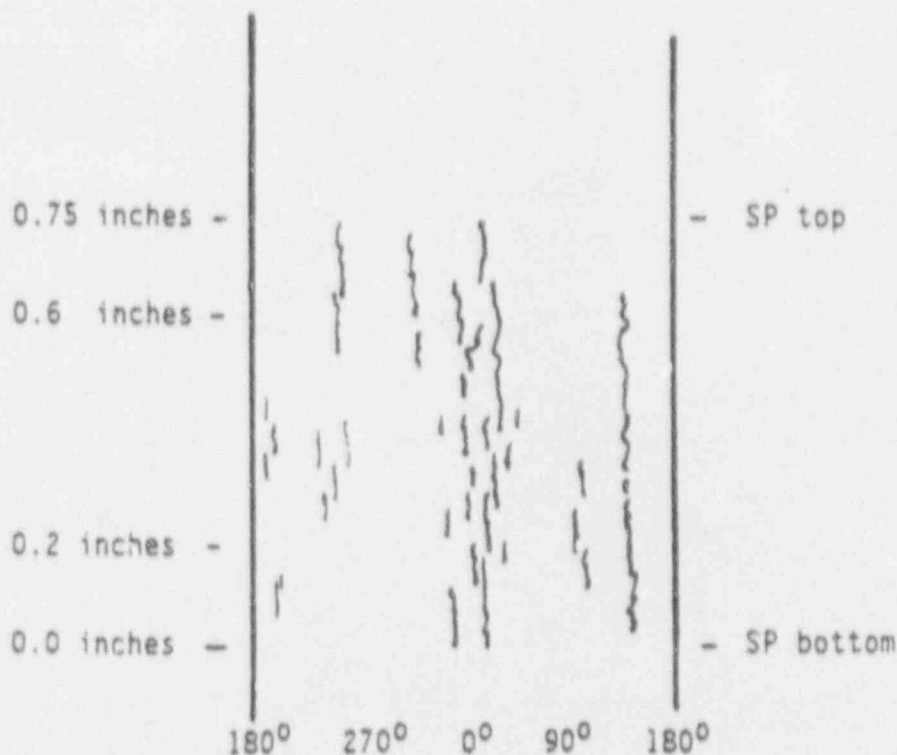
Macrocrack Length = 0.75 inch

Number of Microcracks = at least 6 (ligaments have mostly intergranular features)

Morphology = IGSCC

Figure 10-29 Summary of the burst crack and overall crack distribution in the crevice region of tube 532-2.

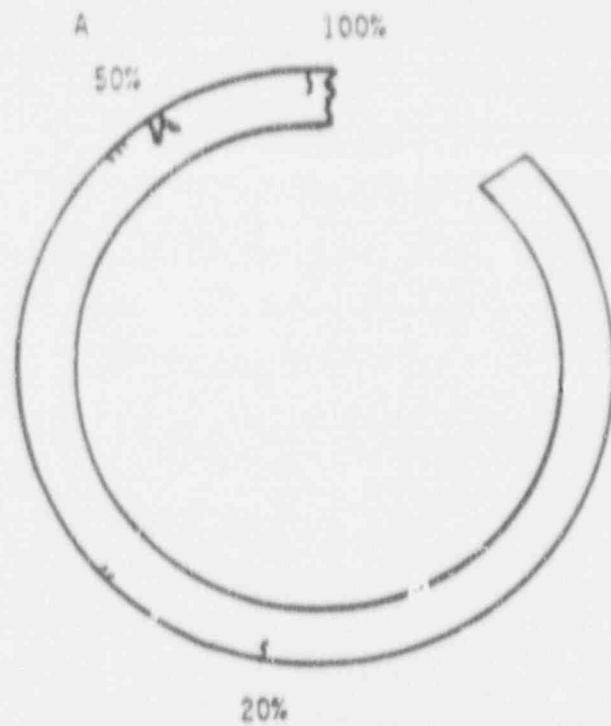
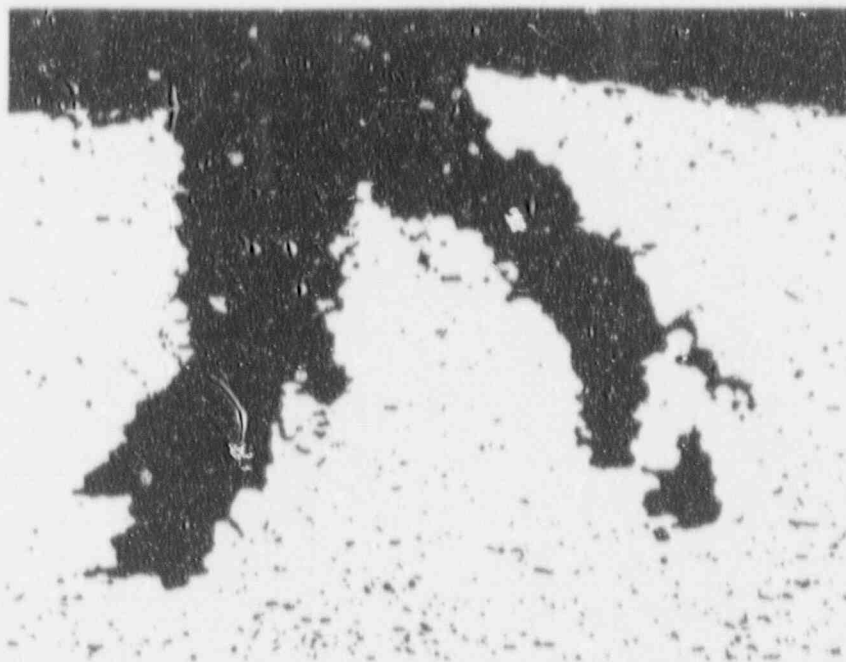
Figure 10-30 Sketch of crack distribution in a metallographic cross section of tube 535 through the center of the crevice and a photomicrograph of crack A. Mag. 100X

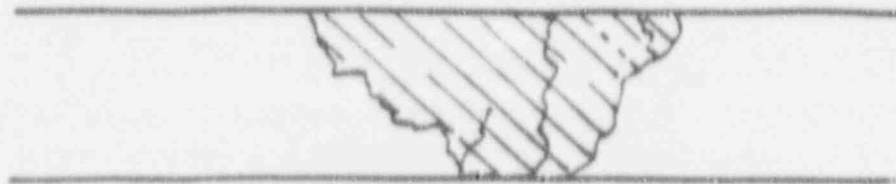
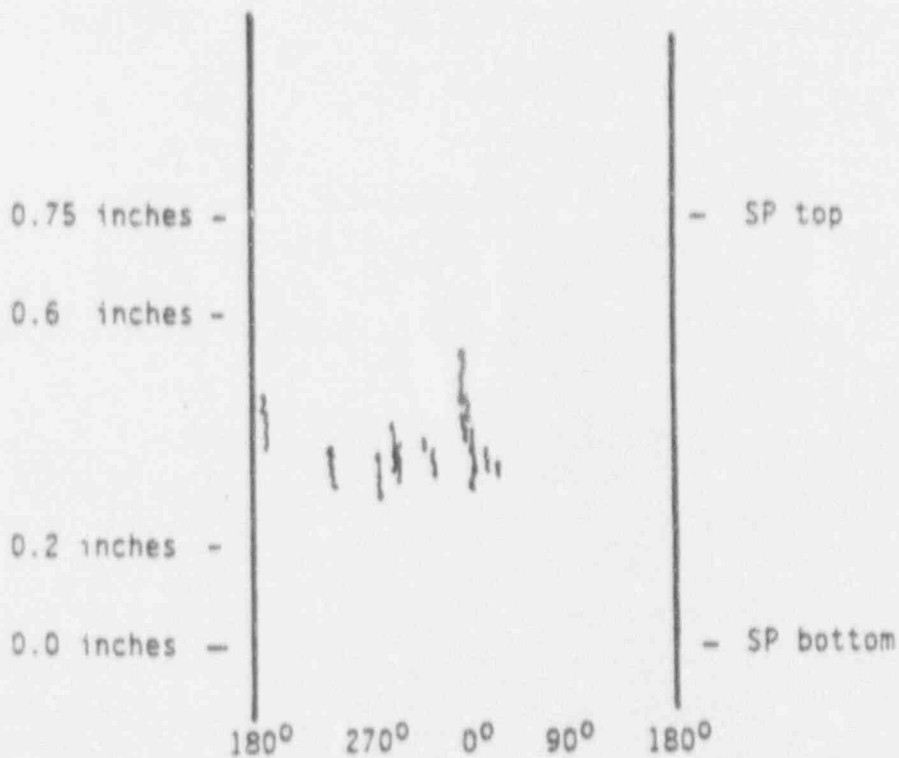
The burst opening in tube 535-1 formed from a cluster of small axial OD origin cracks. Numerous secondary, but small, microcracks were observed around the circumference within the crevice region. Fractography of the burst crack showed that it was composed of three microcracks which joined together by intergranular corrosion to form the macrocrack. The morphology of the macrocrack was IGSCC with negligible IGA aspects. The macrocrack was relatively short (0.28 inch in length) and penetrated through wall for 0.11 inch. A metallographic cross section through the center of the crevice showed numerous secondary cracks, some of which had negligible to minor IGA aspects. The distribution of cracks from the cross section is shown in Figure 10-30 along with a photomicrograph of a secondary crack. A summary of the of burst crack description and of the overall crack distribution is given in Figure 10-31.

Number of Microcracks = 3 (ligaments have intergranular features)

Morphology = IGSCC

Figure 10-31 Summary of the burst crack and overall crack distribution in the crevice region of tube 535-1.

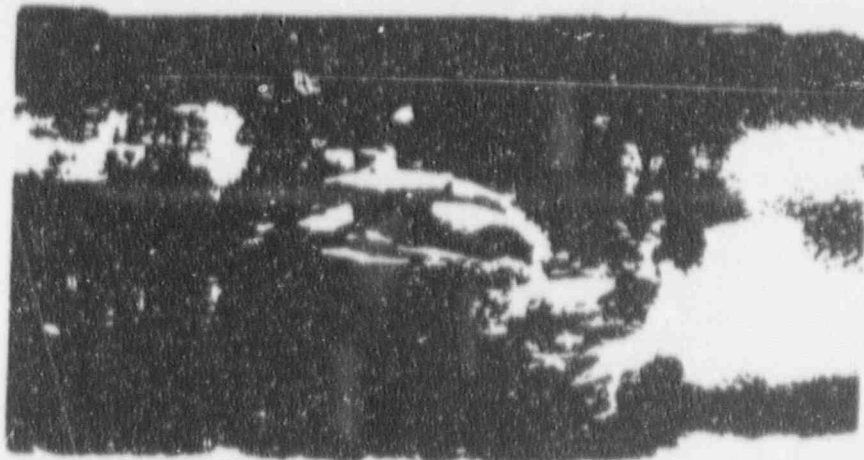
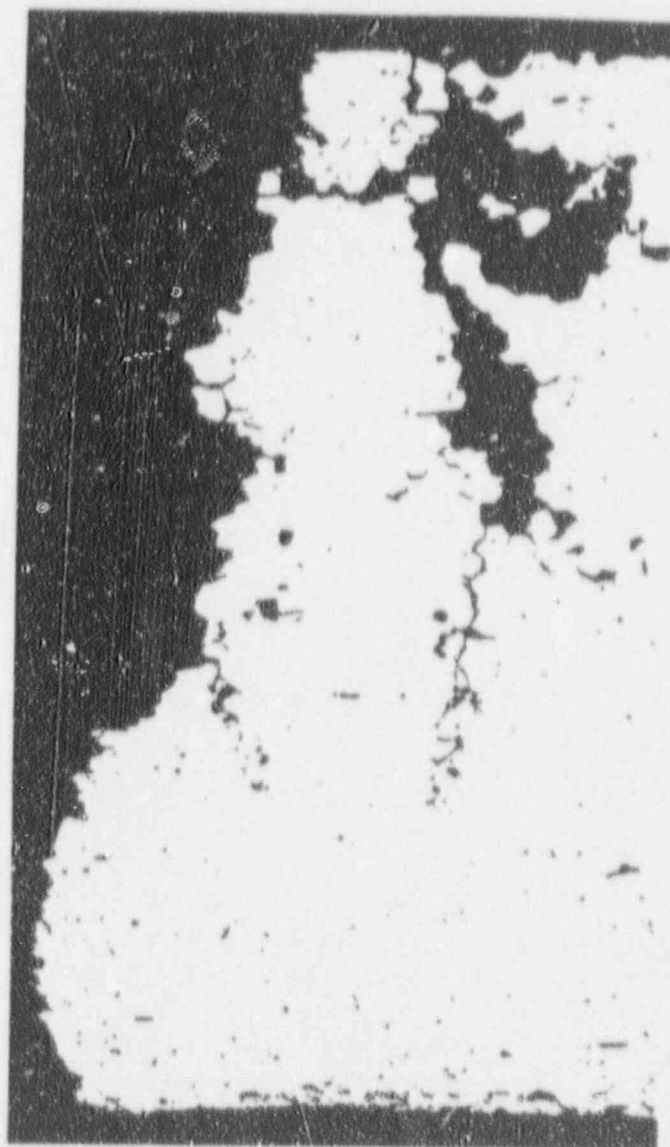
The most degraded area in tube 555-3 was confined to one location within the crevice region, the location where the burst opening occurred. The crack distribution was complex in this region, with numerous parallel axial cracks with short circumferential branches. All cracks were of OD origin. Fractography showed the major macrocrack to be composed of two or three microcracks which joined in an irregular pattern to form the burst crack. The connecting ledges showed ductile fracture features, while the individual microcracks had intergranular features. The macrocrack was 0.75 inch long with a through wall length of 0.42 inch. Metallography of a tube cross section through the region with the highest crack density showed a morphology of IGSCC with some IGA or SCC branch characteristics near the main fracture. A photograph of the burst opening and a photomicrograph of the fracture face at the burst opening is shown in Figure 10-32. Other crack details are summarized in Figures 10-33 and 10-34.

Figure 10-32 Photograph of the burst opening and a transverse photomicrograph of the burst fracture in tube 555-3. Mag. 100X
