WCAP-12872
Revision 2

J. M. Farley Units 1 and 2
SG Tube Plugging Criteria for
ODSCC at Tube Support Plates

Westinghouse Energy Systems

February 1992

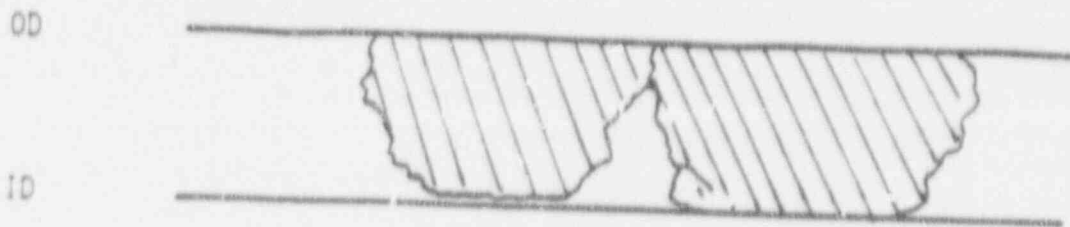
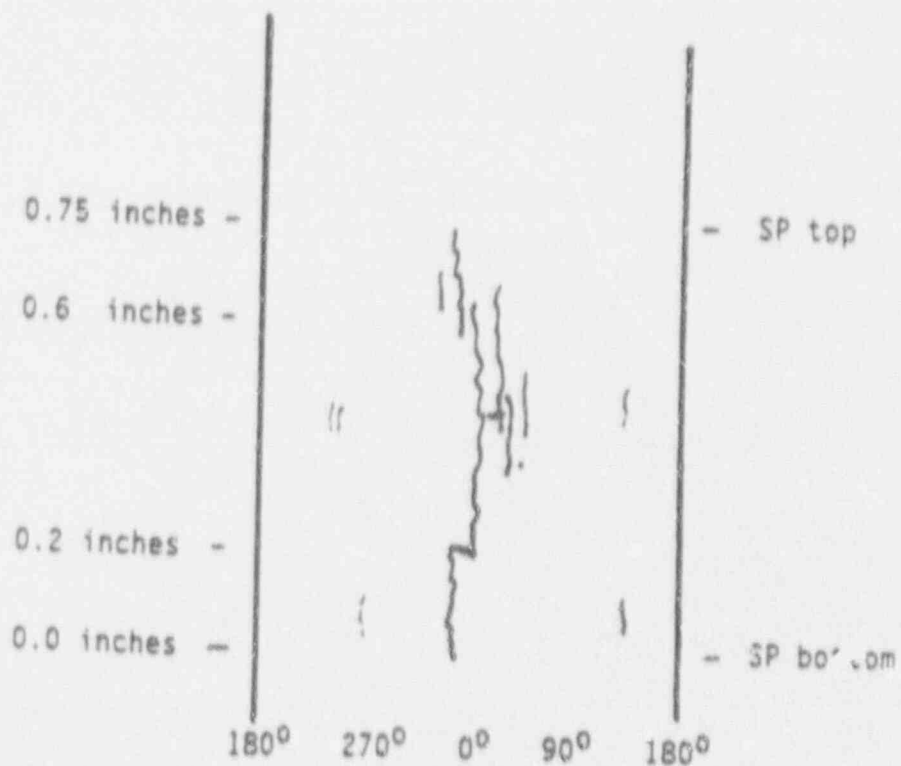
Figure 10-33 Sketch of the metallographic cross section through secondary crevice region cracks in tube 555-3. A photomicrograph of Crack A is also shown. Mag. 100X

Sketch of Burst Crack

Macrocrack Length = 0.75 inch

Number of Microcracks = 2 (separated by ductile ligaments)

Morphology = IGSCC

Sketch of Crack Distribution

Figure 10-34 Summary of burst crack observations and the overall crack distribution observed at the crevice region of tube 555-3.

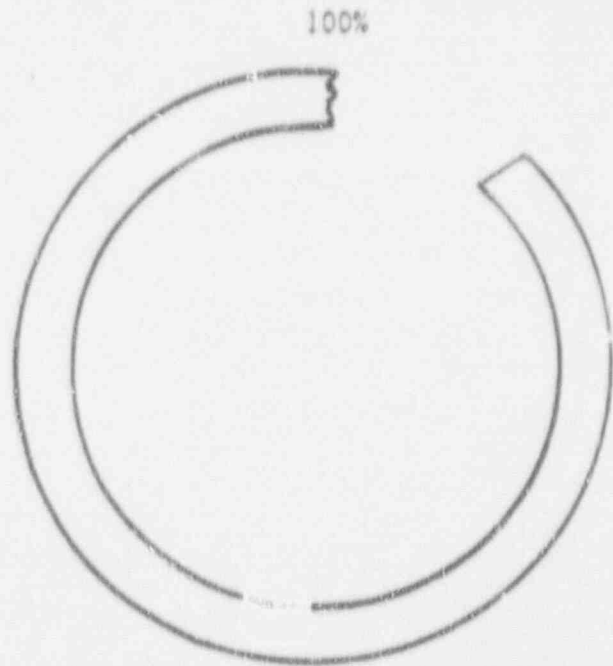
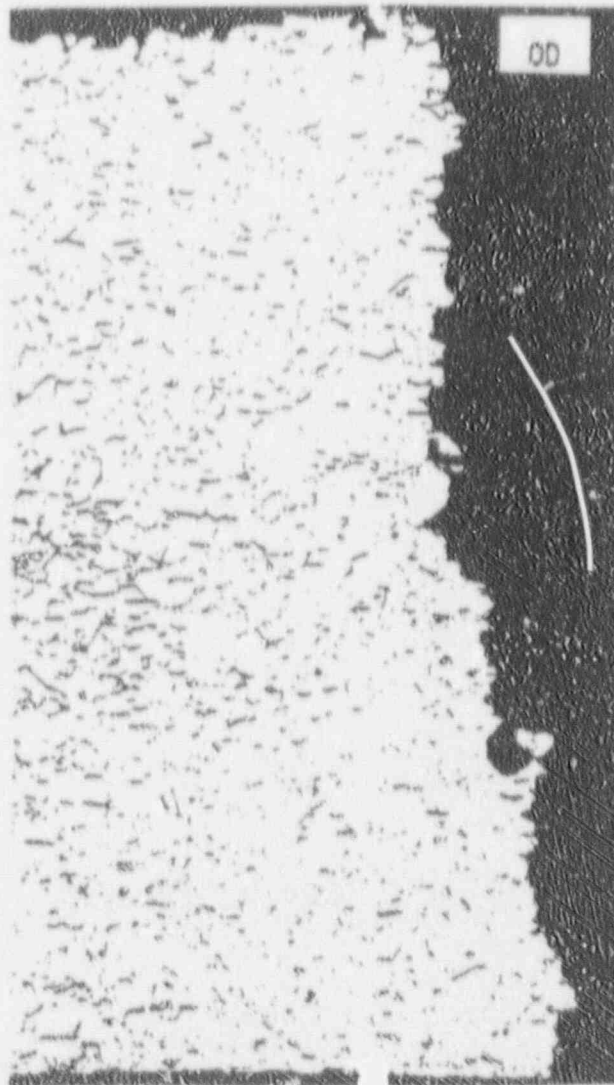
Only one, OD origin, single axial crack was observed after burst testing of tube 576-2. Fractography showed the crack to be 0.30 inch long and it was through wall for 0.22 inch. The macrocrack appeared to be composed of a single microcrack and its morphology was that of IGSCC. A metallographic cross section through the center of the crevice region found no secondary cracks around the circumference. Crack details and crack morphology data are shown in Figures 10-35 and 10-36.

Figure 10-35 Sketch of a metallographic cross section through the center of the crevice region of tube 576-2, showing only the single burst crack, and a photomicrograph of the burst crack.

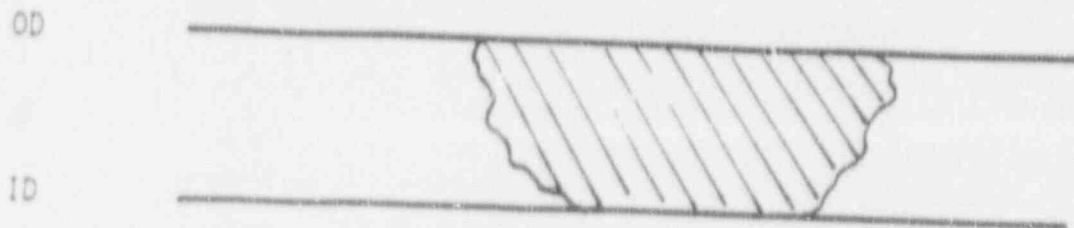
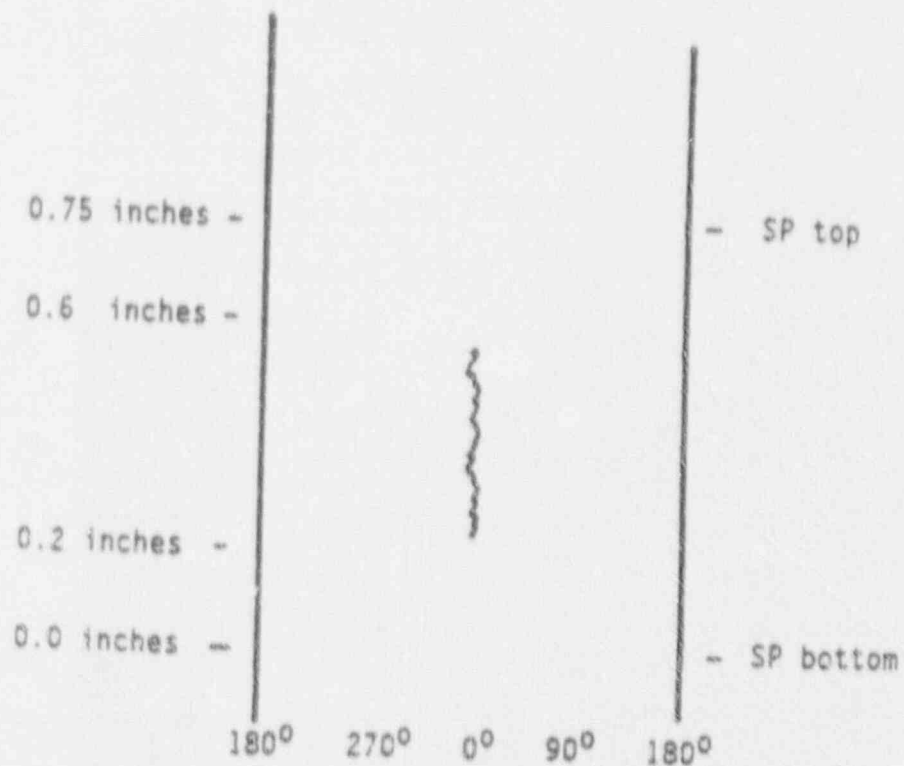
Sketch of Burst Crack

Macrocrack Length = 0.30 inch

Number of Microcracks = 1 (no ligaments)

Morphology = IGSCC

Sketch of Crack Distribution

Figure 10-36 Summary of burst crack observations and the overall crack distribution observed within the crevice region of tube 576-2.

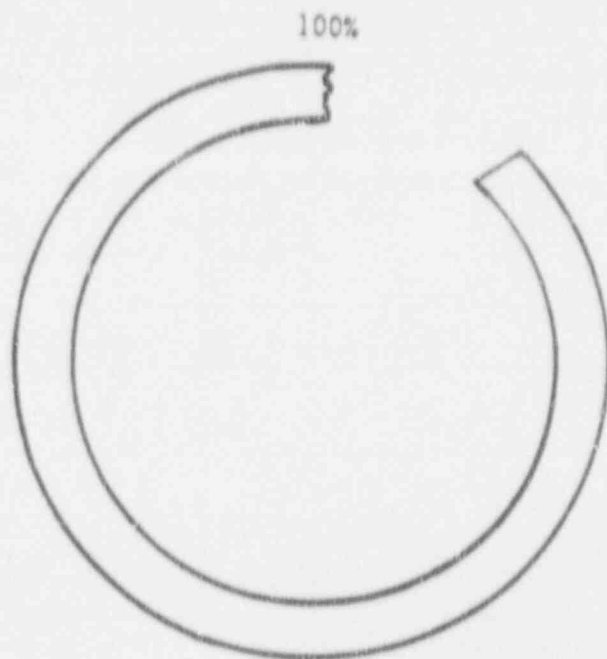
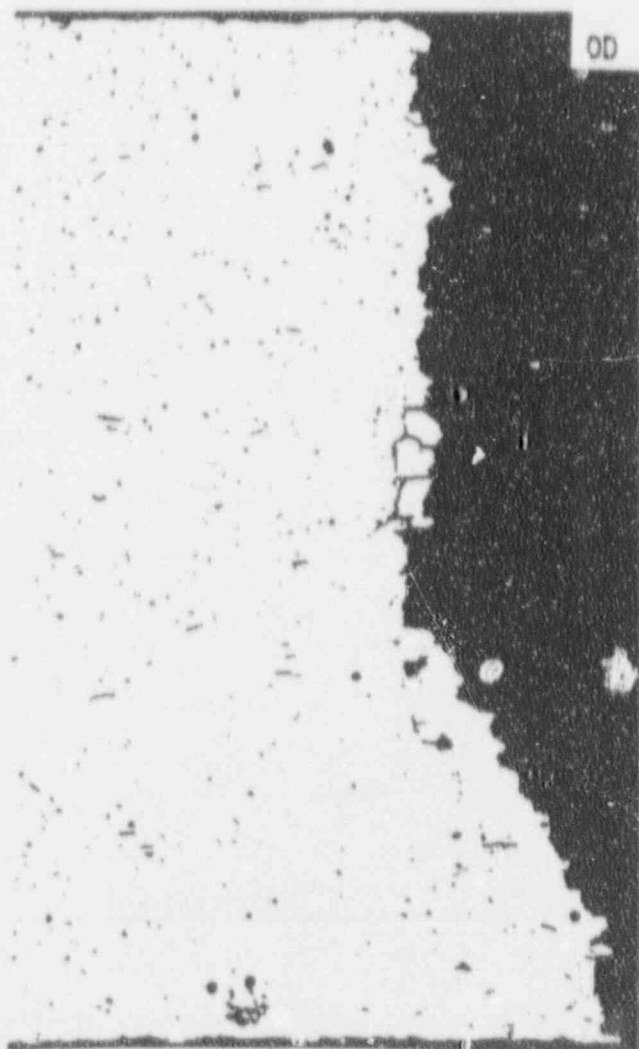
Tube 576-4 also burst with a single crack. Fractography showed the crack to be 0.60 inch long and it was through wall for 0.43 inch. The OD origin intergranular macrocrack was composed of three axial microcracks joined together by ligaments with intergranular features. Visual examination showed a few small axial cracks nearby the burst crack. The morphology of the burst crack was IGSCC with negligible IGA aspects. A metallographic section cut through the center of the crevice found only the burst crack. Crack details and crack morphology data are shown in Figures 10-37 and 10-38.

Figure 10-37 Sketch of a metallographic cross section through the center of the crevice region of tube 576-4, showing only the single burst crack, and a photomicrograph of the burst crack.
Mag. 100X

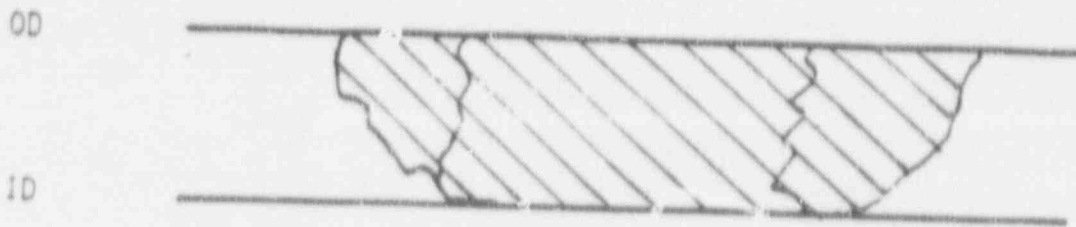
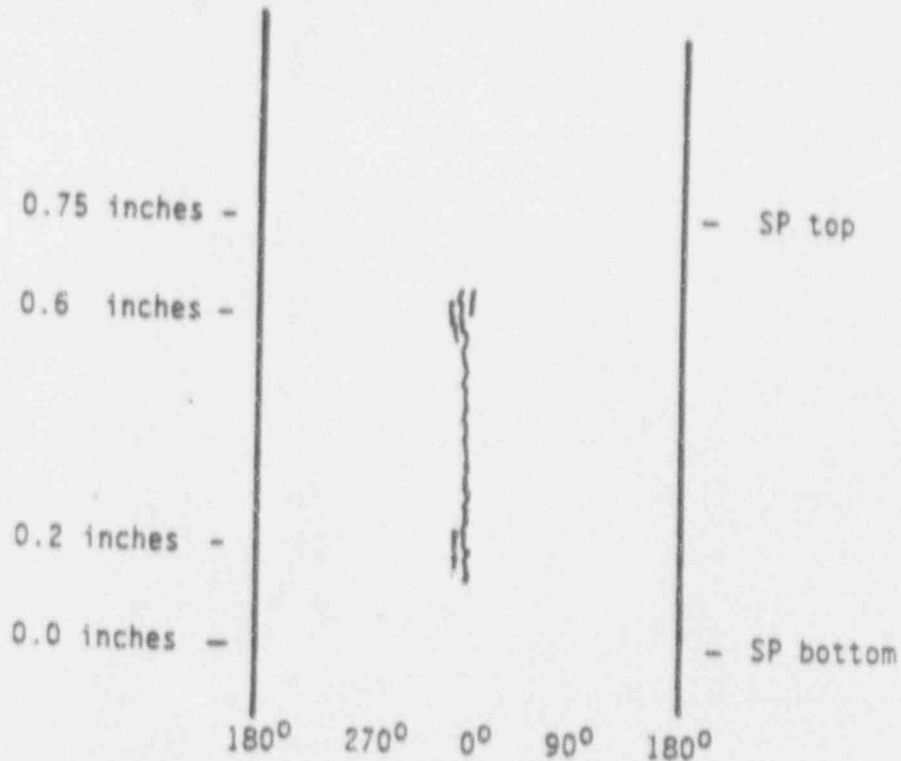
Sketch of Burst Crack

Macrocrack Length = 0.60 inch

Number of Microcracks = 3 (ligaments have intergranular features)

Morphology = IGSCC with negligible IGA features

Sketch of Crack Distribution

Figure 10-38 Summary of burst crack observations and the overall crack distribution observed at the crevice region of tube 576-4.

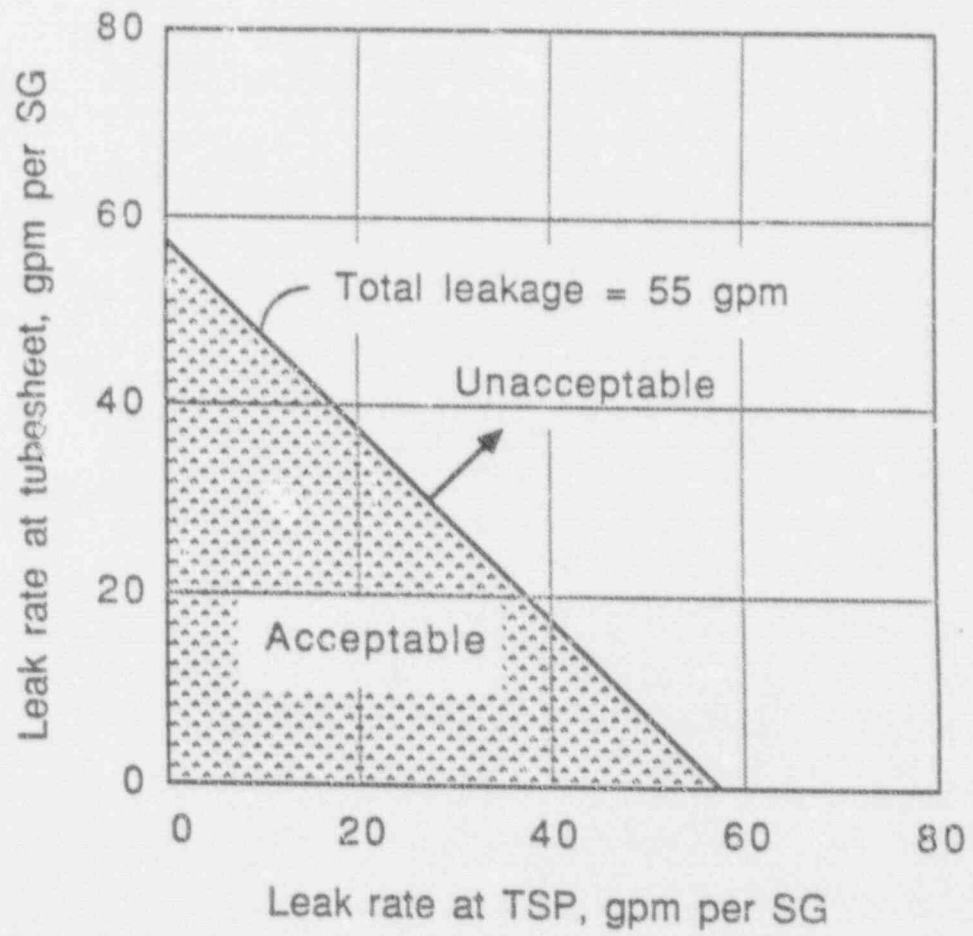
FIGURE 11-19

A calculation has been completed to determine the maximum permissible steam generator primary-to-secondary leak rate during a steam line break for the Farley Unit 1 and 2 steam generators. Based on a 30 rem thyroid dose at the site boundary, a leak rate of 55 gpm is determined to be the upper limit for allowable primary to secondary leakage in the ruptured loop. Each SG in the intact loops is assumed to have primary to secondary leakage of 150 gpd, which is the maximum value defined by the proposed technical specification. The leakage in the faulted loop may be distributed among tubesheet and support plate locations as shown in Figure 11-19.

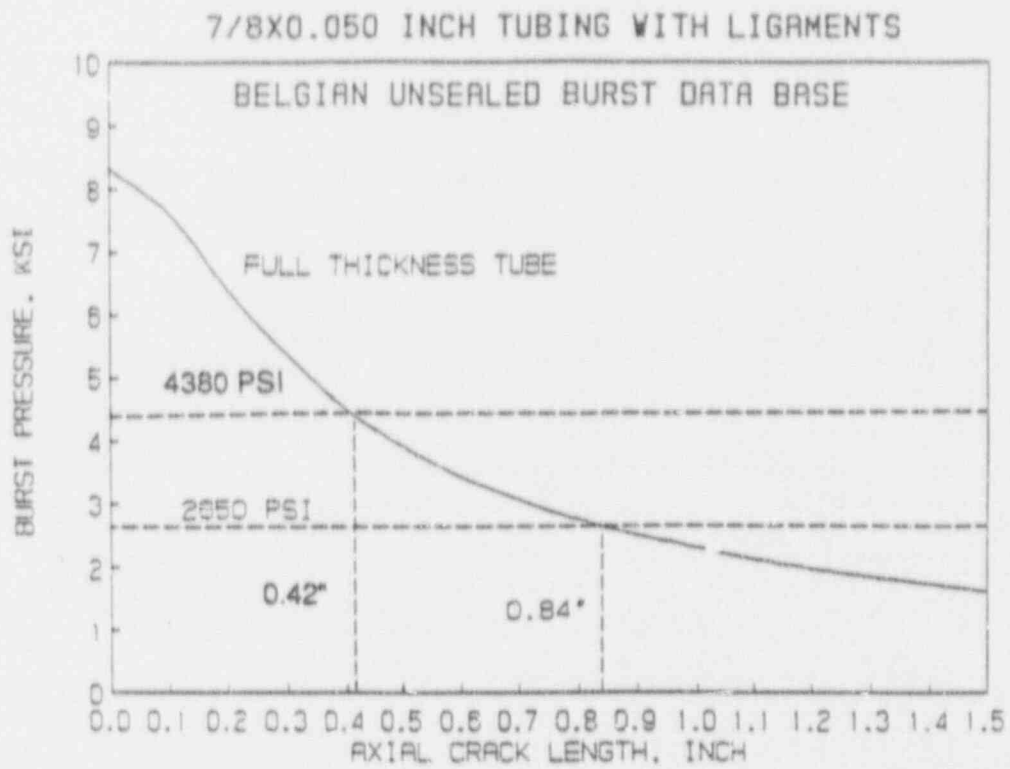
Burst pressure versus axial crack length data from multiple sources are shown in Figure 12-2 as taken from EPRI Report NP-6864-L. The methods to perform the burst tests for the upper figure curves differ in the techniques for applying the required pressure for tube burst. In testing of tubes with through-wall slits [

ja.c. However, recent tests in Belgium have demonstrated that for axial cracks, foil reinforcement of seals leads to the same burst pressures as in tests with very high capacity pumps and no seal whatsoever. This is illustrated in Figure 12-2. The Westinghouse and British curves do not use any seal reinforcement and lie below the Belgian burst curve. The burst data without any sealant system falls along the burst curves where seal reinforcement was used. Therefore it is appropriate to remove the conservatism of the Westinghouse axial crack burst curve and use the Belgian burst curve. The Belgian burst curve for 7/8 inch diameter tubing is shown in the upper plot of Figure 12-2. It is seen that a throughwall crack length of 0.84 inch is required for burst at SLB conditions. The TSP height is 0.75 inch so that even a uniformly throughwall crack equal to the length of the TSP, which is extremely unlikely, would not burst under accident conditions.

The through wall crack lengths resulting in tube burst at 3 times normal operating pressure differentials (4380 psi) and SLB conditions (2650 psi) are about []⁹, respectively, as shown in Figure 12-2. Nominal leakage at normal operating conditions for these crack lengths would range from about []⁹

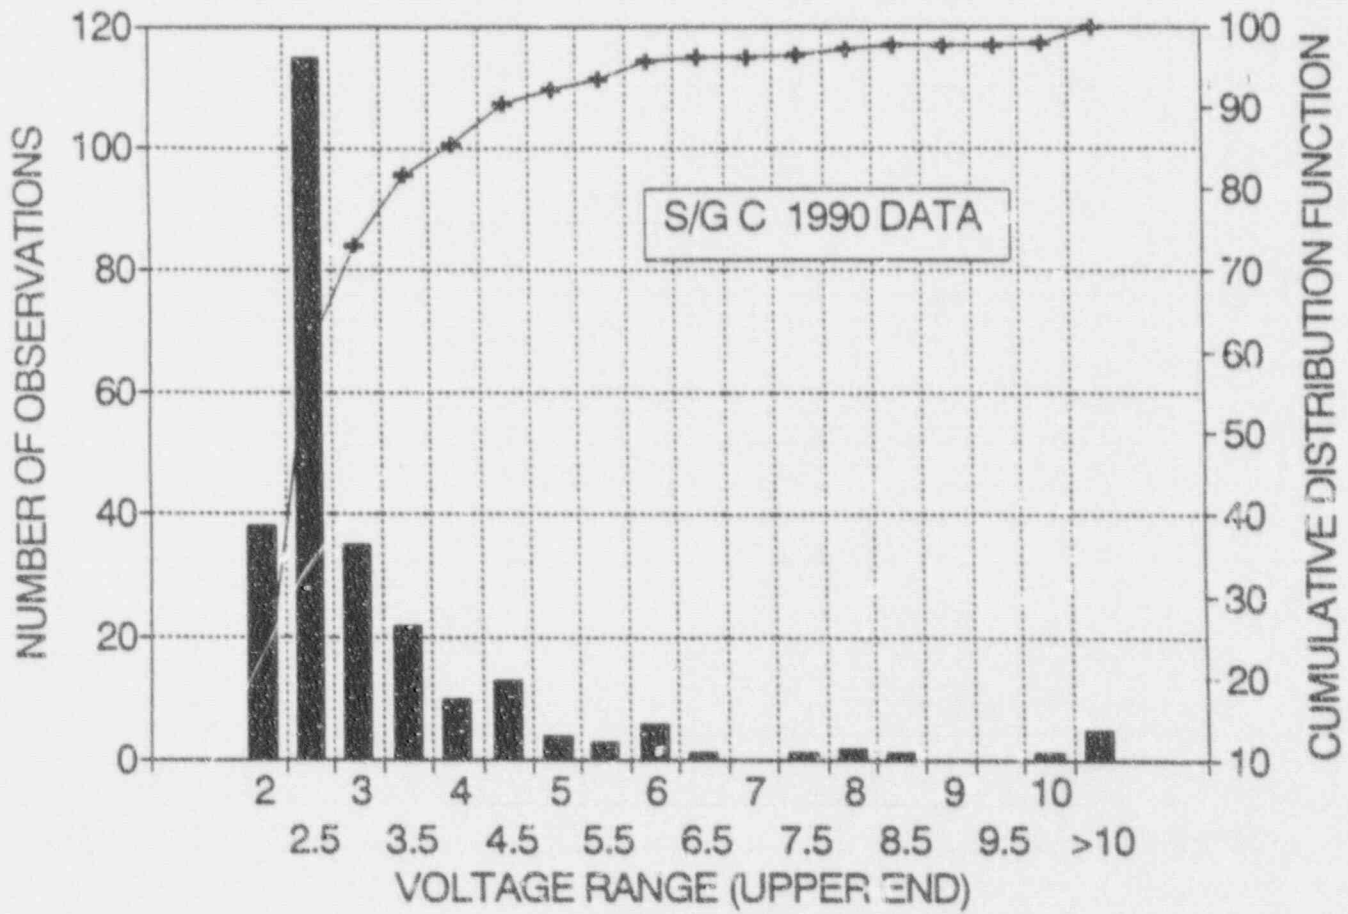
Figure A-14. Farley Unit 1, SG "C" Tube Support Plate Dent Size Distribution

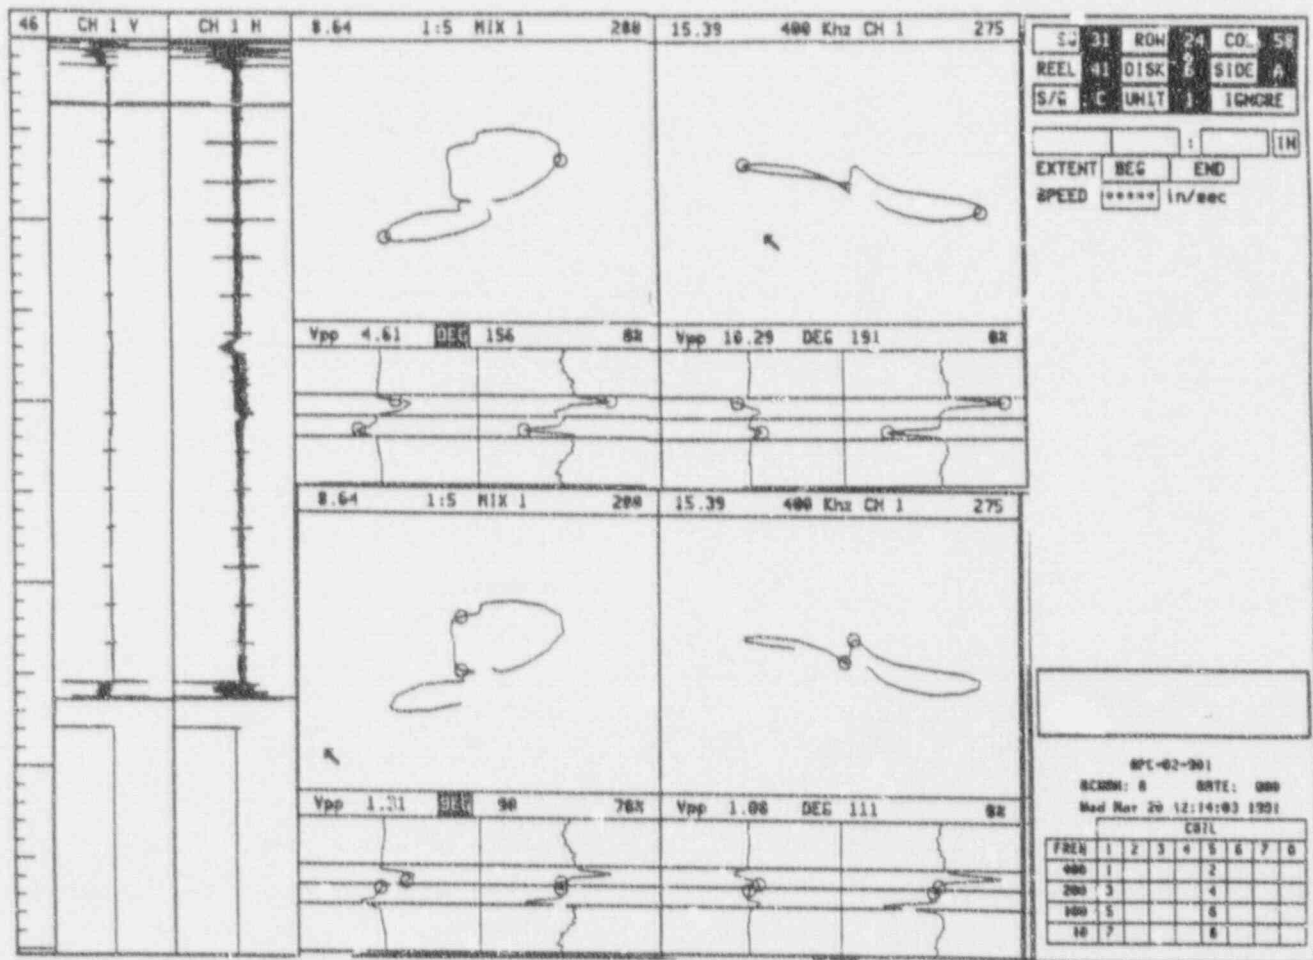
Figure A-15. Example of Bobbin Coil Field Data - Flaw Signals for ODSCC at Dented TSP Intersection

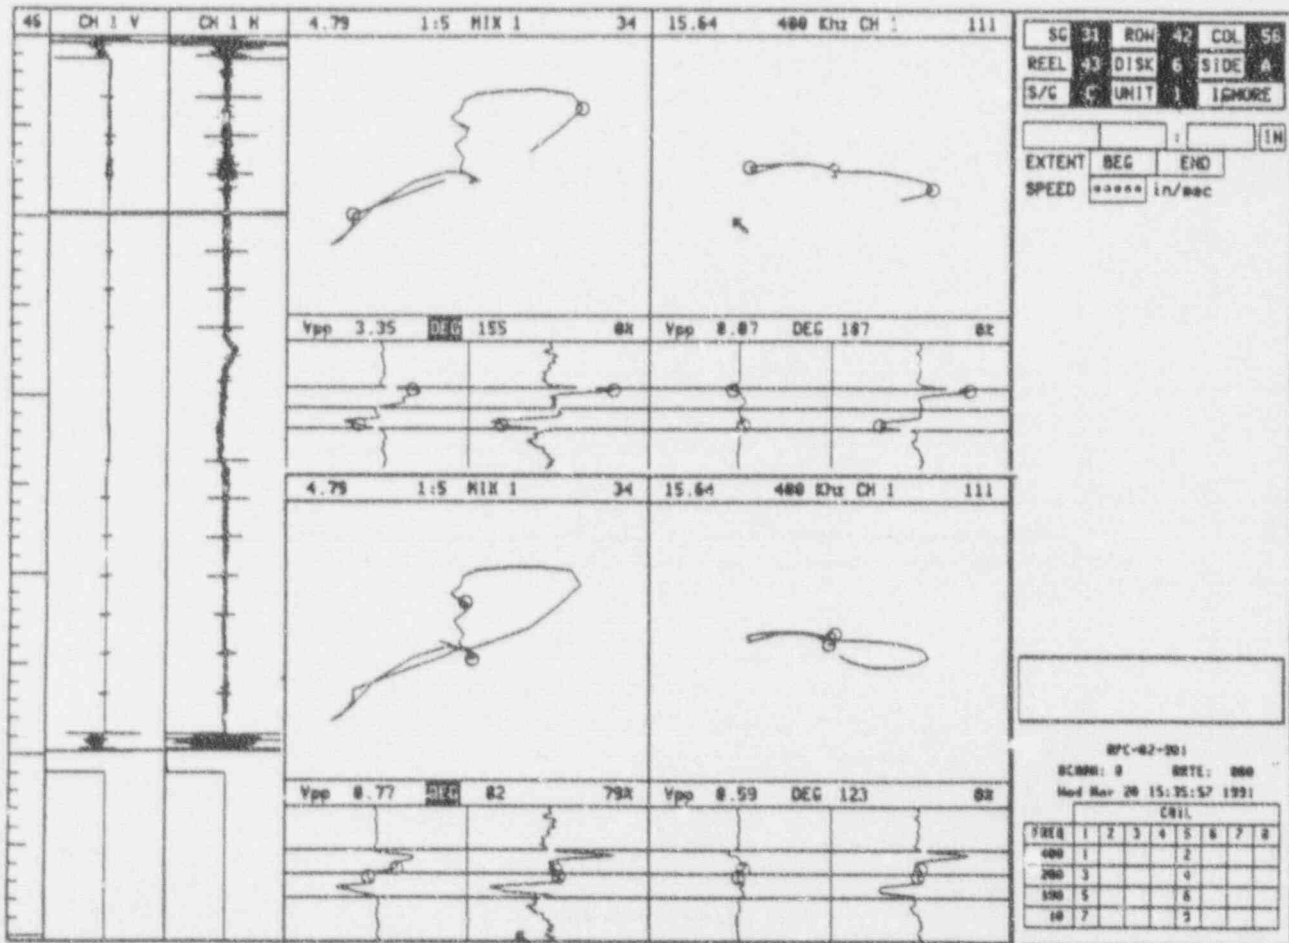
Figure A-16. Example of Bobbin Coil Field Data - Flaw Signals for ODSCC at Dented TSP Intersection

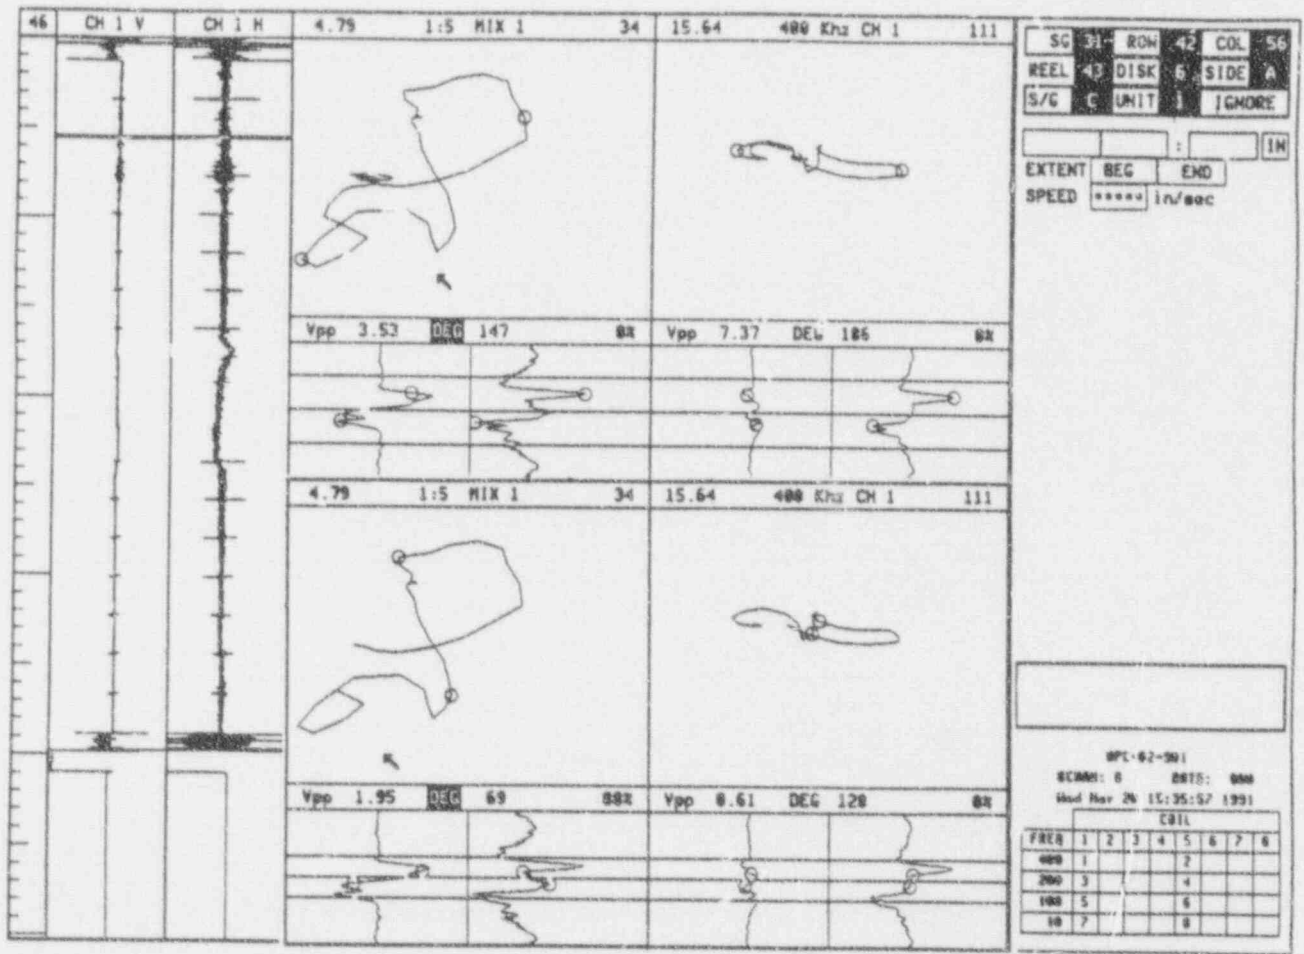
Figure A-17. Example of Bobbin Coil Field Data - Flaw Signals for ODSCC at Dented TSP Intersection

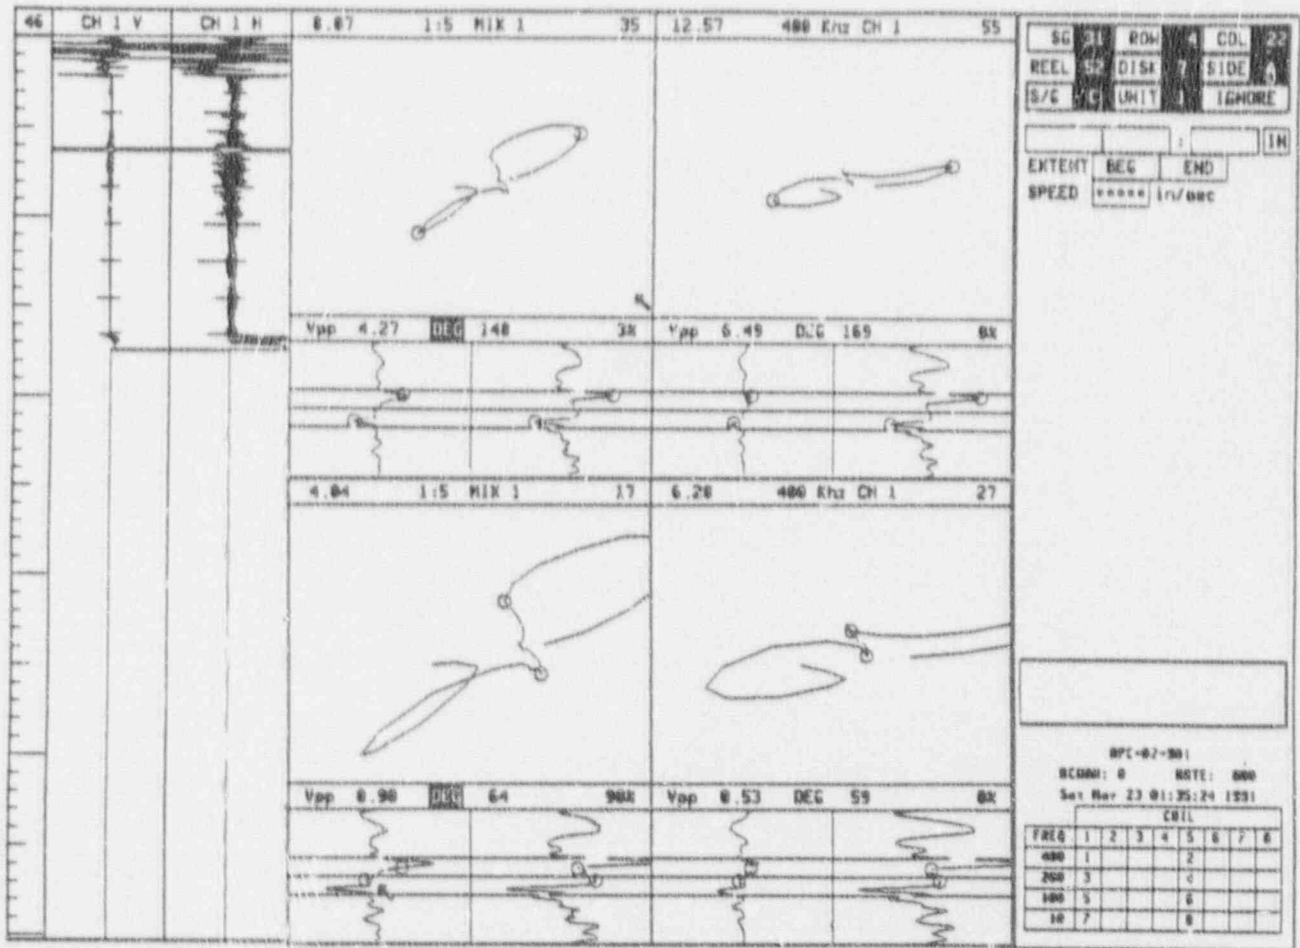
Figure A-18. Example of Bobbin Coil Field Data - Flaw Signals for ODSCC at Dentied TSP Intersection

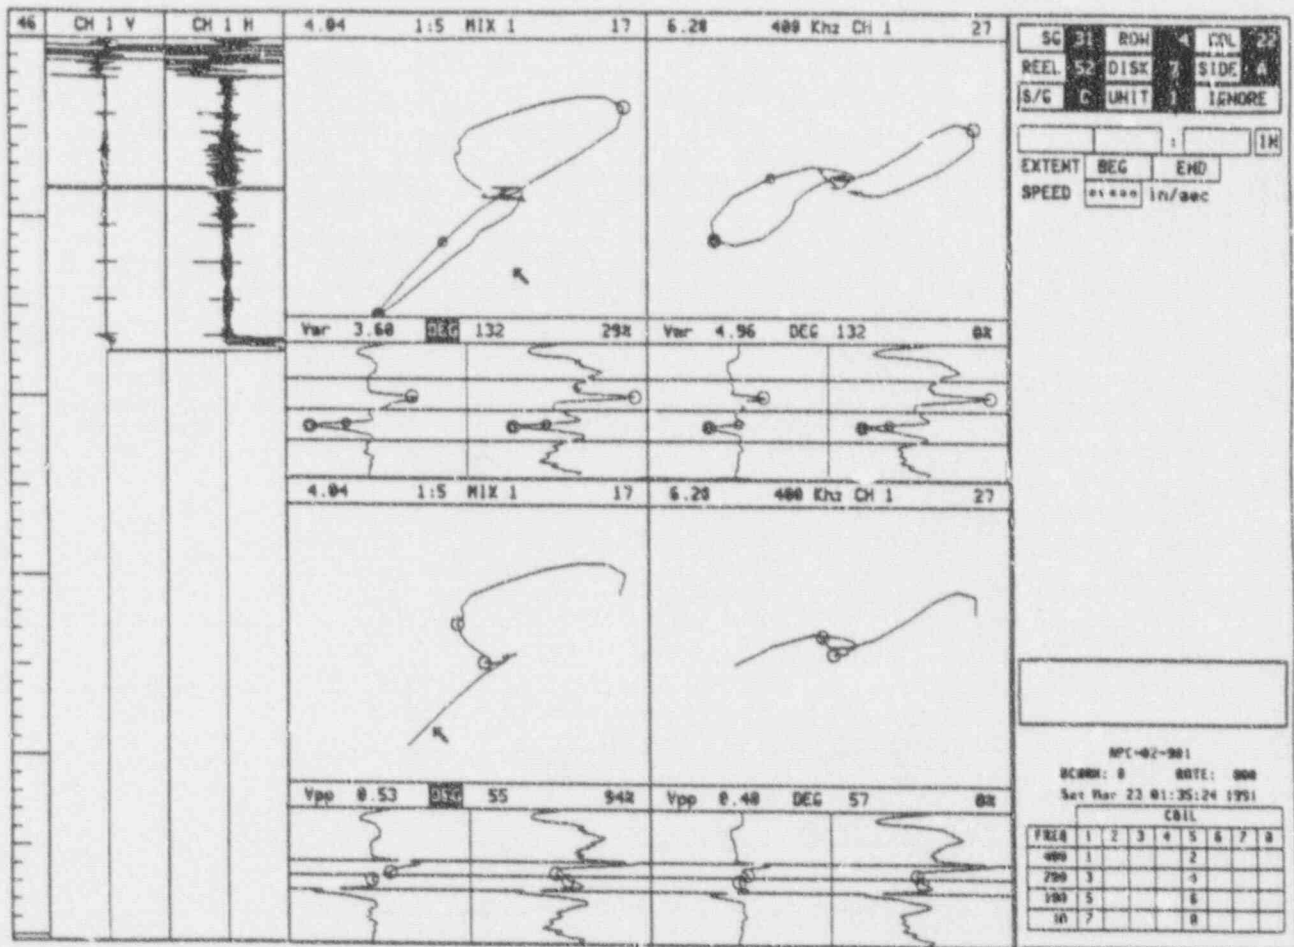
Figure A-19. Example of Bobbin Coil Field Data - Flaw Signals for ODSCC at Dented TSP Intersection

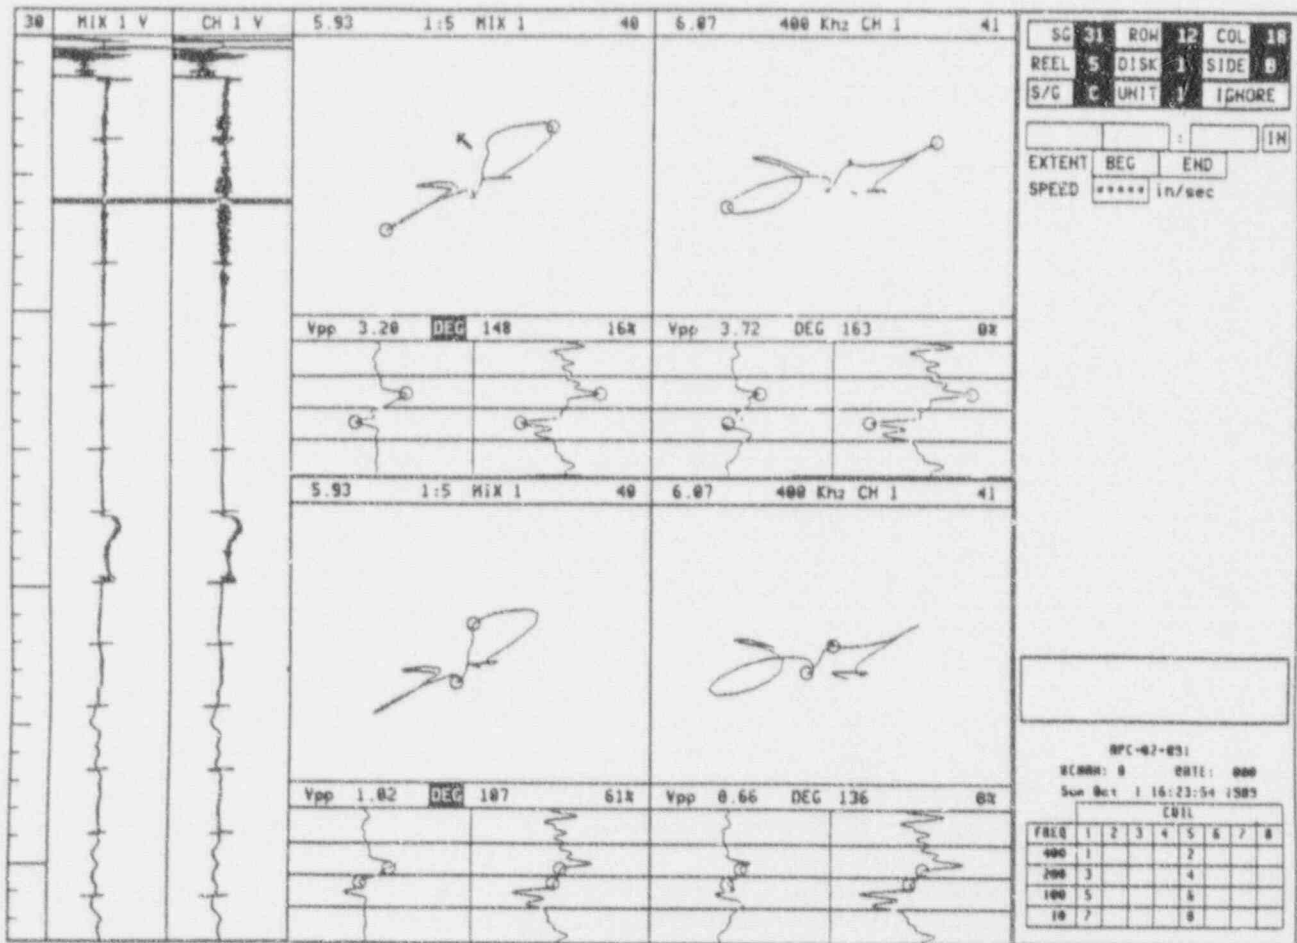
Figure A-20. Example of Bobbin Coil Field Data - Flaw Signals for ODSCC at Dented TSP Intersection

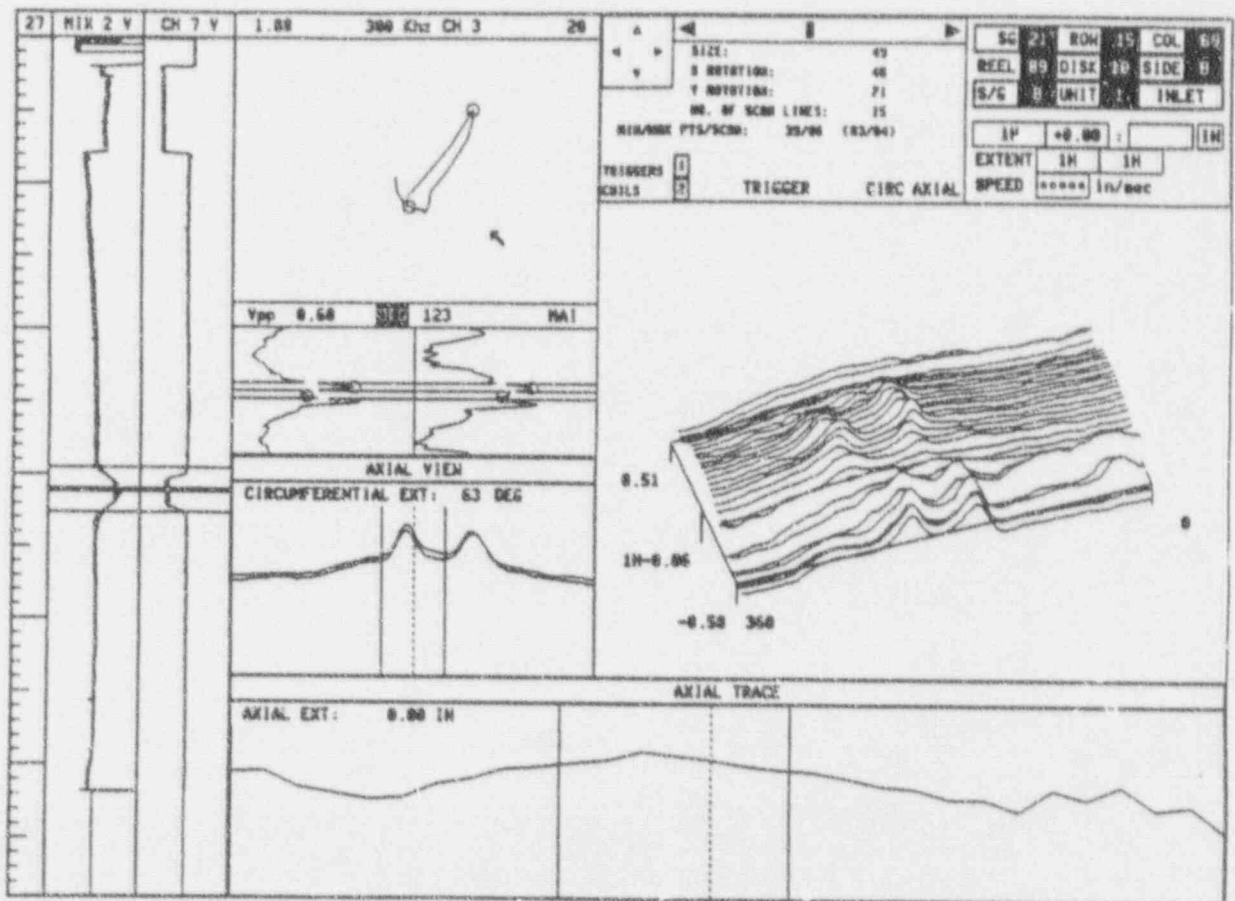
Figure A-22. Axial ODS/SCC Indication at TSP - Farley Unit 1

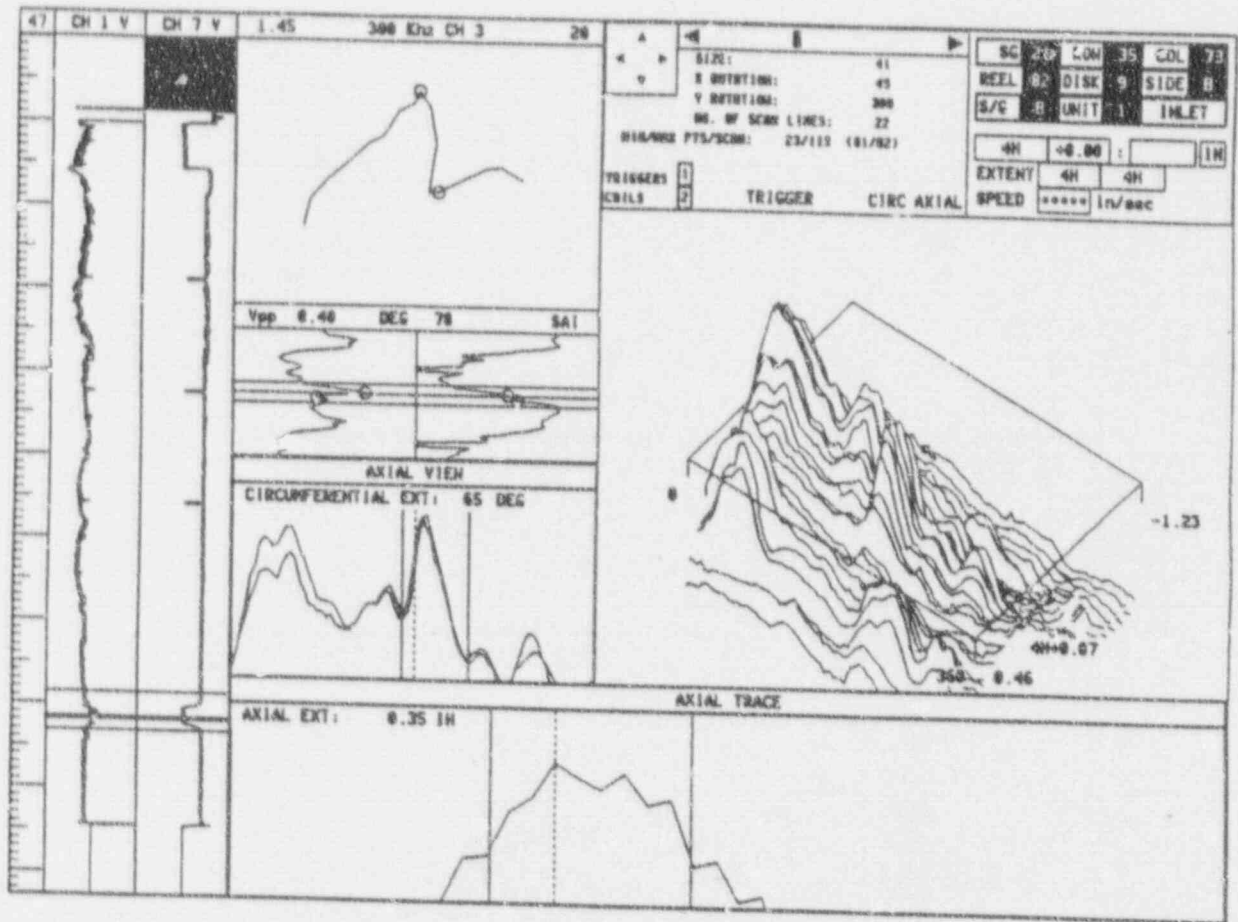
Figure A-23. Axial ODSCC Indications (MAI) at TSP - Farley Unit 1

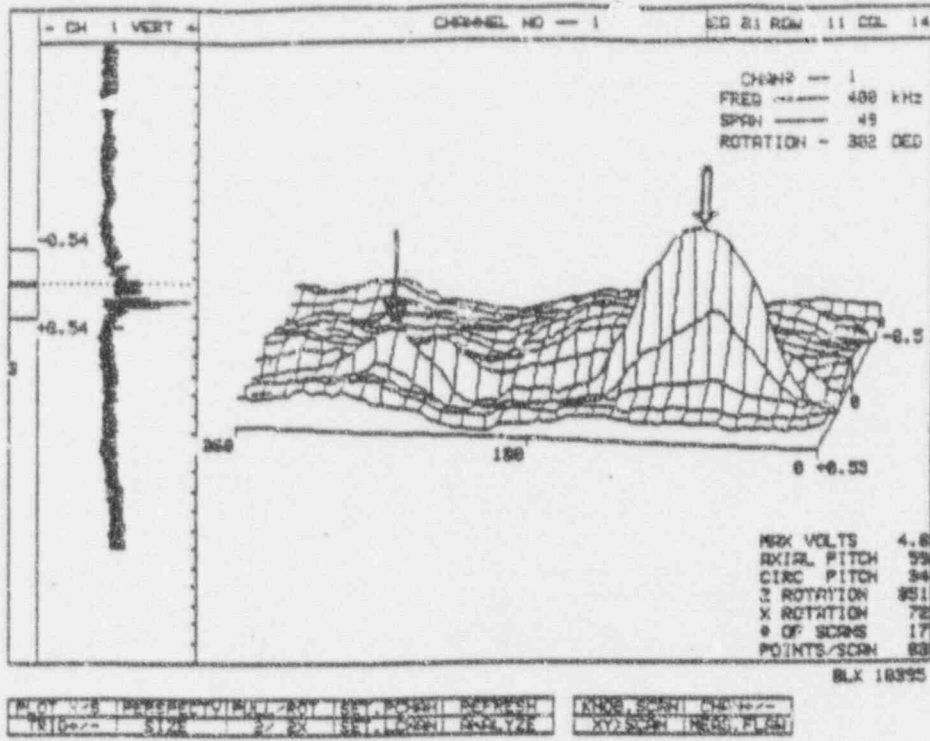
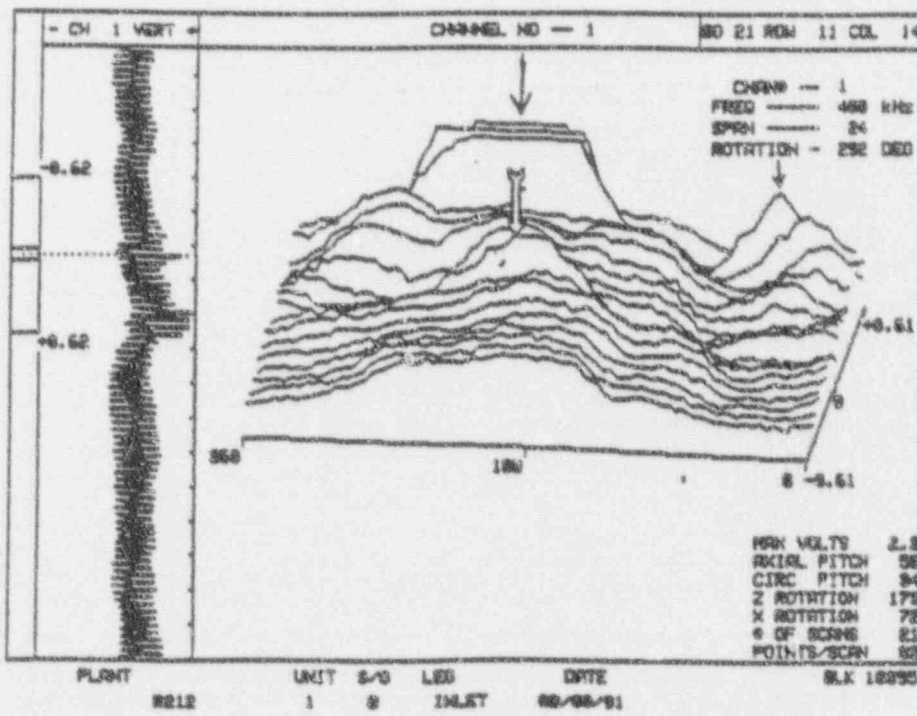
Figure A-24. Circumferential ODSCC Indications at Support Plates

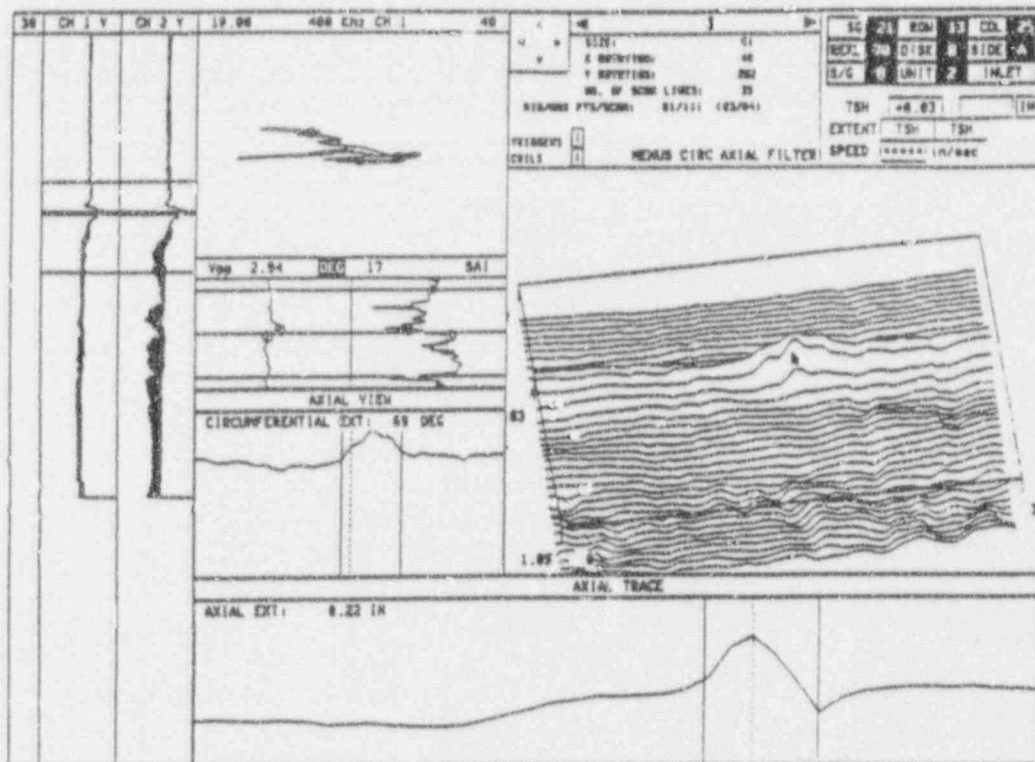
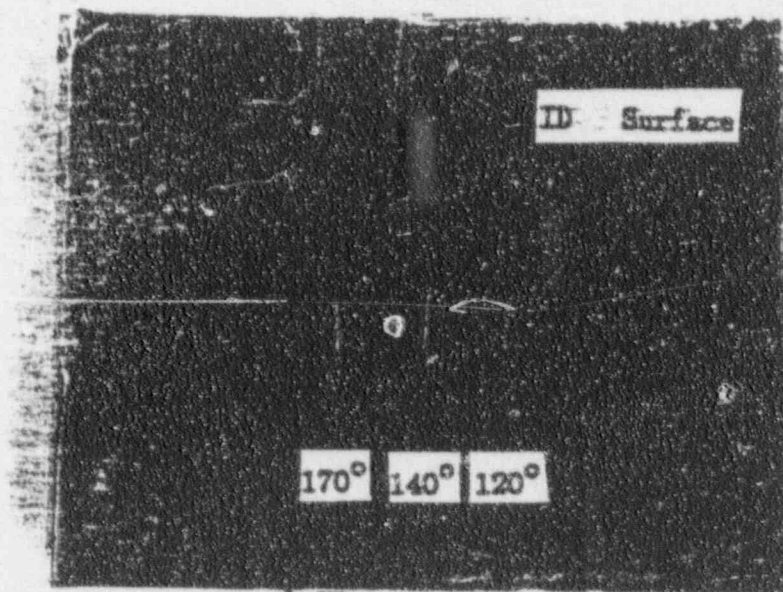
Figure A-25. Farley-2 RPC and Destructive Exam Results for Closely Spaced Axial Cracks

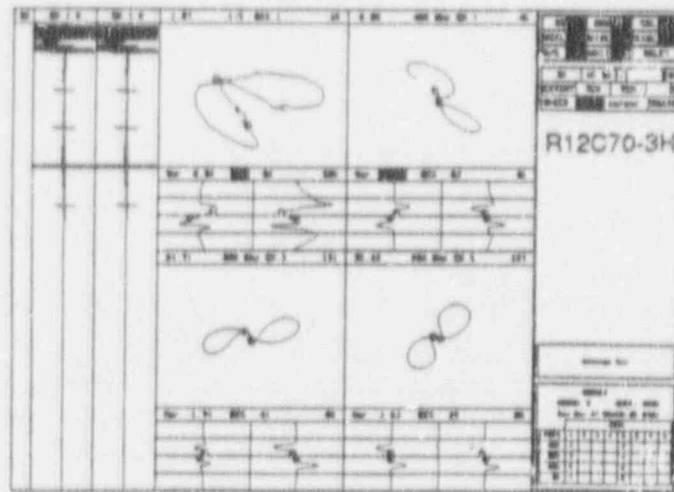
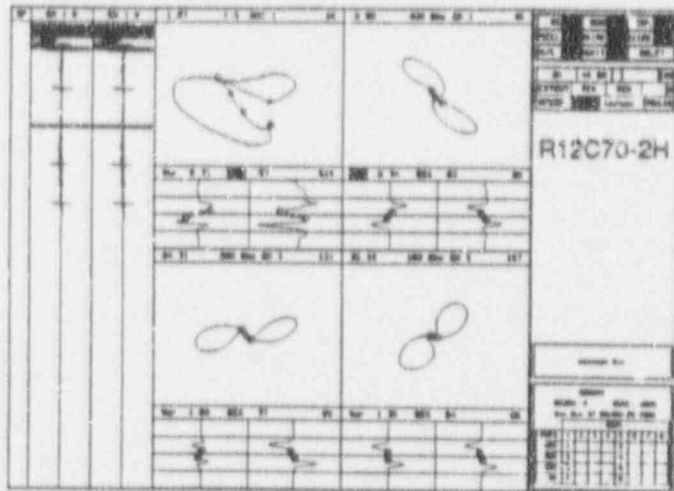
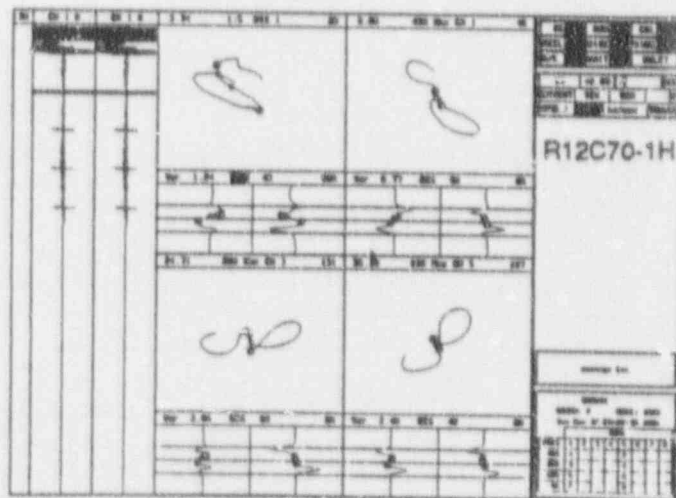
Figure B-8

Laboratory Evaluation of Bobbin Data from Tube R12 C70 at TSPs 3H, 2H and 1H
