WCAP-12872
Revision 2

J. M. Farley Units 1 and 2
SG Tube Plugging Criteria for
ODSCC at Tube Support Plates

Westinghouse Energy Systems

February 1992

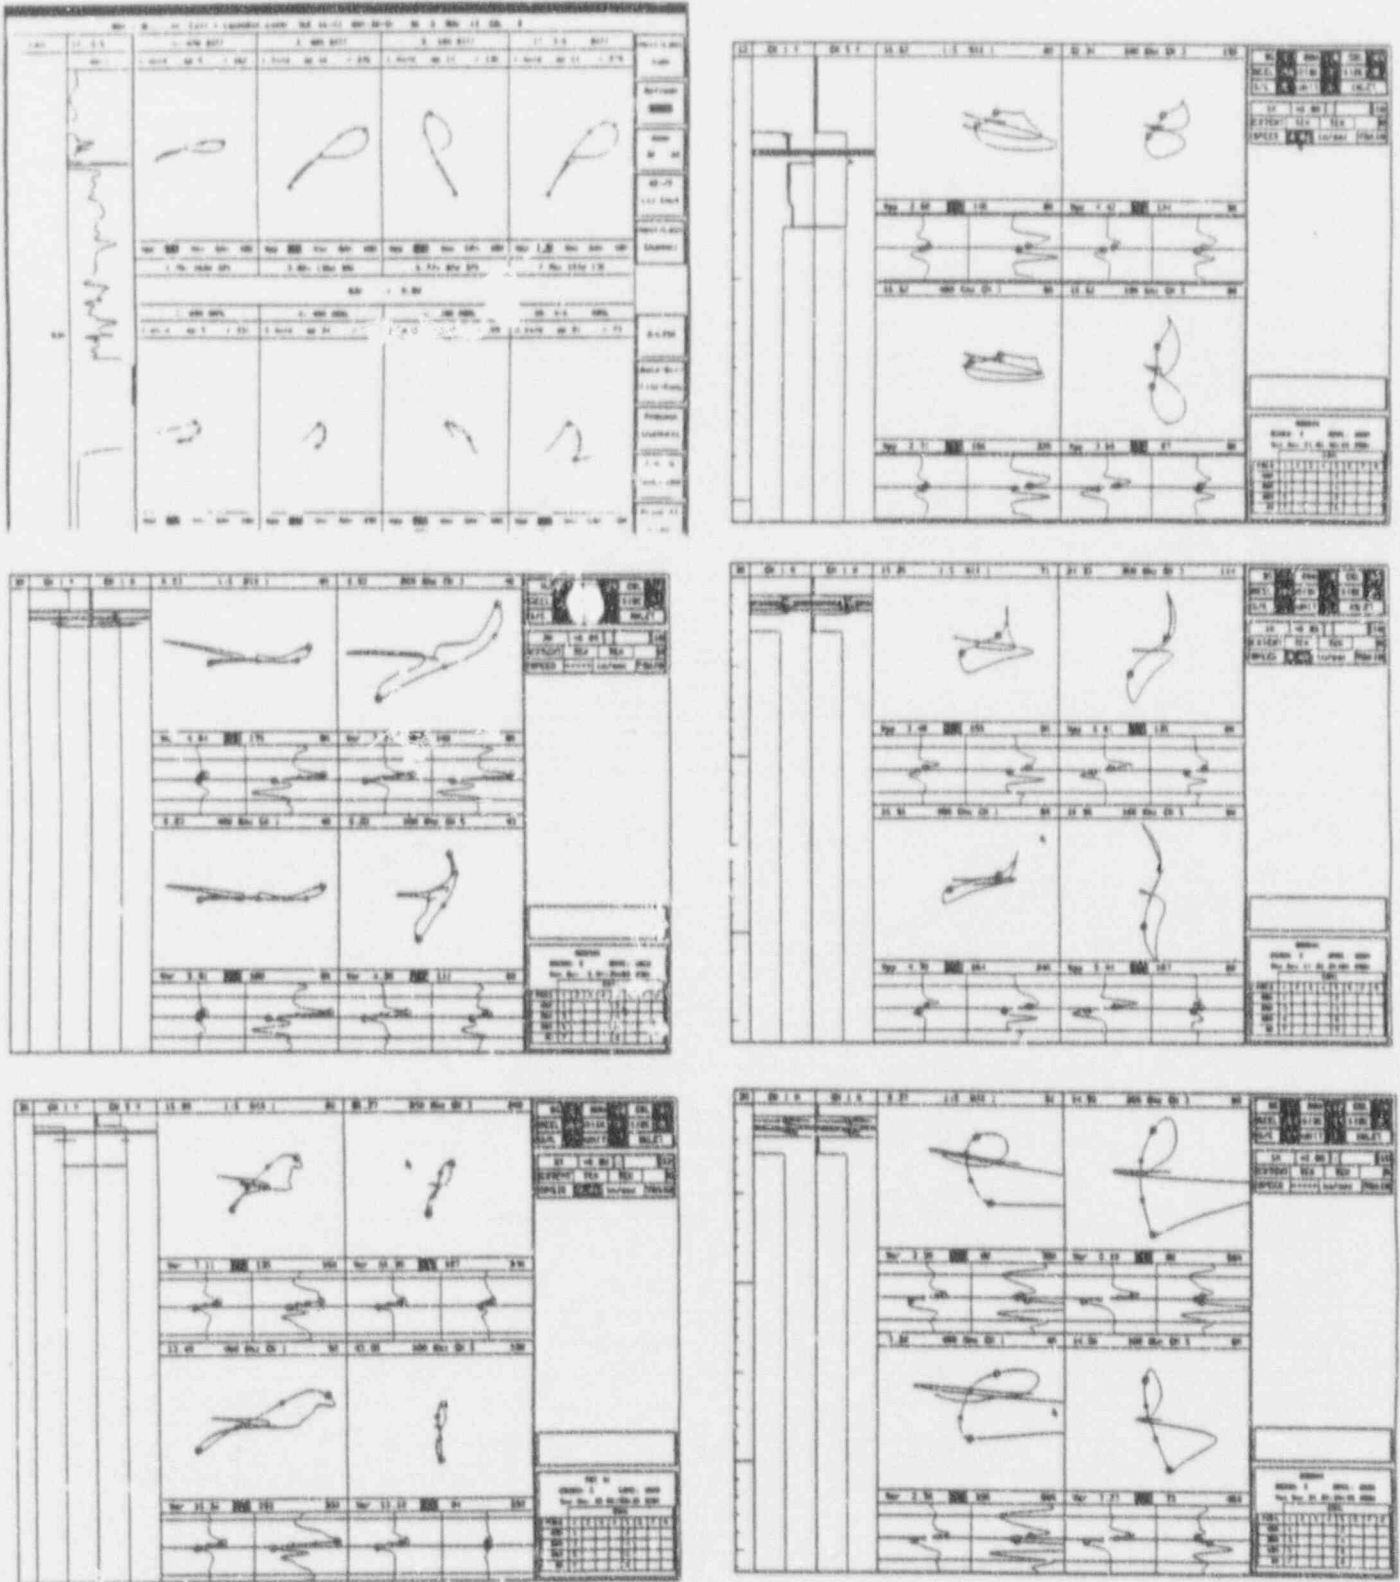
Figure B-9

From Figure B-9, the 5900 psi burst pressure is consistent with the crack length and

Examples of Post-Pull Bobbin Indications Influenced by Tube Deformation

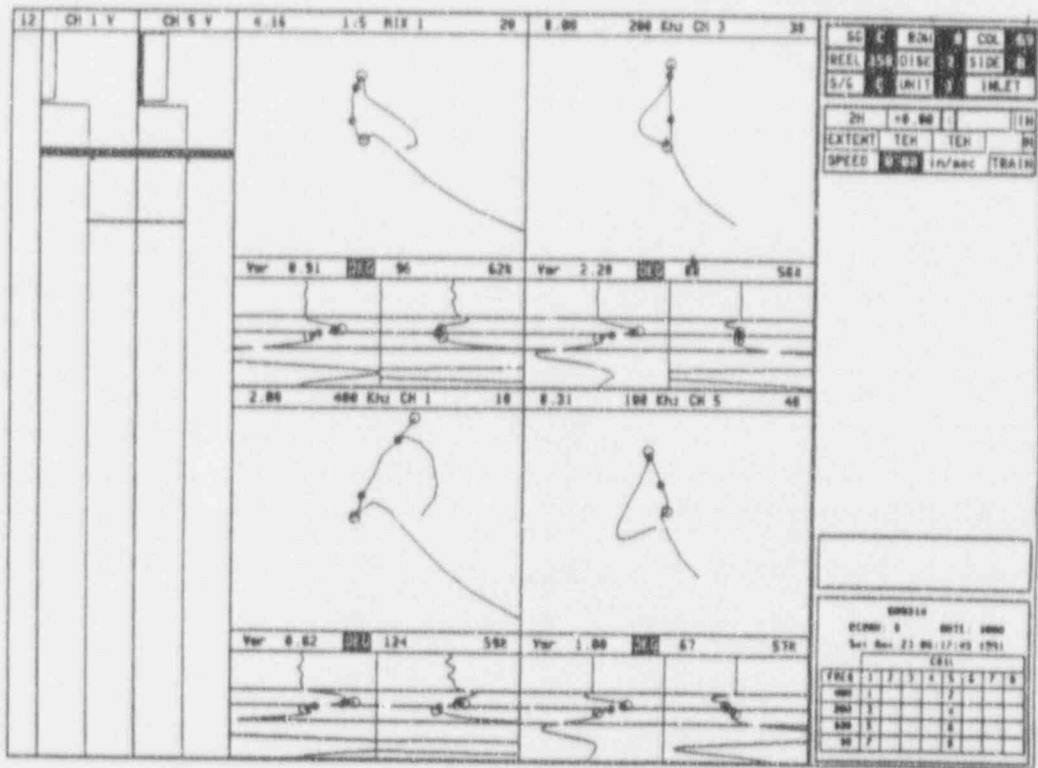
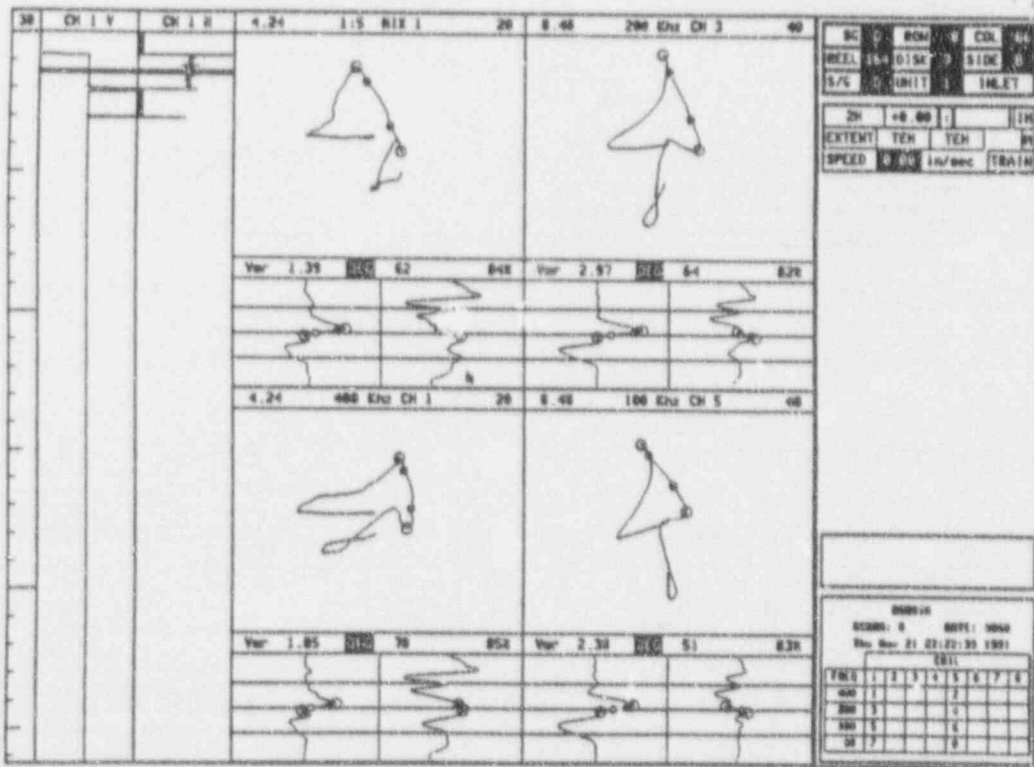
Figure B-10

Examples of Post-Pull Boiling Indications With Minimal Tube Deformation Influence

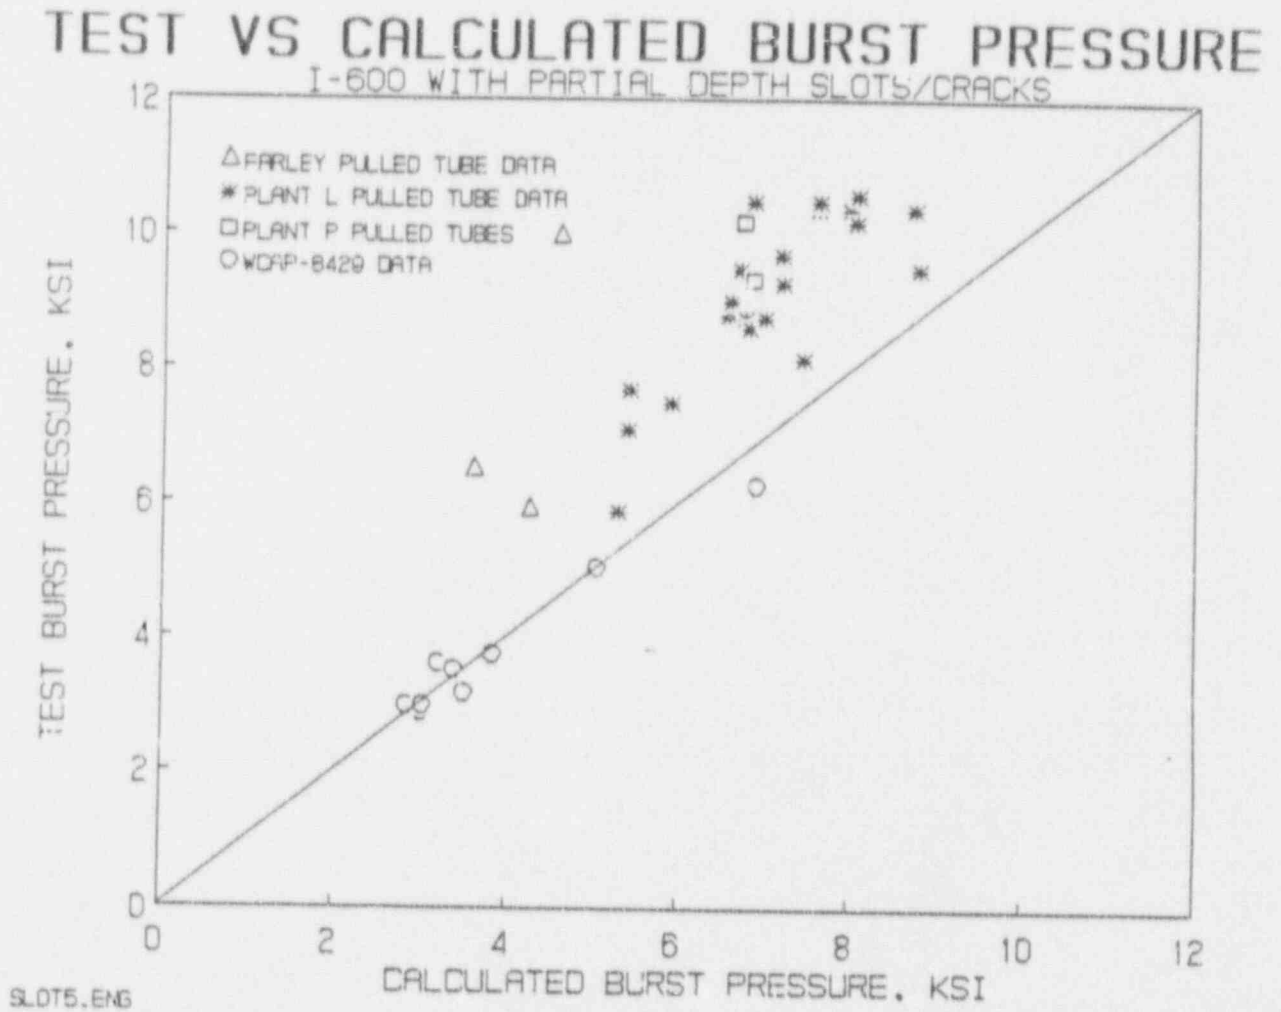
Overall, it is concluded from Figure B-11 that the combined crack morphologies of the Farley, Plant L and Plant P tubes result in burst capability associated with the limiting single crack in an otherwise undegraded tube. That is, the combined crack morphologies do not significantly reduce the burst pressure of the limiting ODSCC crack.

Comparison of Measured Burst Pressures for Farley, Plant L and Plant P
With Calculated Burst Pressures Using Single Crack Model
