MIDLAND PLANT UNITS 1 AND 2  
BECHTEL JOB 7220

WELL OBS-4 SUBSIDENCE REPORT

Prepared by Steven W. Hunt  
Reviewed by John E. Anderson  
June 11, 1982

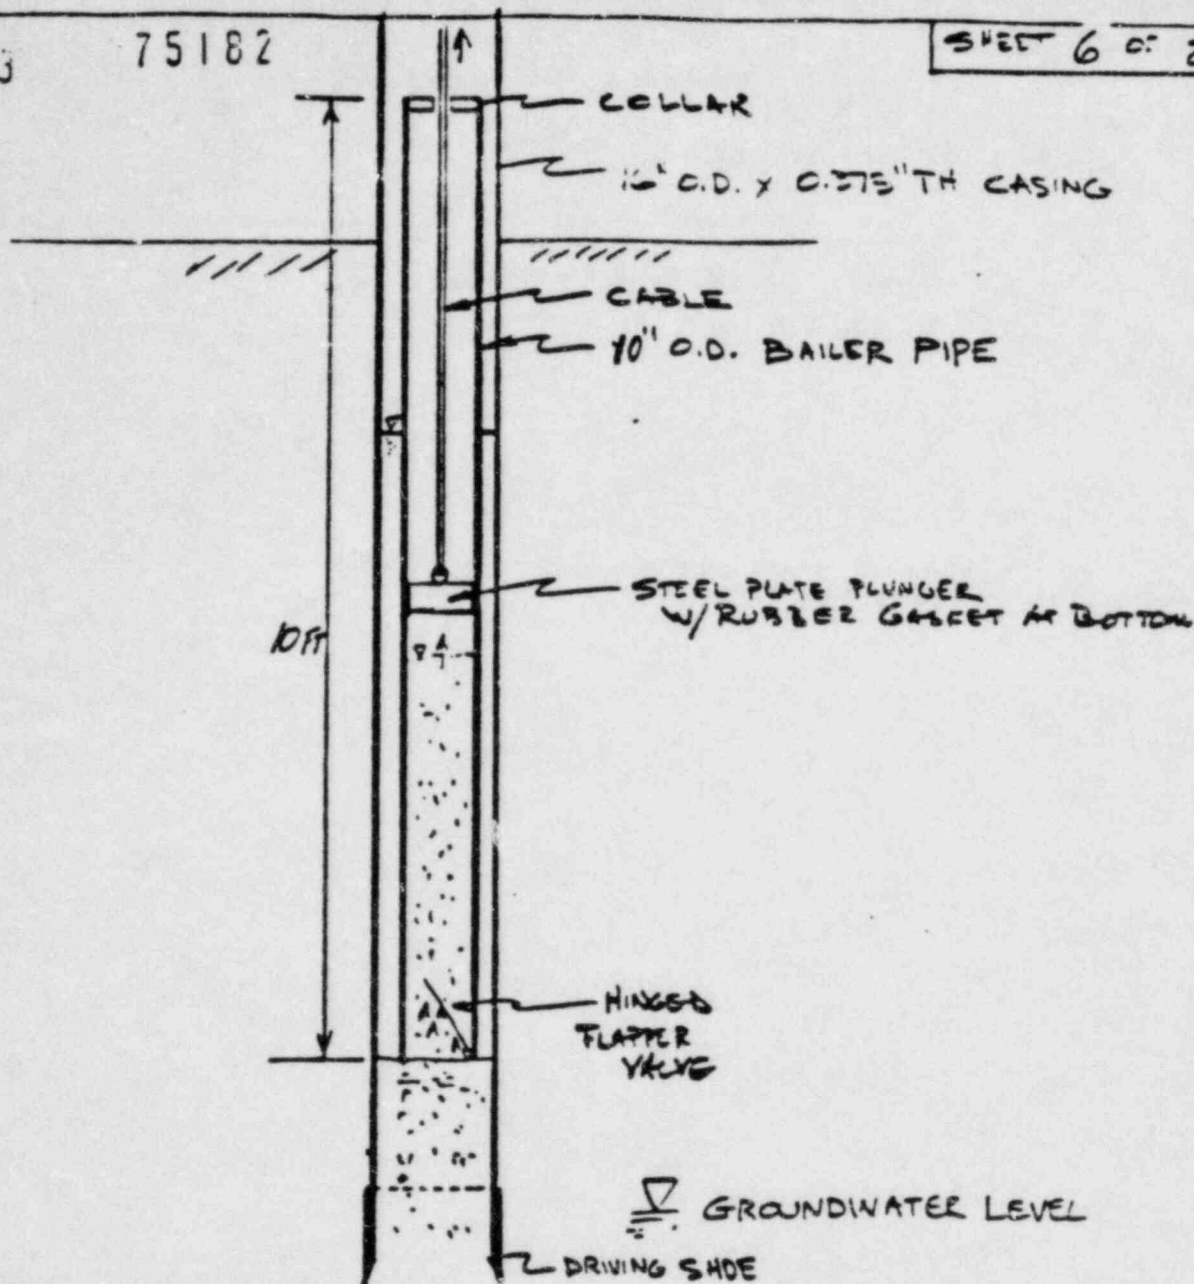
SHEET 6 OF 26

As a result of the bailing operation the initial 12.5 foot section of casing sank under its own weight and a "quick" condition created at the tip while the bailer is sucking material. After the casing sank to an embedment of about 10 feet, bailing was stopped in order to place and weld an additional 12.7 feet of 16 inch pipe onto the casing. After welding, the bailing operation was resumed until the casing stopped advancing at a depth of about 24 feet. In order to try to advance the casing beyond 24 feet without driving, the driller indicated that several bails were taken at or near this depth. The geologist's log of bailing spoils at 24 ft. indicated that clayey sand fill was encountered explaining the arrest of progress and leading to the decision to begin driving.

As previously described, a bailer using suction pressure was used to extract material from inside of the 16-inch diameter casing. The normal procedure was to drive the casing and then excavate to the casing tip using the bailer. However, for Observation Well OBS-4 the casing was advanced to an embedment of 24 feet without driving. Instead the casing was advanced by operating the bailer near the tip of the casing, creating a quick condition during suction and allowing the casing to sink as the tip bearing material was removed. In spite of maintenance of a water level inside the casing of at least 5 feet above the groundwater table, bailer suction pressure when operated near the tip of the casing was likely sufficient to remove material from below and outside of the casing. As the casing was advanced to 24 feet it is likely that a larger volume of material was removed during bailing than was replaced by the volume of the casing.

### BAILER OPERATION:

- \* Bailer lowered to soil surface inside casing
- \* Steel plate plunger slides to bottom
- \* Steel plate plunger lifted sucking soil and water
- \* Steel plate plunger contacts collar raising bailer
- \* Bailer extracted from casing with contents
- \* Contents clumped into a tub
- \* Additional water pumped into casing as required to maintain casing level above ground water level
