Investigation and Analysis of Suspect Fasteners

Event 29257

Final Report

Prepared by Cardinal Industrial Products Division of B&G Manufacturing Co., Inc.

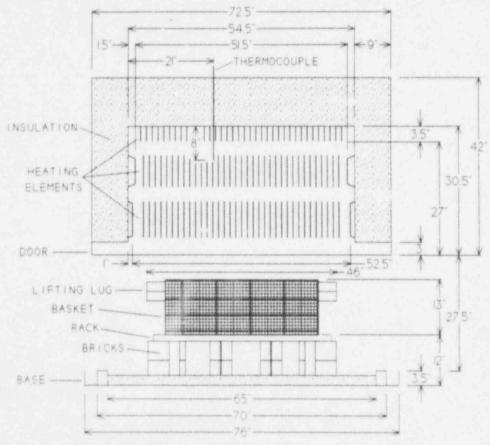
Figure 1 - Furnace Side View Facing Quench Tank

**Furnace:** The furnace has two main components, the base and the door. The base is supported by a steel structure at a height of 4 1/2 feet above the foundation (just lower than the top of the adjacent quench tank). The door is supported by the same structure, and moves vertically to allow for insertion and removal of the parts basket. The door operates hydraulically with a total travel of approximately 30 inches. A rack supported by bricks rests in the center of the base. The basket containing the parts being heat treated is placed on the rack. Both the rack and the basket are made from Inconel. The furnace door houses the heating elements and the thermocouple. There are eleven rows of heating elements; two on each side and three across the ceiling. Side views of the furnace door and base are shown below as Figures 1 and 2. F.gure 1 is the view from the quench tank. Figure 2 is the view from the side perpendicular to the quench tank.

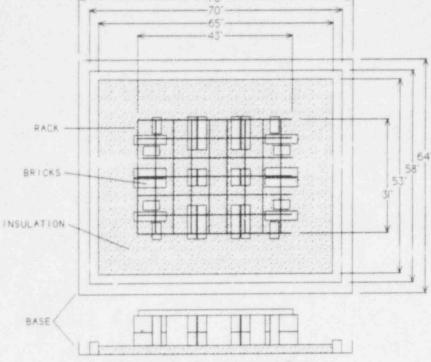
Figure 4 - Top View of Base

Figure 4 is a top view (and side view) of the base with the bottom of the figure facing the quench tank. The bricks used to support the rack are arranged in a symmetrical pattern as shown.
