UNITED STATES
NUCLEAR REGULATORY COMMISSION
WASHINGTON, D. C. 20555

APPLICANT: Consumers Power Company
FACILITY: Midland Plant, Units 1 and 2
SUBJECT: SUMMARY OF THE MAY 23, 1980 MEETING ON PRESERVICE FAILURE OF
THREE REACTOR VESSEL HOLD-DOWN STUDS

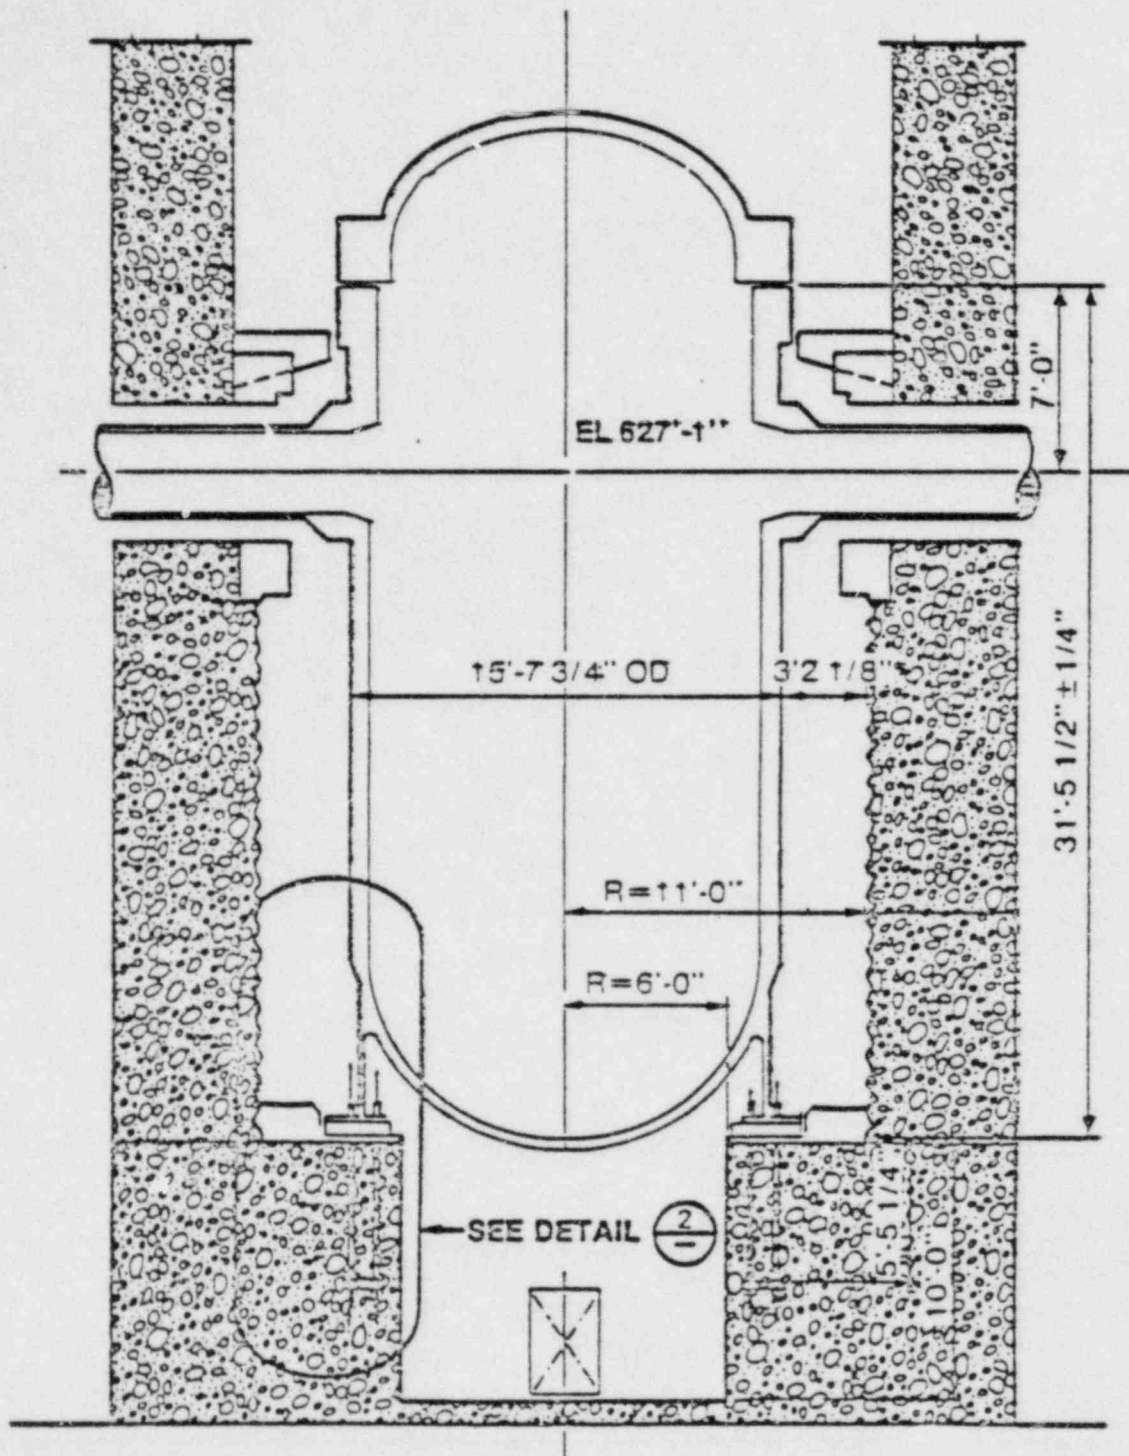
Slide 1

The holddown design for the Midland reactor vessels is shown on Slides 1, 2 and 3 of Enclosure 3. Further detail is shown on FSAR Figure 3.8-30. The design utilizes 96 anchor studs, each 7 feet 4 inches long and 2 1/2 inches in diameter, embedded vertically in the reinforced concrete reactor vessel pedestal and arranged in two concentric rows of 48 studs each. All studs were purchased by Bechtel to a modified version of ASTM-A354-66, Grade BD standards under Bechtel Specification 7220-C-223(Q), Rev. 3. The modification was a waiver of the maximum diameter allowed in the 1966 version for Grade BD bolts. The studs for Midland Unit 1 are nominally AISI 4140 and 4145, while the studs for Unit 2 are all nominally AISI 4340. Stud failure has occurred in Unit 1 only. The Unit 1 failed studs were purchased from Mississippi Valley Structural Steel of St. Louis, Missouri and fabricated by Southern Bolt and Fastener of Shreveport, Louisiana. The stud material originated from Bethlehem Steel and the studs were heat treated by J. W. Rex of Lansdale, Pennsylvania.

REACTOR VESSEL ELEVATION

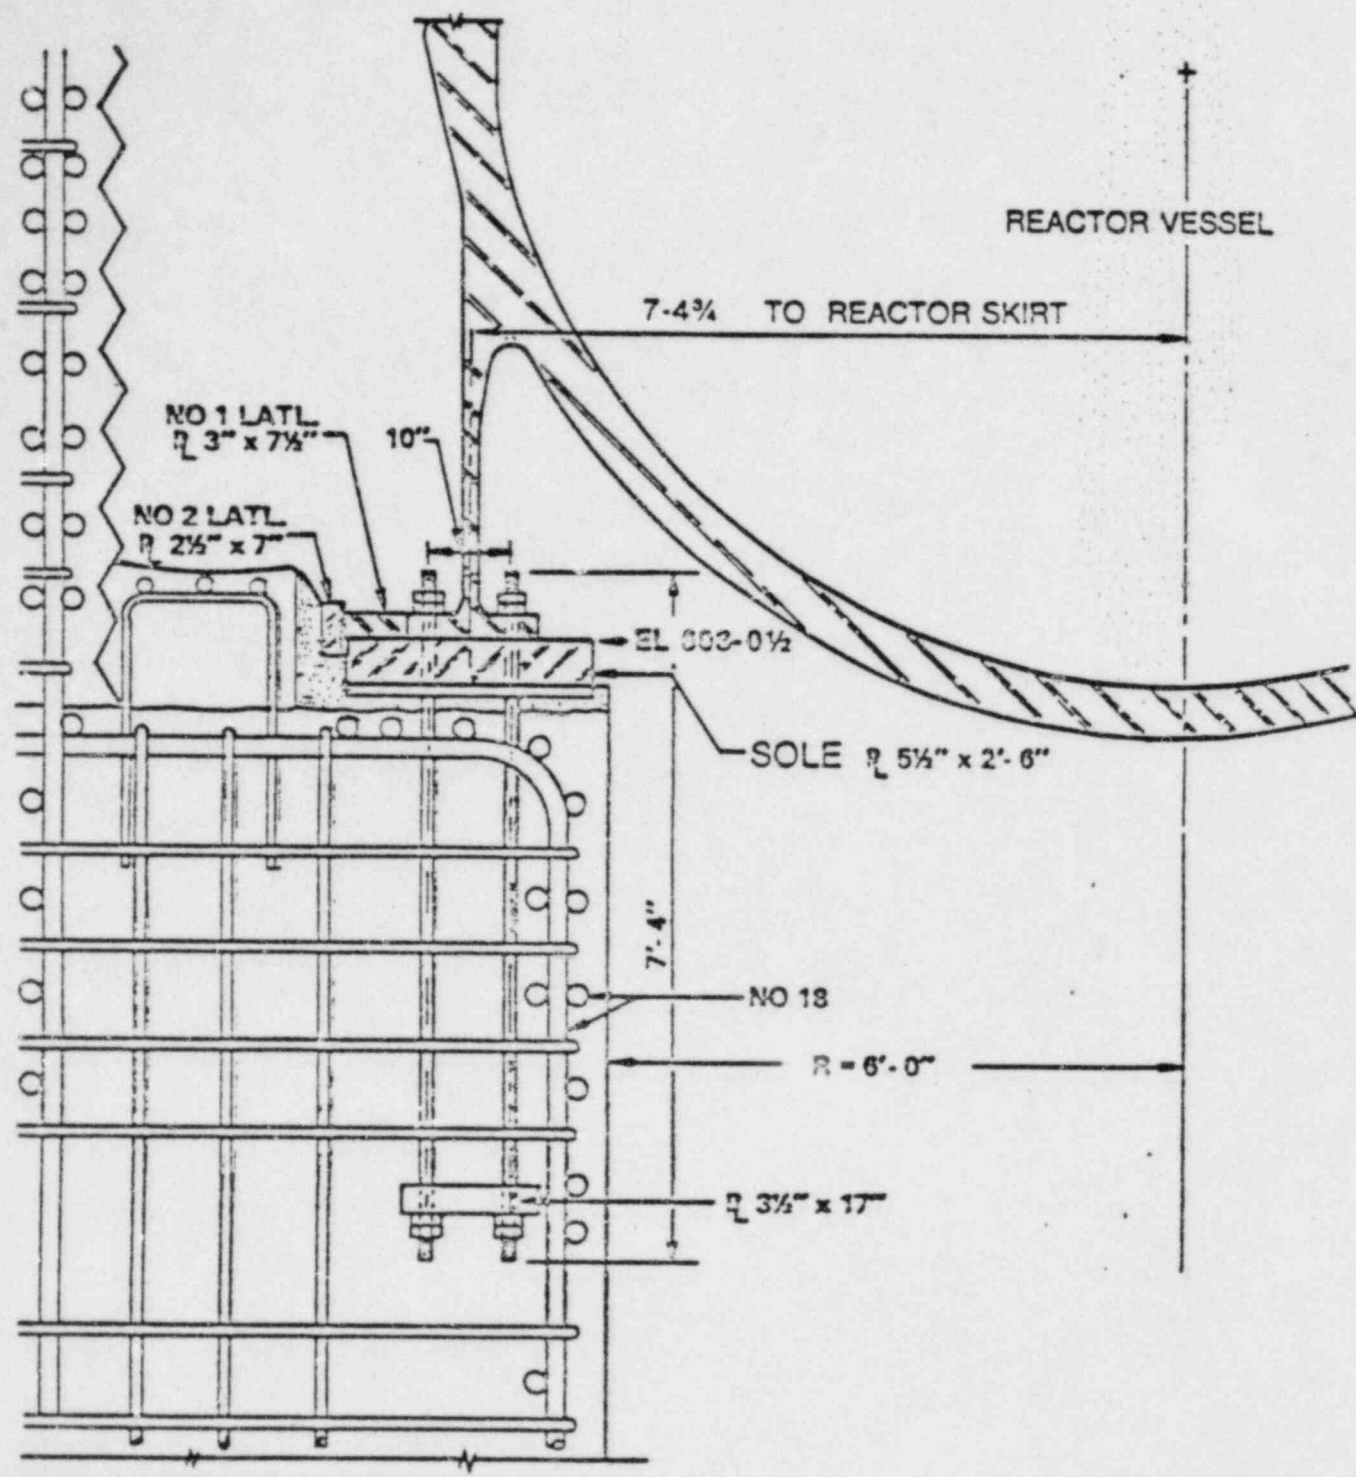
slide 3

DETAIL 2

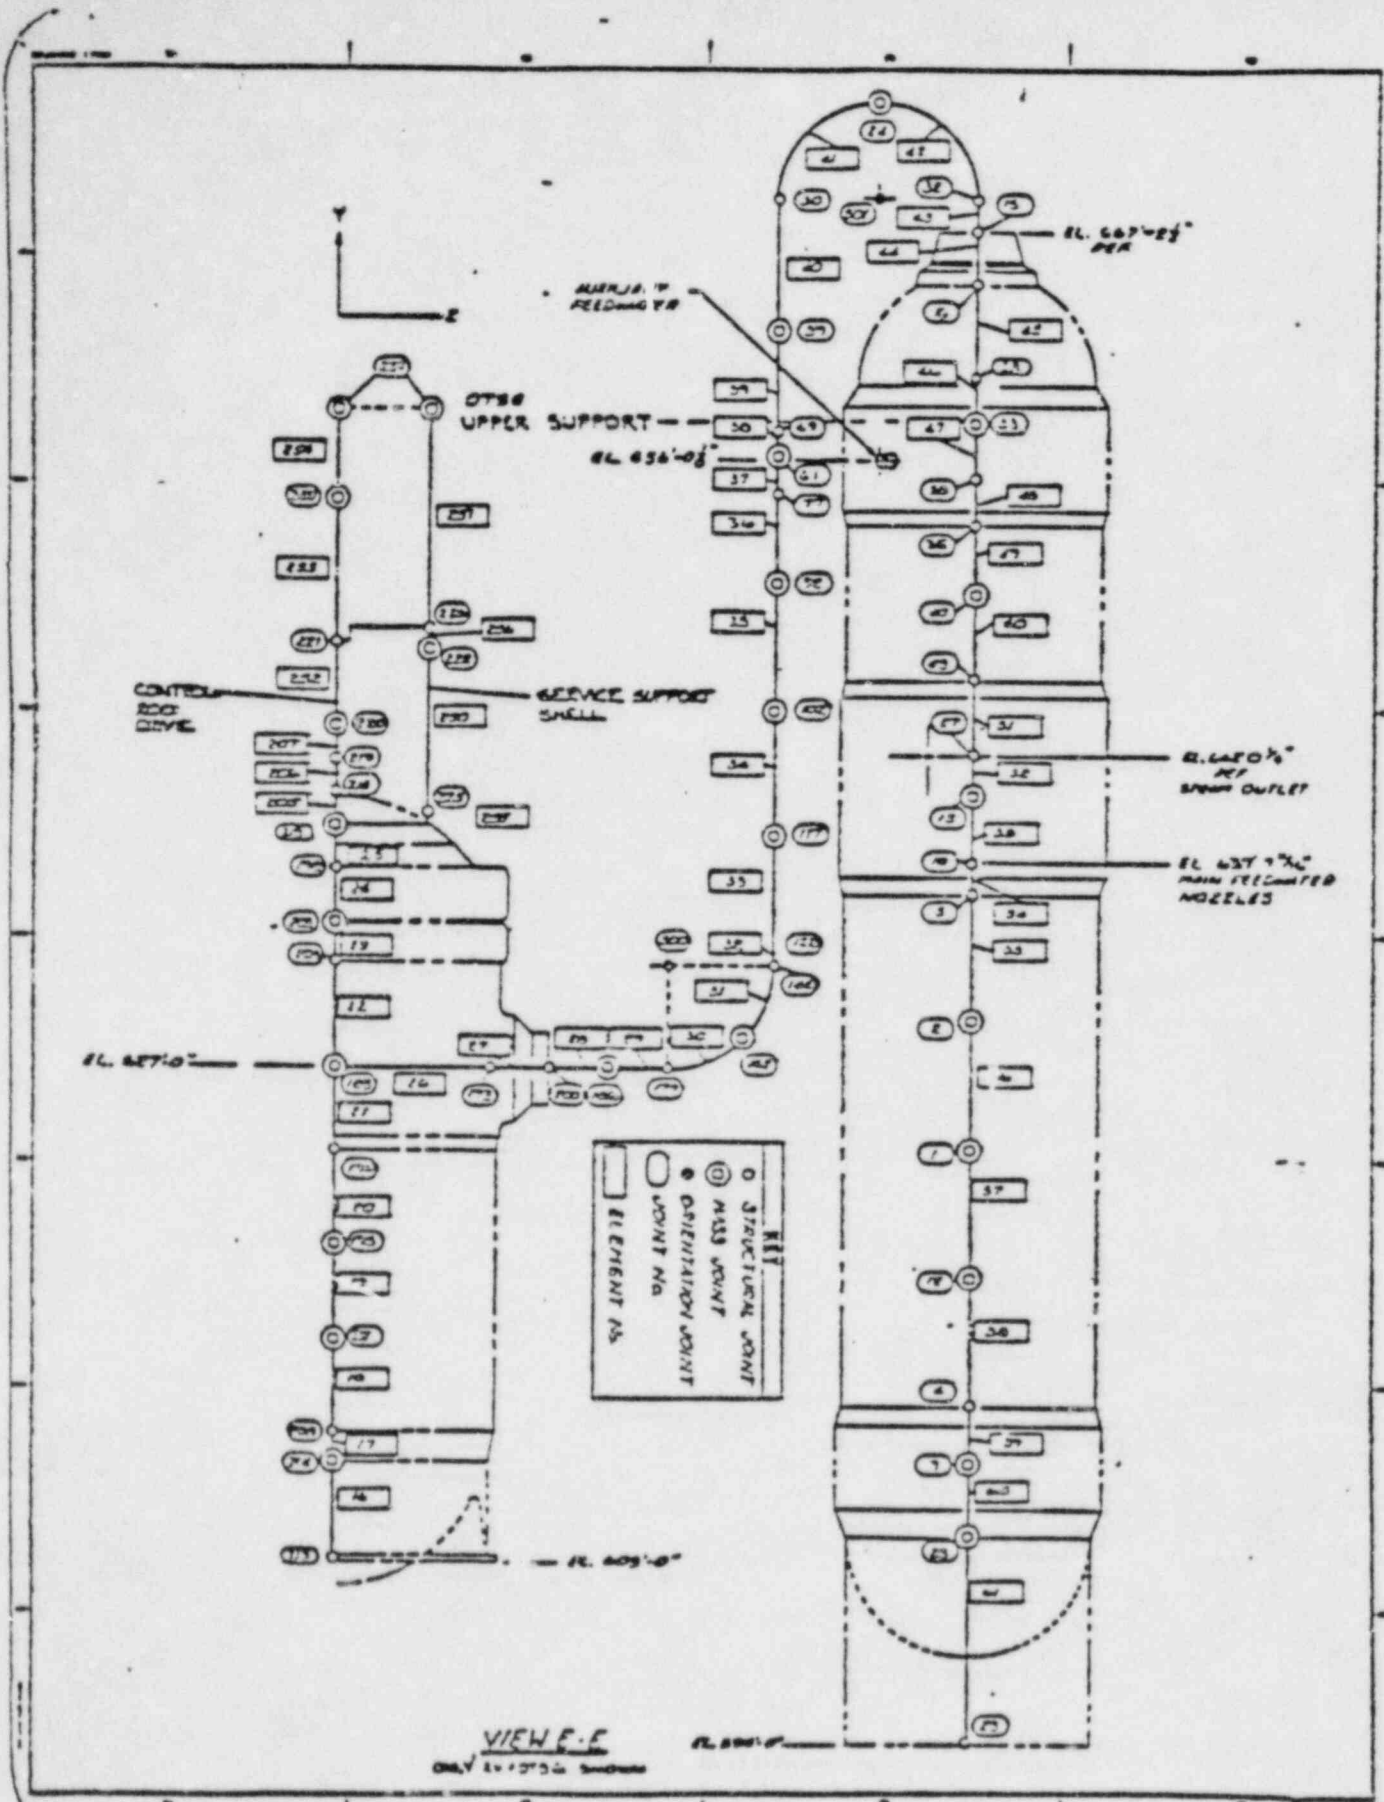
slide 11.

The applicant presented the preliminary results of forces and moments at the reactor vessel skirt support for various LOCA break types and locations. These results are shown in Slide 10. The analytical model and vessel foundation spring rate are shown in Slides 11, 12 and 13. The staff also noted that the upper lateral support design would require a finite element analysis of the interaction of the vessel and bracket support.

VIEW E-E
ONLY 14 OF 24 SHOWN

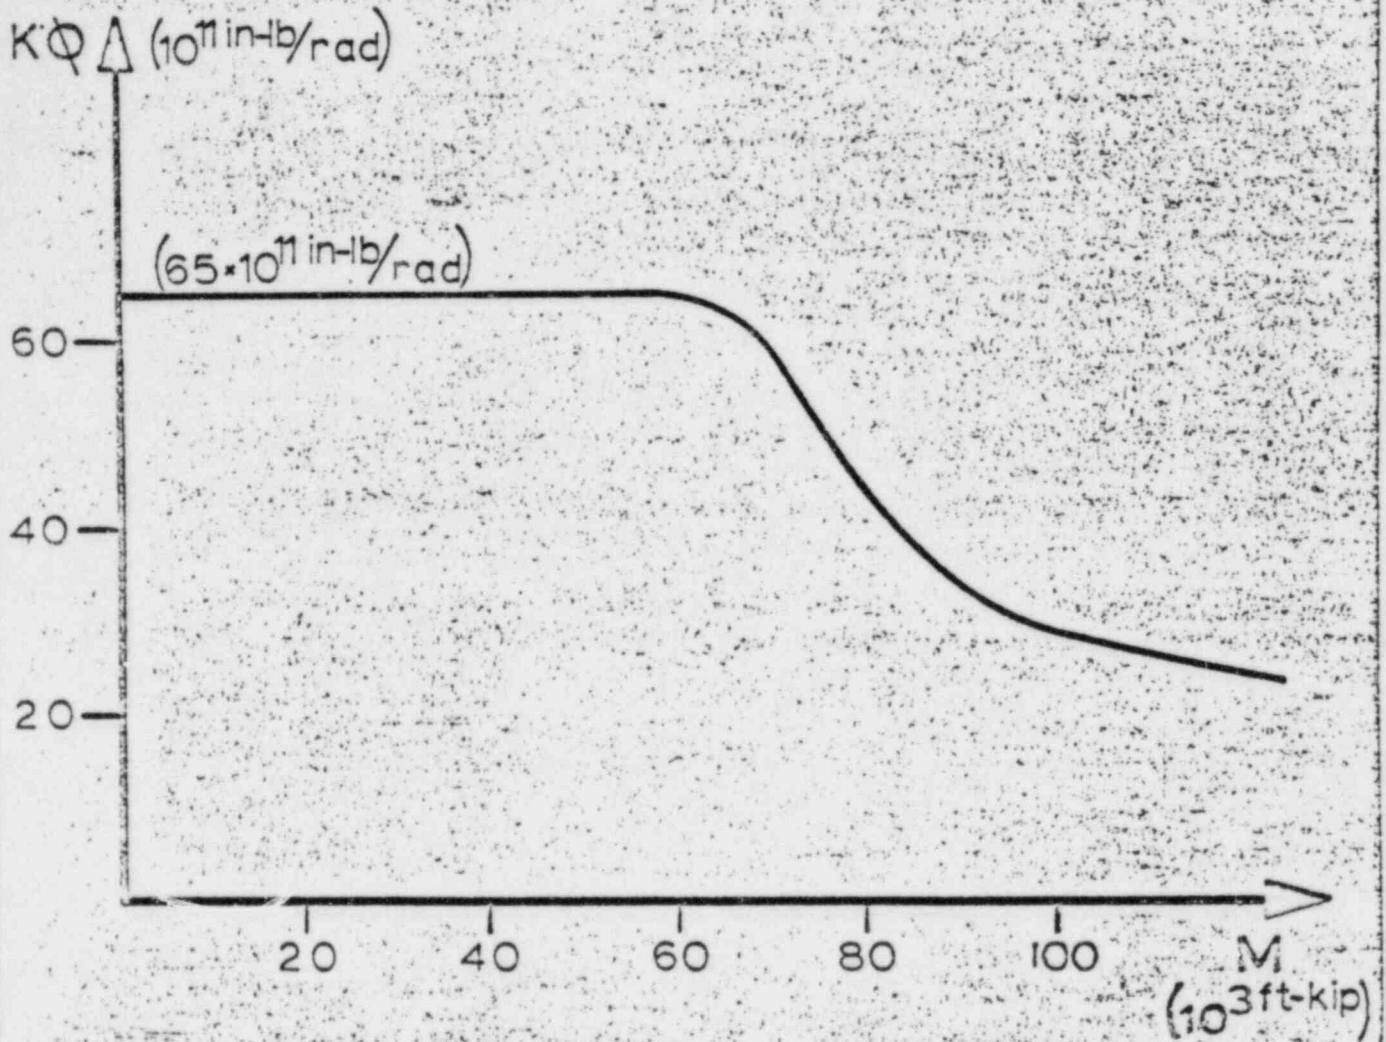
REACTOR VESSEL FOUNDATION
 SPRING RATE

PRELOAD — 55 ksi

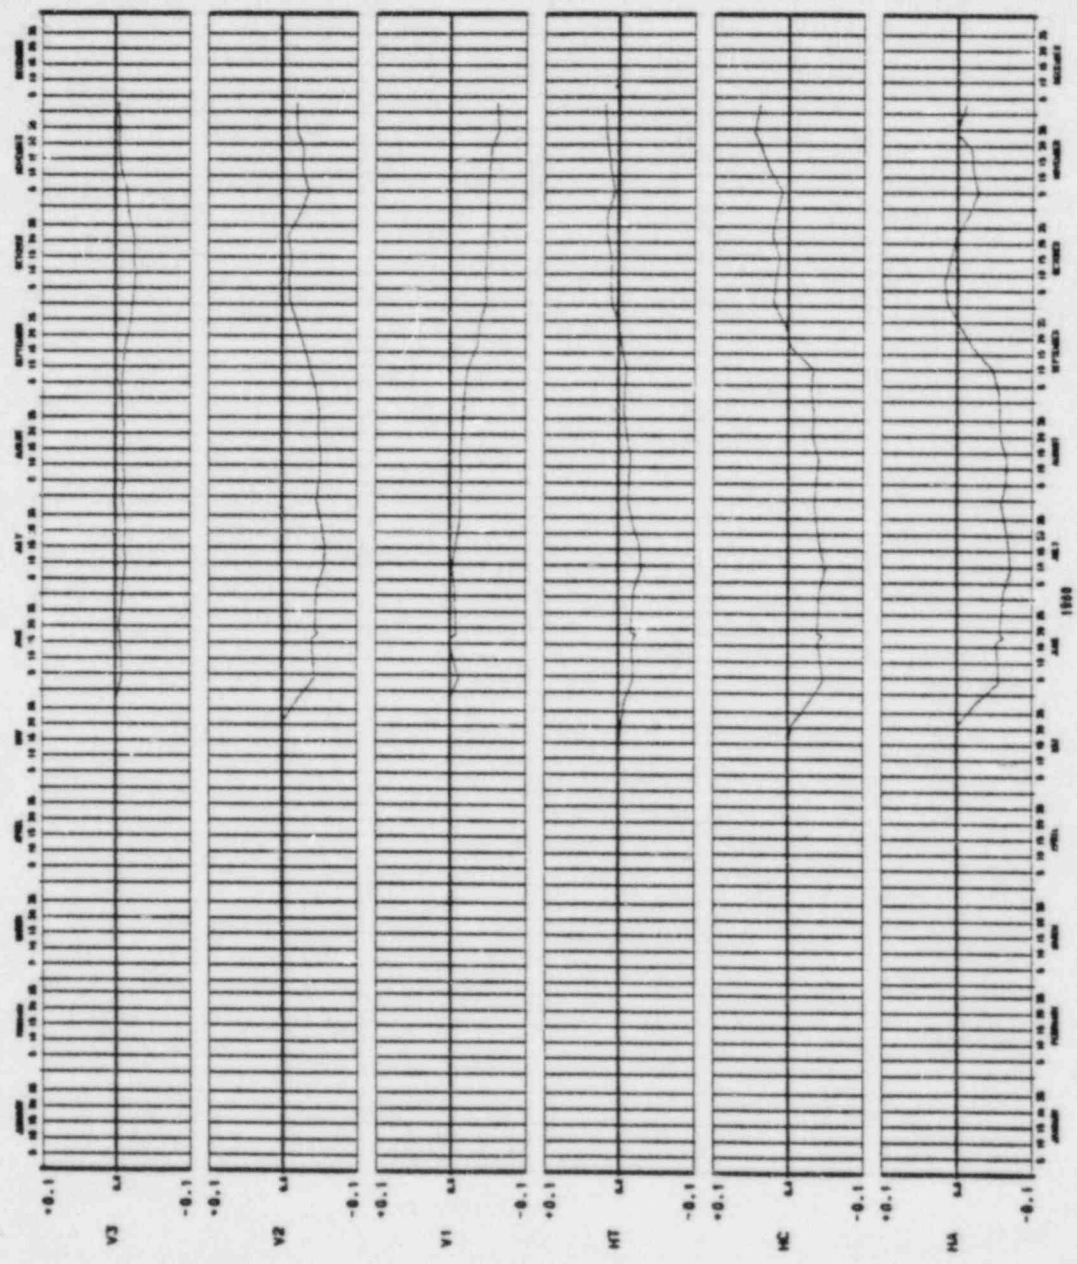
DATE	DESCRIPTION	BY
BECHTEL		
MIDLAND POWER PLANT		
FEEDWATER ISOLATION VALVE CHAMBER MOVEMENT MONITORING		
7220	7220	MID0052

- FIVP MONITORING PART OF OVERALL UNDERPINNING PROGRAM
- REJACK FIVP WHEN SETTLEMENT APPROACHES 3/8 INCH
- CRACK MAP FIVP BEFORE AND AFTER EACH MAJOR CONSTRUCTION ACTIVITY AFFECTING FIVP

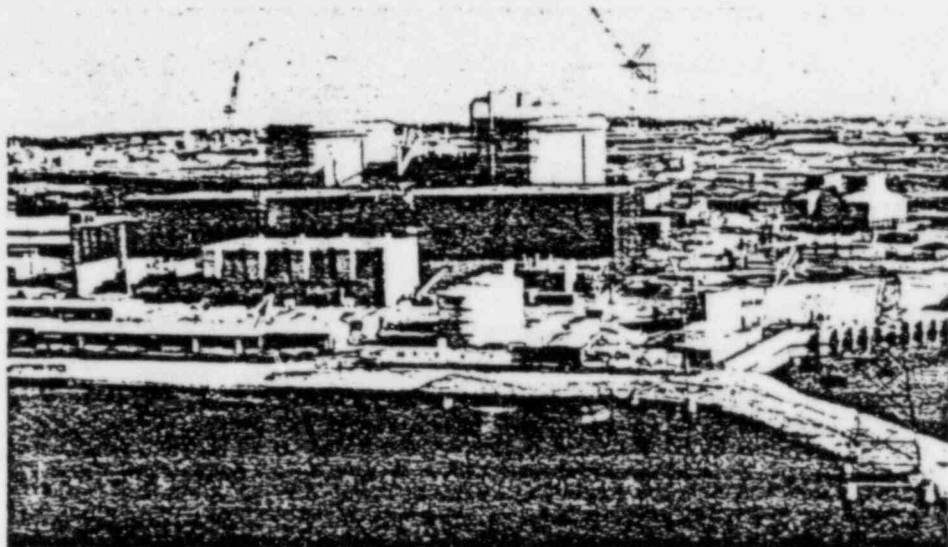
A-plant buildings sited on inadequately compacted fill include diesel generator building (bottom arrow), auxiliary building (top), and pump building (right).
