STRUCTURAL EVALUATION OF THE DIESEL GENERATOR BUILDING -
ASSESSMENT OF THE STRUCTURAL PERFORMANCE
CAPABILITY AND SERVICEABILITY AS POTENTIALLY AFFECTED
BY SETTLEMENT INDUCED CRACKING

TERA CORPORATION

TOPIC TITLE Civil/Structural Design Considerations, Foundations, Concrete/Structural Steel TOPIC NO. 111.5-2, 111.6-2, PAGE 1 OF 3
 ENGINEERING EVALUATION Structural Eval. of the Diesel Generator Bldg CONT. ID. NO. 3201-001-031 REV 0 DATE 12/30/83

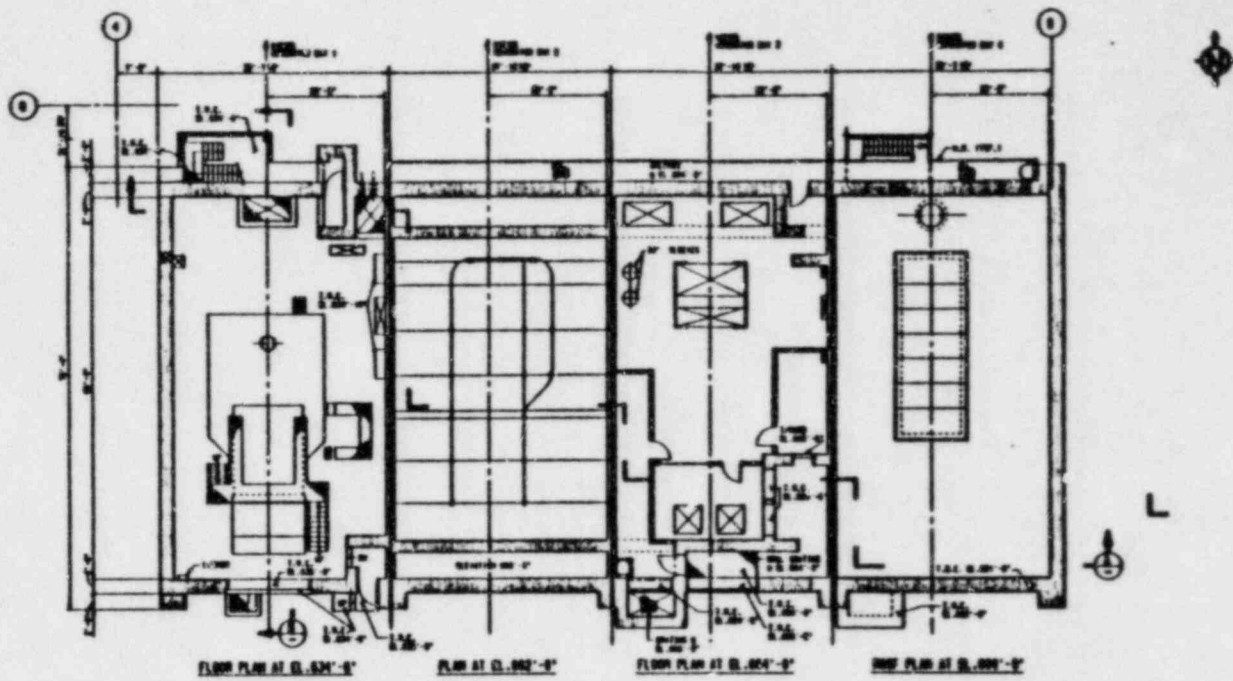
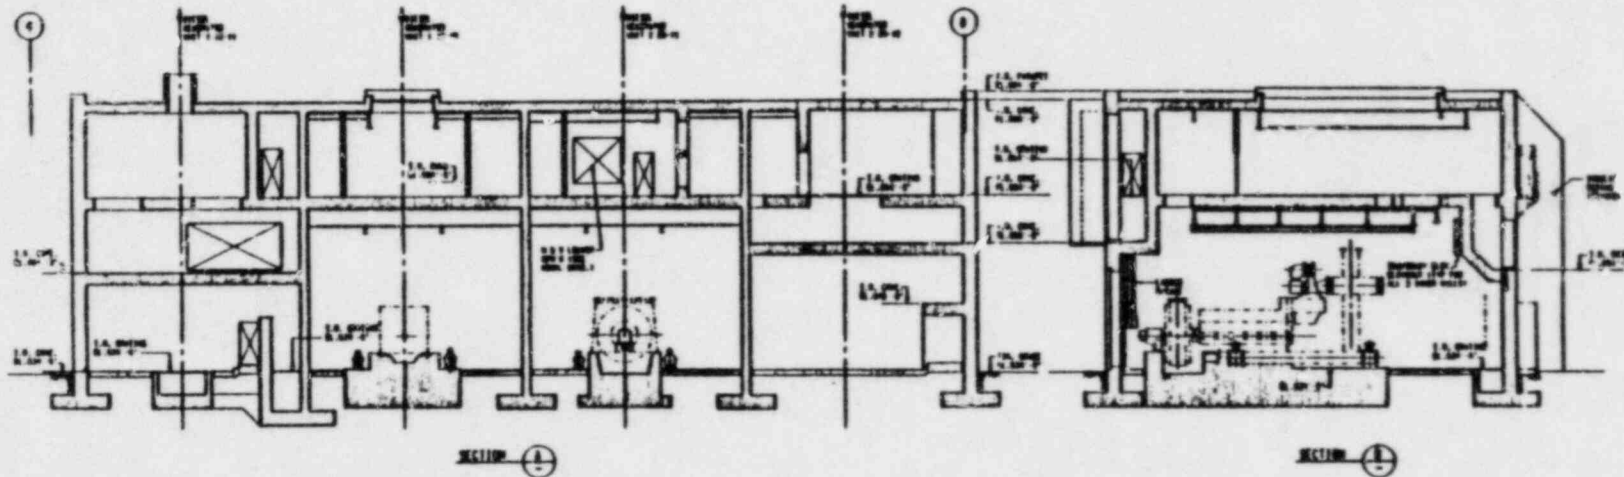
FIGURE 6-1
 DIESEL GENERATOR BUILDING
 PLAN VIEW AND SECTIONS

The diesel generator building (DGB) is a two story reinforced concrete box type building partitioned into four bays, each bay containing one diesel powered electric generator (see Figure 6-1). The purpose of the diesel generators is to supply standby electrical power to operate the Midland plant during power outages and to provide the necessary power to ensure safe shutdown of the plant in the event of a design basis event. Accordingly, the diesel generators and the DGB are classified as Seismic Category I, and as a result must maintain functionability during external events such as earthquakes and tornadoes.

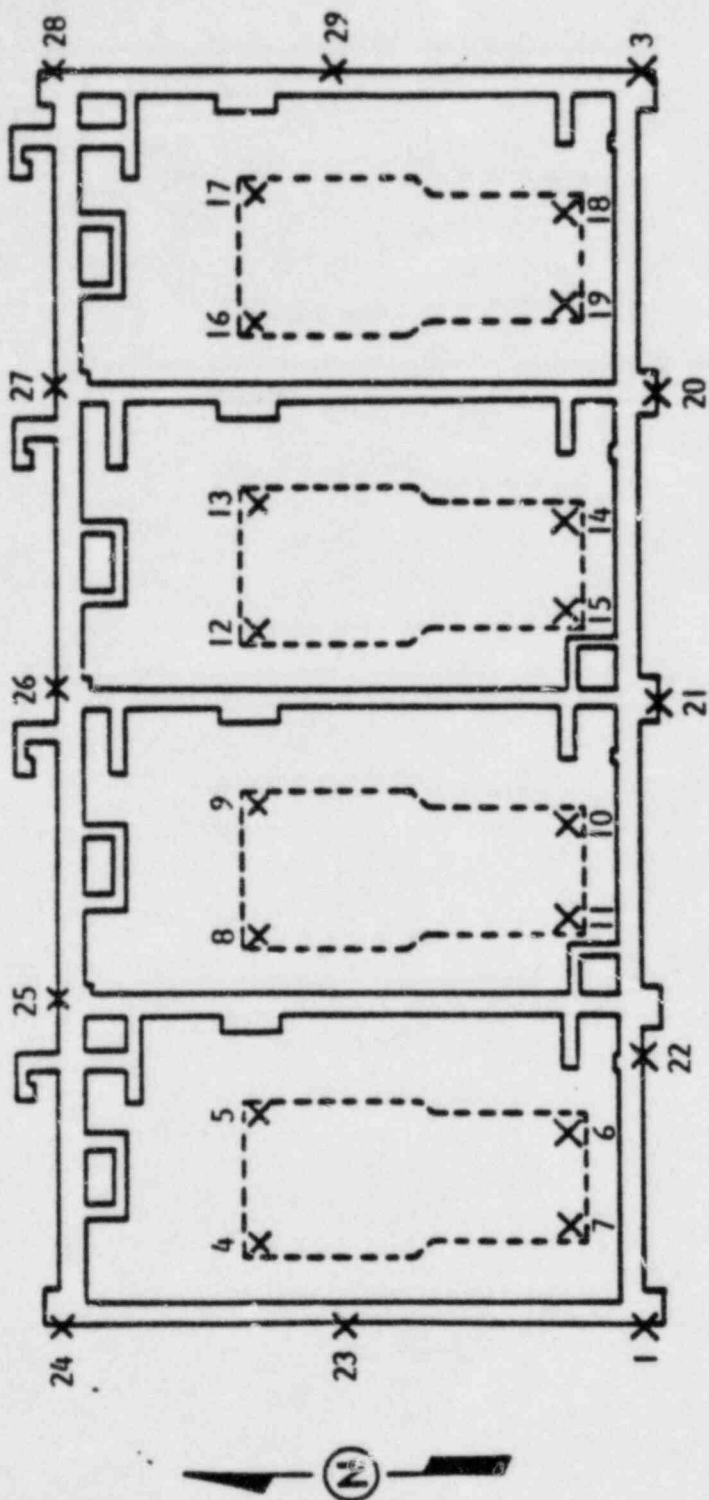
FIGURE 6-2
 DIESEL GENERATOR BUILDING
 SETTLEMENT MARKER LOCATIONS

The building settlements have been monitored at close intervals during the construction period and thereafter. Figure 6-2 presents the location of the settlement markers indicating where survey measurements are taken. The data spans over a period of 5 years with measurements taken approximately every other week. This large amount of data allows one to follow the settlement history through the stages of construction, duct bank isolation, surcharge period, dewatering, and up through the present. It also provides a means of assessing potential random and systematic errors in the measurements. The Midland project has concluded that significant errors exist in the measurements due to a variety of circumstances. A study of these data is presented in the following section.
