Environmental Qualification Test Report
of
Raychem Nuclear Cable Breakout and End Sealing Kits
for
Raychem Corporation
Menlo Park, California

In the matter of Alabama Power Company

REPORT NO. 58442-2
OUR JOB NO. NDO 58442
CONTRACT ---
YOUR P. O. NO. A01183

ENVIRONMENTAL QUALIFICATION TEST REPORT
OF
RAYCHEM NUCLEAR CABLE BREAKOUT AND END SEALING KITS
FOR
RAYCHEM CORPORATION
MENLO PARK, CALIFORNIA

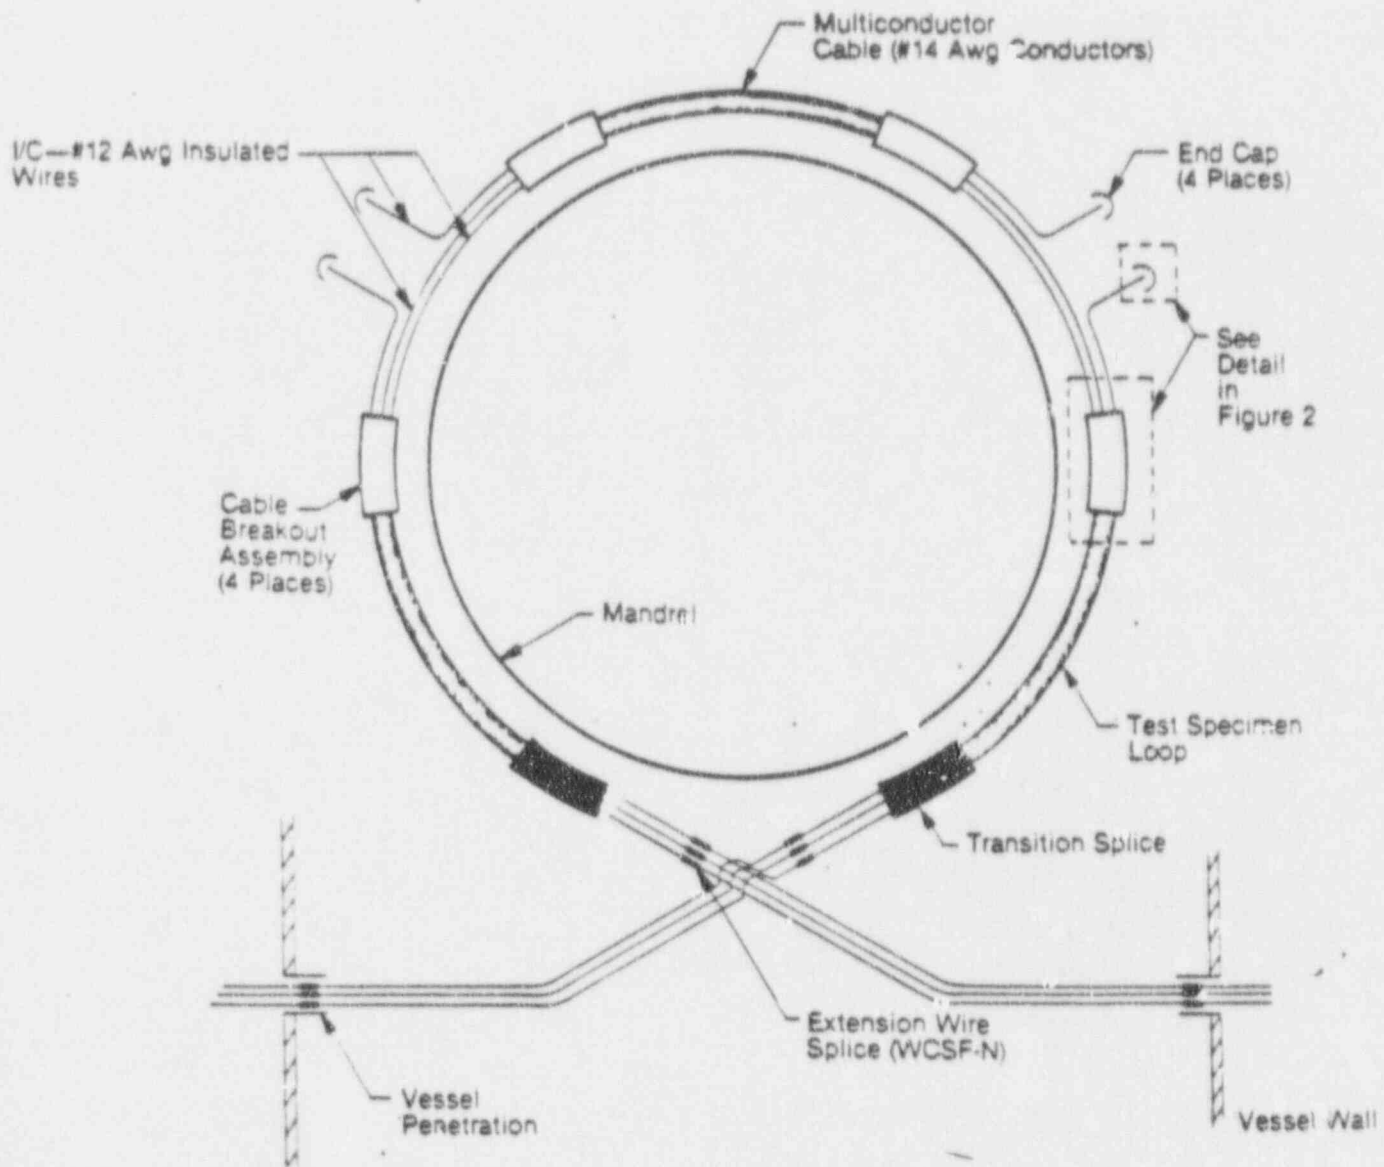
Figure 1 SAMPLE CONSTRUCTION

Each test specimen was comprised of four cable breakouts and four end caps forming a loop as shown in Figure 1. The cable breakouts were tested as part of a transition splice assembly

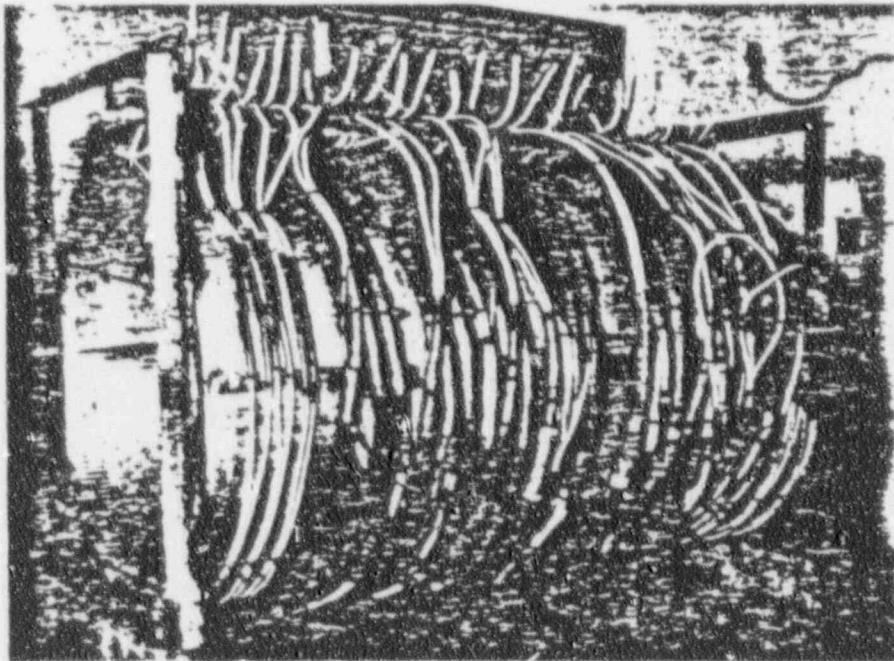
FIGURE 3. Mandrel and Samples

(Specimens 2-1 through 2-6 are located **005510**
in the center section of the mandrel.)

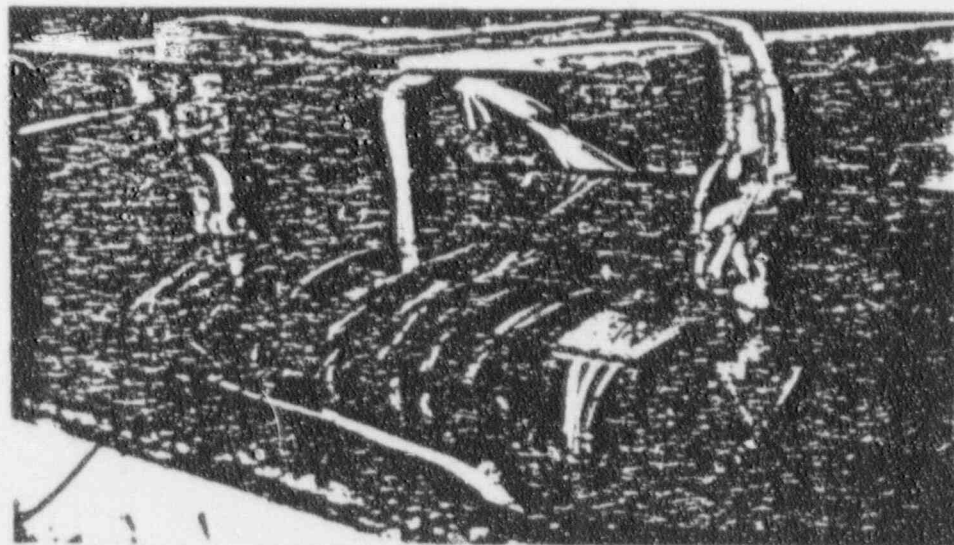
FIGURE 4. Mandrel and Samples Immersed in Water

All specimens again passed the 3.6kV a-c voltage withstand test for five minutes. The insulation resistance values are given in Table 1 on page 14.
