UNITED STATES
NUCLEAR REGULATORY COMMISSION
REGION III
799 ROOSEVELT ROAD
GLEN ELLYN, ILLINOIS 60137

Reports No. 50-329/82-07(DETP); 50-330/82-07(DETP)

Docket Nos. 50-329; 50-330

Midland Plant Units 1 and 2
Attachment 3 to
Report on Cable Installation

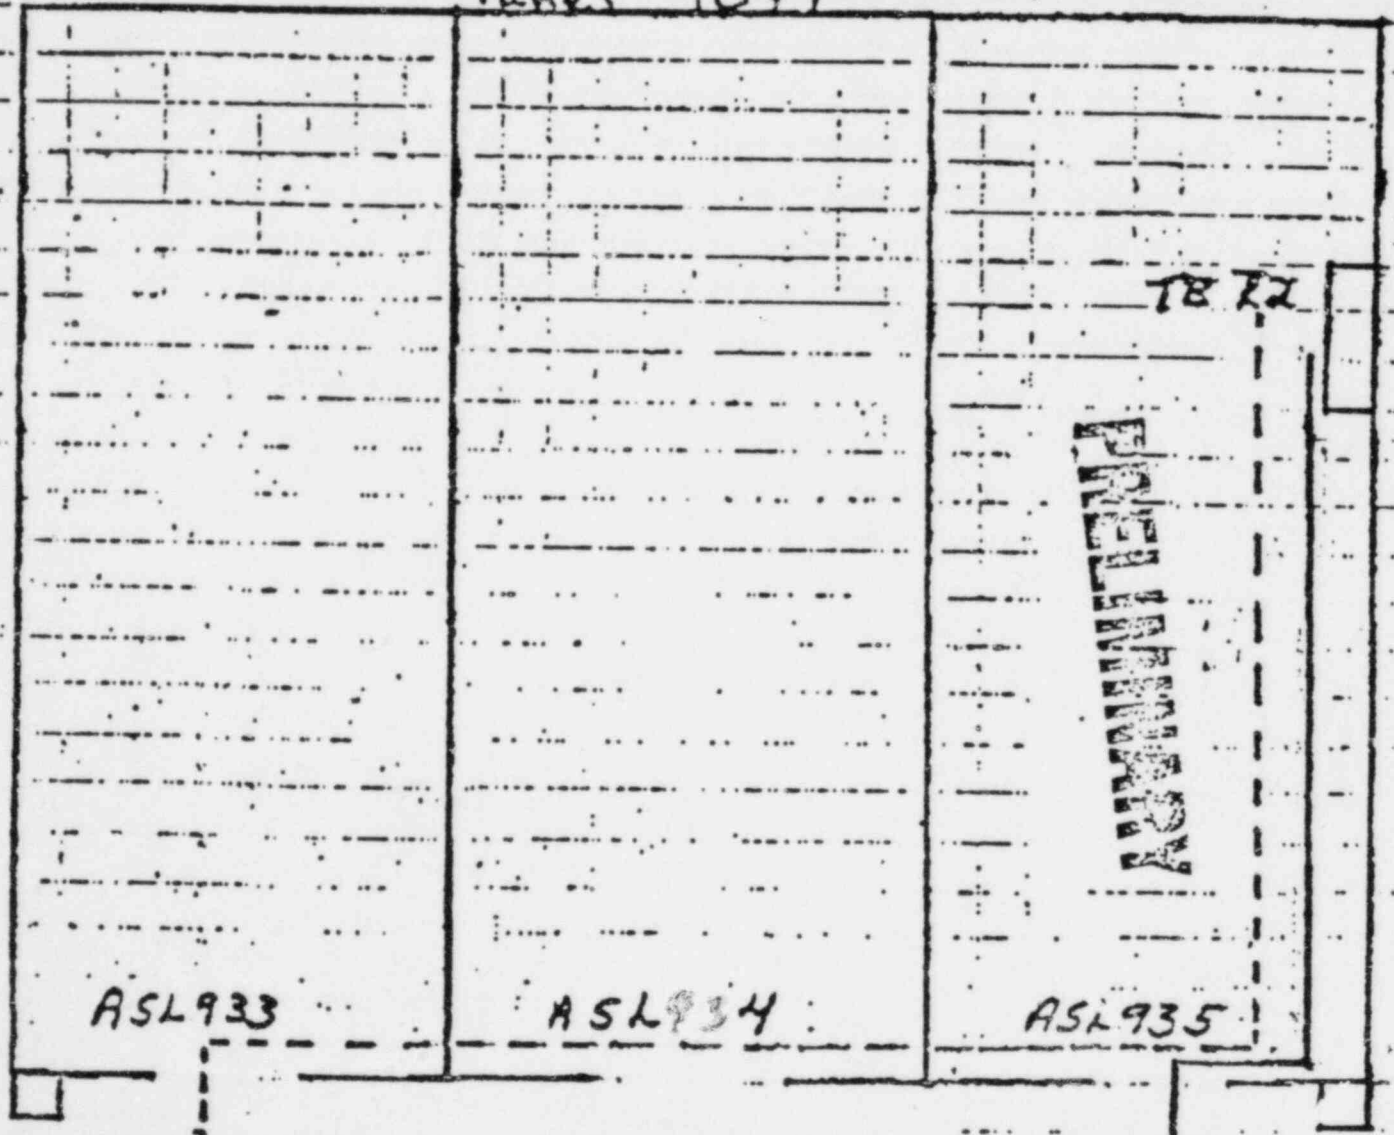
Panel 1C44

Is Routed by field
Should be Routed per E-37

Cable was routed to the wrong compartment of the control panel. Field discovered E37 error then pulled and terminated cable at the correct compartment. E37 did not reflect as-built condition.

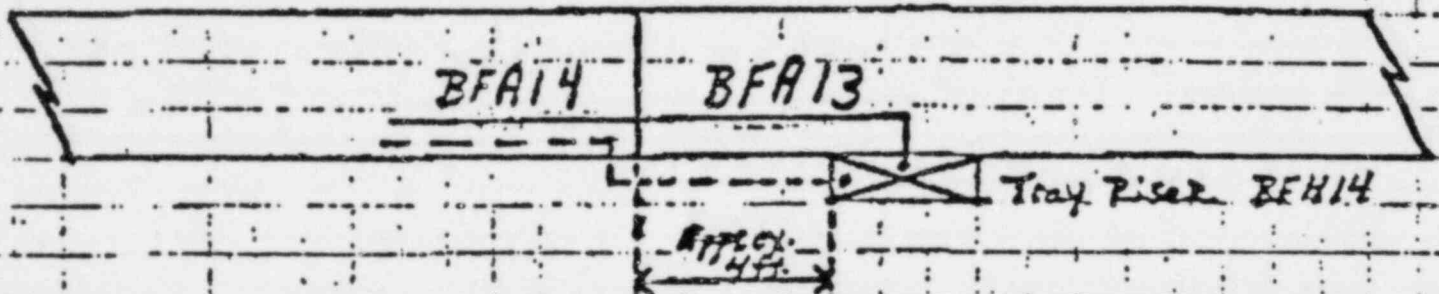
Code # A-2
Design

Cable is Routed-by Field
Cable should be Routed-per E-37

Engineering designed the cable to be airlined between E37 designated vias. The criteria, when in a case like this a Class 1E cable leaves the confines of a raceway, the subject cable will be visually inspected for possible separation violation. This inspection will discover this problem.

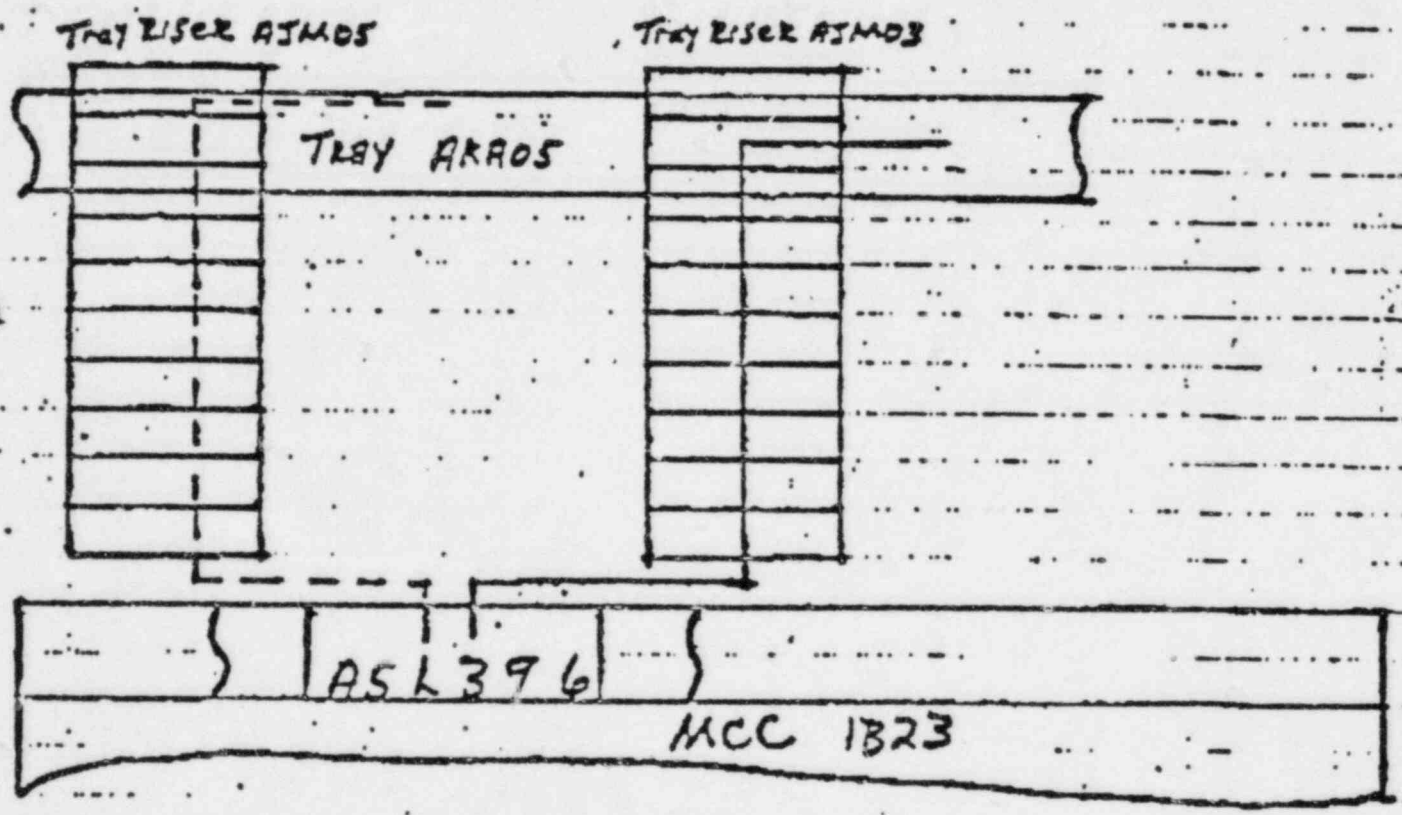
Cable # 1AB2327 A
Code # D-1
Design

Cable is Routed - by field

Cable should be - Per E-37

Cable was not installed as routed in E37 and a voltage violation was created when a power cable was run in an instrumentation tray.

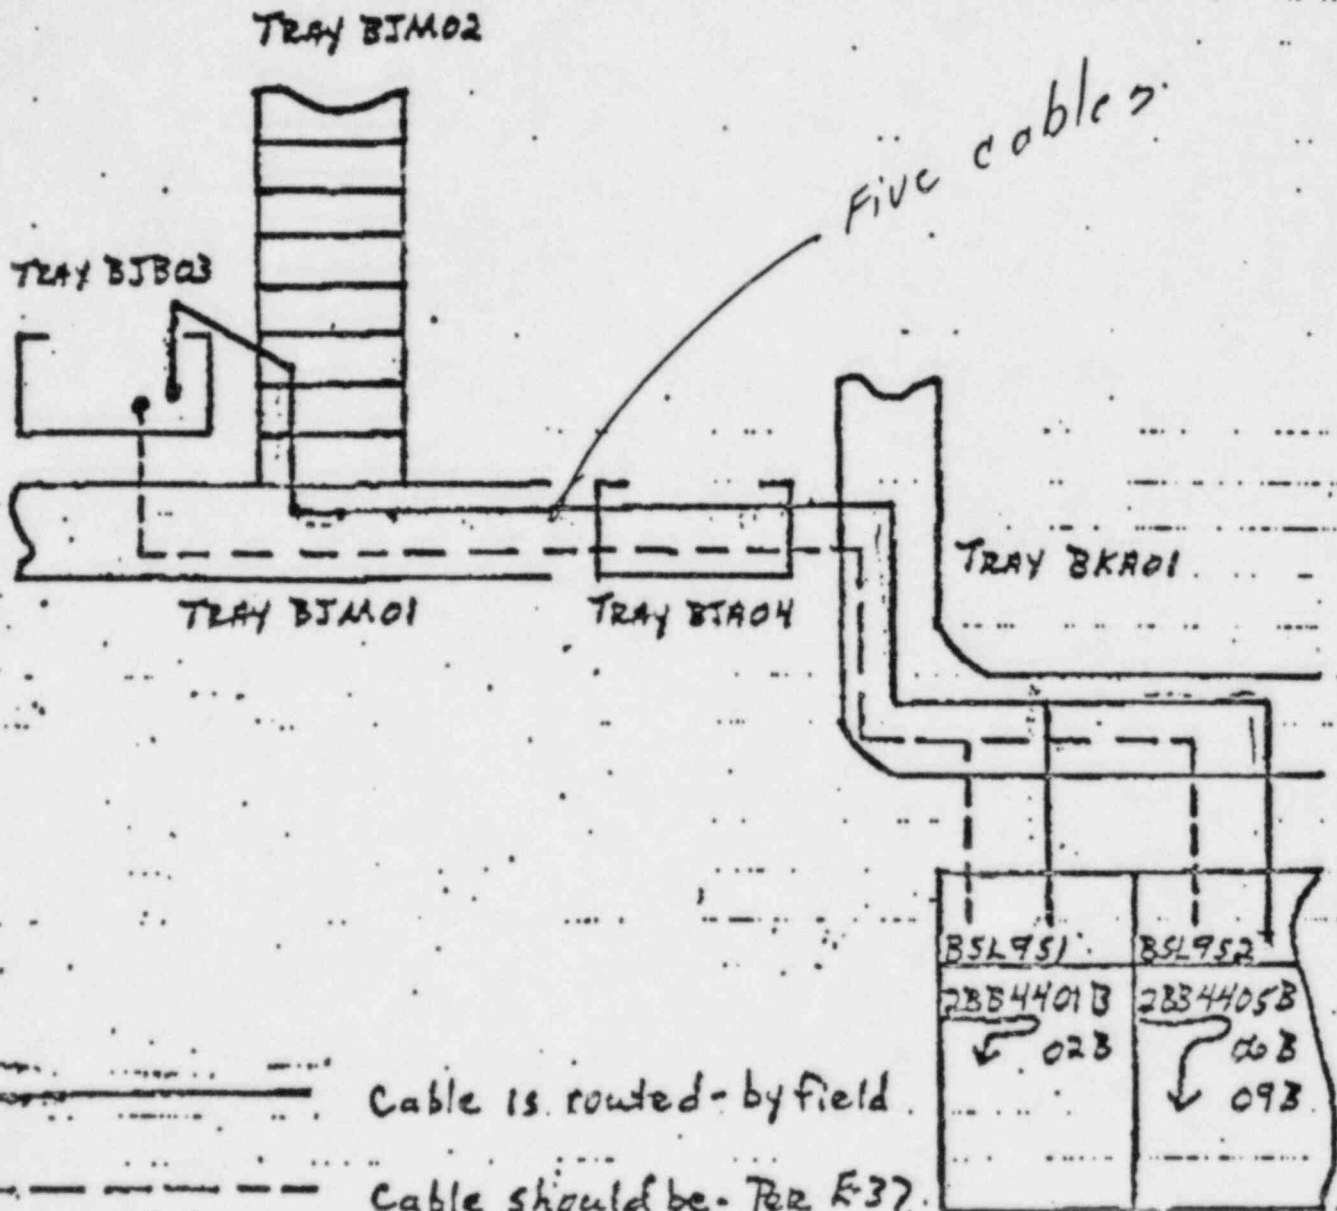
Cable is routed - by field

Cable should be - Per E-37

Voltage violation - Control cables used instrumentation raceway.

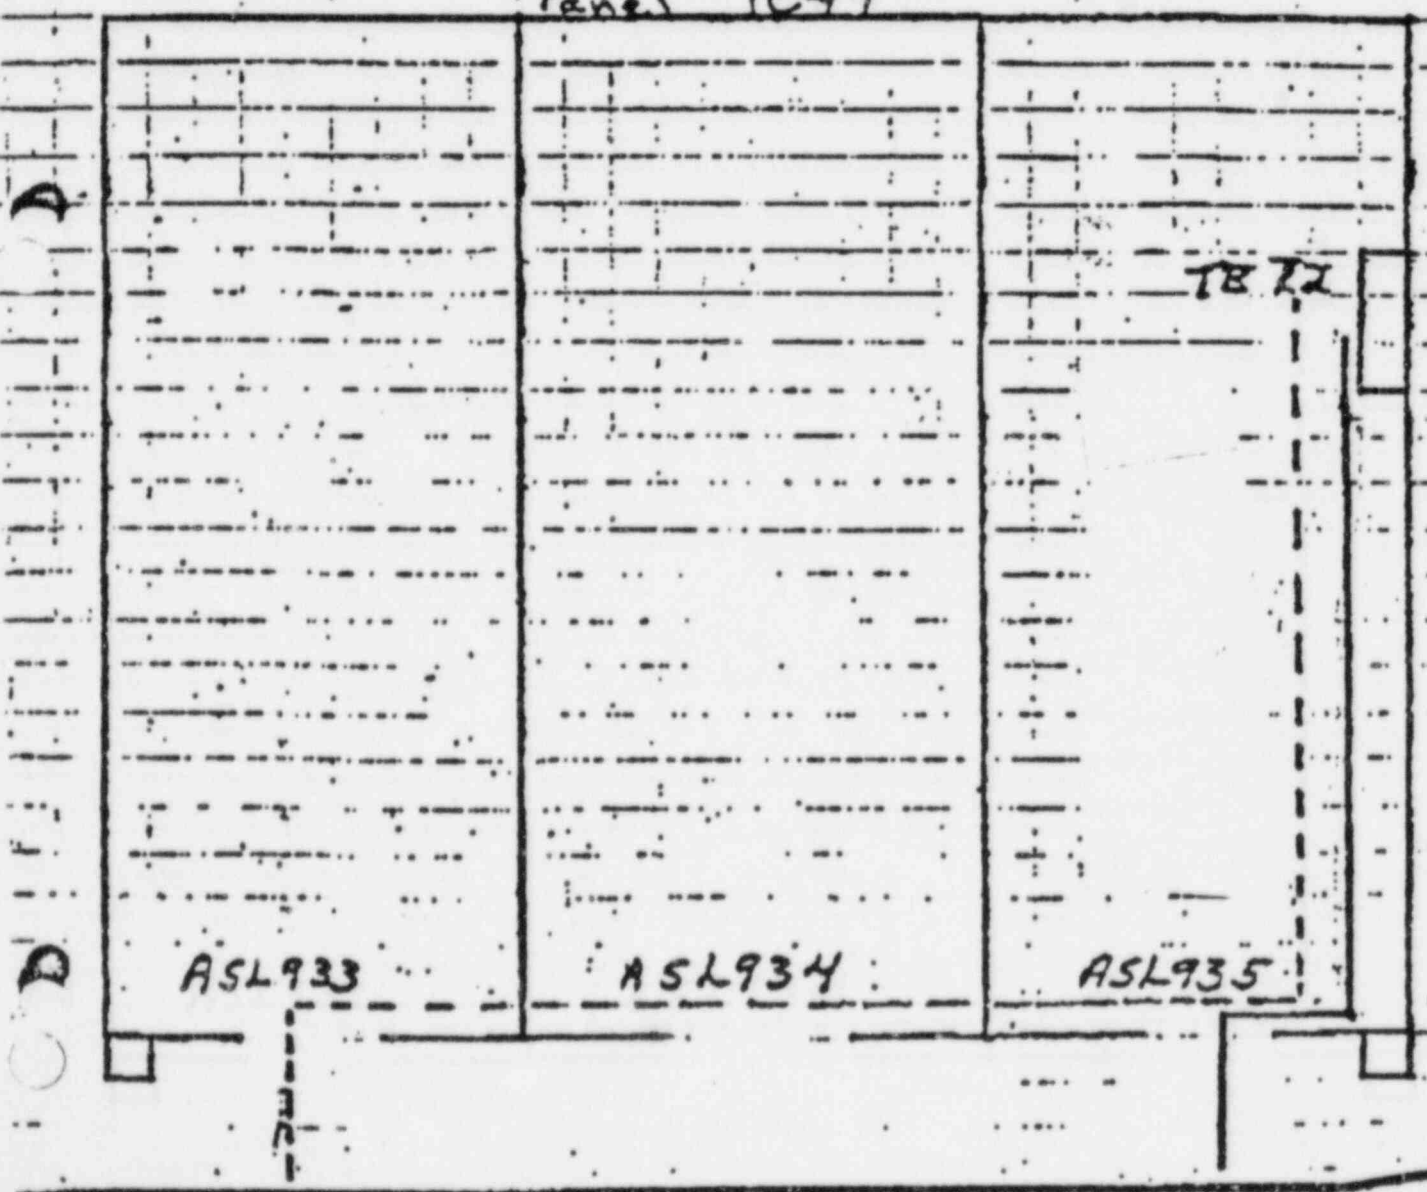
SK-8

Is Routed-by field
Should be Routed-per E-37

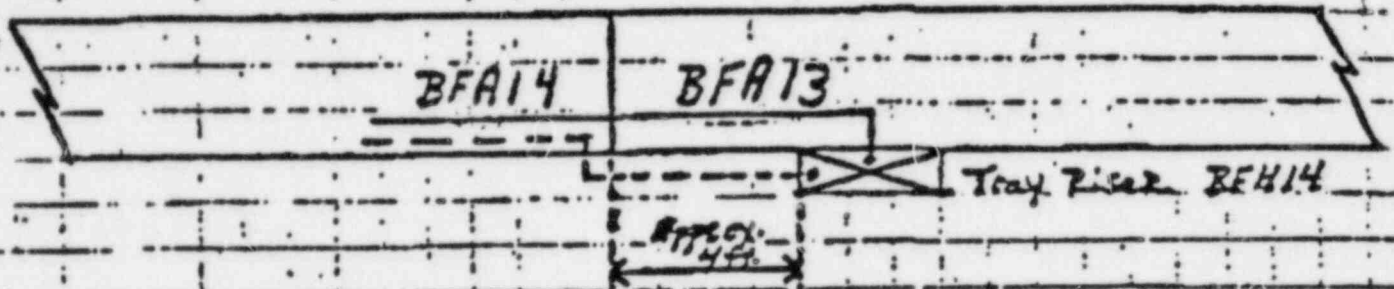
SK-9

Cable is Routed-by Field
Cable should be Routed-per E-37

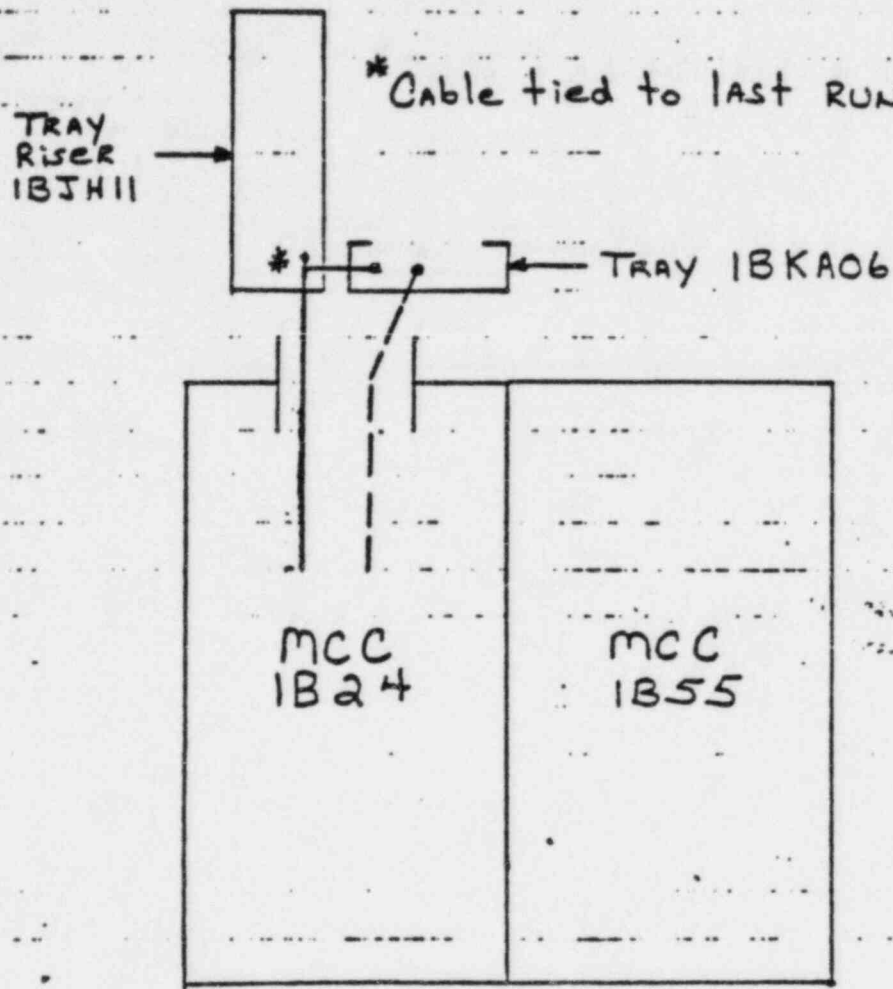
SK#15
Midland Plant Units 1 and 2
Attachment³ to
Report on Cable Installation

Cable # IBB2444 Q
Code # C-1
CONSTRUCTION

————— Actual cable route in field

- - - - - Cable route per E-37

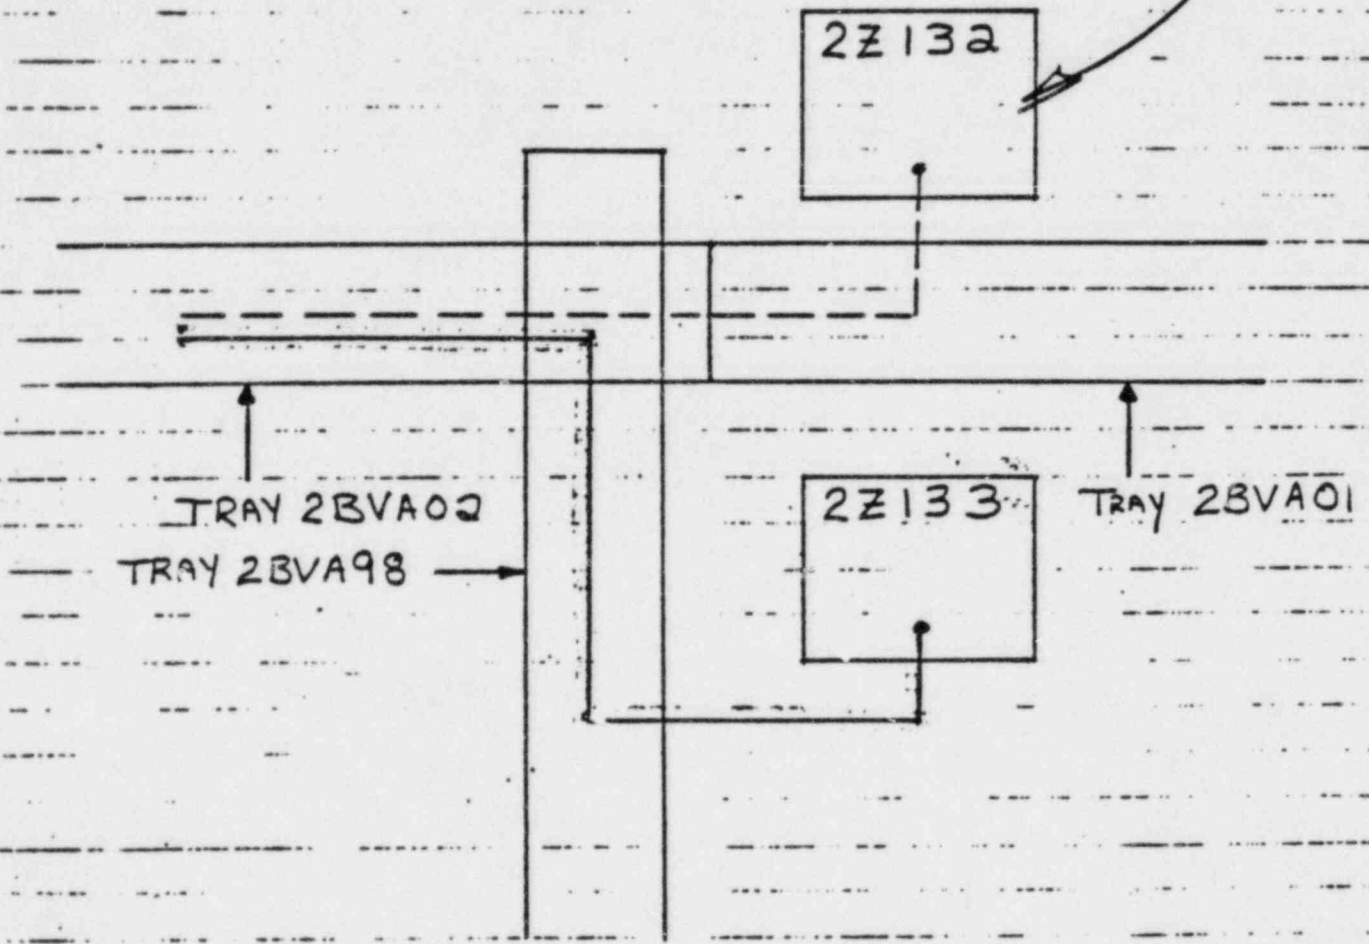
Cable # 2BI067 A
Code # D-1
Construction

----- Cable route per E-37

————— Actual Route of cable in field

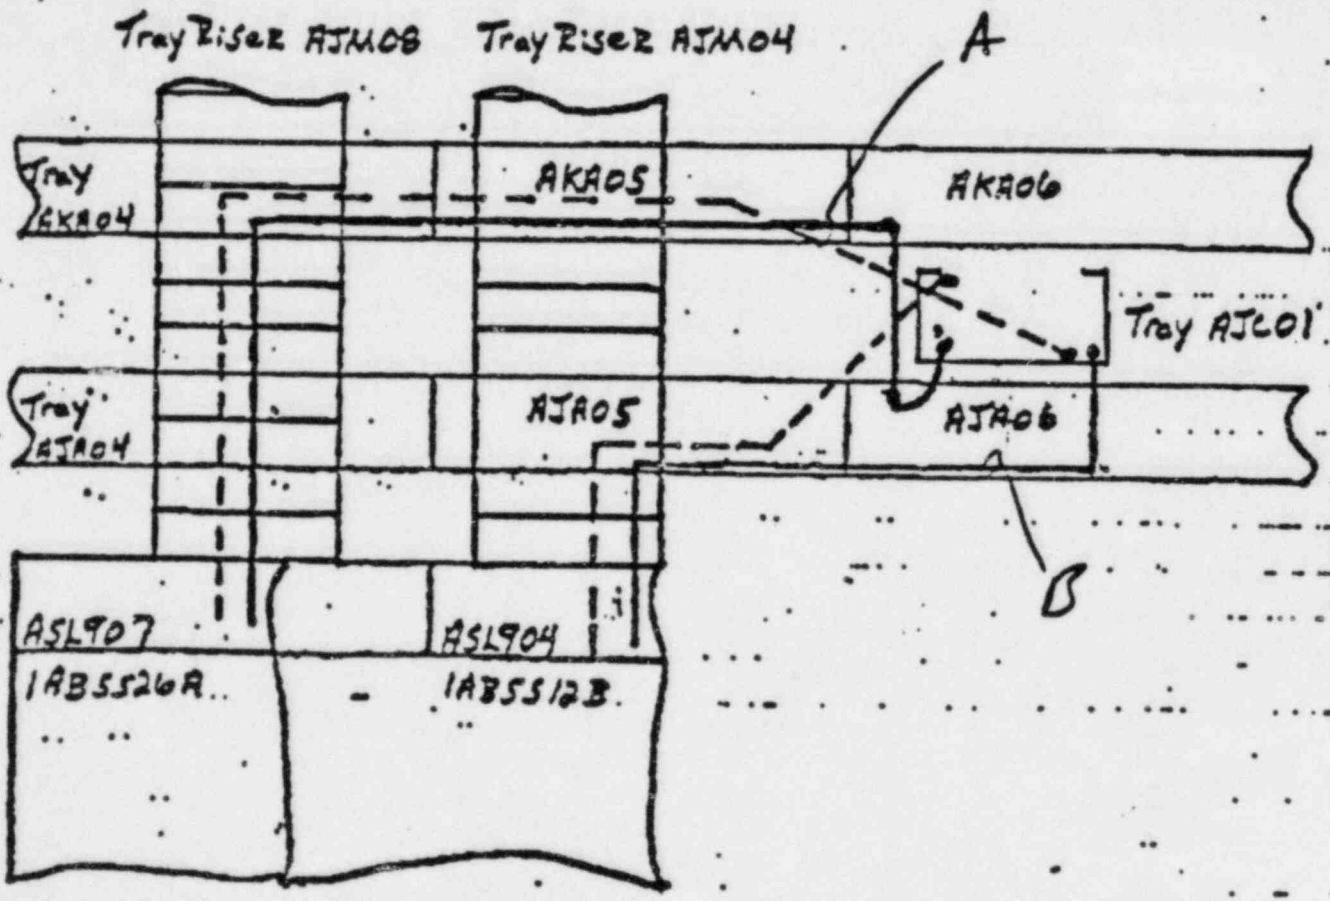
SK 20
Midland Plant Units 1 and 2
Attachment 3 to
Report on Cable Installation

Cable - 1AB5526 A and 1AB5512B
Code # D-1
Construction

———— Cable is routed - by field
----- Cable should be - Per E-37

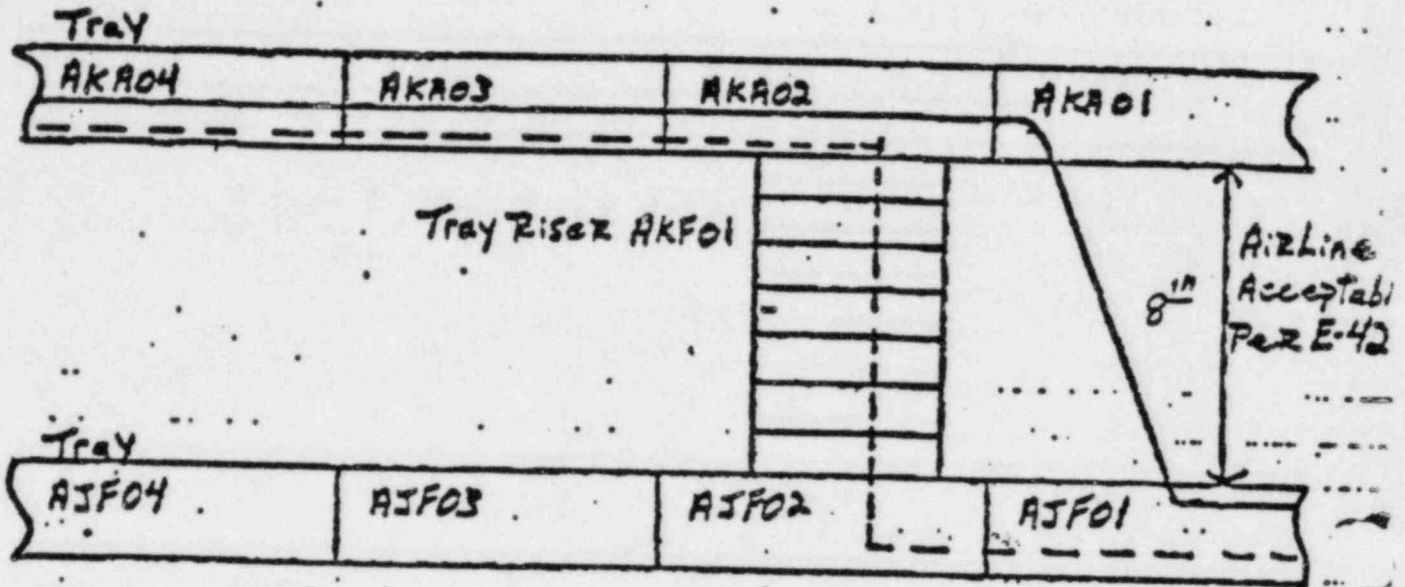
Code # D-1
Construction

———— Cable is Routed - by field

- - - - - Cable should be - Per E-37

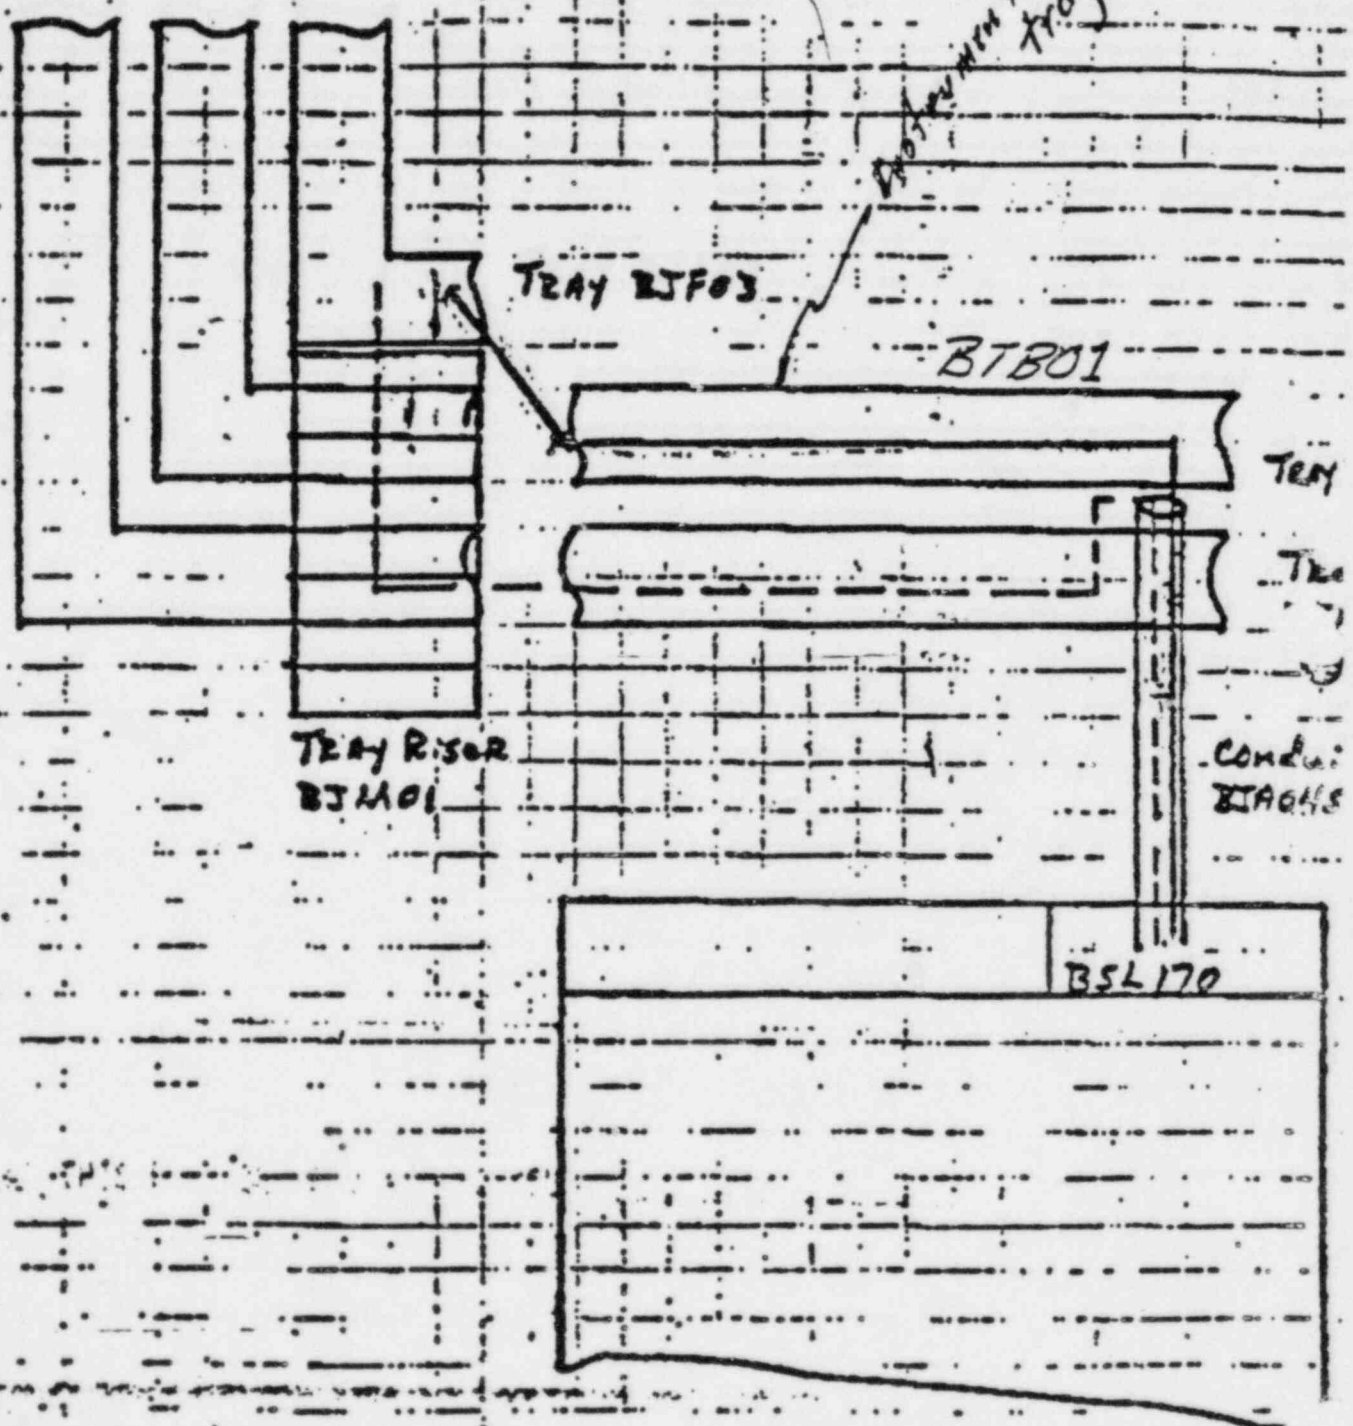
Cables 1BQ403 D & E
Code = D-1
Construction

Cable is routed - by field

Cable should be - per E-37

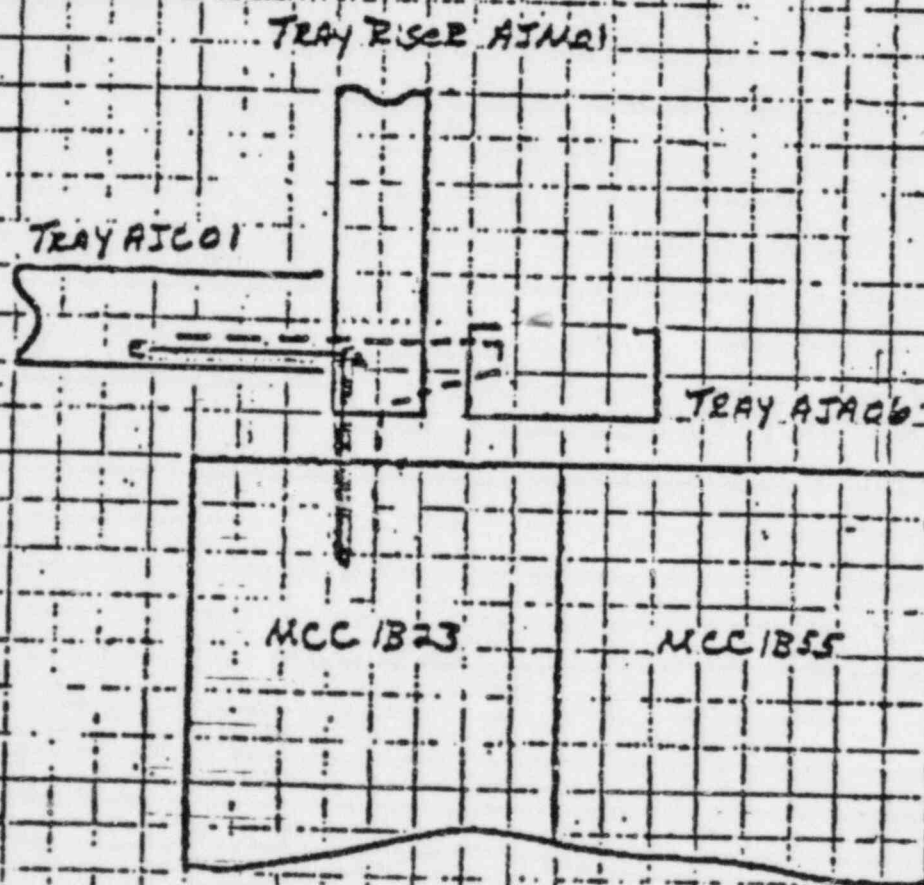
Cable # 1AB2341B
Code # D-1
Design

Cable is Routed - by field

Cable should be - Per E-37
