SDW Public Meeting
Jan 13, 1984

MIDLAND ENERGY CENTER GWO 7020
AUXILIARY BUILDING CRACK EVALUATIONS
File: 0485.16 UFI: 42*05*22*04 Serial: CSC-7074

AUXILIARY BUILDING
CRACK MAPPING EVALUATIONS
FOR
GRILLAGE 8 INITIAL JACKING & REJACKING

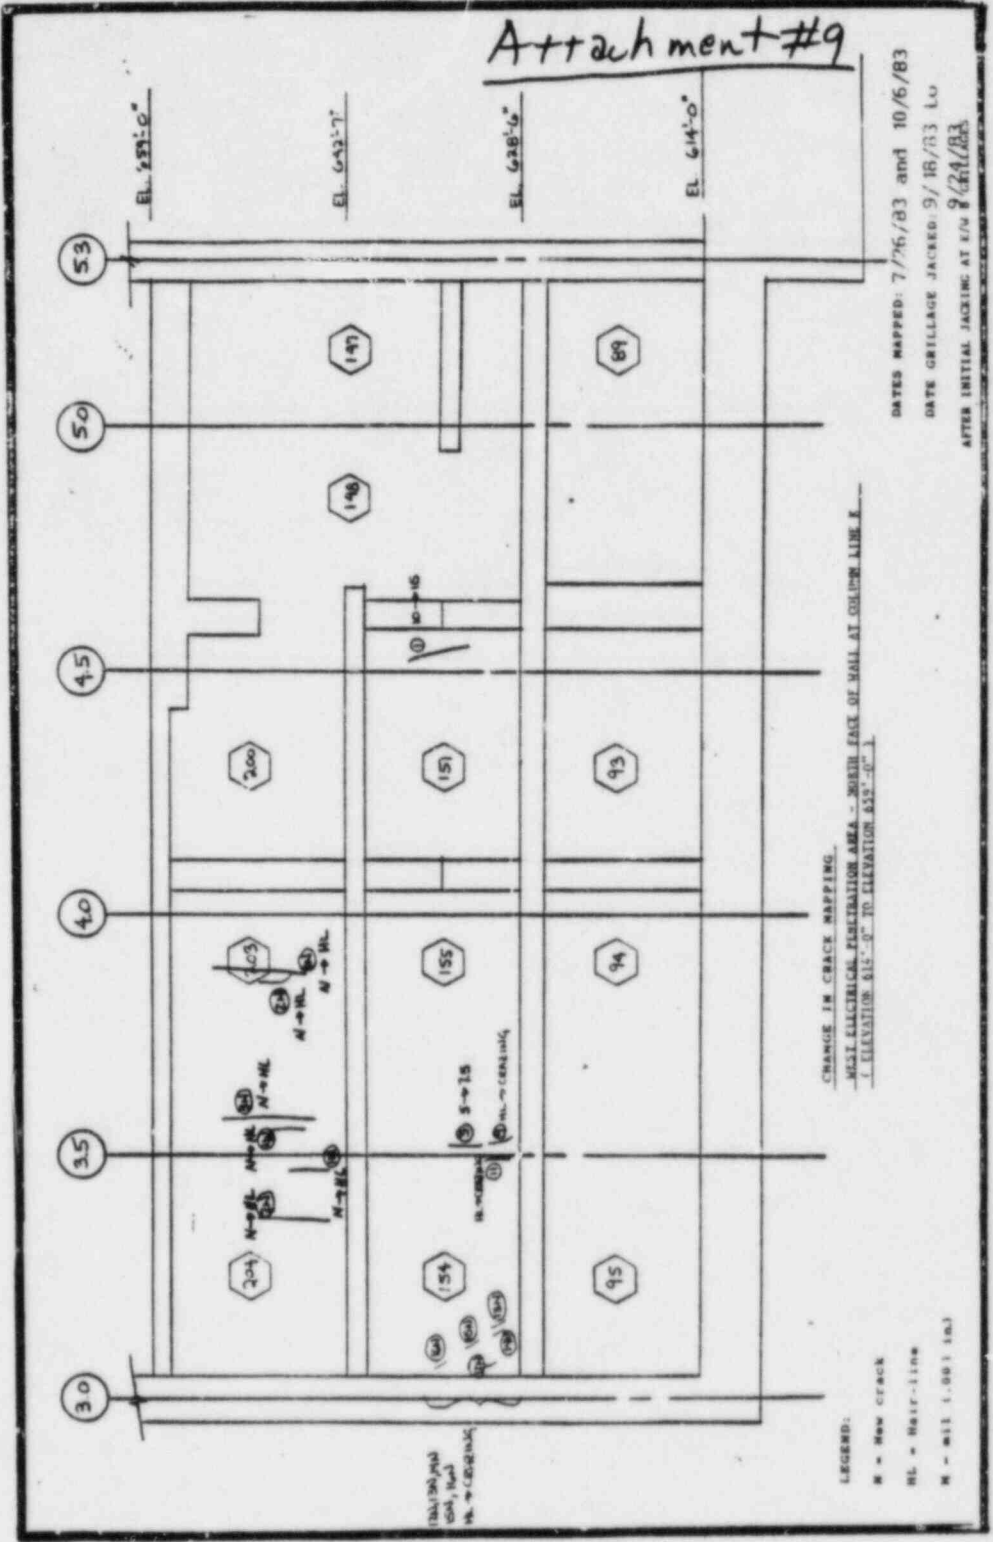
Attachment #9

DATES MAPPED: 7/76/83 and 10/6/83
 DATE CRACKS JACKED: 9/18/83 LU
 AFTER INITIAL JACKING AT 1/4 9/24/83

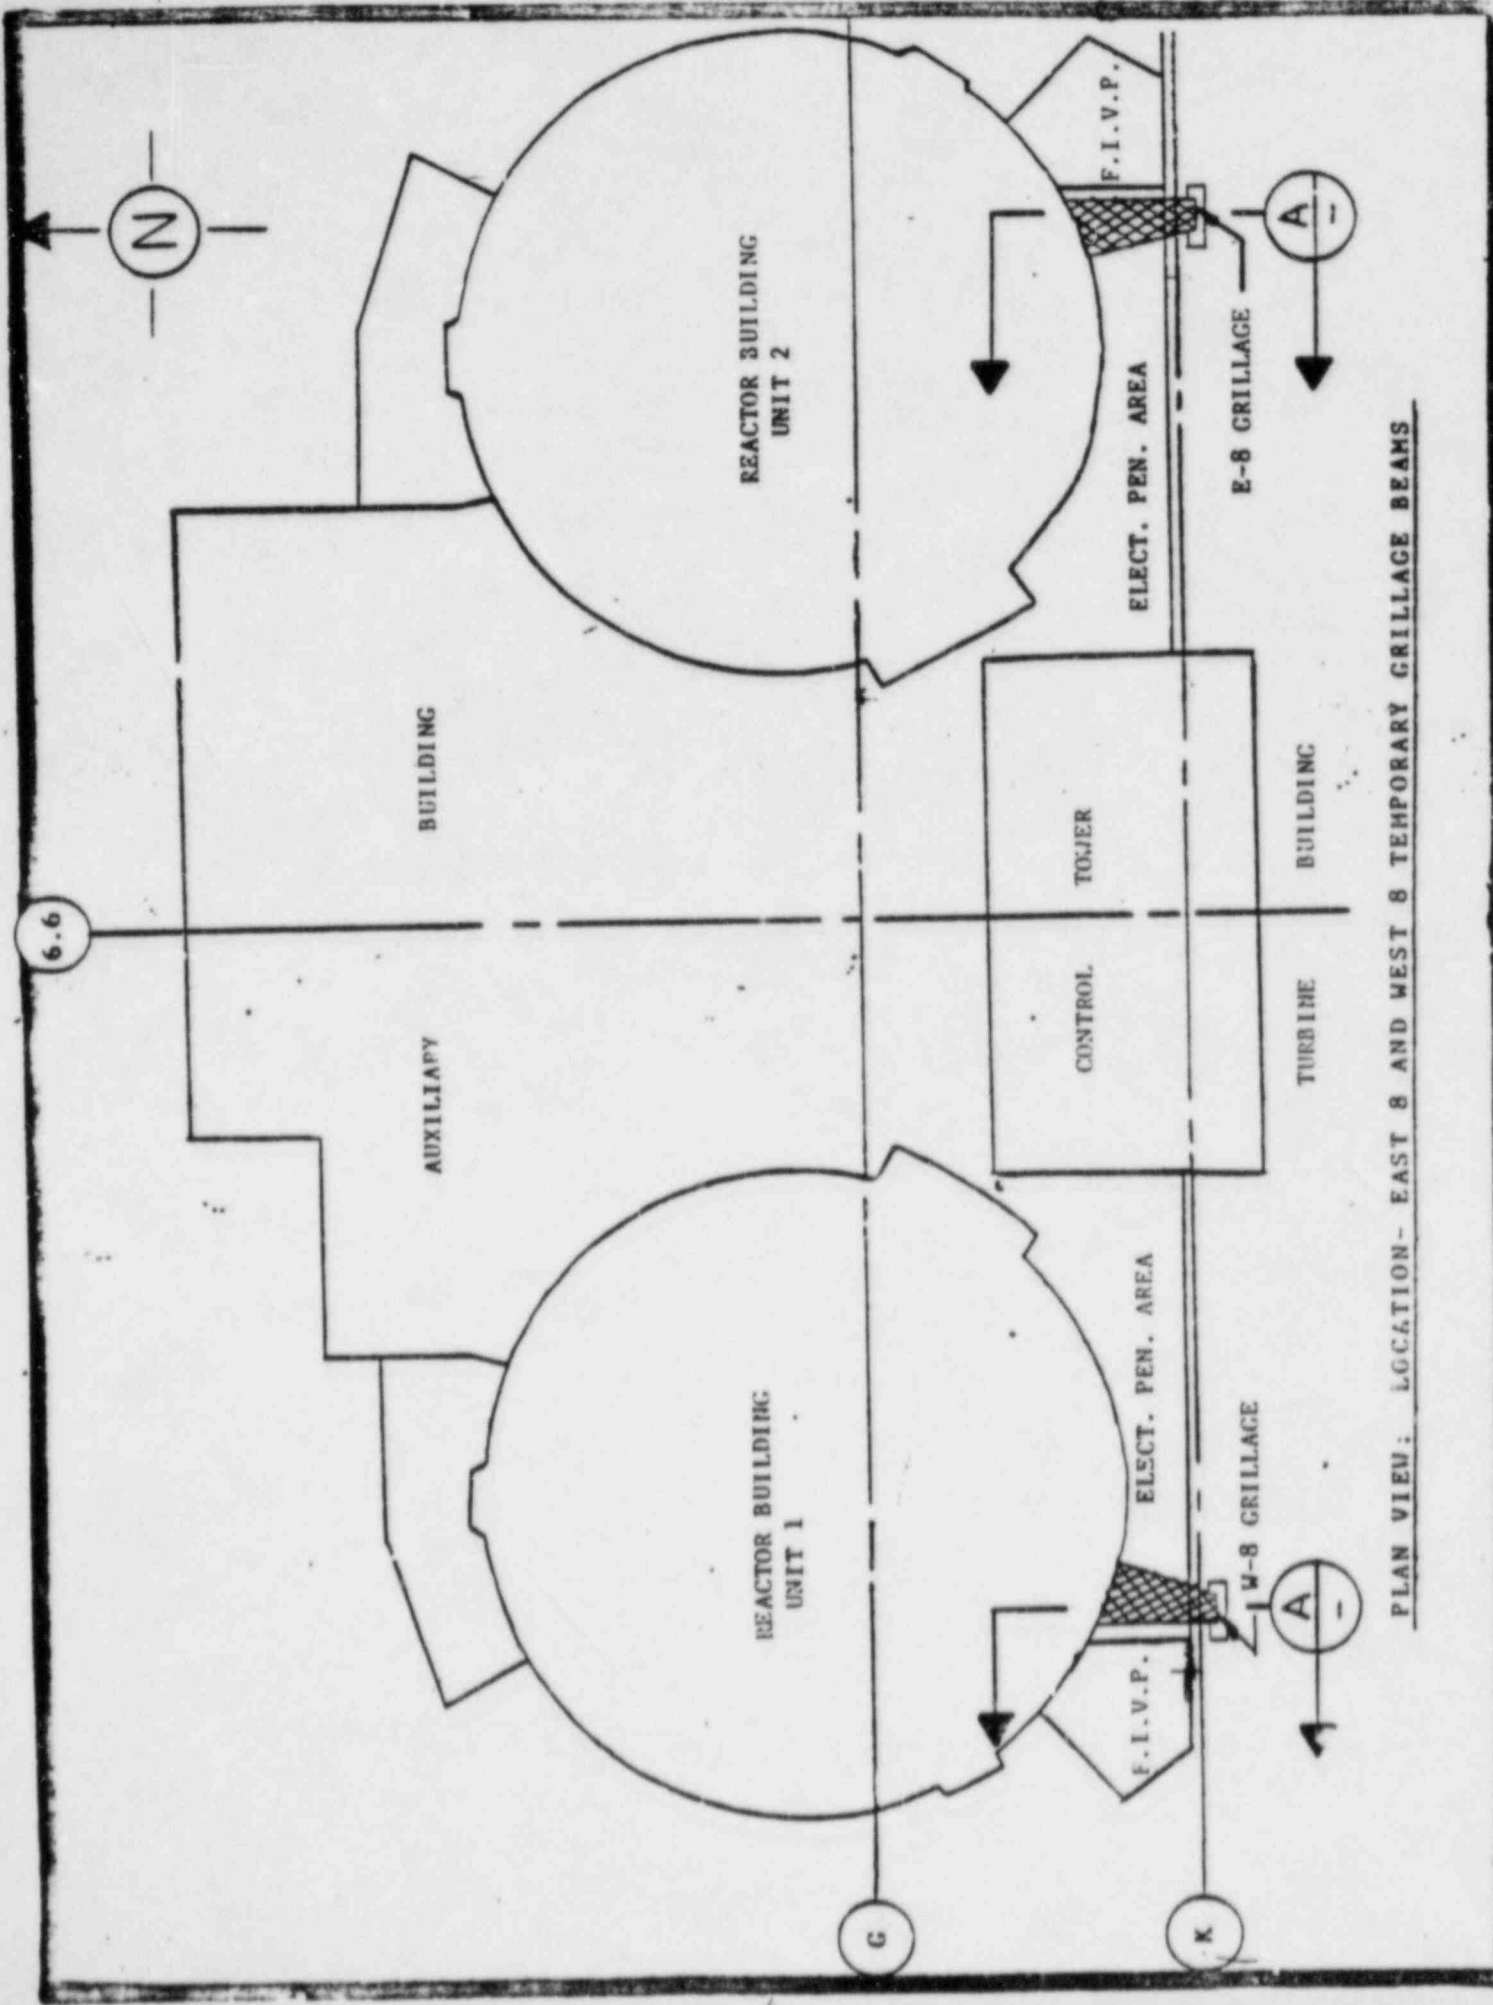
PLAN VIEW: LOCATION - EAST 8 AND WEST 8 TEMPORARY GRILLAGE BEAMS

Width of cracks which had been observed to have changed during initial jacking, were measured after re-jacking. Evaluation of this data, indicates that all measured crack width changes are within the estimated tolerance of .005 inches. None of these cracks reached alert level.

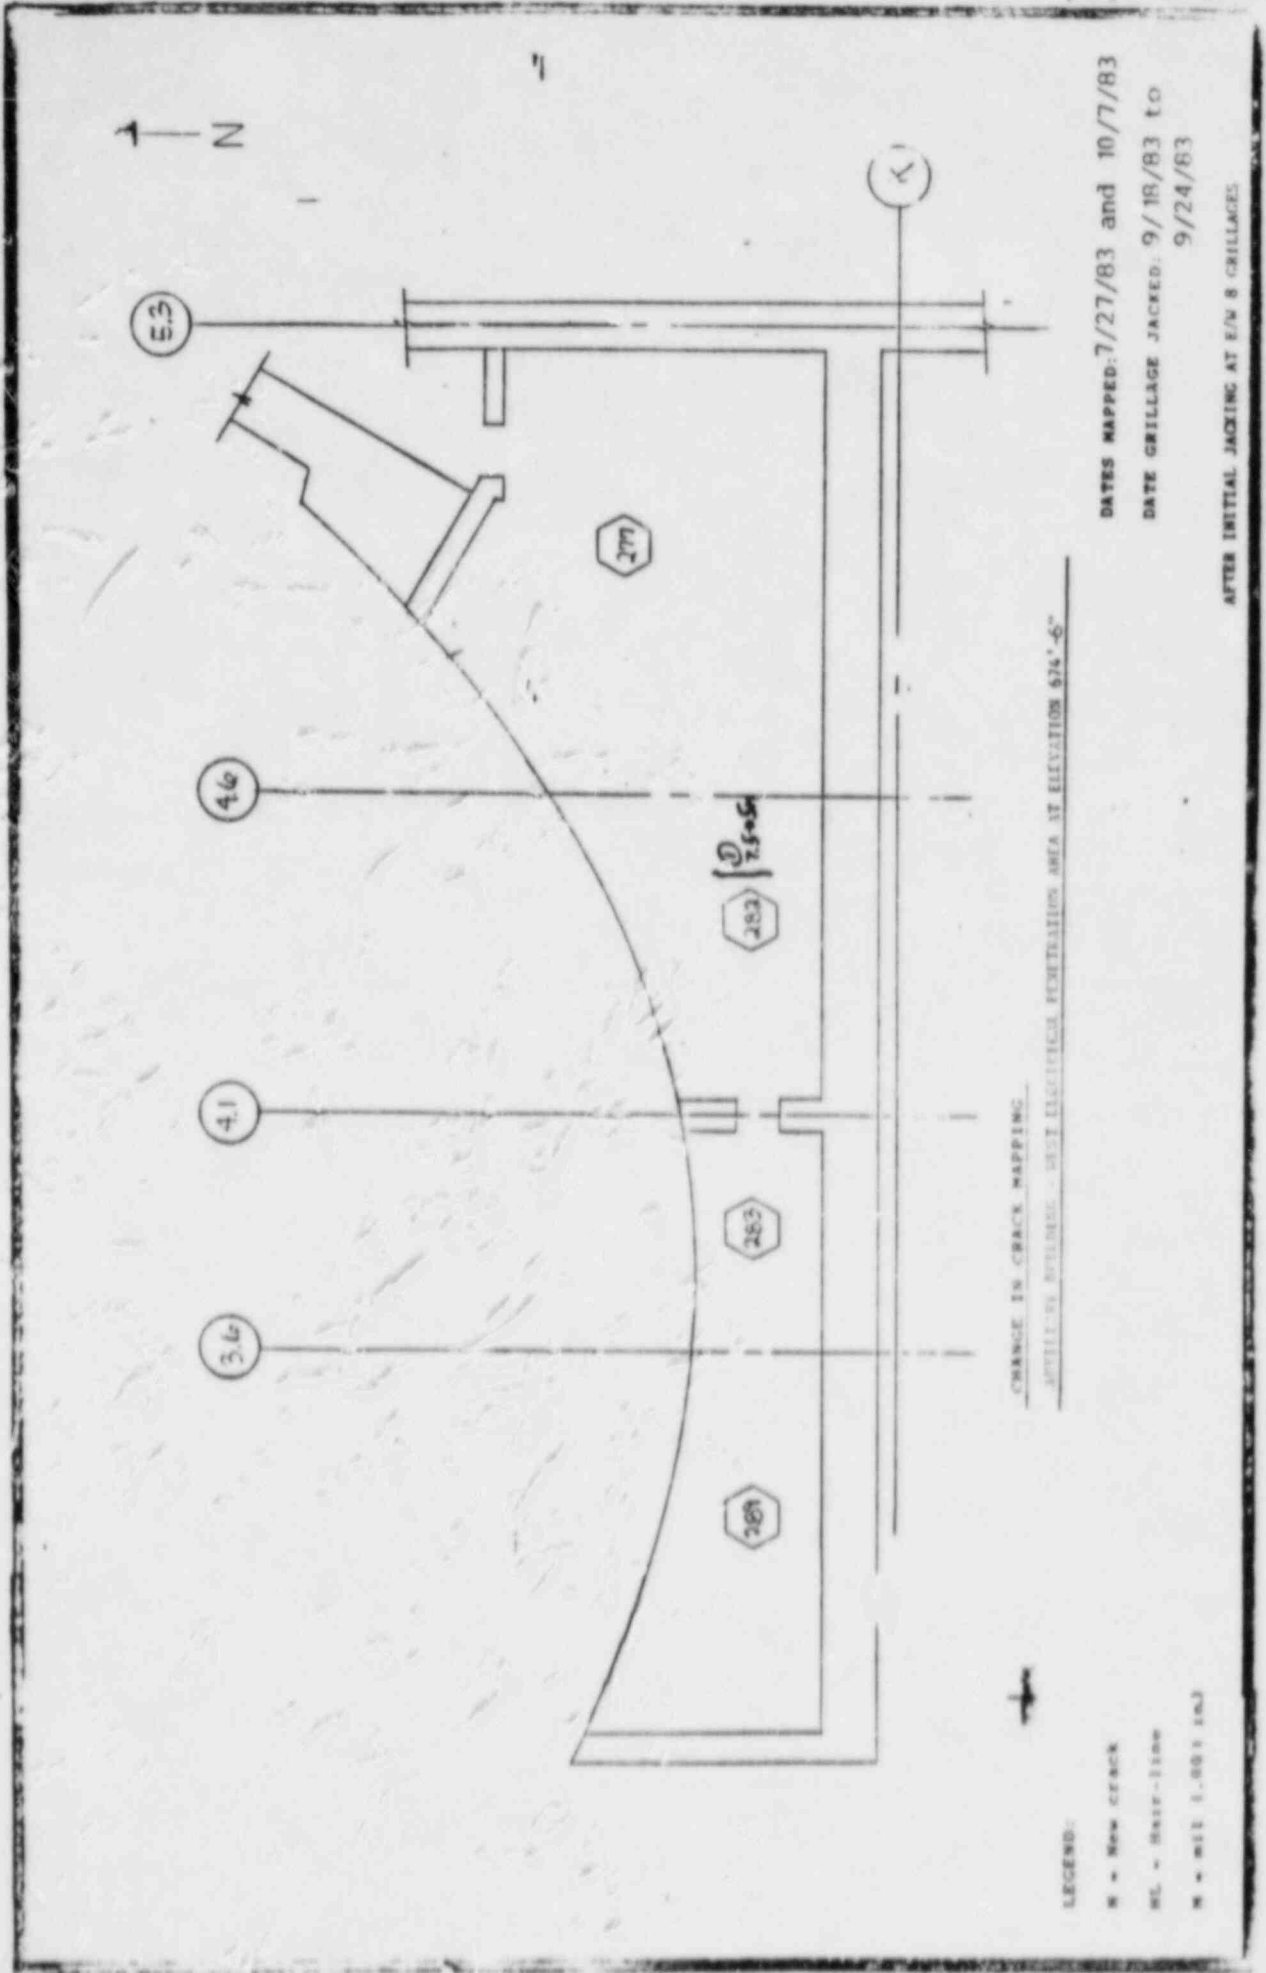
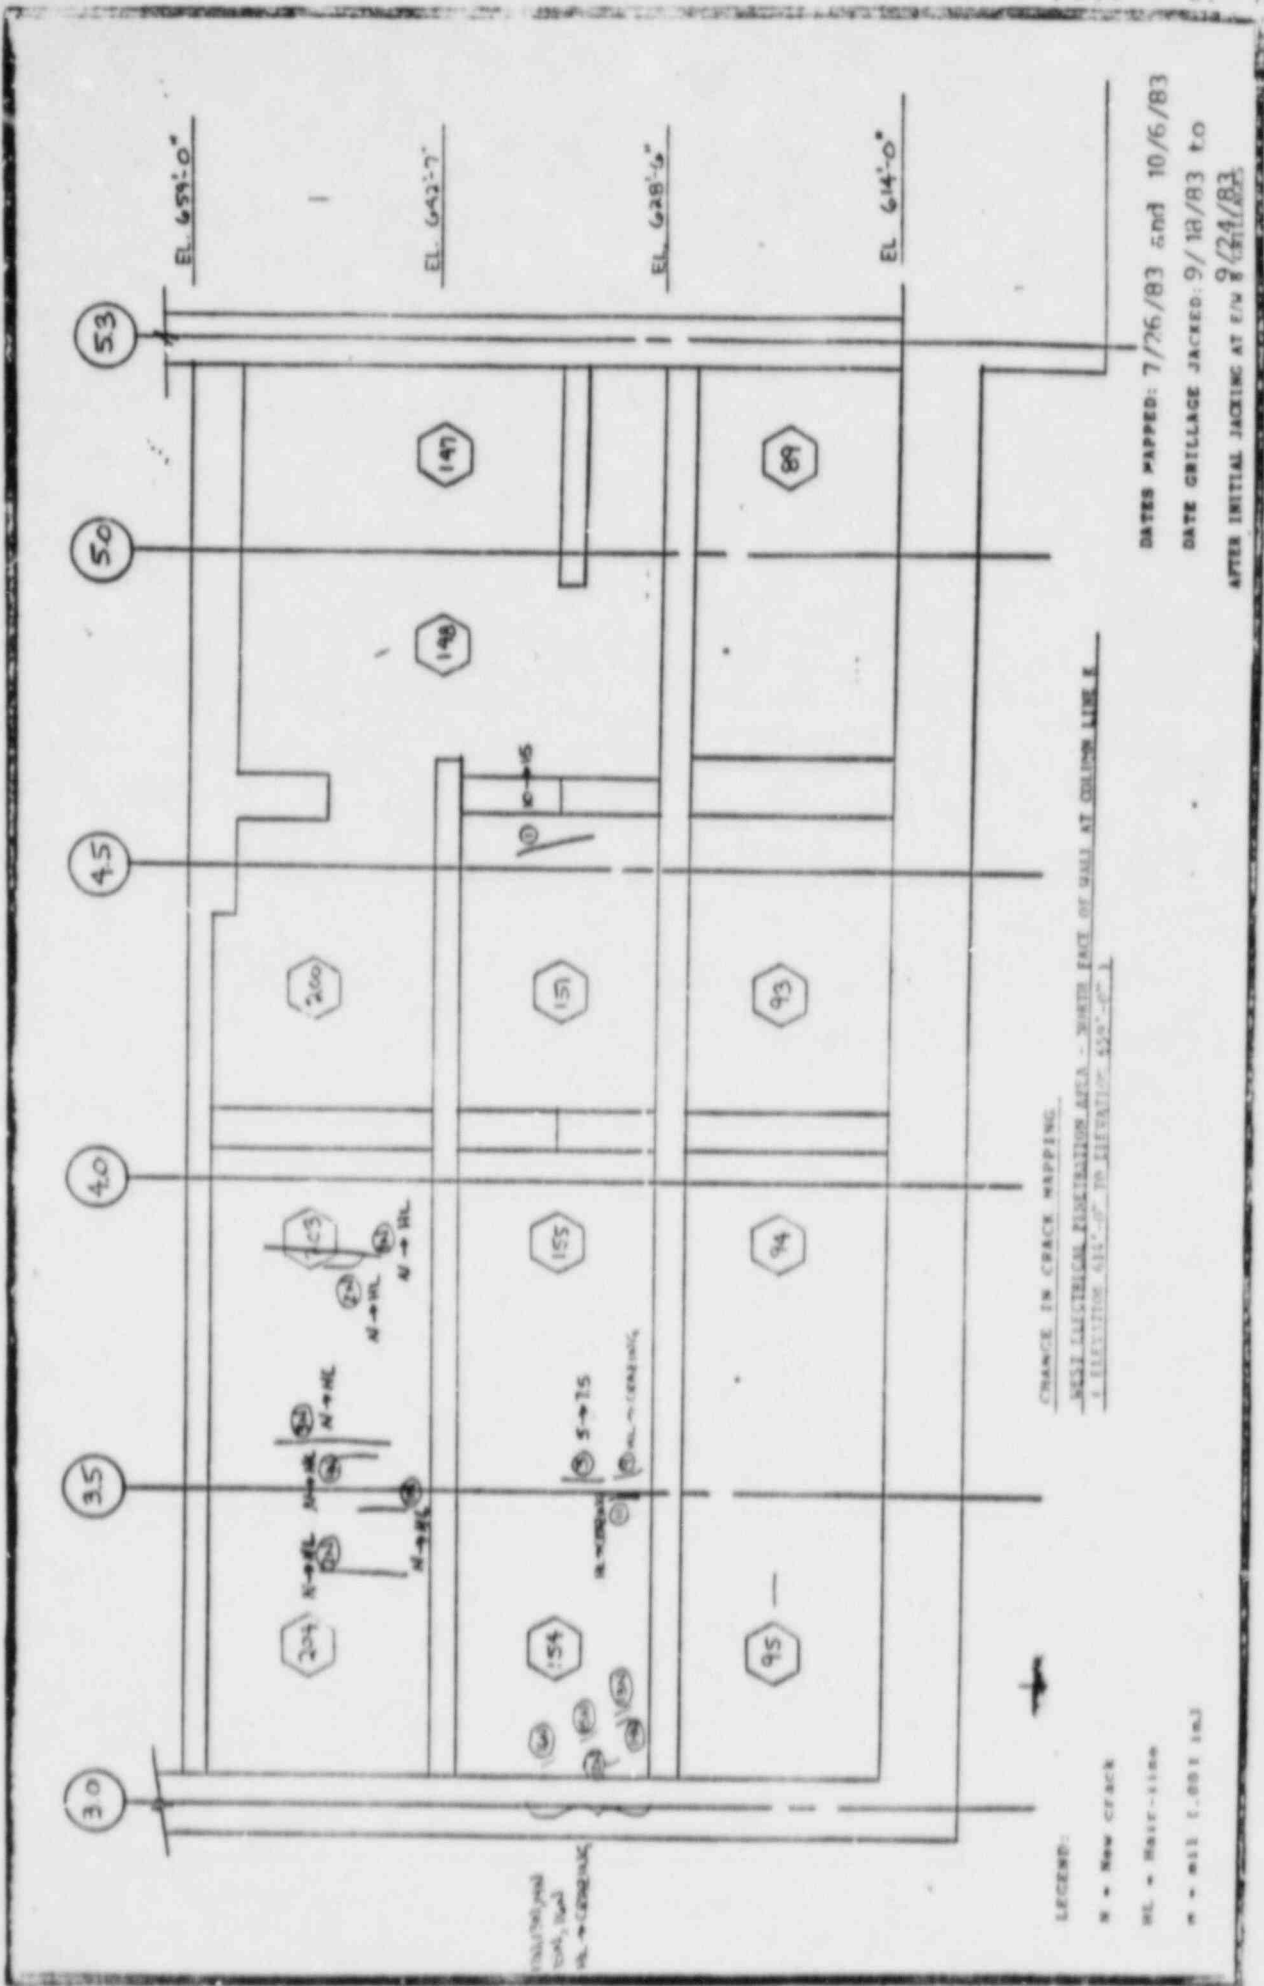
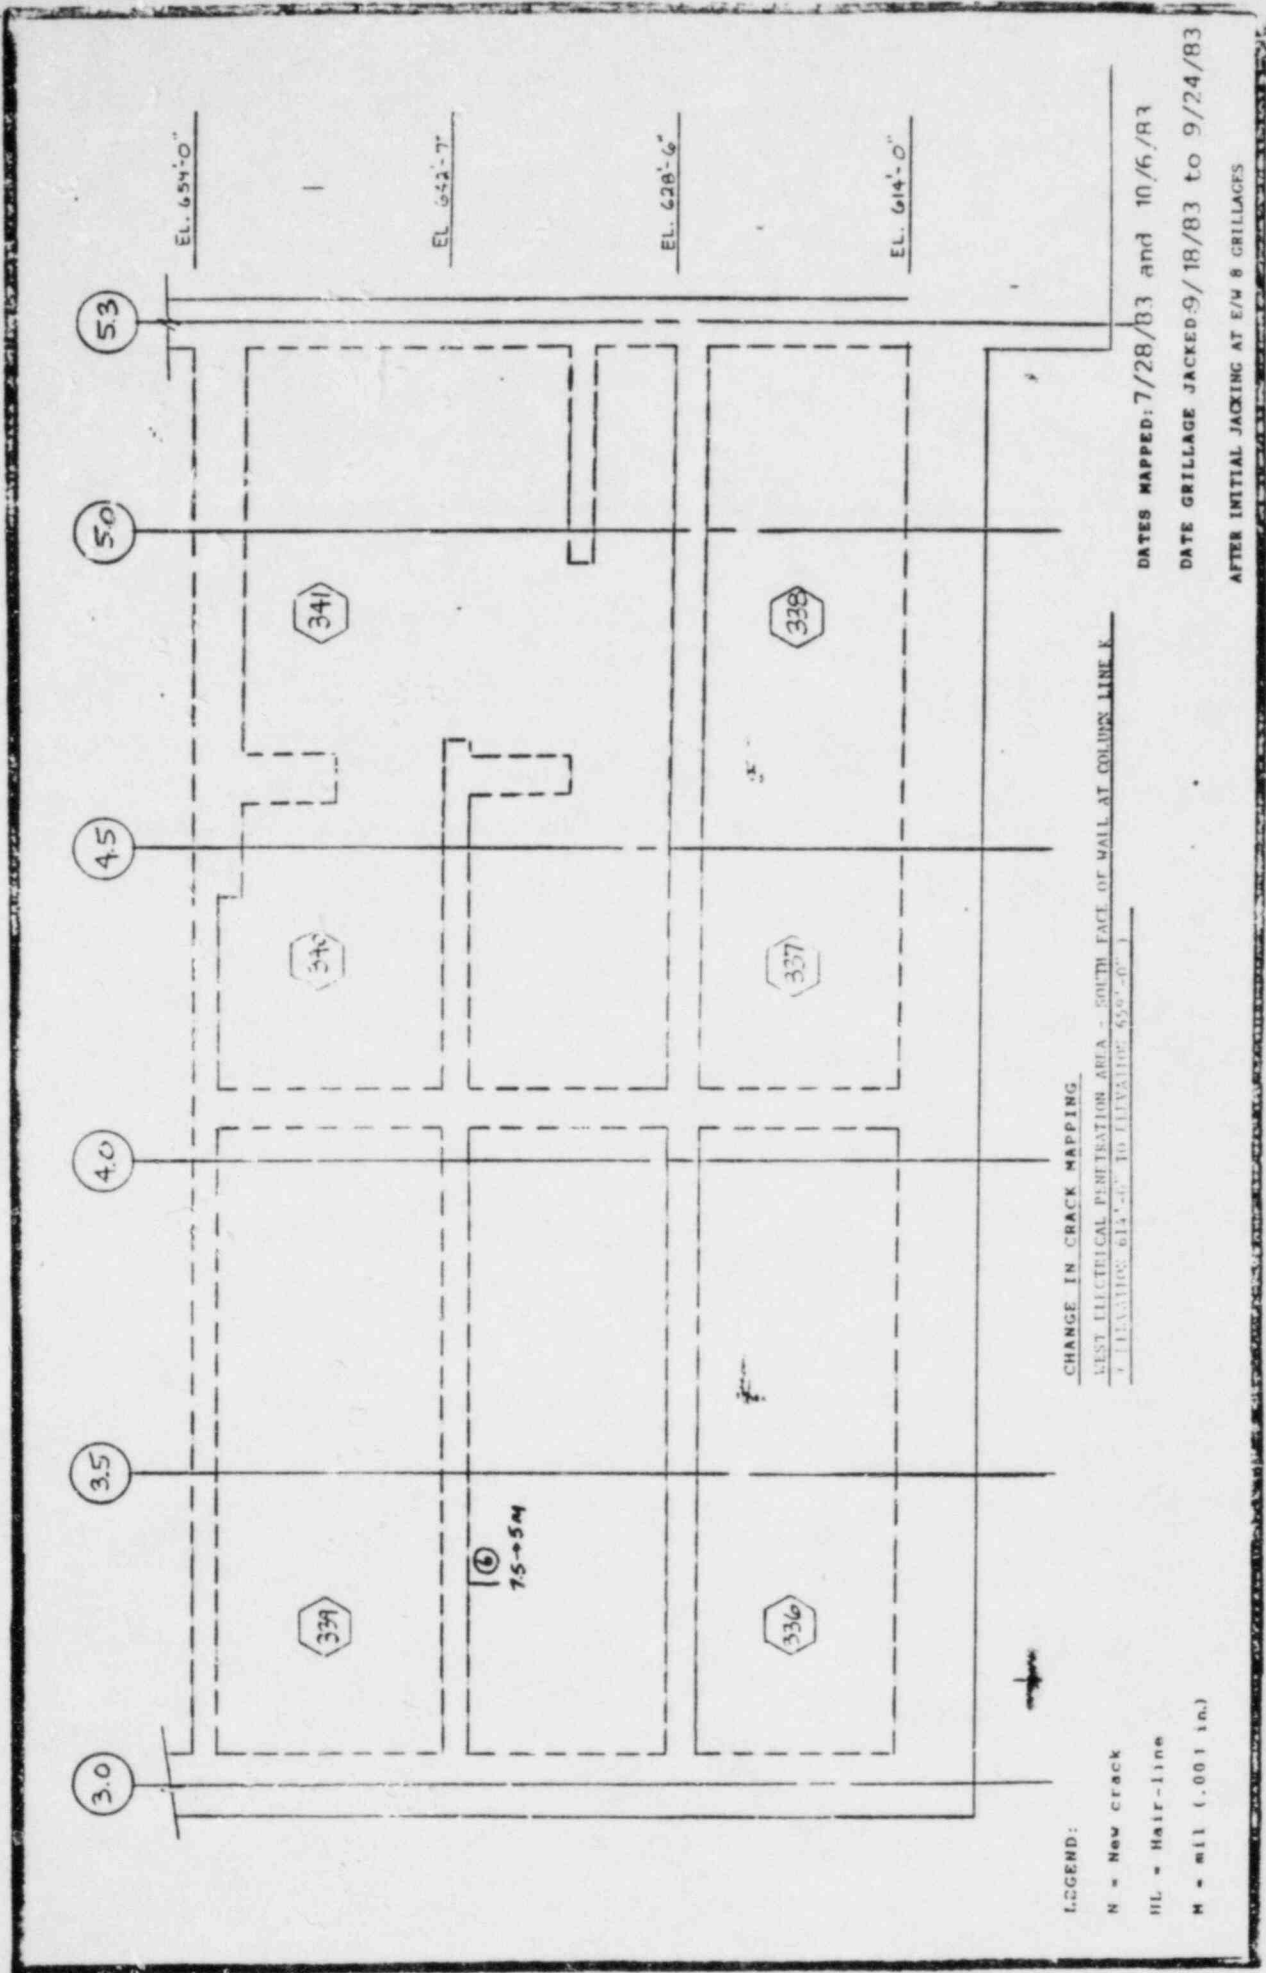
CHANGE IN CRACK MAPPING
 WEST ELECTRICAL PENETRATION AREA AT ELEVATION 659'-0"

LOCATION	AREA	CRACK I.D. NO	CRACK MEASUREMENTS (1 MIL=.001 in.)						EVALUATION
			WIDTH CHANGE AFTER INITIAL JACKING (MILS)			WIDTH CHANGE AFTER REJACKING (MILS)			
			FROM	TO	> 5 MILS	FROM	TO	> 5 MILS	
West EPA Slab @ 628' 6"	146	9N	N	HL	No				Within Tolerance.
West EPA slab @ 659' 0"	238	*3	5	5	Yes				Crack #3 in area 238 is in floor topping with poorly defined worn off edges which could have lead to measurement dispersion. All other cracks within tolerance.
	238	*13N	N	HL	No				
	239	*1	15	10	No	10	5	No	
	239	*6	7.5	5	No				
	242	*8	15	10	No				
West EPA Slab @ 674' 6"	282	1	7.5	5	No				Within Tolerance.
West EPA North face of wall @ Col. Line K 614'-0" to 659'-0"	151	1	10	15	No				Both cracks within tolerance. Cracks were reexamined and traces of paint within the crack indicated that it had formed before underpinning operation.
	154	3	5	7.5	No	7.5	5	No	
	203	*1N	N	HL	No				
	203	*2N	N	HL	No				
	203	*3N	N	HL	No

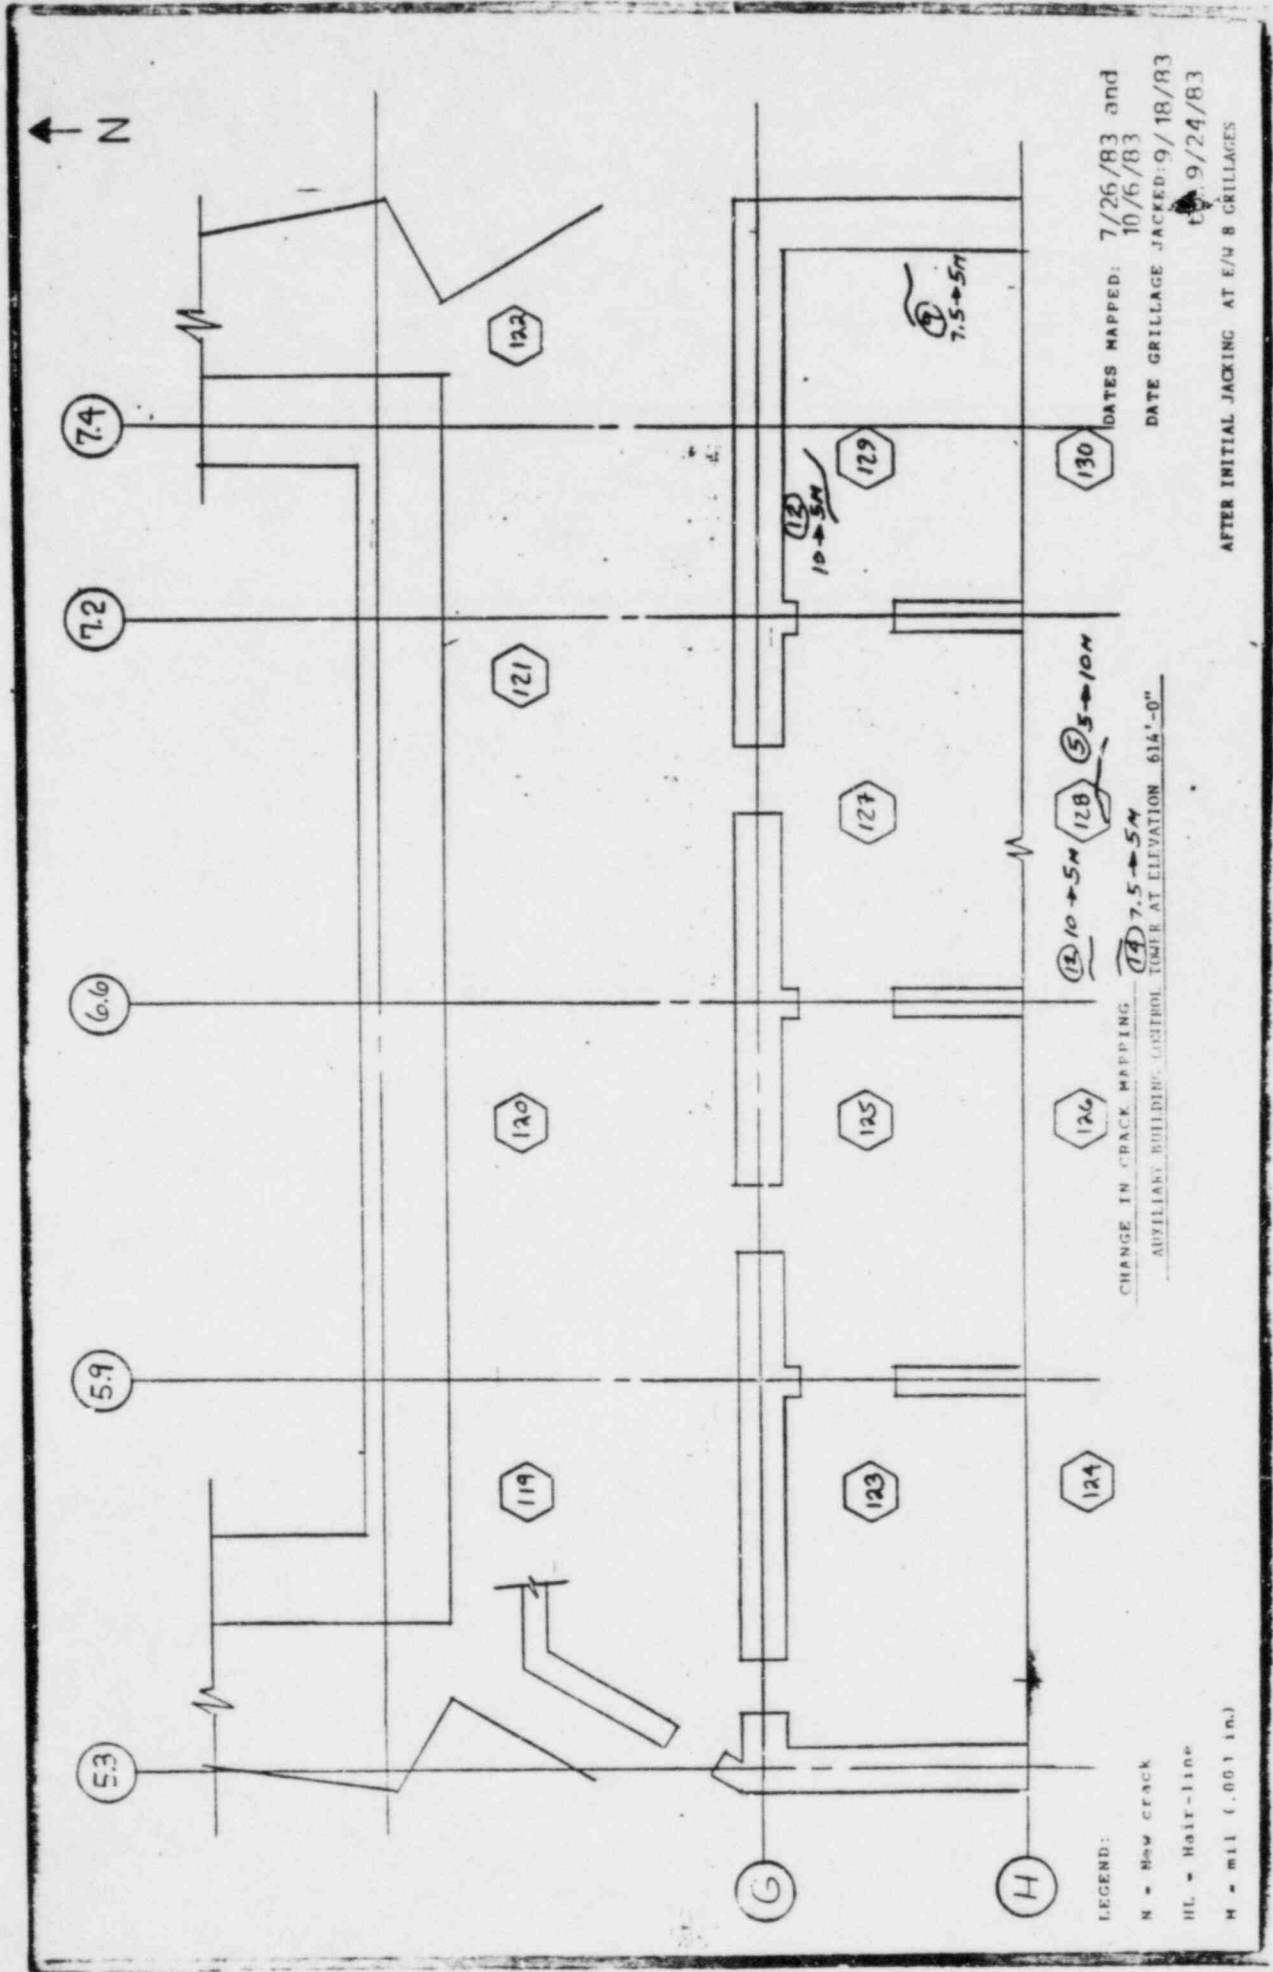
CHANGE IN CRACK MAPPING
 AUXILIARY BUILDING CENTER TOWER AT ELEVATION 646'-0"

DATES MAPPED 7/27/83 and 10/17/83
 DATE GRILLAGE JACKED: 9/18/83 to 9/24/83
 AFTER INITIAL JACKING AT E/W 8 GRILLAGES

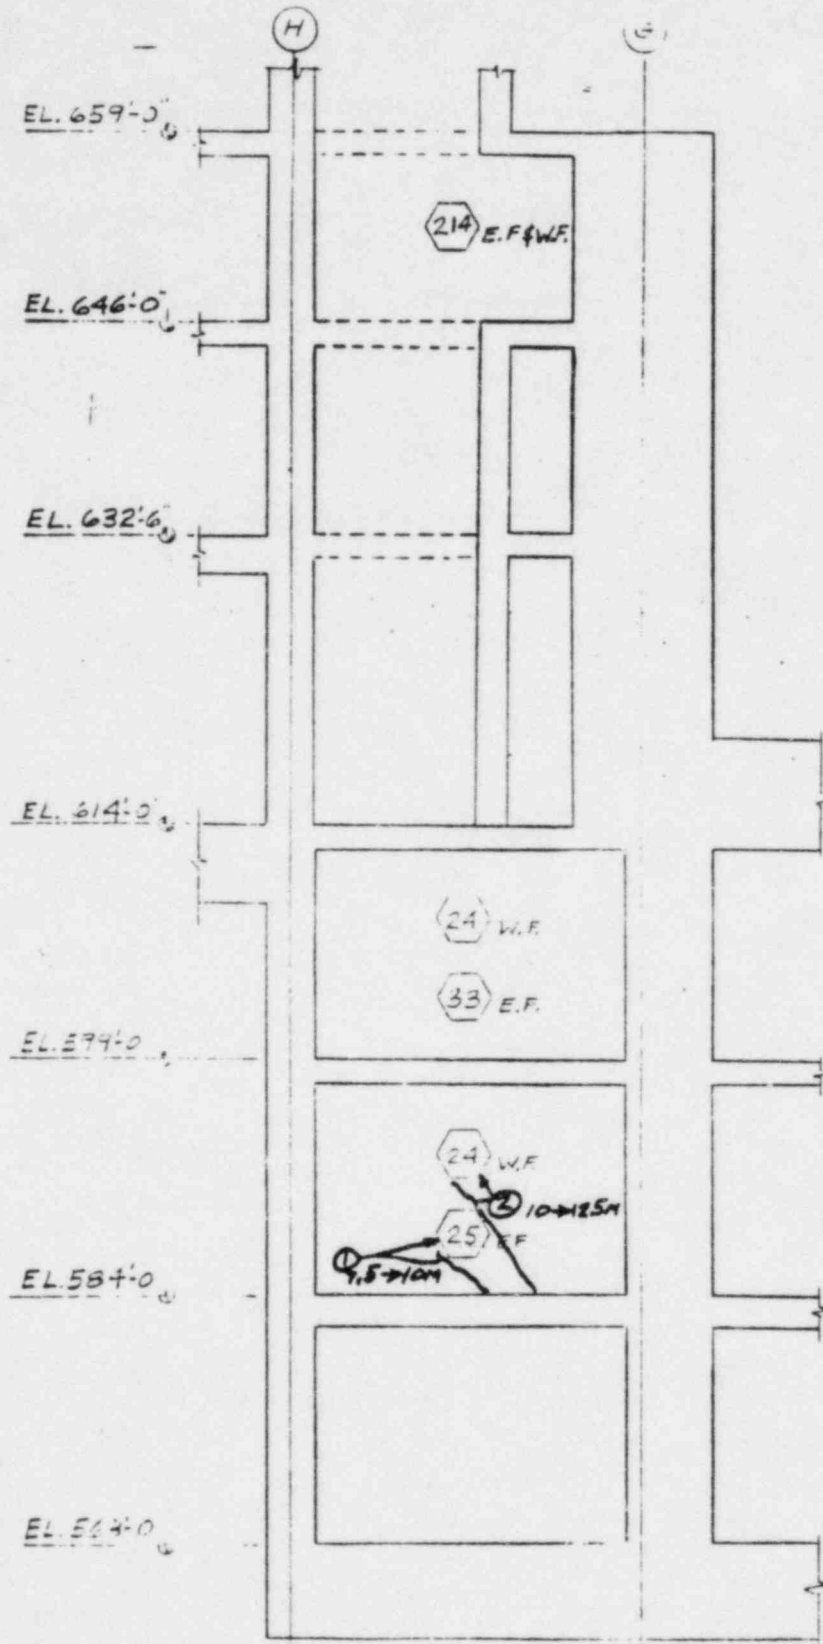
WALL AT COLUMN LINE 5.3 AND 5.6

AFTER INITIAL JACKING AT E/W 8 GRILLAGES

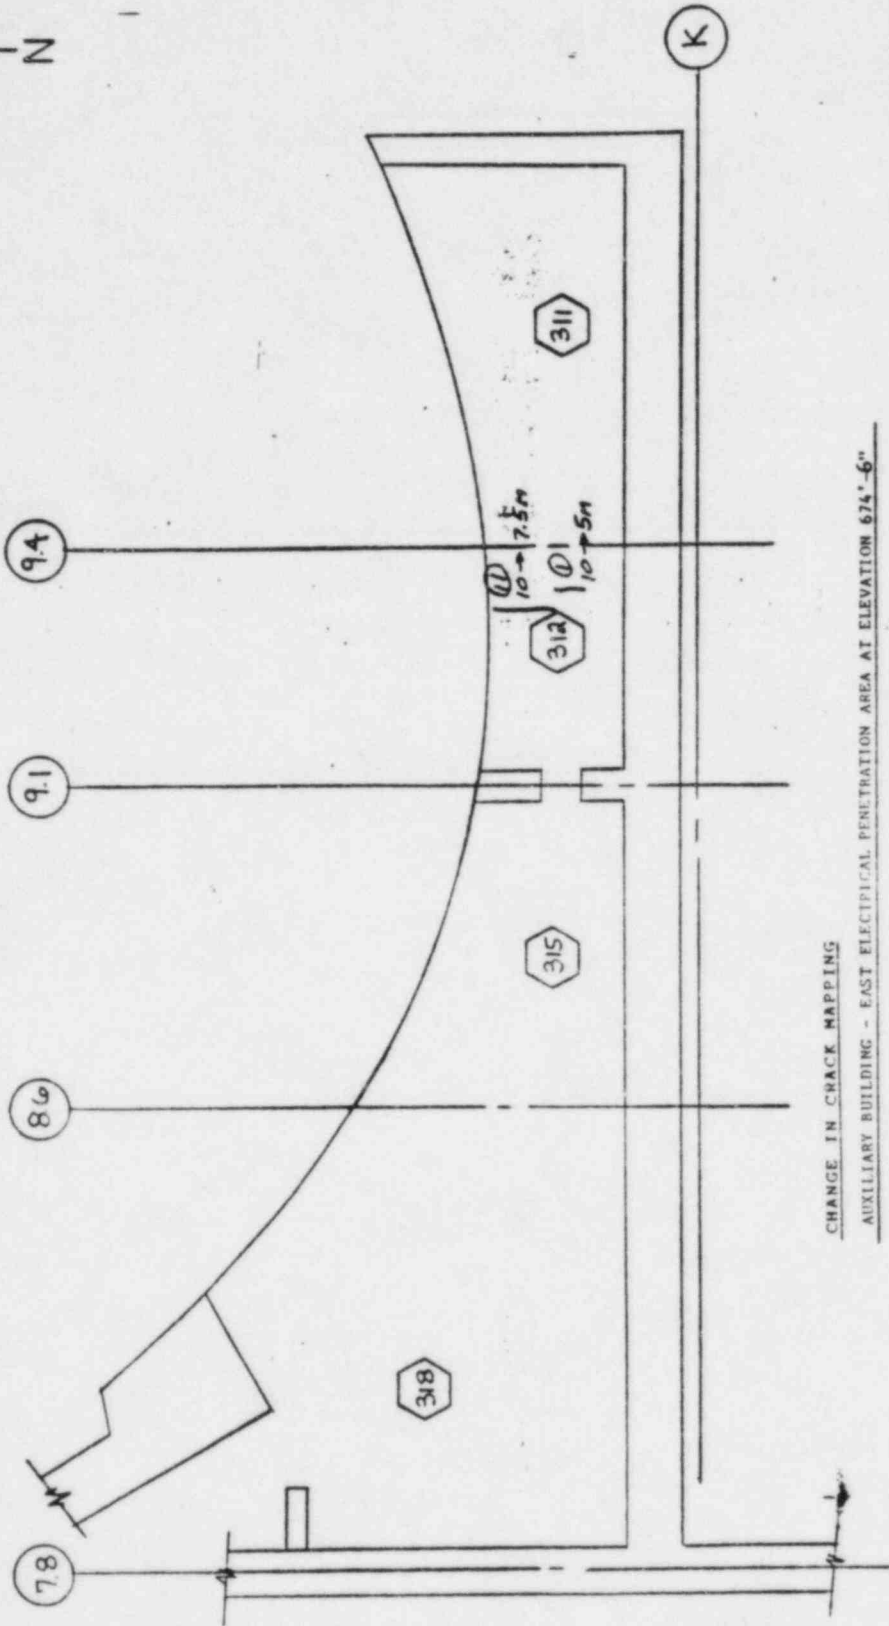
CHANGE IN CRACK MAPPING
 AUXILIARY BUILDING - EAST ELECTRICAL PENETRATION AREA AT ELEVATION 658'-0"

FROM JACKING AT E/W 8 TO 11-28-83
