UNITED STATES NUCLEAR REGULATORY COMMISSION

FACILITY: North Anna Power Station, Unit No. 1 (NA-1)

SUBJECT: MEETING SUMMARY OF MARCH 2, 1992

Steam Generator Mid-Cycle Inspection Outage NRC Startup Approval Meeting

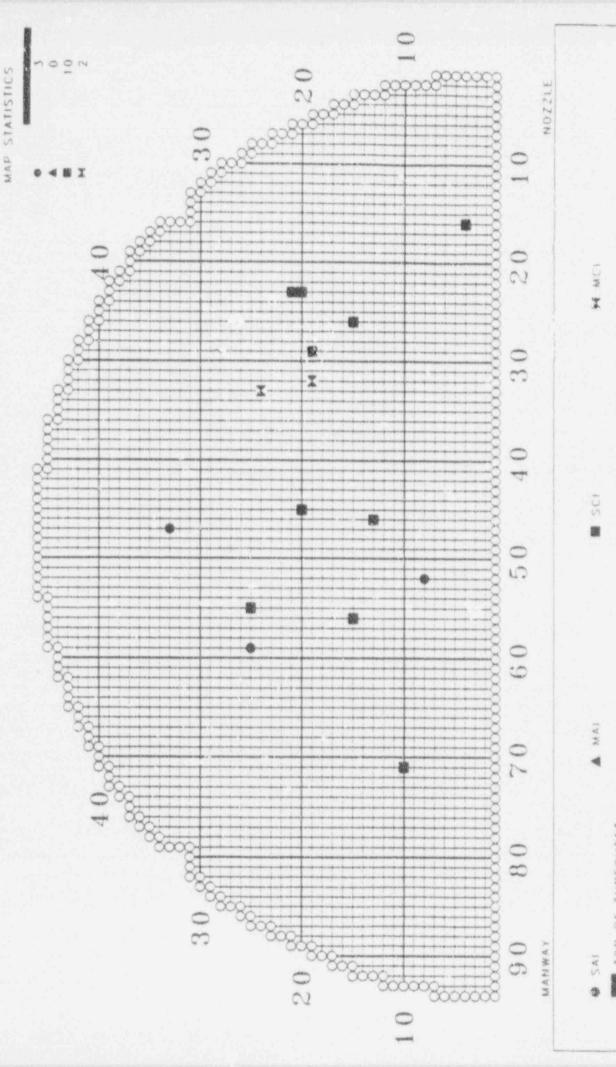
STEAM	GENER	ATOR
# TUBES	Α	В	С
SINGLE AXIAL	3	0	2
MULTIPLE AXIAL	0	0	0
SINGLE CIRCUMFERENTIAL	10	9	7
MULTIPLE CIRCUMFERENTIAL	2	1	2

THERE WERE Q TUBES WITH MIXED MODE DEGRADATION IDENTIFIED IN THE WEXTEX TRANSITIONS.

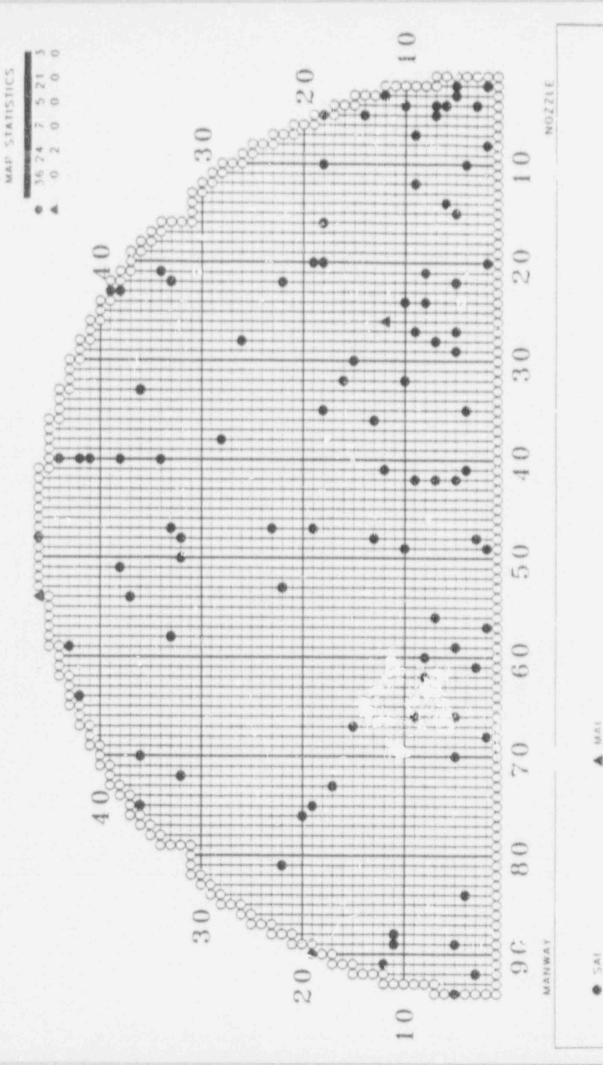
NORTH ANNA UNIT 1 S/G B 2/27 PLUG LIST SUPPORT PLATE AXIAL INDICATIONS (RPC)

TSP AXIAL CRACKS

SAI - SINGLE AXIAL II.DICATION

MAI - MULTIPLE AXIAL INDICATIONS
