Technical Report on the Findings of Task 4

Southwest Research Institute

Sealed Source and Device Design Safety Testing

Investigation of Failed Radioactive Stainless Steel
Troxler Gauges

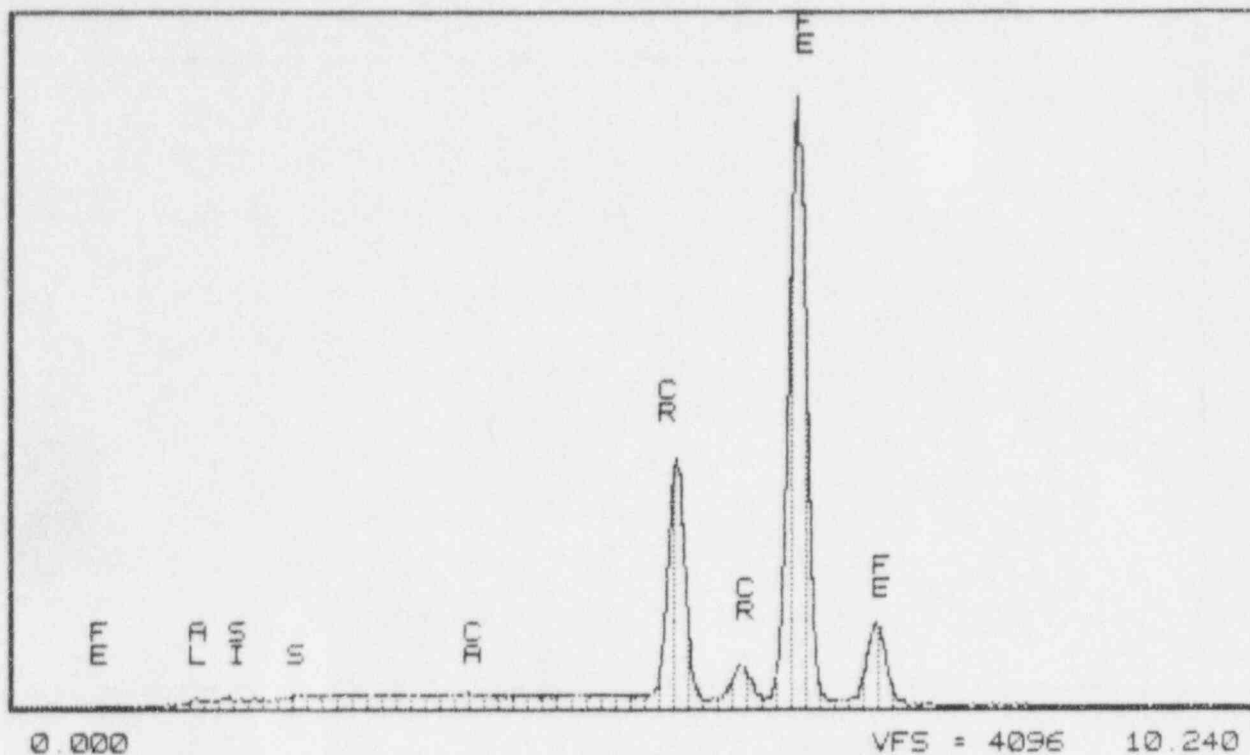
FIGURE 7-1. ENERGY DISPERSIVE X-RAY SPECTRA FOR ROD TOWARDS HOUSING.

83 04-4448-011 TROXLER #12711 LOC C 30KV WD26

Element	K-ratio	Z	A	F	Atom%	Wt%
Fe-K	0.734	1.000	1.072	1.000	76.13	78.67
Cr-K	0.228	1.007	1.019	0.829	20.18	19.41
Si-K	0.003	0.918	2.863	0.998	1.33	0.69
Al-K	0.002	0.947	3.994	0.999	1.82	0.91
S -K	0.002	0.922	1.776	0.994	0.53	0.32
					Total =	100.00%

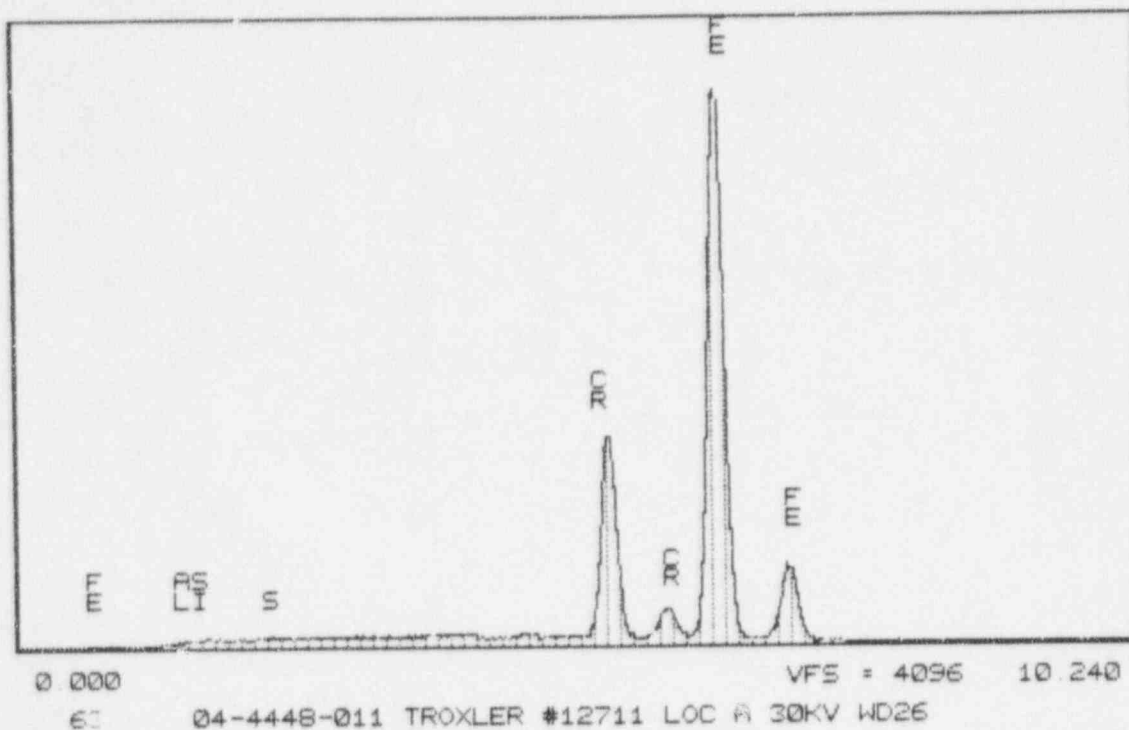
FIGURE 7-2. ENERGY DISPERSIVE X-RAY SPECTRA FOR FLATTENED REGION NEAR TIP.

04-4448-011 TROXLER #12711 LOC A 30KV WD26
 Standardless Analysis
 30.0 kV 40.5 Degrees
