NUREG/CR-6074
04-4448-012
Vol. 4

Sealed Source and Device Design Safety Testing

Technical Report on the Findings of Task 4

Investigation of Sealed Source for
Paper Mill Digester

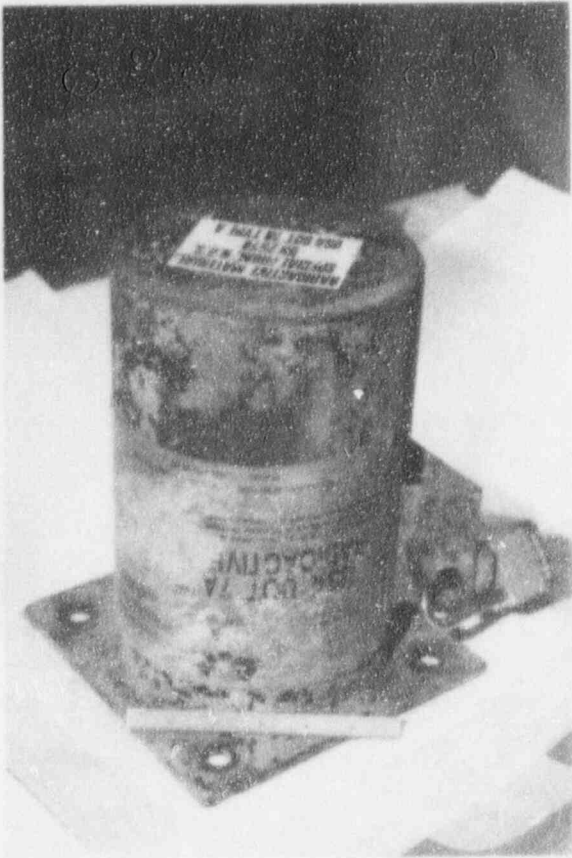
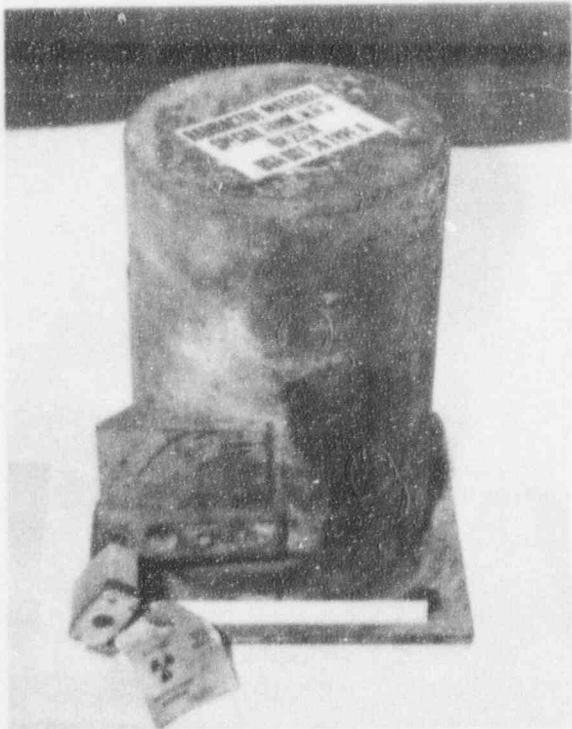
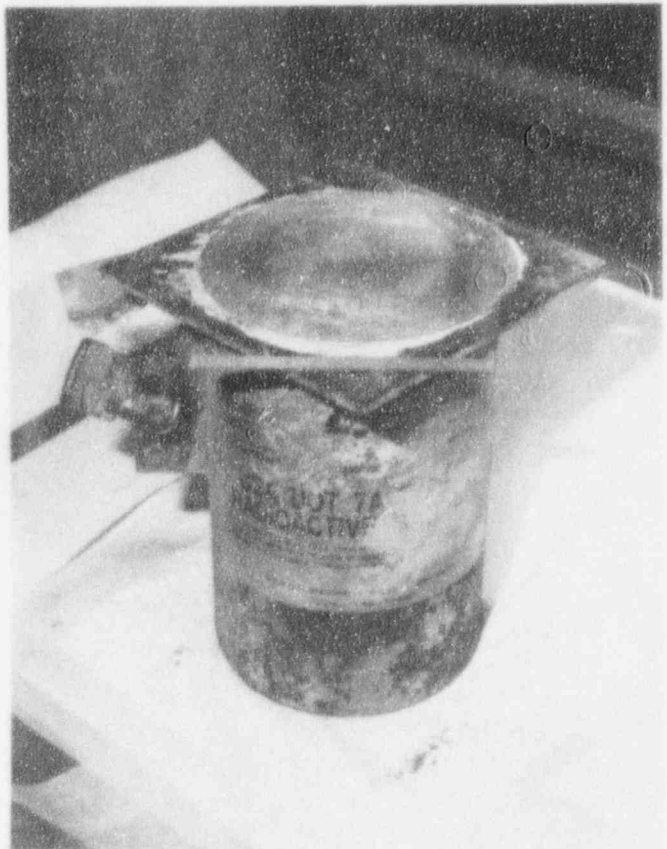
FIGURE 3. PHOTOGRAPHS OF THE HOUSING.

When the Cs-137 source was received from Georgia facility at SwRI, it was examined in the box. The radiation was not above background. The shield was removed from the housing, then the lock for the housing was unlocked, then the aperture plug for the beam rolled back. Figure 3 shows the plug and the holder. The radiation level above the beam measured 65 mR/hr, on the side of the housing the radiation level measured 10.8 mR/hr. A wipe was taken underneath the aperture plug and a 3,000 cpm (0.132 μ curies) removable was detected. The area around the plug and down the beam hole was cleaned using Q-tips and cotton balls.

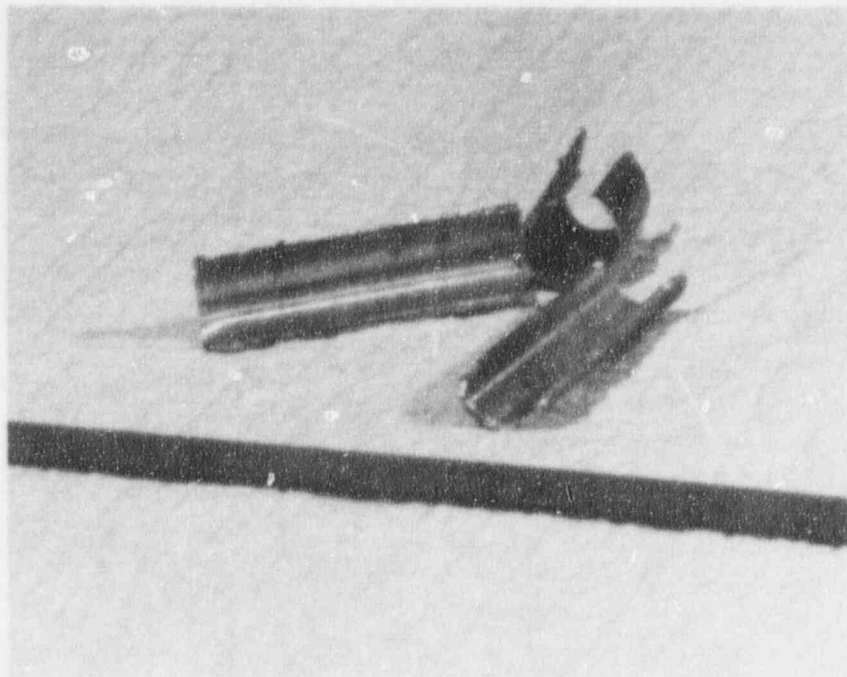
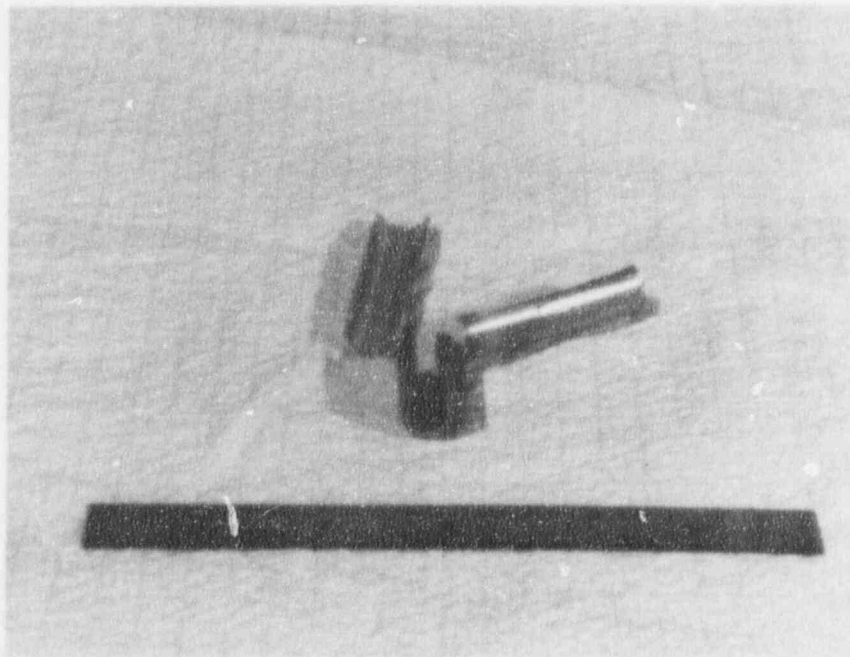
FIGURE 7. PHOTOGRAPHS OF THE AS-SECTIONED ALUMINUM HOLDER.

It was reported to SwRI that the source holder was stainless steel or aluminum, but it was obvious based on the color and weight that the holder was an aluminum alloy. The OD measured 0.563 inch while the ID measured 0.438 inch. The holder tube was cut using a jewelers saw and hack saw, then split in half, as shown in Figure 7, exposing the double encapsulated source. The inside of the tube measured 40,000 cpm (1.82 μ curies).

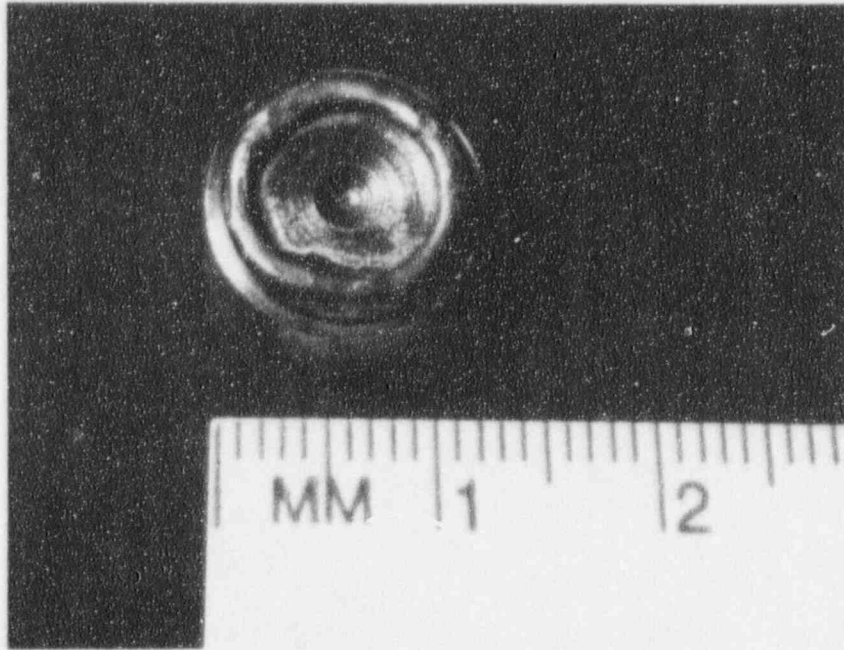
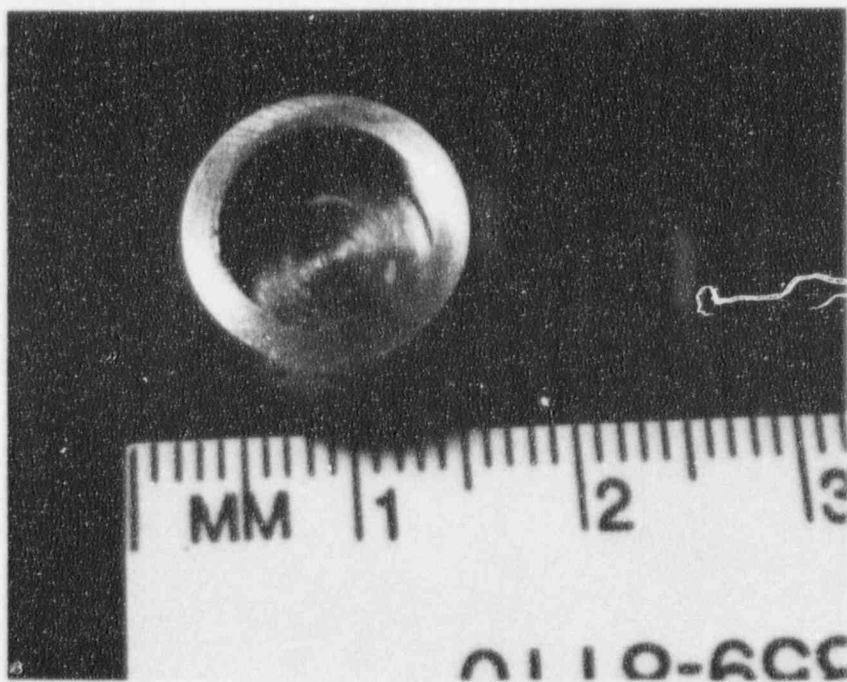
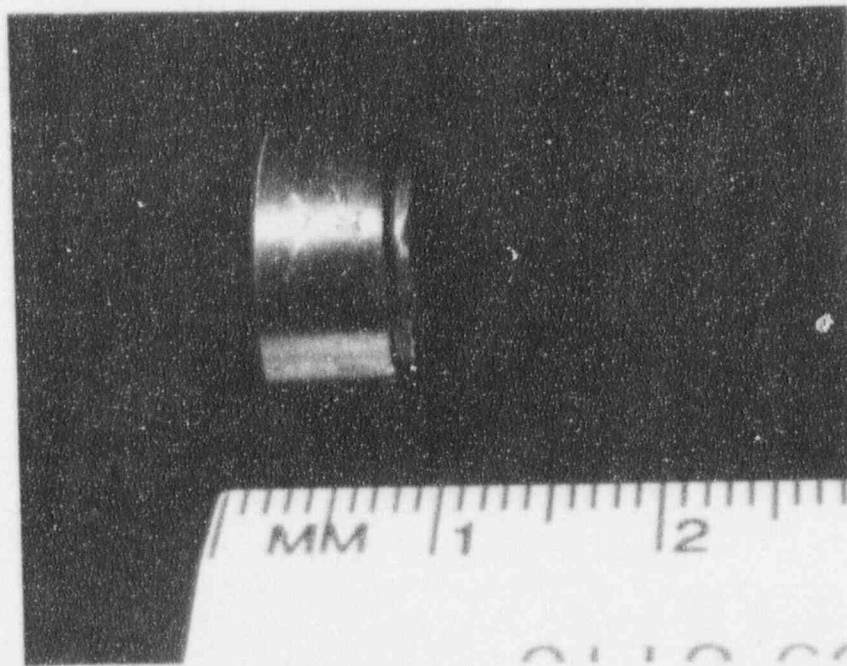
FIGURE 9. PHOTOGRAPHS OF THE SECTIONED OUTER ENCAPSULATION WITH THE WELD.

The next step was to section the outer encapsulation. Before this could be accomplished SwRI had to amend its radioactive material licenses to cut into a source. This amendment was allowed by the state of Texas. In order to cut the outer encapsulation without damaging the inner encapsulation, a special cutting fixture was set-up. The outer encapsulation was chucked into a variable speed drill set at a low rotational speed. The on-off switch was remote from the drill to minimize radiation exposure. The drill and chuck were covered with a plastic sheet and plate to catch the fillings. As the encapsulated source rotated, the source was cut with a jeweler's saw that was held by the manipulators. When the cut was completely through, the welded portion stopped rotating and could be removed. The non-welded half had 40,000 cpm (1.82 μ curies) on the outside, but only about 10,000 cpm (0.452 μ curies) on the inside. The welded and non-welded sections are shown in Figures 9 and 10. The inner capsule was only barely scratched from the cutting operations. No corrosion was evident on the inside capsule.
