SUBJECT: BOARD NOTIFICATION - UPDATE ON MIDLAND STOP WORK STATUS
AND NRC STAFFING CHANGES

The attached memorandum, Norelius to Eisenhut dated April 9, 1984, provides an updated status on the Midland Stop Work Status previously reported in BN-84-023 and discusses the NRC Region III staffing plans for the Midland review.

The Diesel Generator Building (DGB) at the Midland Nuclear Power Plant (NPP) is a reinforced concrete structure which has undergone excessive unequal settlement since its construction. The concrete walls of the DGB have been more extensively cracked than usually expected of such a concrete structure. On the basis of review and evaluation of the Applicant's (Consumer Power Co.) various analytical studies, remedial measures taken, and the commitments made and of the staff's own assessments, the original structural engineering staff reviewer came to the conclusion that the DGB was acceptable. However, an NRC regional inspector disagrees with the conclusion as to the acceptability of the DGB and has expressed his concerns in a hearing before a Congressional Government Oversight Committee.

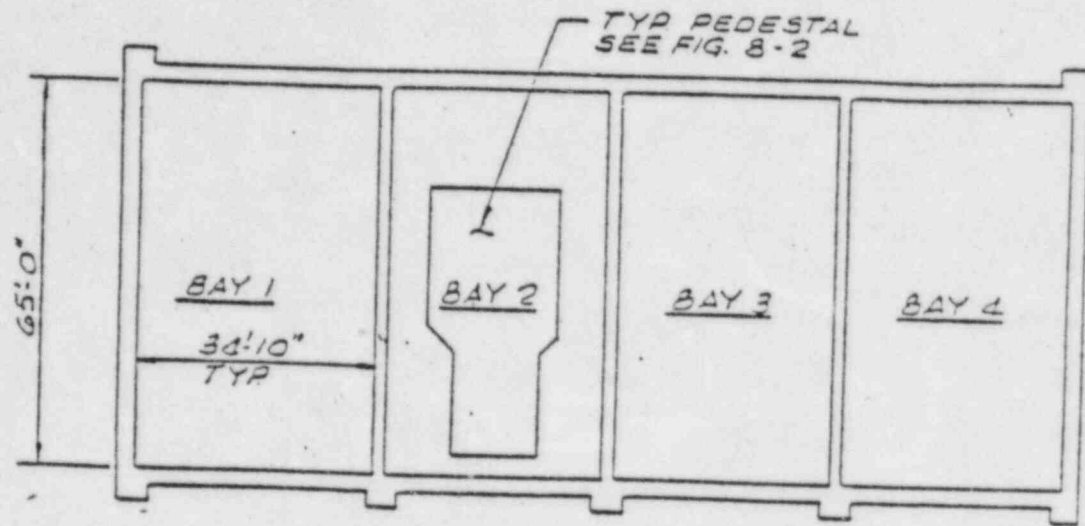
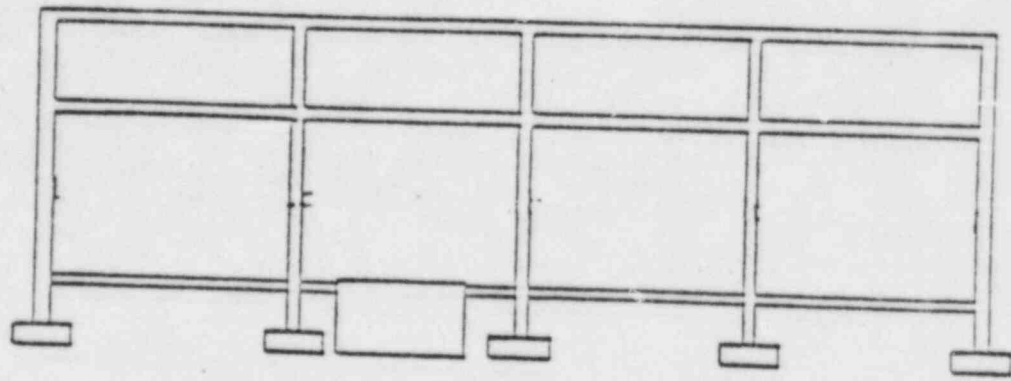
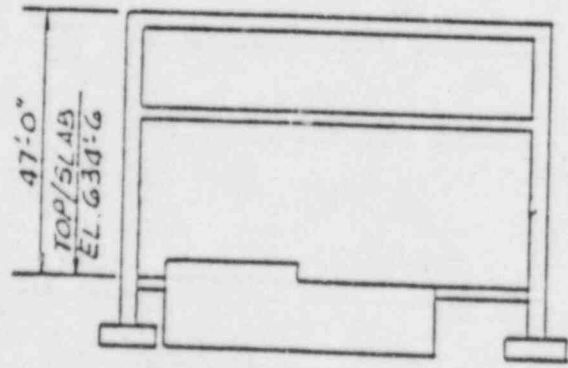
FIGURE 1

The DGB is a two-story, box-type reinforced-concrete (RC) structure with three cross walls that divide the structure into four cells, each of which contains a diesel generator unit. The building is supported on continuous RC footings 10' - 0" wide and 2' - 6" thick founded at plant elevation 628' and resting on a fill that extends down to approximately elevation 603'. The building has exterior wall thickness of 30", roof slab and interior wall thickness of 18". Plan dimensions of DGB are 155' x 70' with a total internal height of approximately 44'. Each diesel generator rests on a 6'-6" thick, RC pedestal that is not structurally connected to the building foundation. Figure 1 shows the general layout of the DGB.

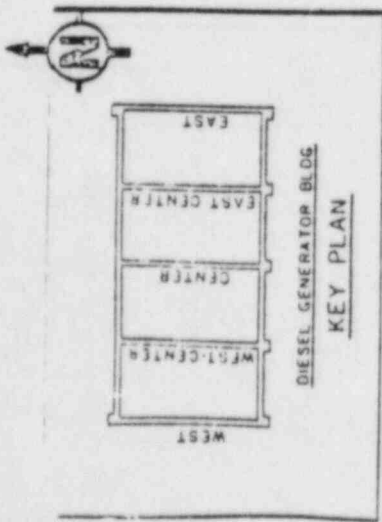
FIGURE 3 A - 2

The effects of the remedial measures taken can be observed from the amount of settlement which the DGB has gone through as indicated in Figure 2 and also from the crack sizes and crack patterns of the walls as shown in Figure 3. Details of both settlement and cracking issues are discussed in the following sections.

1. CRACK SHOWN WERE MAPPED PRIOR TO PLACING THE PRELOAD (12-13-78 TO 12-18-78).
2. NORTH & SOUTH WERE NOT MAPPED SINCE NO SIGNIFICANT CRACKS WERE OBSERVED.
3. IN GENERAL, ALL CRACKS WERE PARALLEL WITH SOME CRACKS WITH A THICKNESS OF 28 MILS AS OF 7-2-79.

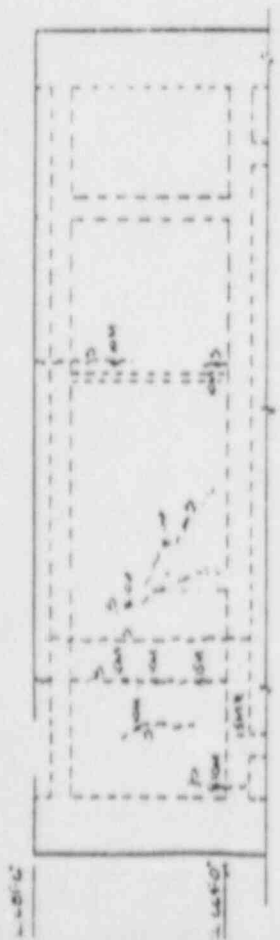
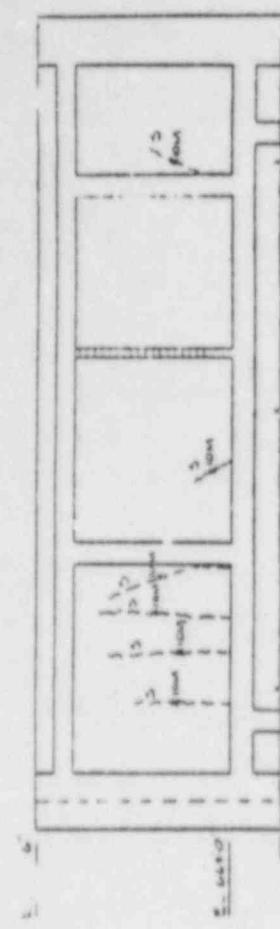
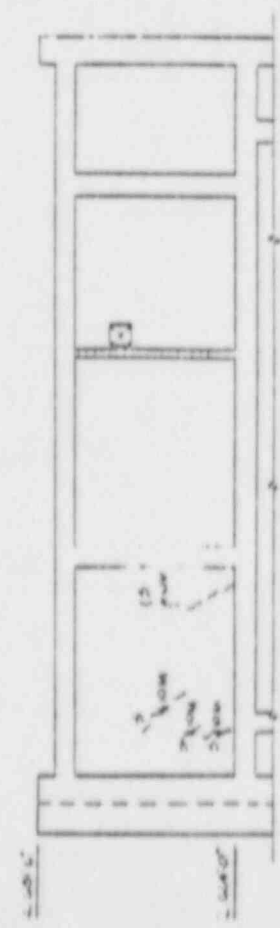
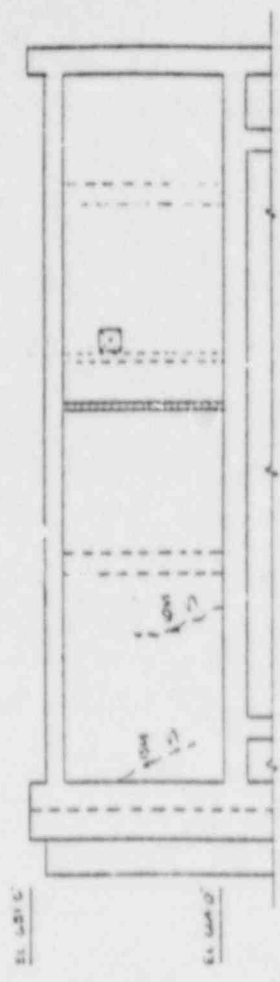
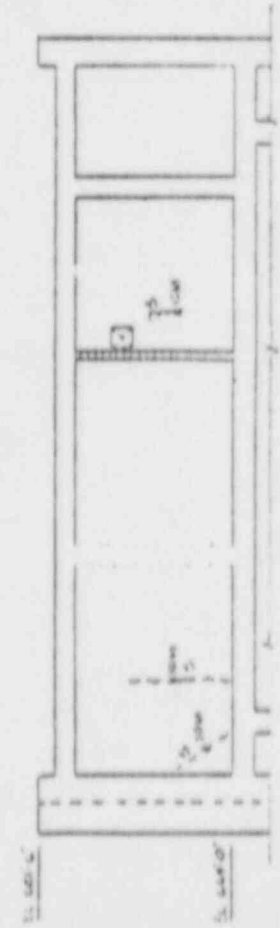
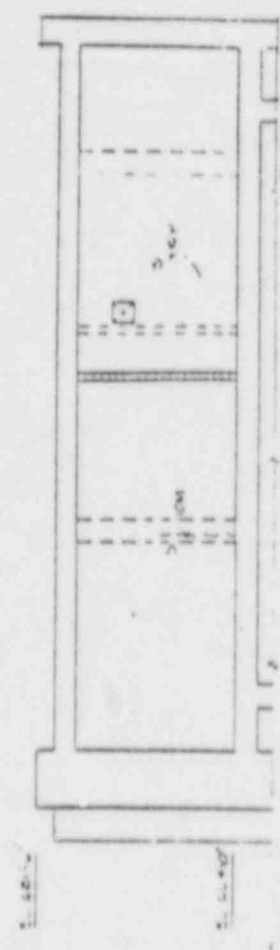
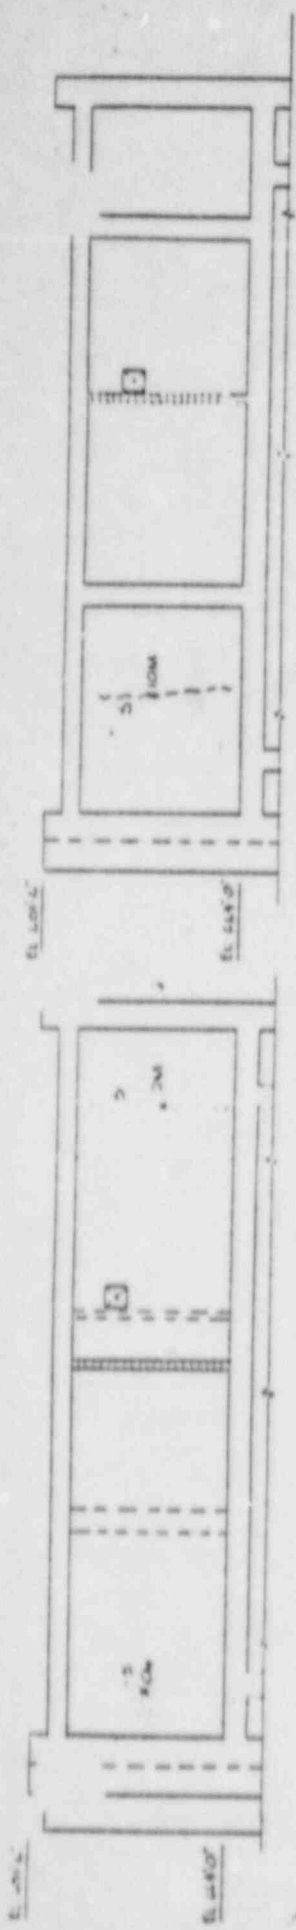
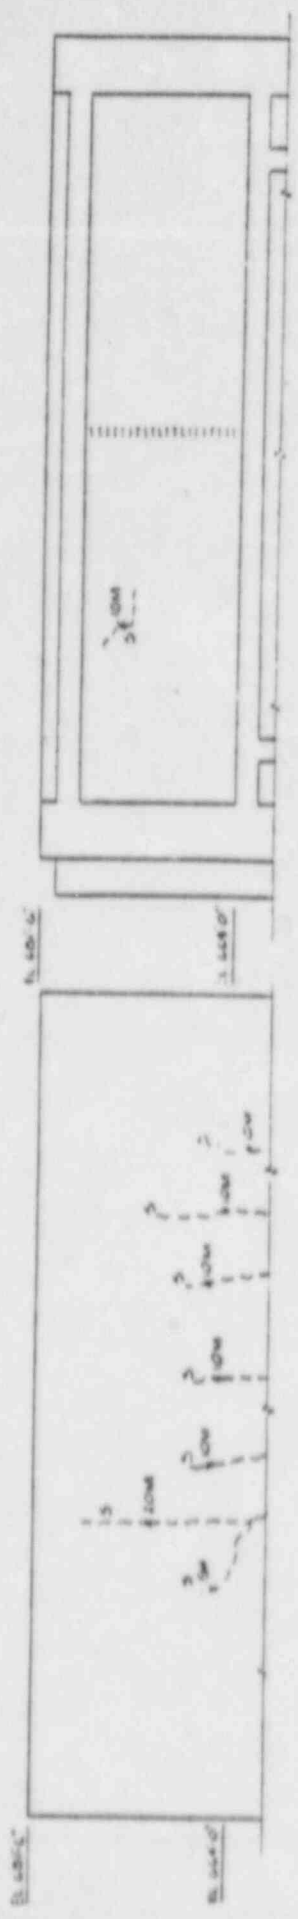
FIGURE 3 B - 2

1. IN GENERAL ALL CRACKS MAPPED IN DEC 1978 WERE HORIZONTAL. SOME CRACKS HAD A THICKNESS OF 28 MILS AS OF 7-7-79.
2. FOR CRACK MAPPING OF WALLS FROM EL. 664'-0" TO EL. 681'-6" SEE F/S. 28-3
3. CRACKS LESS THAN 10 MILLS IN SIZE ARE NOT MAPPED.

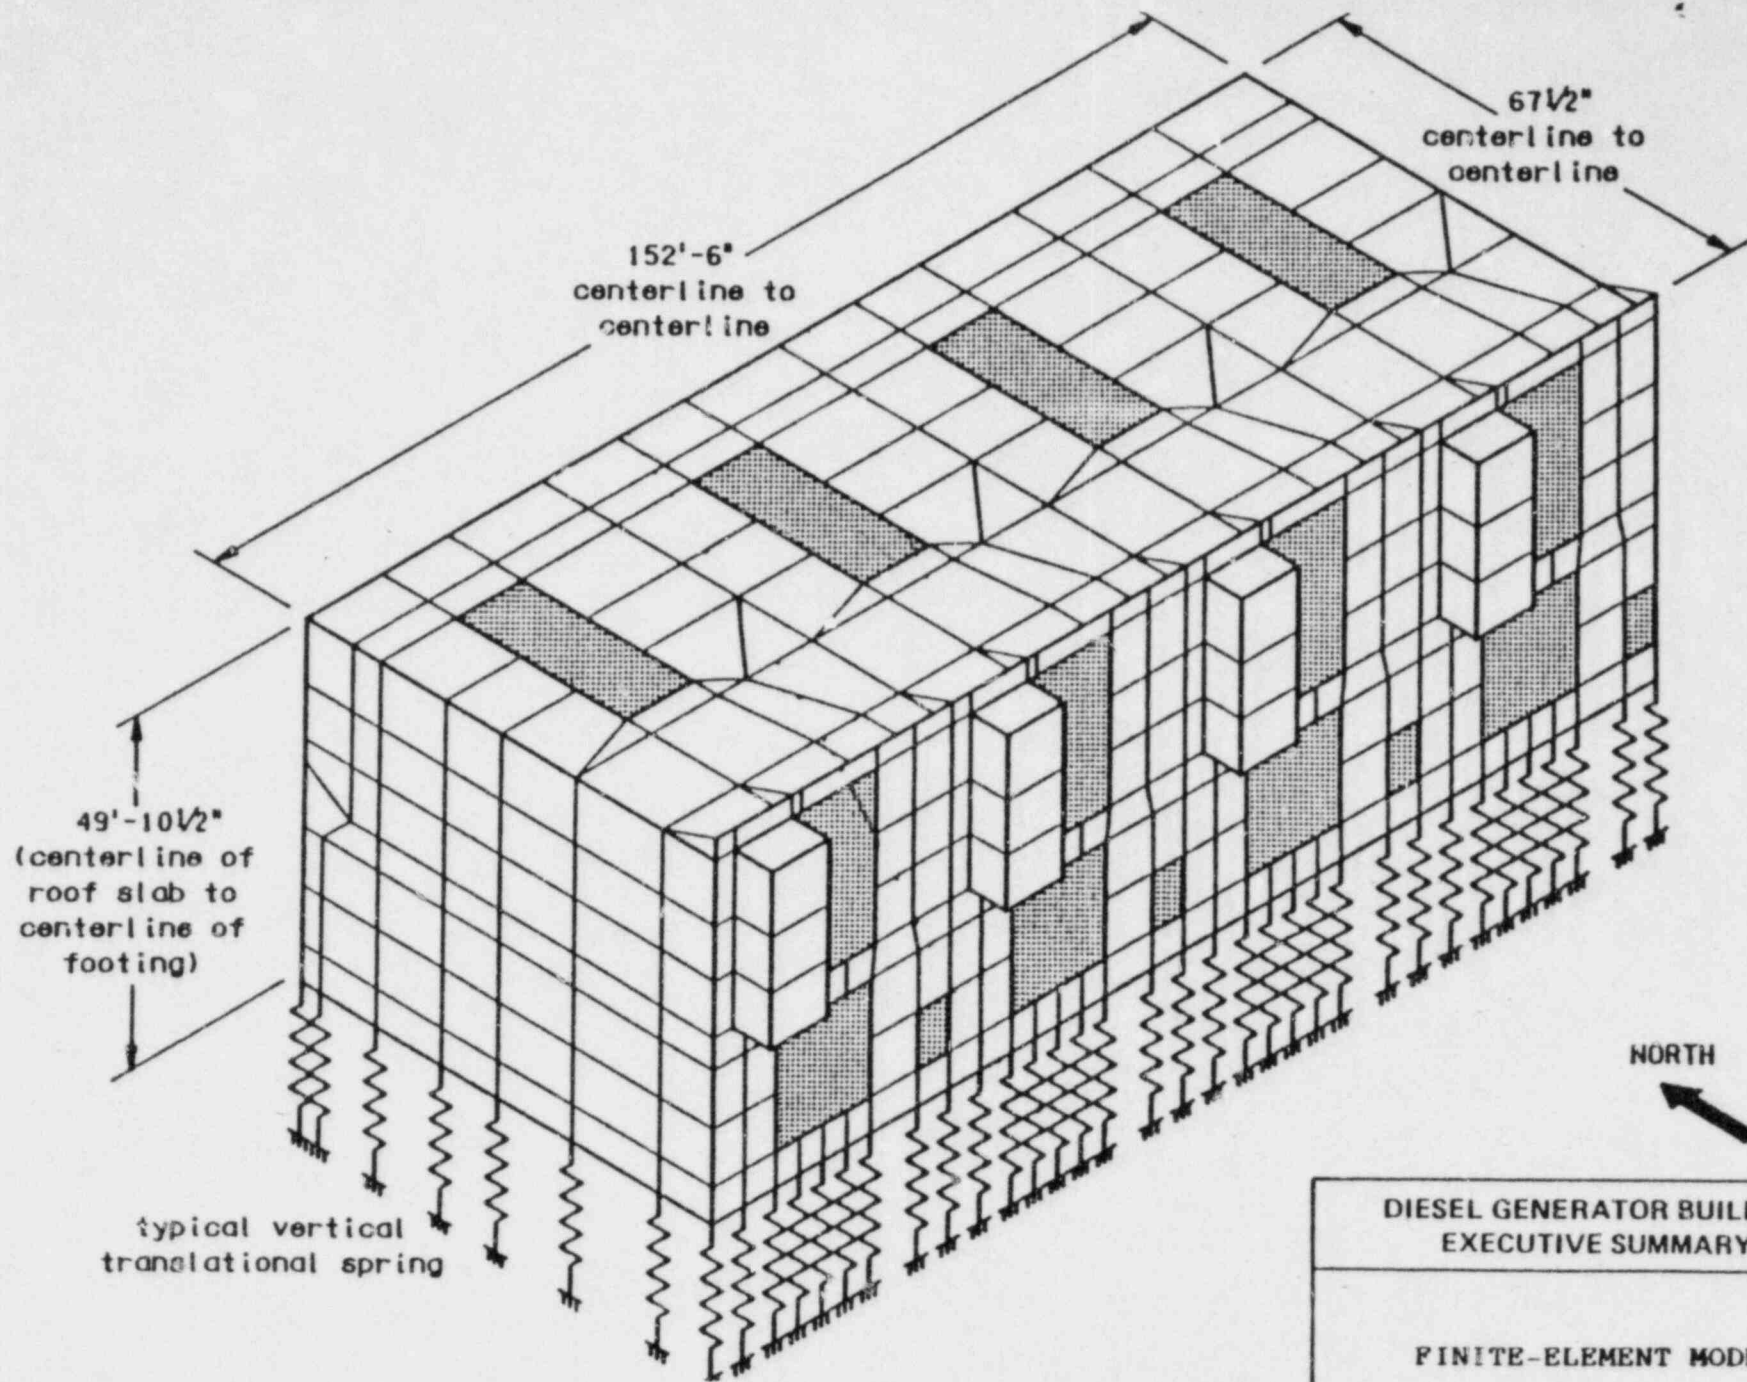
FIGURE 4

shown in Figure 2. With the exception of Case 1A which was analyzed by long hand computation and by idealizing the partially completed DGB as a series of individual beams, the other three cases were analyzed by computer through the discretion of the DGB into a number of finite elements as exemplified in Figure 4. Case 1A was accomplished by passing deflection curve through any three measured neighboring settlement points and selecting the one with the largest curvature for moment computation, and eventually, stress determination. This calculation indicated that the measured displacements would result in a maximum rebar stress of 11 ksi. For the other three settlement cases, individual finite-element models were used. For settlement Case 1B, the finite-element model represents the structure as built to el. 662 f 0 in.

For settlement Cases 2A and 2B, the finite-element model represents a fully completed structure. For Cases 1B, 2A, and 2B, springs were typically calculated at each nodal point along the foundation by dividing the structural load represented at the selected point by the measured or predicted settlement at that point. The finite-element analysis of each case then involved several iterations in which the soil springs were varied until the deflected shape of the DGB, as calculated by the model, approximated the "best fit" settlements. The resulting deflections of the DGB from these analyses as shown in Figures 5 and 6 are not in conformance with the measured values and are almost linearly related. The magnitude of stresses would depend on the final cycle of iteration selected and would bear no relationship to the actual stresses resulting from settlement. Other analyses performed by the Applicant consisted of (1) using zero and near zero soil springs to

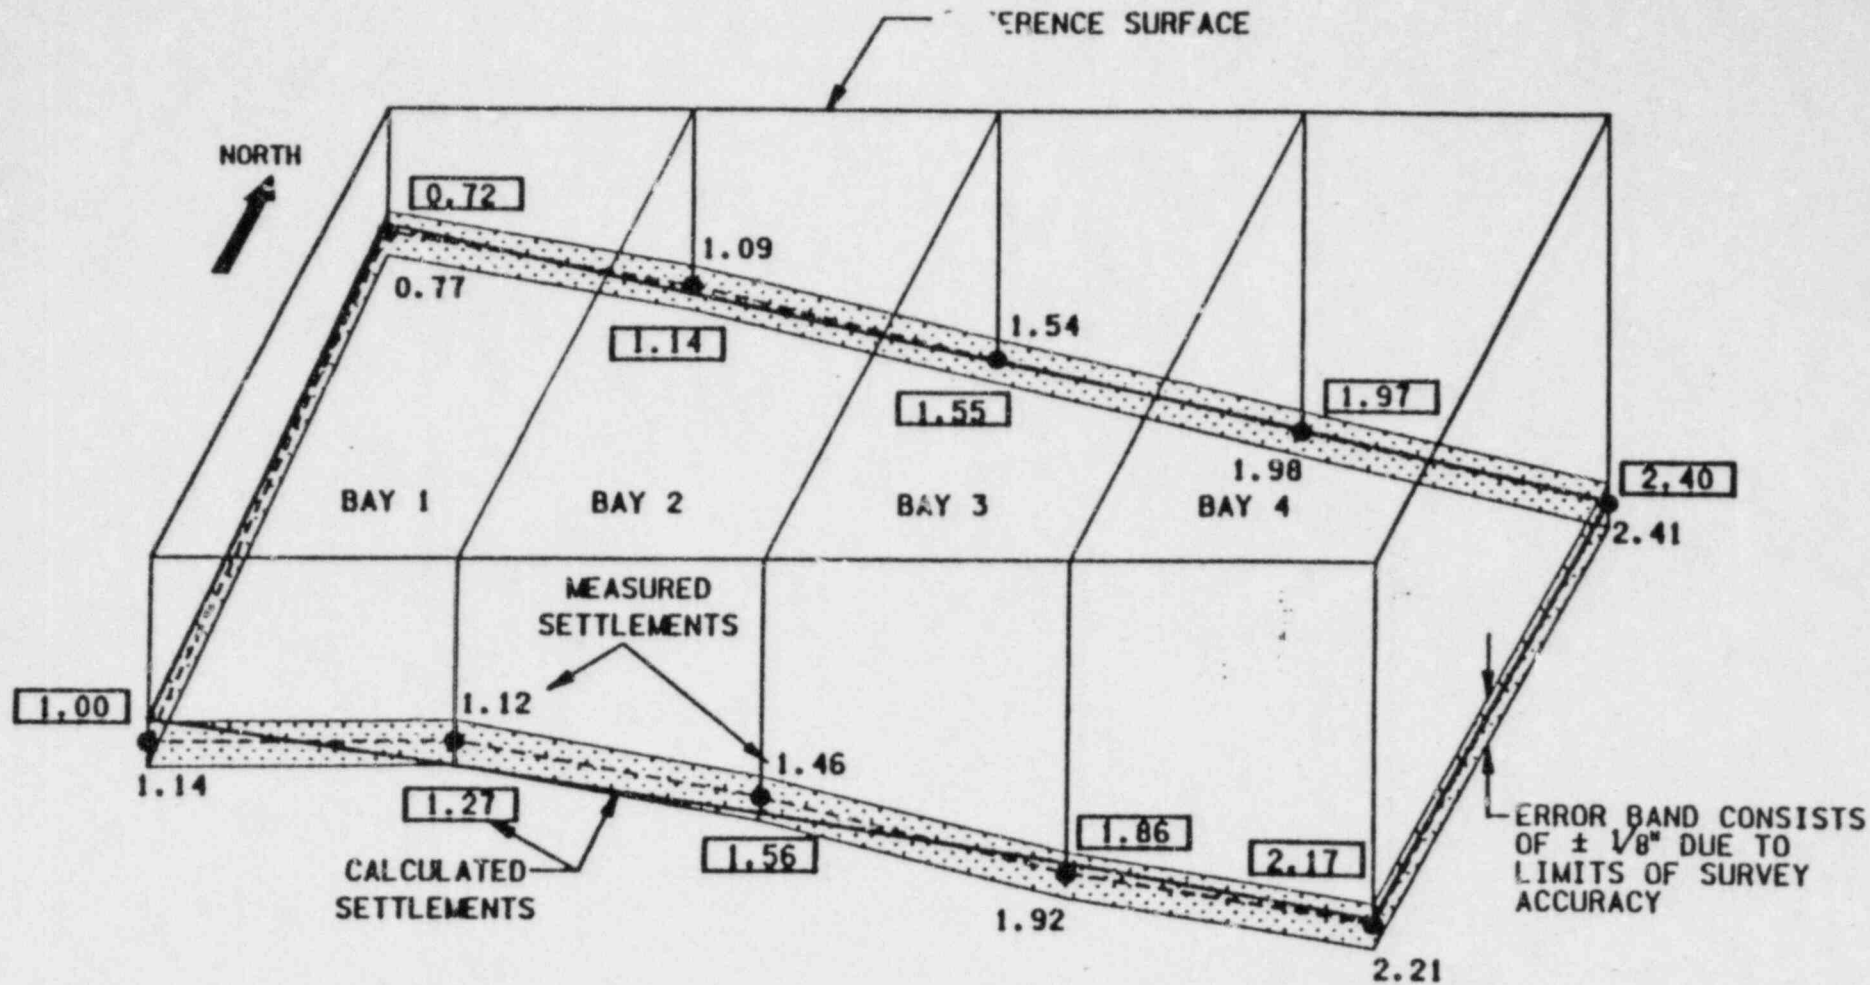
FIGURE 5

<p>DIESEL GENERATOR BUILDING EXECUTIVE SUMMARY</p>
<p>COMPARISON OF SETTLEMENT VALUES PRE-SURCHARGE PERIOD AUGUST 1978 - JANUARY 1979</p>
<p>FIGURE ES-15</p>

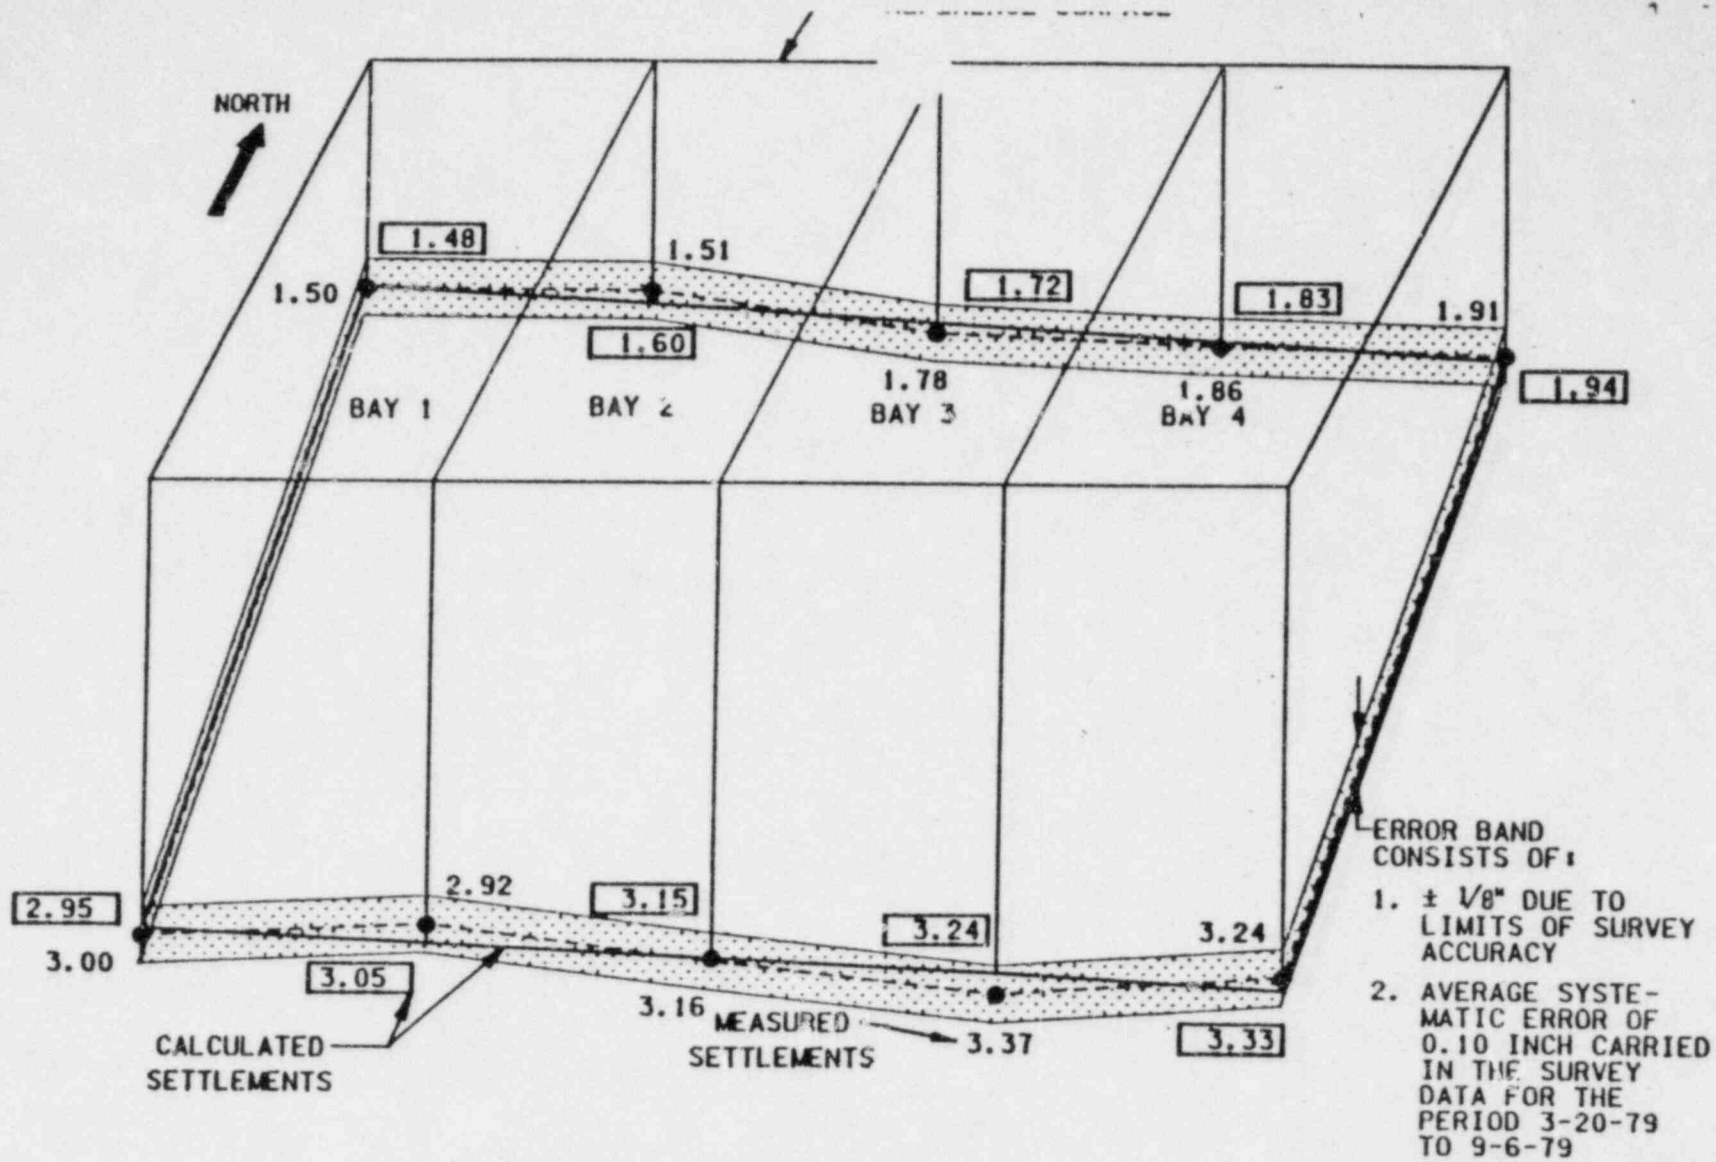
FIGURE 6

DIESEL GENERATOR BUILDING EXECUTIVE SUMMARY
COMPARISON OF SETTLEMENT VALUES SURCHARGE PERIOD JANUARY 1979 - AUGUST 1979
FIGURE ES-16

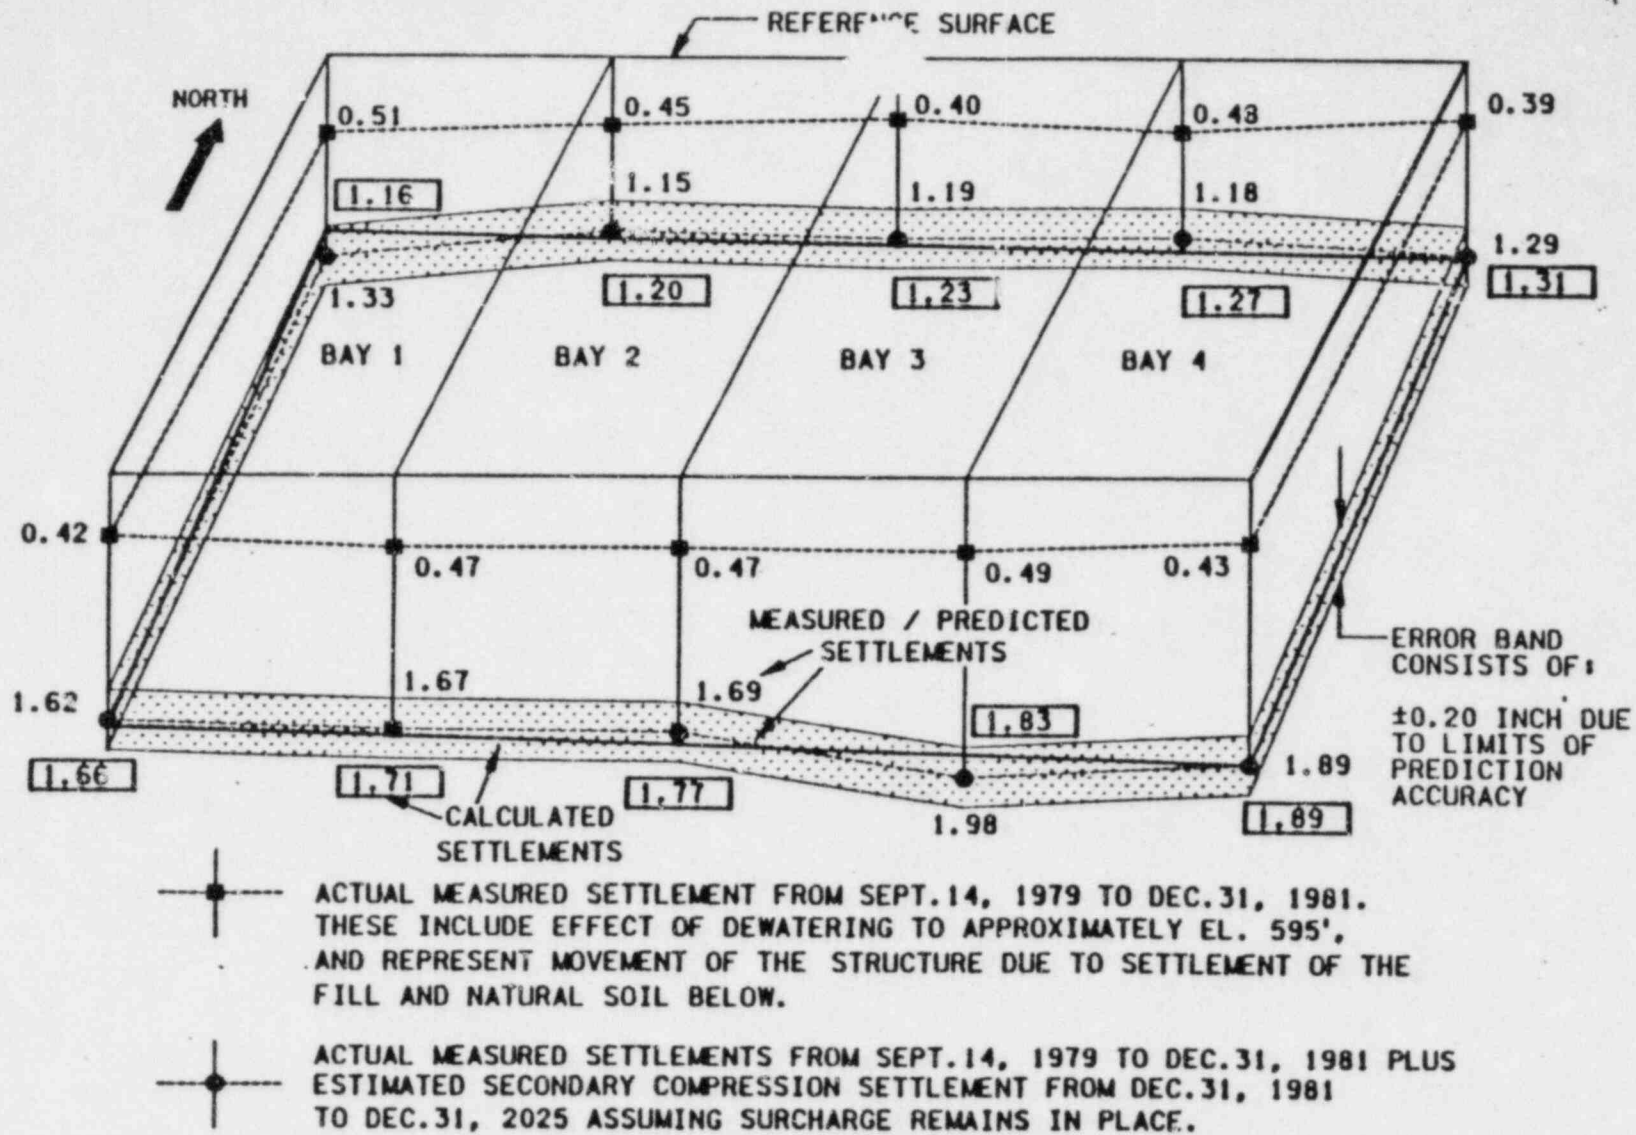
FIGURE 7

DIESEL GENERATOR BUILDING EXECUTIVE SUMMARY
COMPARISON OF SETTLEMENT VALUES POST-SURCHARGE PERIOD SEPTEMBER 1979 - DECEMBER 2025
FIGURE ES-17

Tables 5 and 6 when addressing the settlements on Figs 4 and 43 in causing high stresses and moments should recognize the settlements are predicted to the year 2025. The major portion of these settlements have yet to occur, therefore, a check for cracking due to these settlements can not be made at this time.
